# NILSEN REAL ESTATE APPRAISALS

November 25, 2024

**Re: Vacant Retail Property  
4325 Broadway  
Eureka, CA 95503**

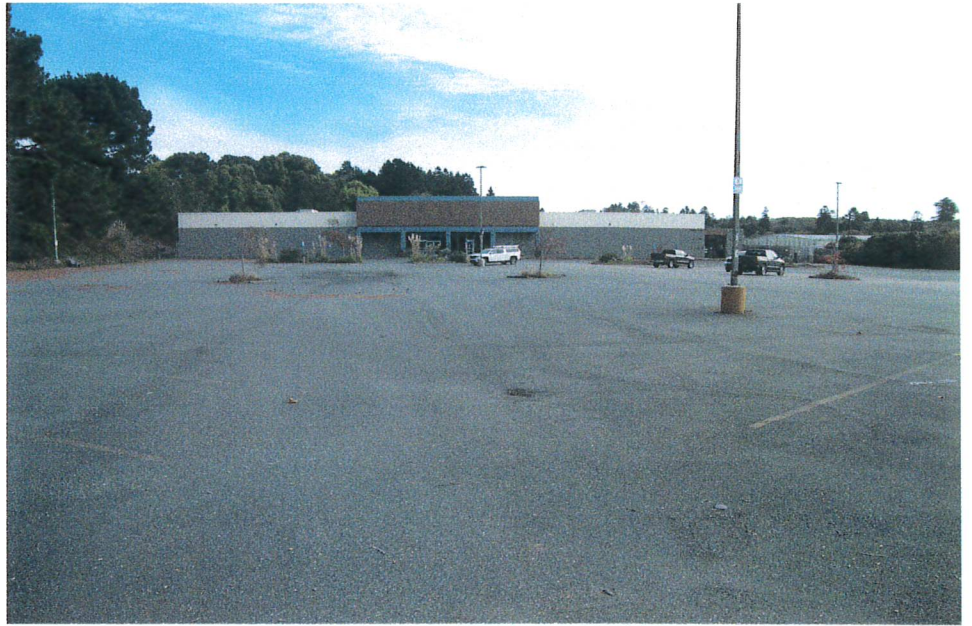
Farther to the north from previous picture along north side of paved off-street parking area. One of the drainage collection inlets is straight ahead. Notice multiple light standards throughout parking lot.

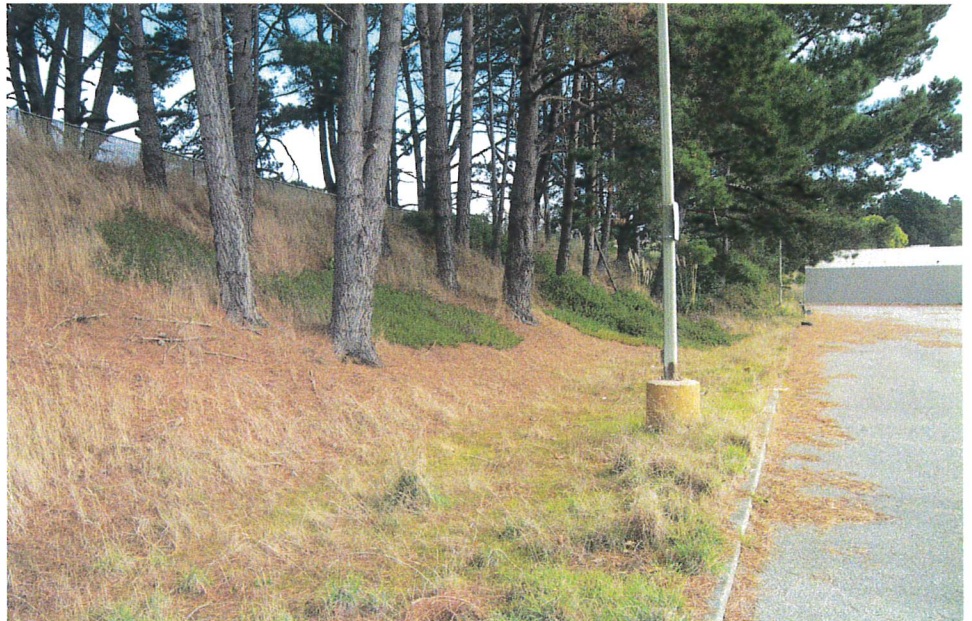
Looking easterly along northern portion of subject property. Notice upward topography with amount of pine trees straight ahead. The north boundary line is on a higher plateau and the location of cyclone fence.

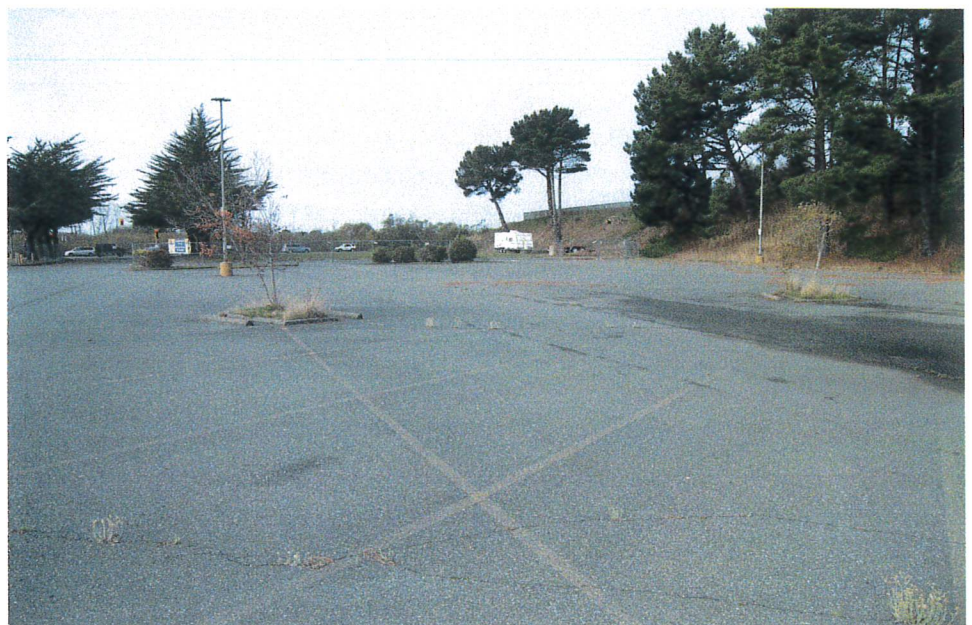
Looking northwest along northern portion of parking lot. Notice overall condition.

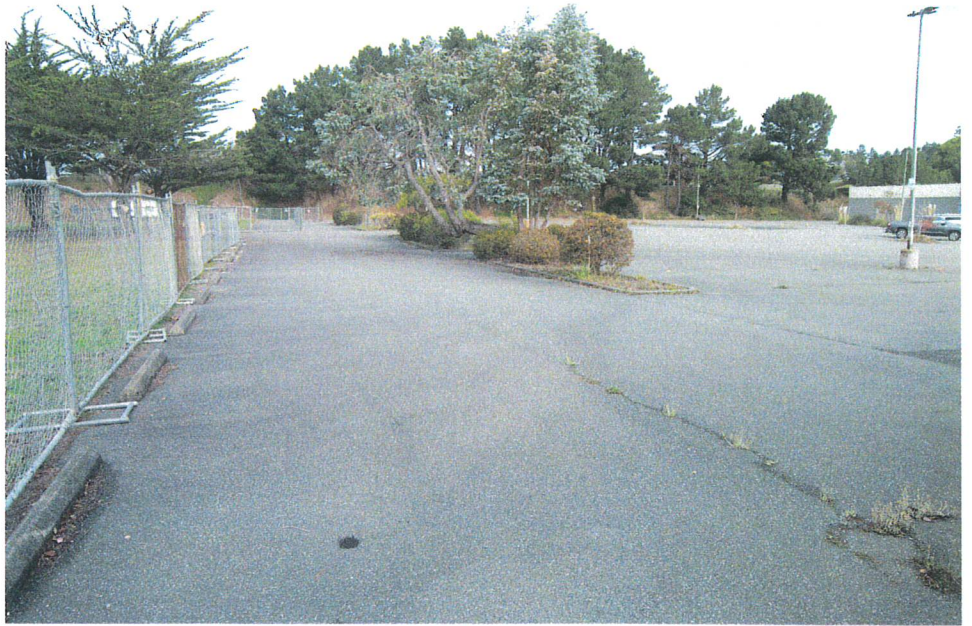
Looking north near southwest corner of overall property. One of the two out parcels is immediately to the left. Notice condition of landscaped islands farther to right.

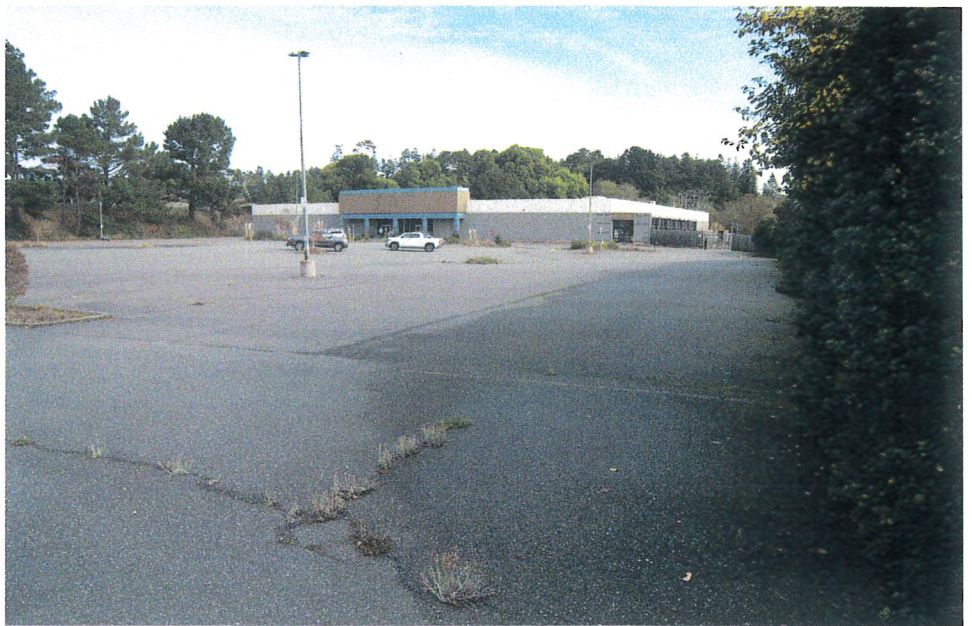
Looking easterly from previous picture with south side of paved driveway and parking lot straight ahead and to the left. Overgrown landscaping is to the right. The south boundary line is approximately 10' farther to right.

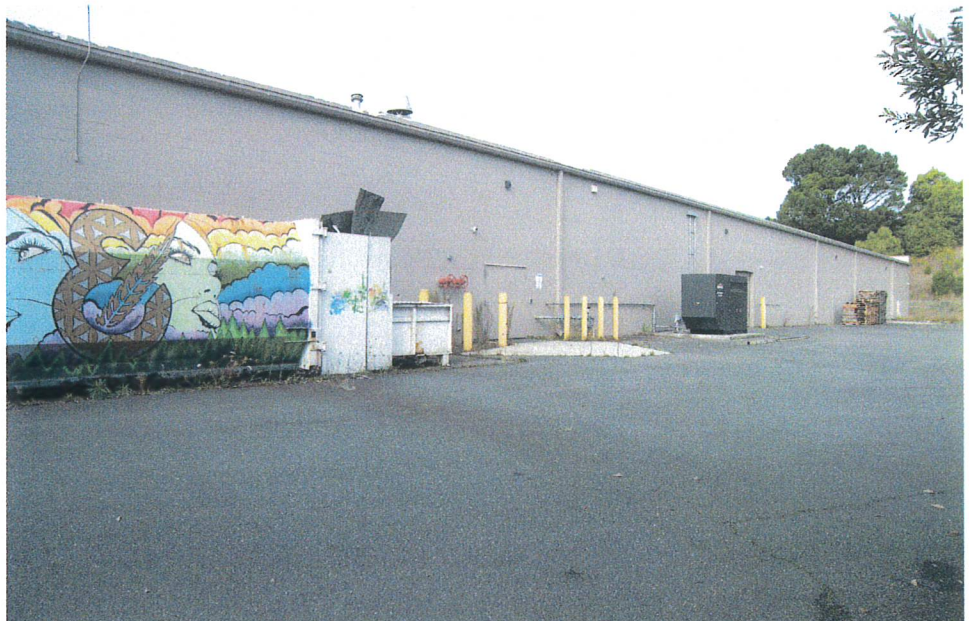
Looking northwest along east side of building. Straight ahead and to the right is a back-up generator for this building.

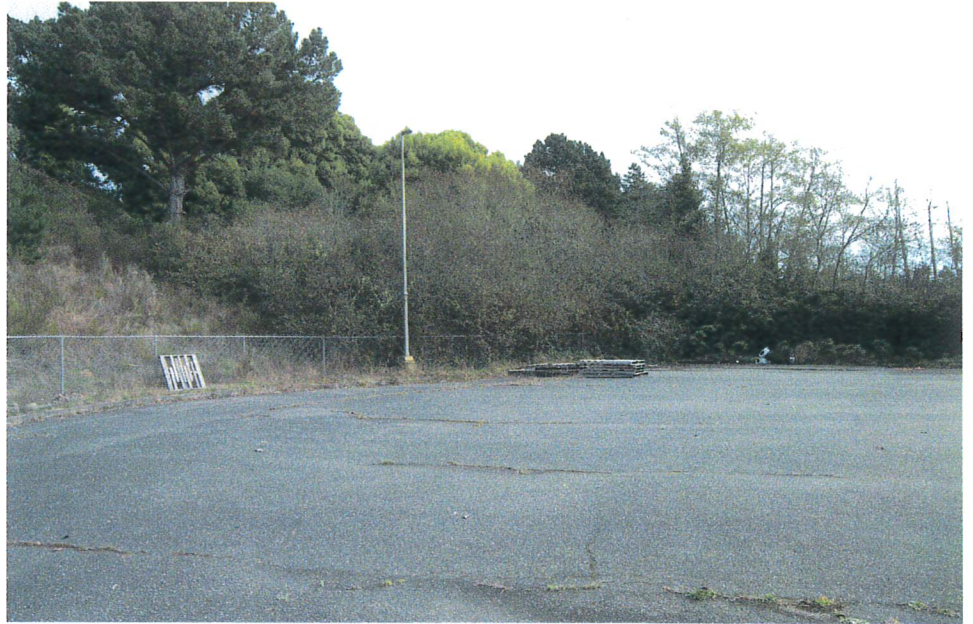
Looking easterly near north side of building. The north boundary line extends along left side of photo. The area considered unusable due to wetland and open drainage areas is straight ahead and to the right.

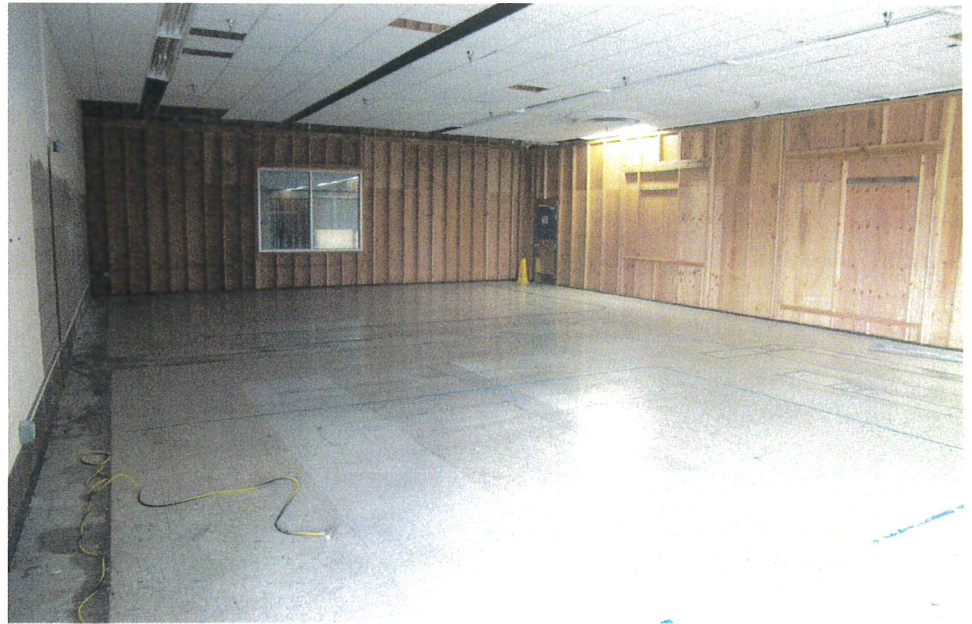
Looking northerly from previous picture along two other newer constructed walls straight ahead and to the right. The west exterior wall extends to the left. Notice condition of floors and ceiling.

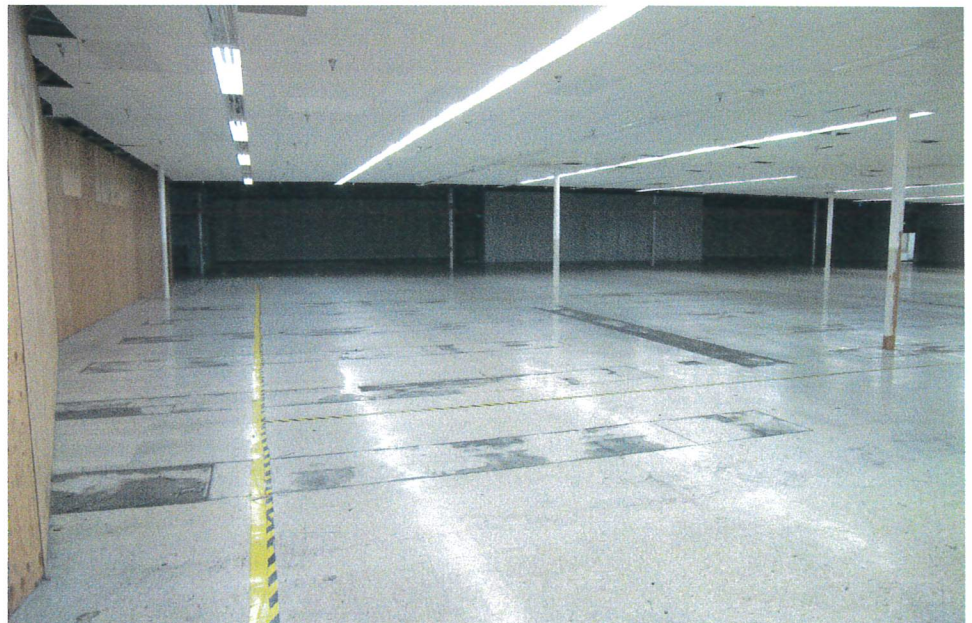
Looking northerly over former open retail sales area. Much of the flooring has not changed for many years.

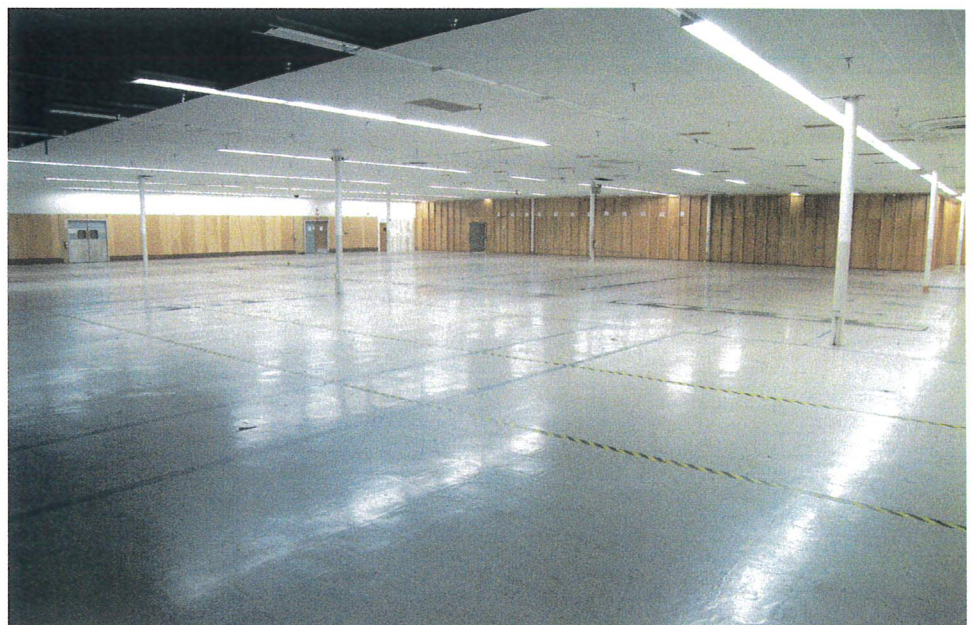
Looking southeast over former retail sales area. Notice removal of drop acoustical ceiling tiles and lighting within this specific area. This extends farther to the left.

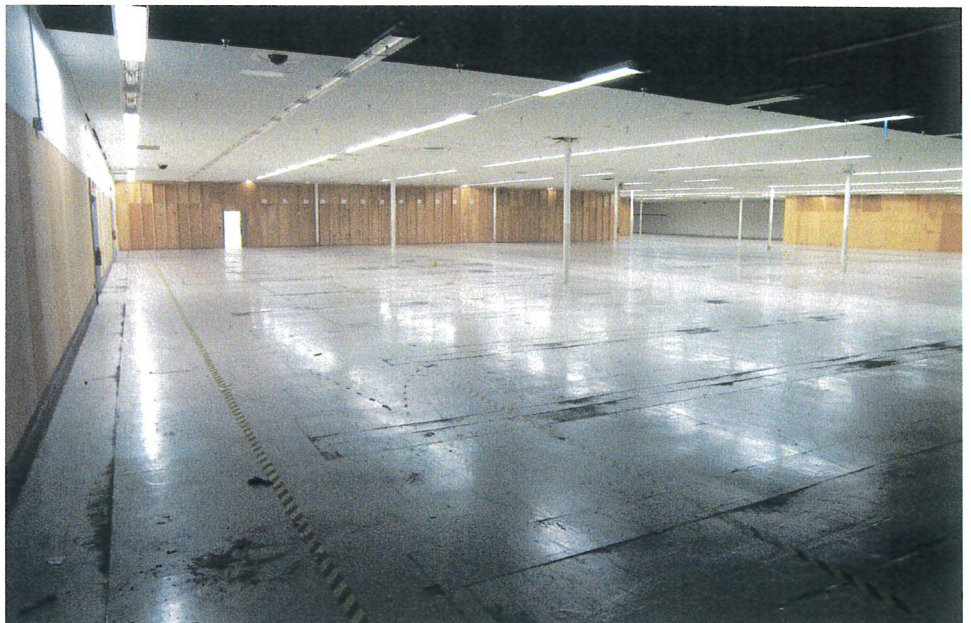
Looking southerly along rear or eastern portion of former retail sales area. Once again, notice the transition from removal of ceiling and lights with original straight ahead.

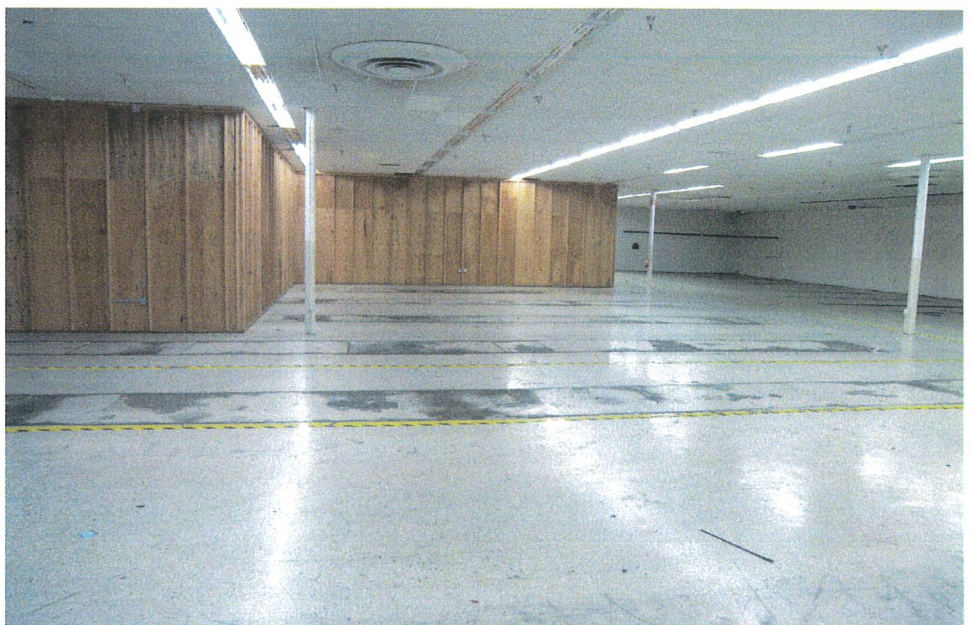
Looking southerly near middle of open retail sales area. Two additional wood frame demising walls were installed by the prior owner.

The previous owner, up until six± weeks ago, constructed interior walls of various size, “specialty rooms” and two separate refrigerator/cooler rooms. The overall condition of all these various items is considered average to below average±. This does include the exterior walls and parking. Client to be aware of the above information and satisfy themselves accordingly.

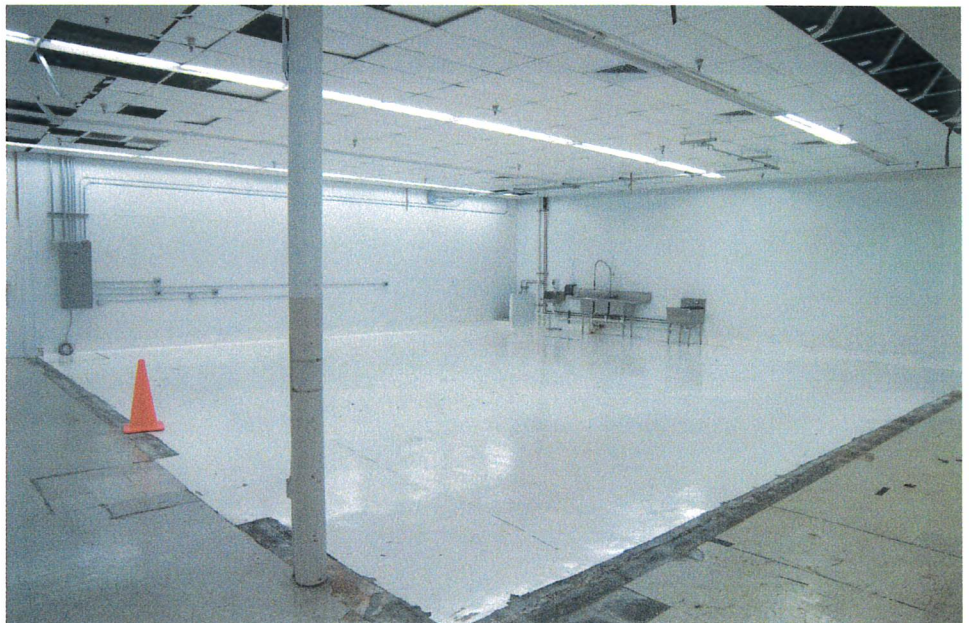
Looking southeast over what perhaps was former location of kitchen. These walls were removed, as well as other personal property items.
