# **We Are Up Project**

## **Initial Study & Proposed Mitigated Negative Declaration**

County of Humboldt  
PLN-2022-18047 CUP/SP  
APN 509-181-057

# Aquatic Resources Delineation and Sensitive Habitat Report\_Rev2 We Are Up Housing Project

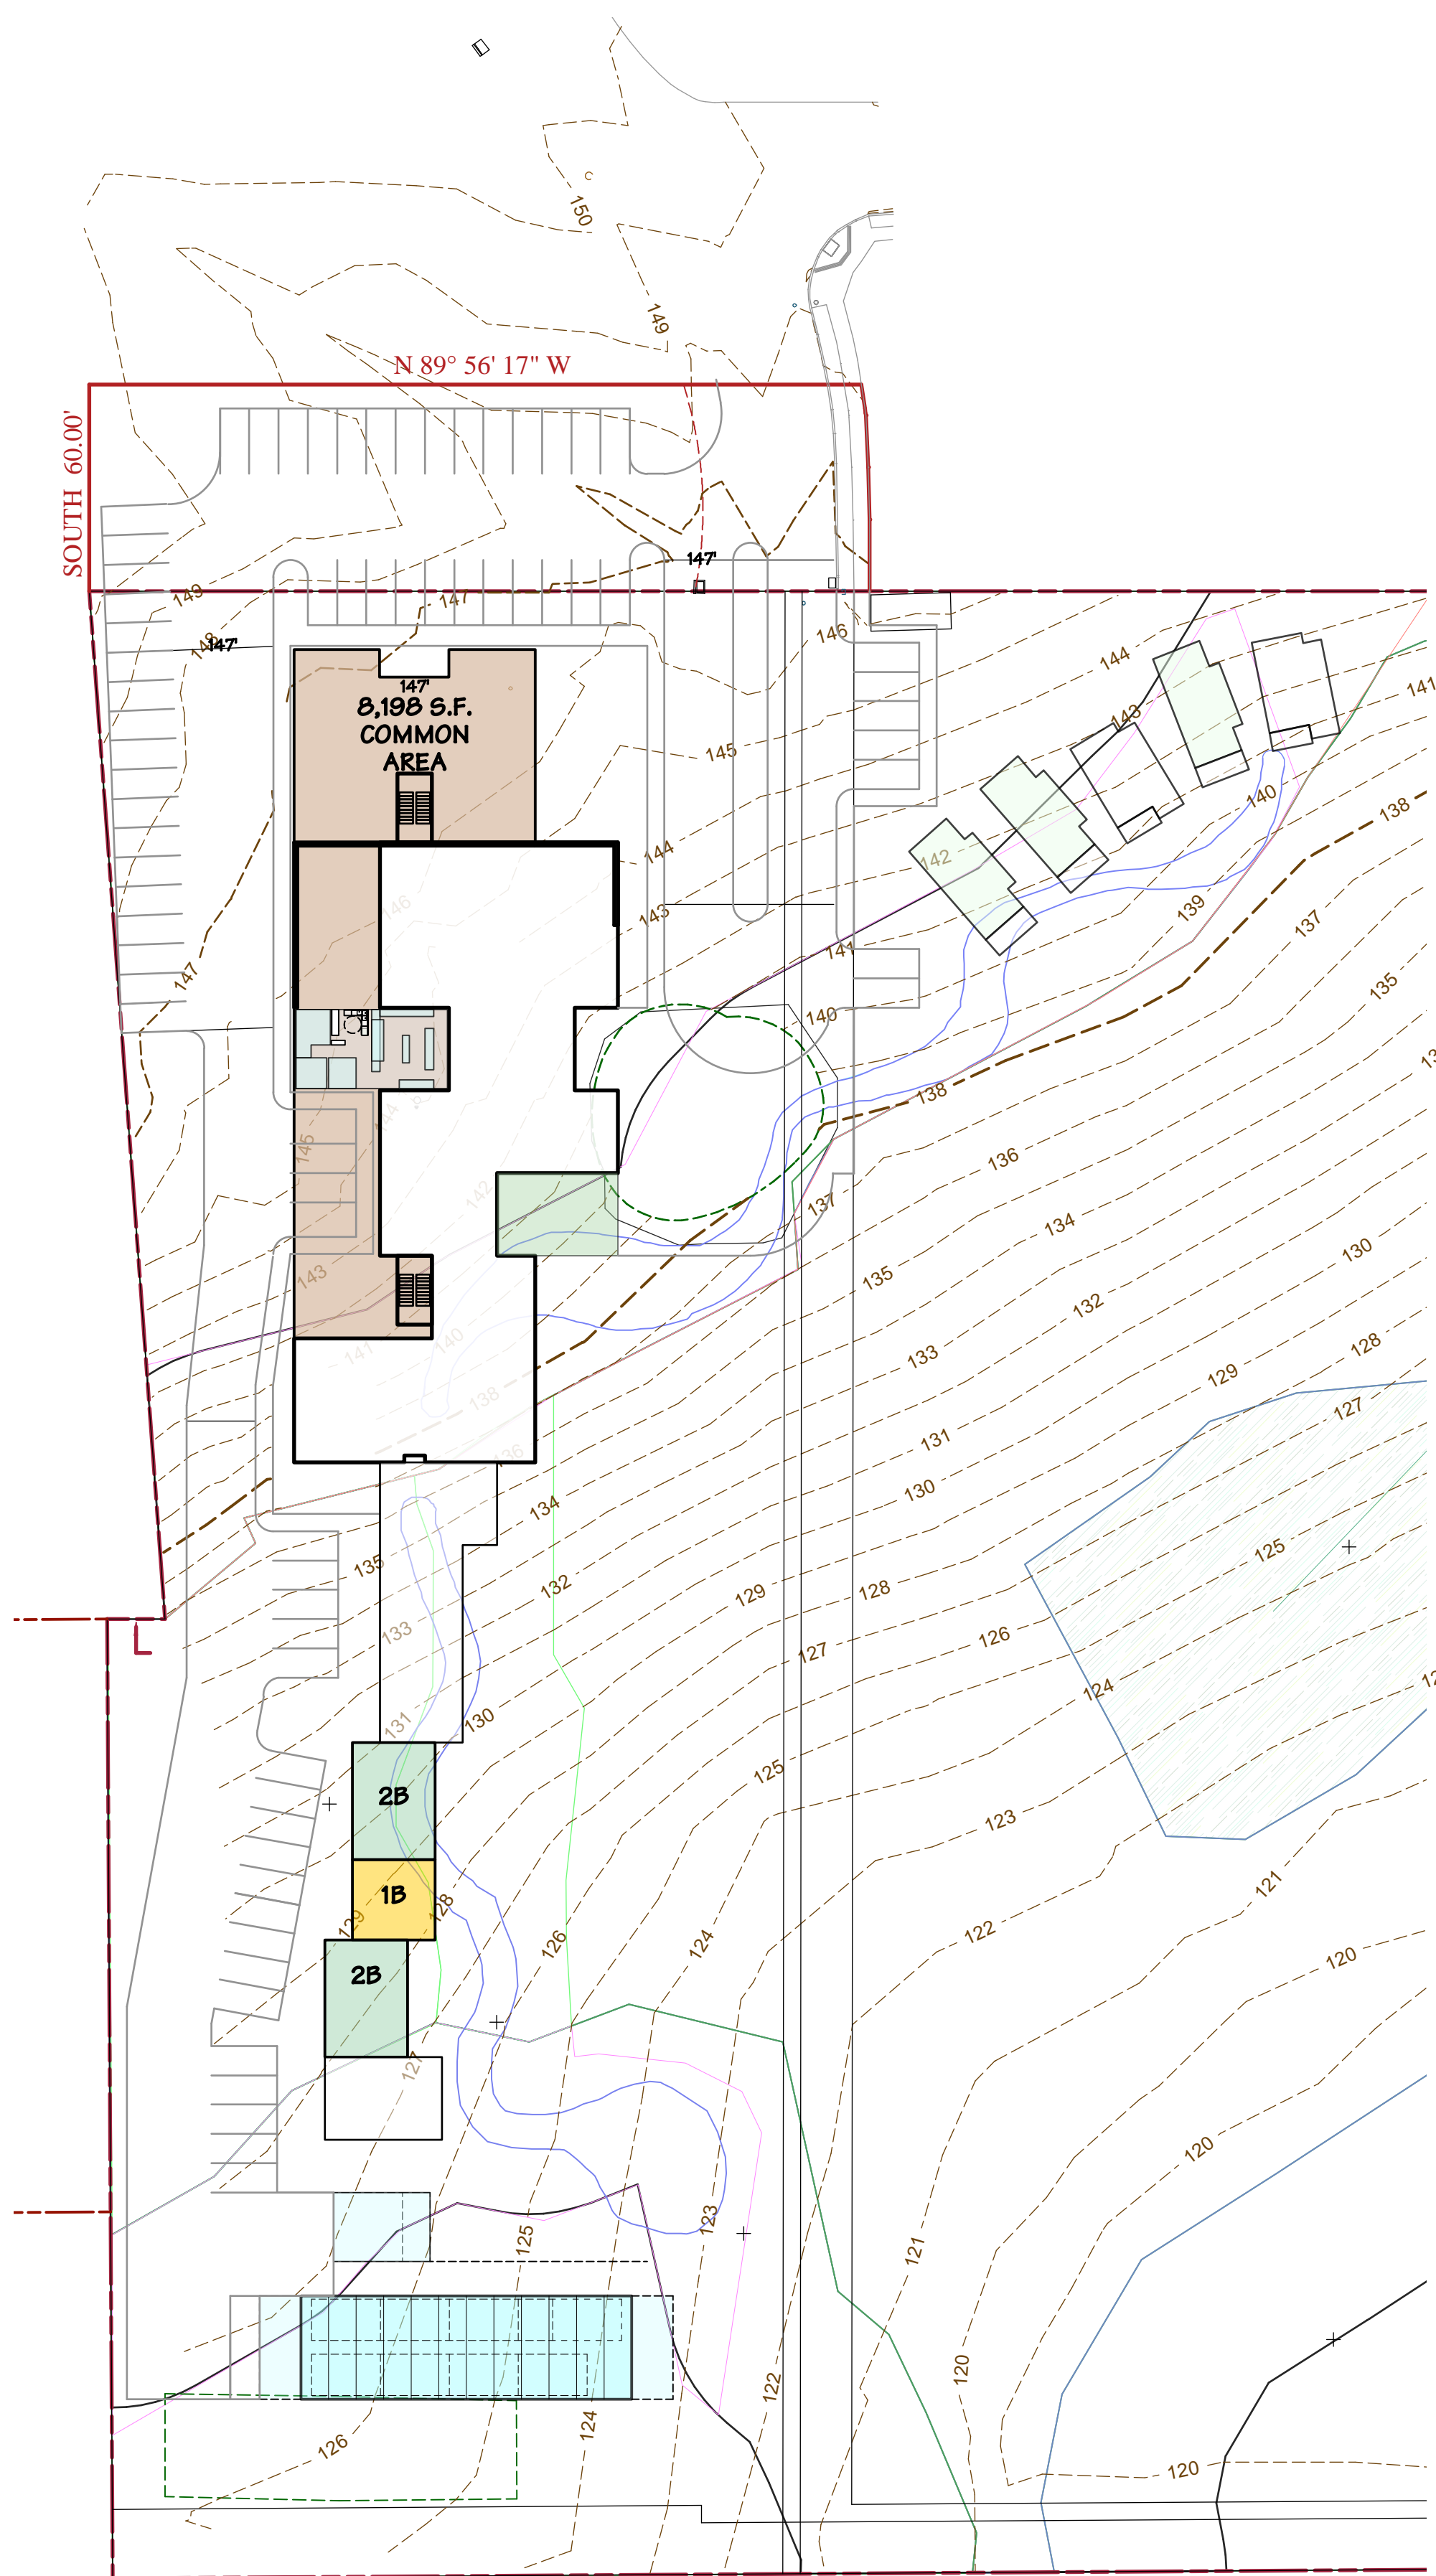
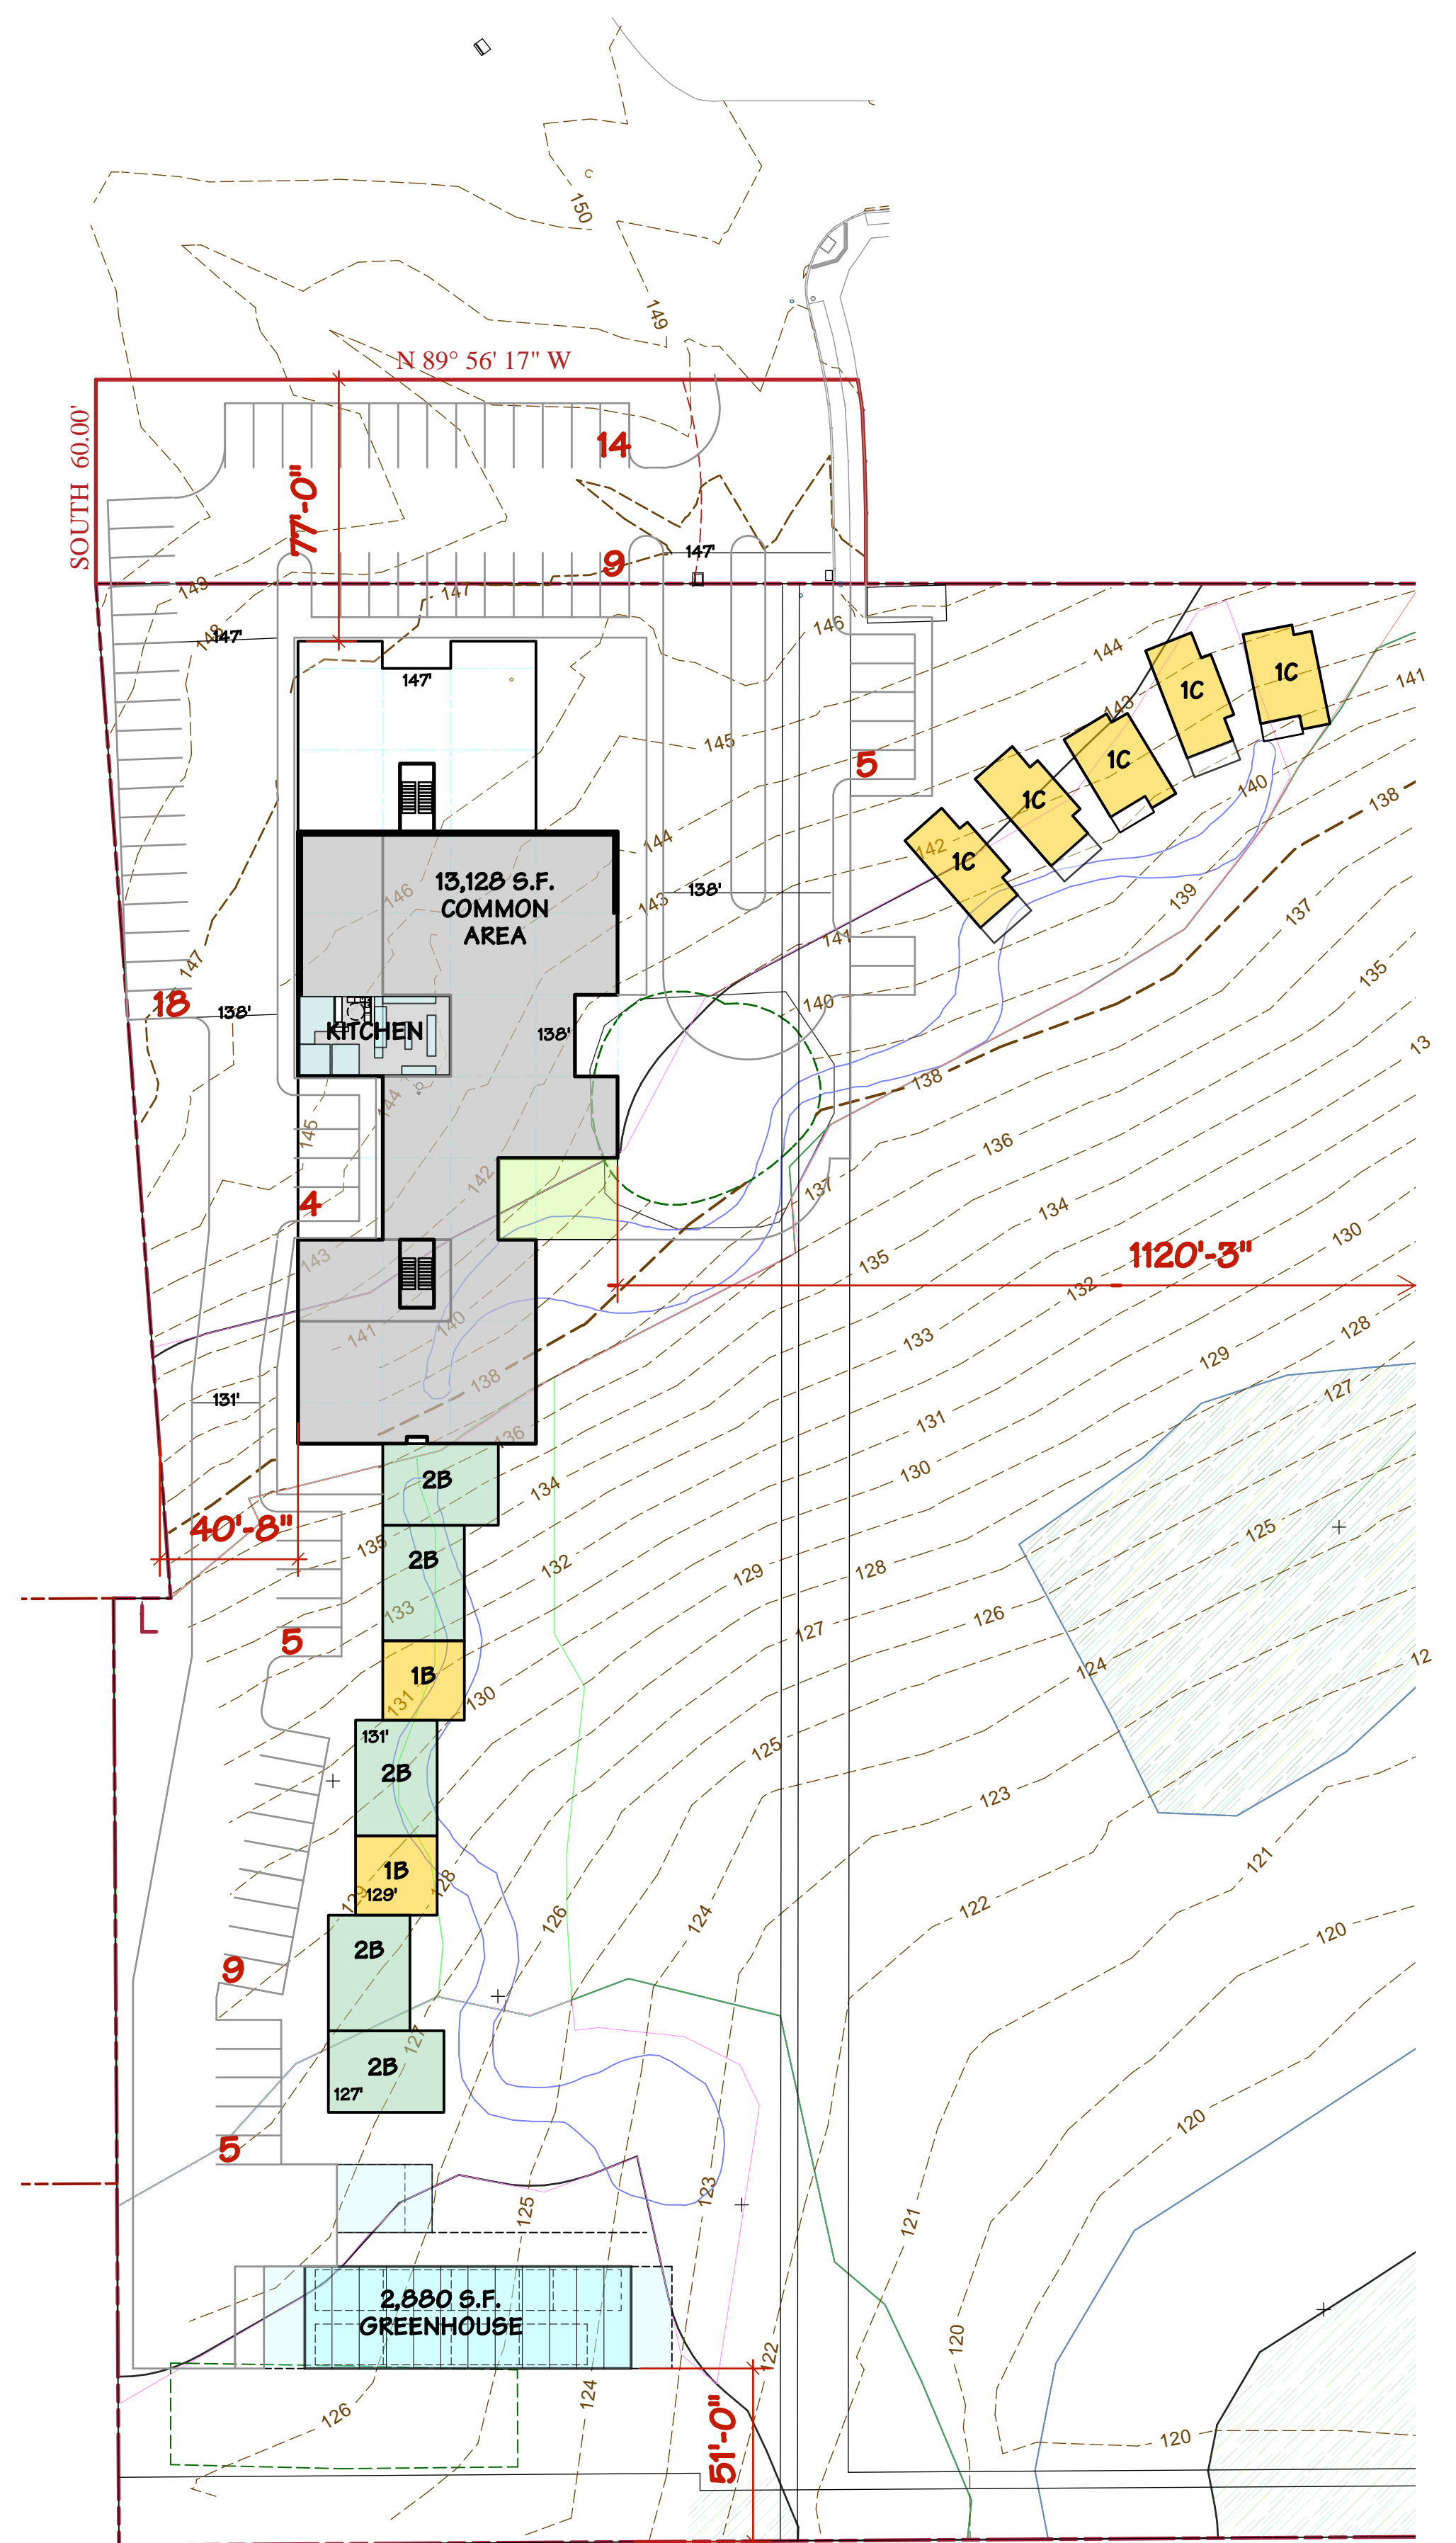
**FIGURE 3**

**MEZZANINE LEVEL**

**MAIN LEVEL**

**Main and Mezzanine Layout**

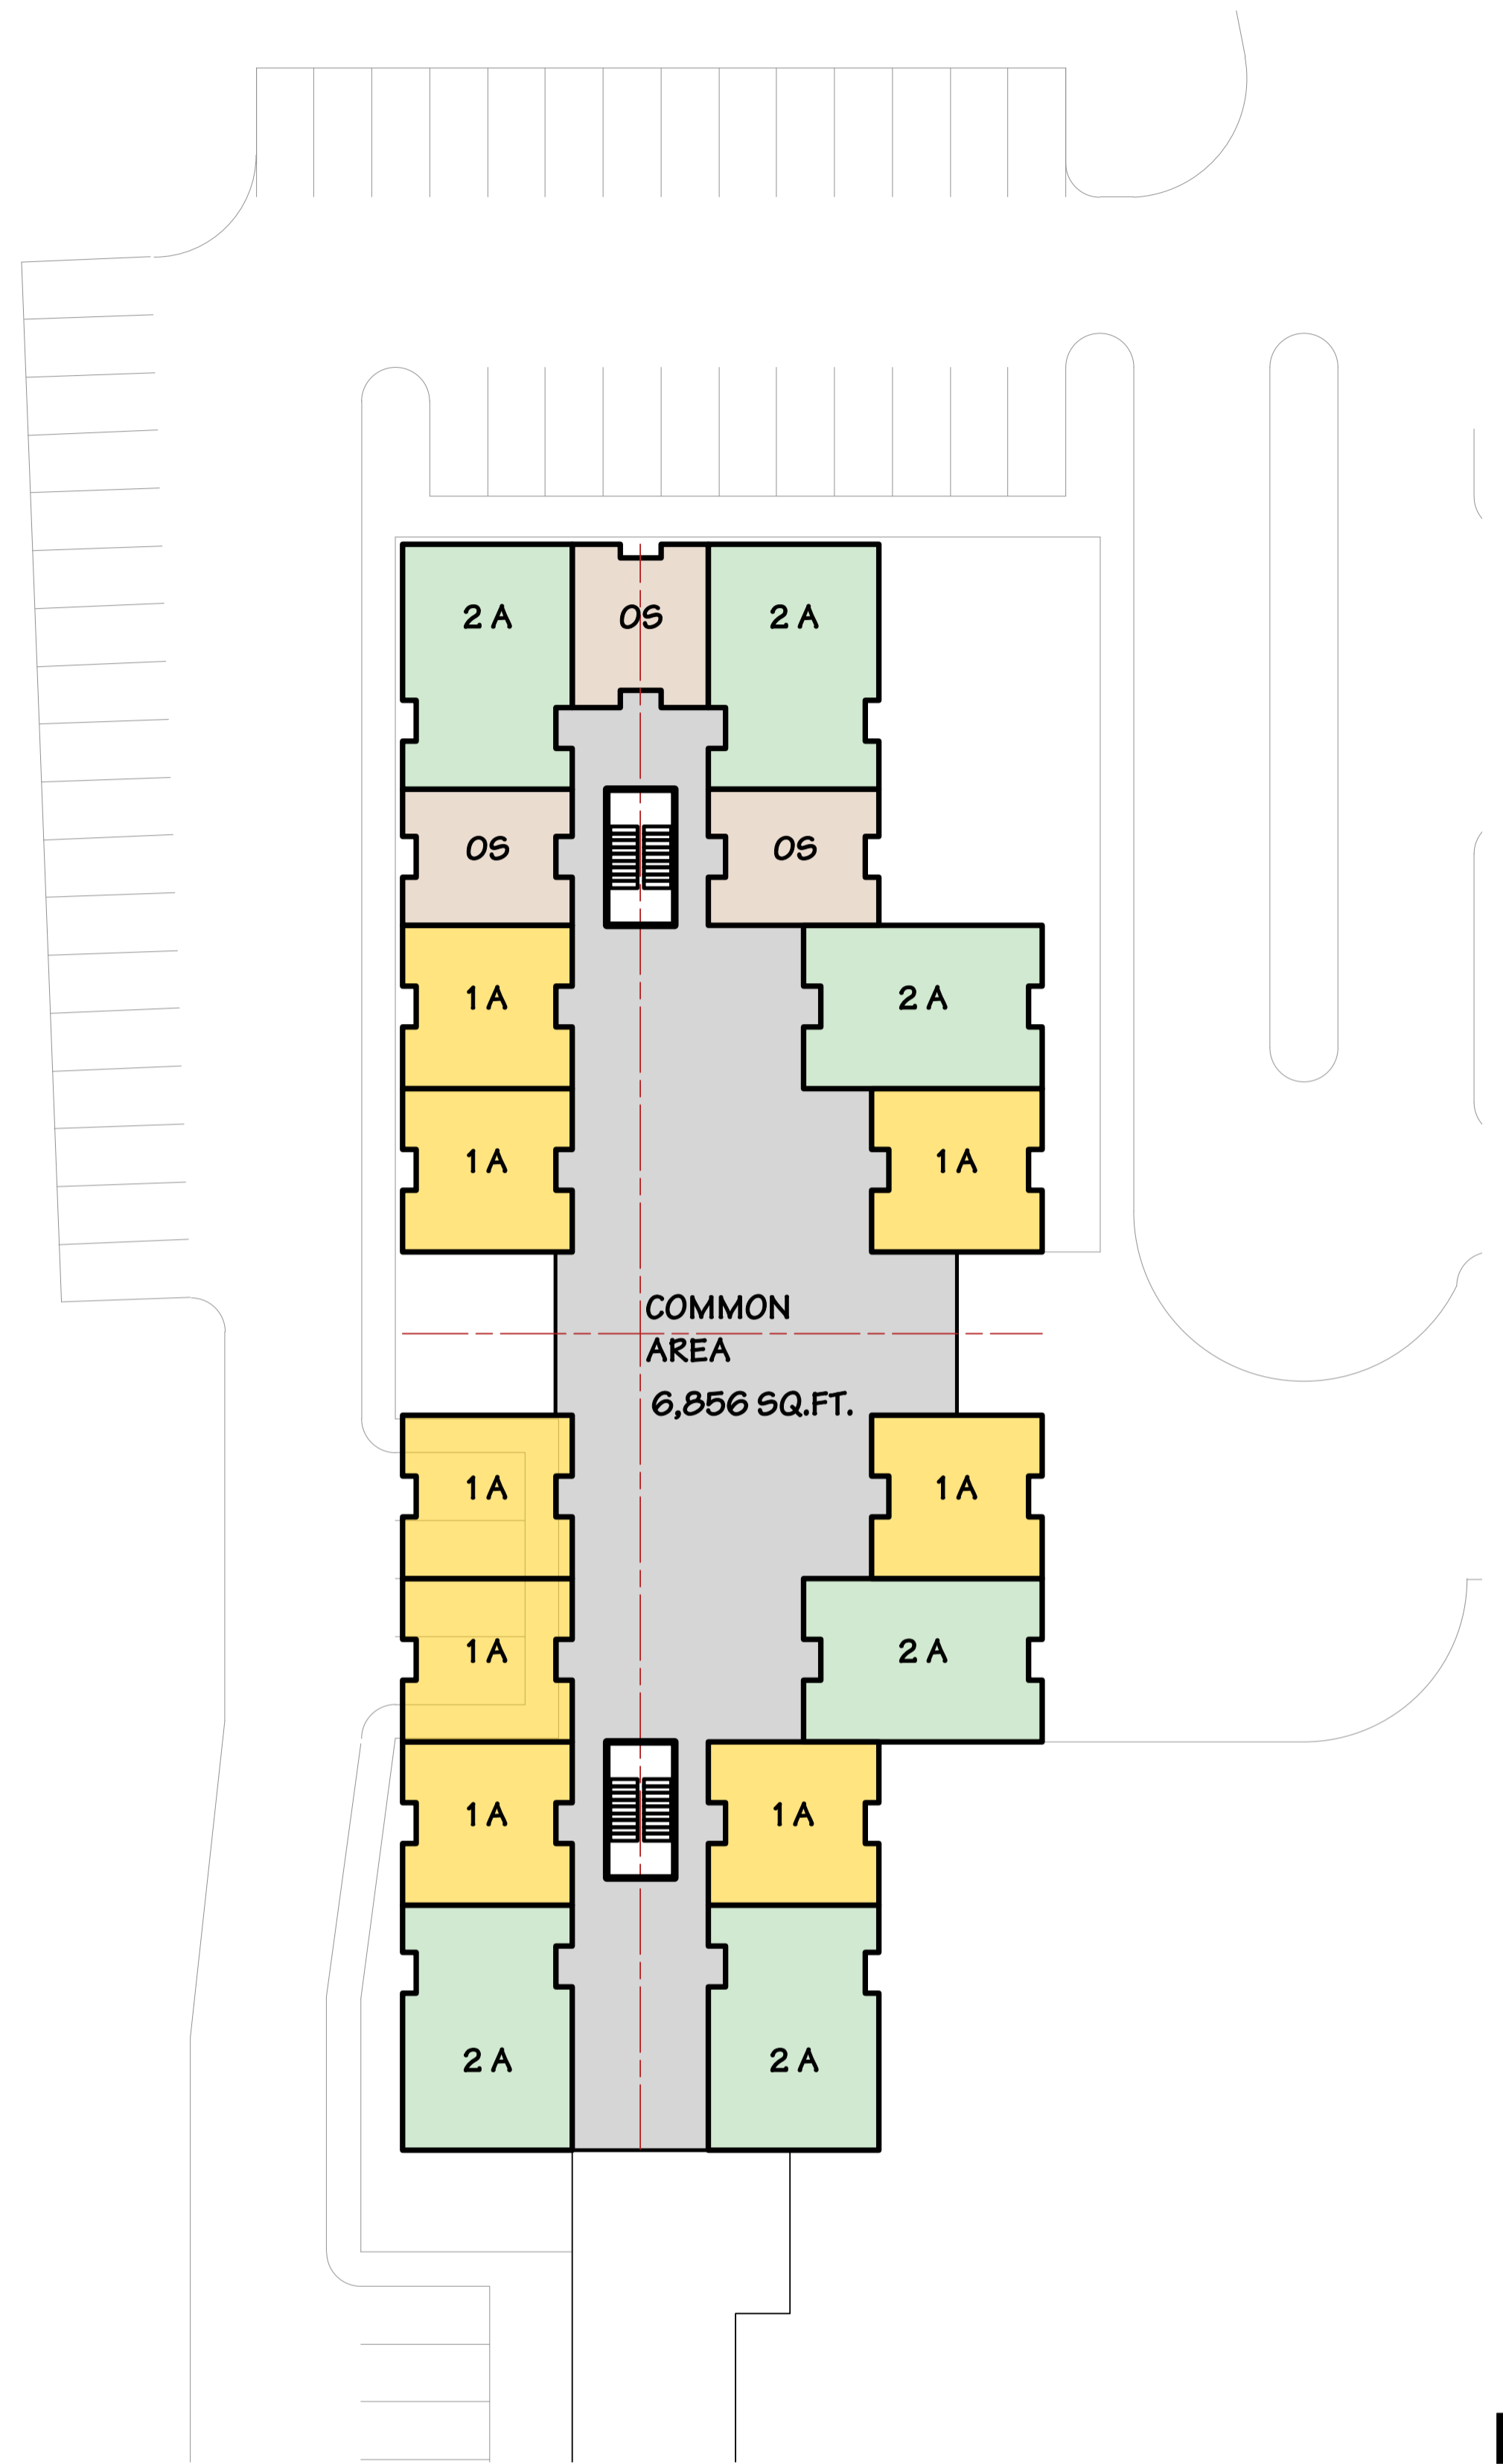
**FIGURE 4**

**TOP LEVEL**

**UPPER LEVEL**

**Upper and Top Layout**

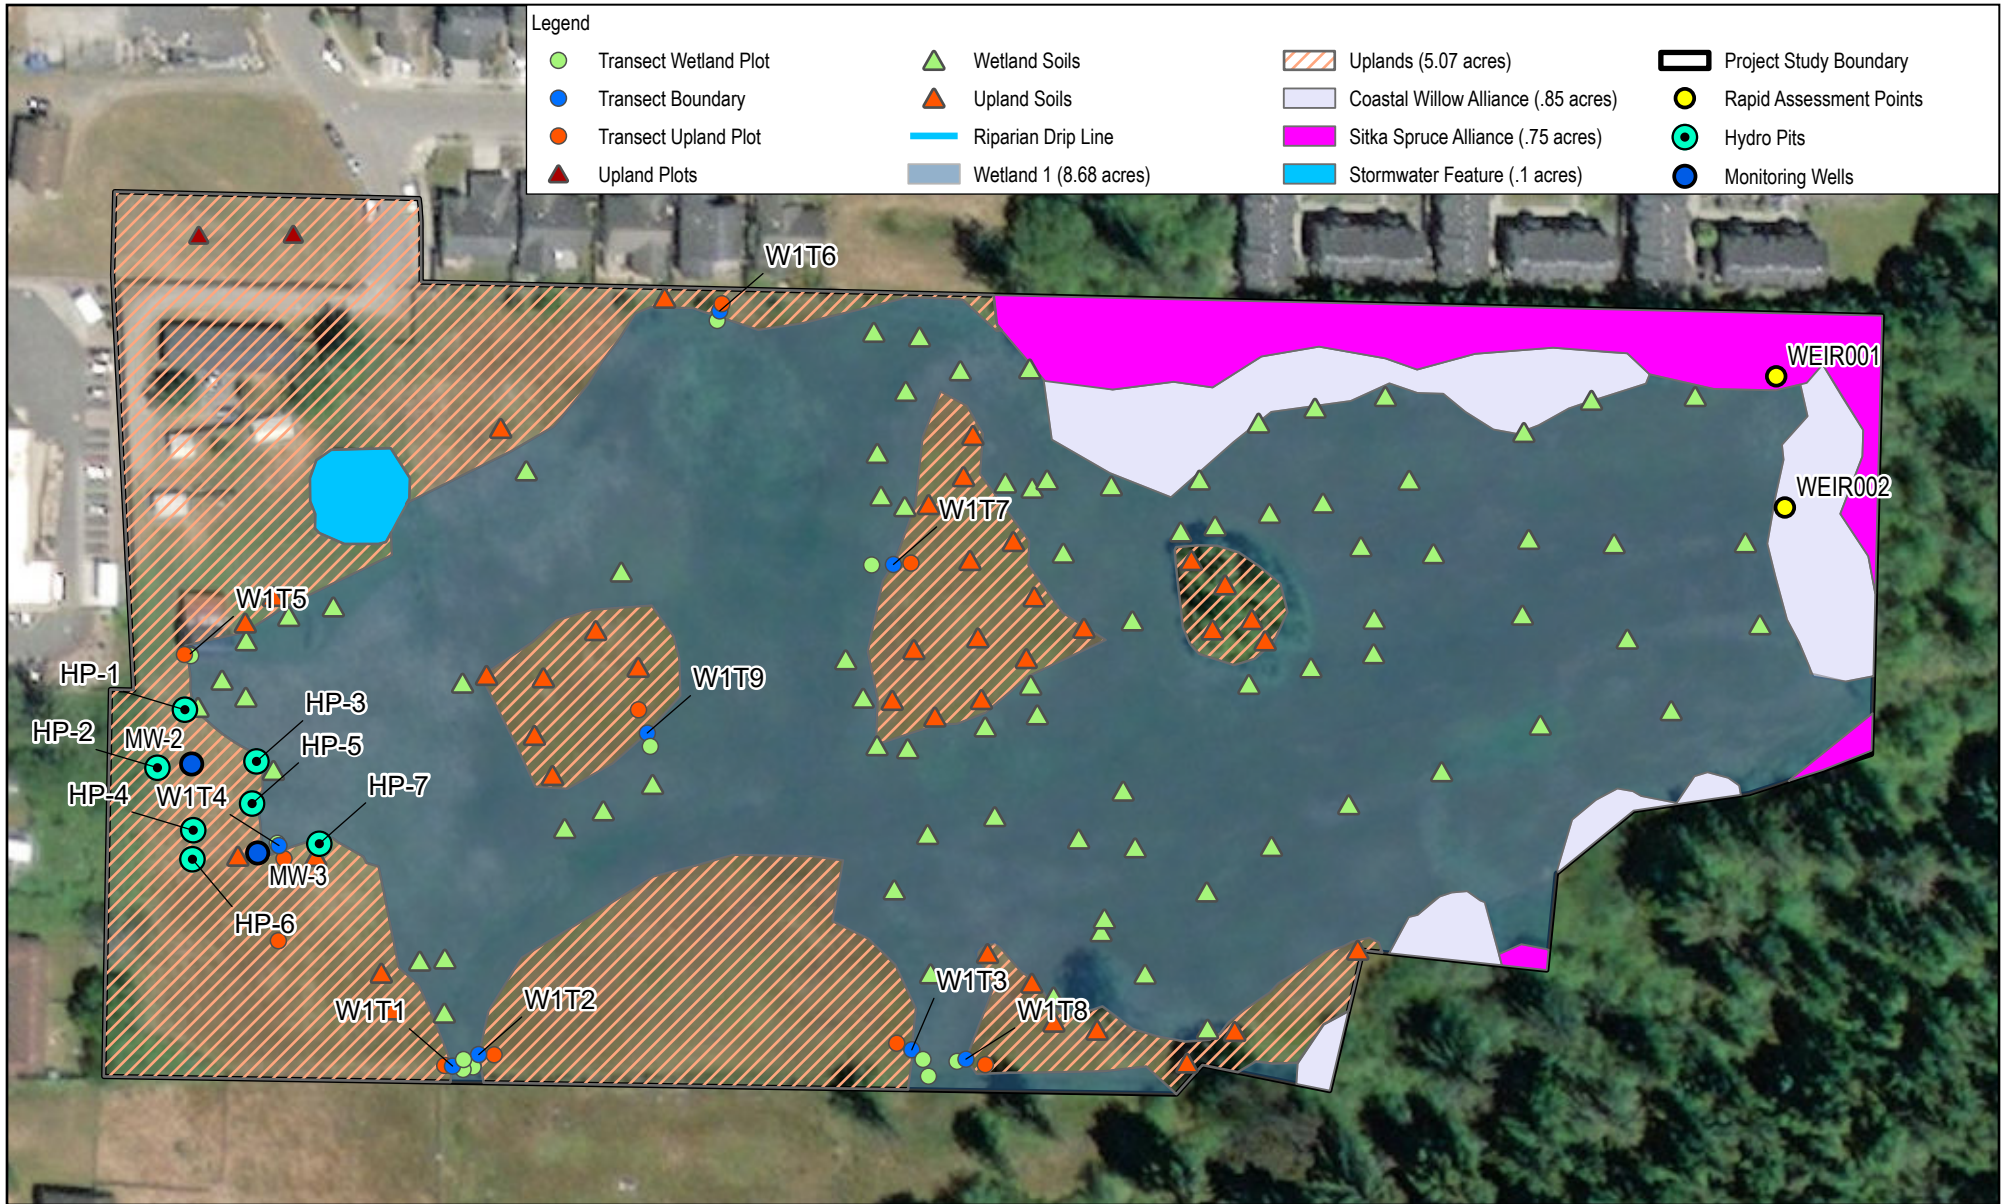
**FIGURE 3**

- Transect Wetland Plot
- ▲ Wetland Soils
- Uplands (5.07 acres)
- Project Study Boundary
- Transect Boundary
- ▲ Upland Soils
- Coastal Willow Alliance (.85 acres)
- Rapid Assessment Points
- Transect Upland Plot
- Riparian Drip Line
- Sitka Spruce Alliance (.75 acres)
- Hydro Pits
- ▲ Upland Plots
- Wetland 1 (8.68 acres)
- Stormwater Feature (.1 acres)
- Monitoring Wells

This report supports the Project's environmental documentation, permitting, and construction planning as deemed appropriate. The proposed PSB encompasses 15.4 acres (**Appendix A Figure 3**). This report is subject to, and must be read in conjunction with, the limitations set out in Section 6, Special Terms and Conditions, and the assumptions and qualifications contained throughout the report.

The Riparian Corridor of Mill Creek was mapped to the drip line, and no wetlands were assessed underneath the canopy. The Riparian Dripline can be found in **Appendix A, Figure 3**. Much of the two SNCs are present within the Mill Creek Riparian corridor.

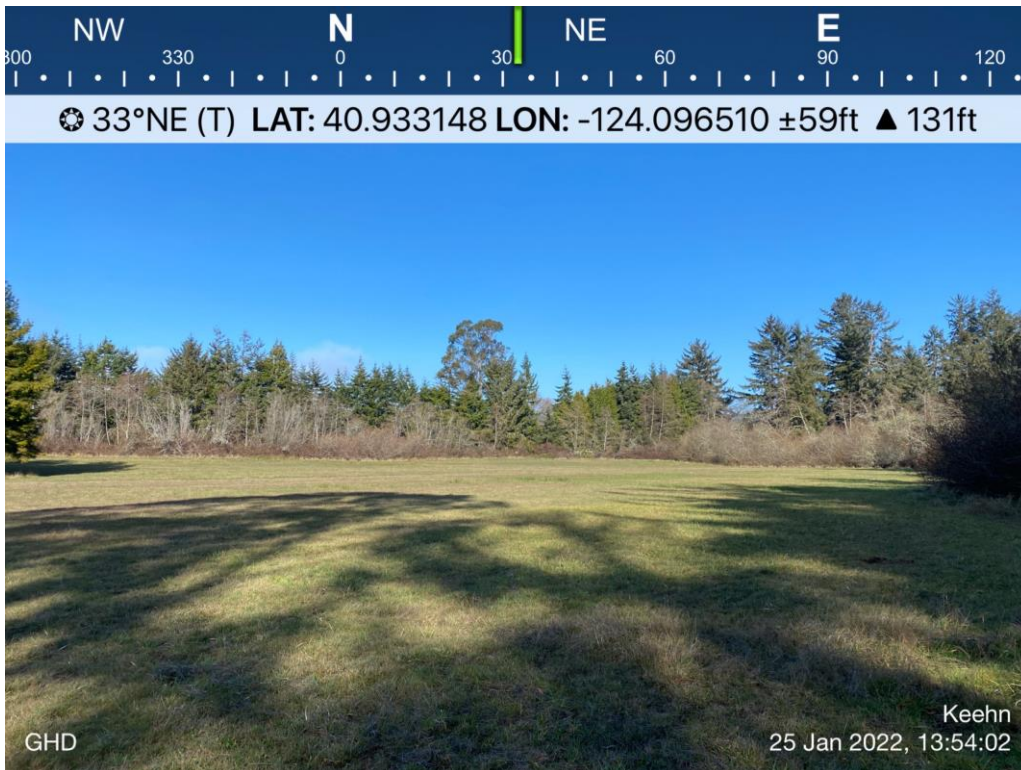
Photo 2. The northeastern edge of the PSB, showing the Coastal Willow Alliance backed by the Sitka Spruce Alliance behind it.

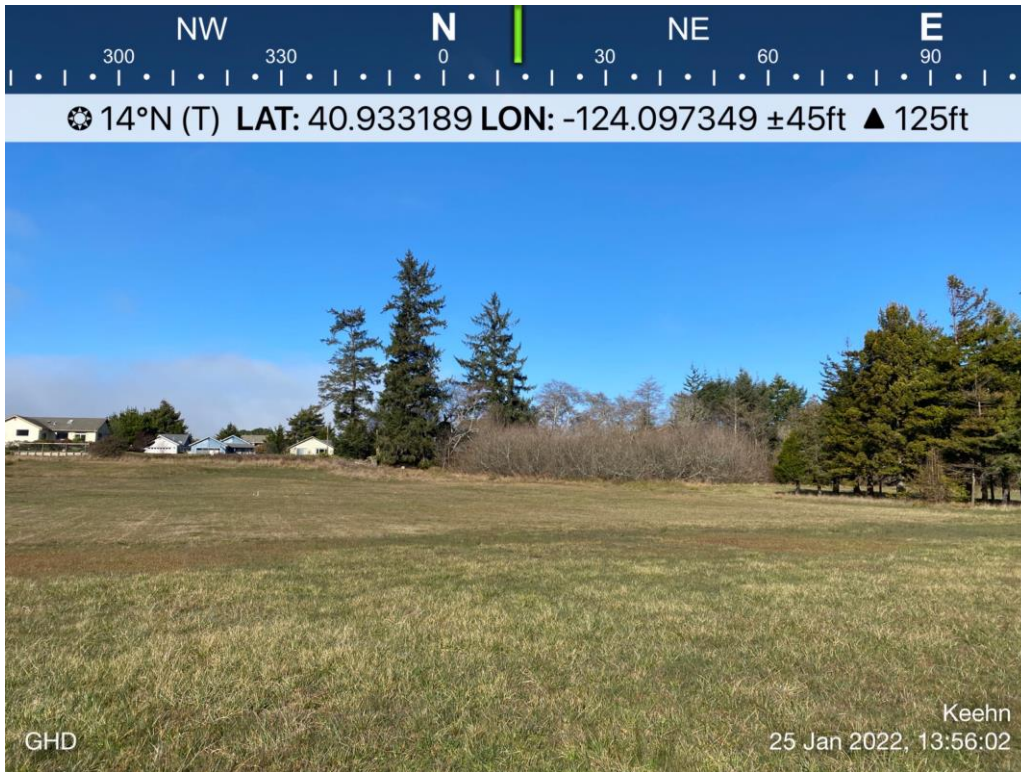
Photo 5. Viewing a swale in the center of the PSB facing North.

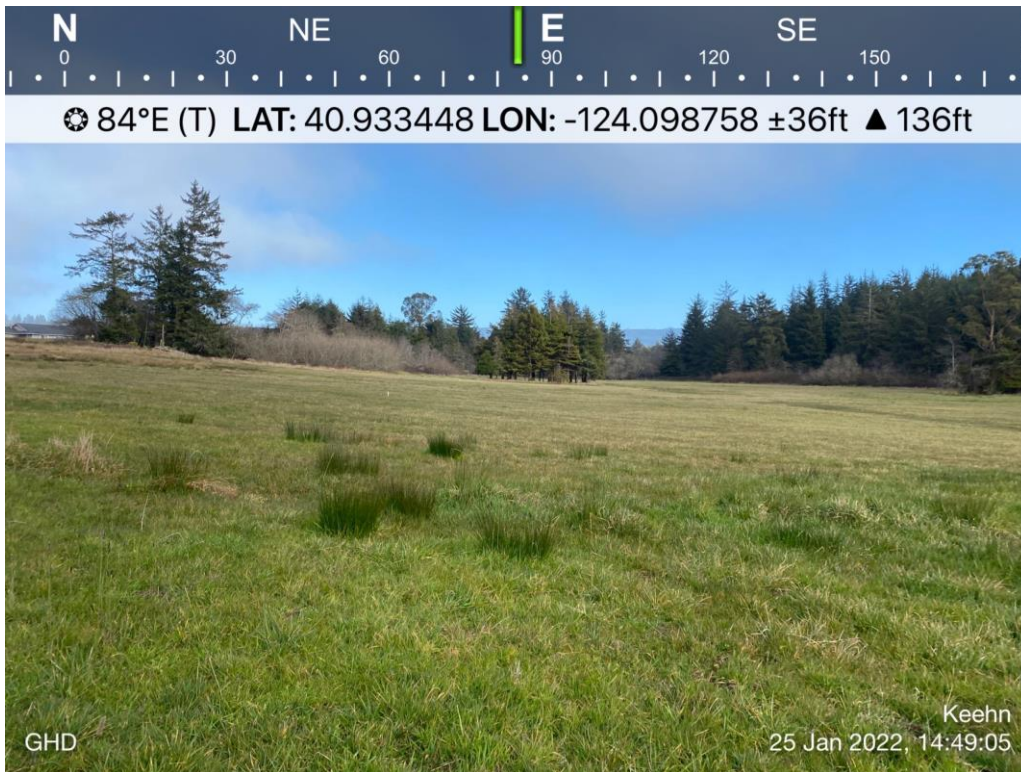
Photo 6. Viewing more hydrophytic vegetation within Wetland 1, present on the upper slope.

Wetland 1 was open and mostly free of rooted woody vegetation and is classified according to the Cowardin system as a Palustrine Emergent wetland (PEM) (FGDC 2013). The vegetation was primarily characterized by redtop (*Agrostis stolonifera*, FAC), reed fescue (*Festuca arundinacea*, FAC), common velvetgrass (*Holcus lanatus*, FAC), Italian rye grass (*Festuca perennis*, FAC), slough sedge (*Carex obnupta*, OBL), and mountain bod sedge (*Scirpus microcarpus*, OBL). Wetland 1 mostly passed the dominance test for hydrophytic vegetation (wetlands plots).

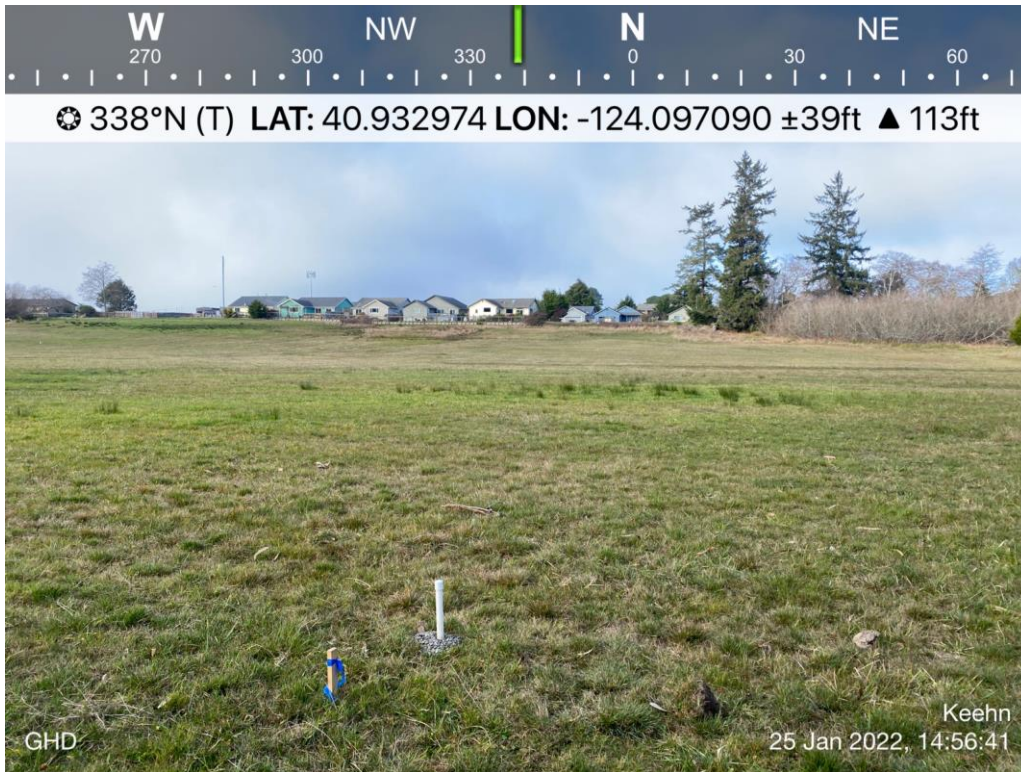
Photo 7. Viewing a swale at the base of the slope within Wetland 1.

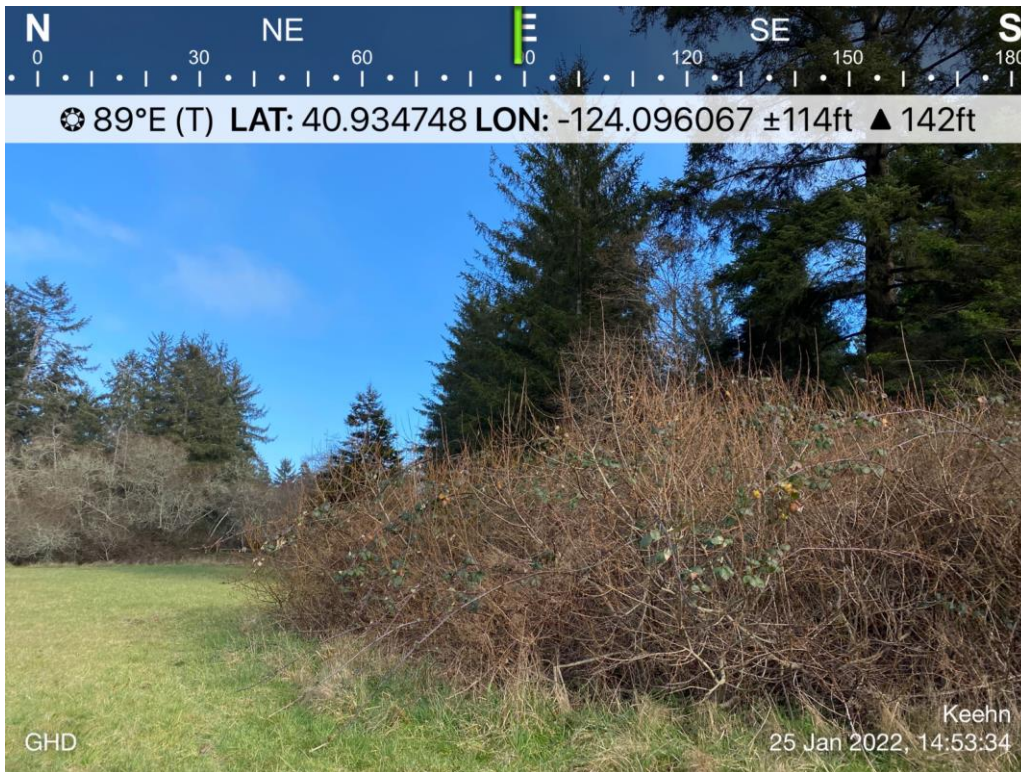
Photo 8. Dormant Coastal Willow Alliance SNC within the riparian corridor of Mill Creek.

The Coastal Willow Alliance corresponds to the Rapid Assessment datasheet WEIR002 in **Appendix D**. The Coastal Willow Alliance was observed in the north, northwest, and southwest edges of the PSB and covers 0.85 acres of the PSB. This SNC contained a tree canopy cover of 2% red alder (*Alnus rubra*), a shrub layer of 85% coastal willow (*Salix hookeriana*), and 20% California blackberry. The Coastal Willow Alliance has a State ranking of S3, therefore qualifying it as an SNC.

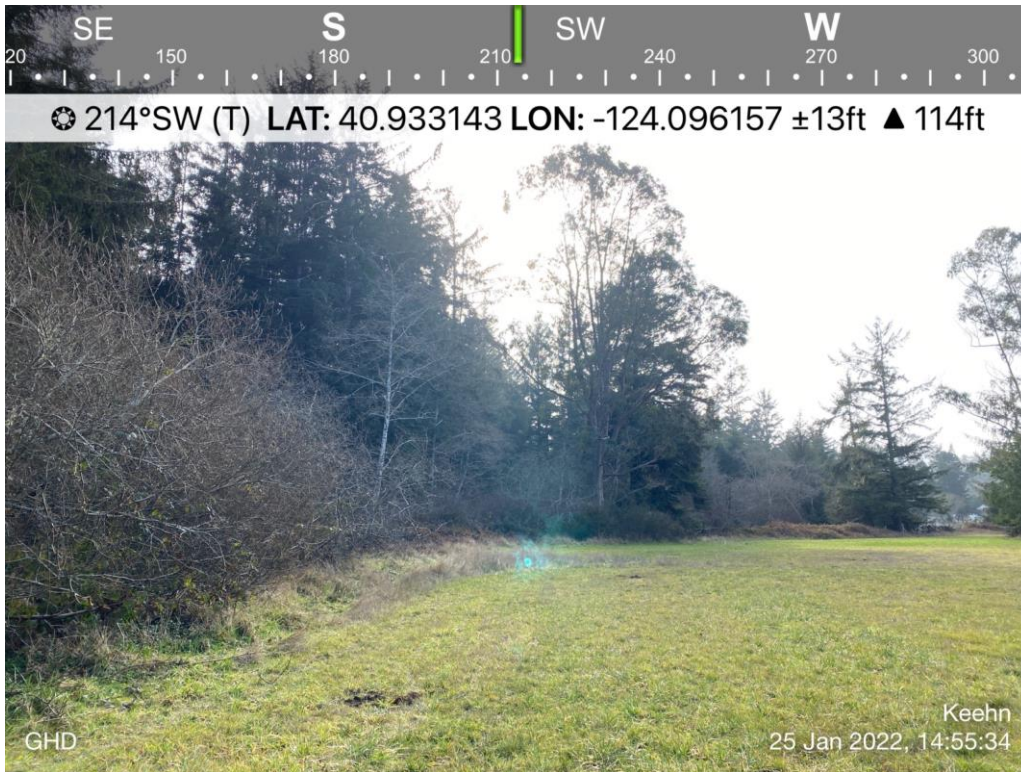
Photo 9. SNCs Coastal Willow Alliance backed by Sitka Spruce Alliance within the riparian corridor of Mill Creek.

The Sitka Spruce Alliance corresponds to the Rapid Assessment datasheet WEIR001 in **Appendix D**. The Sitka Spruce Alliance was observed in the north, northwest, and southwest edges of the PSB and covers 0.75 acres of the PSB. This SNC contained a tree canopy cover of 40% Sitka spruce (*Picea sitchensis*), 35% red alder (*Alnus rubra*), and 20% incense cedar (*Thuja plicata*), and is associated with California blackberry (*Rubus ursinus*). The Sitka Spruce Alliance has a State ranking of S2, therefore qualifying it as an SNC.

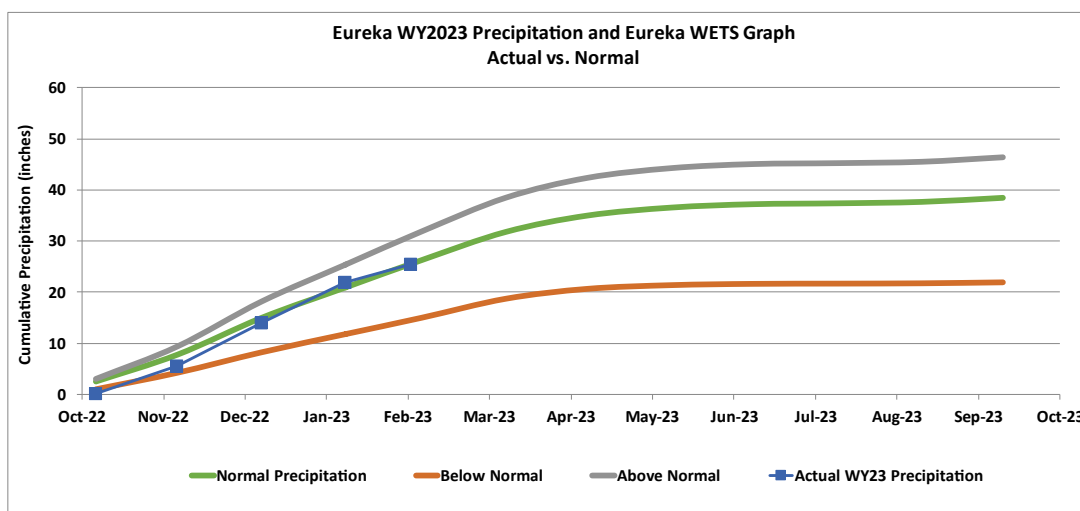
*Figure 1 Eureka, California WY 2023 Precipitation and WETS graph*

Rainfall data (as of February 24, 2023) for Eureka for the 2023 water year (October 1, 2022, to September 30, 2023) is shown in **Figure 1**. Below normal, normal, and above normal rainfall data from the WETS Table for Eureka are shown for comparison.
