Comment evaluation memo pertaining to the Initial Study and
Proposed Mitigated Negative Declaration for the Humboldt
Bay Trail South Project

Comment Evaluation Memo

Project: Humboldt Bay Trail South
Lead Agency: County of Humboldt
Department: Public Works
Document Type: Initial Study and Mitigated Negative Declaration
Applicable Law: California Environmental Quality Act
30-day Comment Period: February 16, 2018 through March 19, 2018
State Clearinghouse No: 2018022036
Web Site: www.humboldtbytrail.info
Date Prepared: July 16, 2018

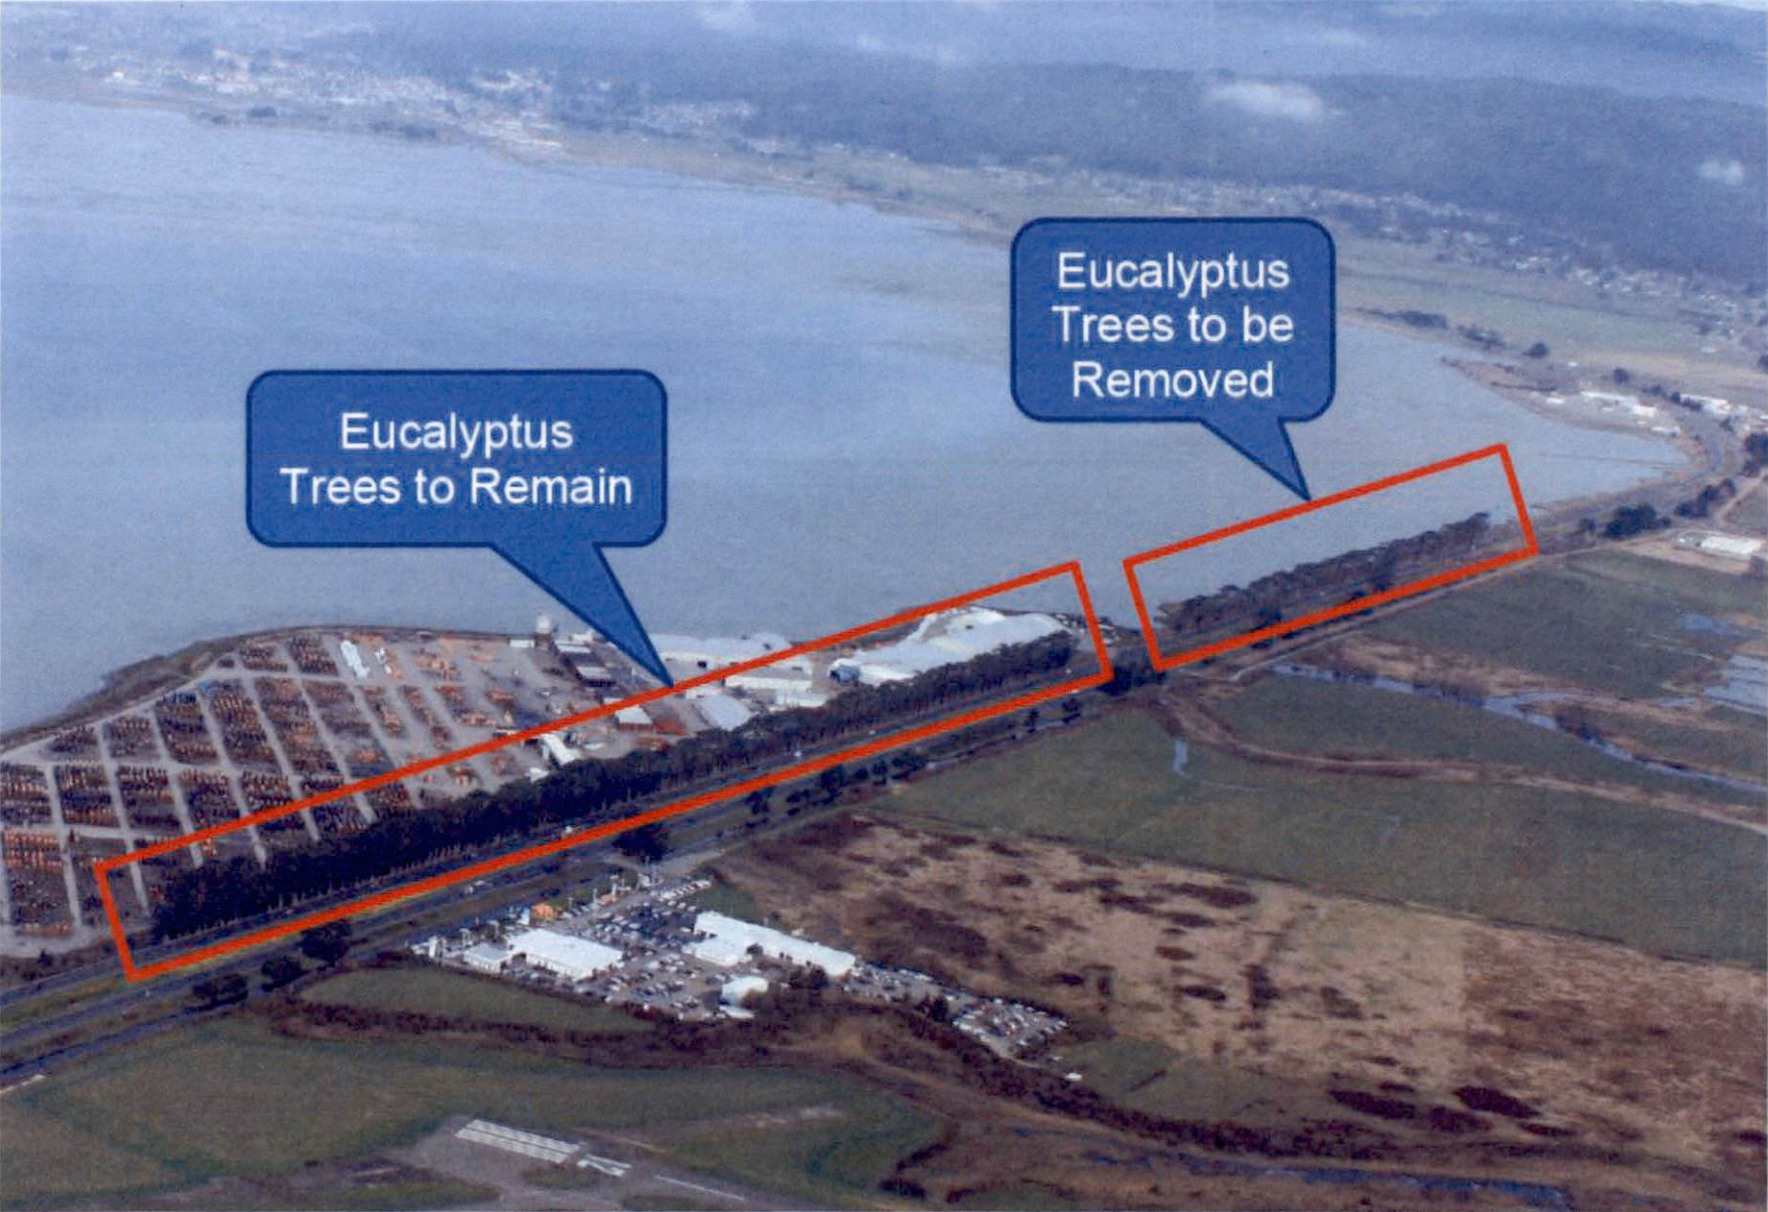
Proposed Eucalyptus Tree Removal Area

Segment 7 – Eucalyptus North

Several comments were received on the proposed removal of the northern group of eucalyptus trees situated in a row along Highway 101, north of the California Redwood Company former mill site. Approximately 219 trees larger than eight inches in diameter would be removed over a distance of 2,500 feet. These trees are situated directly adjacent to Segment 7 of the proposed trail and would present a significant safety hazard to trail users. The northern group of trees represents approximately 42 percent of the entire row of eucalyptus trees near the mill site. The group of trees situated south of the mill site entrance (over a distance of 3,400 feet) would not be affected by the Project. An exhibit depicting the tree removal area is provided in Attachment B.

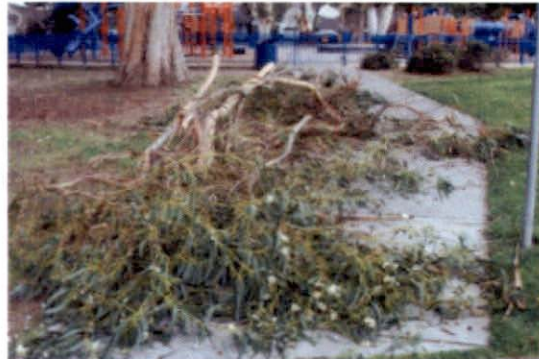
Photo by Amy Kacher.

Amy Kacher, a mother whose three young children play at the park, said a 36-foot limb fell on the path to the entry gate to the playground on the Channing side on Friday morning. She could not budge the limb, she said.

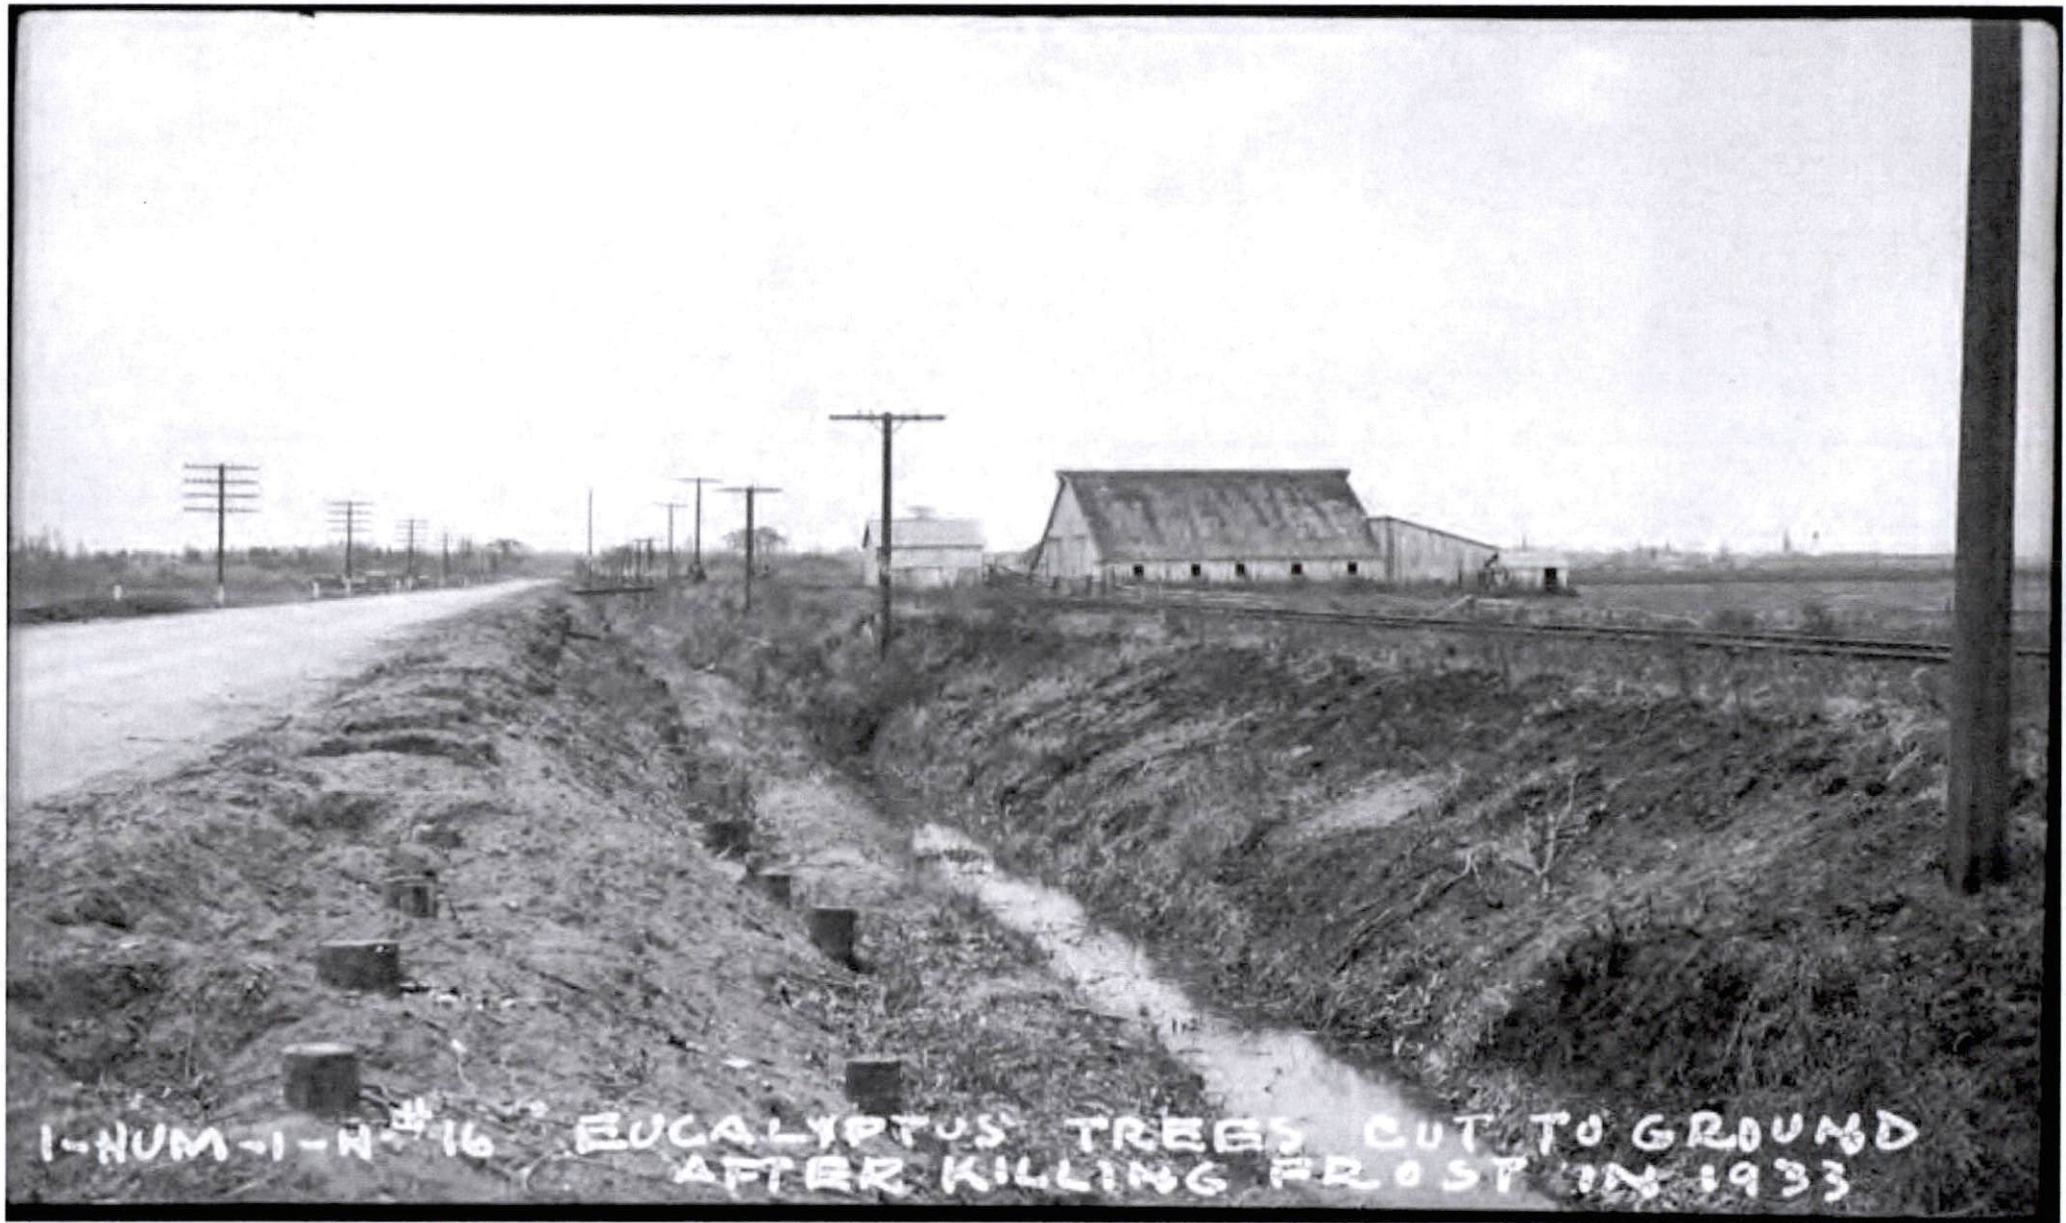
I-NUM-1-N-#16 EUCALYPTUS TREES CUT TO GROUND
AFTER KILLING FROST IN 1933

A historical photograph indicates that the trees in front of the main barn on the Devoy property were cut down after a damaging frost in 1933. An aerial photograph indicates that trees were replanted in the southern section by 1937. According to Eureka resident Gemma Fiamma, her father, Caesar Fiamma, helped re-plant trees in the southern section (south of the current mill entrance) as part of the Works Progress Administration, while the trees in the northern section were planted as a separate action. Historical photographs indicate that trees reached a height of approximately 75 feet by 1949. The highway was expanded to become a four-lane separated freeway in 1954 and 1955. Historical photographs indicate the eucalyptus trees were heavily trimmed (topped) in 1969.

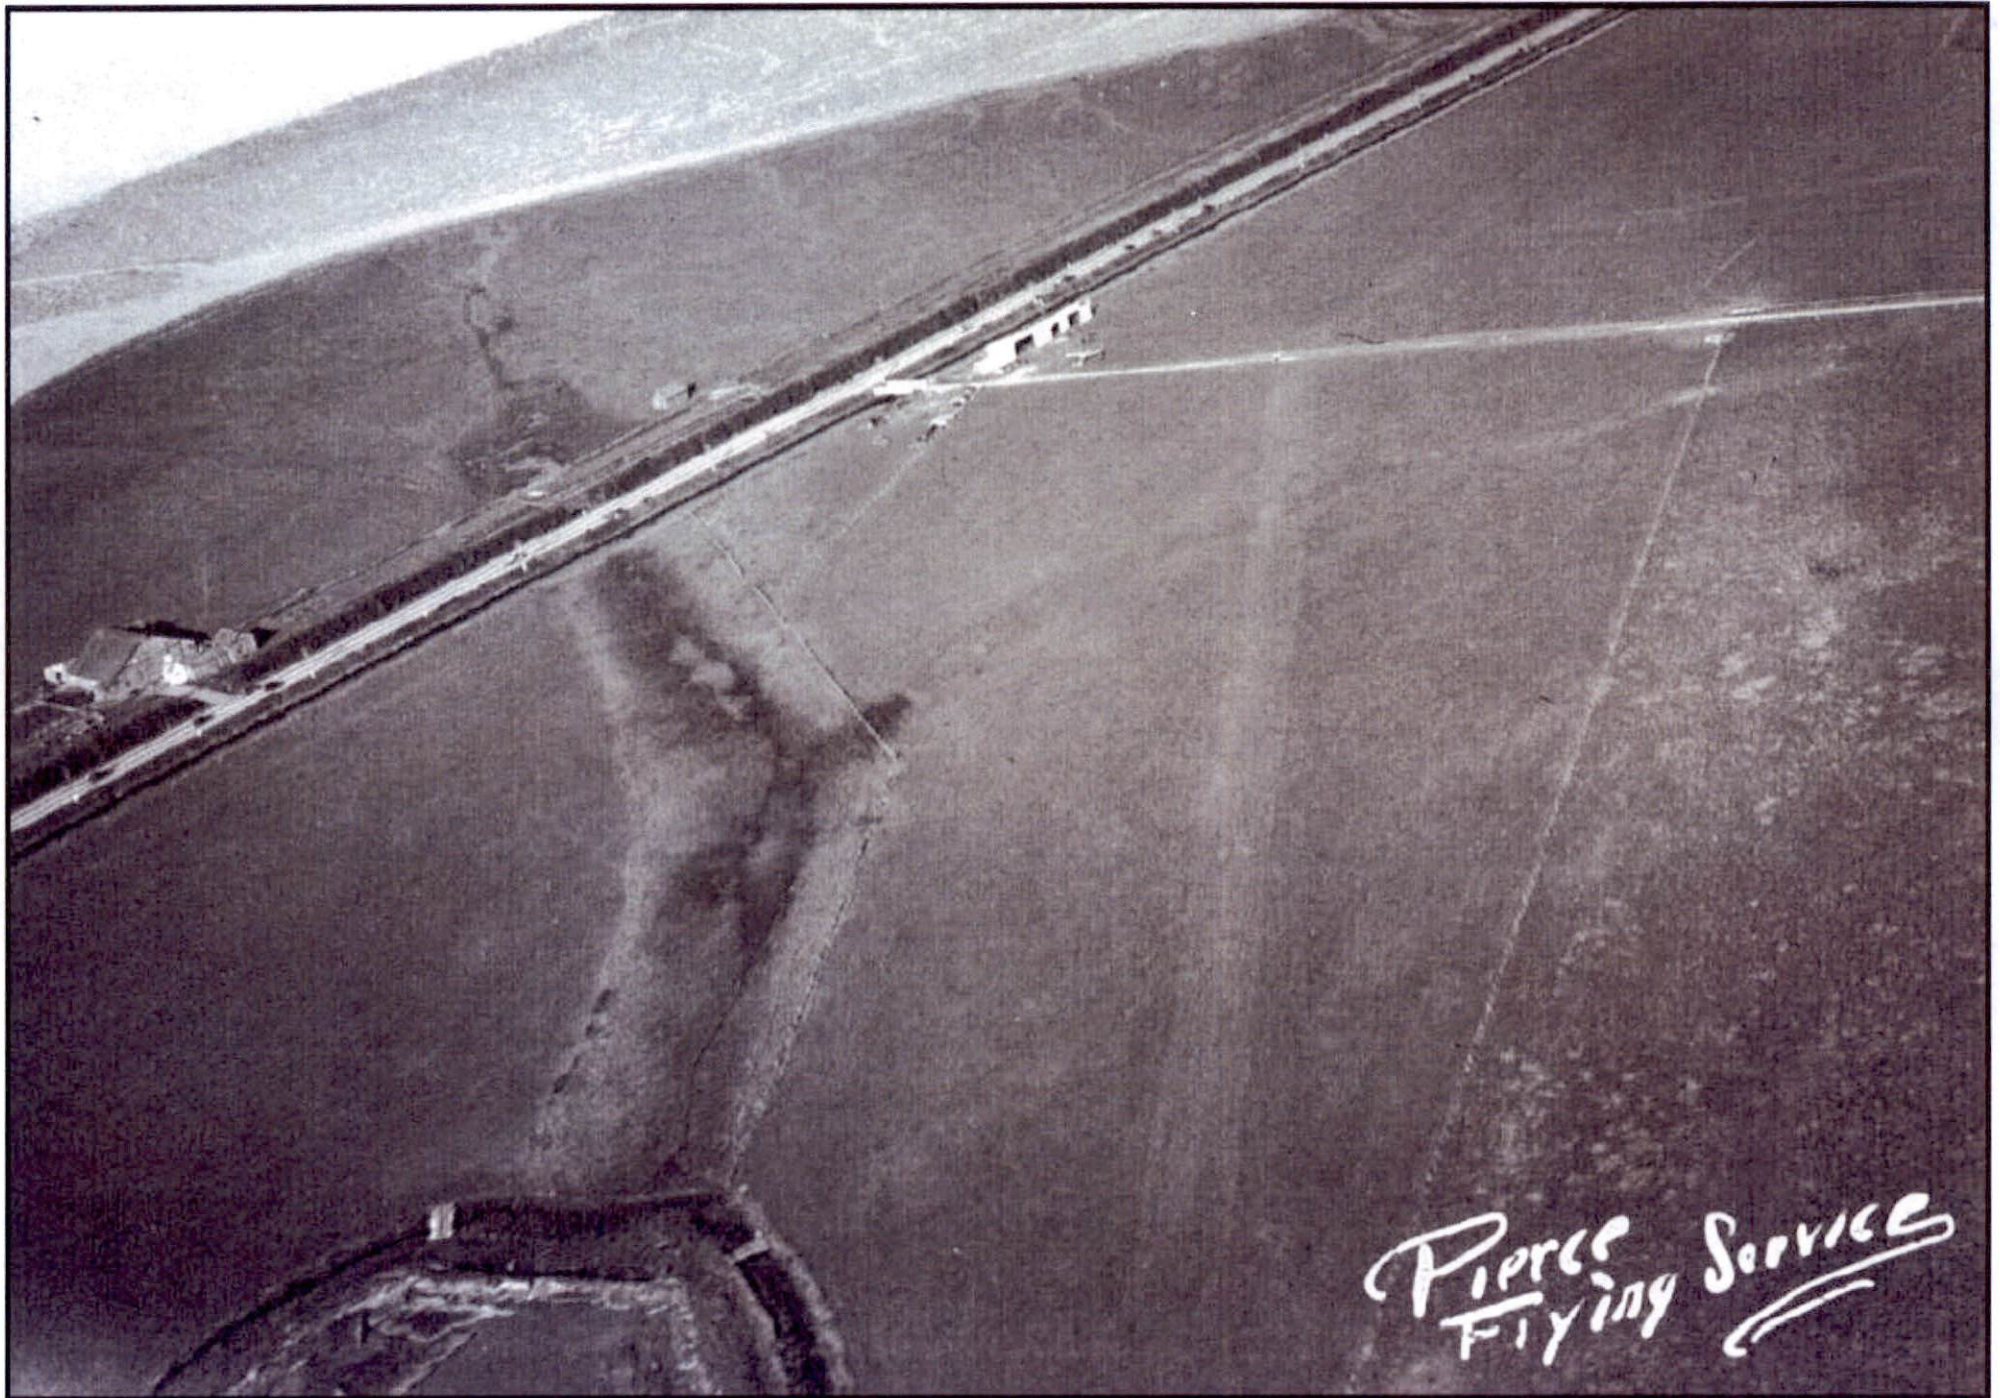
P-4: Aerial photo of original Murray Field by Pierce Flying Service, 1937.

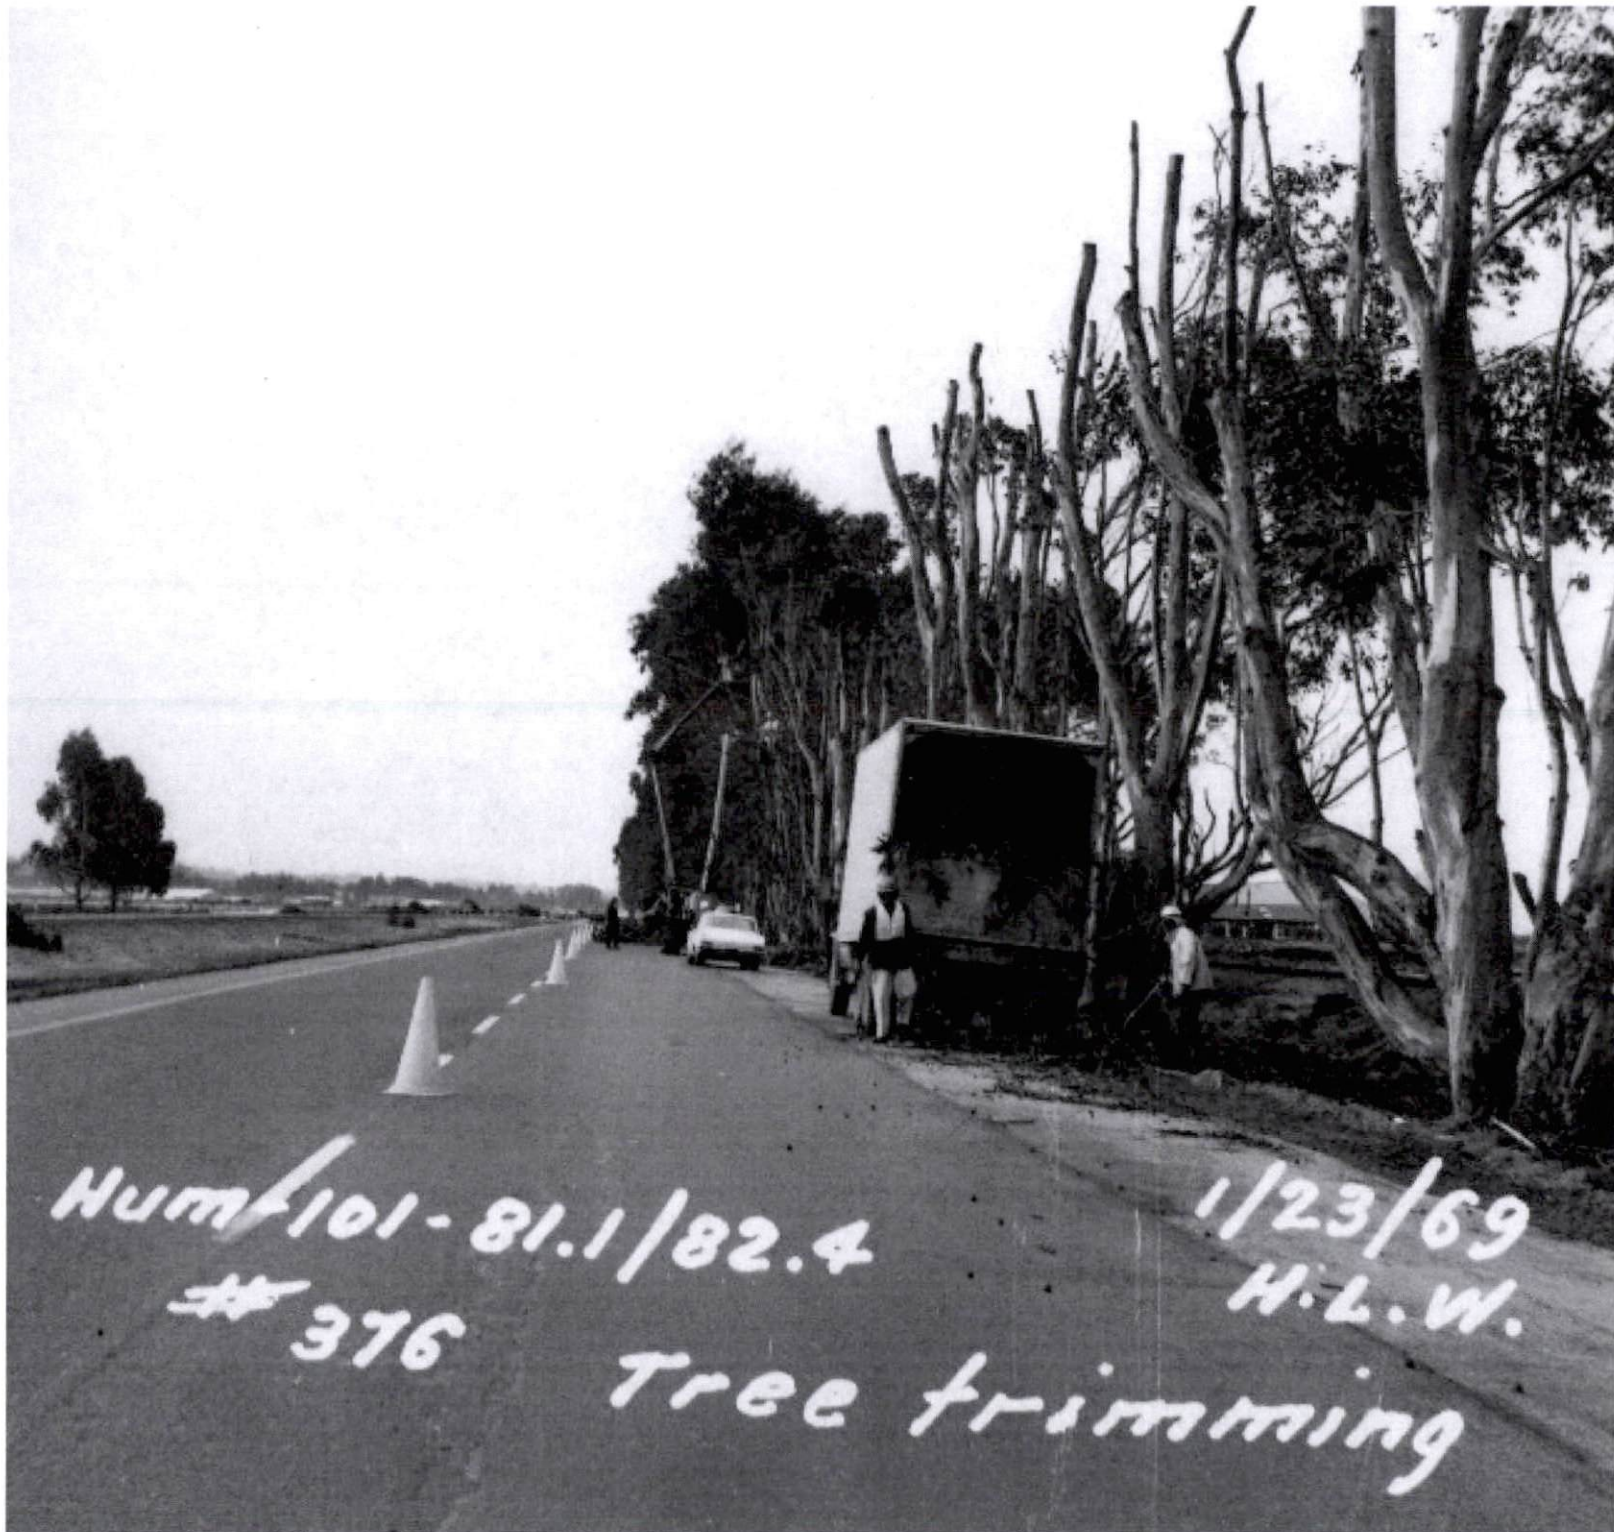
376

Tree trimming

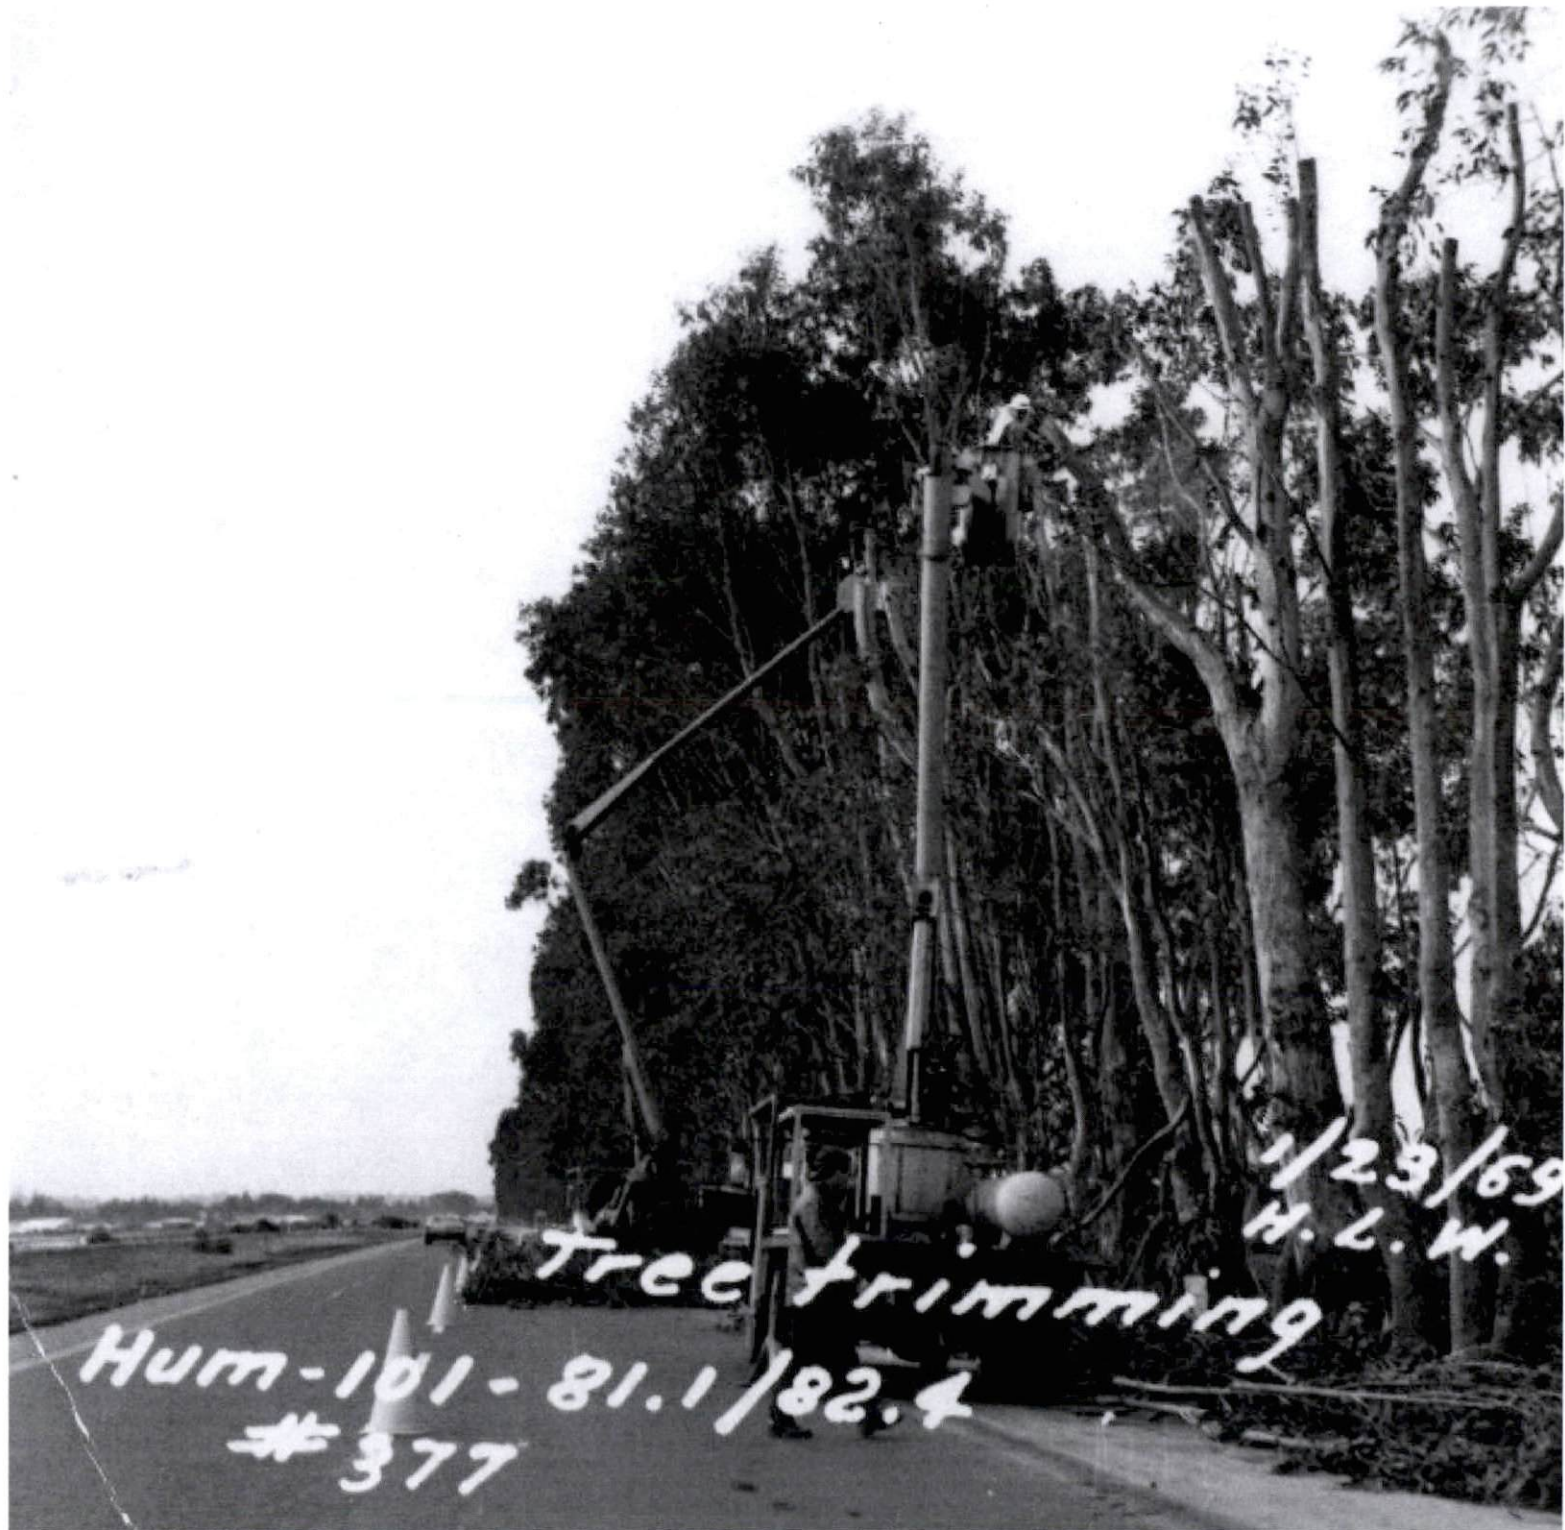
1/23/69
H. L. W.
Tree Trimming
Hum-101-81.1/82.4
#377
