**Subject: Notice of Violation, Transmittal of Inspection Report for September 7, 2023, Inspection of Humboldt County Assessor's Parcel Number 107-054-036-000, and Requirement to Respond within 30 days**

**North Coast Regional Water Quality Control Board**  
**Cannabis Water Quality Inspection Report**  
 APN(s): 107-054-036-000

<b>Inspection Date and Time</b>			
Inspection Date		September 7, 2023	
Inspection Start Time:	07:30	Inspection End Time:	10:30
<b>Site Location</b>			
Address/Location		47730 Mattole Road, Honeydew, CA 95545	
County		Humboldt	
Assessor's Parcel Number(s) (APN(s))		107-054-036-000	
Watershed		Upper North Fork Mattole River	
<b>Property Owner Contact Information</b>			
Property Owner		Evan Kouchalakos	
Mailing Address		74 Amherst Road, Merrimack, NH 03054	
<b>Warrant Information</b>			
Agency Responsible for Warrant		CDFW	
Person Responsible for Warrant		Josh Zulliger	
Warrant Date		September 7, 2023	
<b>Lead Inspector, Team Members, Other Agencies and Personnel Onsite</b>			
Lead Inspector Name		Katherine Hawken	
Lead Inspector's Credentials		Water Resource Control Engineer	
Office/Regional Board		North Coast Regional Water Quality Control Board	
Author of

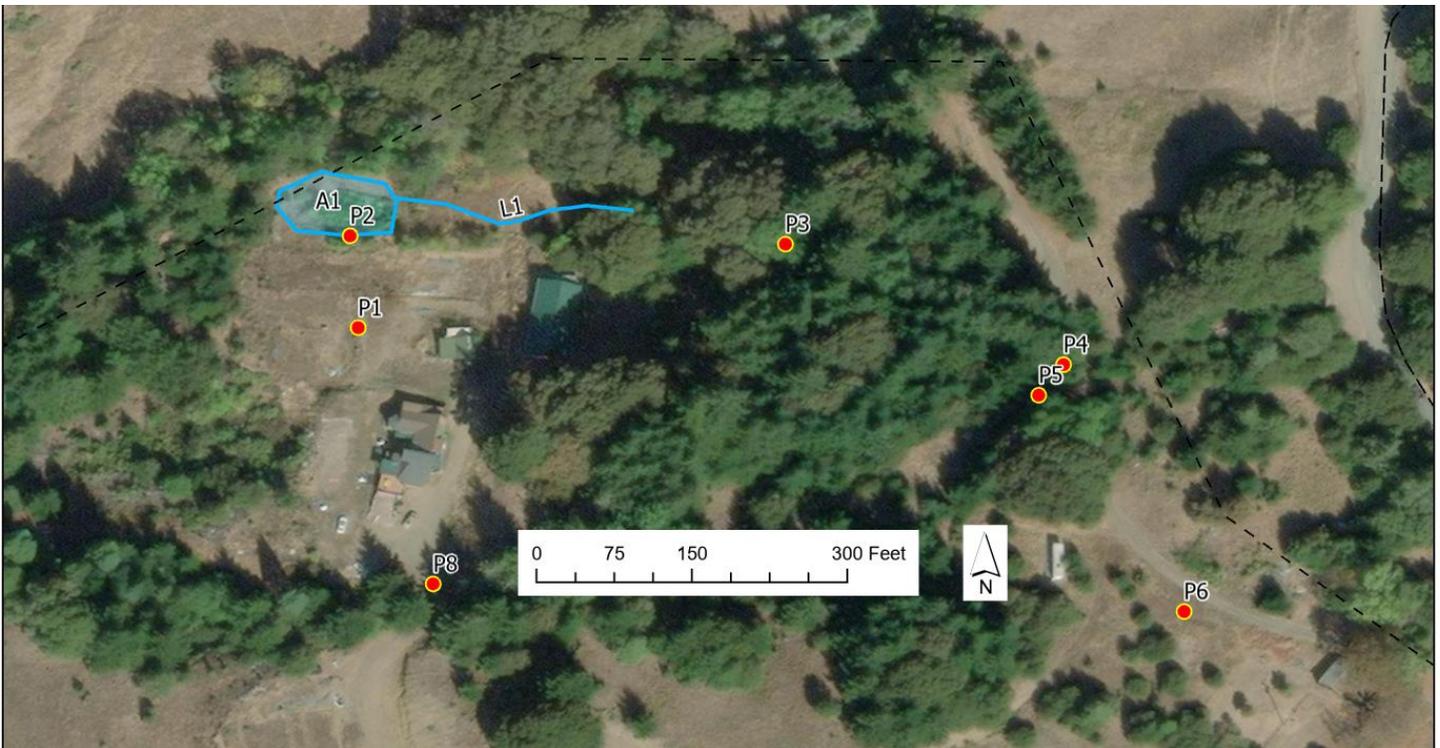
**Figure 1: Site Map** with dashed parcel boundaries and points (P), line (L), and area (A) of interest. P7 was determined to be off parcel and is not included in this map or report.

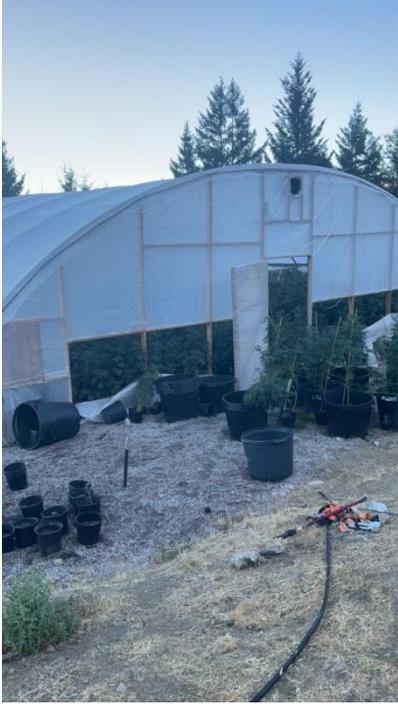
P1: I observed two hoop houses with plastic flooring, and cannabis plants in pots. I observed a pile of potting soil in front of the hoop houses. I left a field notice on the property with the warrant.

<b>P1</b>	
<b>Category:</b> Cultivation Area (CA)	
<b>Description:</b> Two hoop houses with plastic tarp floors and cannabis plants in pots.

<b>Photo Number:</b> 1
	<b>Photo Description:</b> Front of hoop house with cannabis plants and pile of potting soil.
	Facing North

1. If you and/or your tenant(s) plan to continue commercial cannabis cultivation, enroll for coverage under the State Water Board's Order WQ 2019-0023-DWQ, General Waste Discharge Requirements and Waiver of Waste Discharge Requirements for Discharges of Waste Associated with Cannabis Cultivation Activities.
2. Relocate all cannabis cultivation activities, supplies, and trash outside of the riparian setbacks (50 feet from Class III, 100 feet from Class II, 150 feet from Class I).
3. Regularly contain and dispose of all waste/ trash, including used motor oil, at a licensed transfer site. Remove cultivation related waste from surface waters.

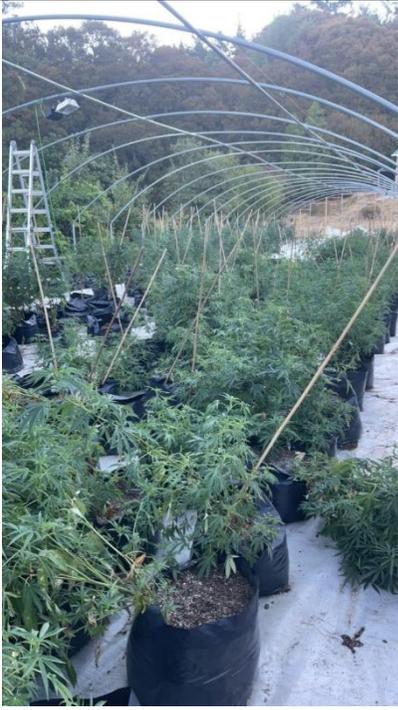
<b>Photo Number:</b> 2
	<b>Photo Description:</b> Inside view of second hoop house.
	Facing Northeast

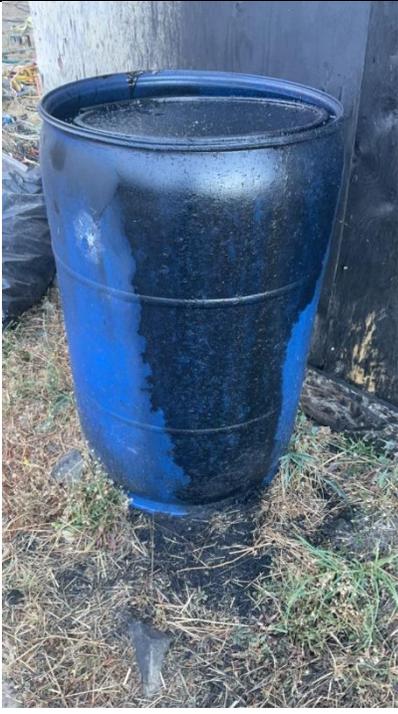
P2: I observed a barrel full of suspected used motor oil. The area smelled of petroleum and I observed a discharge to land at the base of the barrel where the ground was blackened.

**Description:** Spilled used oil.

<p><b>Photo Number: 1</b></p>
	<p><b>Photo Description:</b> Barrel of suspected used motor oil with evidence of spilling, and discharge to land.</p>
	<p>Facing Southeast</p>

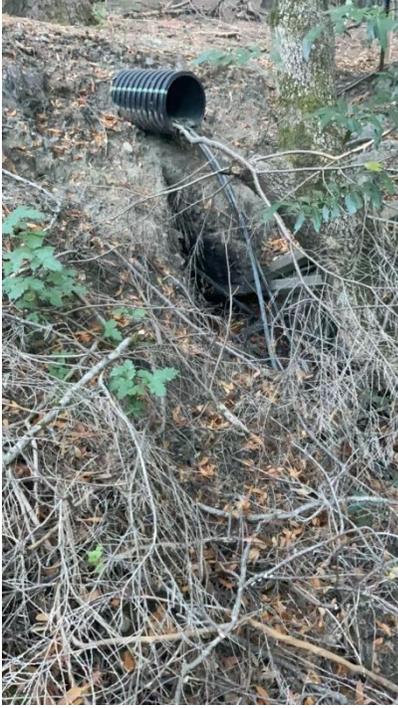
P3: I observed a 16-inch diameter plastic culvert stream crossing with ponding at its inlet. I observed a clogged metal culvert left in the road prism, and evidence of the stream overtopping the road. I observed a road ditch discharging to the stream at the culvert inlet.

<b>Photo Number:</b> 1
	<b>Photo Description:</b> Culvert outlet perched 4 feet above stream channel.
	Facing Southeast

4. Retain a qualified professional to assess the culvert stream crossings for capacity to convey a 100-year flow event and associated debris, disconnect road ditches from watercourses, and recontour roads to prevent discharge to receiving waters.
5. Apply for a 401 water quality certification prior to work instream to replace culverts.
6. Work with the State Water Board Division of Water Rights and the California Department of Fish and Wildlife to obtain necessary permits to divert and store water.
7. Do not use water storage bladders unless the bladder is safely contained within a secondary containment system with sufficient capacity to capture 110 percent of a bladder's maximum possible contents in the event of bladder failure.

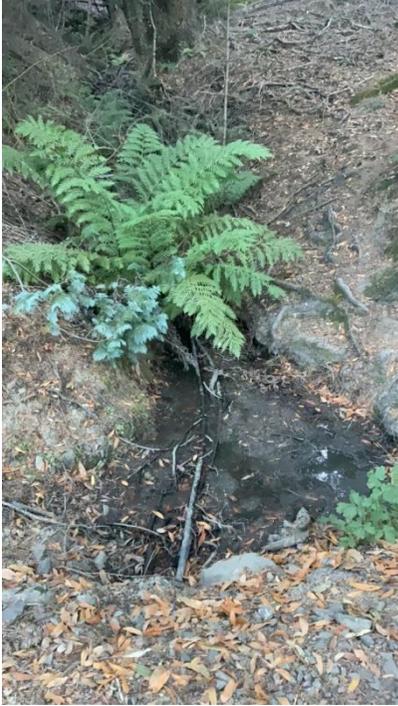
<b>Photo Number:</b> 2
	<b>Photo Description:</b> Ponding at undersized culvert inlet.
	Facing East

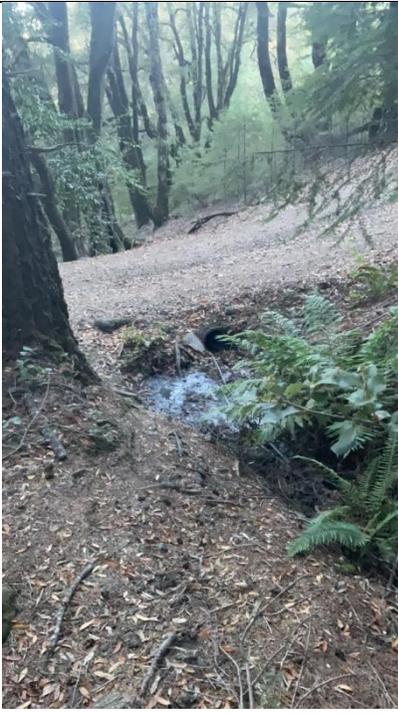
<p><b>Photo Number: 3</b></p> <p><b>Photo Description:</b> View from uphill of culvert inlet.</p> <p>Facing Northwest</p>

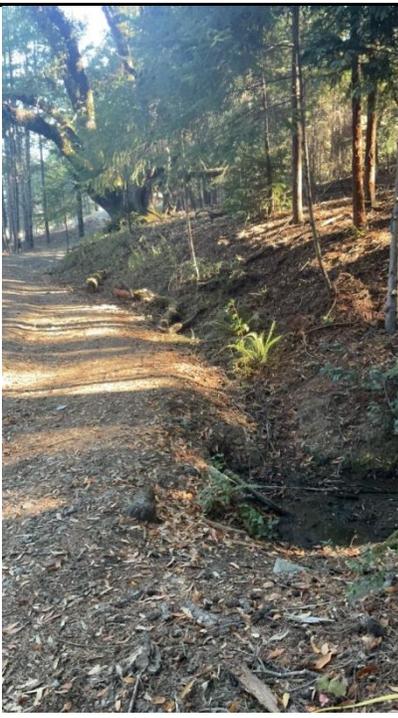
<p><b>Photo Number: 4</b></p> <p><b>Photo Description:</b> Road ditch discharging into inlet of culvert.</p> <p>Facing North</p>

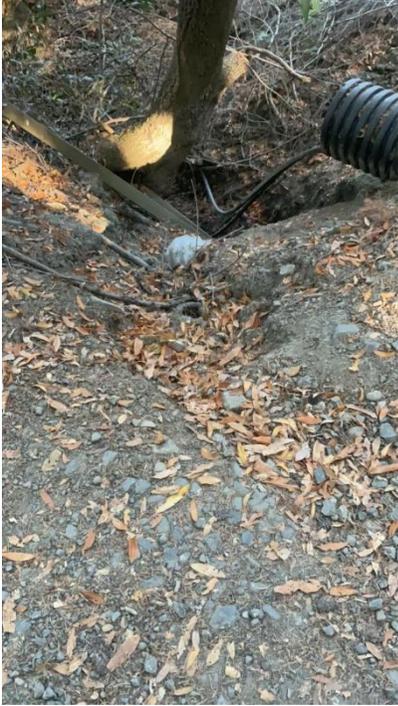
<b>Photo Number: 5</b>
		<b>Photo Description:</b> Old metal culvert and evidence of stream overtopping road prism.
		Facing Northwest

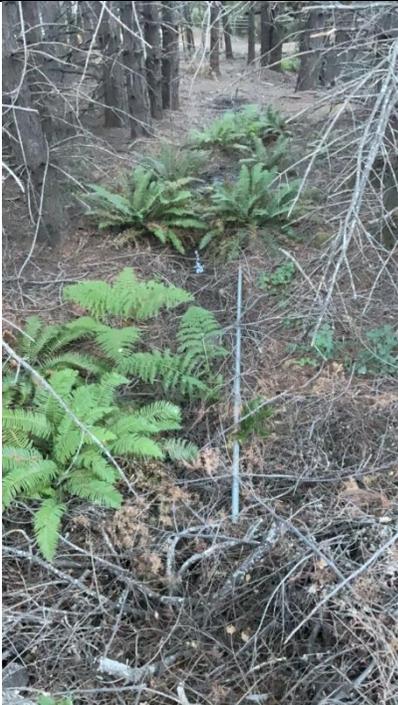
P4: I observed a spring with an approximately 50-foot wet area below it. I observed electrical conduit in the spring channel.

<b>Photo Number: 1</b>
		<b>Photo Description:</b> Surface water spring.
		Facing West

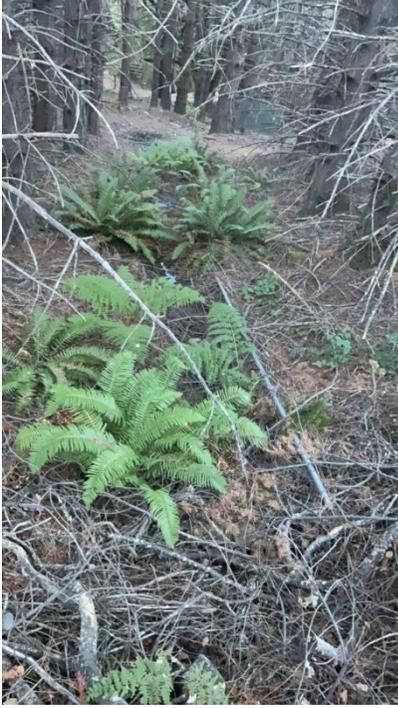
<b>Photo Number: 2</b>
		<b>Photo Description:</b> Electrical conduit in spring channel.
		Facing West

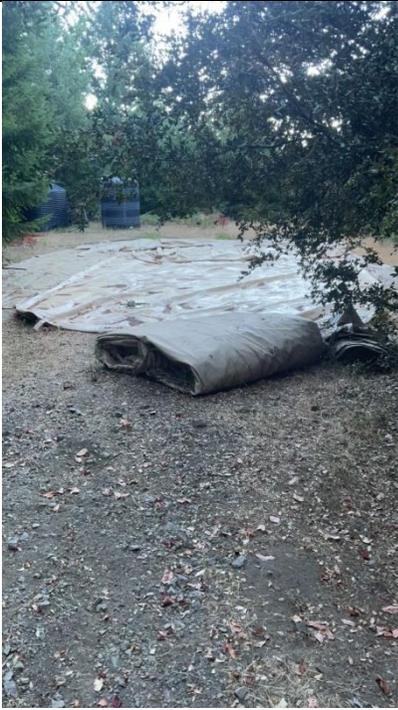
P5: I observed inactive water storage bladders, and water storage tanks on a flat.

<b>Photo Number: 1</b>
		<b>Photo Description:</b> Water bladders and tanks on flat.
		Facing Southwest

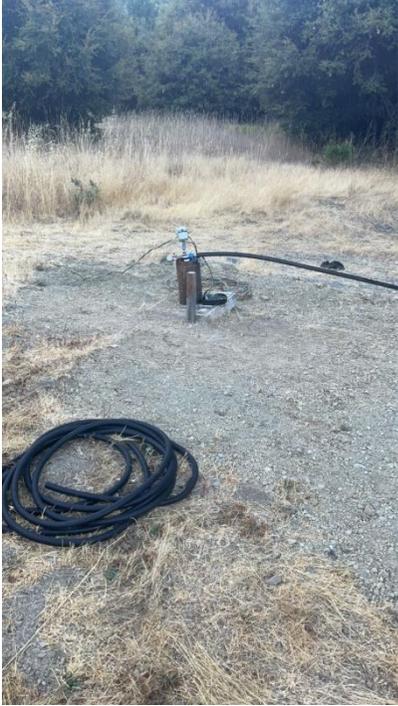
P6: I observed a groundwater well in an upland area. The well did not appear to be connected to the cultivation area.

<b>Photo Number:</b> 1 <b>Photo Description:</b> Groundwater well. Facing South

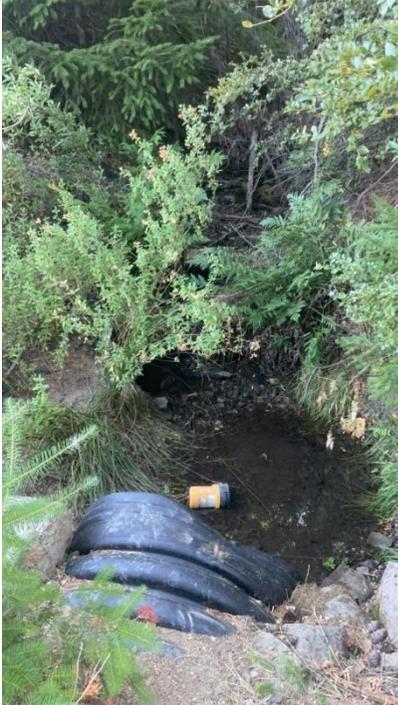
P8: I observed a plastic culvert stream crossing with ponding at its inlet. I observed a disconnected submersible pump in the ponded area. I observed a road ditch discharging to the stream at the culvert inlet. I observed trash at the culvert outlet, and the road prism eroding into the stream.

<b>Photo Number:</b> 1 <b>Photo Description:</b> Culvert inlet with ponding, and submersible pump. Facing Northeast

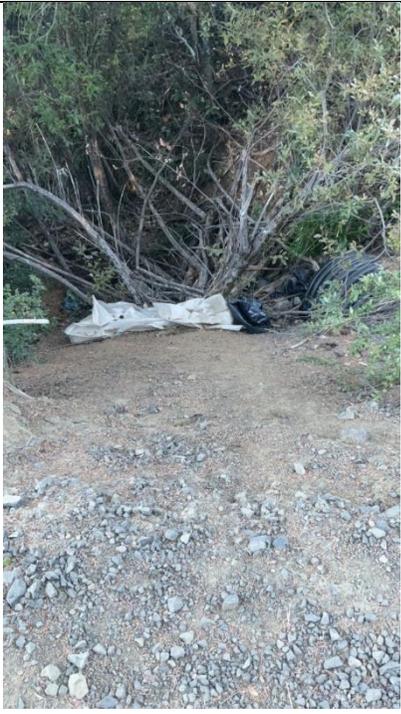
<p><b>Photo Number: 2</b></p> <p><b>Photo Description:</b> Dirt road prism eroding into stream at culvert outlet. Trash in stream.</p> <p>Facing West</p>

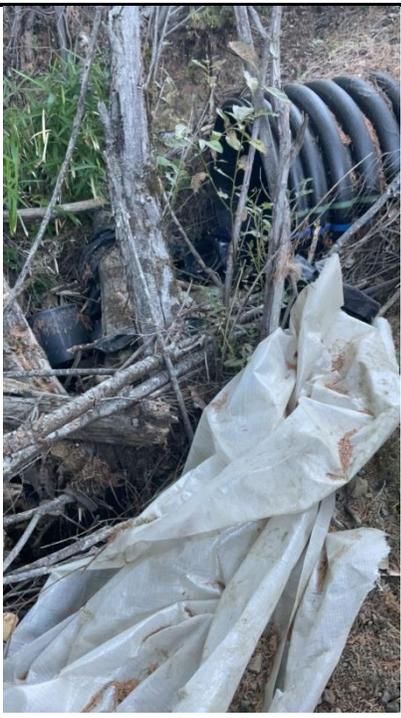
<p><b>Photo Number: 3</b></p> <p><b>Photo Description:</b> Trash at culvert outlet.</p> <p>Facing North</p>

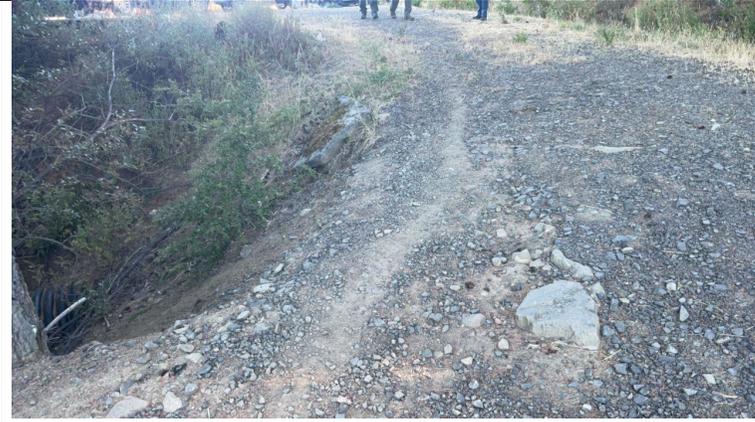
**Photo Number: 4**  
**Photo Description:** Eroding dirt road prism.  
Facing West

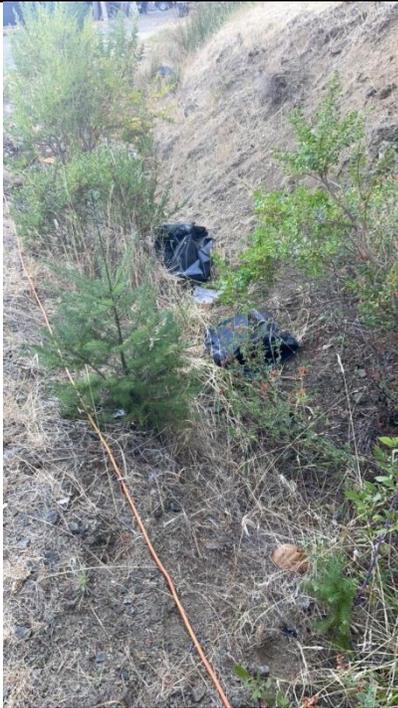
**Photo Number: 5**  
**Photo Description:** Road ditch with trash leading to culvert inlet.  
Facing North

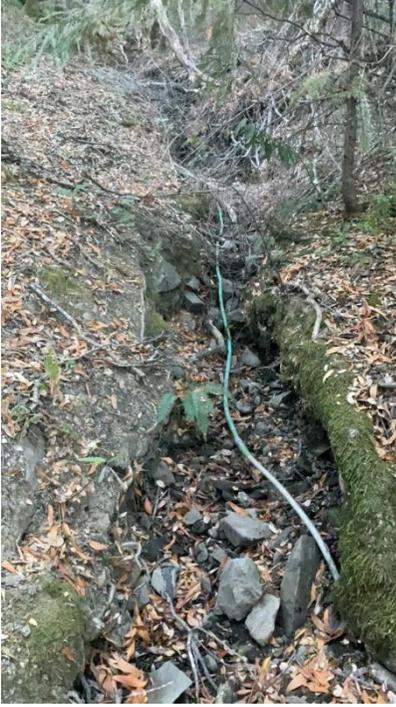
L1: I observed a watercourse channel with portions of cobble substrate, and dirt substrate. I observed cultivation related waste in the stream. I observed the stream discharges to a pond/ wetland feature.

<b>Photo Number:</b> 1
	<b>Photo Description:</b> View of watercourse channel with cobble.
	Facing East

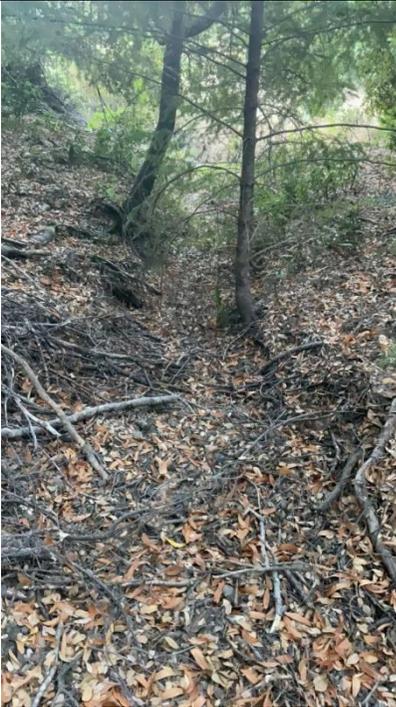
<b>Photo Number:</b> 2
	<b>Photo Description:</b> View of watercourse channel with reduced slope approaching wetland/ pond area.
	Facing West

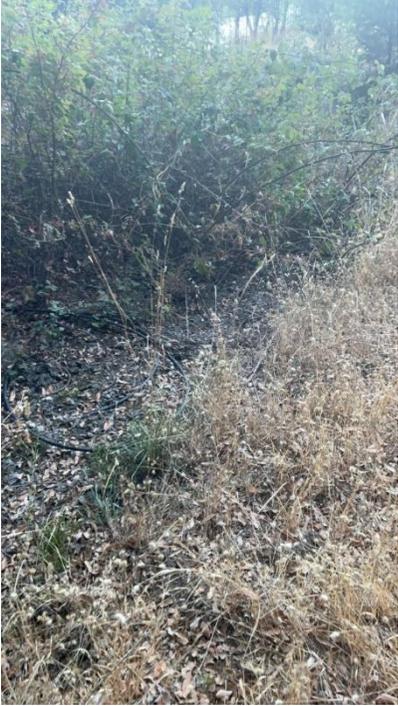
<b>Photo Number: 3</b>
	<b>Photo Description:</b> Trash in wetland/ pond.
	Facing Southwest

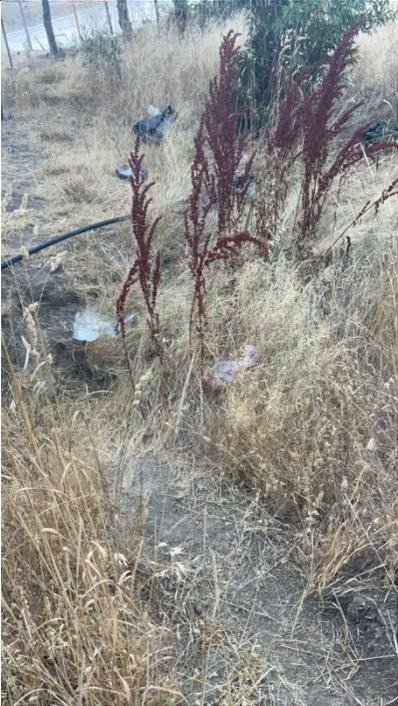
<b>Photo Number: 4</b>
	<b>Photo Description:</b> Trash in watercourse.
	Facing Southwest

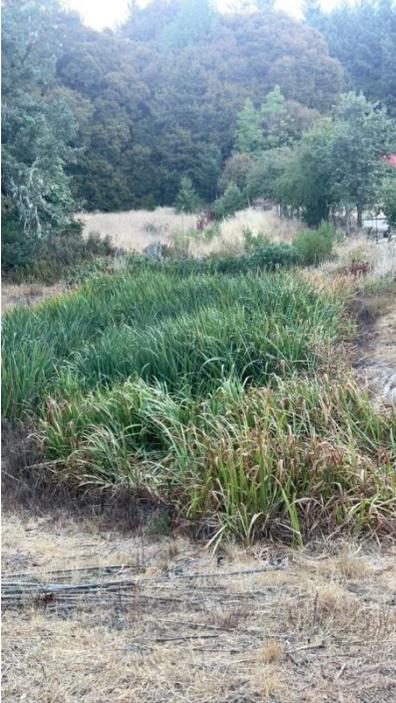
A1: I observed a pond/ wetland feature with hydrophytic plants including rushes, willows, penny royal, and grasses. I observed cultivation related waste in the pond/ wetland. I observed a metal culvert connecting the wetland/ pond at high flows to an adjacent watercourse running along the northwest parcel boundary. I observed the wetland/ pond feature was approximately 20 feet from the cultivation area P1 at the closest edge.

<b>Photo Number:</b> 1
	<b>Photo Description:</b> Wetland feature with rushes, willows, penny royal, and grasses.
	Facing East

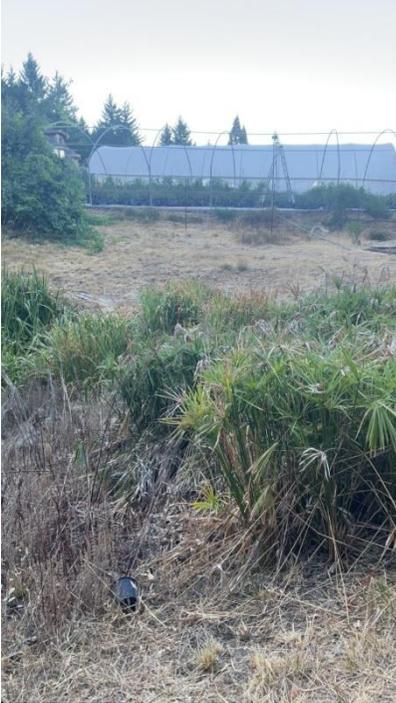
<b>Photo Number:</b> 2
	<b>Photo Description:</b> View of cultivation area proximity to wetland/ pond.
	Facing South

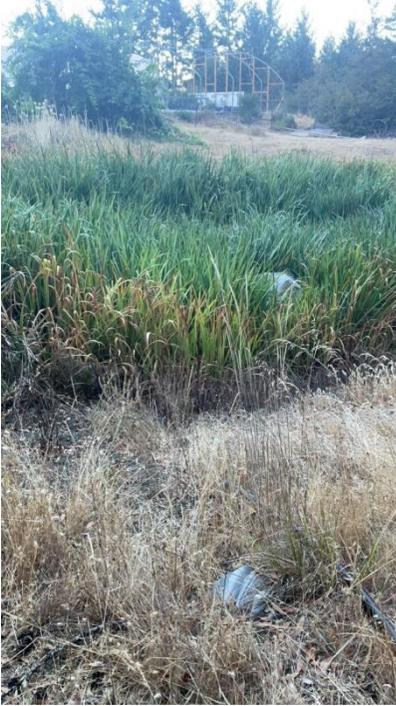
<b>Photo Number: 3</b>
	<b>Photo Description:</b> Metal culvert on wetland/ pond side. Plastic tarps and grow bag in wetland/ pond.
	Facing Southwest

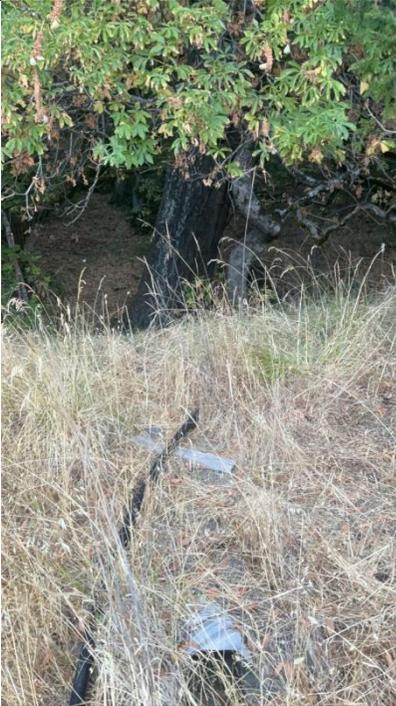
<b>Photo Number: 4</b>
	<b>Photo Description:</b> View of metal culvert inlet from wetland/ pond side and 20 foot berm to adjacent watercourse on parcel boundary.
	Facing North

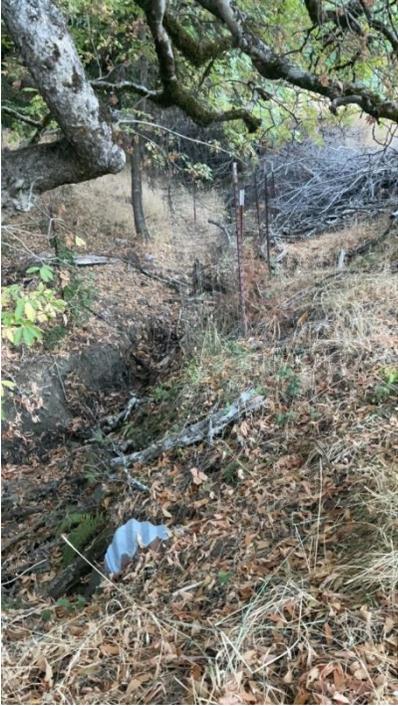
<b>Photo Number: 5</b>
	<b>Photo Description:</b> Culvert on watercourse side. Metal plant cages, metal stakes, and slash in stream.
	Facing East

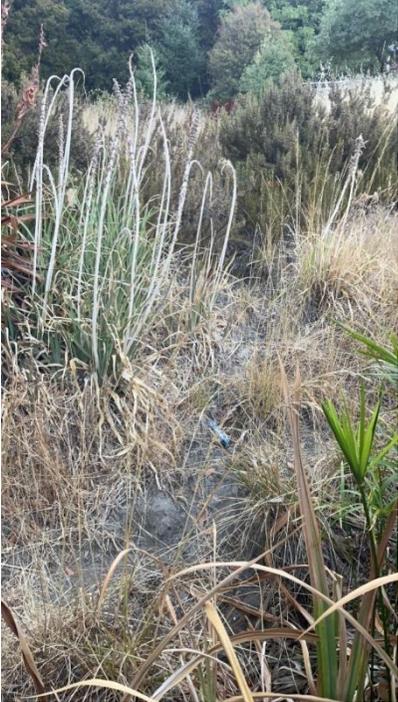
<b>Photo Number: 6</b>
	<b>Photo Description:</b> Watercourse coming into wetland/ pond feature.
	Facing East

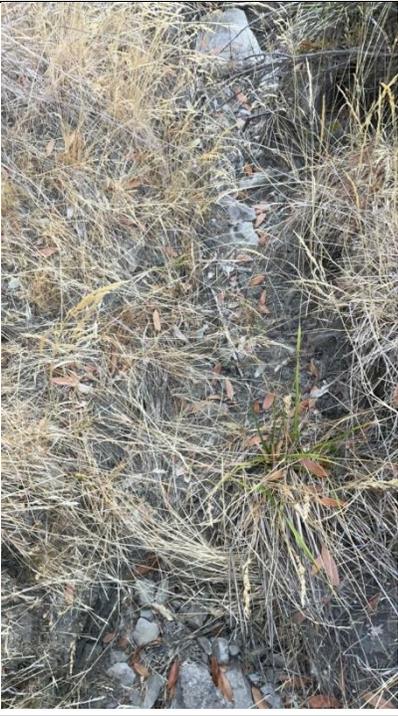
<b>Photo Number:</b> 7
	<b>Photo Description:</b> Watercourse channel approximately 20 feet from cultivation area.
	Facing East
