Sacred Groves Green Cemetery Project Geology, Soils, and Site Suitability

October, 2024

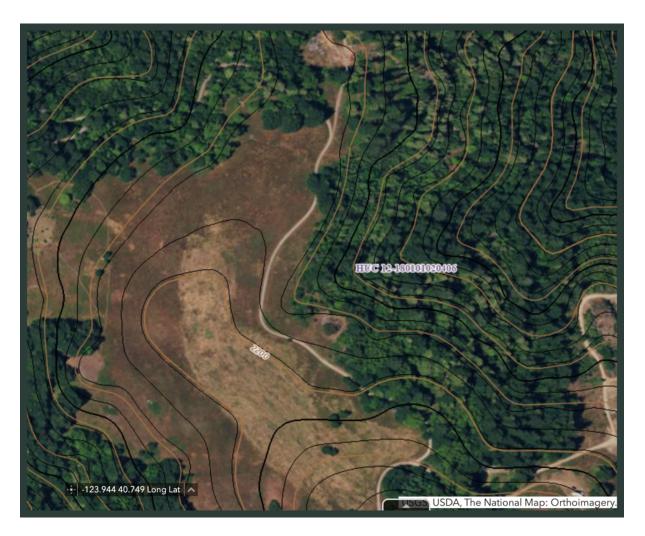
Map showing land elevation contours. The area is in the subwatershed (HUC12) of 180101020408, within the Mad River Basin, and is at elevation of ~2,200 feet.

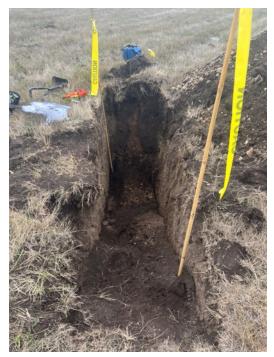
Excavator-dug soil examination pit and location.

The full area was walked with small soil pits, auger holes, gopher excavations, and a large soil examination pit in what was considered a typical setting in the project area. Vegetation and drainage patterns were observed over 2 years during the wet and dry seasons.

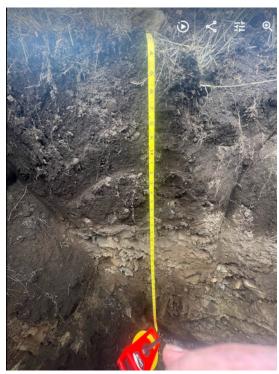
Detailed view of Winegrass soil

Soil texture is highly favorable. It has a loam texture in the upper and clay loam in the lower horizons. (Both loams and clay loams have well-balanced particle-size distribution and are of high fertility and suitability for plant growth and decomposition, as well as habitat and forage value for wildlife and livestock.)

Soil reaction is very slightly acidic (pH 6.5-6.8), with high cation exchange capacity, and 3-5 percent organic matter in the A horizon.

Rockiness is low, with some rock in the lower horizons and less than 10% rock overall.

Soil depth: Soil depth to bedrock is greater than 80 inches.

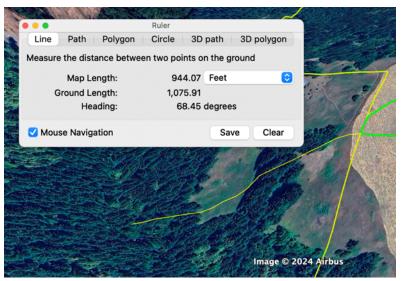
Measurement of slope length from the lowest end of the project area to Black Dog Creek. The terrain is shown at 3x exaggeration.

Water features: Except for the seep area in the meadow but outside the project area, there are no surface water features in the project area. The closest surface water feature, Black Dog Creek, is approximately 1,000 feet slope distance from the lowest extent of the project area.
