Mad River Properties, Inc.

Water Resource Protection Plan
APN: 223-061-049

ROAD EVALUATION DOCUMENTATION: APN 223-061-049

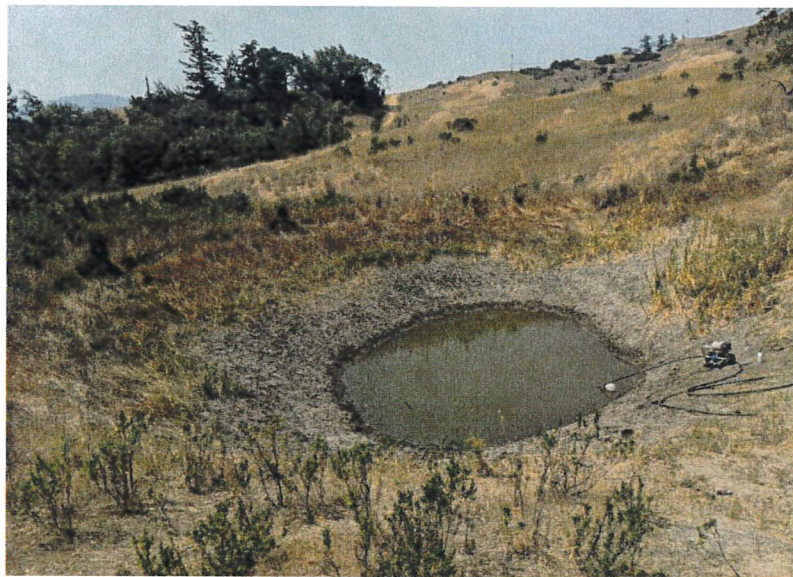
Map Feature: M1RM#3

Map Feature	Description	Corrective Action	Priority (1 Highest – 4 Lowest) & Anticipated Completion Date.
M1RM#3	Pond & Gasoline powered pump located in pond	Remove pump when not in immediate use and store in a covered area. Install rocked pond overflow per LSAA.	Priority 4, October 1 st 2018

Figure 3: Pond & Gasoline powered pump

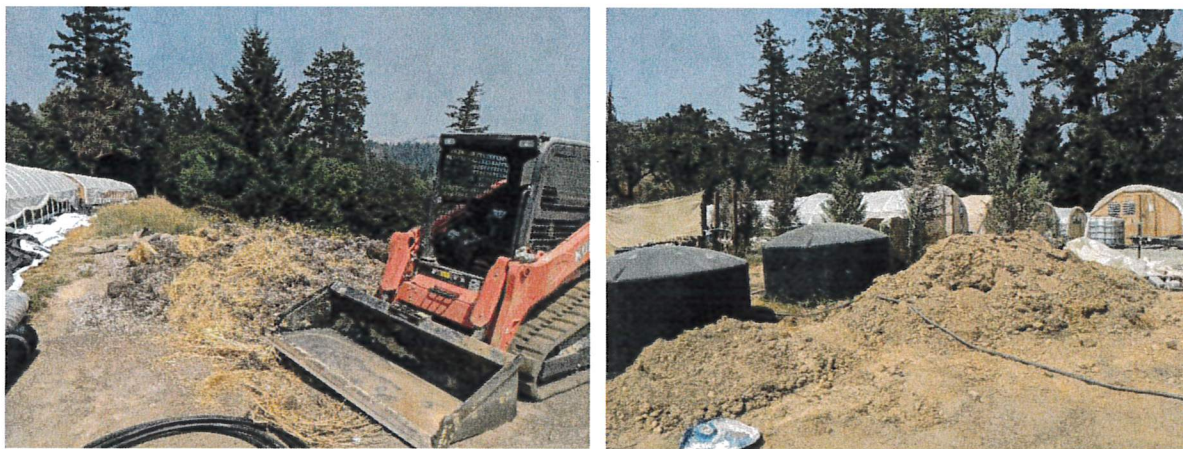
Figure 4: M1RM#4 Spent Potting Soil & Grading Spoils

Map Feature	Description	Corrective Action	Priority (1 Highest – 4 Lowest) & Anticipated Completion Date.
M1RM#4	Grading spoils & spent potting soil	Remove spent potting soil from near slope. Consolidate, cover with secured tarps, & surround with straw wattles prior to rain events or wet season.	Priority 3, October 1 st 2018

Spent potting soil has been located on the edge of the flat near the hill slope. The slope is vegetated and no delivery appears to have occurred to any nearby water courses. Prior to the 2018-2019 wet season, it is recommended that spent soil and spoils be located on flat ground, away from watercourses, and covered. Further, any disturbed earth on the graded flat should be either surfaced with gravel or covered with straw and seeded with native grass seed.

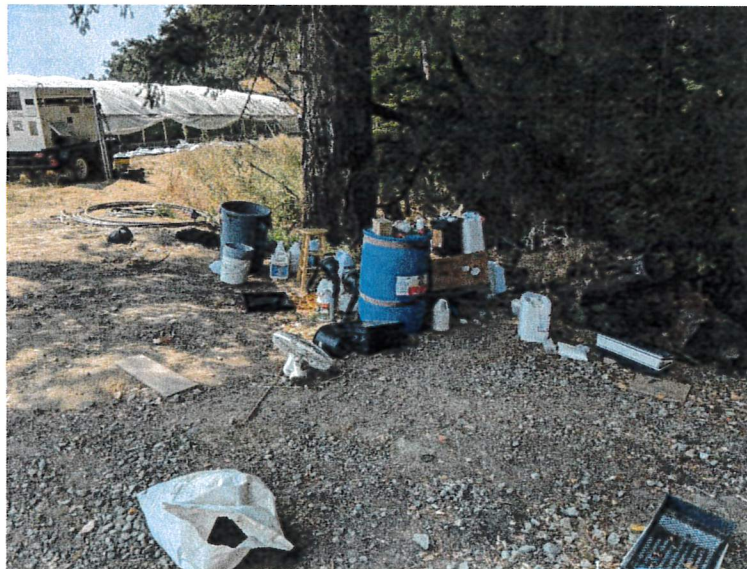
Map Feature M1RM#5

Map Feature	Description	Corrective Action	Priority (1 Highest – 4 Lowest) & Anticipated Completion Date.
M1RM#5	Spent nutrient containers	Nutrient containers when not in use should be stored in the shed on the flat, in secondary containment. Spent containers should be stored similarly until disposed of appropriately.	Priority 3, October 1 st 2018

Figure 5: M1RM#5 Storage of nutrient containers

Nutrient containers have been stored inappropriately, but do not appear to be located near any watercourses, nor contributing to nutrient rich runoff. Prior to the 2018-2019 wet season, it is recommended that all containers be relocated to a covered area when not in immediate use and spent containers be stored in a covered area until disposed of at an appropriate facility.

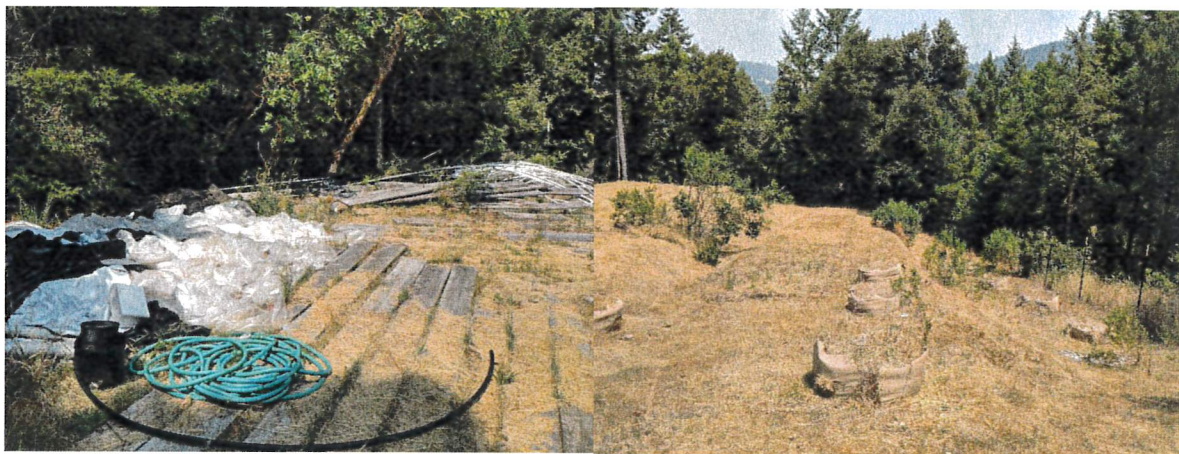
Map Feature M2RM#3

Map Feature	Description	Corrective Action	Priority (1 Highest – 4 Lowest) & Anticipated Completion Date.
M2RM#3	Legacy Cultivation area	Remove remaining cultivation/construction supplies consisting of plastic and fence posts.	Priority 4, October 1 st 2020

Figure 7: Remaining construction materials & soil bags

This legacy cultivation flat was constructed on a natural bench along a ridgeline. It is currently vegetated with grasses and small shrubs and appears stable. Cultivation is no longer occurring on the flat but some cultivation related materials remain. Soil bags should be removed, and potting soil should be brought back to an area designated for soil disposal near the main operation. Construction materials and supplies should be removed including uncovered rebar. It is unlikely that regrading would provide any substantial benefit to the habitat or landscape, and would potentially liberate sediment during construction. Therefore, after removal of all cultivation soil and supplies, the site may be abandoned and allowed to further revegetate naturally.

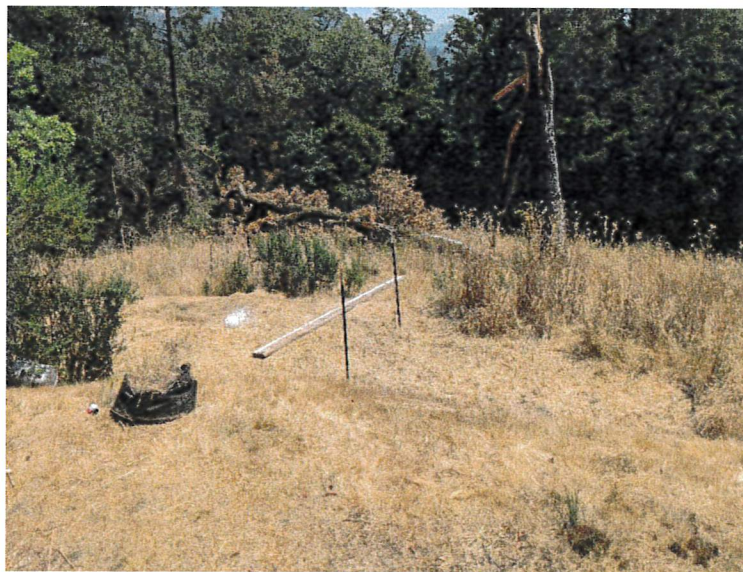
Map Feature M2RM#4

Map Feature	Description	Corrective Action	Priority (1 Highest – 4 Lowest) & Anticipated Completion Date.
M2RM#4	Legacy Cultivation area	Remove remaining cultivation/construction supplies consisting primarily of metal fence posts and miscellaneous debris.	Priority 4, October 1 st 2020

Little to no grading appears to have occurred at this legacy site. Removal of debris should effectively restore the site to near-native conditions.

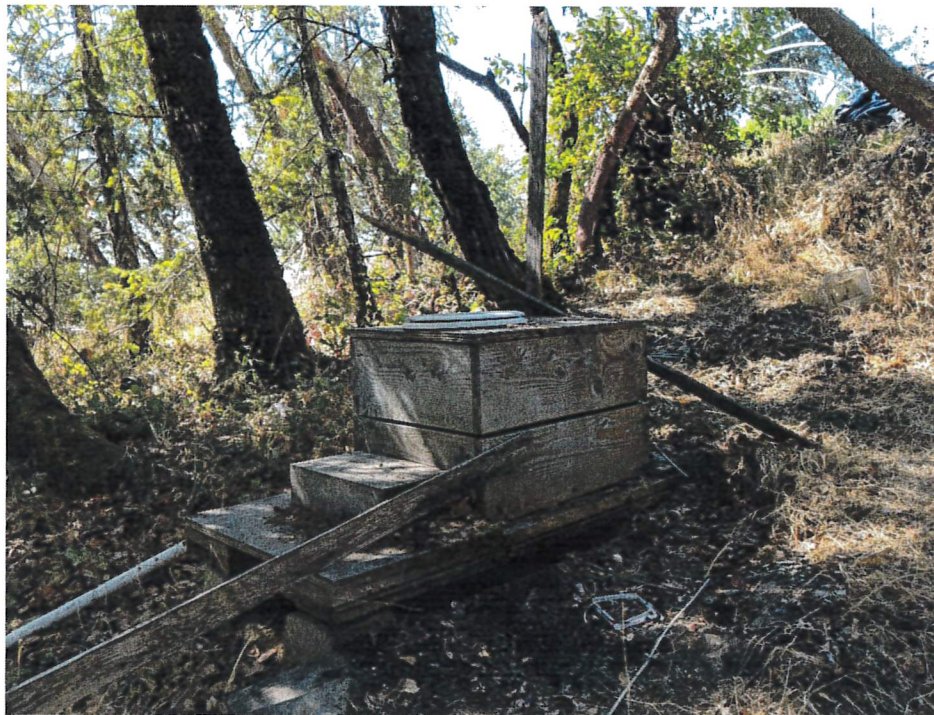
Map Feature M3RM#1

Map Feature	Description	Corrective Action	Priority (1 Highest – 4 Lowest) & Anticipated Completion Date.
M3RM#1	Legacy Outhouse	Per instruction from Humboldt County Department of Environmental Health: Fill in outhouse pit and remove toilet.	Priority 2, October 1 st 2019

Figure 8: Legacy outhouse pit, M3RM#1

All use of this toilet has already ceased per cultivation manager, and staff are instead using the portable toilet located on site. OurEvolution recommends that an additional portable toilet be located closer to this work area to encourage compliance among staff. (See M3RM#5 below).

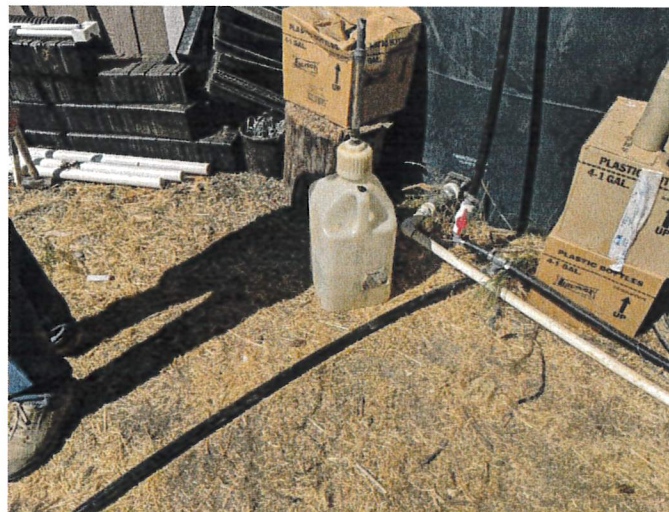
Map Feature M3RM#2

Map Feature	Description	Corrective Action	Priority (1 Highest – 4 Lowest) & Anticipated Completion Date.
M3RM#2	Portable Generator / Fuel Canisters	Fuel canisters should be labeled and stored as described in the section below related to petroleum products. Generator should be stored similarly unless in immediate use. Refueling should occur only in designated areas with appropriate spill-prevention and cleanup kit.	Priority 3, October 1 st 2018

Figure 9: Unlabeled fuel canister stored without cover or secondary containment.

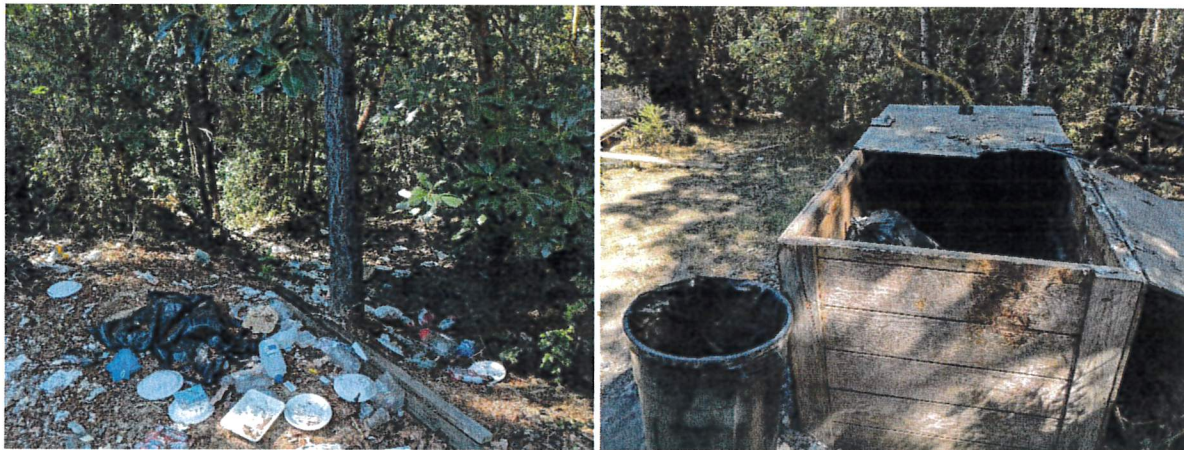
Map Feature M3RM#3

Map Feature	Description	Corrective Action	Priority (1 Highest – 4 Lowest) & Anticipated Completion Date.
M3RM#3	Trash/Refuse Pile	Store in designated area prior to	Priority 3, October 1 st 2018

Figure 10: One bag of trash appears to have been ripped open, but over all trash is stored in a covered storage bin, pictured right.

Overall trash and refuse is handled appropriately, stored in a covered area and disposed of regularly. It However, it appears one bag of trash was ripped open by animals behind the nearby structure. This should be cleaned up/removed, but no change in procedure for handling refuse appears necessary.

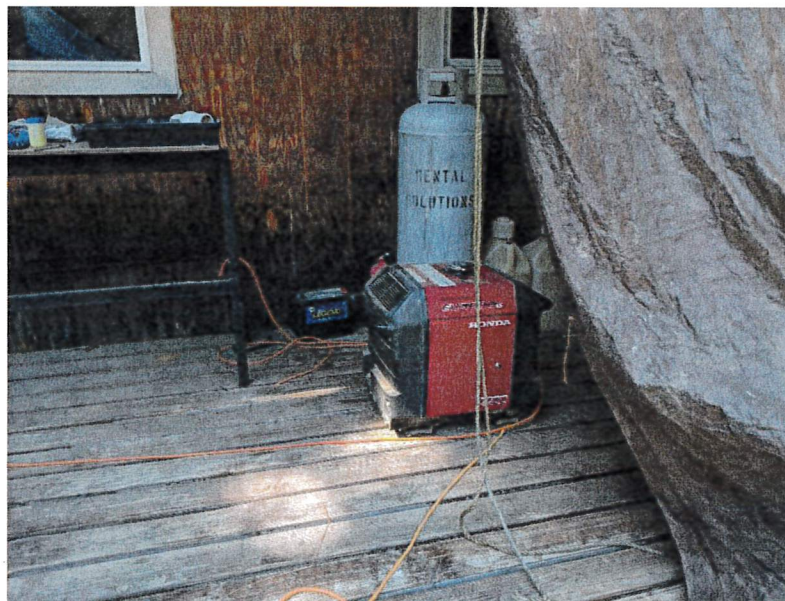
Map Feature M3RM#4

Map Feature	Description	Corrective Action	Priority (1 Highest – 4 Lowest) & Anticipated Completion Date.
M3RM#4	Portable Generator / Fuel Canisters	Fuel canisters should be labeled and stored as described in the section below related to petroleum products. Refueling should occur only in designated areas with appropriate spill-prevention and cleanup kit.	Priority 3, October 1 st 2018

Figure 11: Portable gas canisters stored without secondary containment.

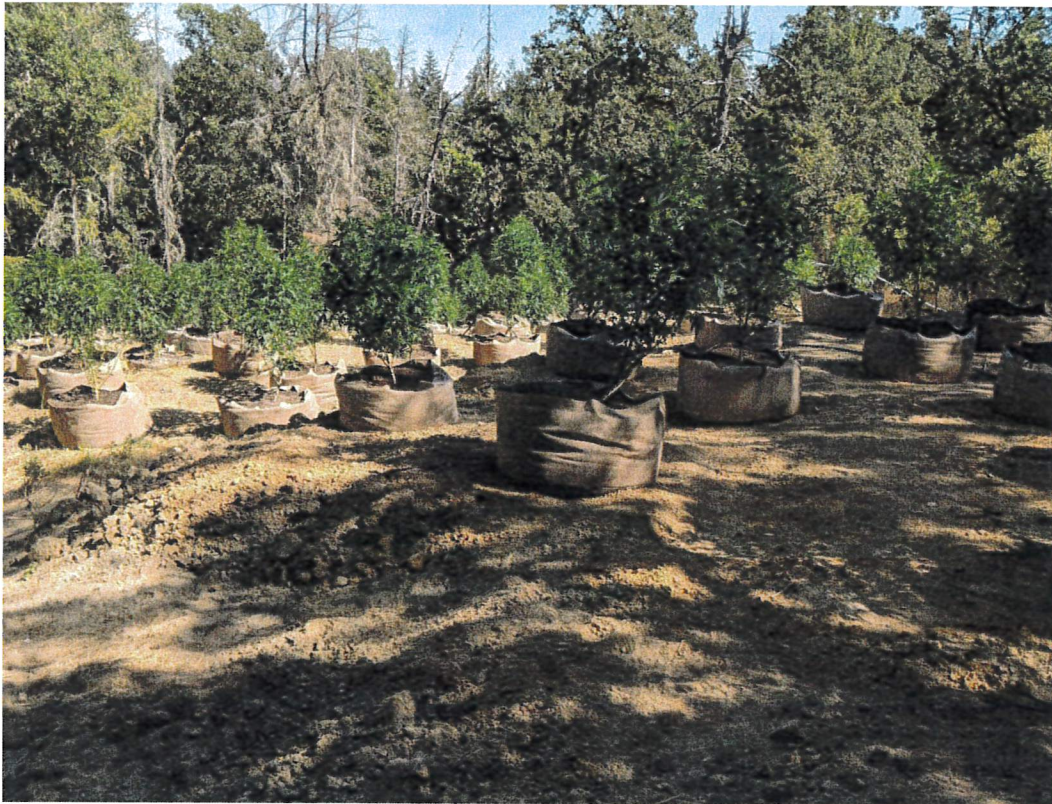
Map Feature M3RM#6

Map Feature	Description	Corrective Action	Priority (1 Highest – 4 Lowest) & Anticipated Completion Date.
M3RM#6	Disturbed Earth	Apply straw and Caltrans grass seed mix to all areas with disturbed earth.	Priority 3, October 1 st 2019

Figure 12: Disturbed earth near cultivation area

There is a small section of disturbed earth near the cultivation area. OurEvolution recommends applying straw and grass seed to all areas with exposed earth with repeated application until vegetated. No active discharge of sediment to waters of the state was noted since a vegetated perimeter surrounds the site.

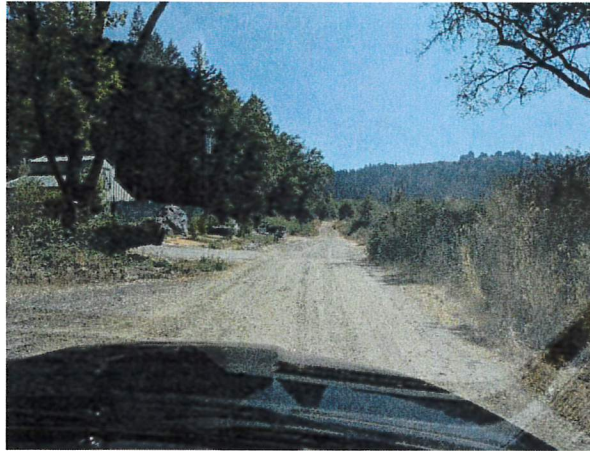
Gravel road in good condition, no substantial cur

Figure 1: Typical Road Section

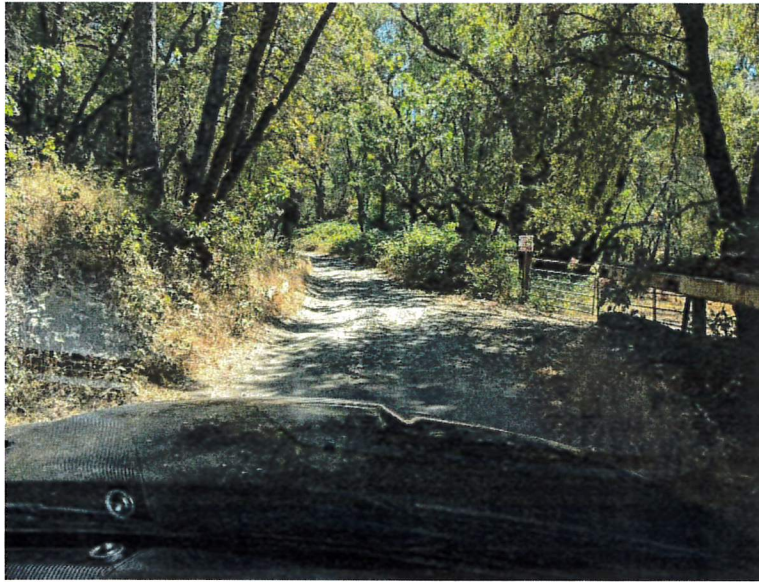
Figure 3: Driveway / turnout area, STA: 18+31FT

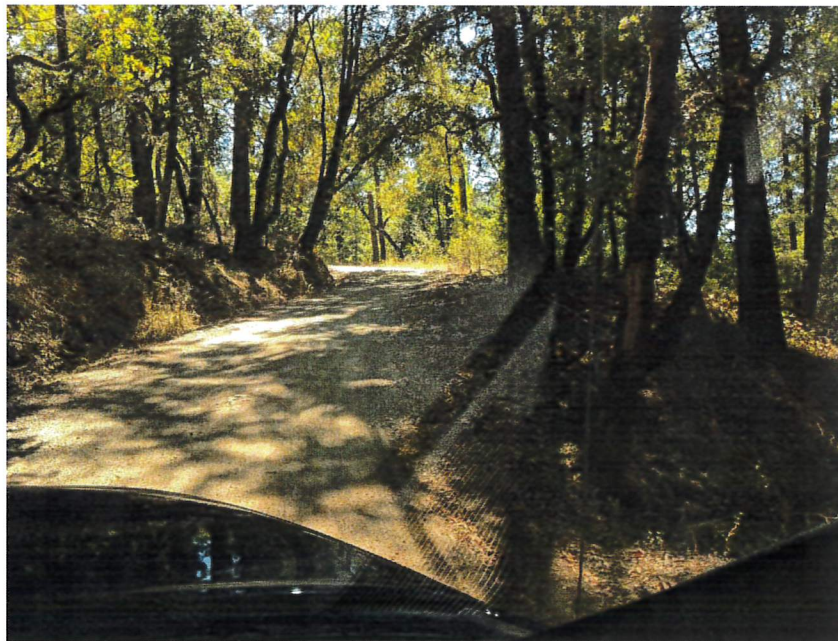
Figure 4: Road and widened shoulder sufficient to allow vehicles to pass.

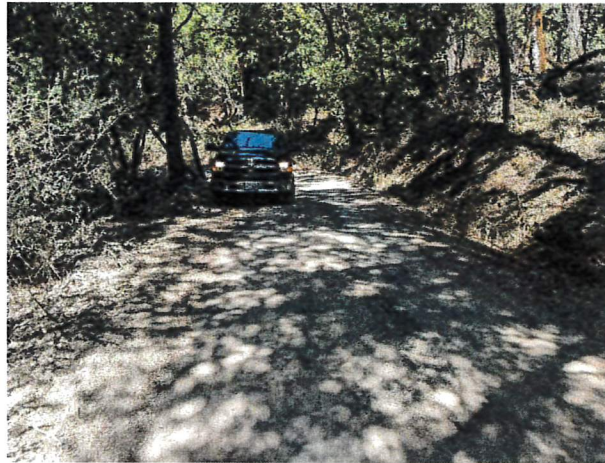
Overall Description:
Gravel road in good condition, one curve of approach standard.

Figure 5: Typical Section, road segment #2

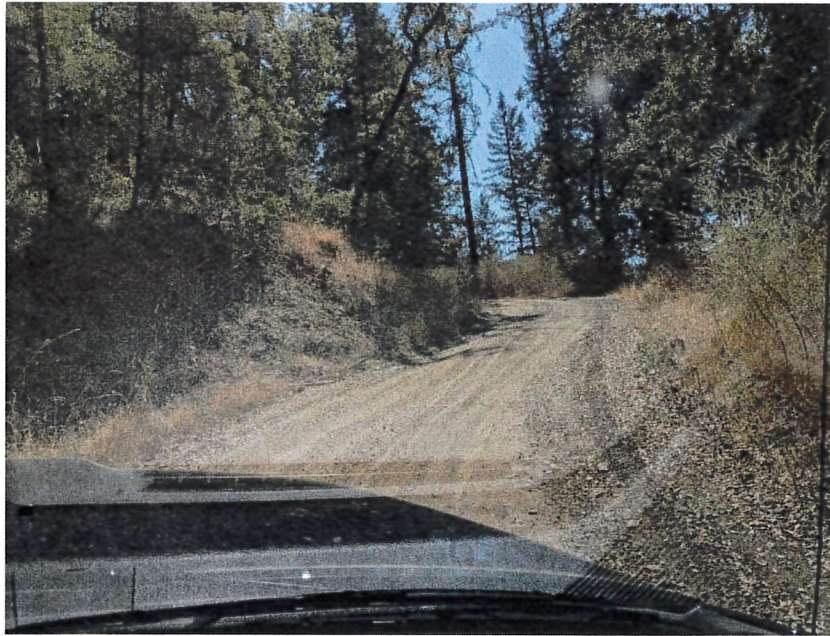
Figure 6: Road segment 4 typical section

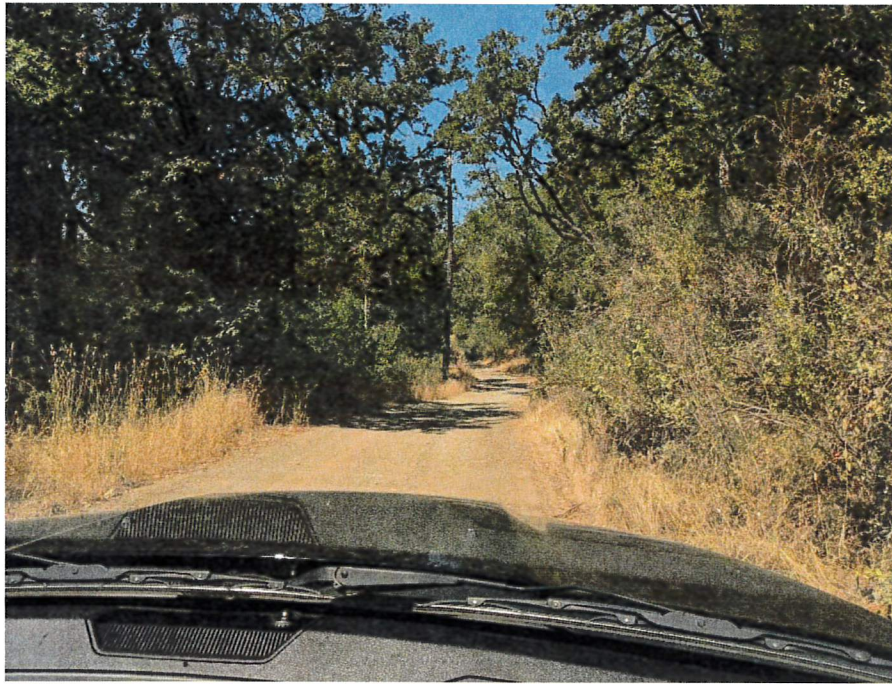
Figure 7: Vehicle pass point with good visibility STA:38+59FT

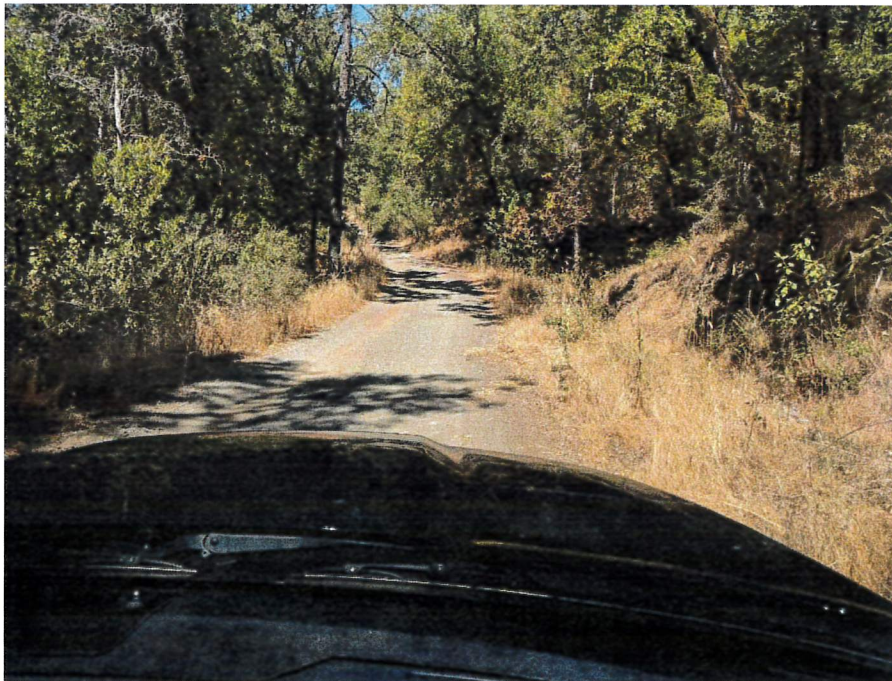
Figure 8: Widened shoulder to the right sufficient to allow vehicles to pass. STA:39+71FT
