OMSBERG & PRESTON

ROAD EVALUATION REPORT for
STAPP & SHOWER'S PASS ROAD
BRIDGVILLE, CALIFORNIA
APN 317-033-006

July 15, 2019
(Job. No. 16-1924)

Road Evaluation – Supporting Information (Imagery)

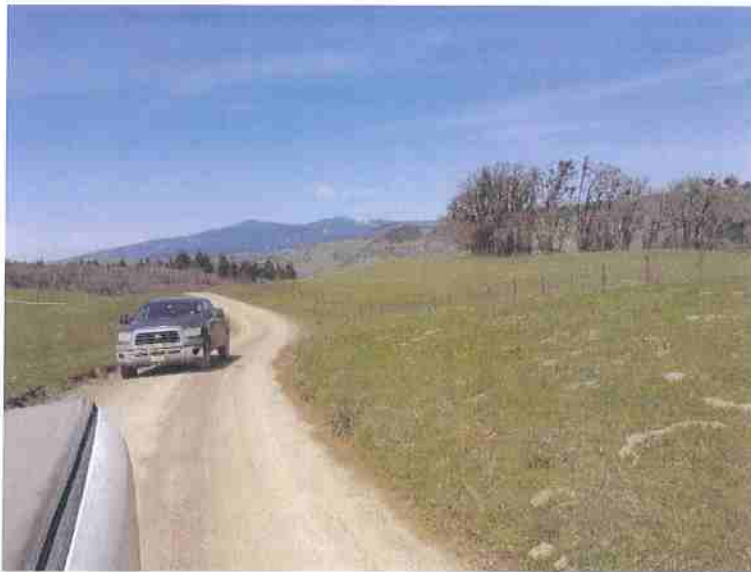
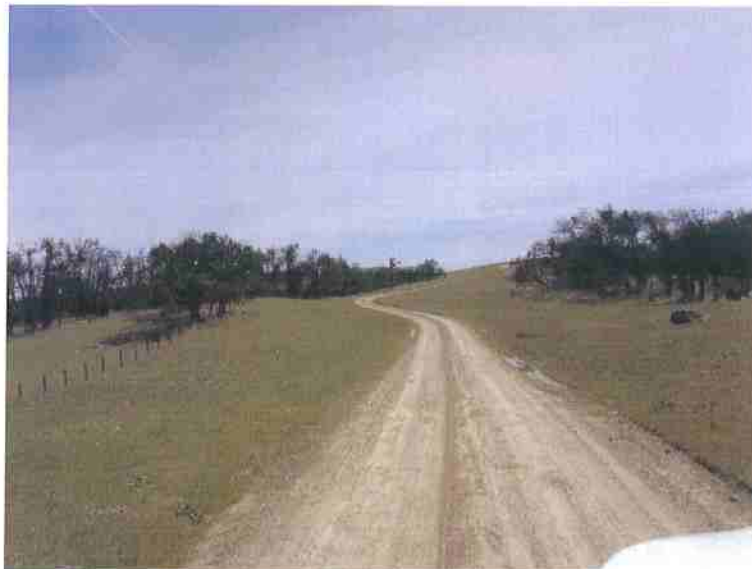
Mile 4.0 (4-mile Marker on Shower's Pass Road): 0+15+0=15ft wide road prism; Good visibility and sight distance. Recommend a constructing a rocked turnout in this area.

Mile Marker (Road Specific)	Contineuous Mile Marker (From 4mi Post)	Travel Way (ft)	Site Visit Notes	Recommendations	Priority
4.0	0.0	15	Start of Road Eval., 4-Mile post on Shower's Pass Road. Could use rocked turnout in this area	Install RH turnout	Low

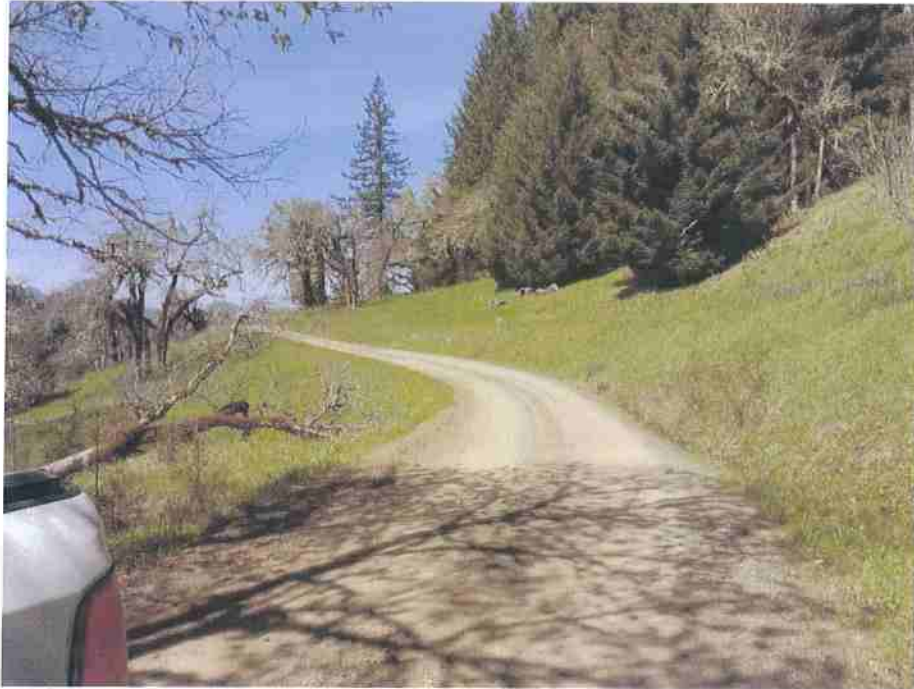
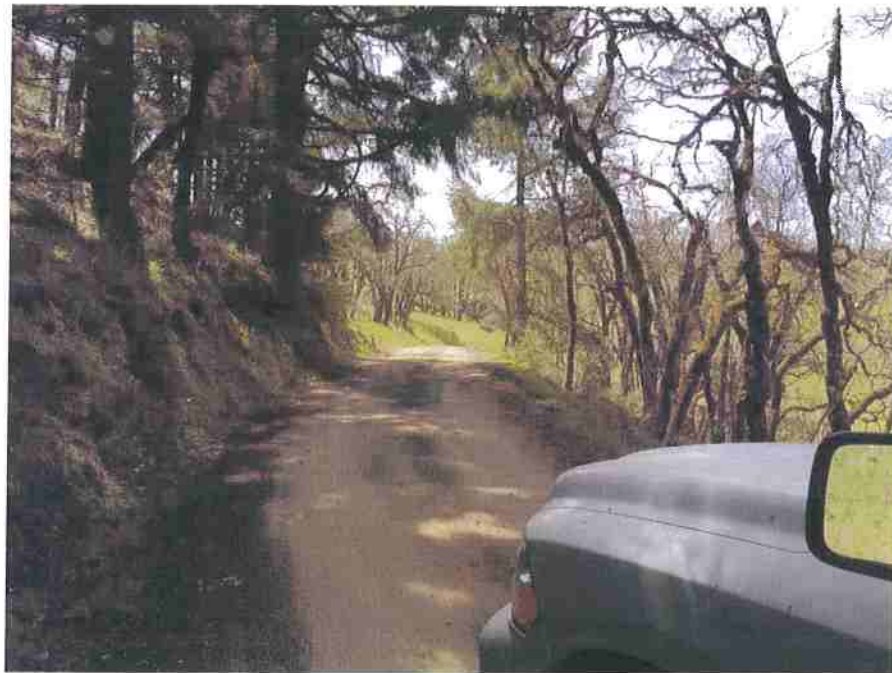
Mile 4.5 (Shower's Pass Road): 0+18+0=18ft wide road prism; Good visibility and sight distance.
Forward

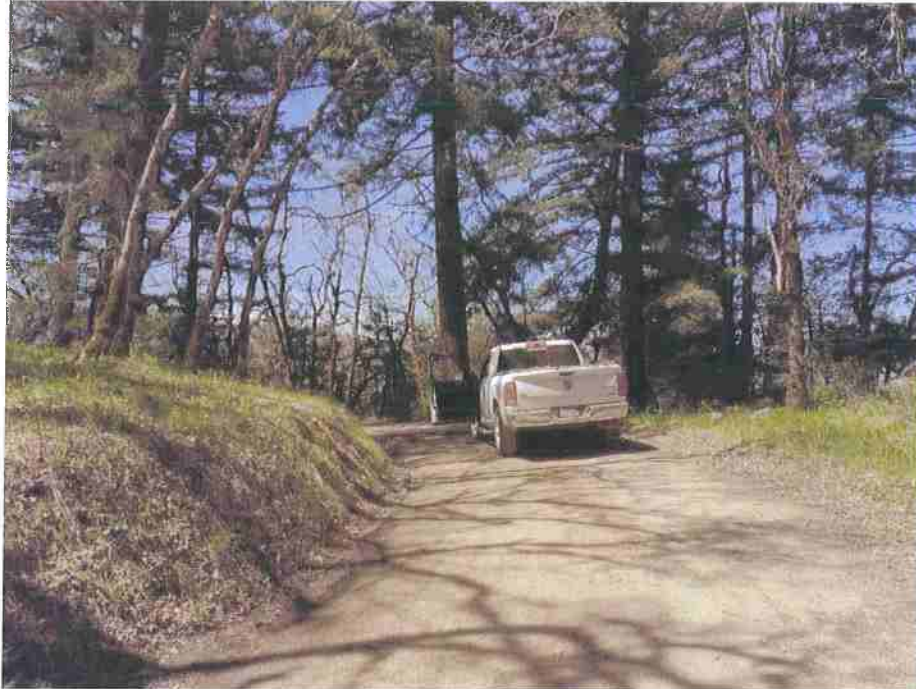
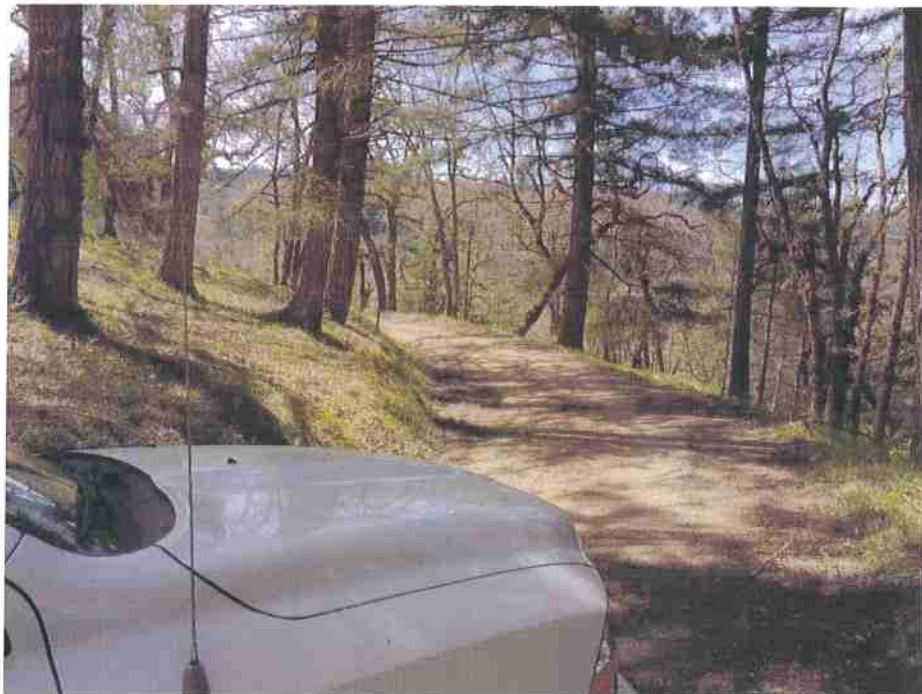
Forward

At MP 4.9 on Shower's Pass road, a curve has poor sight distance and has recommended improvements. Otherwise, narrow spots have adequate turnout-options and/or sight distance and meet the intent of Road Category 4 standards. Other minor problem areas are identified in the "Supporting Information" section of the report.

Mile 4.9 (Shower's Pass Road): $0+16+2=18$ ft wide road prism; curve with inadequate site distance and visibility, recommend "shaving" off rounded corner on left side of top photo for better visibility.

We recommend a turnout be constructed at MP 4.9 on Shower's Pass Road due to inadequate sight distance around the curve. This improvement would be appropriate for a single applicant to be responsible for.

4.2	0.2	-	Turn off to Fort Baker Ranch		
4.3	0.3	-	Rock query		
4.5	0.5	18	GSD		
4.9	0.9	-	Curve w/ inadequate S.D., shave off curve - Pictures	Remove material from RH cut-bank for better sight distance. Deposit material on roadway & cover with gravel	Med

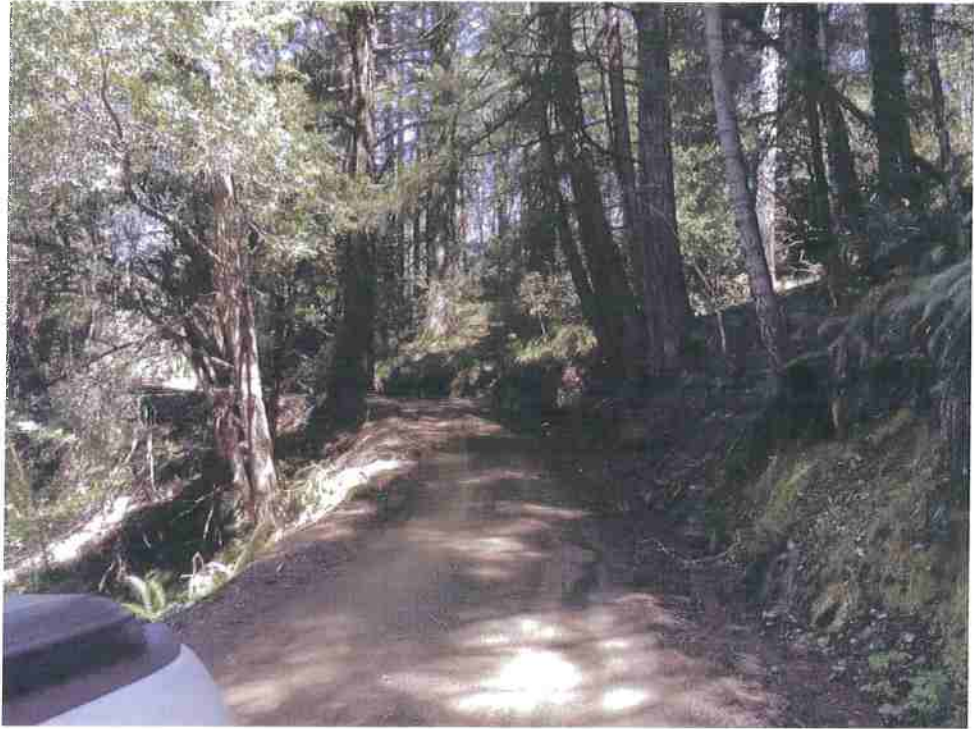
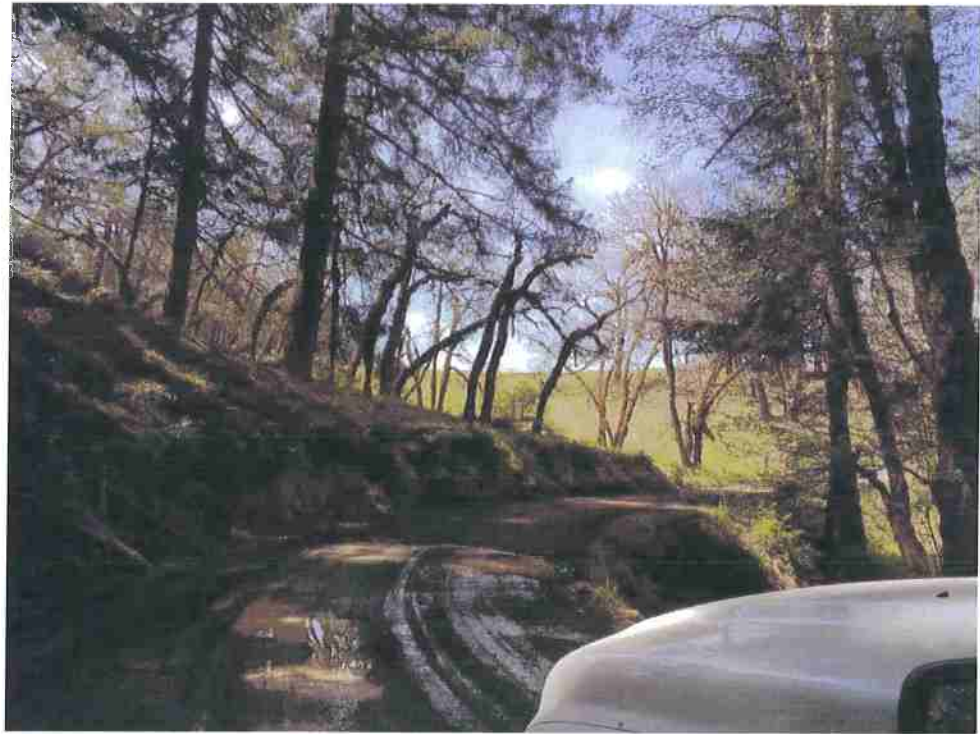
Mile 5.0 (Shower's Pass Road): 0+16+0=16ft wide road prism; Good visibility and sight distance.
Forward

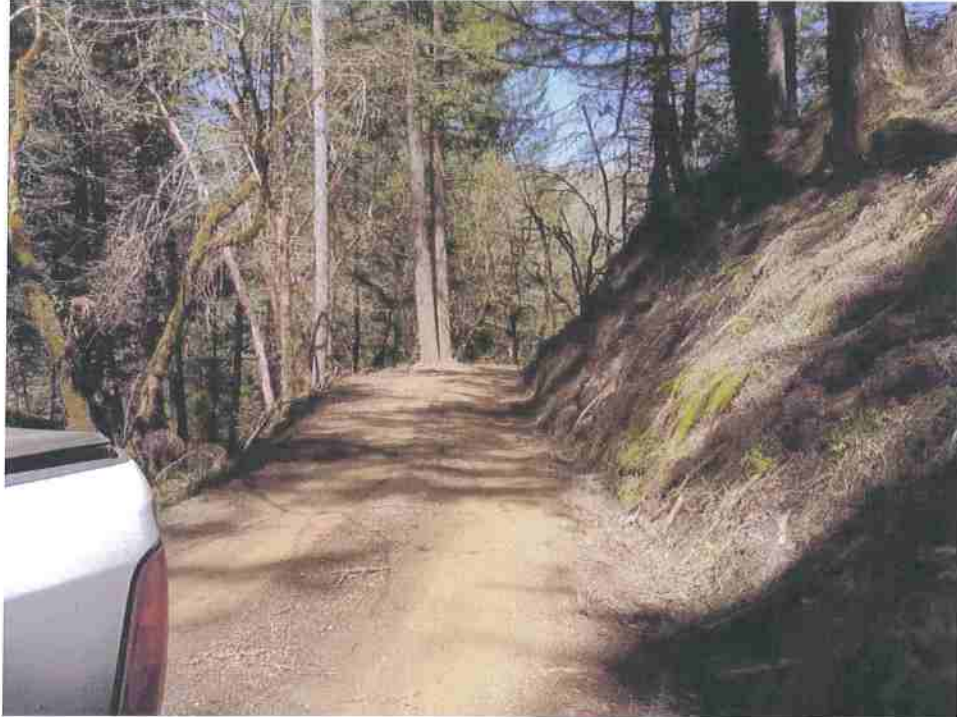
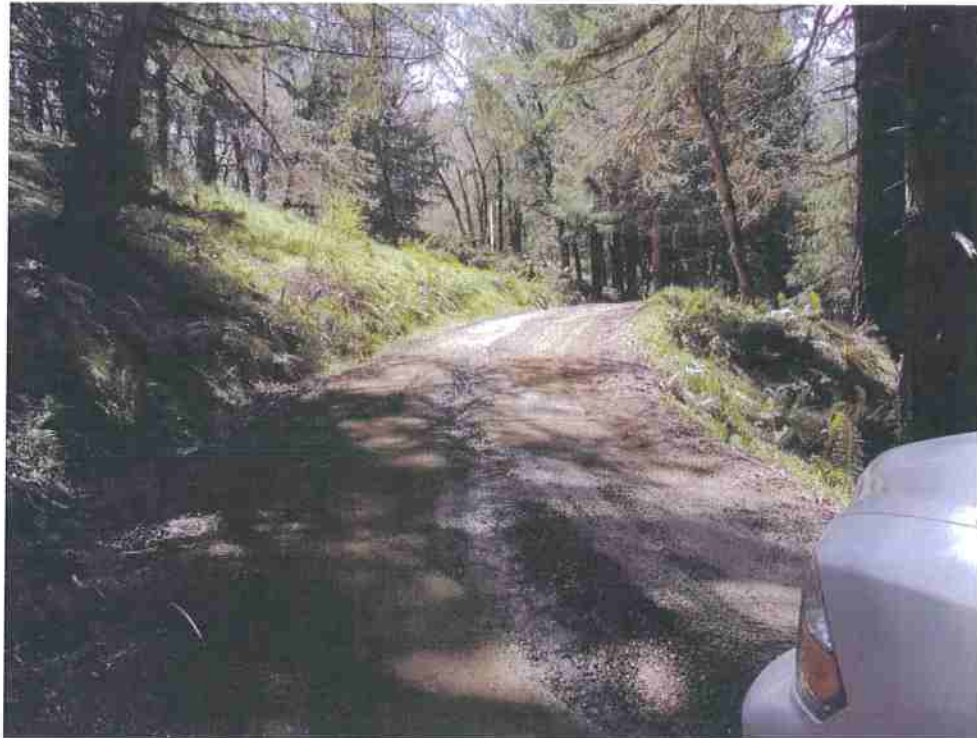
Mile 5.5 (Shower's Pass Road): $2+13+3=18$ ft wide road prism; Good visibility and sight distance; wet area, consider installing drainage features.

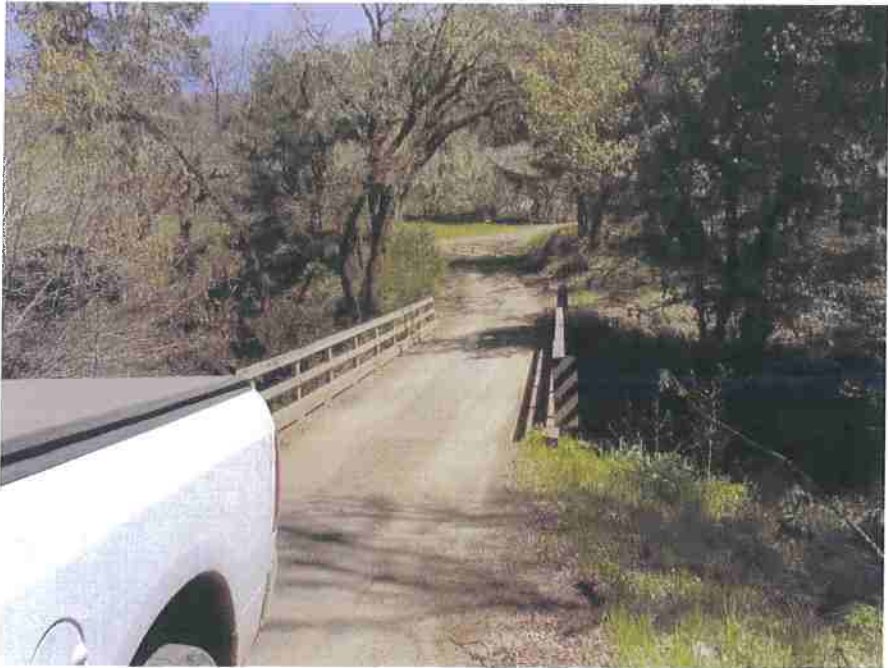
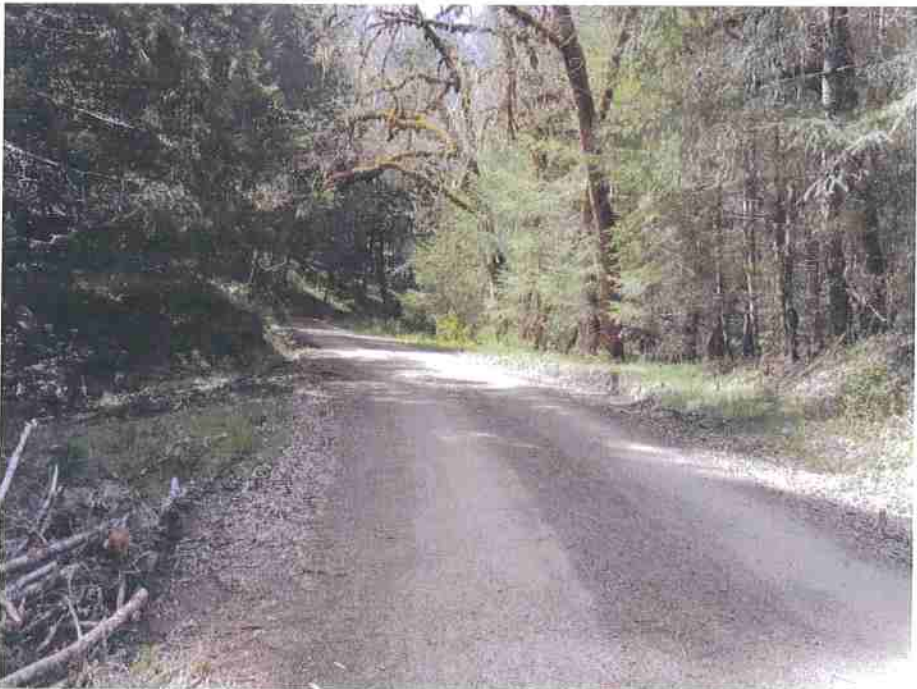
Mile 6.0 (Shower's Pass Road): 5+15+0=20ft wide road prism; Good visibility and sight distance, one lane bridge with turnouts on both sides of the bridge.

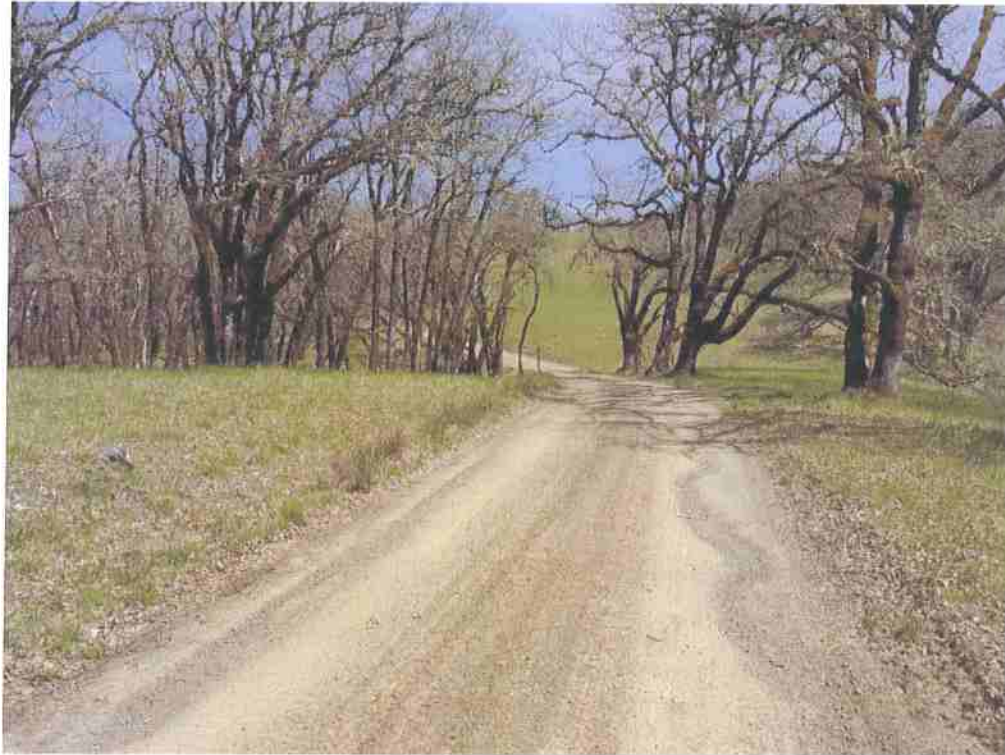
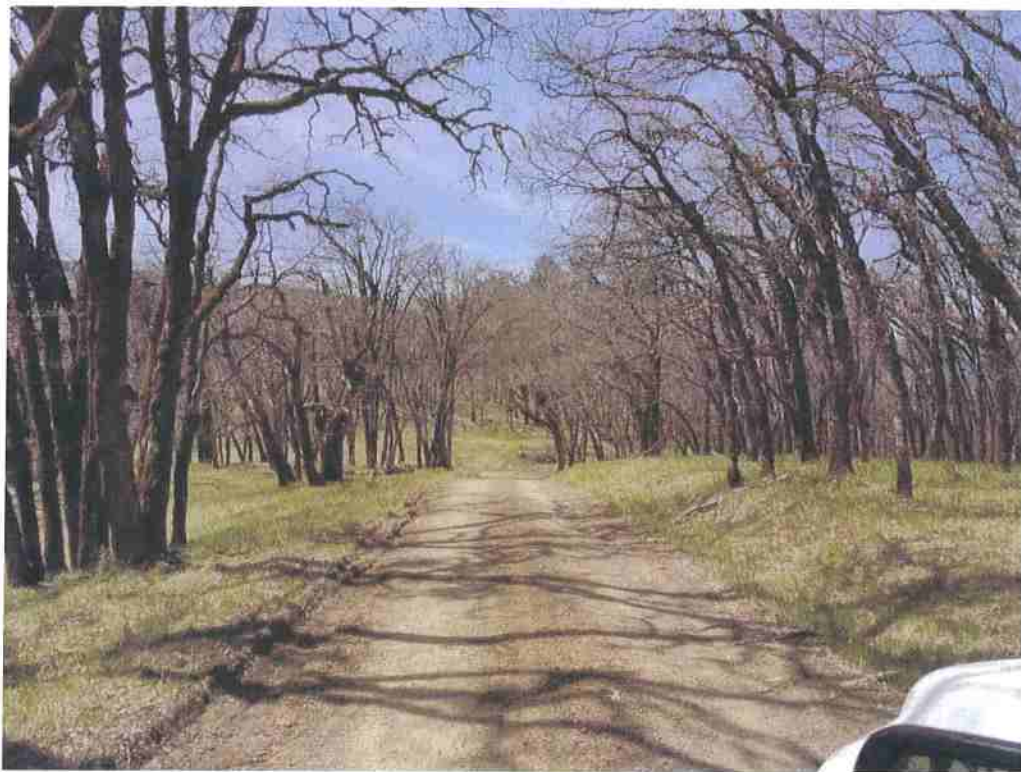
Mile 6.5 (Shower's Pass Road): 2+17+0=19ft wide road prism; Good visibility and sight distance;
Turnouts forward and backward.
Forward

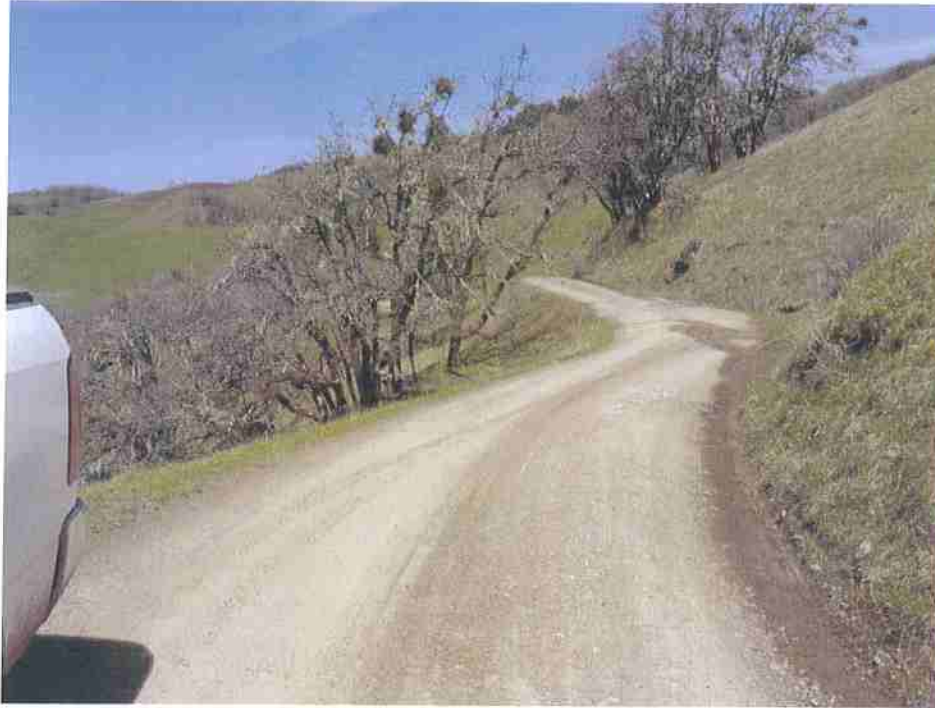
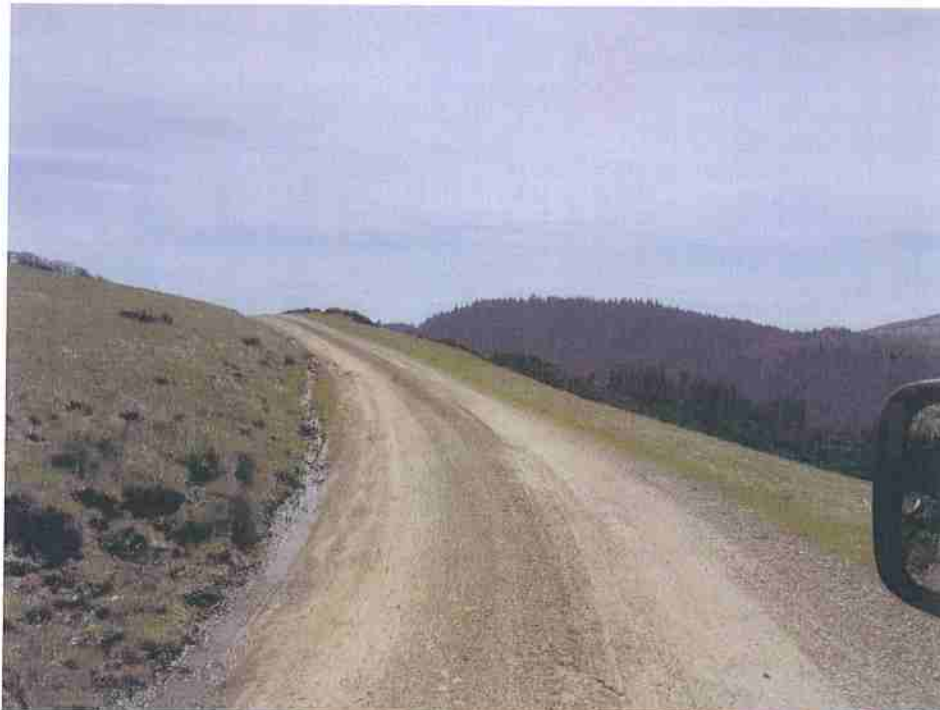
Mile 7.0 (Shower's Pass Road): 0+16+0=16ft wide road prism; Good visibility and sight distance; Turnouts forward and backward.

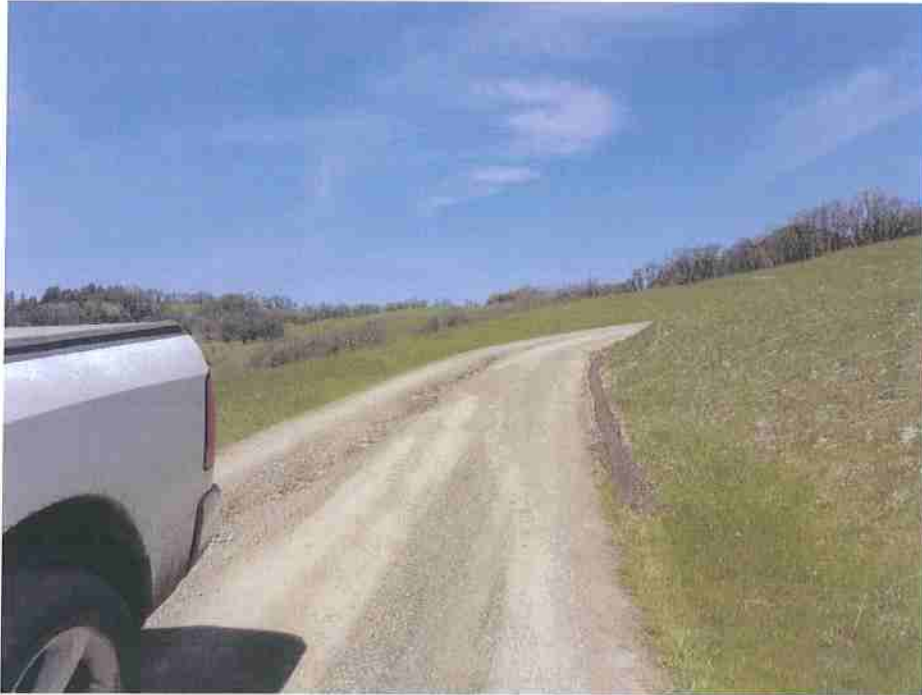
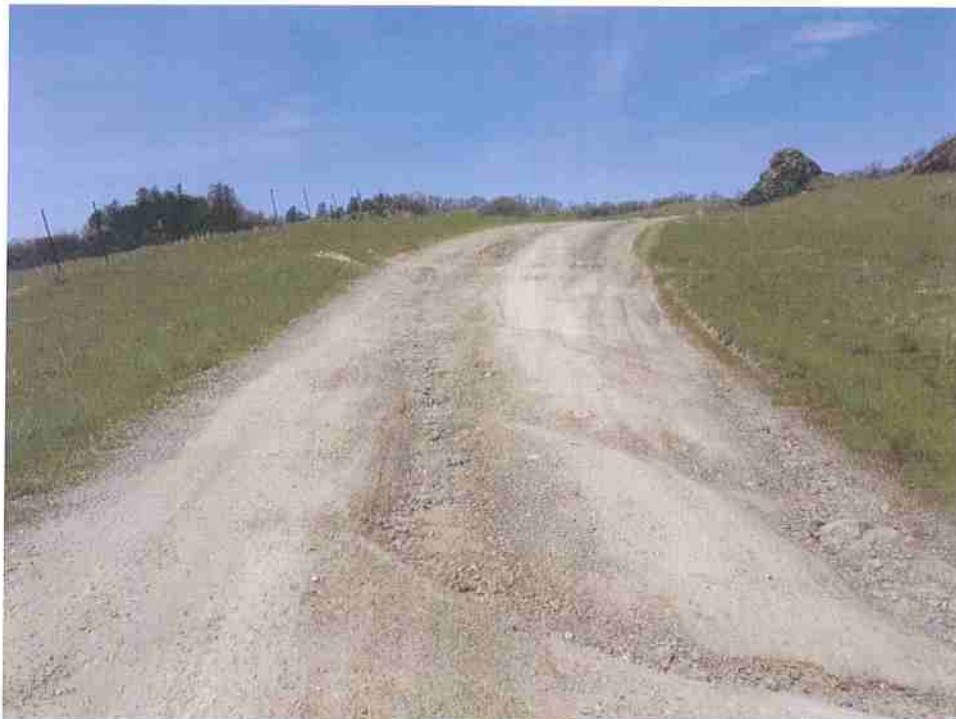
Shower's Pass Road: Severe erosion with steep travel ways was observed from MP 7.5-8.3. See recommendation table for possible improvements.

Mile 7.5 (Shower's Pass Road): 0+16+0=16ft wide road prism; Start of severe roadway erosion, continues until Stapp Road turnoff. Adequate visibility and sight distance.

Shower's Pass Recommendations: The portion of Shower's Pass road from MP 7.5-8.4 is severely eroded through insufficient drainage pathways. In our judgment this portion of Shower's Pass Road is the highest priority for repairs, through drainage grading, rocking & construction of 2-3 turnouts. This would be a large undertaking that should not be shouldered by a single applicant if there are other residents/applicants using this road for access to their parcels.

7.5	3.5	16	GSD, with turnout	Severe erosion from MP 3.5-4.2, recommend regrading lead-off ditches and constructing a RH Turnout	High
7.7	3.7	-	Erosion - pictures

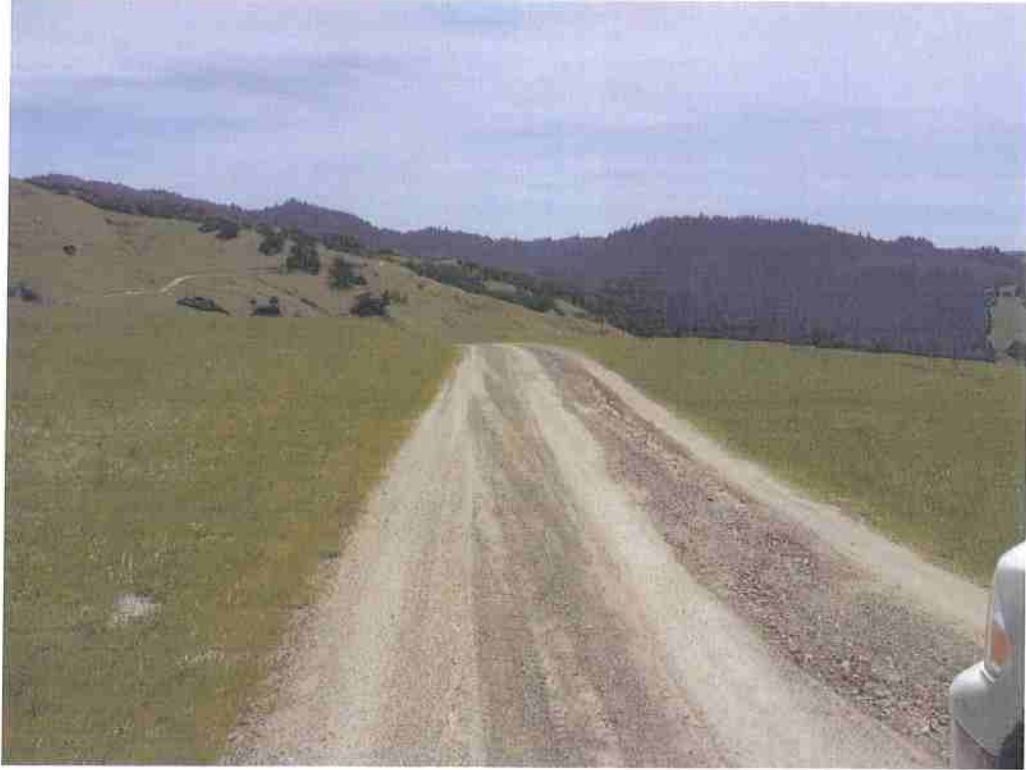
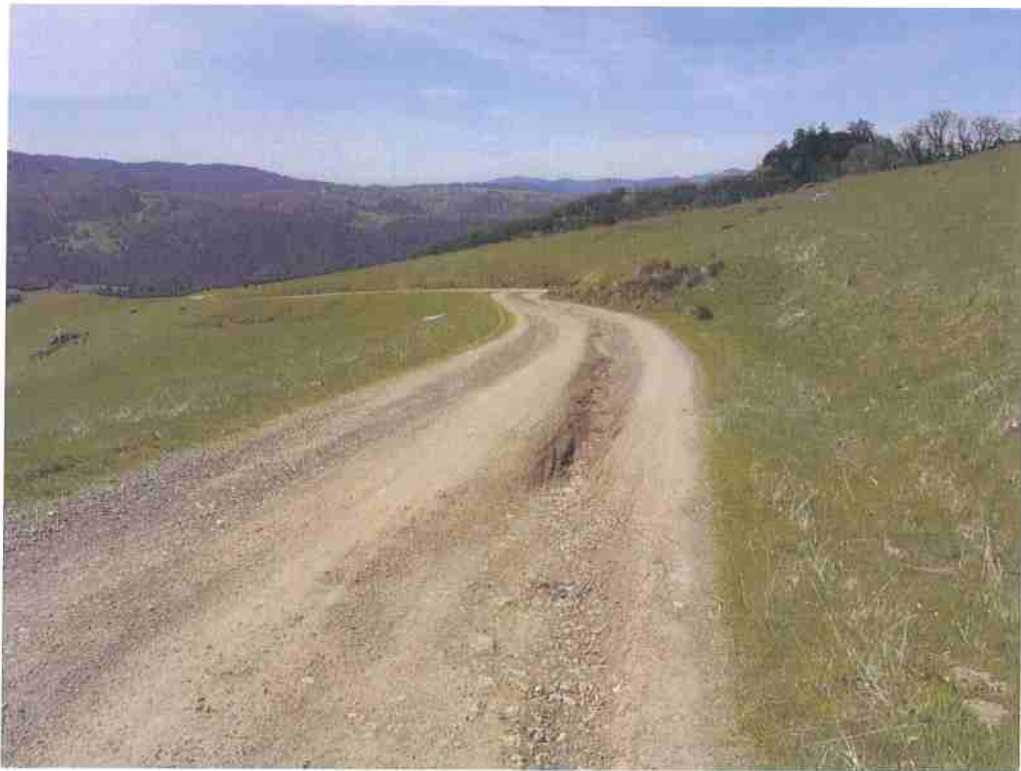
Backward

Mile 7.7 (Shower's Pass Road): 0+16+0=16ft wide road prism; Continuation of severe roadway erosion, continues until Stapp Road turnoff. Adequate visibility and sight distance.

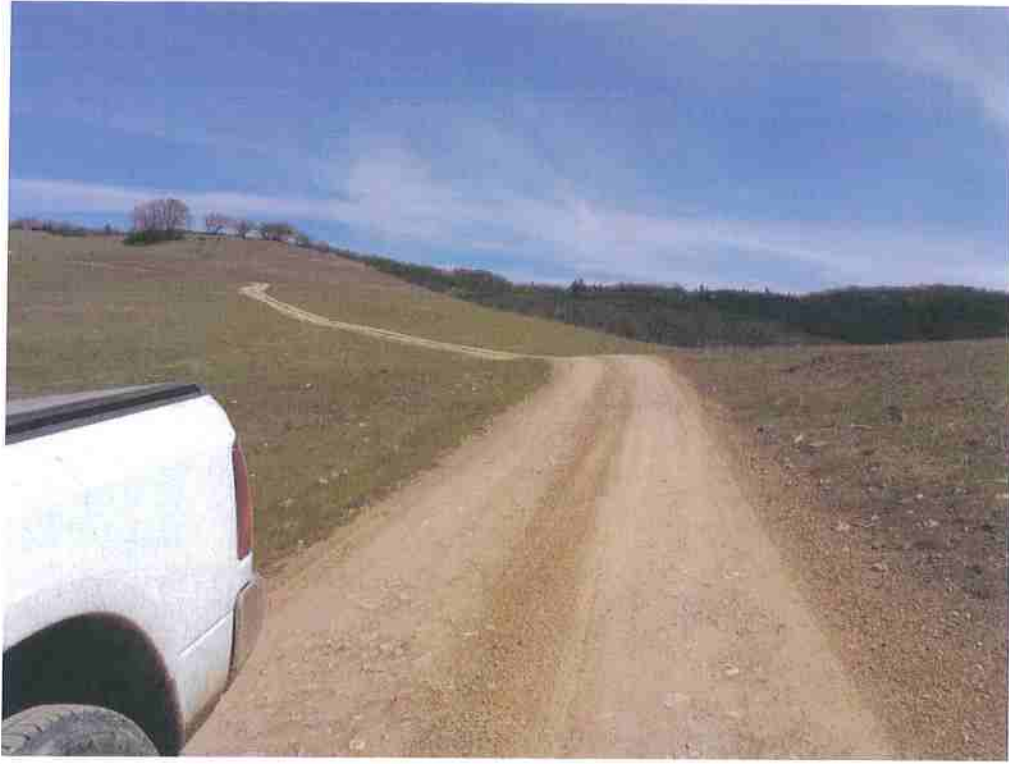
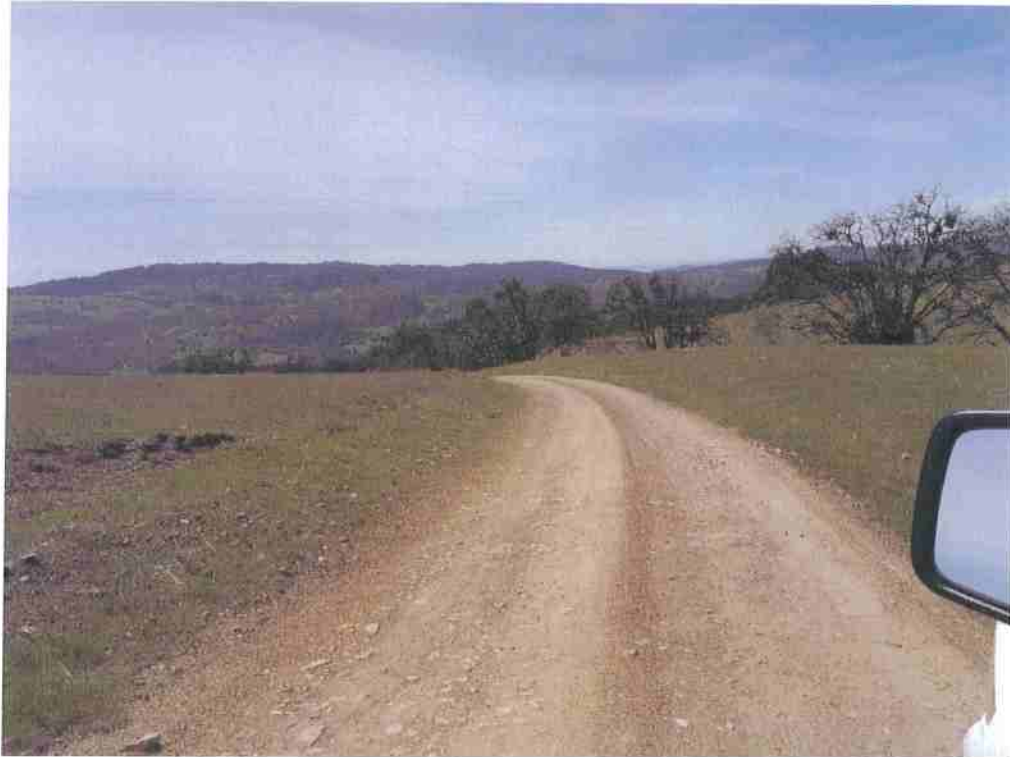
Mile 8.0 (Shower's Pass Road): $1+16+1=18$ ft wide road prism; Good visibility and sight distance; turnouts backwards and forwards.

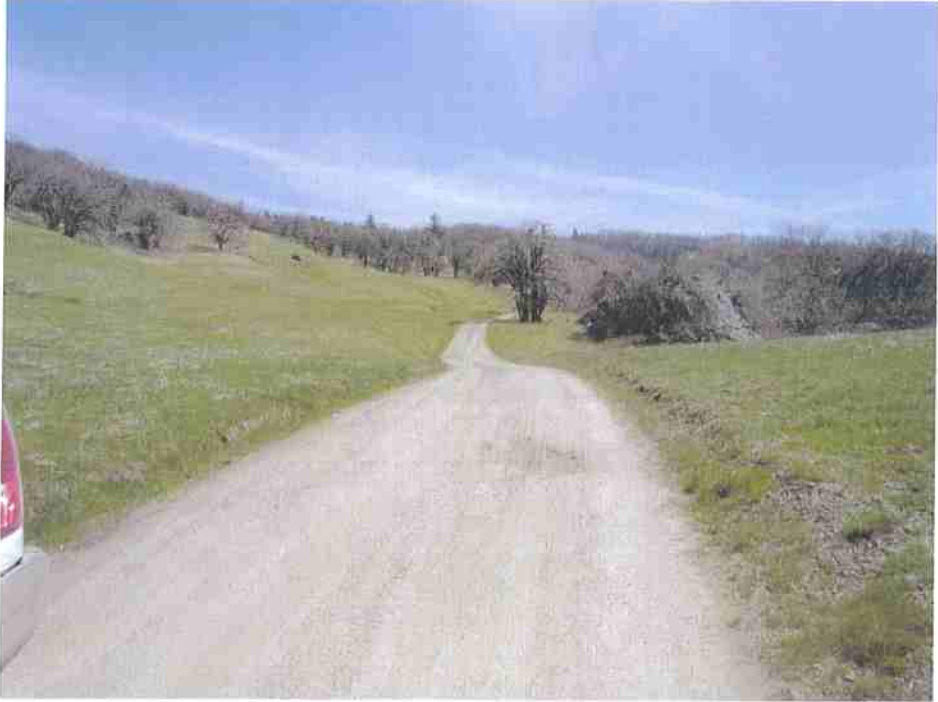
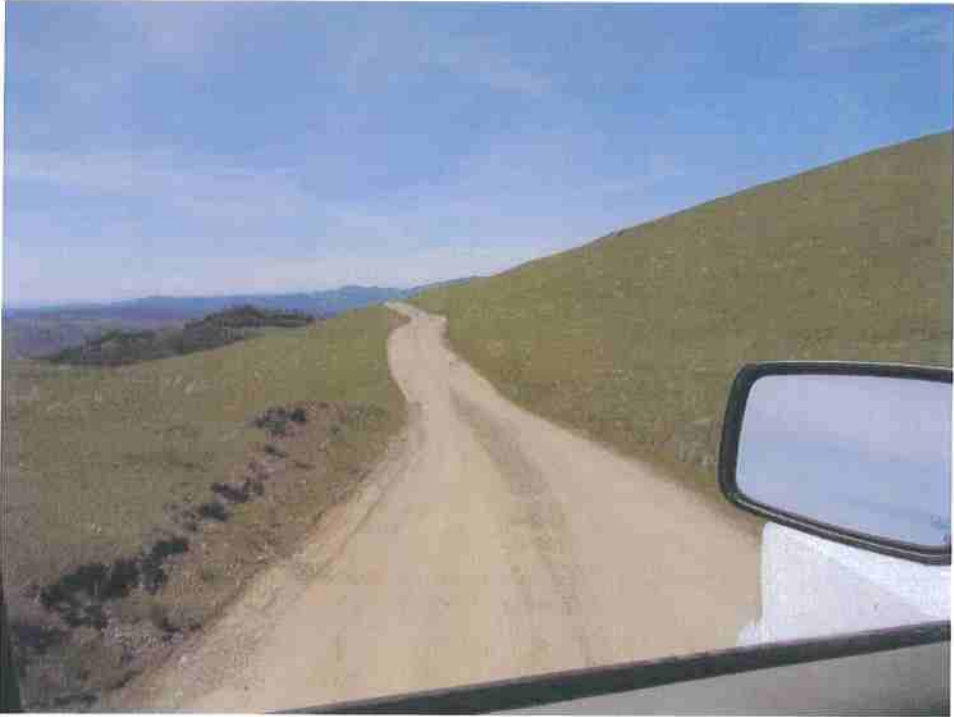
Mile 0.0 (Stapp Road): $0+17+1=17$ ft wide road prism; Shower's Pass Road Intersection at Shower's Pass MP 8.4; Good visibility and sight distance; 0.1 miles from turnout
Forward

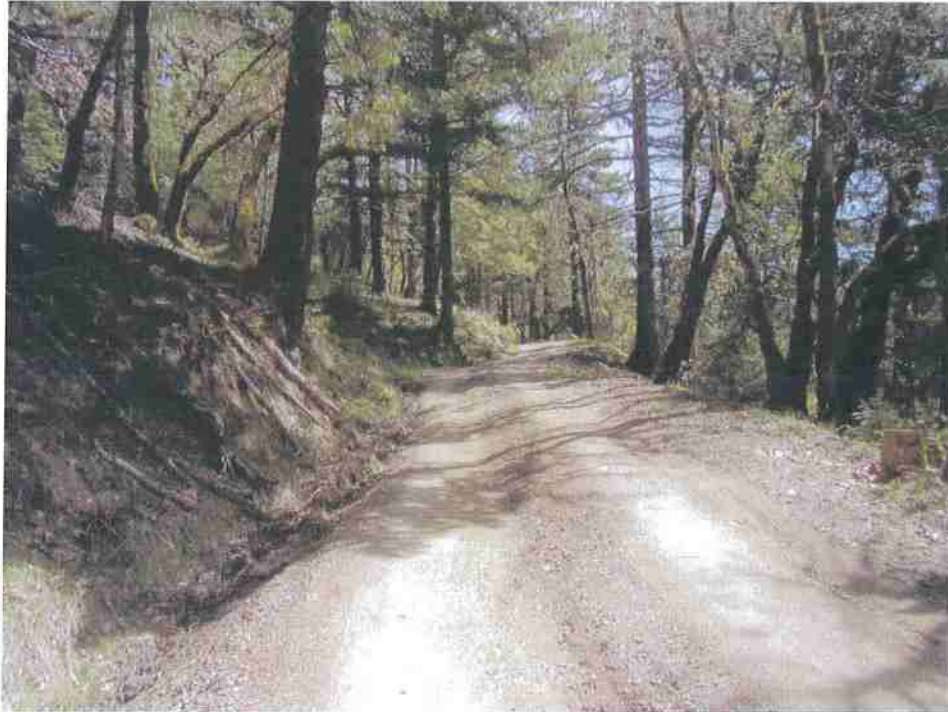
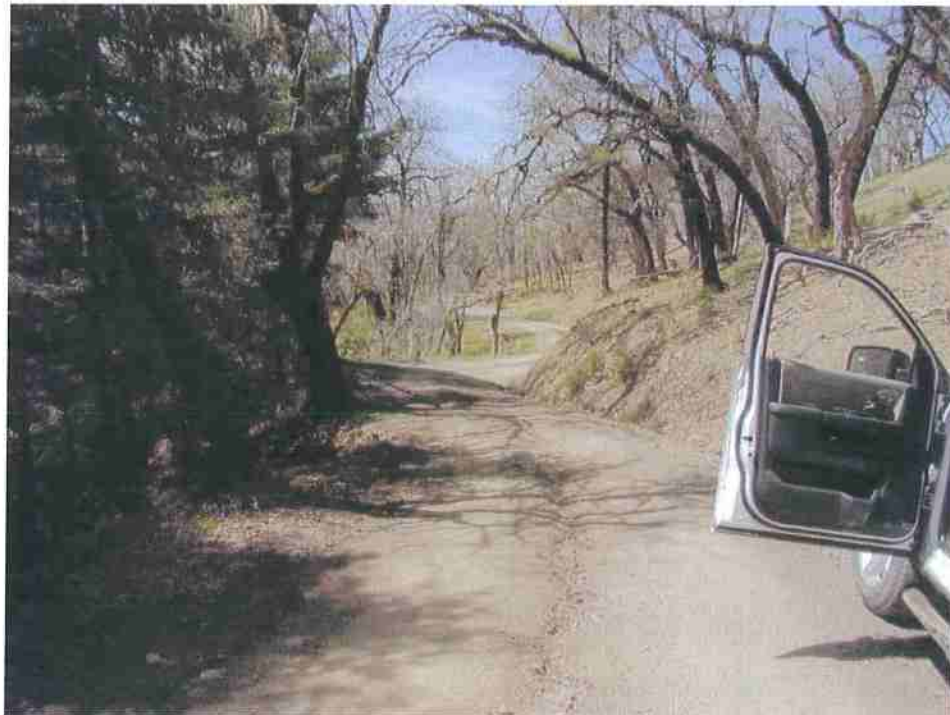
Mile 0.5 (Stapp Road): $3+20+3=26$ ft wide road prism; Adequate visibility and sight distance; wide enough for two lane traffic

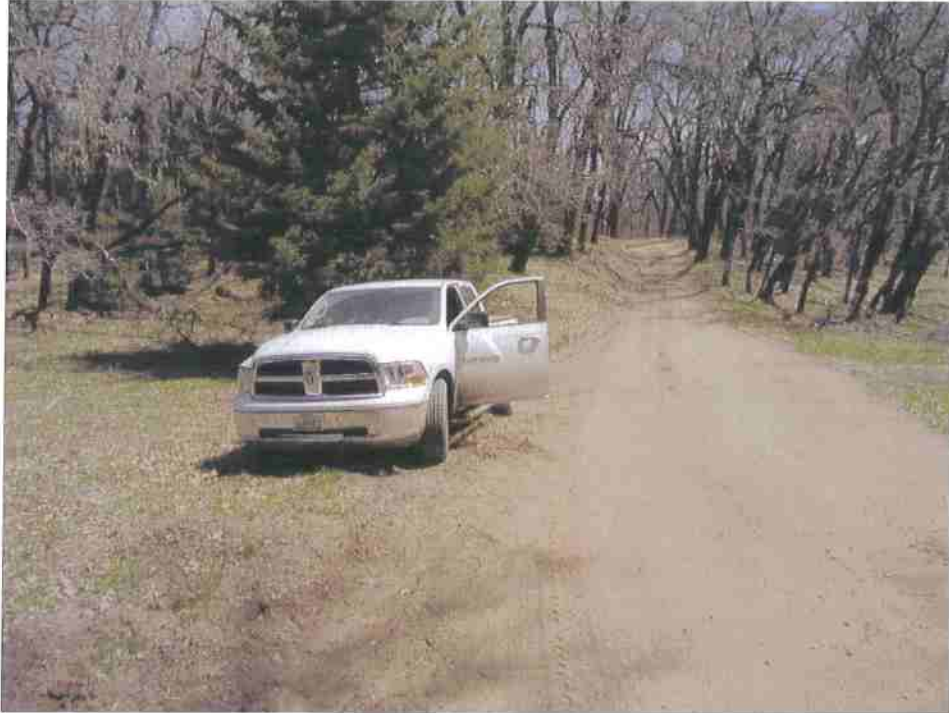
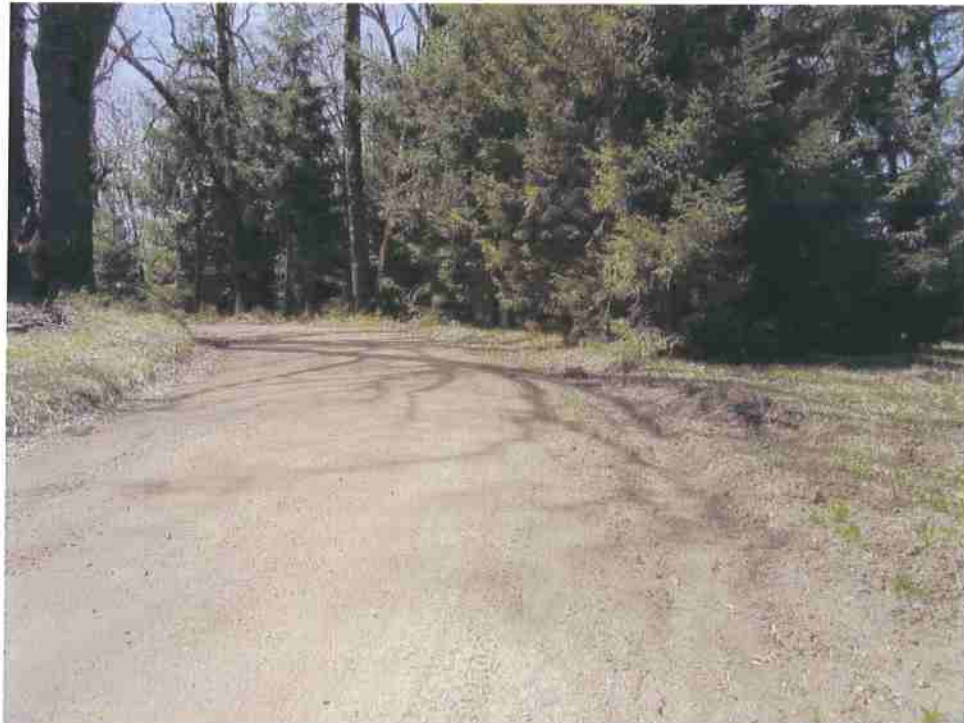
Mile 1.0 (Stapp Road): 3+23+0=26ft wide road prism; Good visibility and site distance; Large turn-outs forward and backward.

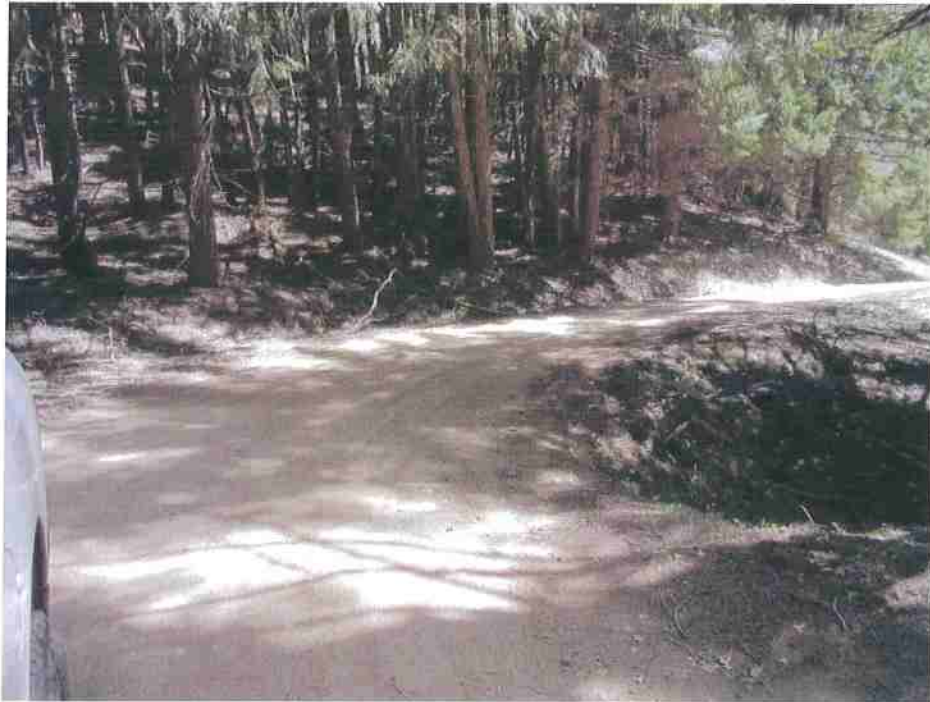
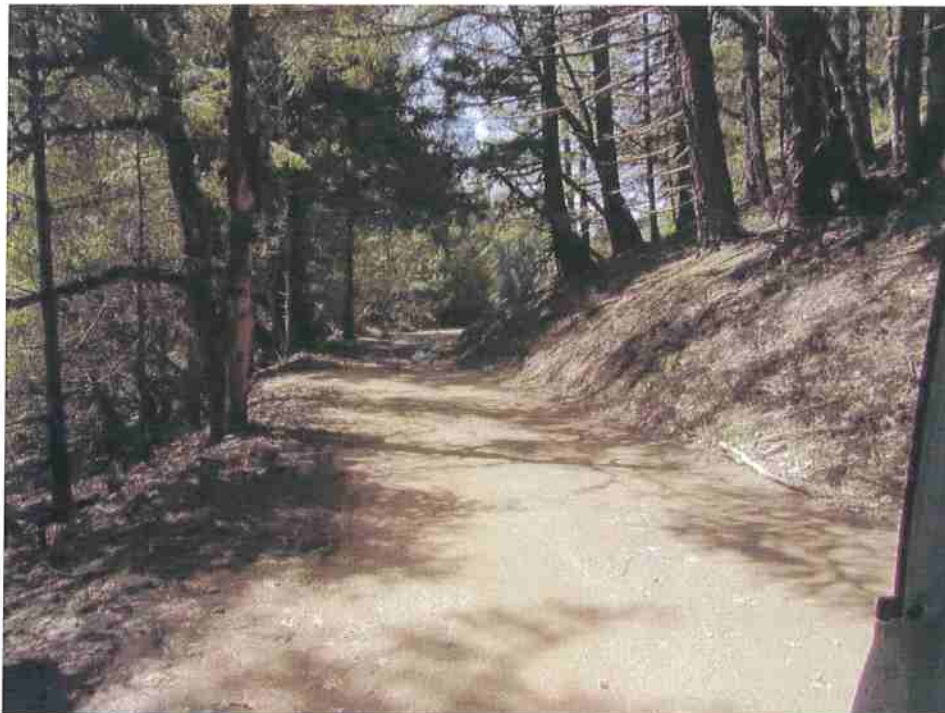
Mile 1.5 (Stapp Road): 0+17+2=19ft wide road prism; Adequate sight distance and visibility;
Turnouts forward and backward.

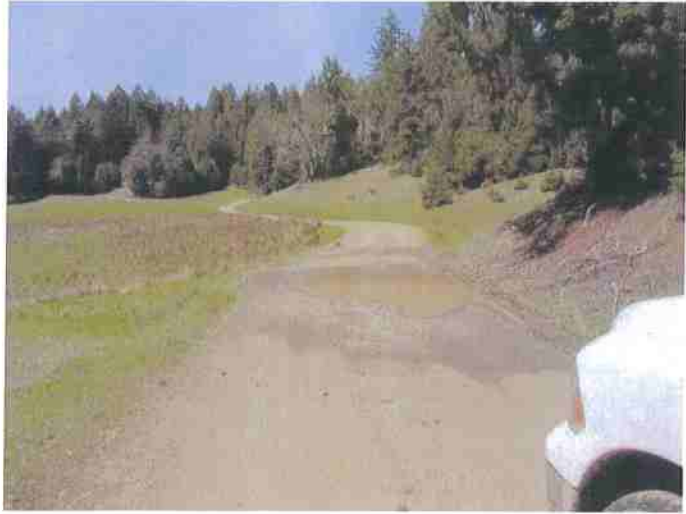
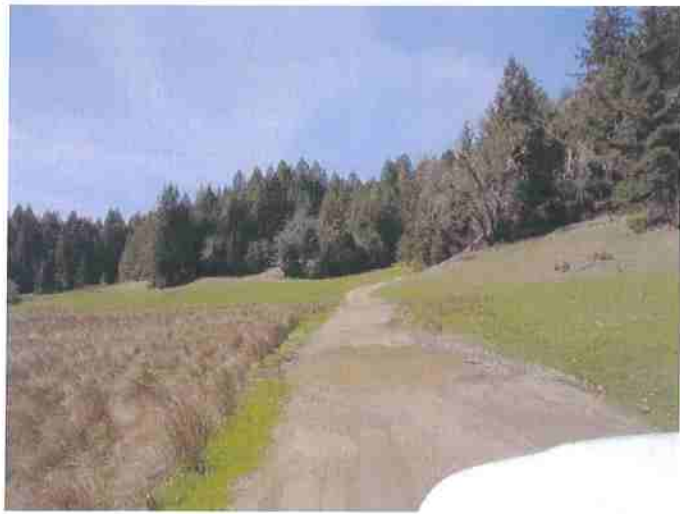
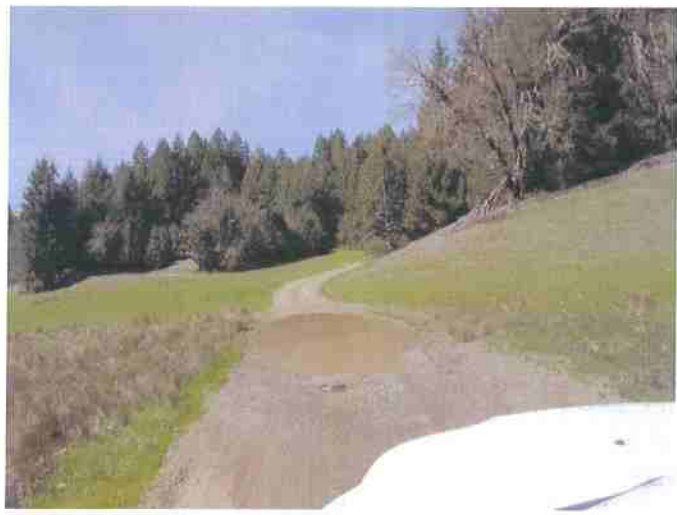
Stapp Road – Public Recommendations: Severe ponding in the roadways was observed at MP 1.8 within the county-maintained portion of Stapp road. Ponding alleviation is recommended to avoid any further road degradation. Severe potholes were also observed at MP 2.3 and 2.5.

Mile 1.8 (Stapp Road): 2+13+0=15ft wide road prism; Severe ponding in the roadway, propose rocked culvert to alleviate drainage problem. Good visibility and sight distance; Turnouts needed. Backward

0.1	4.5	17	GSD		
0.6	5.0	20	3 ft shoulder both sides		
1.1	5.5	23	3 ft L shoulder, GSD		
1.6	6.0	17	2ft R shoulder, GSD		
1.9	6.3	-	water holes	County drainage maintinace needed + RH Turnout	Med
