OMSBERG & PRESTON

ROAD EVALUATION REPORT for
STAPP & SHOWER'S PASS ROAD
BRIDGVILLE, CALIFORNIA
APN 317-033-006

July 15, 2019
(Job. No. 16-1924)

Road Evaluation – Supporting Information (Imagery)

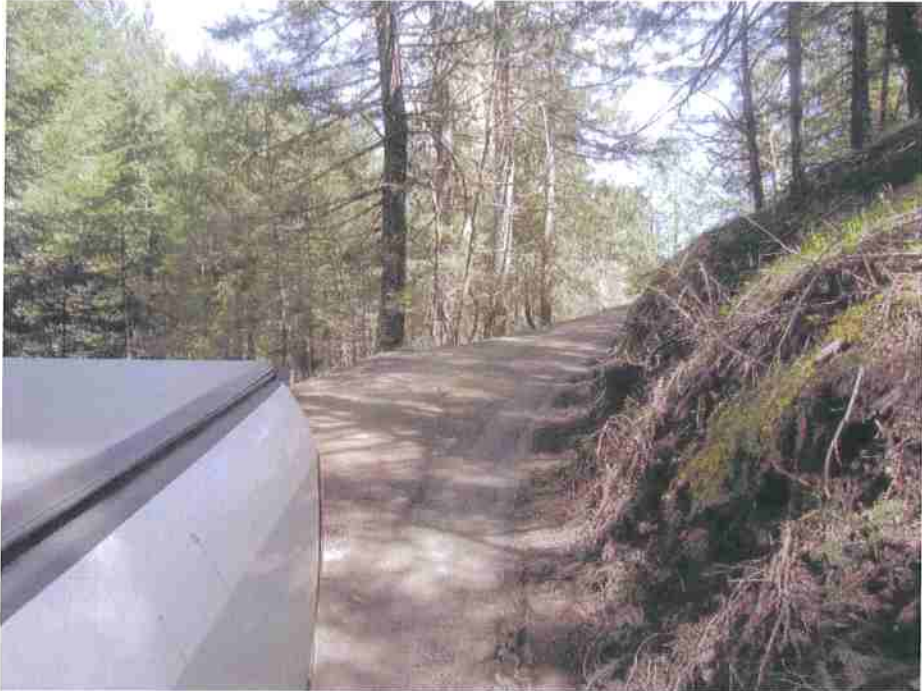
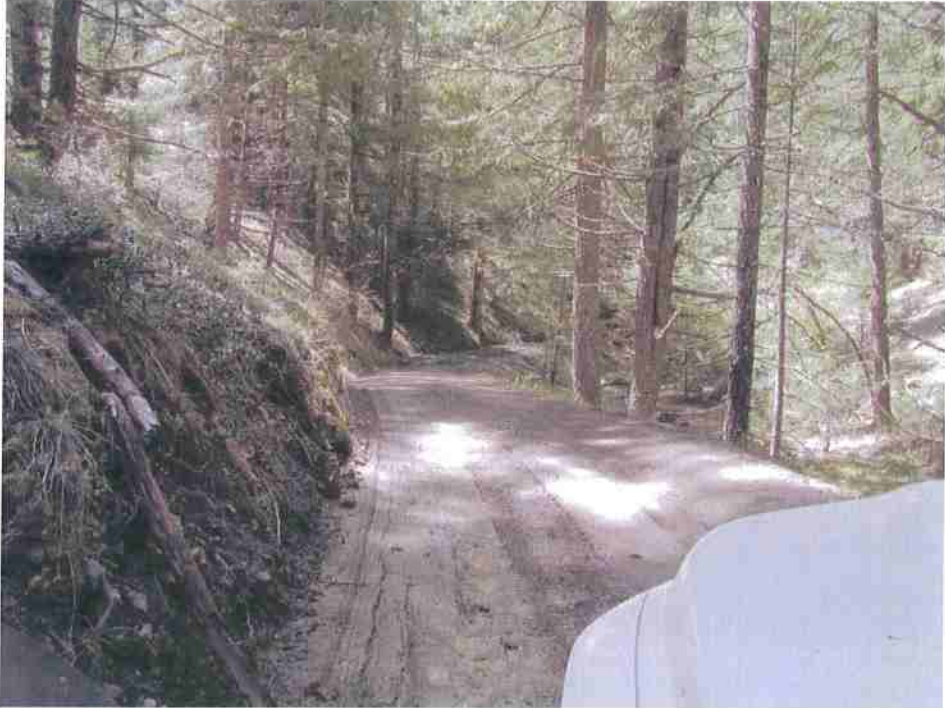
Mile 2.0 (Stapp Road): 2+13+0=15ft wide road prism; Adequate visibility and O.K. sight distance;
No turnouts & culvert too short.

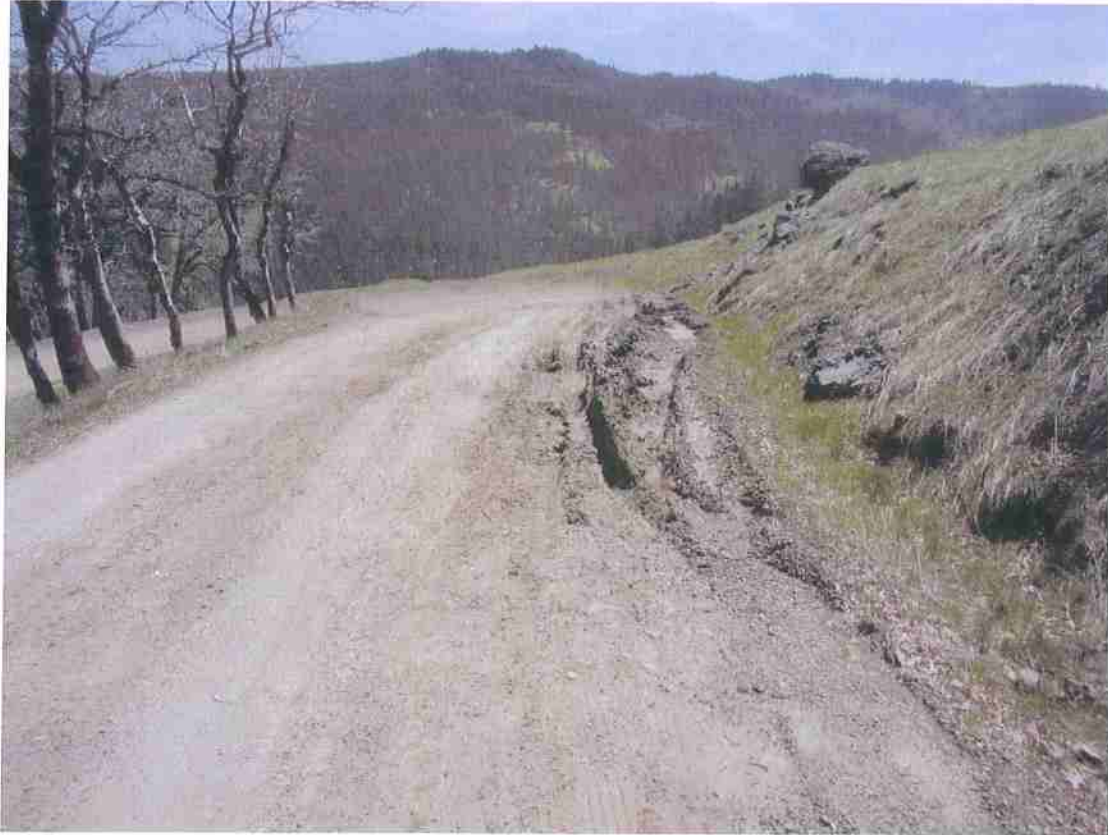
Forward

Stapp Road – Public Recommendations: Severe ponding in the roadways was observed at MP 1.8 within the county-maintained portion of Stapp road. Ponding alleviation is recommended to avoid any further road degradation. Severe potholes were also observed at MP 2.3 and 2.5.

Mile 2.3 (Stapp Road): 0+16+3=19ft wide road prism; Adequate visibility and sight distance;
Drainage issues causing severe pot-holes.

2.1	6.5	-	Culvert too short		
2.1	6.5	13	2ft L shoulder		
2.4	6.8	-	Drainage problems -see pictures, O.K. site distance	County drainage maintinace needed	Med

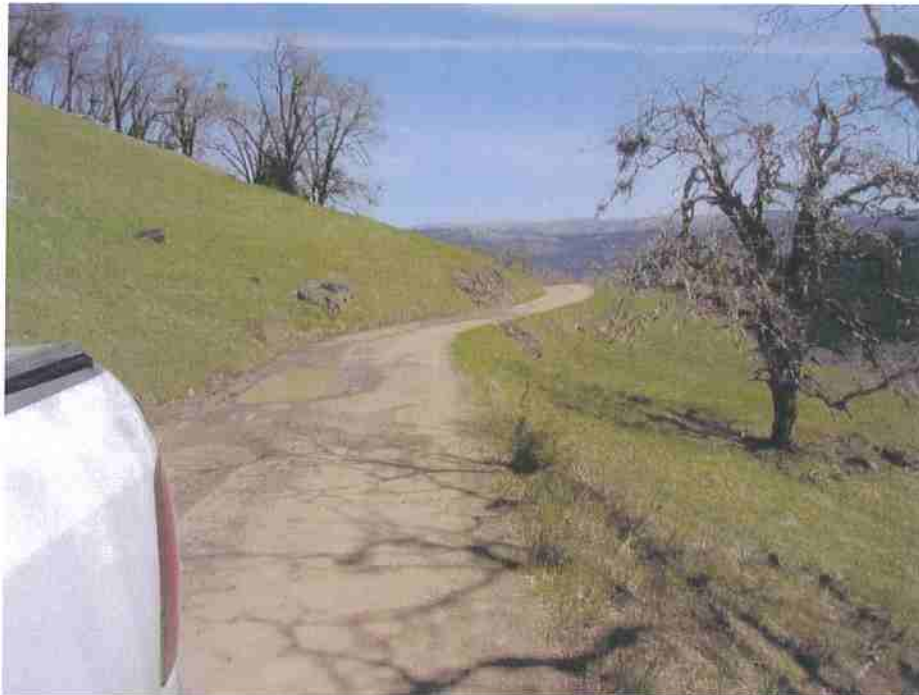
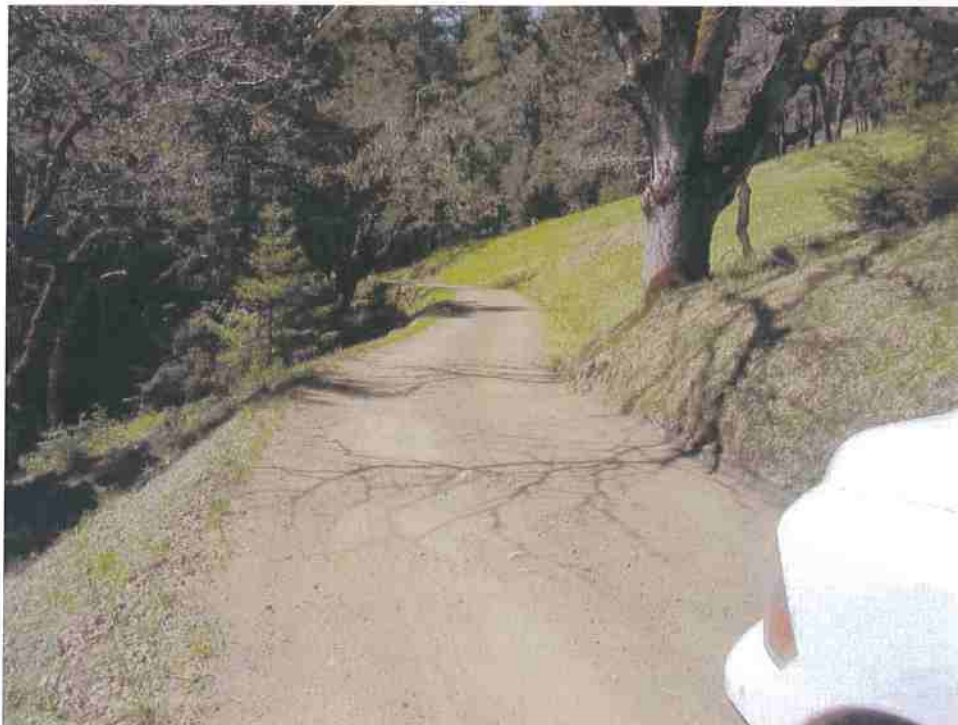
Stapp Road (Public): Drainage issues observed at MP 2.5 and 2.7, possible rolling dip installation needed. Further drainage maintenance by the county is needed at MP 1.8 and 2.3.

Mile 2.5 (Stapp Road): 0+14+0=14ft wide road prism; Good visibility and sight distance; Turnouts needed; Rough road due to drainage issues, needs more cross-slope.

2.6	7.0	14	GSD, Rough due to drainage issues, needs more x-slope & rolling dips	Insall Rolling dip and rocked drainage outlet	Med
2.8	7.2	-	sever erosion/drainage causing rough road - see pictures	Insall Rolling dip and rocked drainage outlet	Med

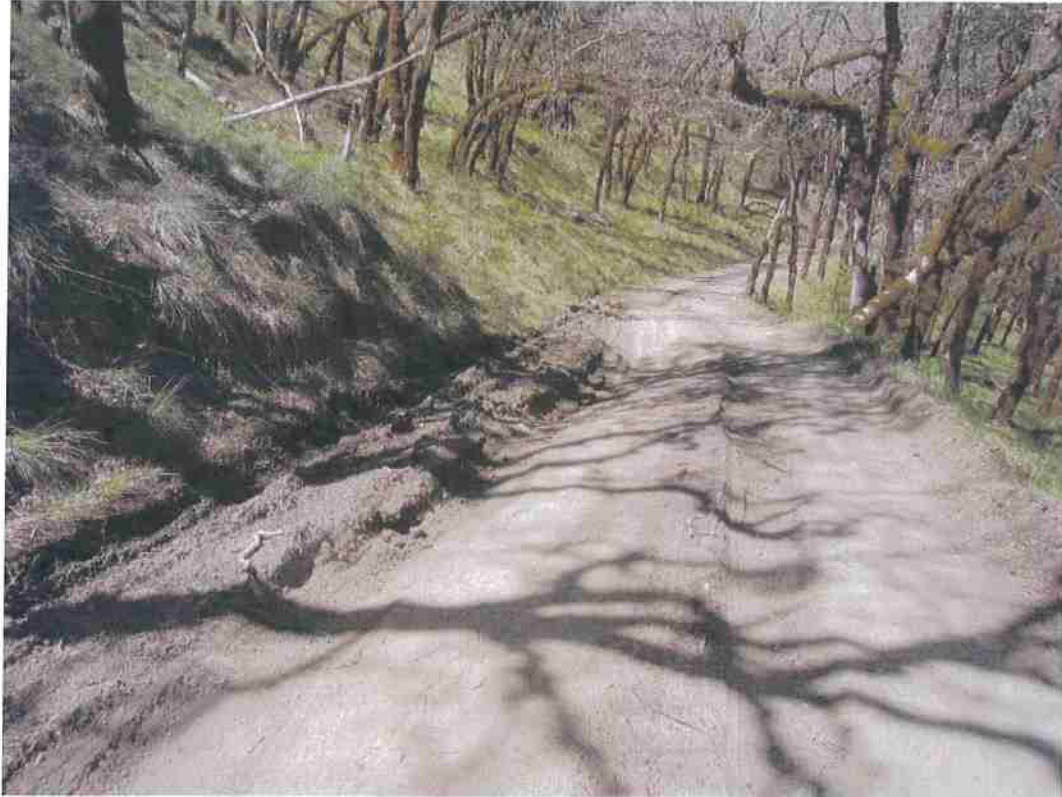
Forward

Mile 2.7 (Stapp Road): 0+14+0=14ft wide road prism; Good visibility and sight distance; Turnouts needed; Rough road due to drainage issues, needs more cross-slope.

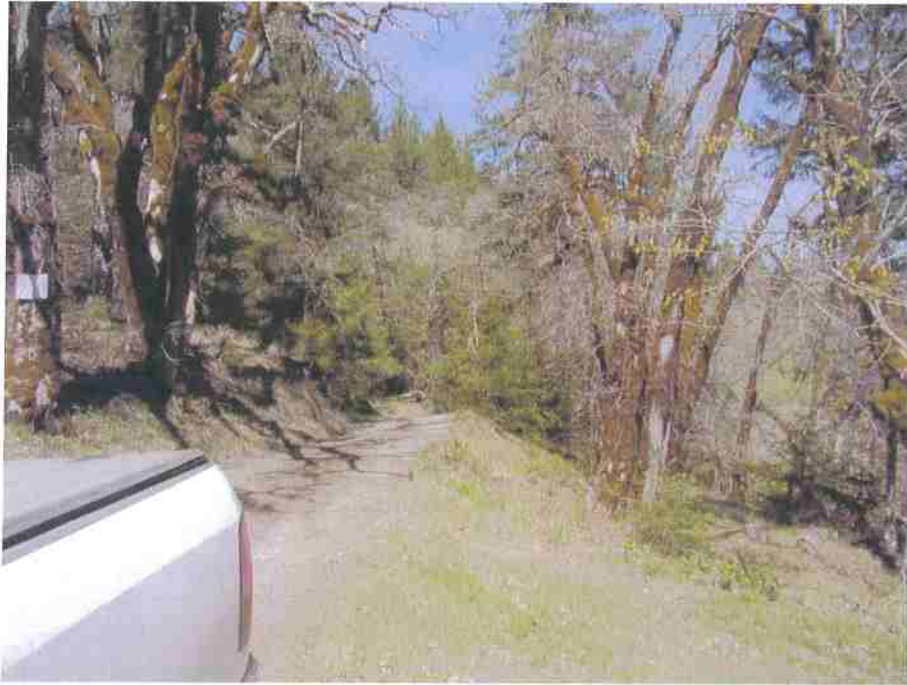
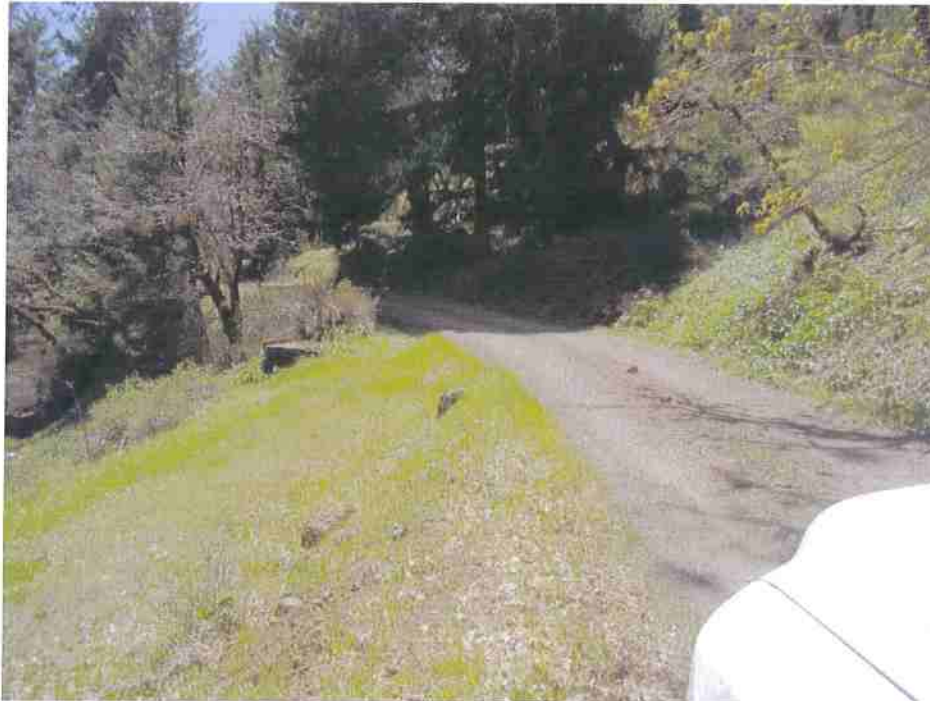
Mile 0.0 (Stapp Road – Private): 0+15+0=15ft wide road prism; Good visibility and sight distance; Turnouts forward and backward; Location of locked private gate on Stapp Road.

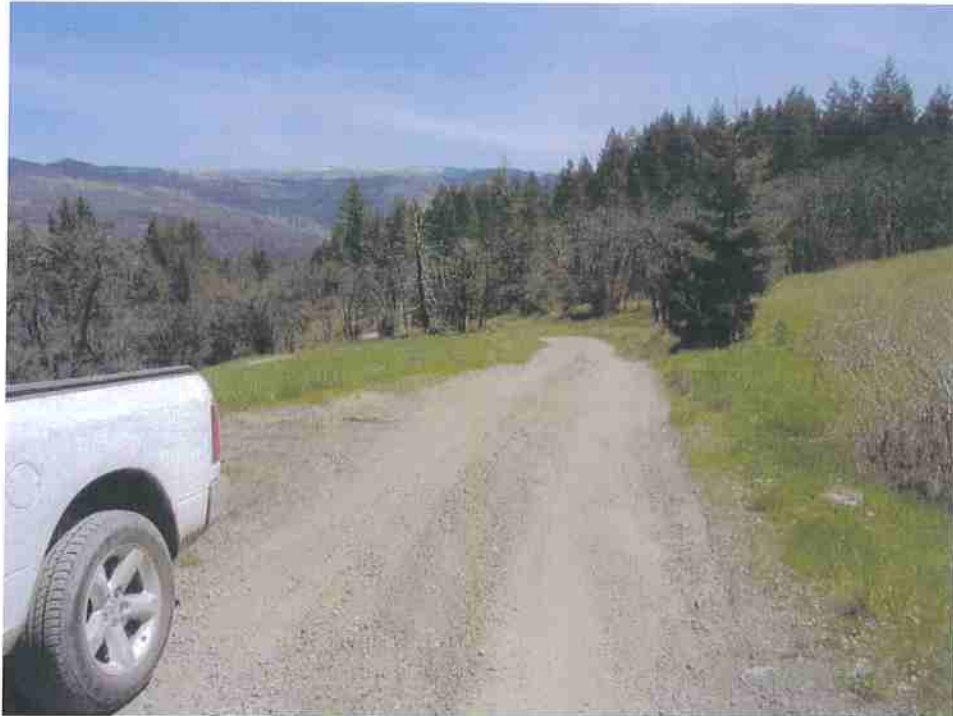
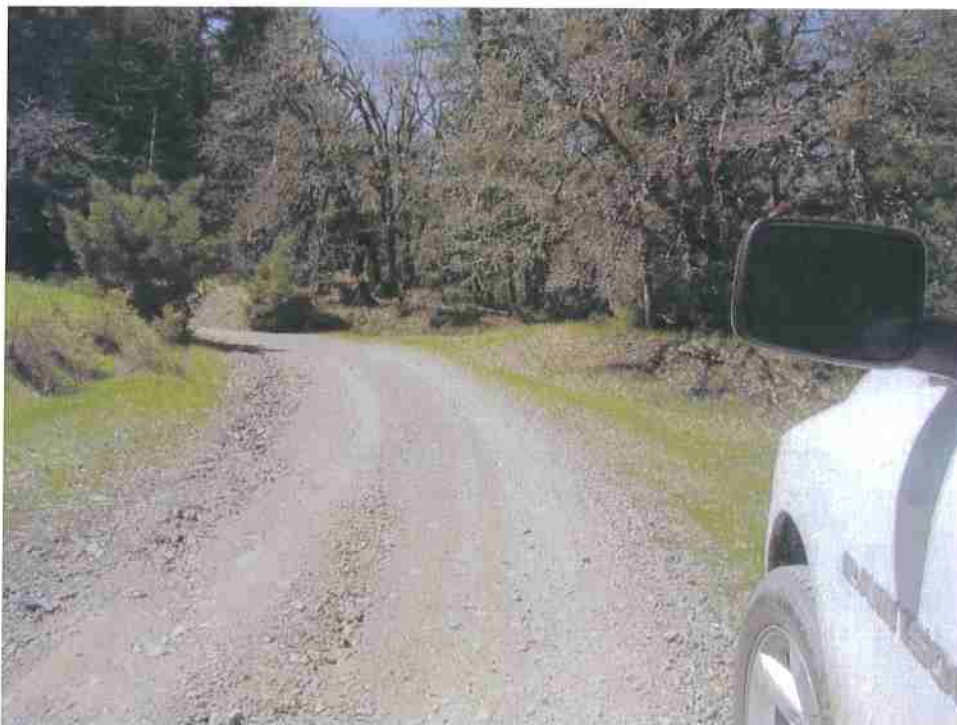
Mile 0.5 (Stapp Road – Private): $3+16+3=22$ ft wide road prism; Good visibility and sight distance; Turnouts forward and backward.

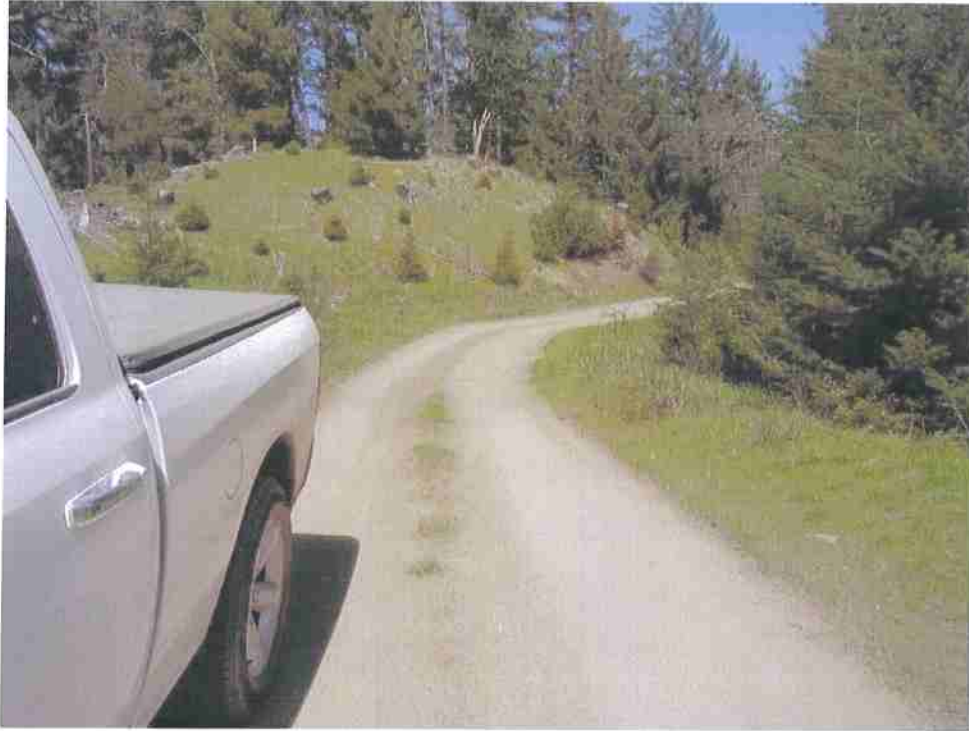
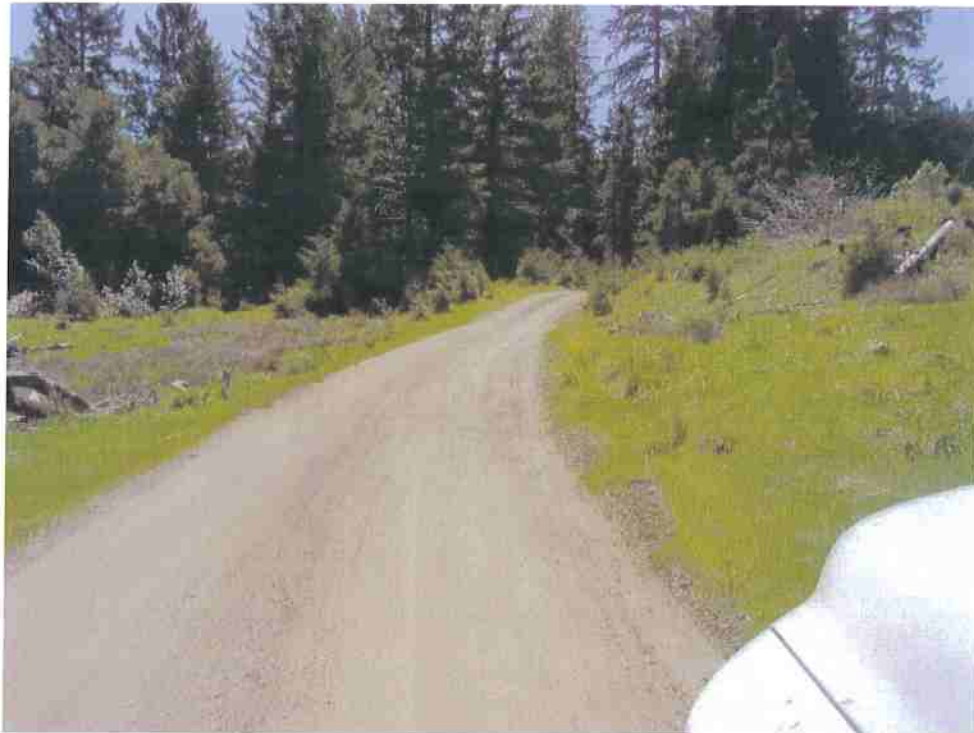
Mile 1.0 (Stapp Road – Private): $0+13+6=19$ ft wide road prism; Good visibility and sight distance; Turnouts backwards and forwards.

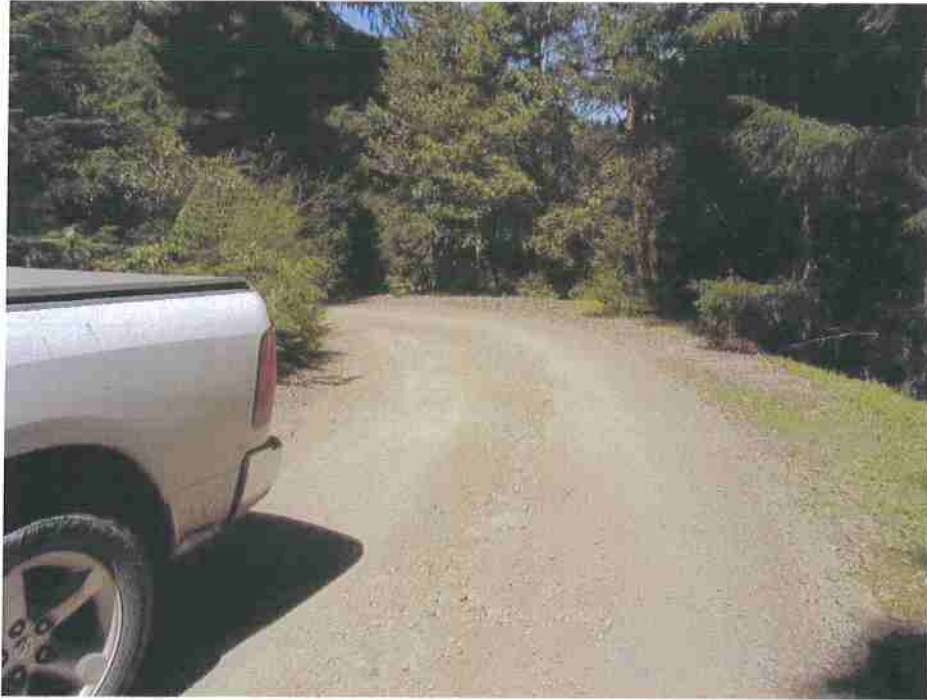
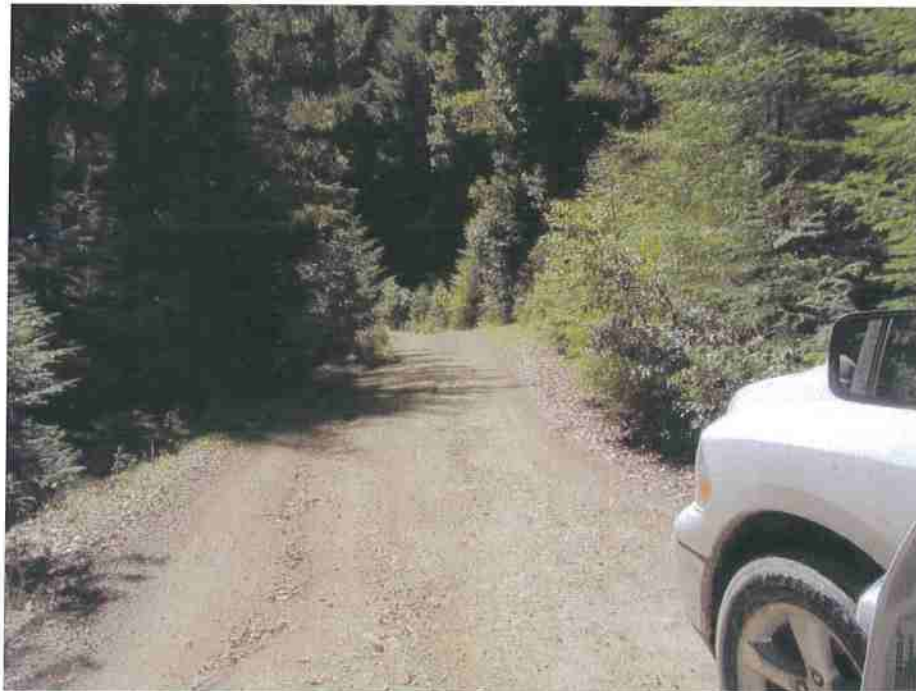
Mile 1.5 (Stapp Road – Private): $0+15+3=18$ ft wide road prism; Good visibility and sight distance; Turnout forwards.

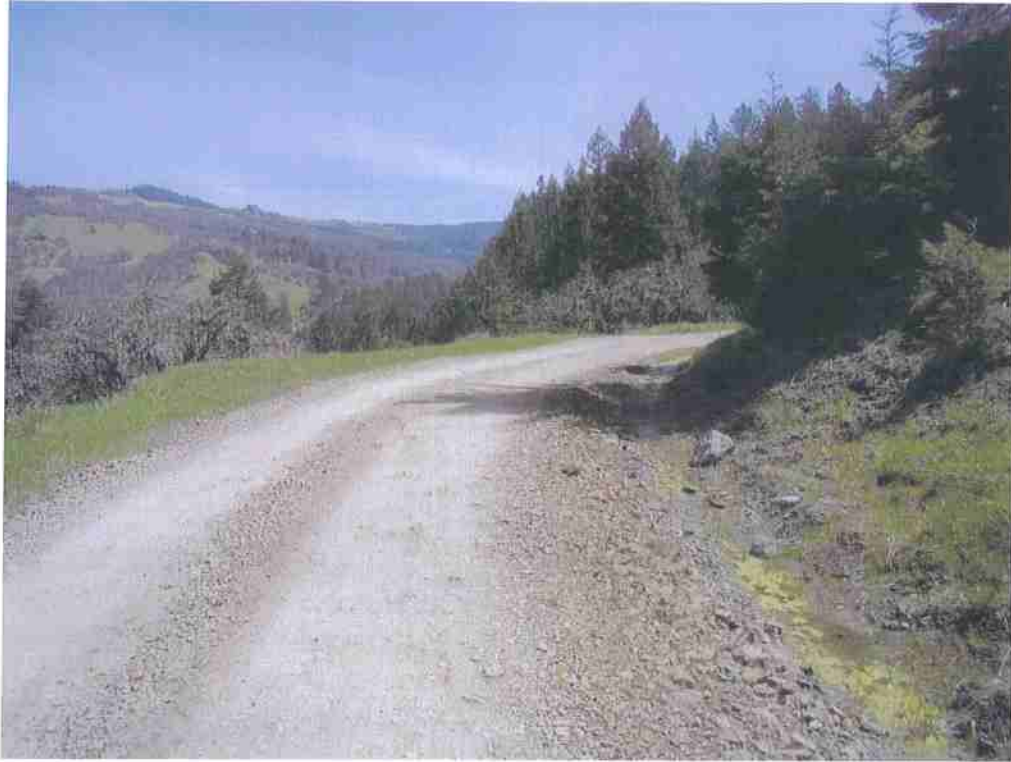
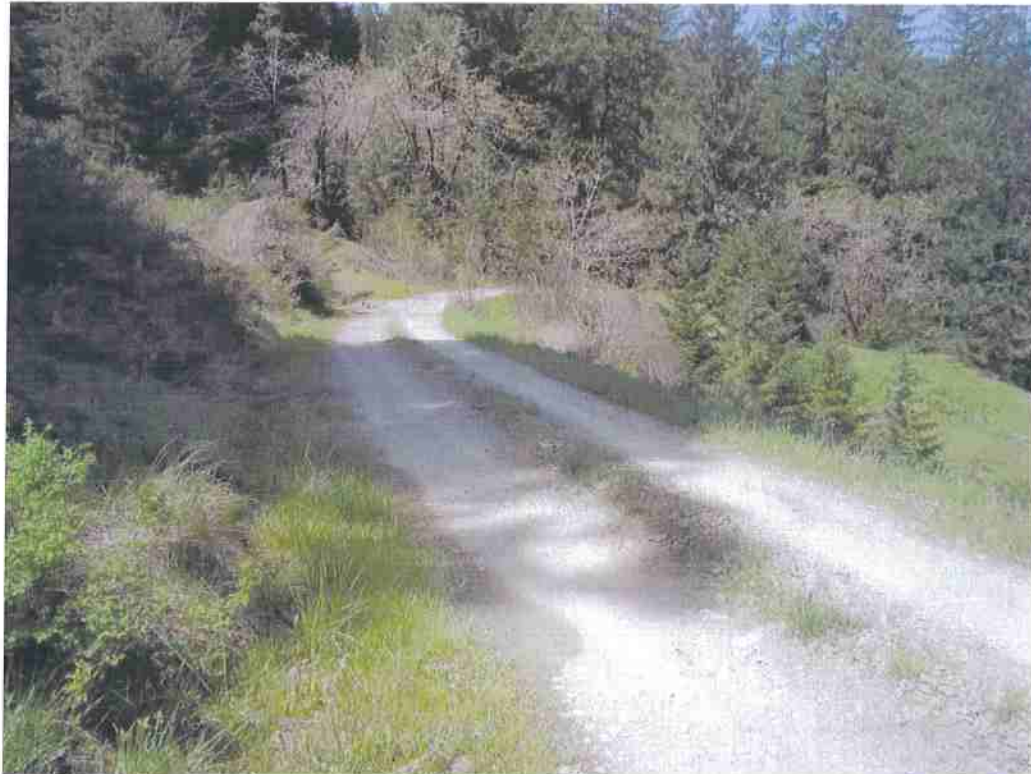
Mile 2.0 (Stapp Road – Private): $0+13+6=19$ ft wide road prism; Good visibility and sight distance; Turnouts backwards and forwards.

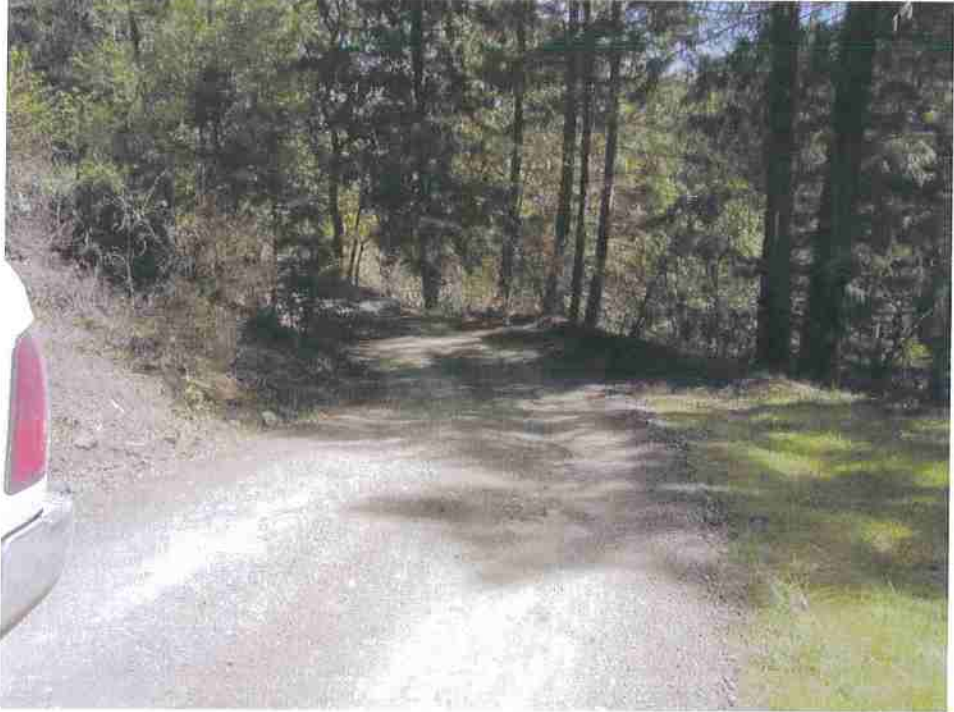
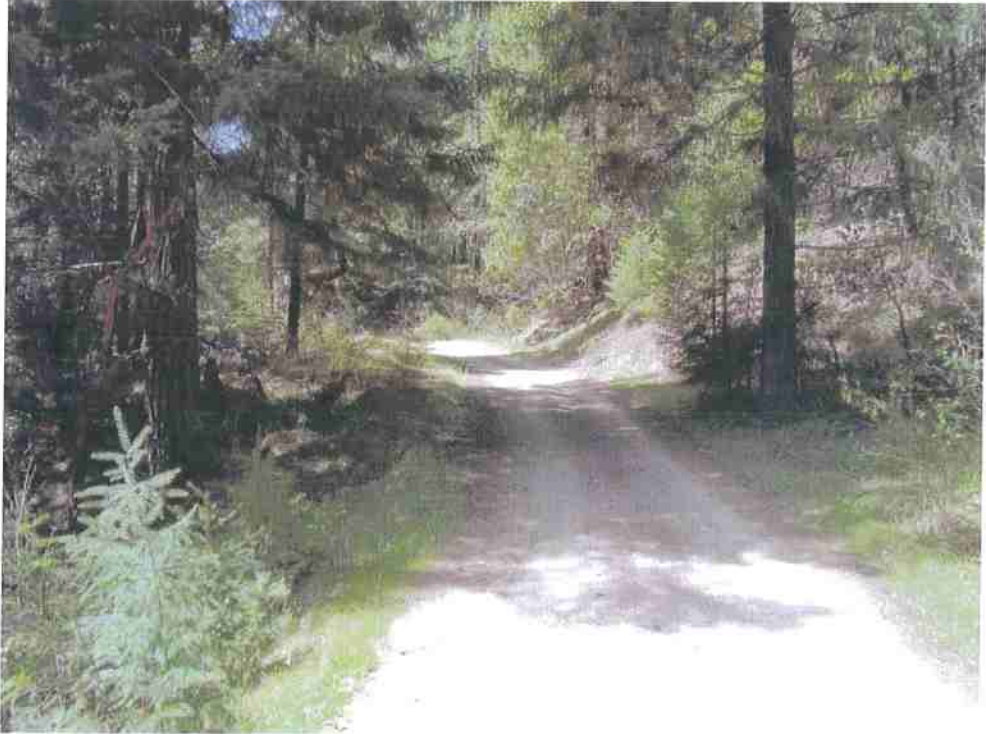
Stapp Road (Private): Drainage issues observed at MP 2.5, see recommendation section for improvements.

Mile 2.5 (Stapp Road – Private): $2+13+2=17$ ft wide road prism; Adequate visibility and sight distance; Turnout right; Needs rolling dip.

Stapp Road – Private Recommendations: A rolling dip that drains to the right is proposed at MP 2.5 to aid in erosion control. Additionally, the private section of Stapp Road from MP 4.1-4.3 is not suitable for 2-wheel drive passenger vehicles (too steep) without costly realignment requiring new easements. It is recommended that only cultivation and drying is allowed on site to minimize use on this portion of Stapp Road. The road is currently adequate for these purposes.

2.0	9.5	12	GSD		
2.5	10.0	13	Rolling dip + turn out	Install Rolling Dip and RH Turnout	Med
2.8	10.3	-	major creek crossing		
3.1	10.6	19	GSD + Turn out		
3.5	11.0	20	GSD

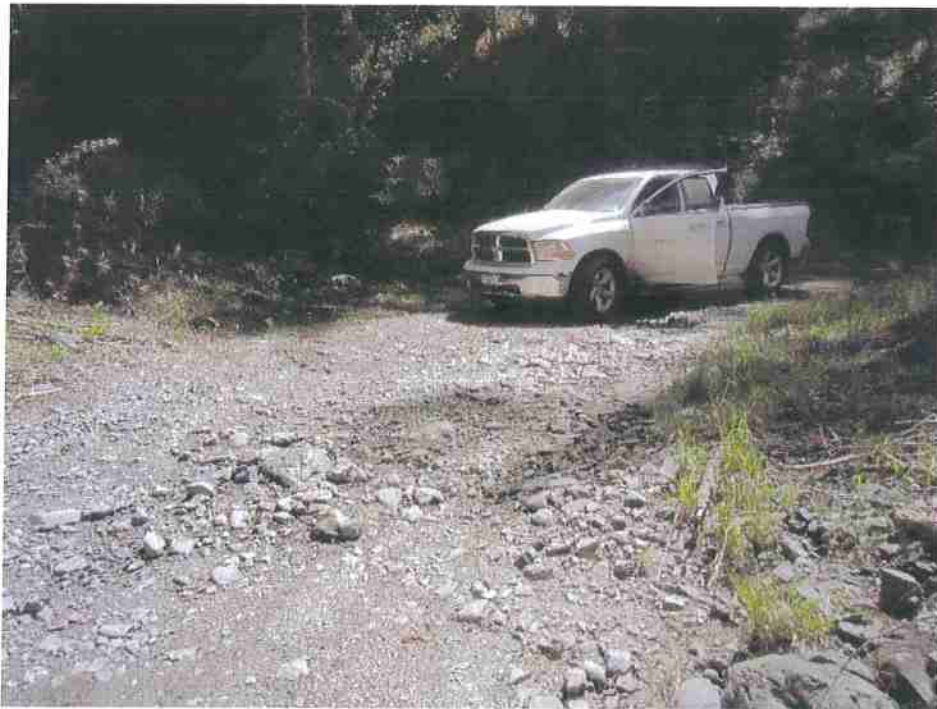
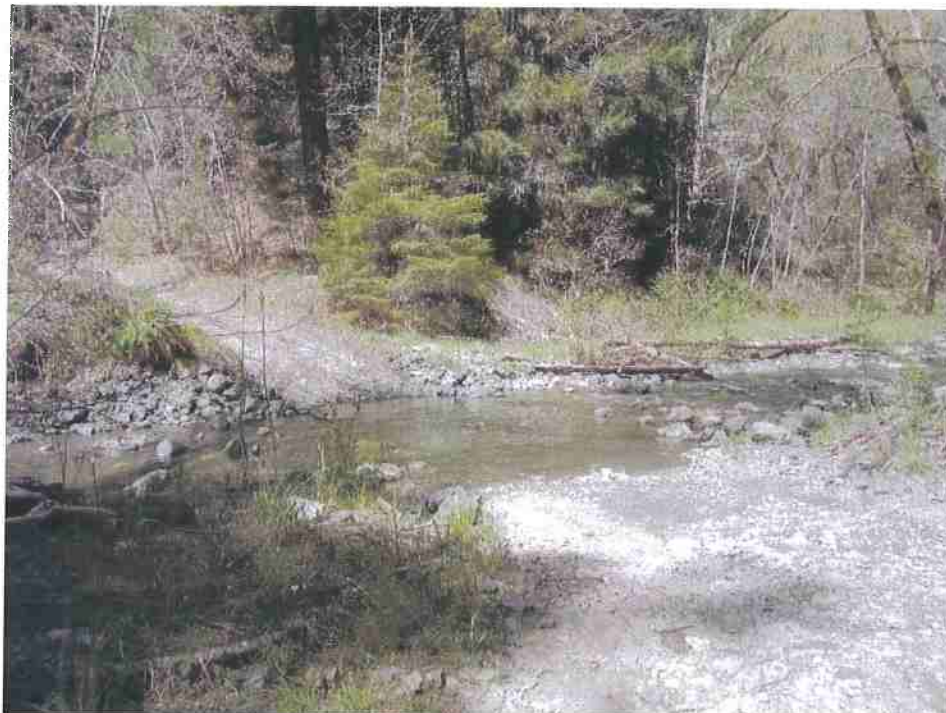
Mile 2.8 (Stapp Road – Private): 0+18+0=18ft wide road prism; Major stream crossing (Showers Creek), adequate site distance. See CDFW LSAA Notification No. 1600-2017-0444-R1 for crossing rights, Issued 03/13/18.

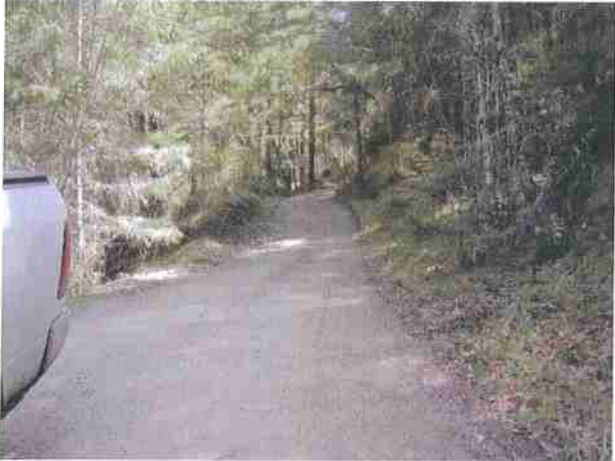
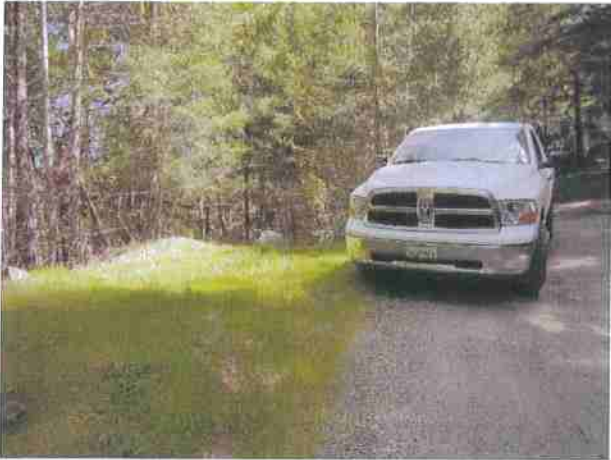
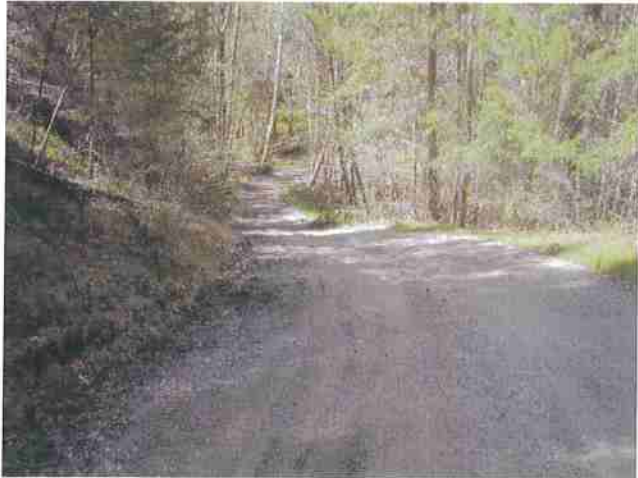
Mile 3.0 (Stapp Road — Private): 0+19+0=19ft wide road prism; Good visibility and sight distance; Turnout left hand side.

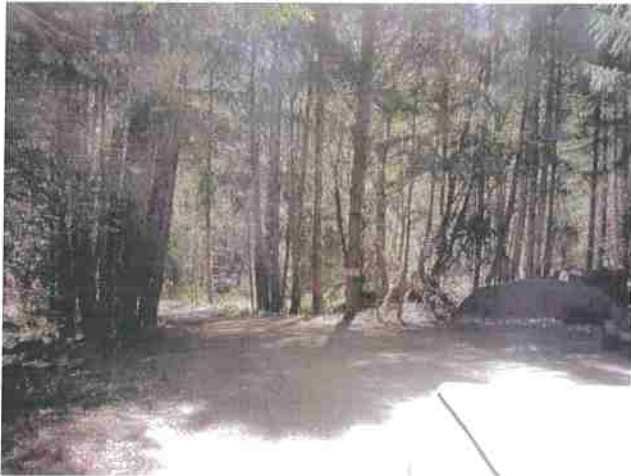
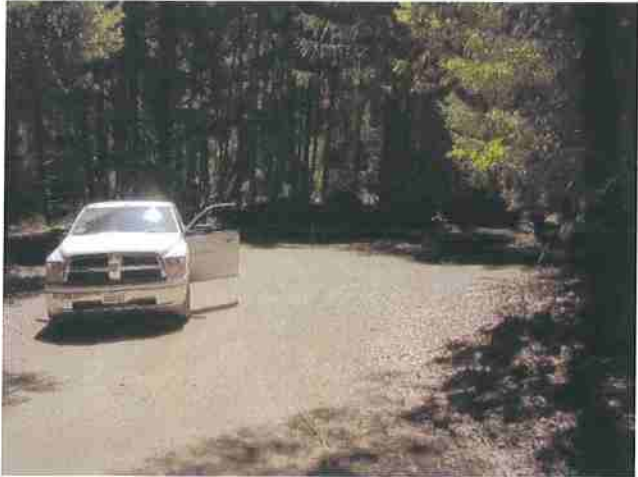
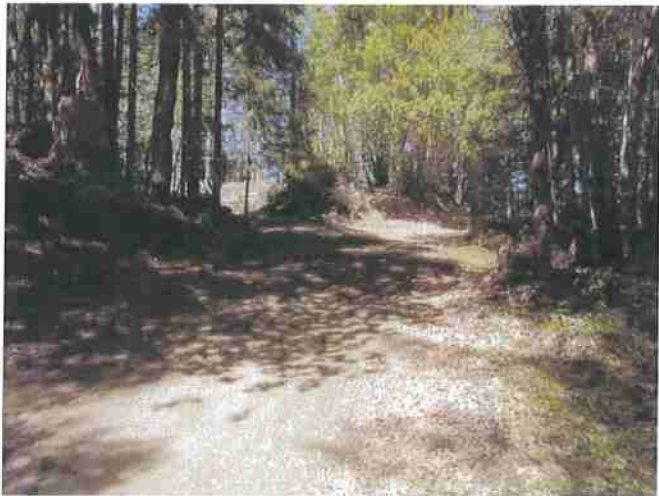
Mile 3.5 (Stapp Road – Private): 0+20+0=20ft wide road prism; Good visibility and sight distance; Large turnout & intersection.

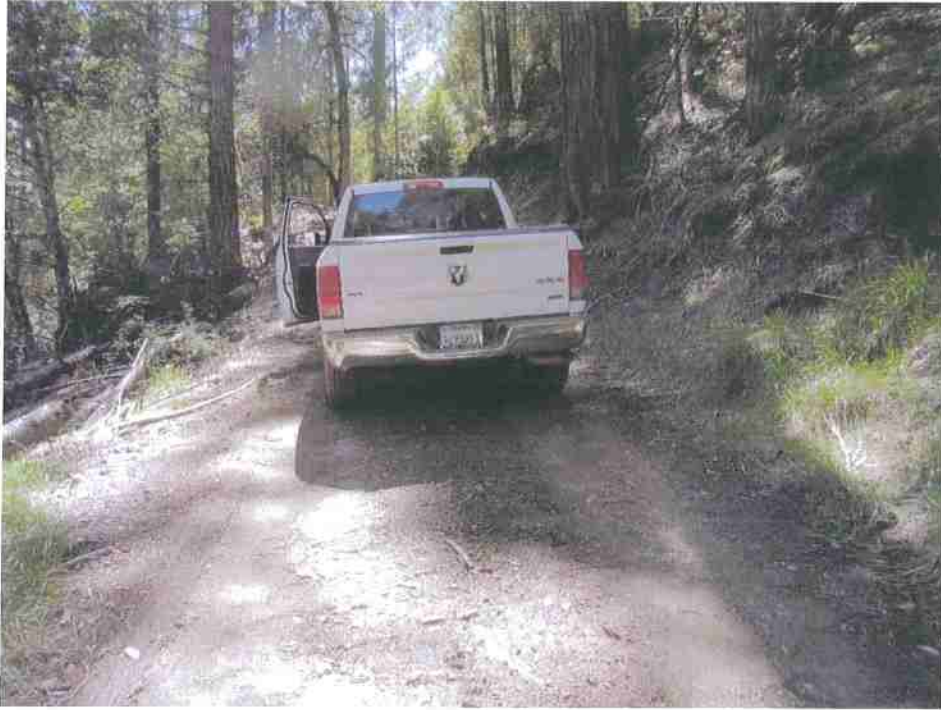
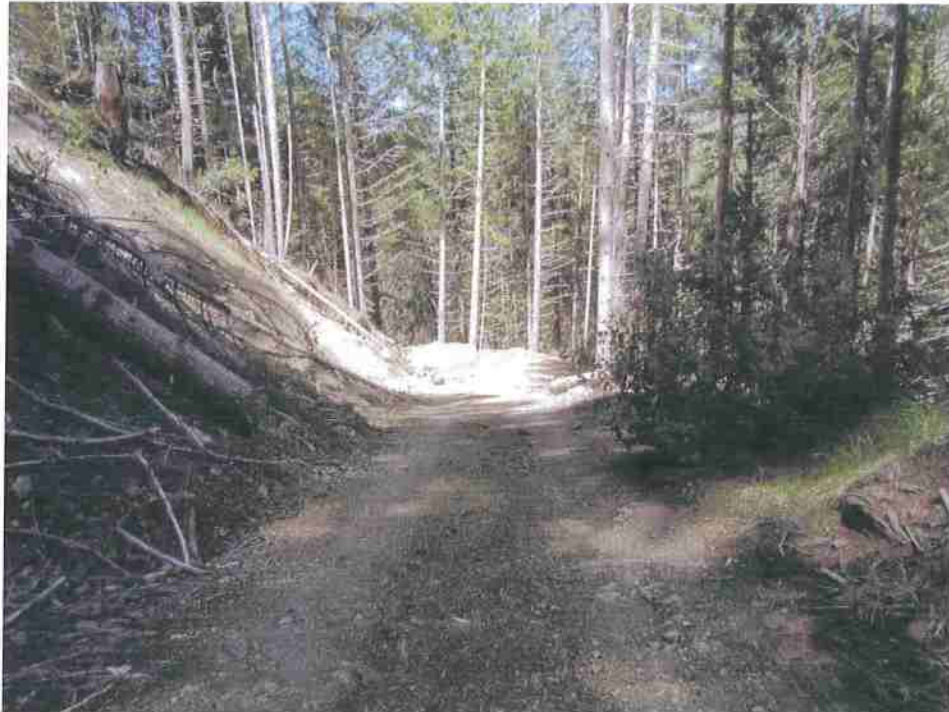
Mile 4.1 (Stapp Road – Private): 0+18+0=18ft wide road prism; Good visibility and sight distance; Steep Grade (8-24% Slope), 4WD necessary at all times.

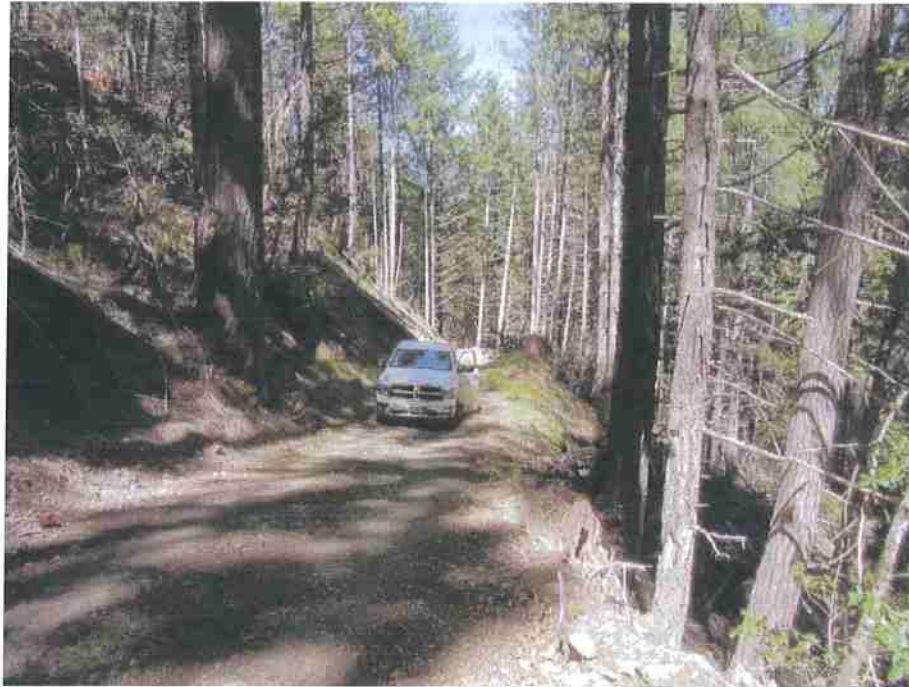
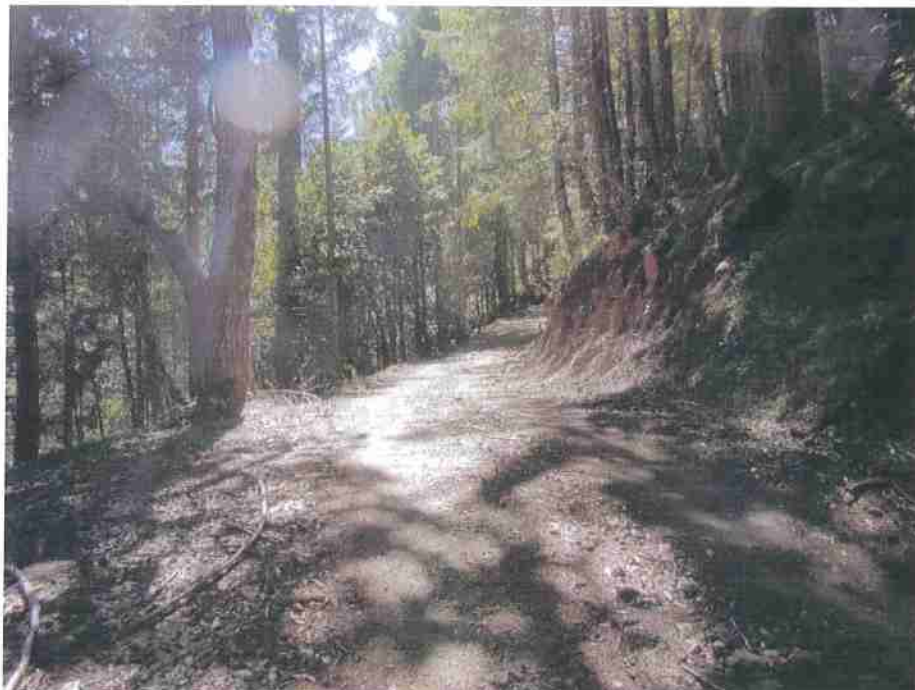
Mile 4.3 (Stapp Road – Private) 0+18+0=18ft wide road prism; Good visibility and sight distance; Steep Grade (8-24% Slope), 4WD necessary at all times

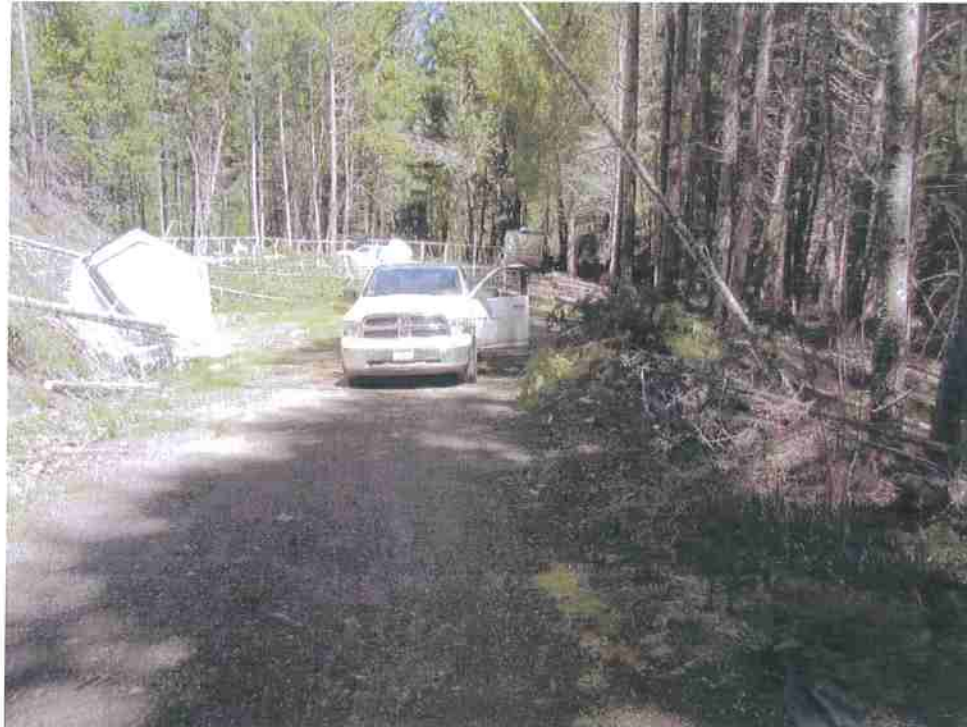
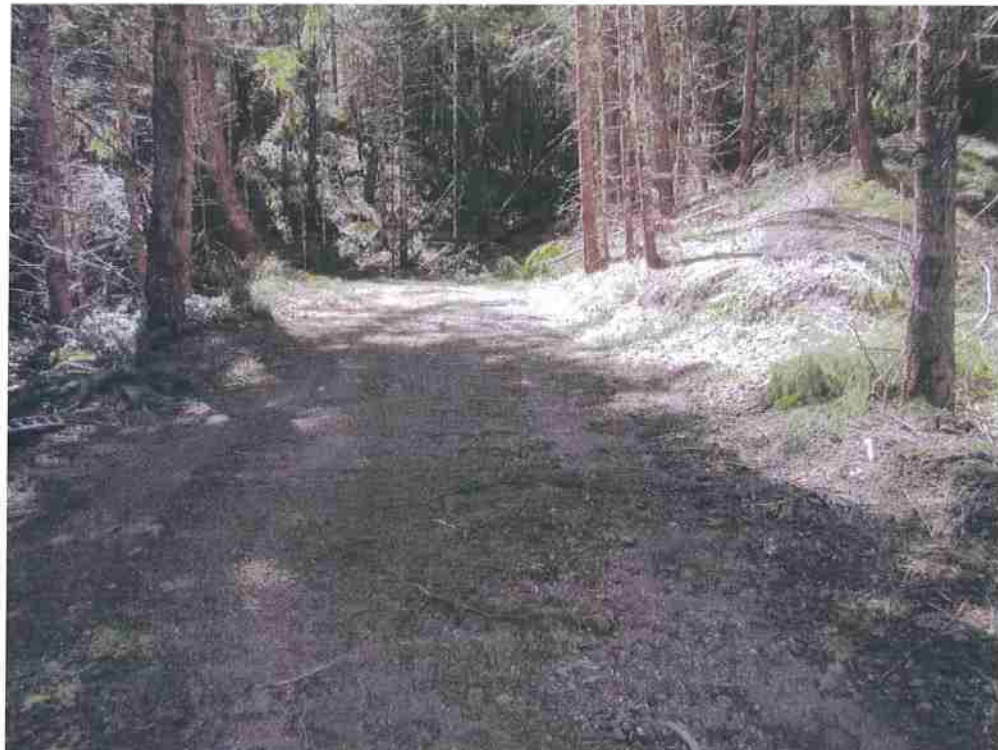
Mile 4.6 (Stapp Road – Private) 1+15+2=18ft wide road prism; Good visibility and sight distance; Turnouts forward and backward.
