# Aquatic Resource Delineation Report

01/26/2023

*Prepared for:*  
Marko Teovski  
APN 208-241-017-000

This document provides the results of an aquatic resource delineation conducted on APN 208-241-017-000 in Humboldt County, California. The purpose of this report is to delineate the boundaries of a suspected wetland so that regulatory setbacks can be accurately determined and observed by the project. The assessment occurred during the dry season and thus hydrologic determinations are tentative, but are based on rational within the method. No jurisdictional wetland was identified as a result of this report.

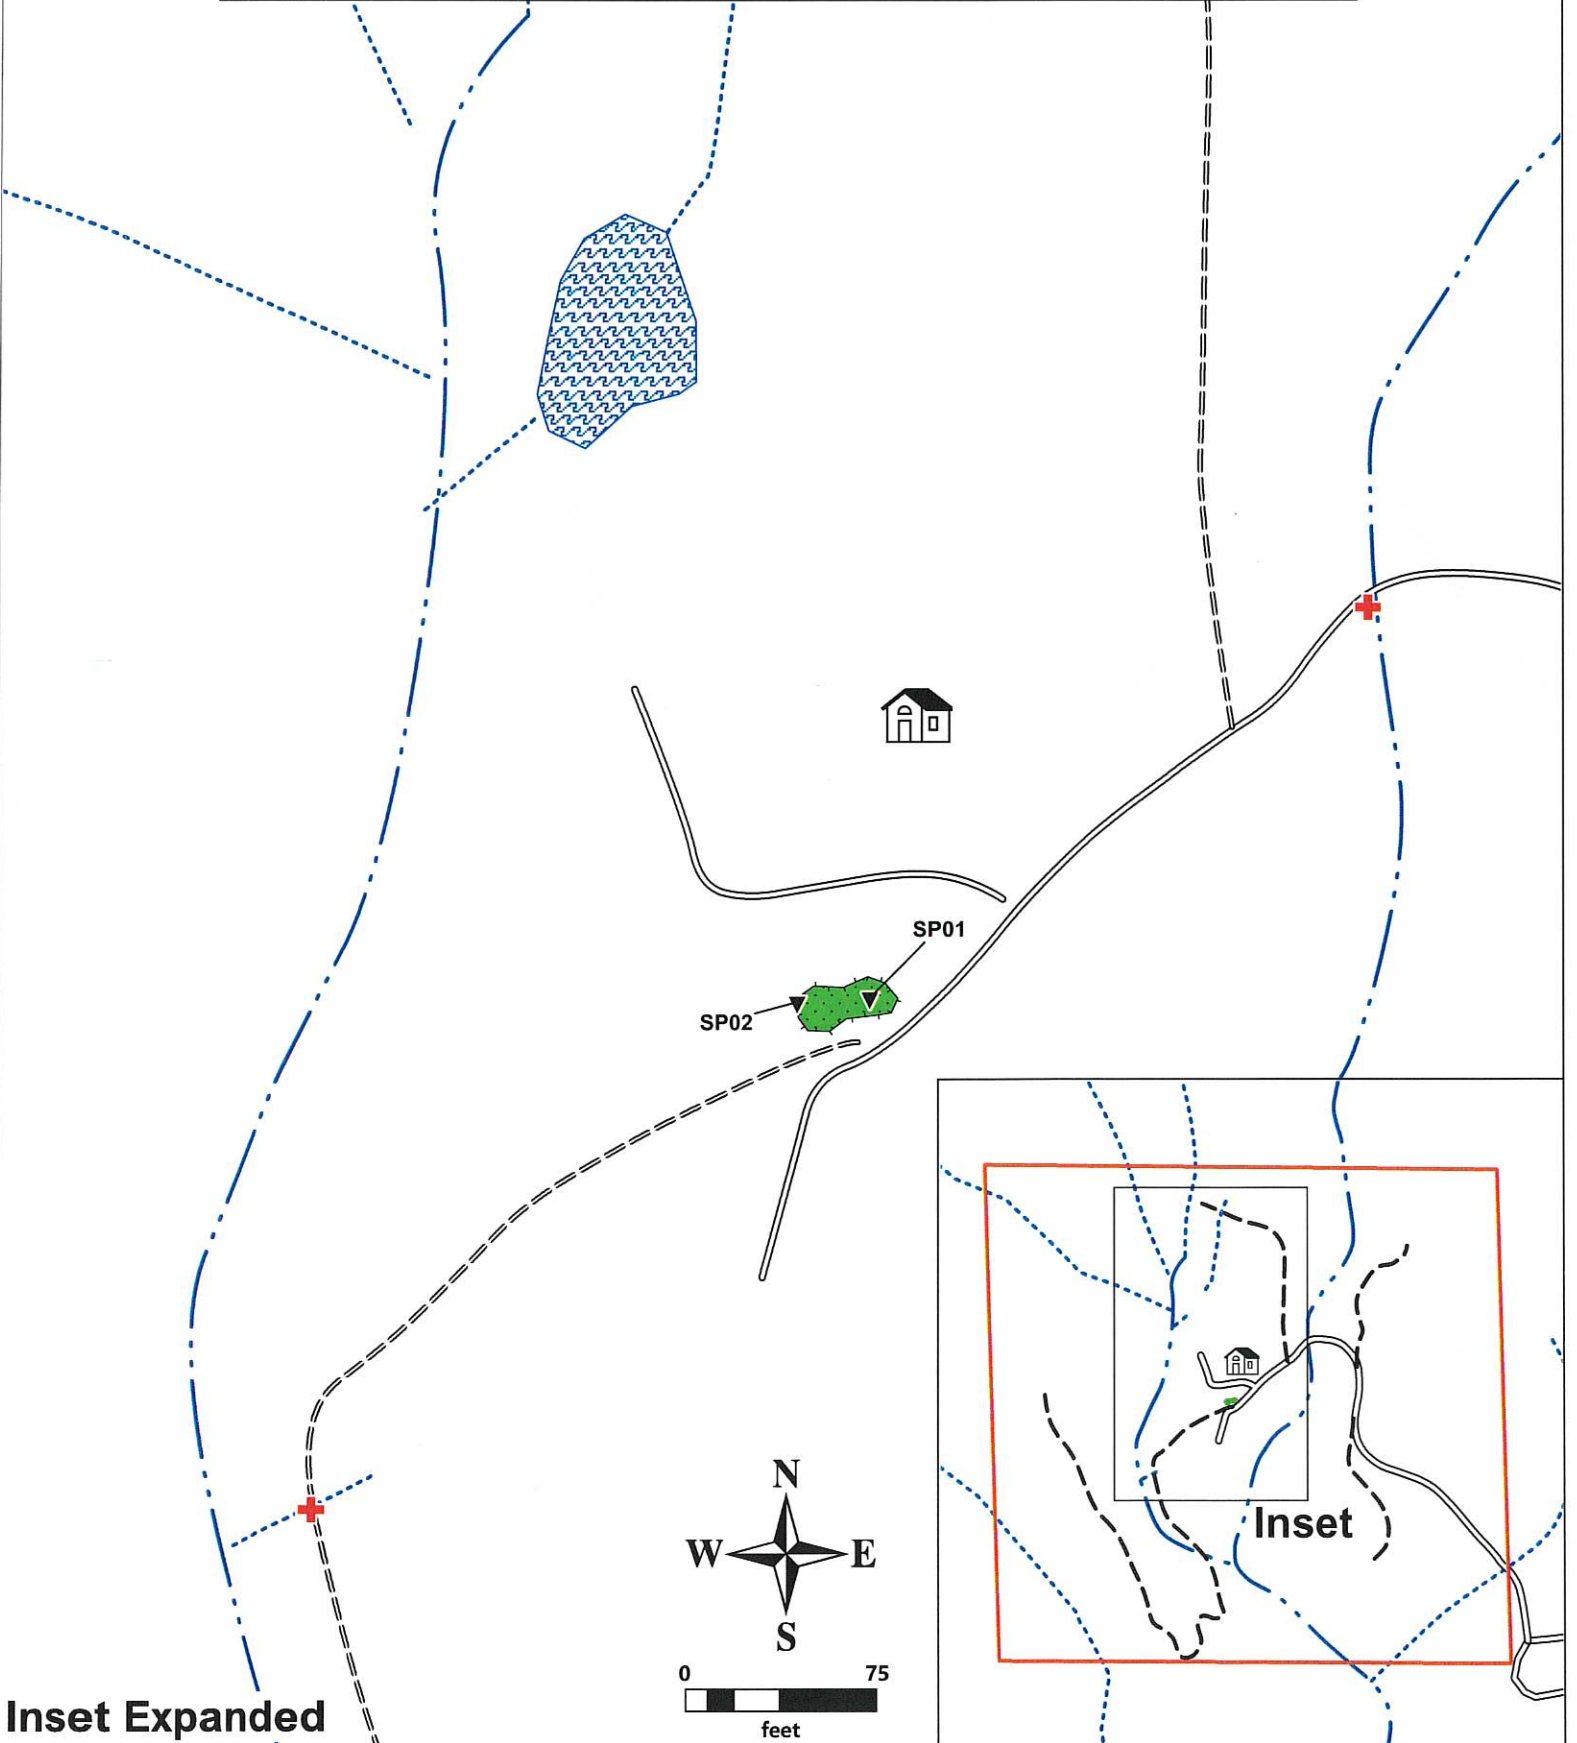
# Appendix 2 - Detailed Map

Two sample points were placed within the spreading rush plant community to test for wetland parameters. The first sample point [SP01] is located in the eastern portion of the spreading rush community near the center of the plant community. The second sample point [SP02] was located on the western edge of the plant community, to assess conditions at the edge of the feature. Parameters at both sample points were similar with little variation documented.

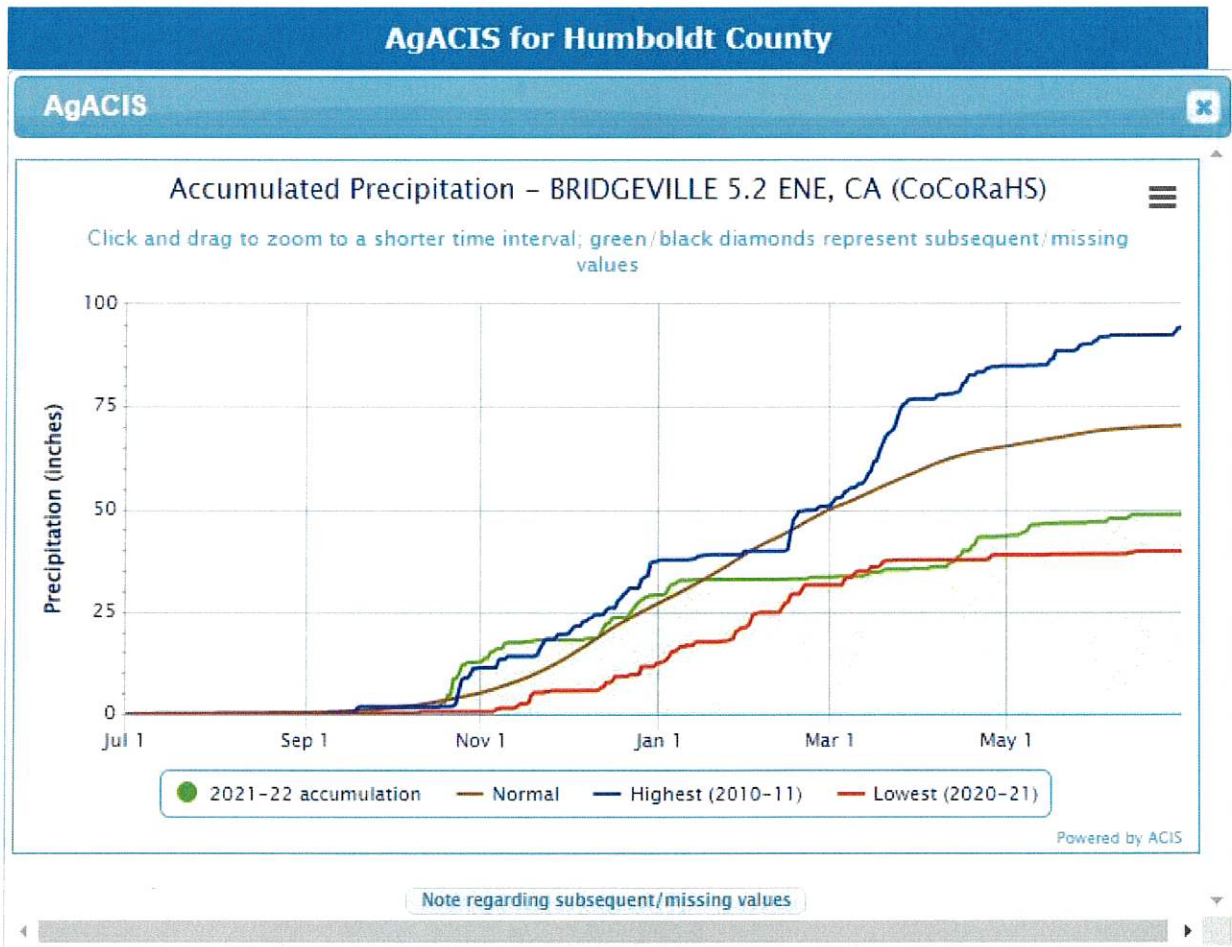
### Appendix 3 – Rainfall Data

Rainfall accumulation for the Bridgeville rain meter from July 01, 2021 to June 30, 2022.

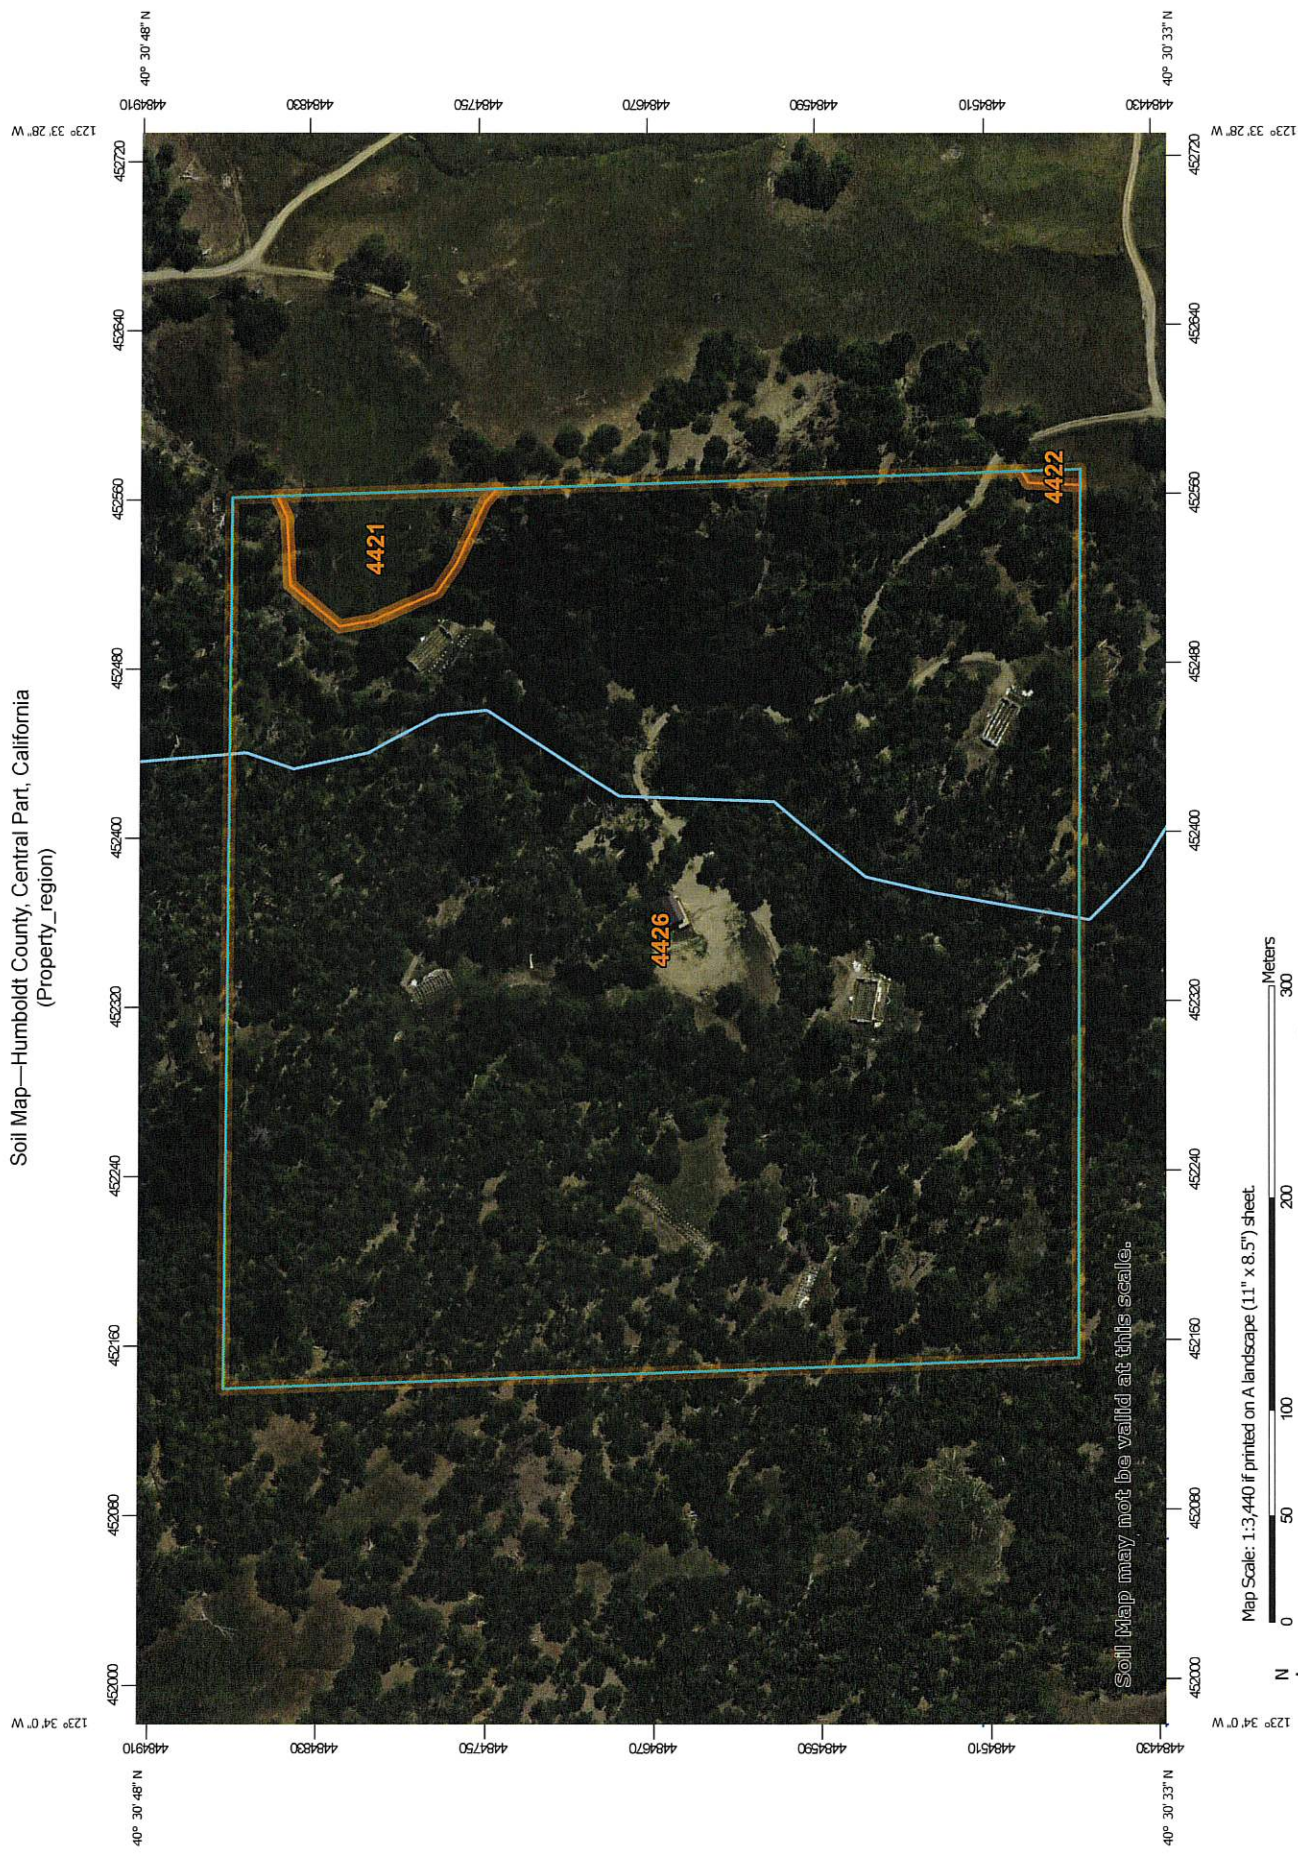
Soil Map—Humboldt County, Central Part, California  
(Property\_region)

- 4426 – Pasturerock-Coyoterock-Maneze complex, 15 to 50 percent slopes, dry. This soil type generally consists of 40% Pasturerock dry, 25% Coyoterock dry, 15%Maneze dry, and 20% other soil components. These soils are sourced from colluvium derived from sandstone and mudstone. Generally, these soils are dominated by clay and loam textures with variable amounts of gravel. These soils are well drained with hydric soils ratings that range from C-D.
