# Wetland and Other Waters Delineation Report

Assessor's Parcel Numbers  
015-111-006, 008, 012, and 013  
Eureka, California

**December 2021**  
**021184**

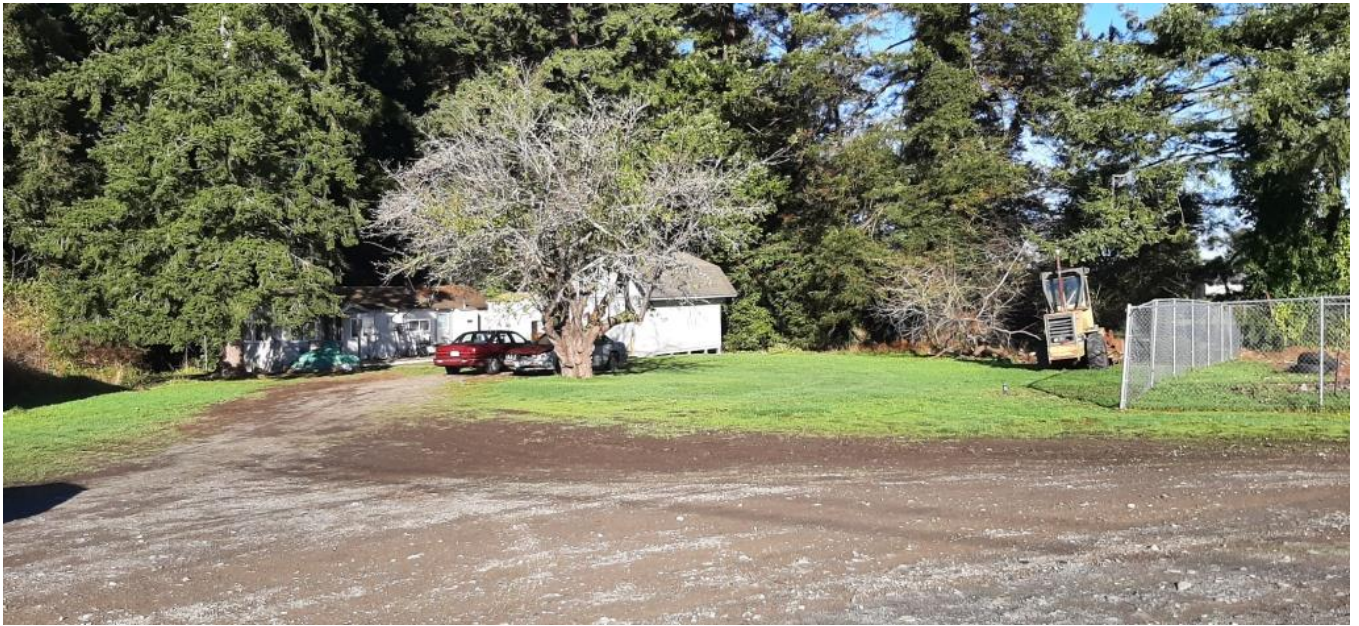
**1**

**Photo 1: Existing residential structure and outbuildings on APN 015-111-012, looking west towards coast redwood forest on gulch hillslope. Photo taken November 11, 2021.**

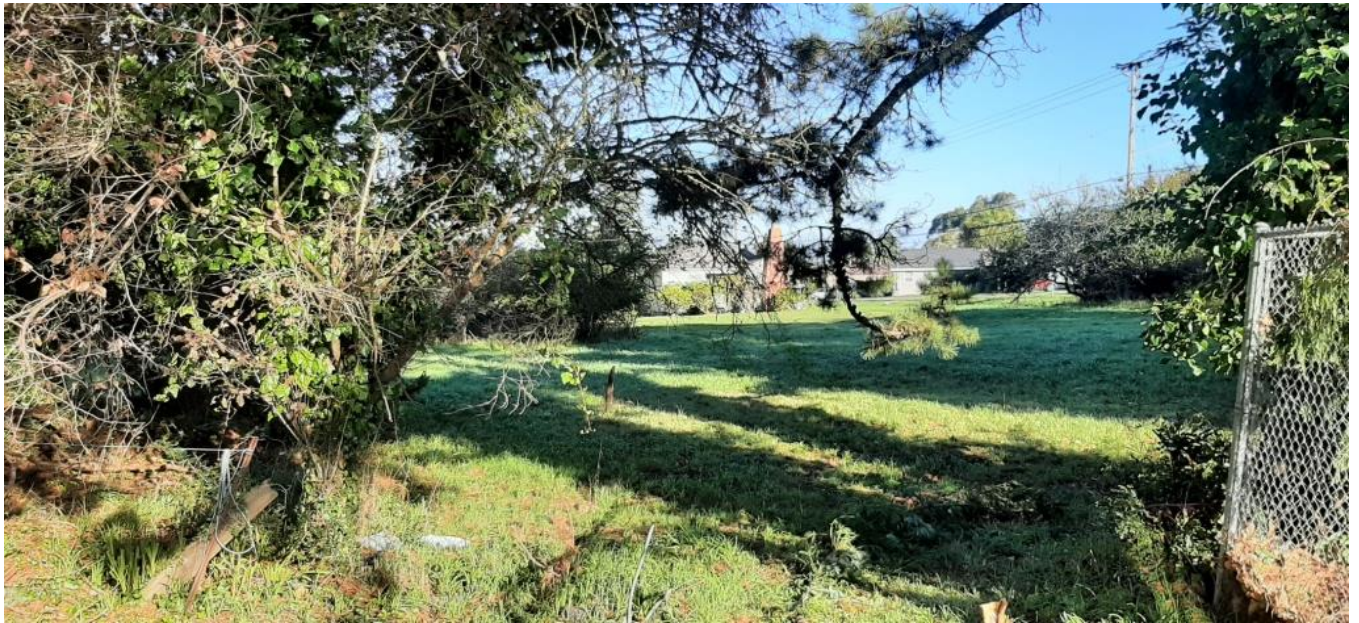
TP2 was excavated north of TP1 as an additional investigation of conditions within the flat upper terrace (Figure 2; Appendix 1, Photo 2). One wetland parameter (hydrophytic vegetation) was present at this TP, and therefore TP2 and the surrounding area do not meet State or USACE wetland definition.

**Photo 2: Looking north across non-native lawn towards structures on APN 015-111-006. Photo taken November 11, 2021.**

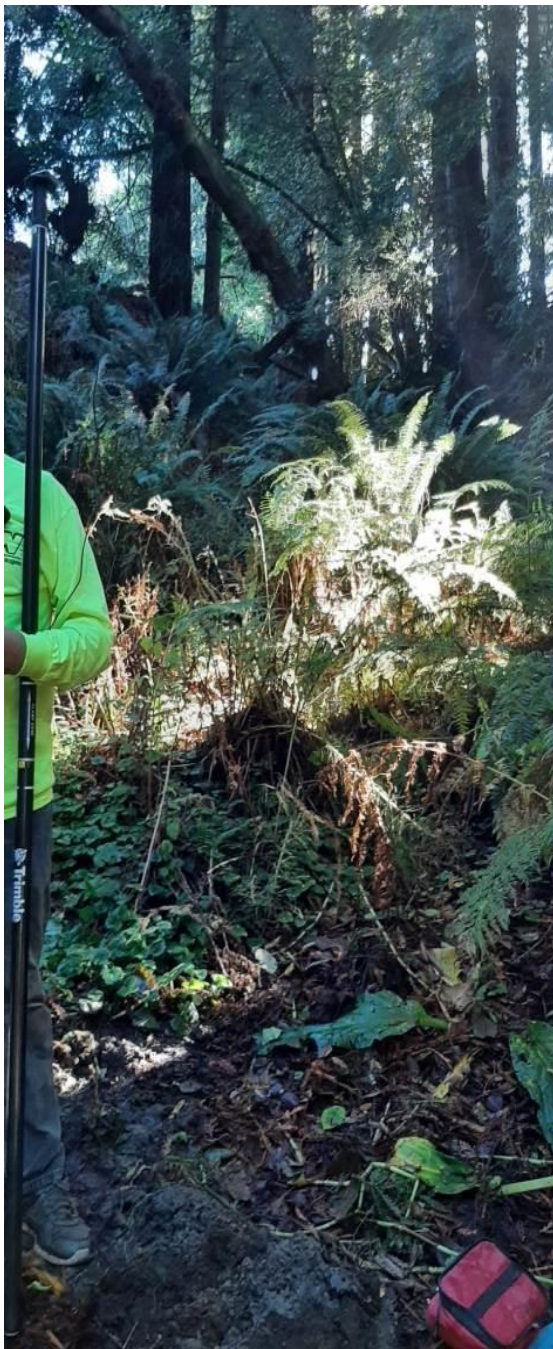
**Photo 3: Typical vegetation in northwest-southeast drainage gulch. Photo taken November 11, 2011.**

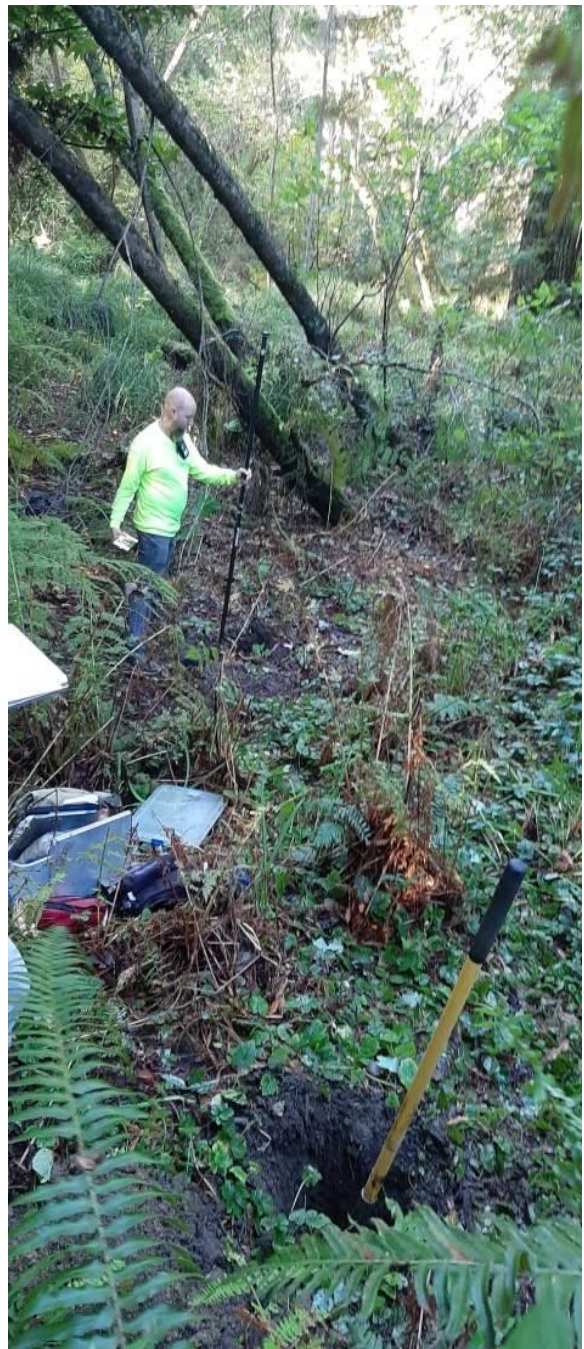
Hydric soil indicators observed were the Depleted Below Dark Surface (A11), Depleted Matrix (F3) and "Other" for the observance of the alpha, alpha-Dipyridyl reaction within the top 12 inches of the soil surface, therefore meeting the criteria for the hydric soil parameter.

The primary hydrology Presence of Reduced Iron (C4) indicator was observed (alpha, alpha-Dipyridyl reaction within the top 12 inches), therefore meeting the criteria for the hydrology parameter.

**Photo 4: TPs 4 and 5 (TP5 with yellow shovel and TP4 with GPS antenna pole). Photo taken November 11, 2011.**

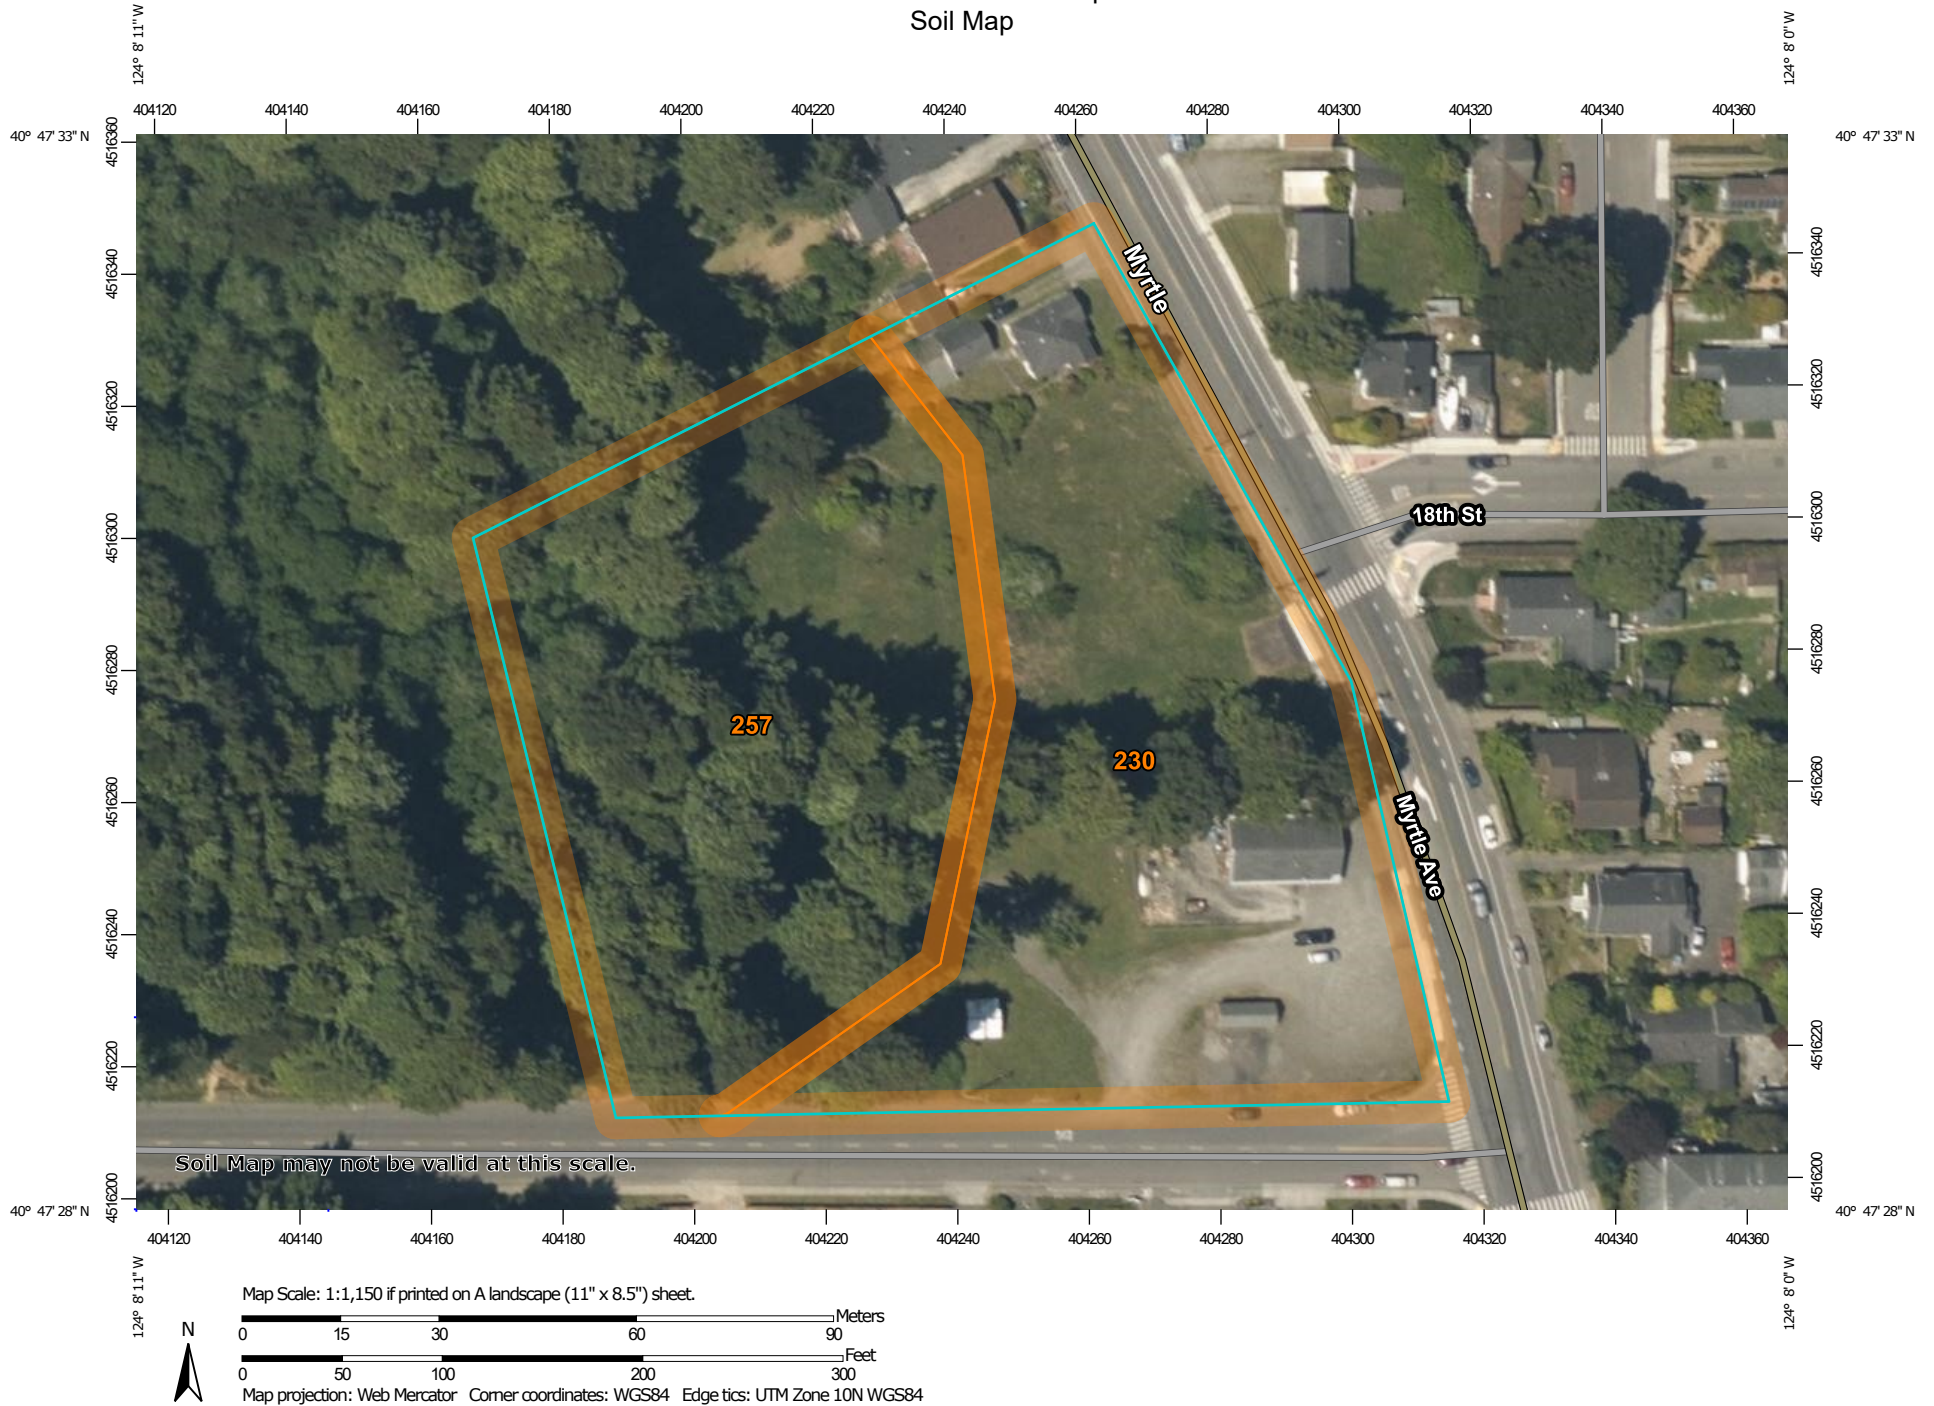
# Custom Soil Resource Report Soil Map

The underlying soils in the study area have the USDA-NRCS soil map unit designation 230—Hookton-Tablebluff complex, 2 to 9 percent slopes and 257-Lepoil-Candymountain complex, 2 to 15 percent slopes, as described below (Appendix 2, Soil Map). The site-specific soil description at each exploratory soil TP is included in the wetland determination data forms found in Appendix 3, with photos in Appendix 1.
