# **Preliminary Jurisdictional Wetland and Other Waters Delineation**

**Emerald Family Farms, LLC  
Willow Creek, California**

September 2016  
016225.003

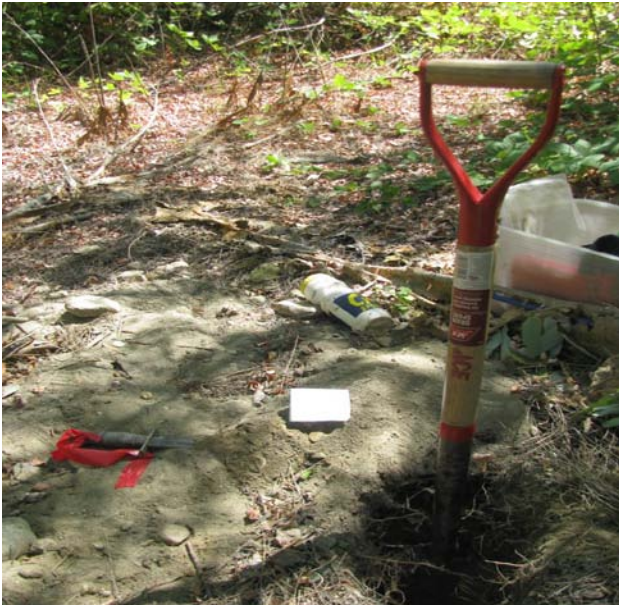
**Photo B-5 TP3 Site**

TP3U is 23 feet away from TP3W due to a broad transitional area where the algal mats stop and hydric soils end. Vegetation is the only parameter met, and it consists of the following: tree stratum–20 percent arroyo willow; sapling/shrub stratum–60 percent Himalayan blackberry and 5 percent arroyo willow; herb stratum–5 percent tall cyperus (*Cyperus eragrostis* [FACW]) and 5 percent bent grass (*Agrostis exarata* [FACW])).

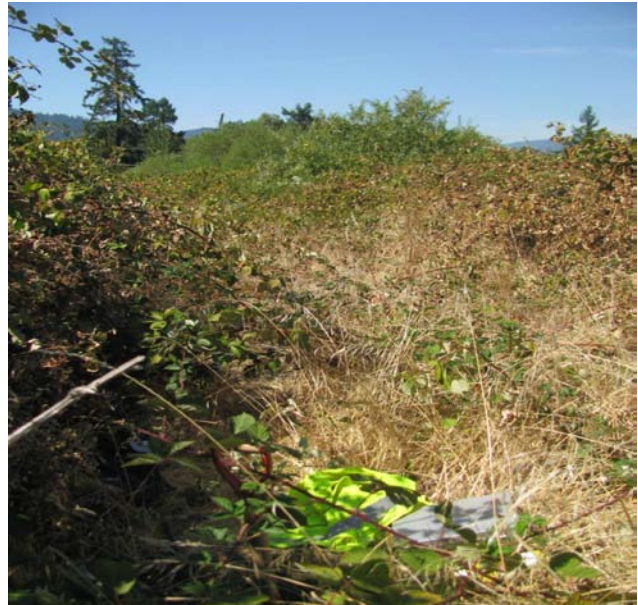
**Photo B-6 TP4 Site**

The onsite vegetation found is as follows: sapling/shrub stratum–60 percent Himalayan blackberry; herb stratum–80 percent wild oat (*Avena sativa* [UPL]), 10 percent blue wildrye (*Elymus glaucus* [FACU]), and 2 percent medusa head (*Elymus caput-medusae* [NL])).

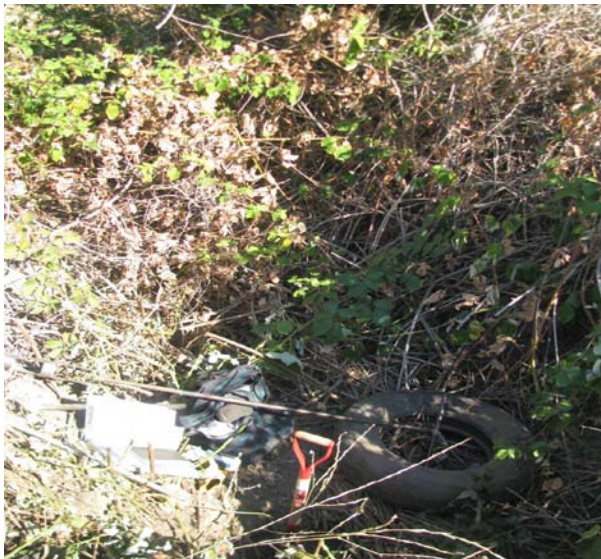
**Photo B-7 TP5 Site**

TP5 was excavated to see if this closed basin is a wetland site (Appendix B, Photo B-7). There is a berm between this basin and the TP1 site. It was difficult to find “normal circumstances” because of the loose soils spilling into the swale. One area was found to be representative of “normal circumstances” (a surface at least older than five years). None of the wetland parameters was present, and this basin is determined not to be a wetland site. A second, paired test pit was not performed due to the lack of three wetland parameters in the most likely location for wetlands to occur in this vicinity.

The onsite vegetation found is as follows: sapling/shrub stratum–70 percent Himalayan blackberry; herb stratum–30 percent wild oat and 5 percent black mustard (*Brassica nigra* [NL]).

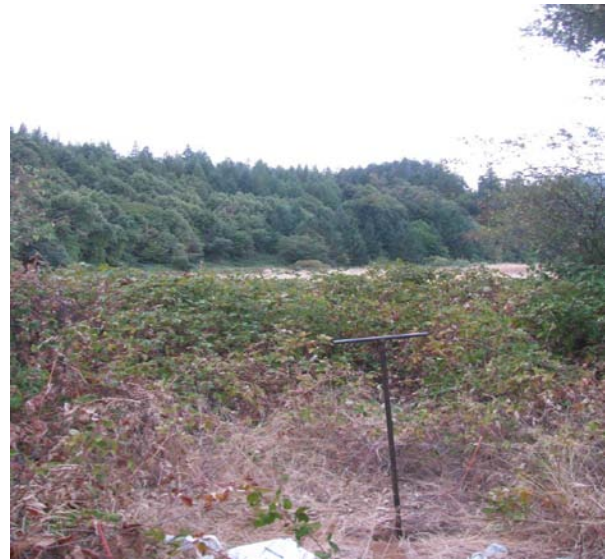
**Photo B-8 TP6 Site**

The onsite vegetation found is as follows: sapling/shrub stratum–70 percent Himalayan blackberry; herb stratum–50 percent Kentucky blue grass (*Poa pratensis* [FAC]), 10 percent blue wildrye, 2 percent Queen Anne's lace (*Daucus carota* [FACU]), and 2 percent orchard grass (*Dactylis glomerata* [FACU]).
