Riparian and Stream Assessment
For
Showers Creek
Kneeland, CA

April 26th, 2017

Prepared for:
Timberland Resource Consultants
Fortuna, CA

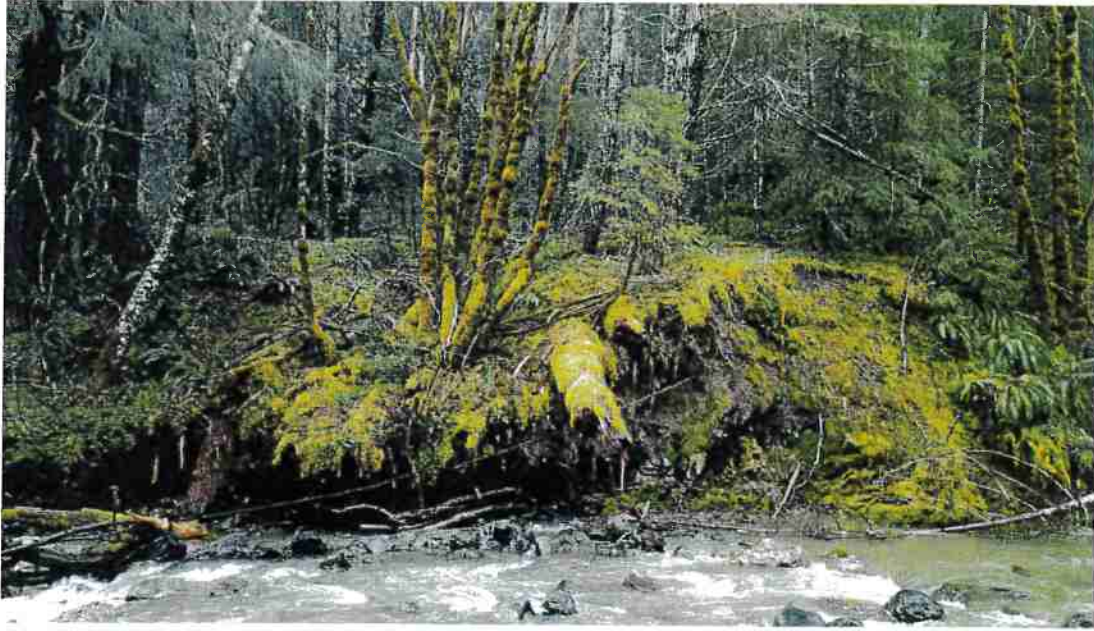
Picture 3: This is a photograph of the eastern stream bank. Photo date: 04/07/2017
