# TECHNICAL MEMORANDUM

SUBJECT: Road Evaluation for APN 221-031-010: Segment 4 -

On November 19, 2017 Joel Monschke conducted a field evaluation of Segments 4 and 5 as described above. Information in this Technical Memorandum pertains to Segment 4 covering 4.2 miles of private community-maintained road (Thomas Road, also known as Lower Samuels Ranch Loop Road) from Salmon Creek School to the Serendipity sign.

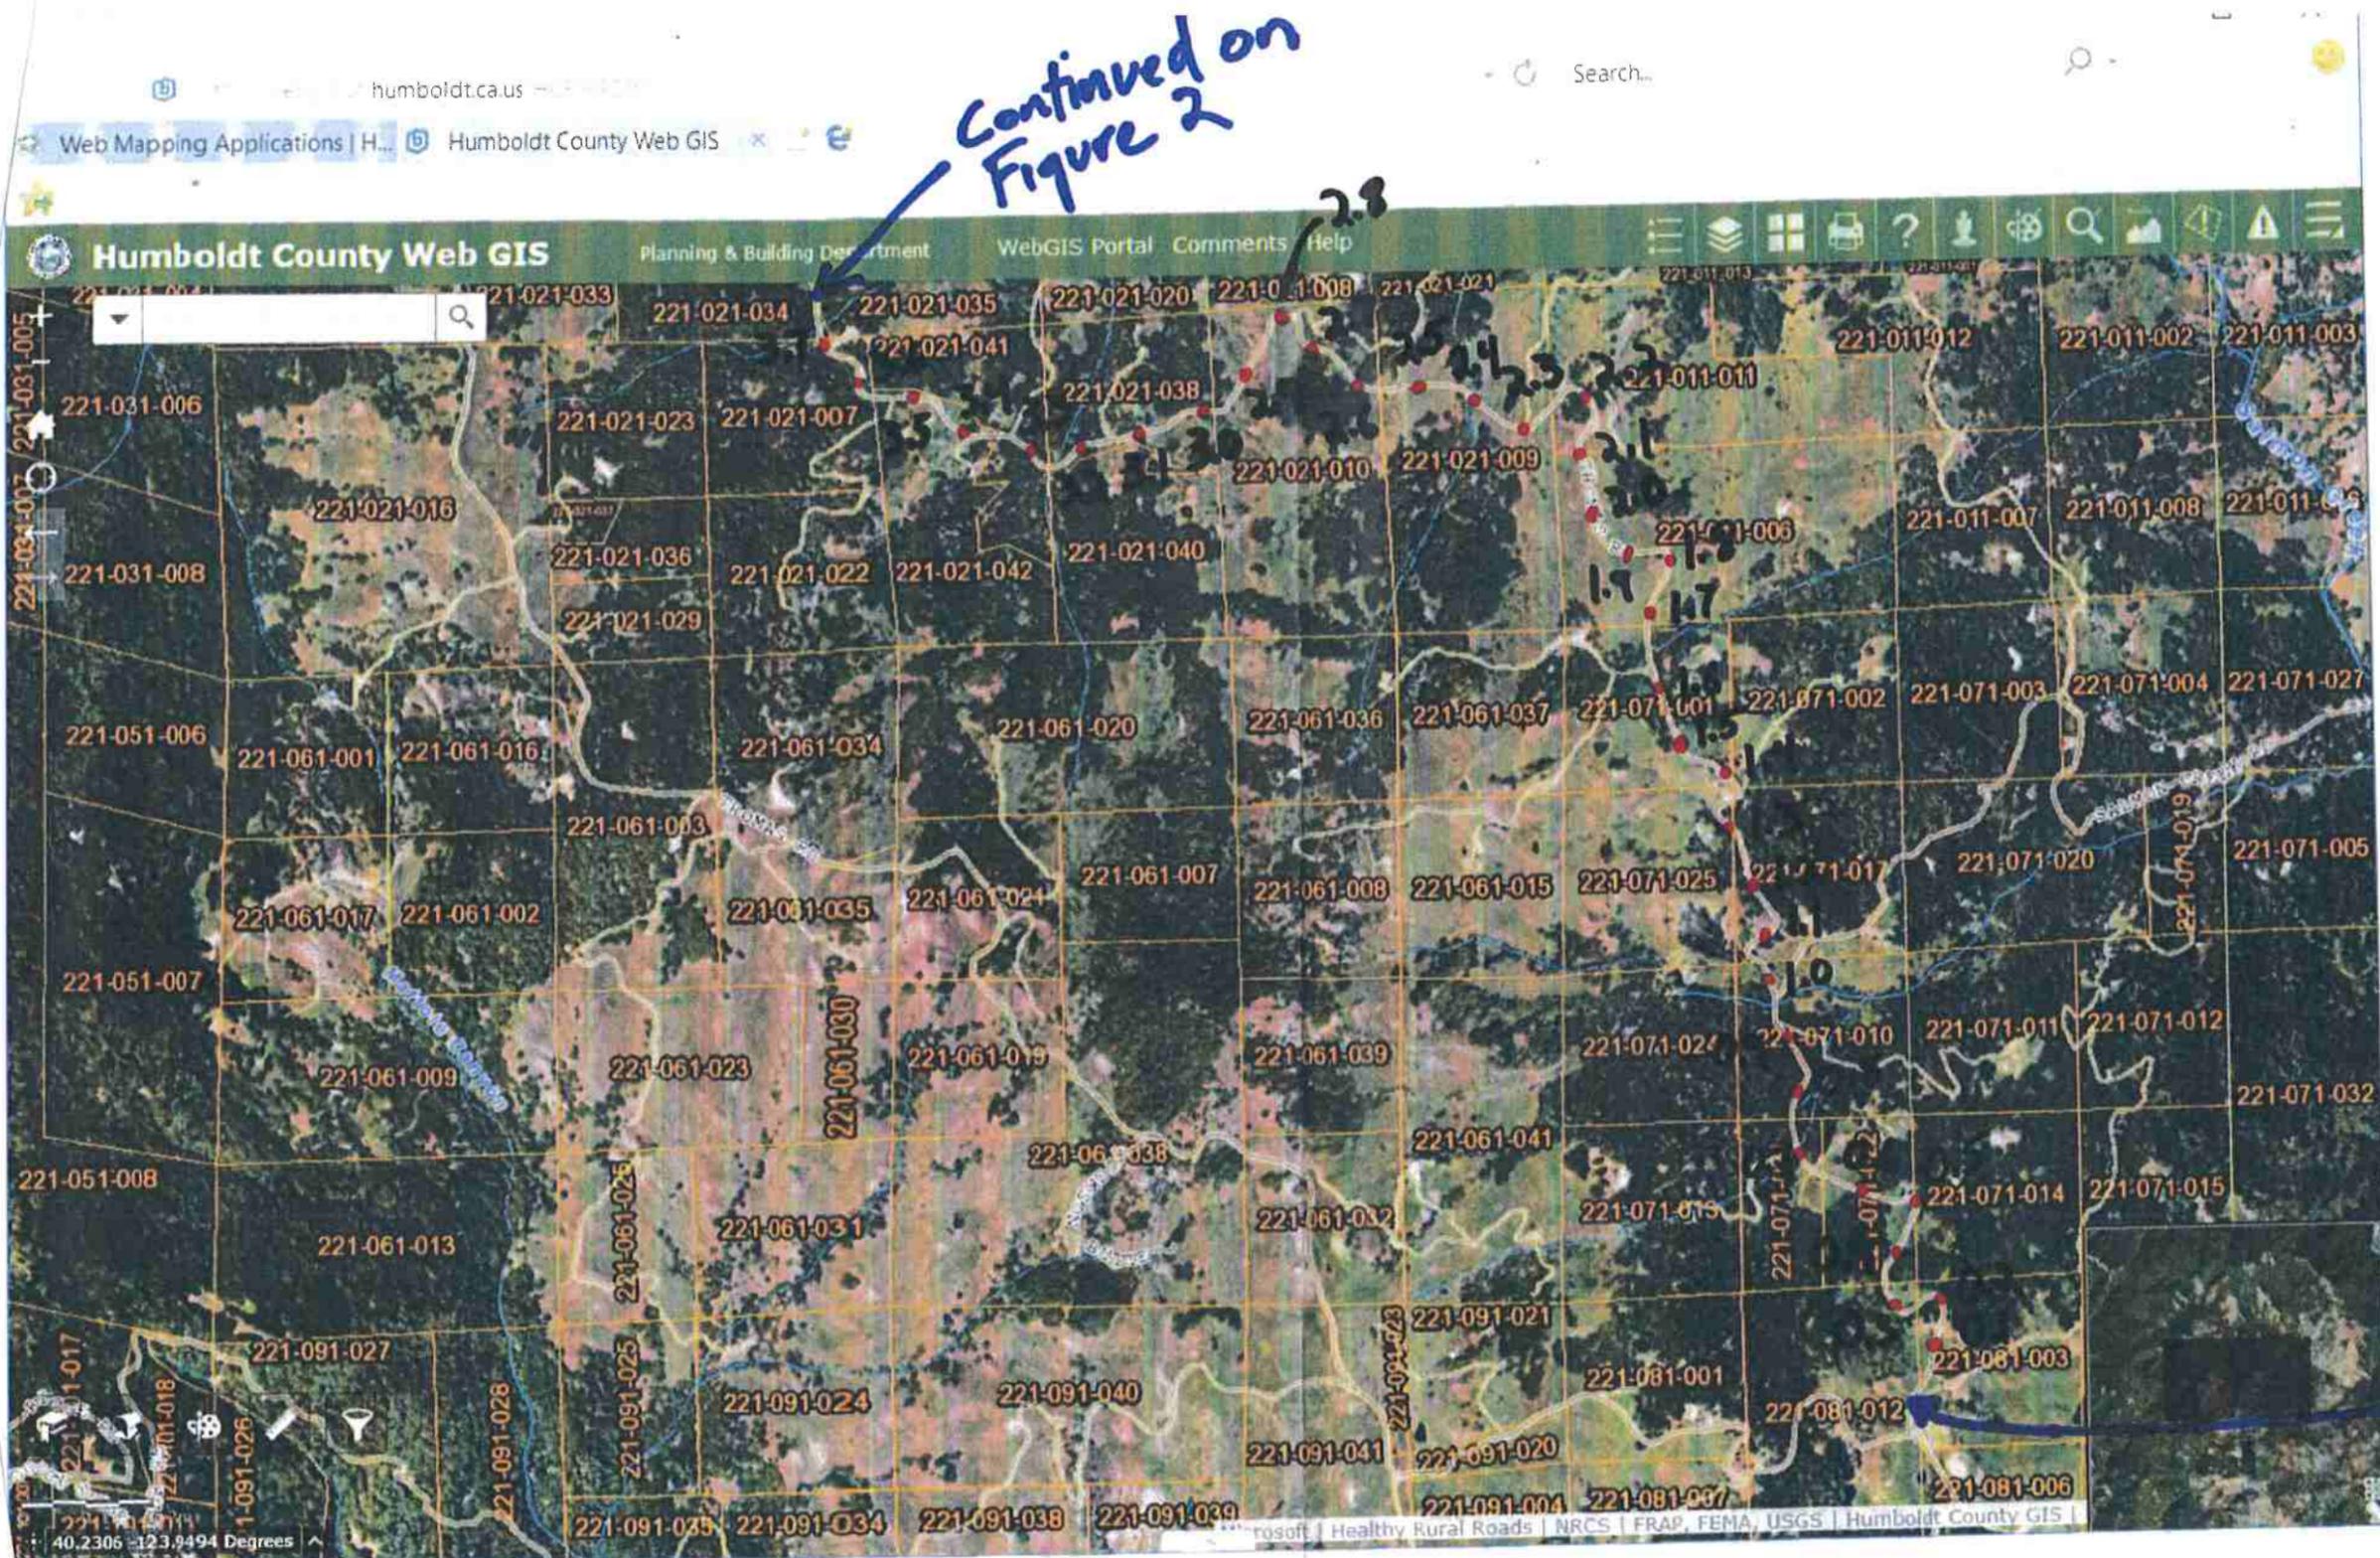
Figure 1. Map of Road Segment 4 Mile 0.0 to Mile 3.7

The following measurements were taken along this road segment at 0.1 mile intervals as shown on Figures 1 and 2:

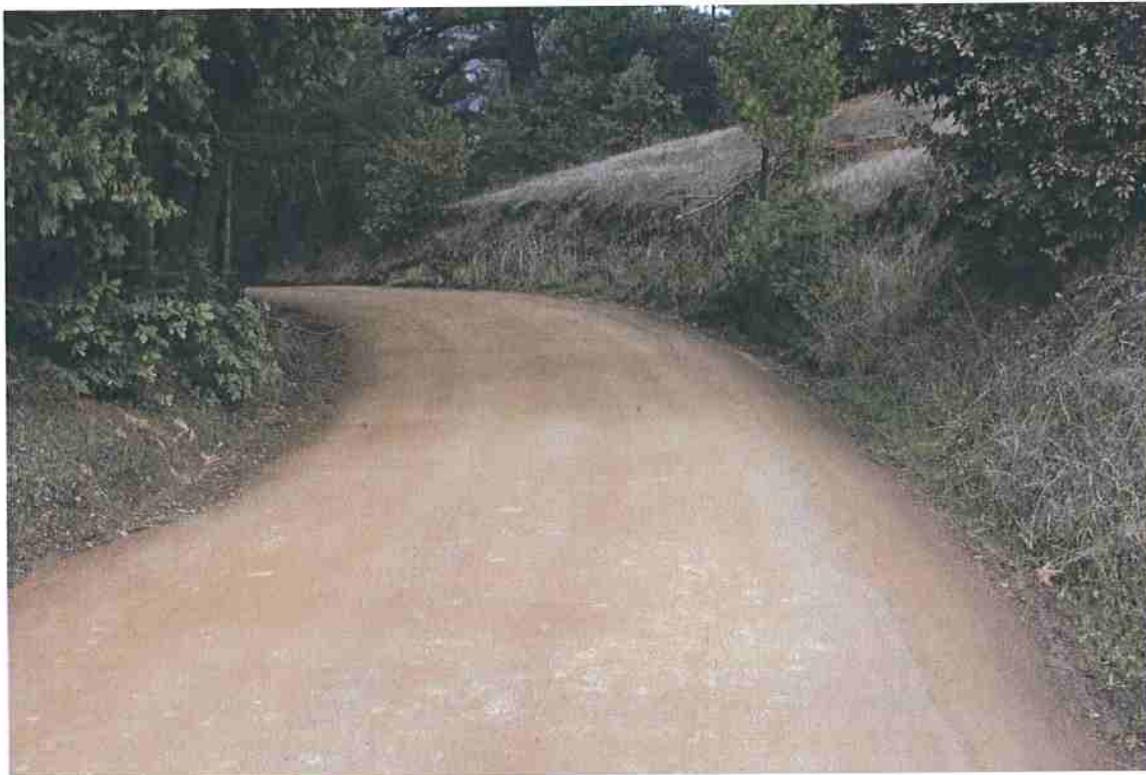
Photo 2 - Mile 0.15: minor pinch point, 16' width, 1' shoulders, clear vegetation to improve visibility.

Brush road segments as recommended above to improve visibility at narrow sections; potentially install sign at corner at mile 2.8.

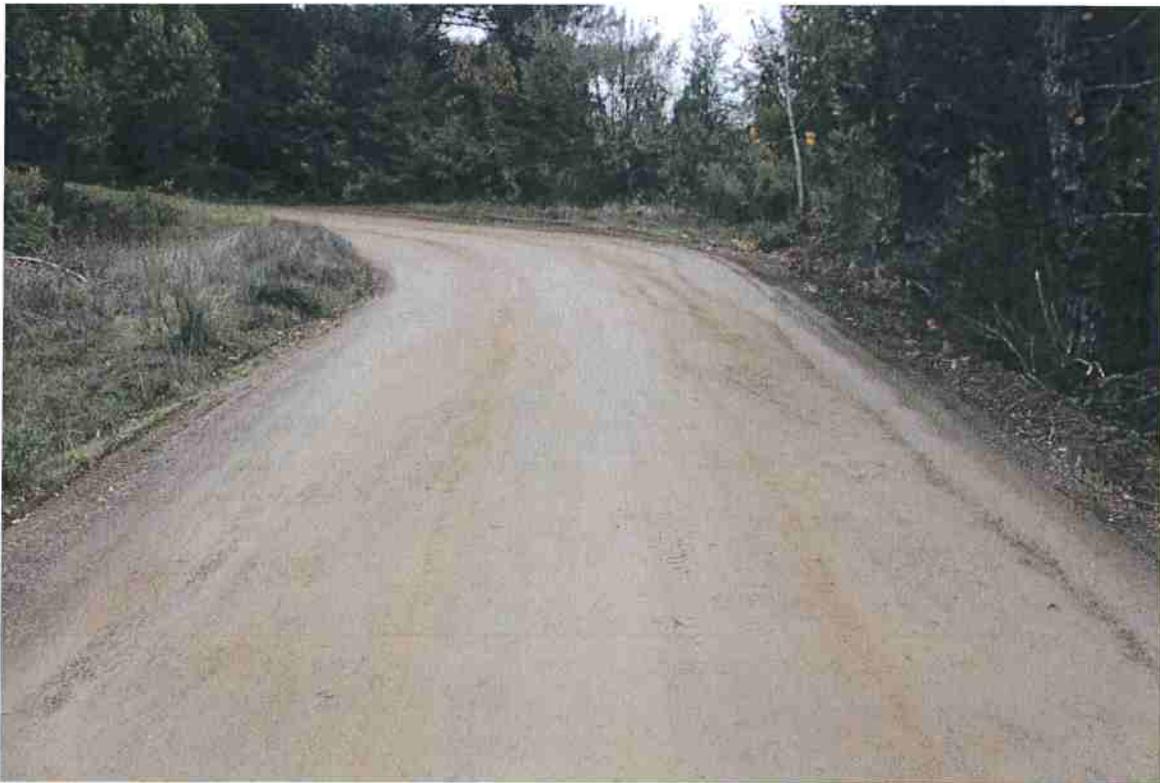
Photo 4 - Mile 0.3: 18' width 2' shoulders

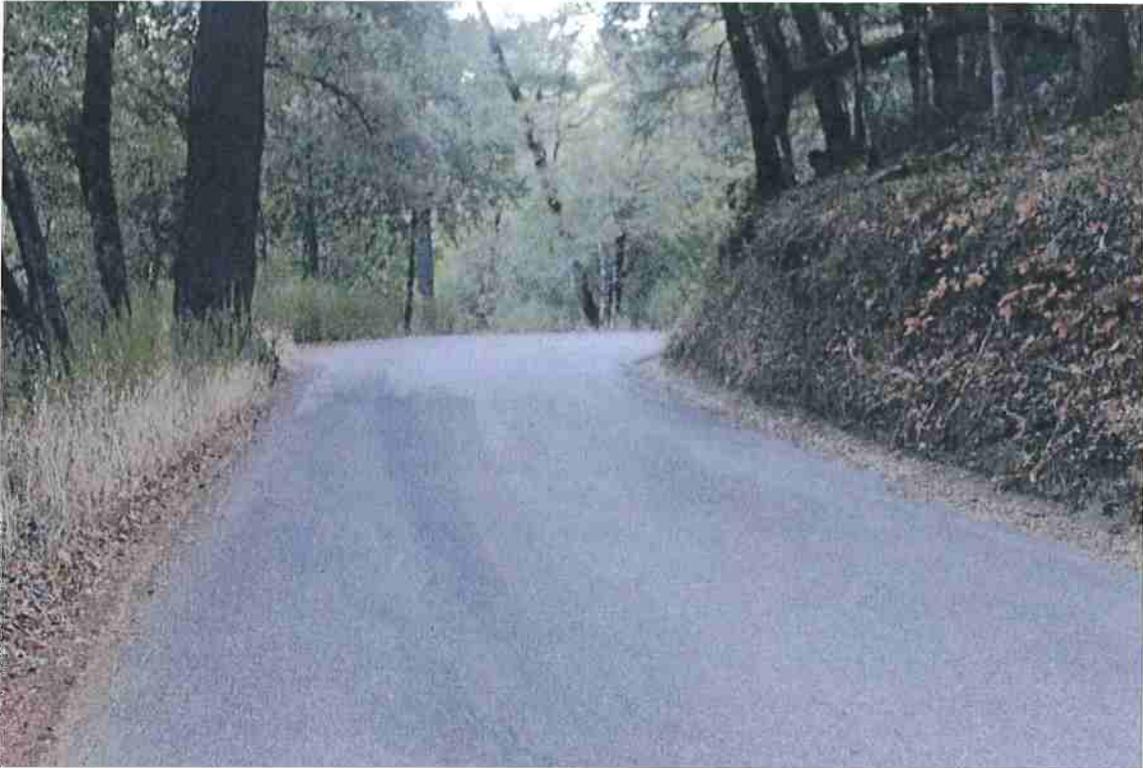
- Mile 1.0: 15-ft-wide pinch point with 1-ft shoulder caused by tree at blind corner.
- Mile 1.1: 20-ft road width with 1-ft shoulder.
- Mile 1.2: 20-ft road width with 1-ft shoulder.

**Photo 11.** Mile 1.0: Pinch point at tree on blind corner; 15-ft road width with 1-ft shoulder. Recommend widening.

- Mile 0.1: Cut vegetation to improve visibility, upgrade pavement to allow for minimal 18' wide driving surface width where feasible
- Mile 1.0: We recommend widening the roadway including removal of a Douglas Fir tree to improve the road width and visibility at the blind corner.
- Mile 1.9 to mile 2.2: There are some pinch points along this segment, but the segment traverses steep terrain so widening would be difficult and have potentially significant environmental impacts. Recommend signage reminding drivers to slow down and stay on their side of the road.
- Mile 2.4: We recommend widening the corner on the inside to improve width and visibility at the blind corner. Also nearby at mile 2.35, need to repair slumping outboard edge of road.

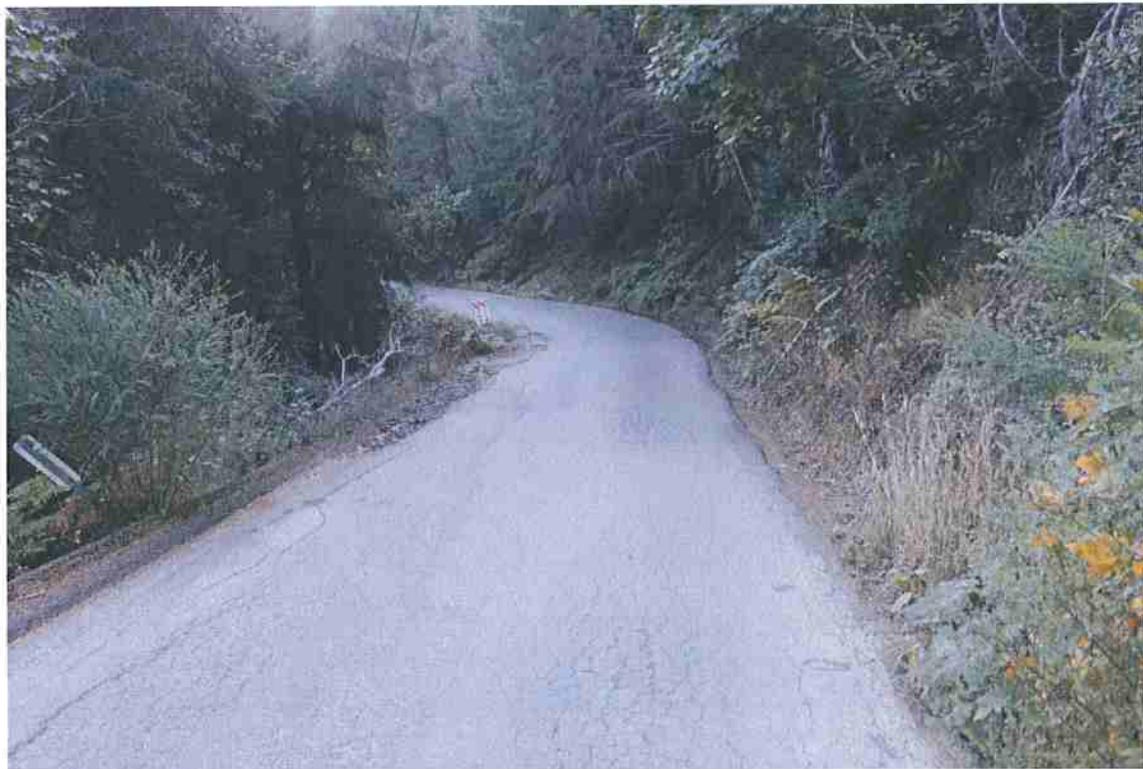
- Mile 2.3: 20-ft road width with 2-ft shoulder.
- Mile 2.35: ~15-ft-wide pinch point at partial road failure
- Mile 2.4: 16-ft road width with 1-ft shoulder. Dangerous blind corner.

Photo 26. Mile 2.35: ~15-ft road width pinch point at partial road failure.

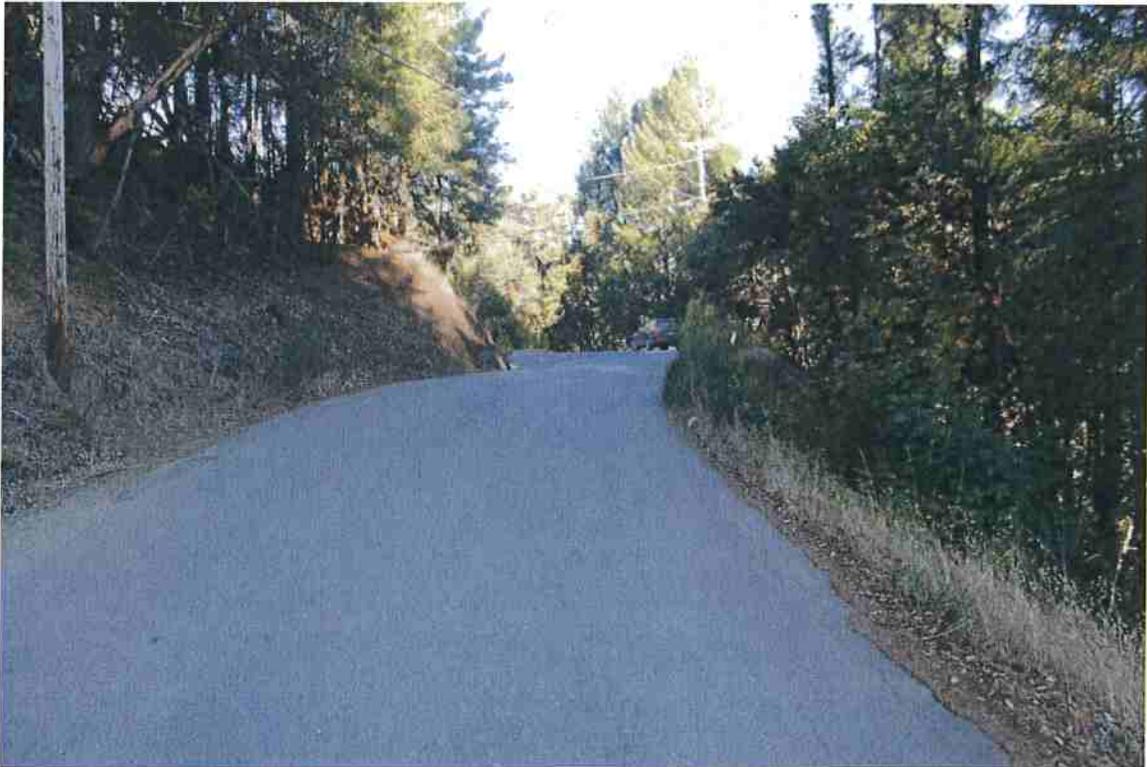
Photo 28. Mile 2.4: 16-ft road width with 1-ft shoulders at blind corner. Potential spot to widen corner on the inside to improve width and visibility.

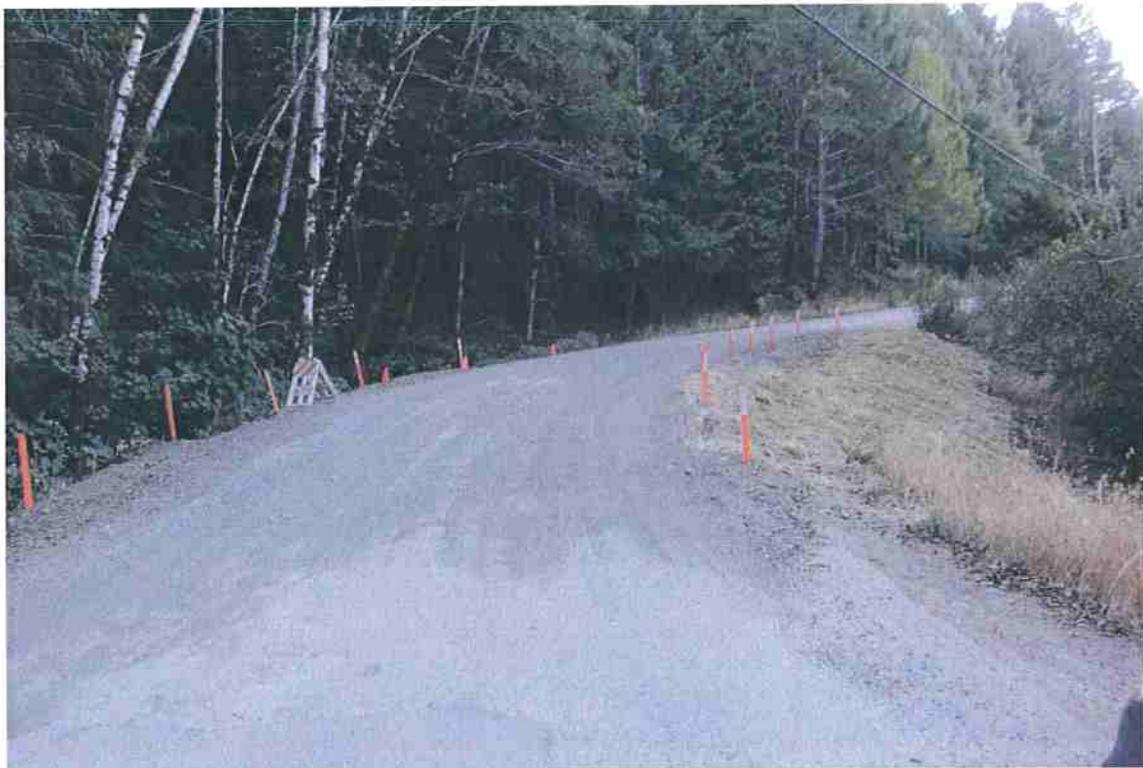
- Mile 2.6: The culvert at this location was recently repaired. The short segment over the culvert is gravel and 18-ft wide with 2-ft shoulder.
- Mile 2.7: 20-ft road width and 2-ft shoulder.

Photo 30. Mile 12.6: Recent culver repair, short gravel segment. 18-ft road width with 2-ft shoulders.

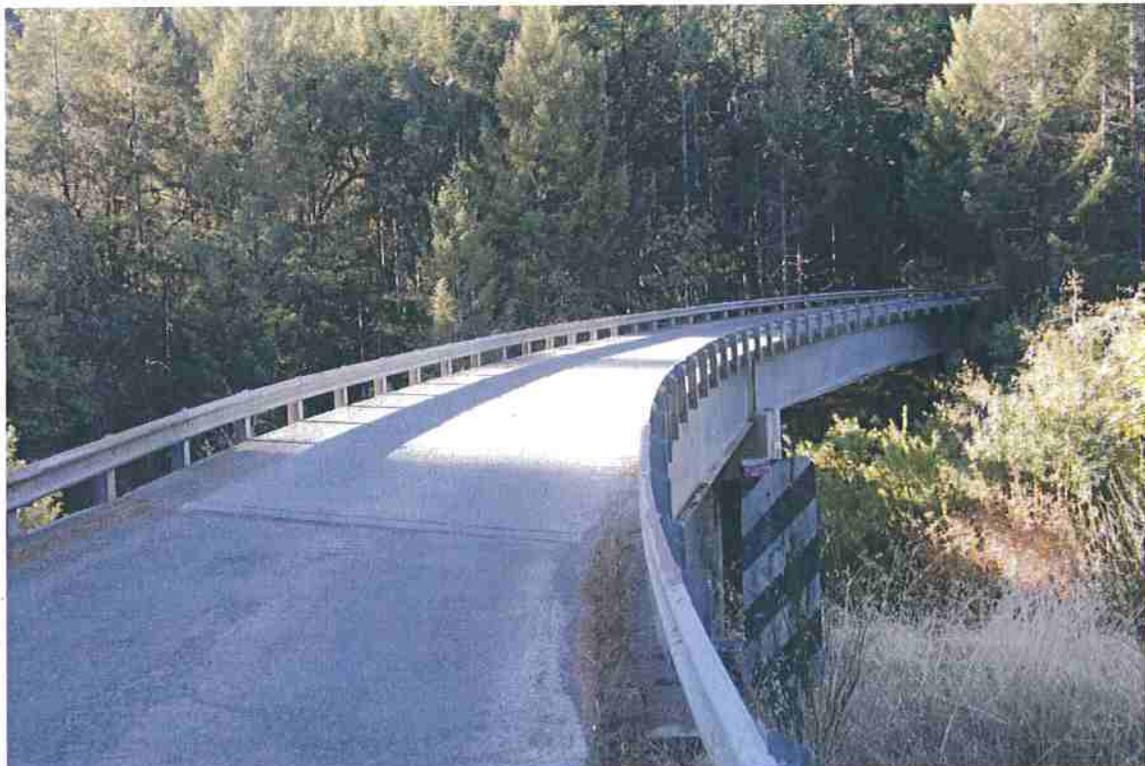
**Photo 38.** Mile 3.3: 16-ft wide bridge, no shoulders. Recommend removing vegetation on west extent of bridge to improve visibility.

- Mile 3.3: We recommend removing vegetation on western extent of bridge to improve visibility.
- Mile 3.4: We recommend widening corner on inside to improve width and visibility at blind corner.

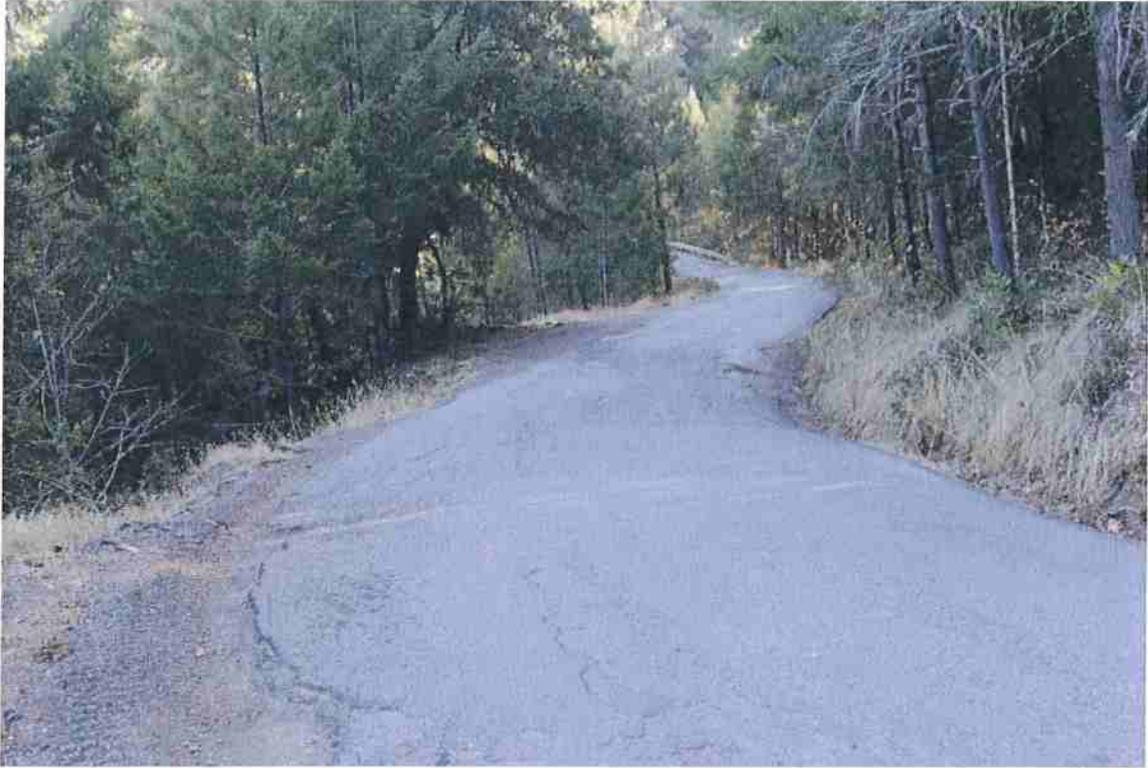
**Photo 39.** Mile 3.4: 16-ft road width with 1-ft shoulder. Pinch point at downgradient extent of blind corner. Potential spot to widen corner on inside to improve width and visibility.

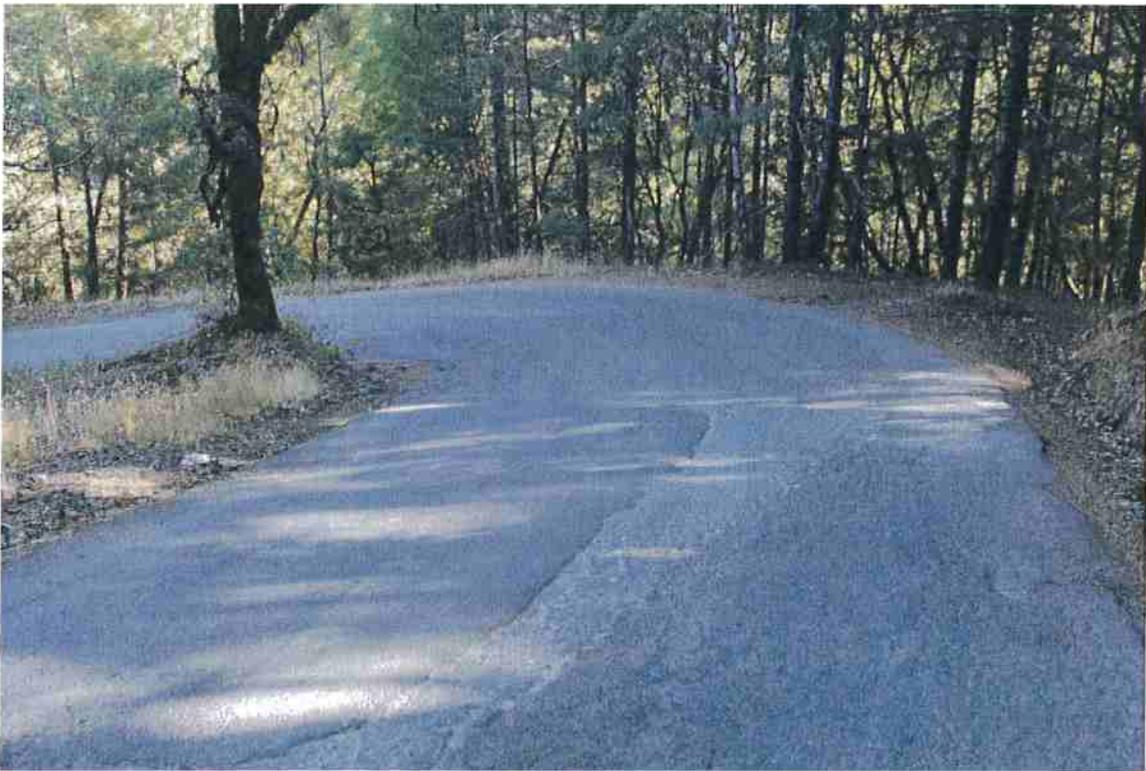
**Photo 40.** Mile 3.5: 18-ft road width with 1-ft shoulder. Very steep, sharp corner where trucks often get stuck. Consider re-engineering grade and curve radius.

- Mile 3.5: Although the width and visibility on this corner is adequate, it is very steep and dangerous because large trucks frequently get stuck. We recommend re-engineering the corner to reduce grade and lengthen radius of curve. This work could potentially utilize the cut material from the other road widening sites.

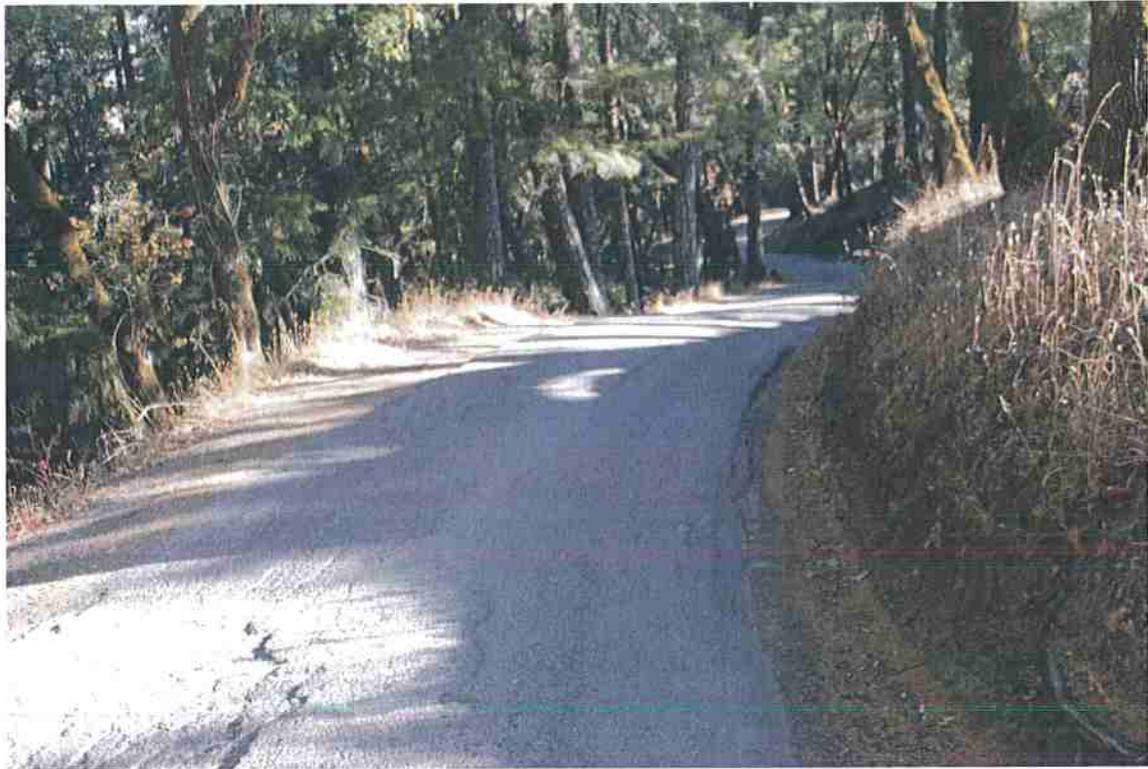
**Photo 41.** Mile 3.6: 12-ft road width with 2-ft shoulders. Pinch point but decent visibility with turnouts.

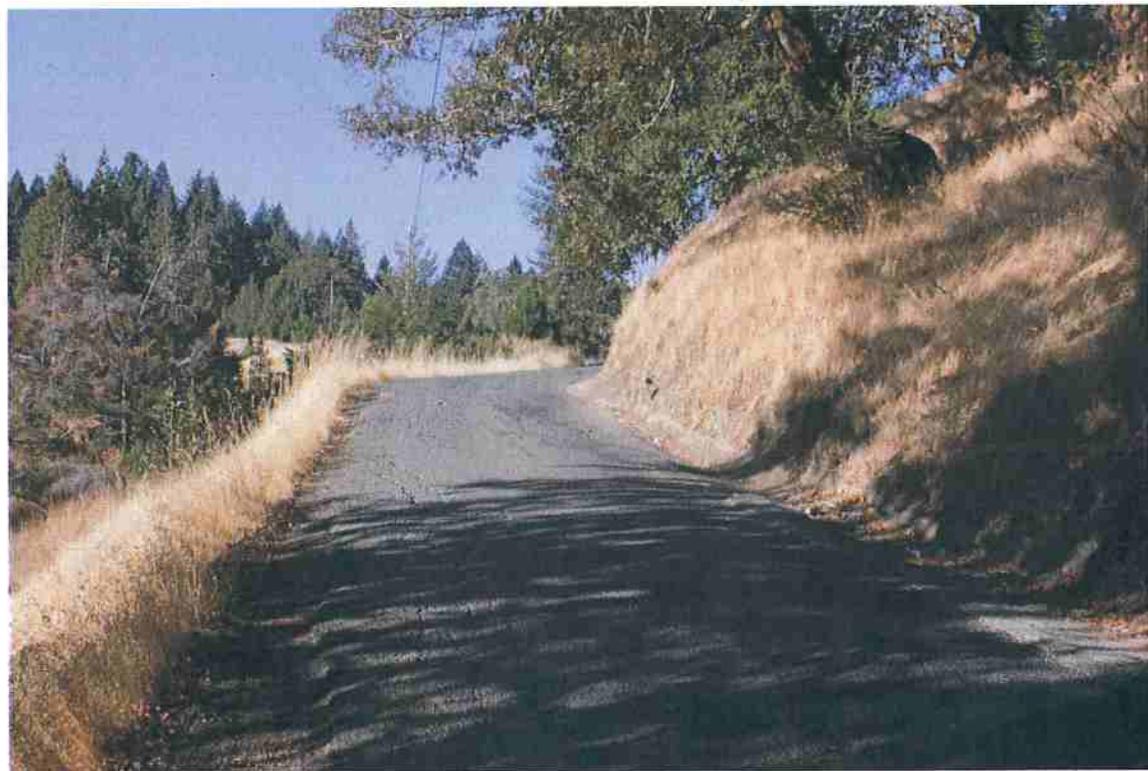
**Photo 42.** Mile 3.65: Blind corner - 12-ft road width with 1-ft shoulders. Potential location to widen corner on inside to improve width and visibility.

- Mile 3.65 to mile 3.7: Potential locations to widen several corners on inside to improve road width and visibility at blind curves.
- Mile 3.7: Potential location to widen corner on inside to improve road width and visibility at partially blind curve.

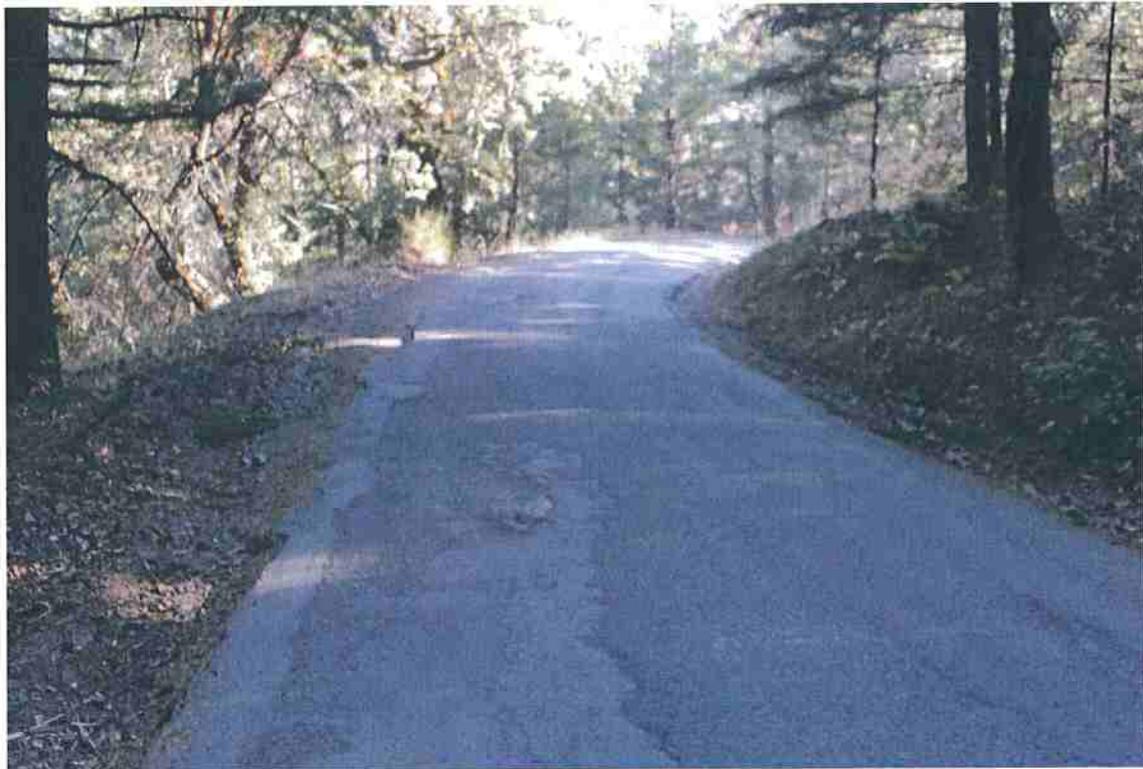
- Mile 3.7: 12-ft road width with 10ft shoulder. Partially blind corner with deep ditch.
- Mile 3.8: 18-ft road width with 1-ft shoulder.
- Mile 3.9: 15-ft road width with 2-ft shoulder, broken pavement edges make segment more treacherous.

**Photo 46.** Mile 3.9: 15-ft road width with 2-ft shoulders. Broken pavement edges make segment more treacherous.

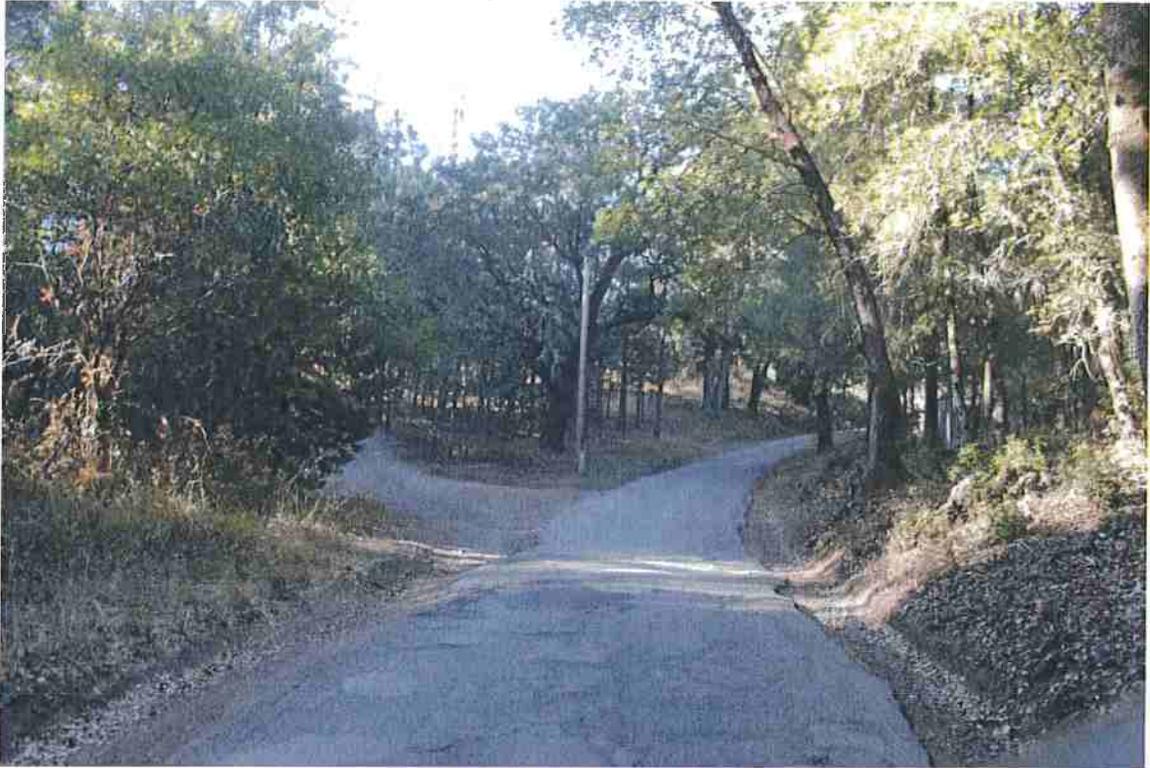
- Mile 4.0: 15-ft road width with 2-ft shoulder, broken pavement edges make segment more treacherous.
- Mile 4.1: 20-ft road width with 2-ft shoulders at intersection with Upper Thomas Road. End of County-maintained road (and end of segment 2).

**Photo 47.** Mile 4.0: 15-ft road width with 2-ft shoulders. Broken pavement edges make segment more treacherous.

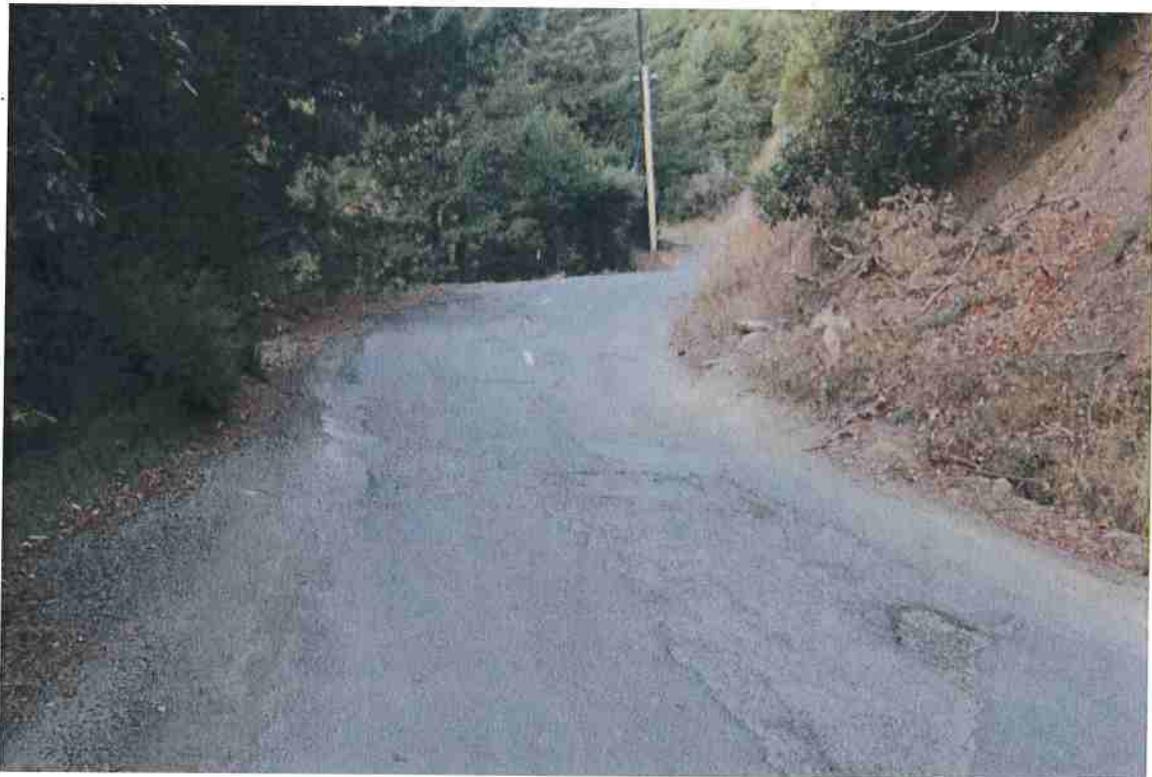
- Mile 0 to 0.7 (Beginning at Maple Hills Road): Paved, with yellow stripe, 18–24 foot (ft) width with 2-ft gravel shoulders, “equivalent category 4 road” with exception of one pinch point at mile 0.3 (14 ft width with no shoulders) caused by recent debris slide and tree (see photo in Appendix A). The pinch point is at a blind corner making it dangerous.

**Photo 2.** Mile 0.3: Pinch point at recent debris slide and tree; 14' width, no shoulder, blind corner, dangerous spot.

- Mile 0.3: We recommend removing trees and dirt that has slumped off cut slope. Widening roadway to 20 feet with shoulders, need to consider environmental impact (high priority).
- Mile 0.8 to 1: This is a trickier road segment to widen due to a deep landslide in the vicinity. However, minor improvements to the roadway could improve safety and width including paving work to stabilize the inboard ditch and outboard edge of the roadway at select locations and fix pavement edges that are broken and treacherous at numerous locations.

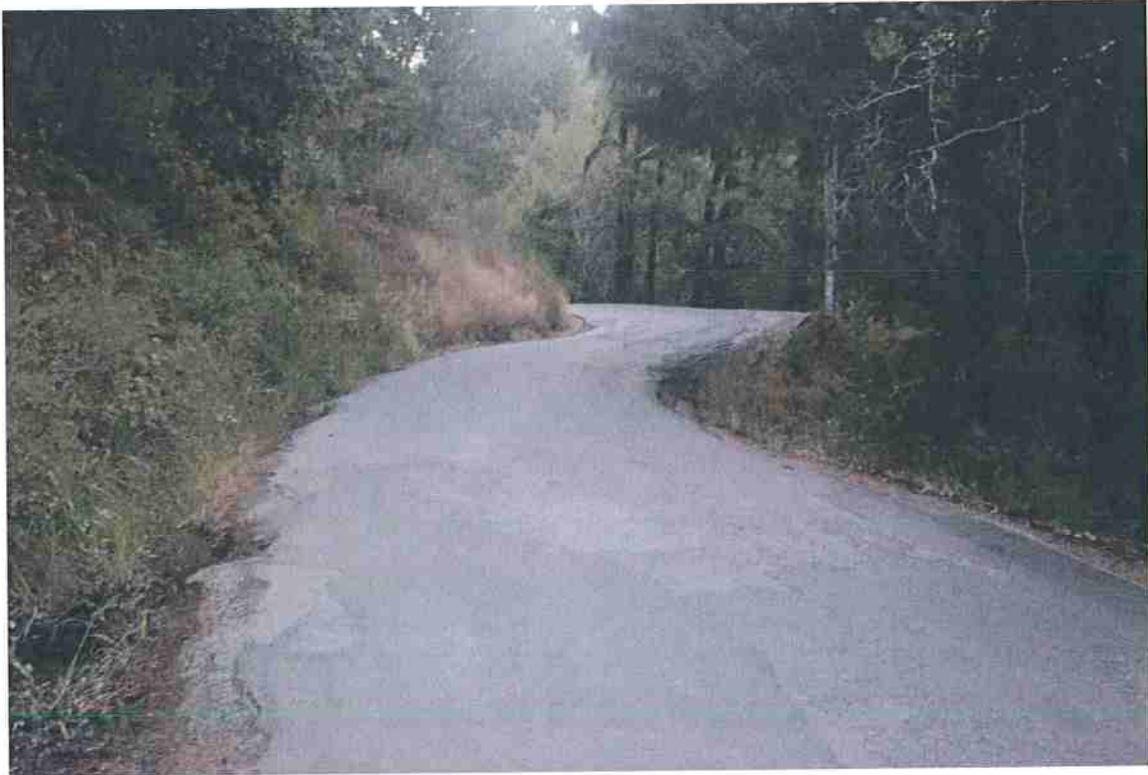
Photo 3. Mile 0.8: relatively narrow section, 16' width, no shoulder, deep ditch.

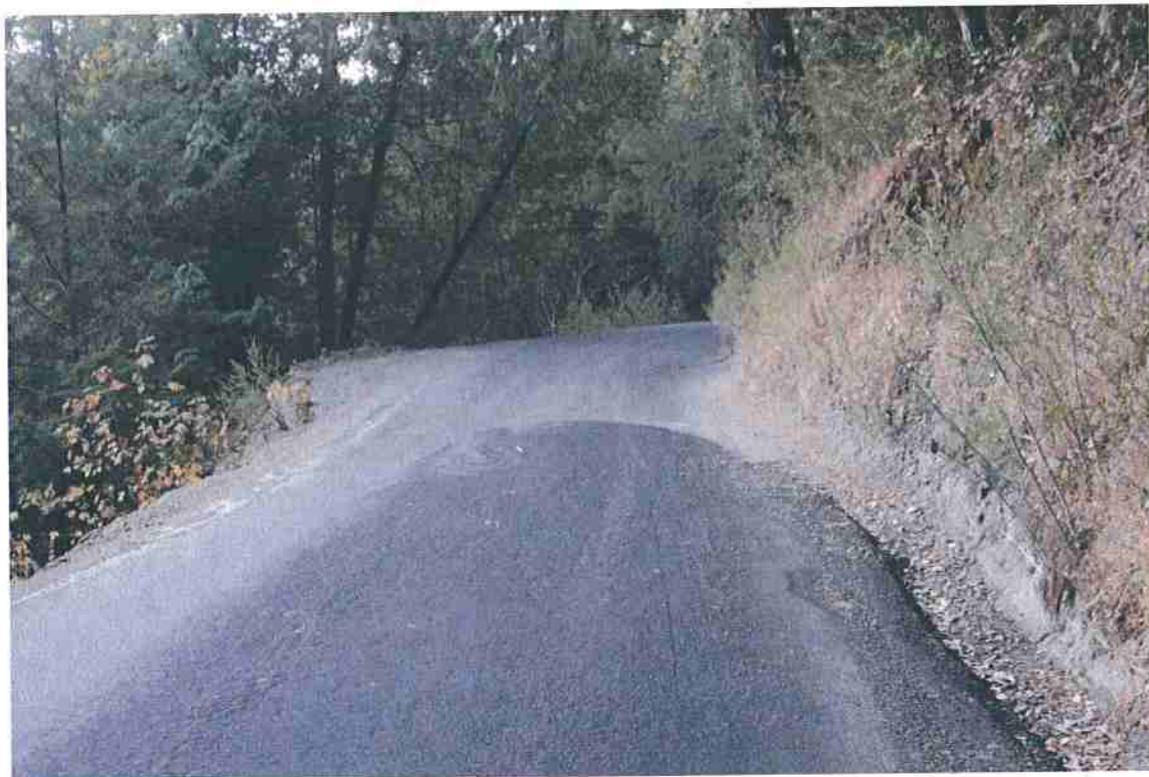
Photo 4. Mile 0.9: relatively narrow section, 15' width, 1' shoulders.

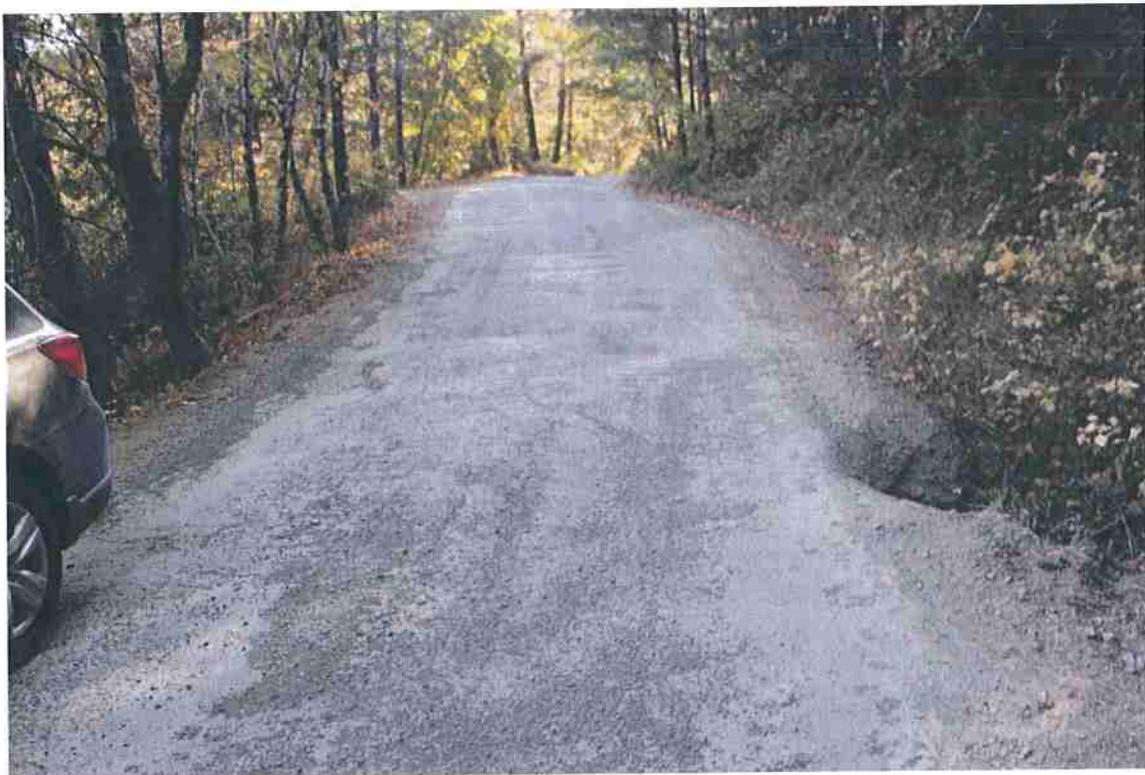
Photo 2. Mile 0.2: 16-ft road width with no shoulder at culvert crossing. The road could be widened at the culvert but there is decent visibility at the site so widening is not necessary.

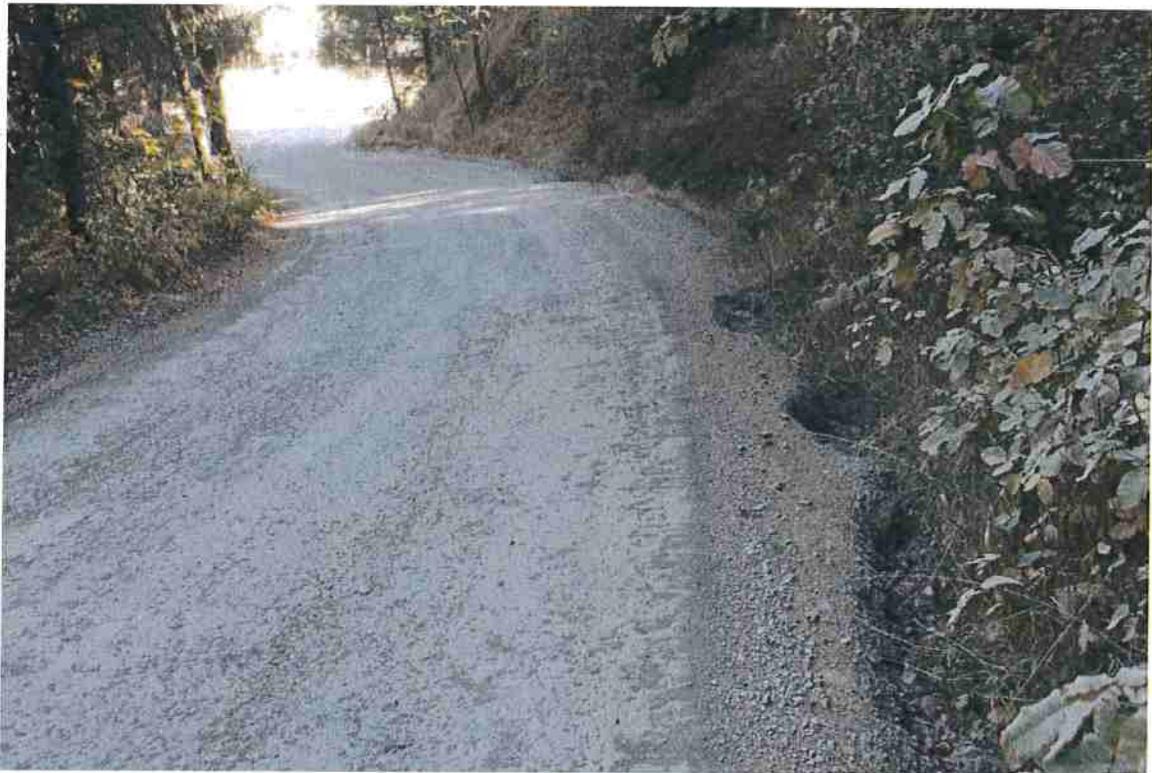
Photo 4. Mile 0.35: Inboard ditch eroding into road.

- Mile 0.35: replace culvert to widen road at pinch point. Armor inboard ditch to eliminate erosion of the road. Note that this is a moderate priority as compared to the recommendations in Segment 2 (County-maintained Thomas Road).

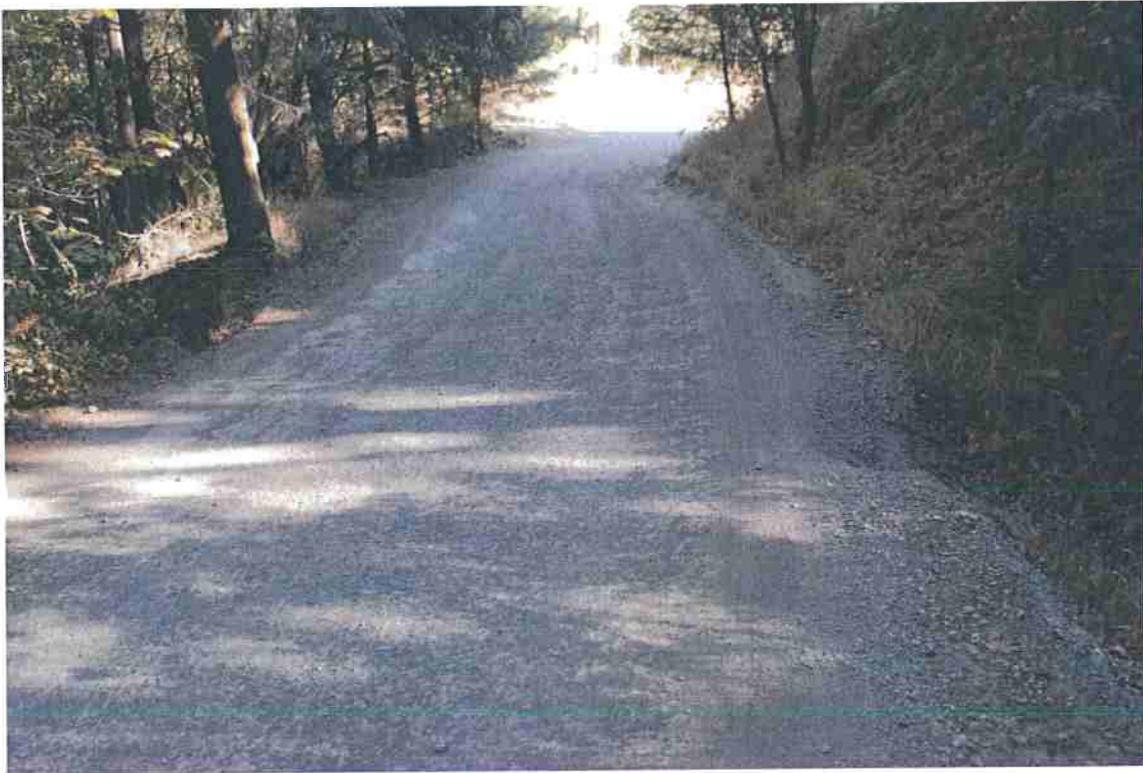
**Photo 5.** Mile 0.35: Pinch point at culvert; 16-ft road width with no shoulder and partial blind corner.
