# TECHNICAL MEMORANDUM

SUBJECT: Road Evaluation for APN 221-031-010: Segment 4 -

On November 19, 2017 Joel Monschke conducted a field evaluation of Segments 4 and 5 as described above. Information in this Technical Memorandum pertains to Segment 4 covering 4.2 miles of private community-maintained road (Thomas Road, also known as Lower Samuels Ranch Loop Road) from Salmon Creek School to the Serendipity sign.

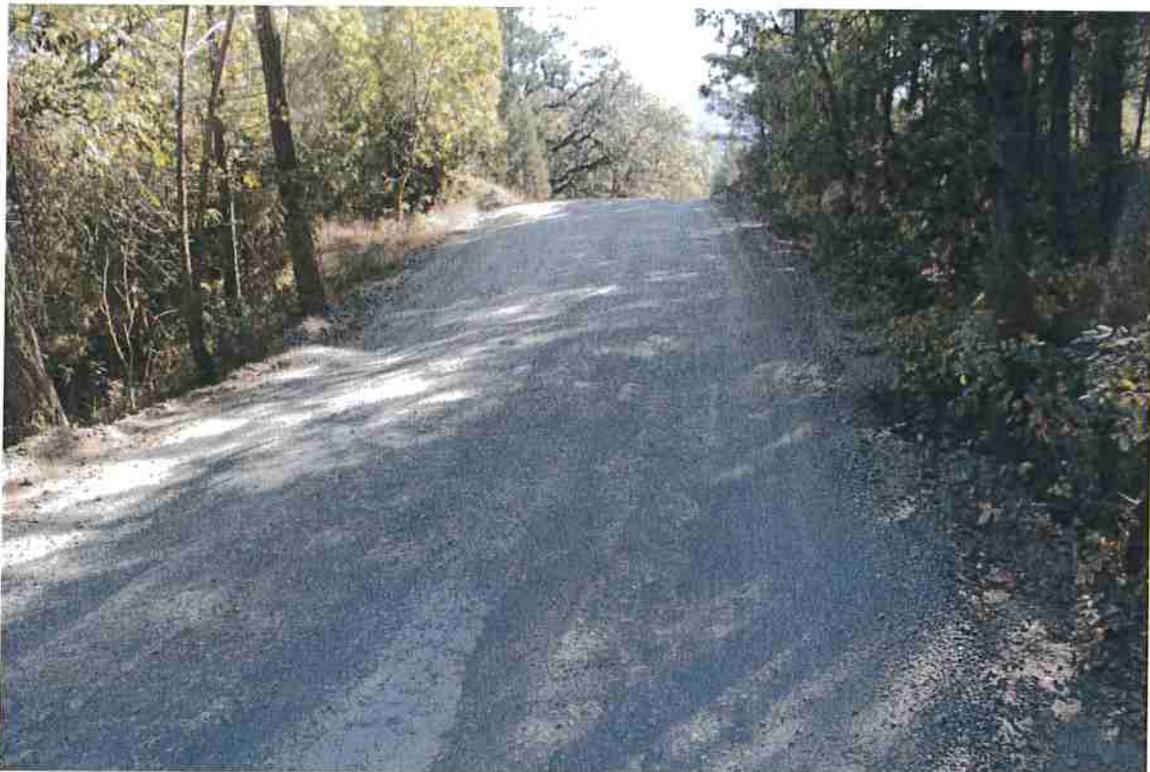
Photo 8. Mile 0.55: Pinch point at culvert; 16-ft road width with no shoulder. The road could be widened at the culvert location but there is decent visibility.
