Fault Rupture Hazard Evaluation

Proposed Subdivision of APN 510-371-010
2424 Bolier Avenue
McKinleyville, California

Proposed Subdivision of APN 510-371-010, 2424 Bolier Avenue, McKinleyville, California

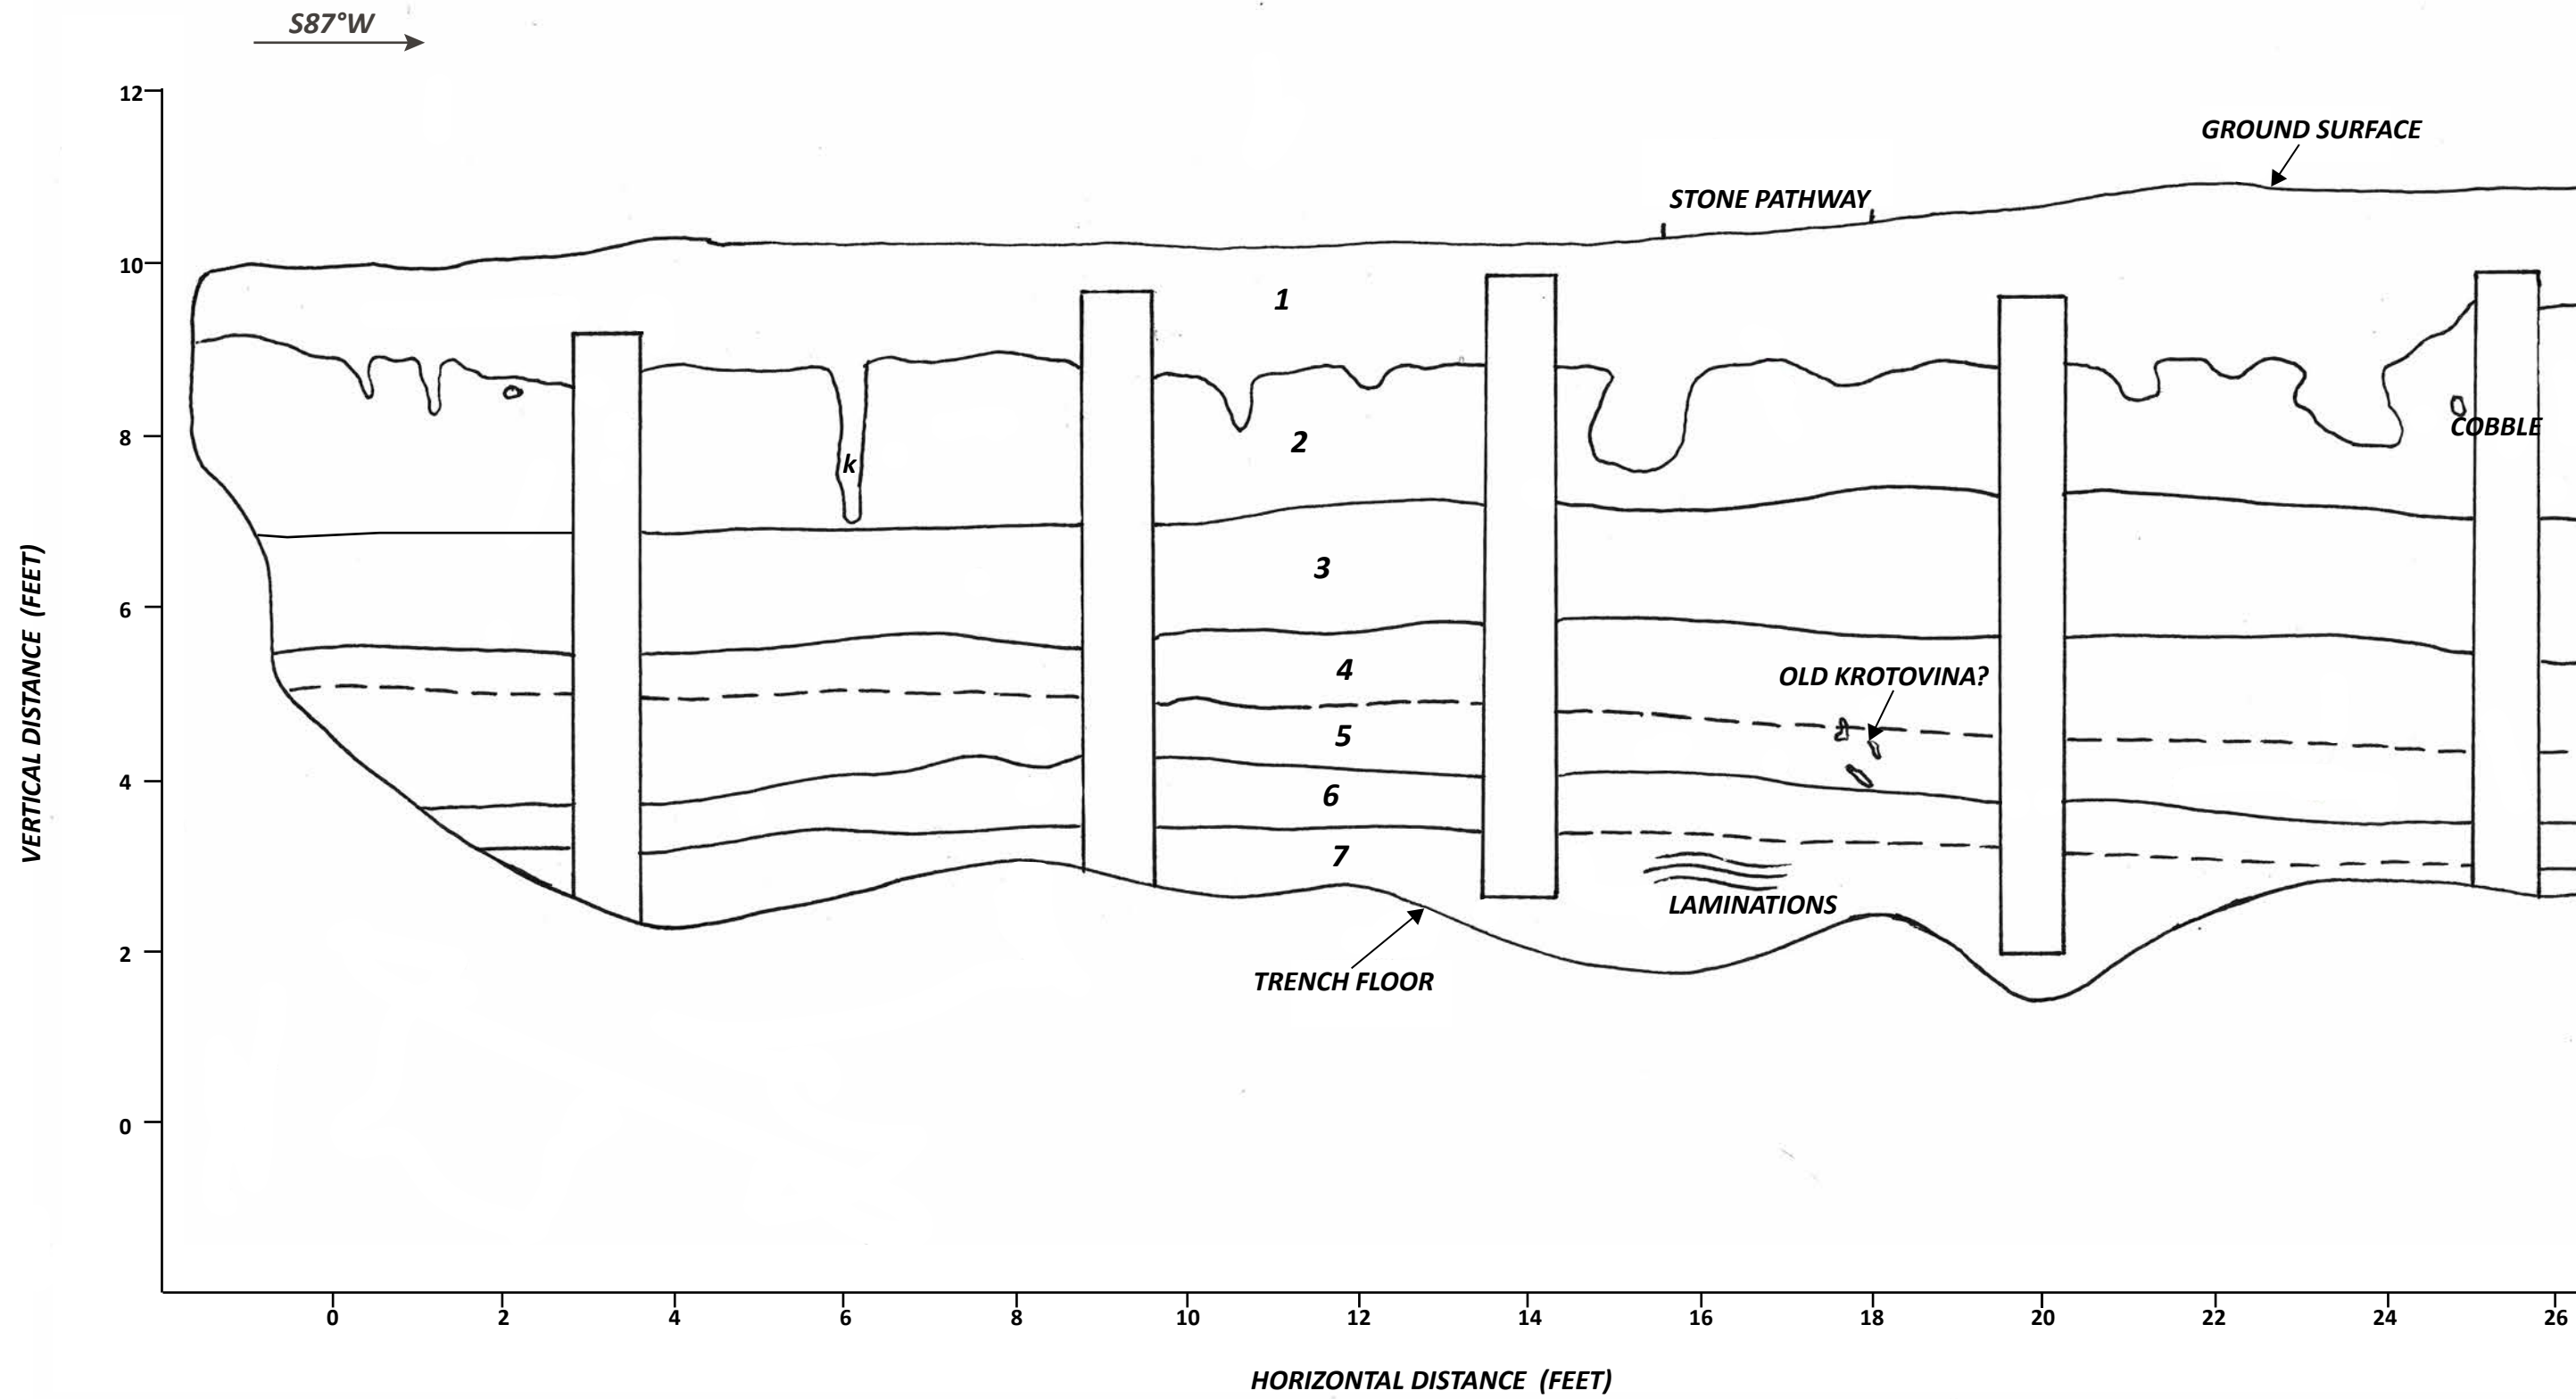
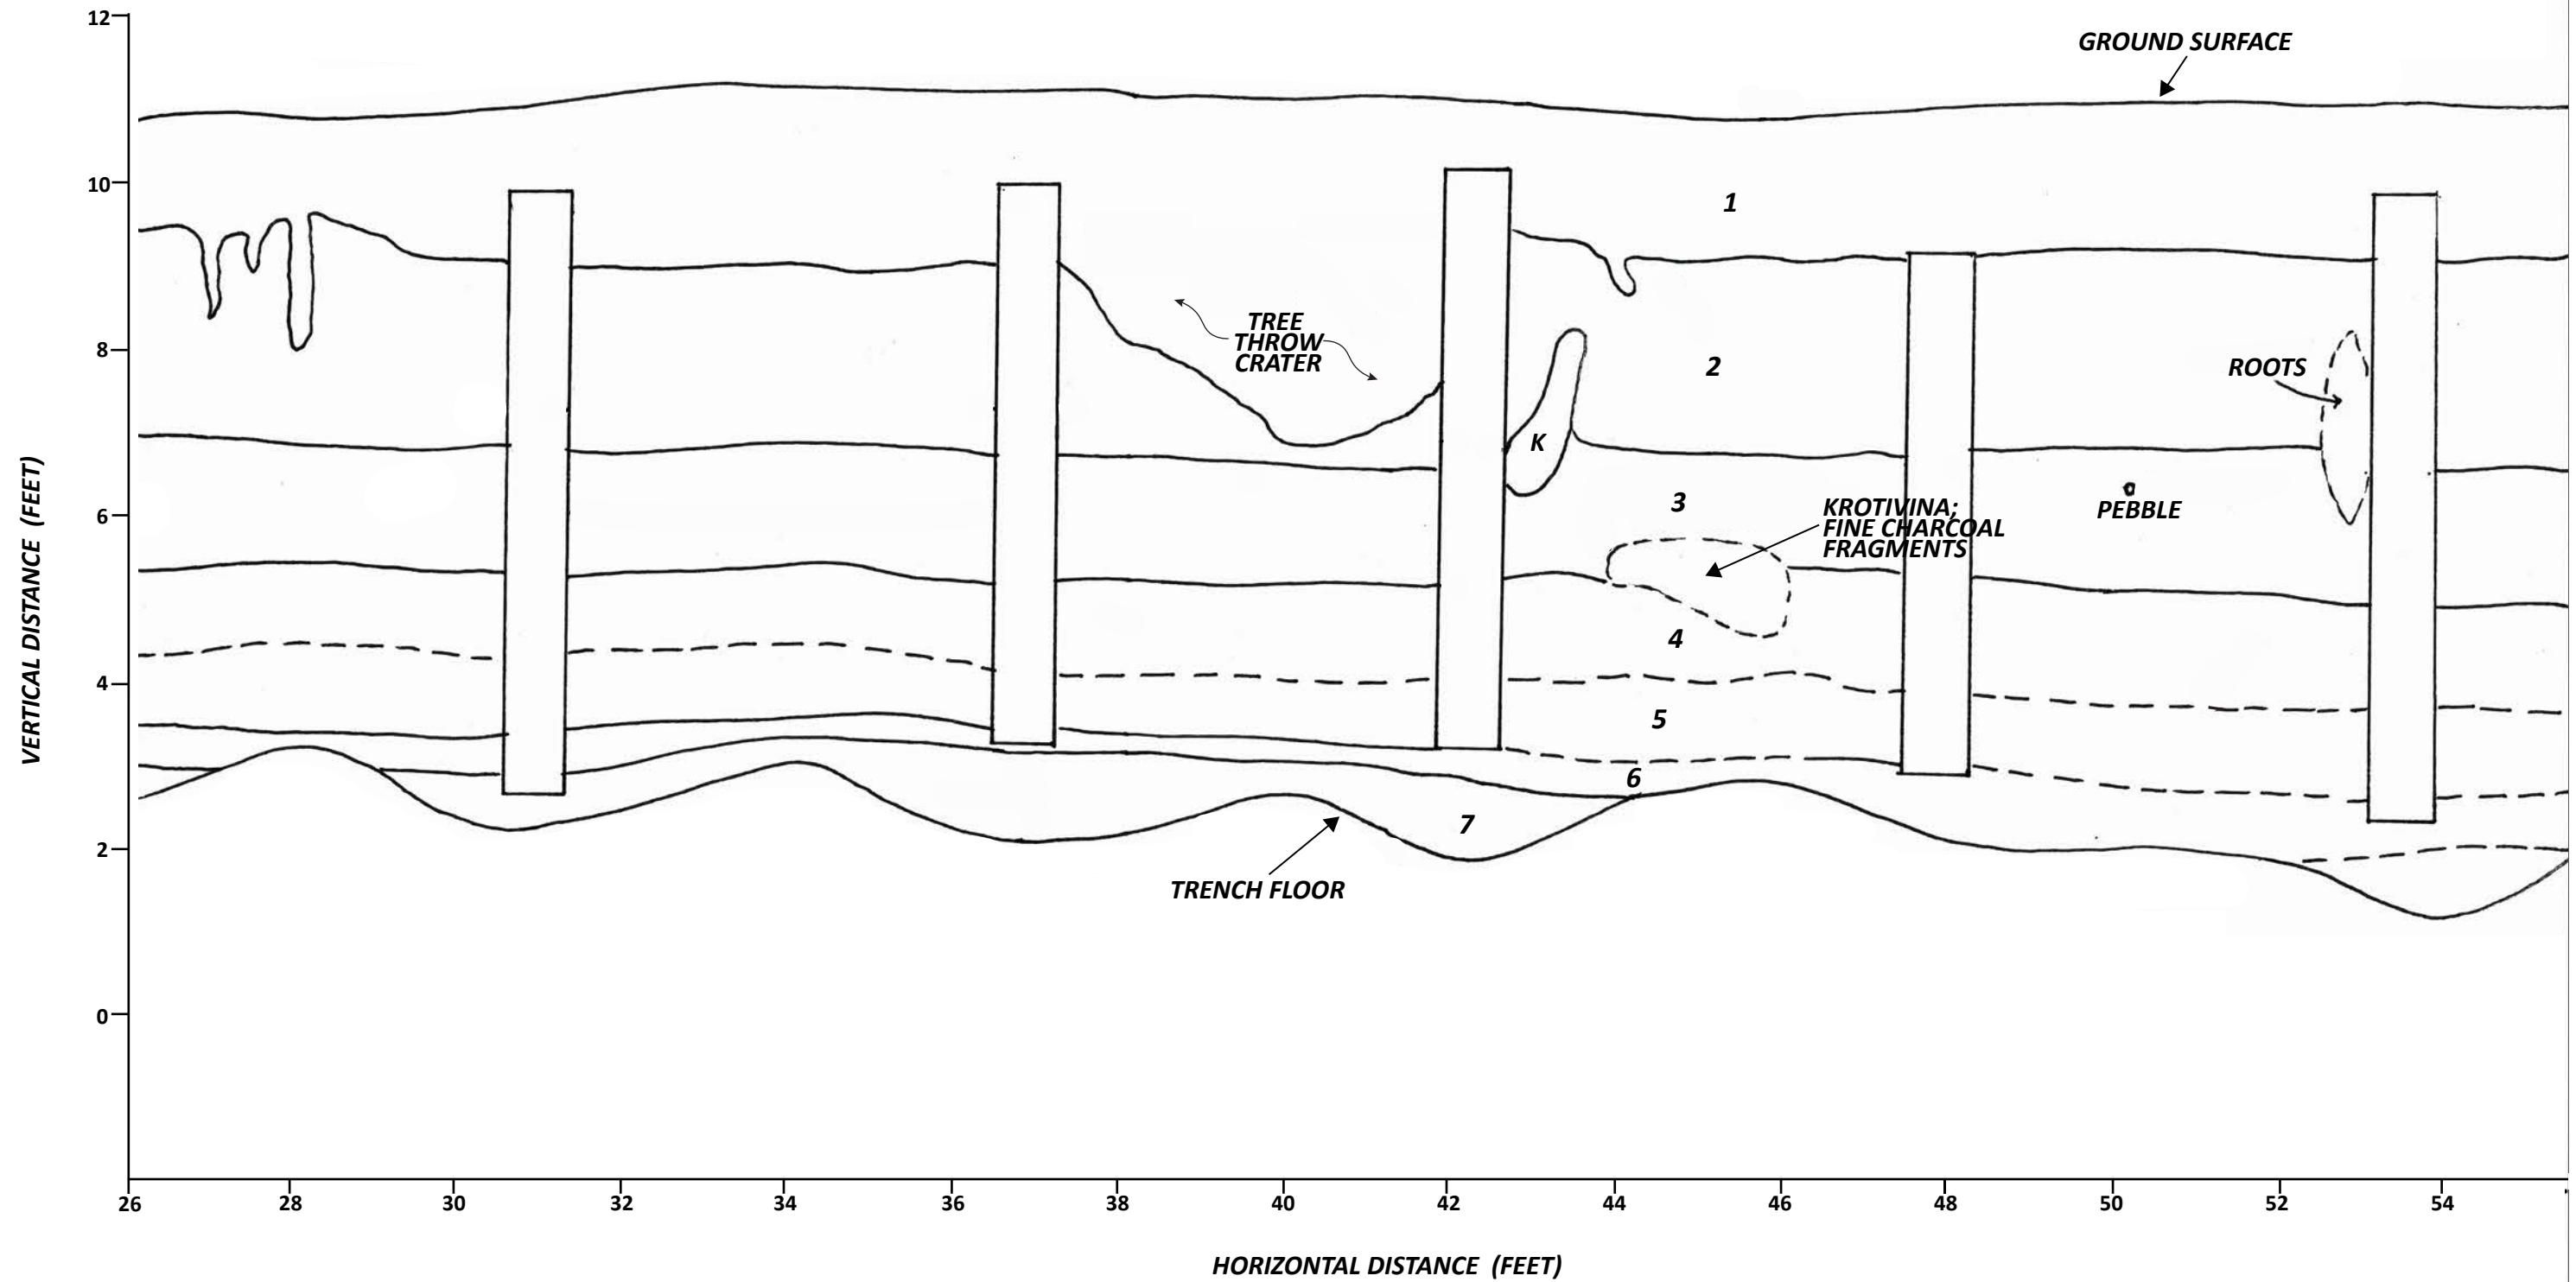
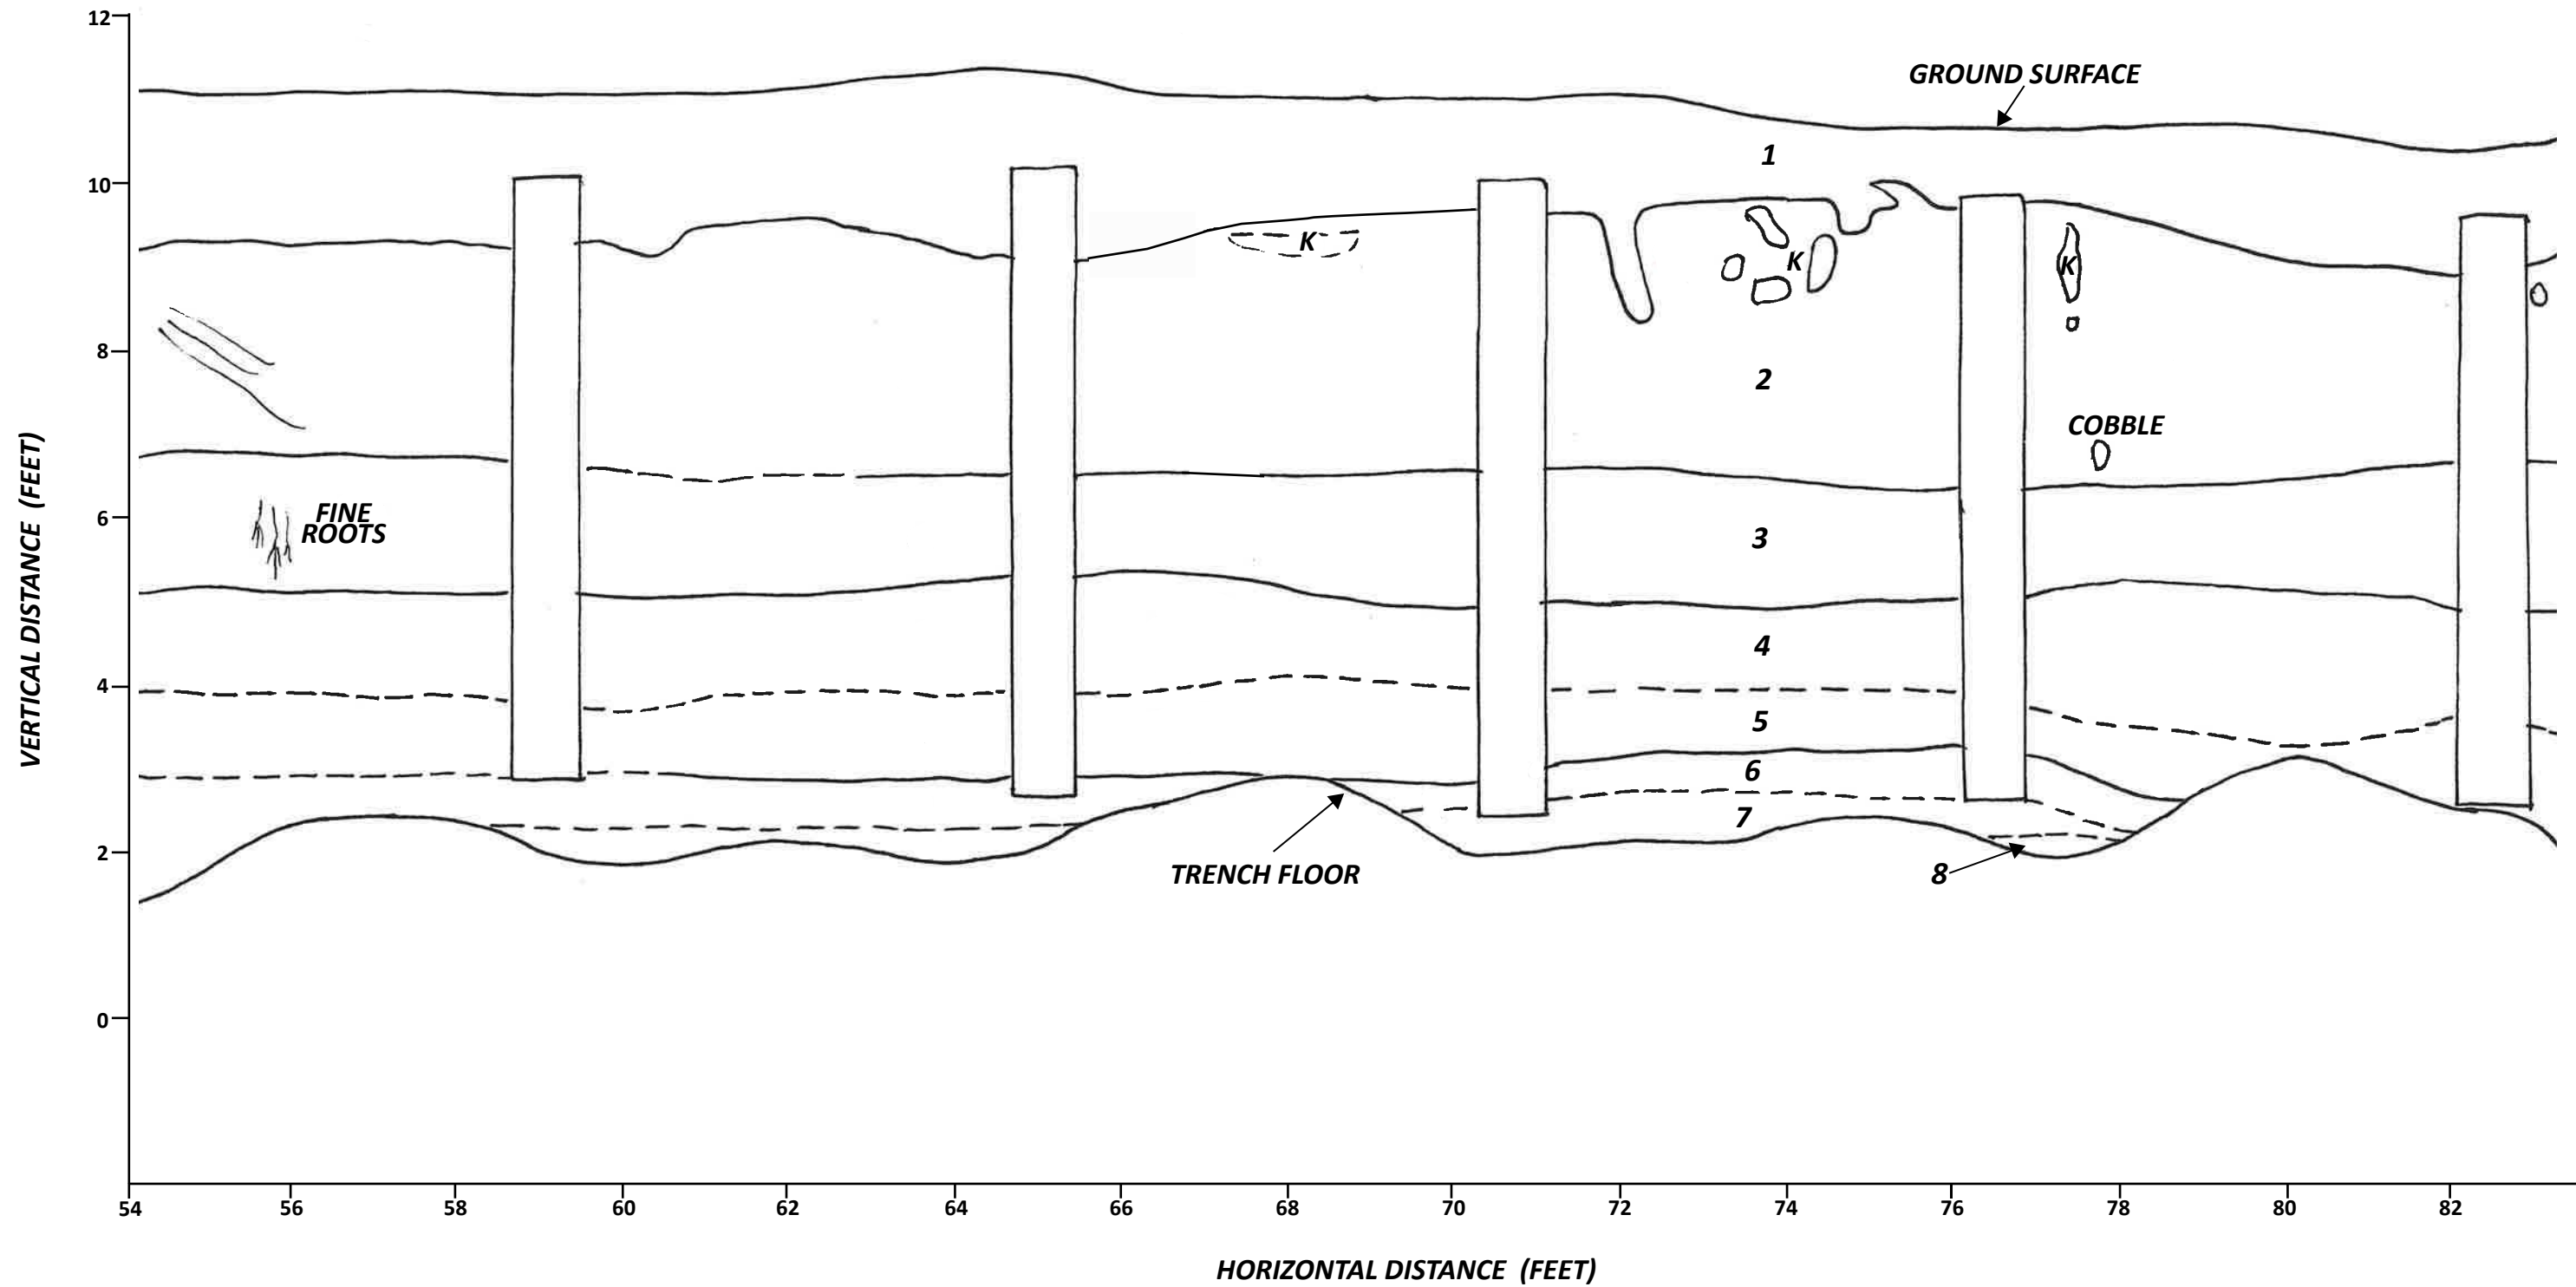
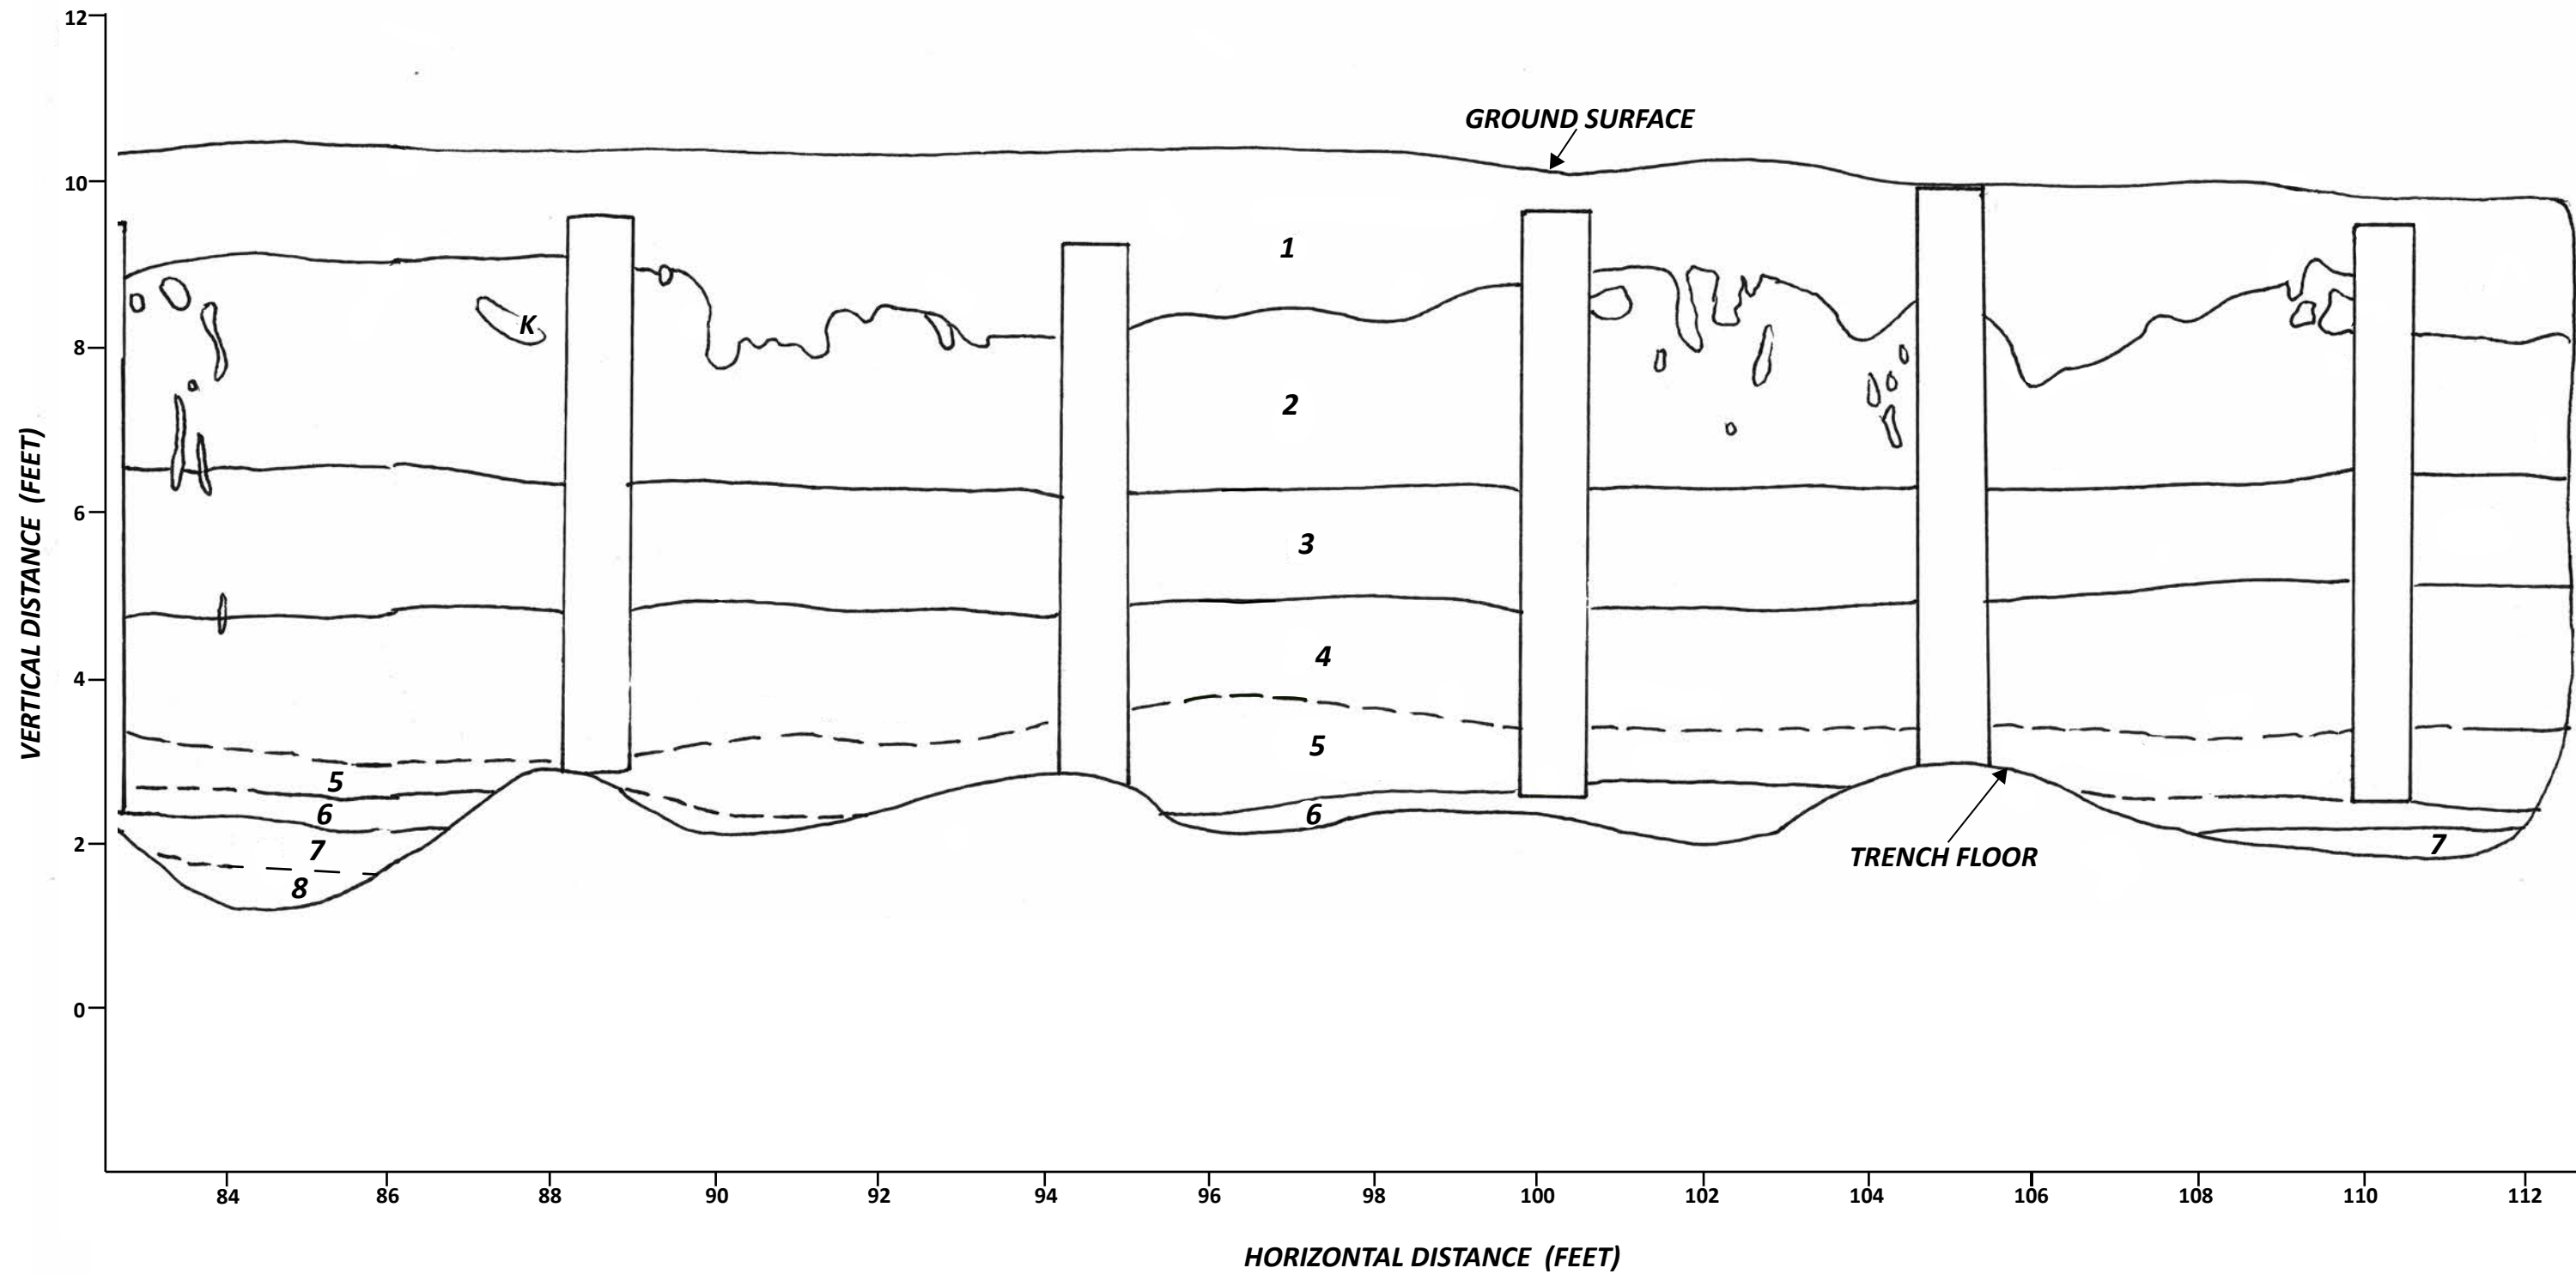
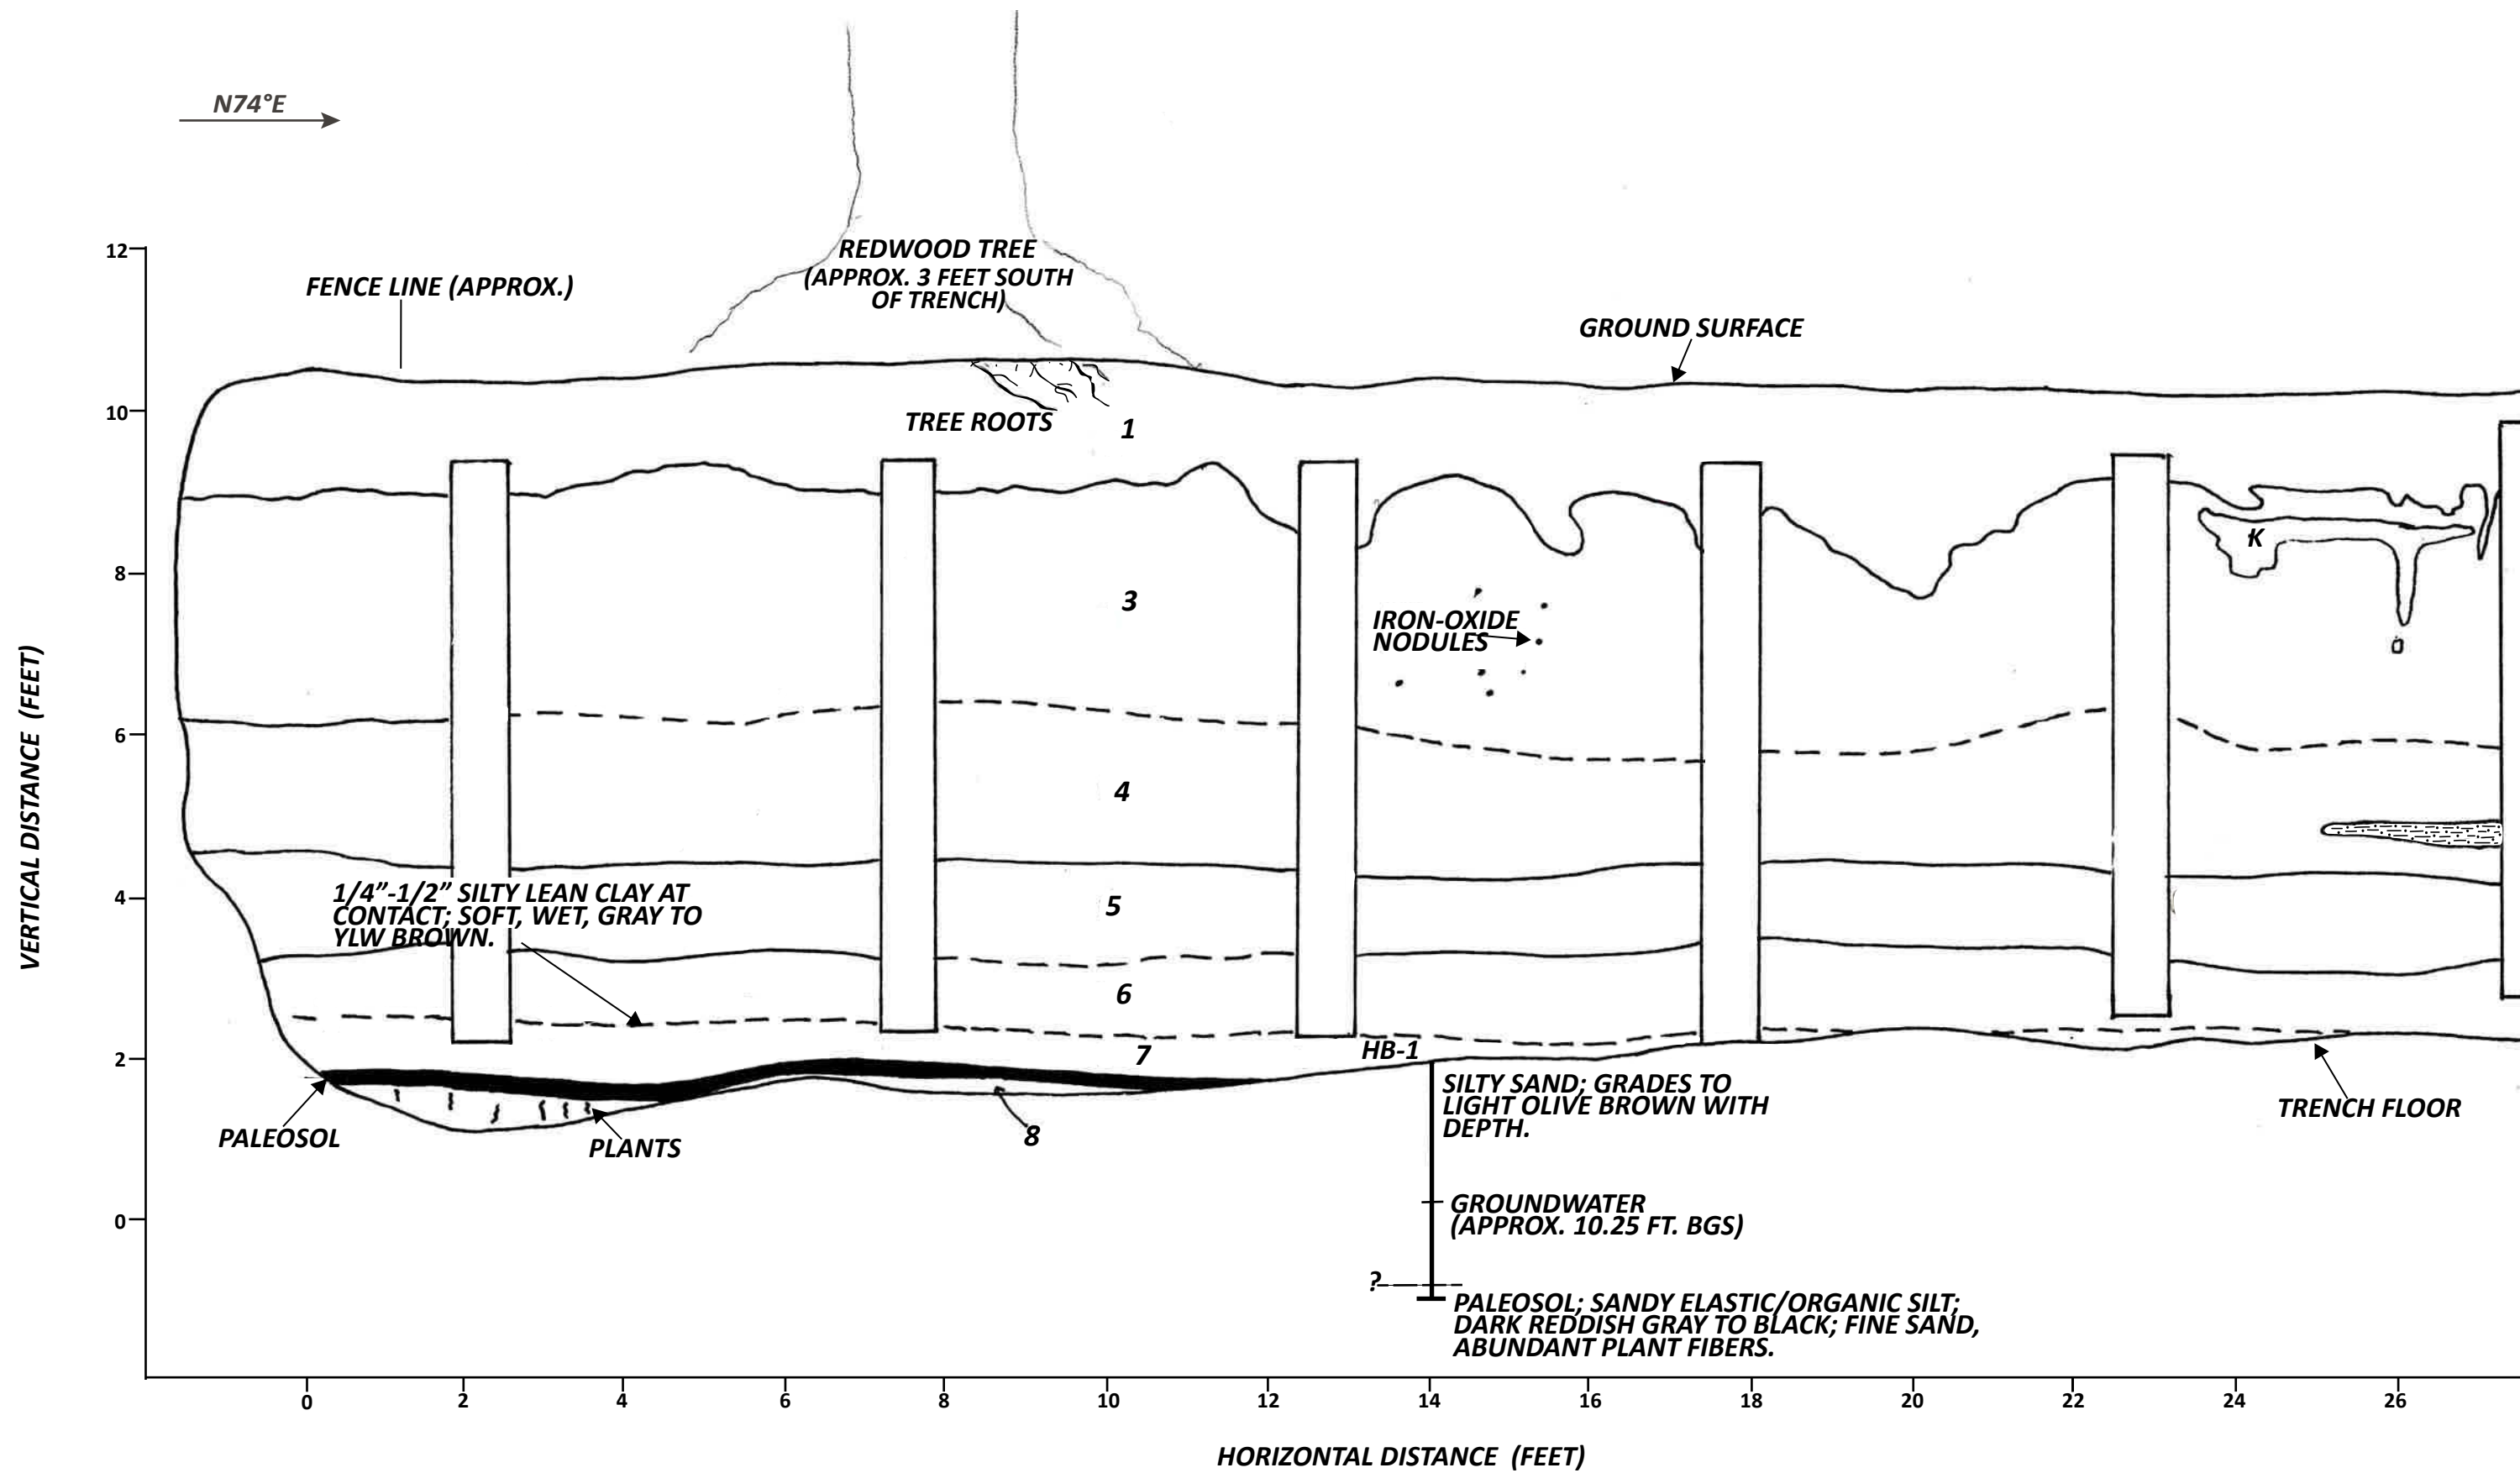
The stratigraphy exposed in the trenches consisted of up to eight distinct, mappable units. The stratigraphy in each trench generally consisted of a dark brown native eolian (wind-blown) deposit, locally disturbed and reworked in places, and underlain by marine terrace deposits along the entire length of both trenches. The units are described below and shown on the trench logs in Appendix 2.

The uppermost paleosol is a soft, dark reddish gray to black, sandy elastic/organic silt (shown in solid black on trench logs T2-1, T2-2, and T2-3). The layer is about 2 to 4 inches thick and contains

1. The trenching investigation exposed geologic materials that provide sufficient control for evaluating the late Pleistocene and Holocene faulting history at the site. The marine terrace sediments exposed in the trenches offer excellent stratigraphic continuity for interpreting deformation associated with the past fault rupture events. Contacts between Units 4, 5, and 6 served as the primary marker horizons for this assessment.

2. No evidence of Holocene faulting was observed in the exposed subsurface stratigraphy on the subject property. The stratigraphic contacts between Units 4, 5, and 6 were observed to be undisturbed, laterally continuous, and planar, confirming the absence of fault rupture and secondary deformation (tilting, warping, folding) across the site. Additionally, there is no evidence of secondary deformation or faulting in any of the other logged units.
