The following is an evaluation of potential timberland conversion on proposed cannabis cultivation sites and associated areas included in the Humboldt County Cannabis Permit Applications for Paul Cabeen within APNs 107-096-007 and 107-095-003. Please accept this letter as the RPF's written report required by Humboldt County Code, Ordinance No. 2559 (Commercial Medical Marijuana Land Use), Section 55.4.10 (j), cited below.

Timberland Resource Consultants (TRC) inspected and evaluated the proposed cultivation sites and associated areas contained within the application on June 5th, 2017. Landowner Paul Cabeen also attended the field inspection. The RPF and his representatives have exercised due diligence in reviewing all sites and all available resources to fully assess potential timberland conversion. This report evaluates the cultivation sites and associated areas for timber operations only. All other land alteration such a grading, construction, and other permit-regulated activities do not fall within the scope of this report. All property features and sites unrelated to cultivation activities also do not fall within the scope of this report. All findings are summarized in the rep

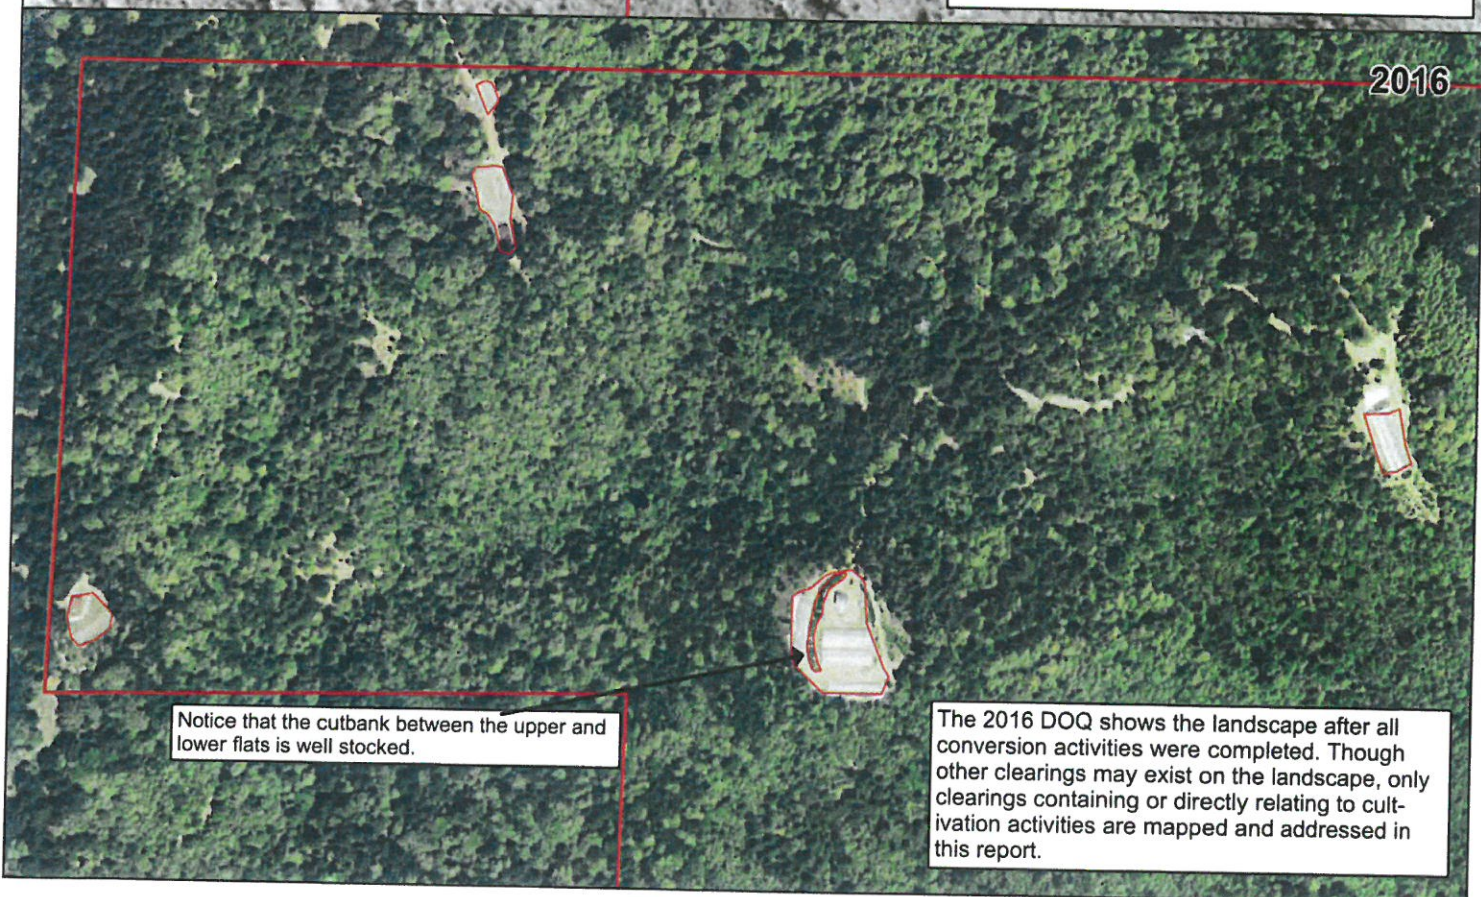
Notice that the cutbank between the upper and lower flats is well stocked.

The 2016 DOQ shows the landscape after all conversion activities were completed. Though other clearings may exist on the landscape, only clearings containing or directly relating to cultivation activities are mapped and addressed in this report.

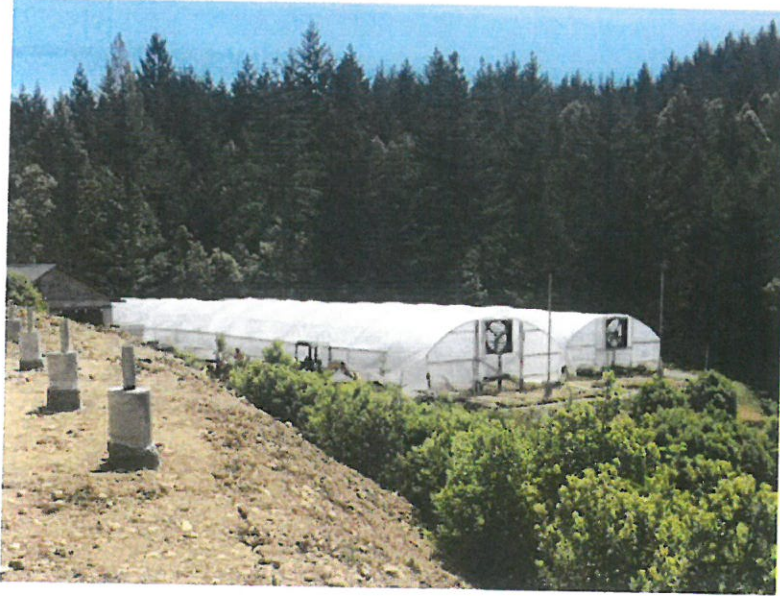
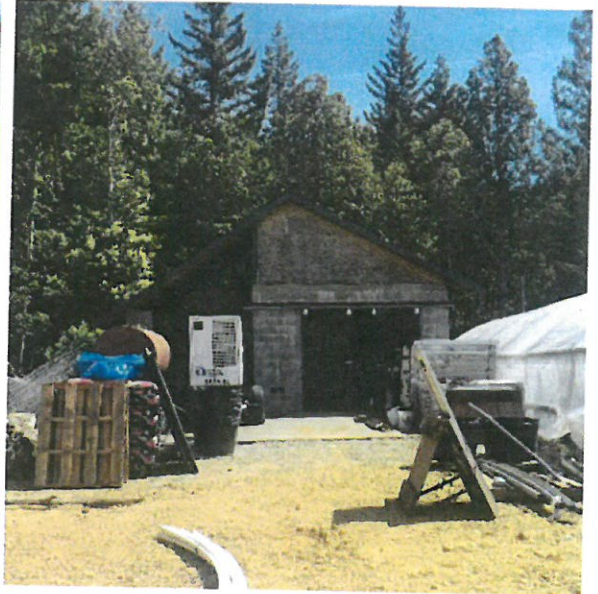
Cultivation Site 1 represents the active cultivation site as well as four surrounding associated areas (totaling 0.47 acres) located in the southeastern portion of the property (see Photos 1-4). The breakdown of specific acreages is shown in the table below:

Photos 1 and 2: View of Solar Array Area (still under construction) and Cultivation Site 1 facing east (left). View of the Generator Battery & Inverter Shed facing northeast (right).

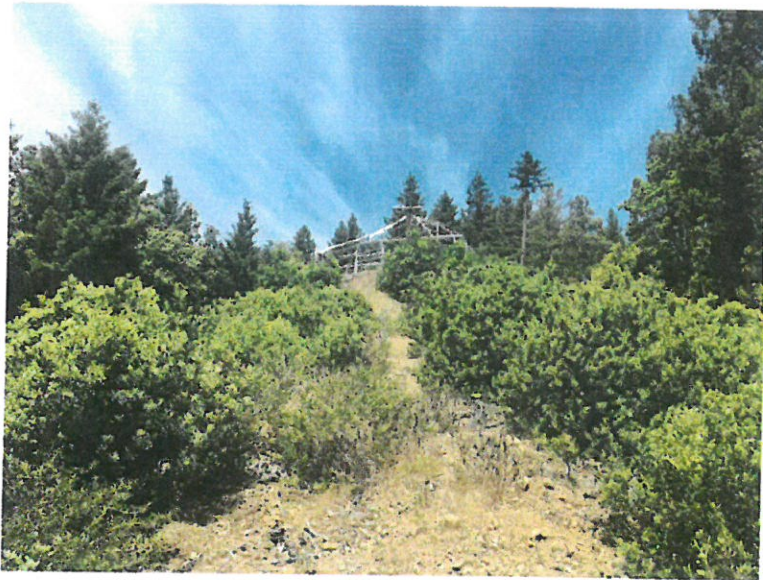
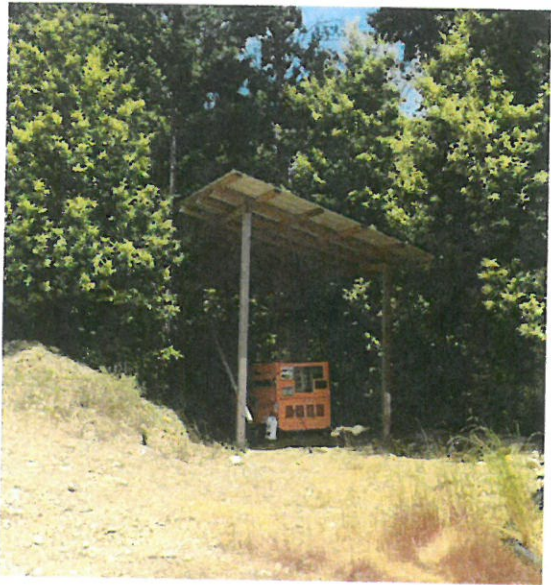
Cultivation Site 2 is a 0.20-acre area located in the northeastern portion of the property (see Photo 5). Between 2005 and 2009, the area was cleared of trees and vegetation including all stumps. No commercial operations occurred. Most slash and woody debris was scattered or piled along the northeastern and southern edges of the cultivation site. The cultivation activities observed onsite impede the use of this space for current timber growth and harvesting; in this way, the landowner has effectively converted the single use of this space from timber production to agricultural cultivation. Thus, Cultivation Site 2 constitutes a timberland conversion.

Photos 5 and 6: View of Cultivation Site 2 facing north (left) and view of the generator at Cultivation Site 2, which is not in use; this site is not included in the total conversion area because the area meets stocking standards of the FPRs.

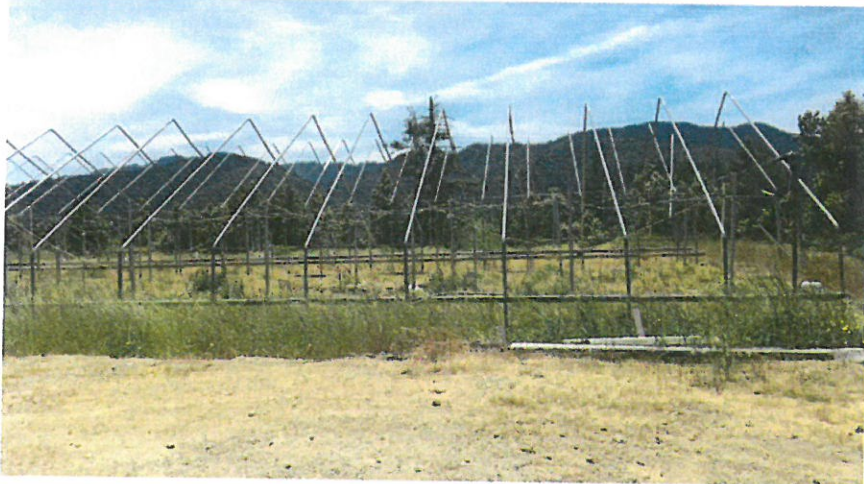
Cultivation Site 3 is a 0.87-acre area located near the center of the property (see Photos 7-9). Between 2005 and 2009, the area was cleared of trees and vegetation including all stumps. No commercial operations occurred. Most slash and woody debris was piled or scattered along the western and southern sides. The Cultivation Site 3 polygon excludes a strip of land representing the cut-bank between the upper and lower flats (see note on DOQ Map 2). This strip is fully stocked to Forest Practice Rules (FPR) standards with Douglas-fir seedlings and saplings; thus, it is not included in the conversion area. The cultivation activities observed onsite impede the use of this space for current timber growth and harvesting; in this way, the landowner has effectively converted the single use of this space from timber production to agricultural cultivation. Thus, Cultivation Site 3 constitutes a timberland conversion.

Photos 7: View of the upper flat of Cultivation Site 3, facing south. Not Pictured: Worker Cabin.

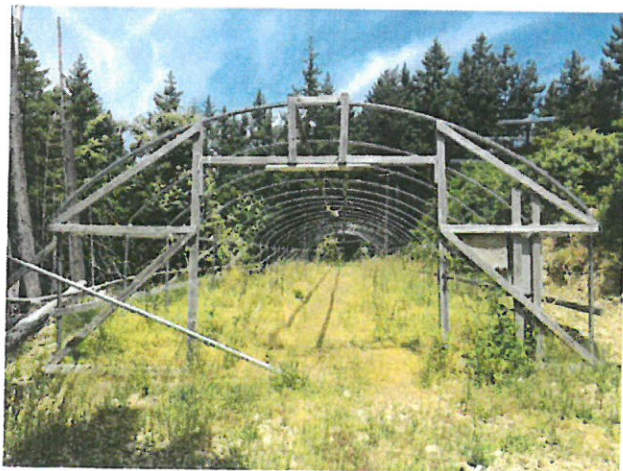
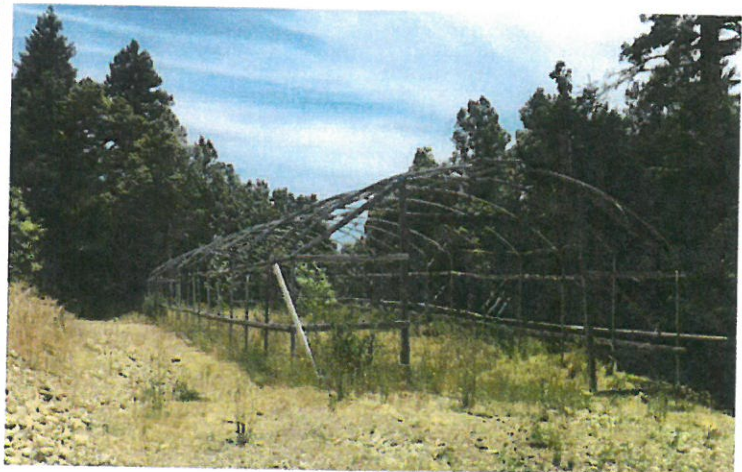
Photos 8 and 9: View of the lower flats of Cultivation Site 3, facing north (left) and west (right).

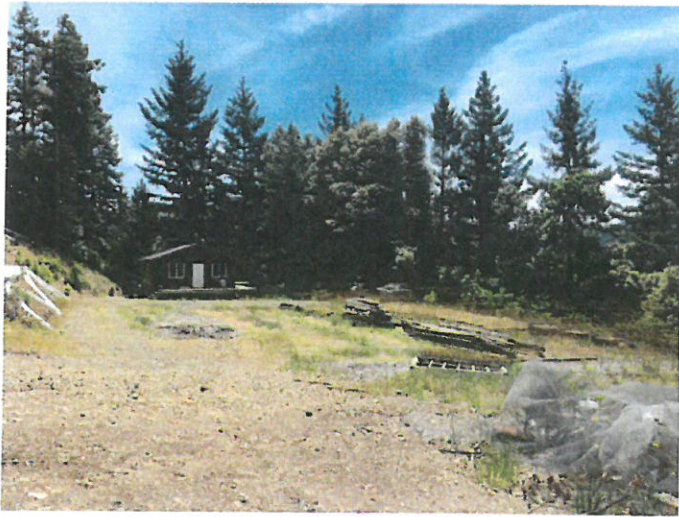
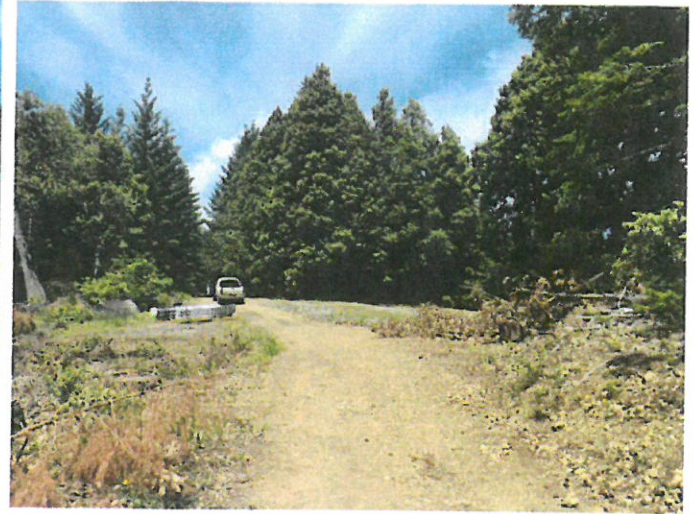
Cultivation Site 4 consists of two areas (totaling 0.29 acres) located in the northwestern portion of the property (see Photos 10 and 11). As shown on DOQ Map 2, the northern area of Cultivation Site 4 was mostly cleared as of 1998, likely a remnant road turnout or log landing. The southern area of Cultivation Site 4 does not appear to occupy a remnant logging feature. Between 2005 and 2009, all trees and vegetation were removed including stumps. No commercial operations occurred. Most slash and woody debris was scattered or piled along the western and northern sides of the southern area. The cultivation activities observed onsite impede the use of this space for current timber growth and harvesting; in this way, the landowner has effectively converted the single use of this space from timber production to agricultural cultivation. Thus, Cultivation Site 4 constitutes a timberland conversion.

Photos 10 and 11: Views of Cultivation Site 4; the southern portion, facing south (left), and the northern portion, facing north (right).

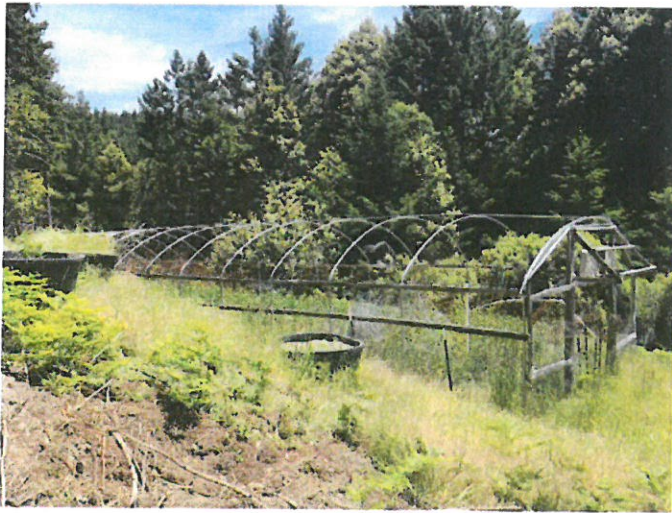
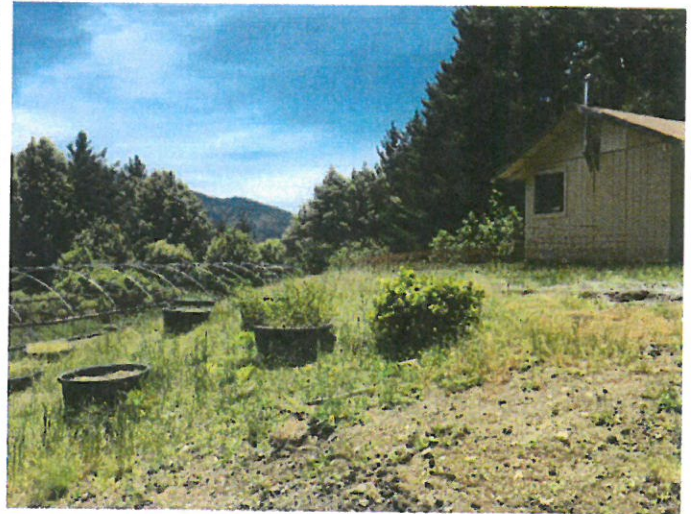
Cultivation Site 5 is a 0.19-acre area located in the southwestern portion of parcel 107-095-003 (See Photos 12 and 13). As shown on the Quadrangle in the General Location Map, Cultivation Site 5 once occupied a natural grassland or prairie as indicated by the white polygon. However, over time, this site was encroached upon by the surrounding stand, and now occupies productive timberland (as shown on DOQ Map 2). Between 1998 and 2005, the site was initially cleared of trees and vegetation. Between 2005 and 2009, the site was expanded. No commercial operations occurred. Most slash and woody debris was scattered or piled along the eastern and southern edges of the site. The cultivation activities observed onsite impede the use of this space for current timber growth and harvesting; in this way, the landowner has effectively converted the single use of this space from timber production to agricultural cultivation. Thus, Cultivation site 5 constitutes a timberland conversion.

Photos 12 and 13: Views of Cultivation Site 5 (including the Dry Shed) facing east (left) and facing west (right).

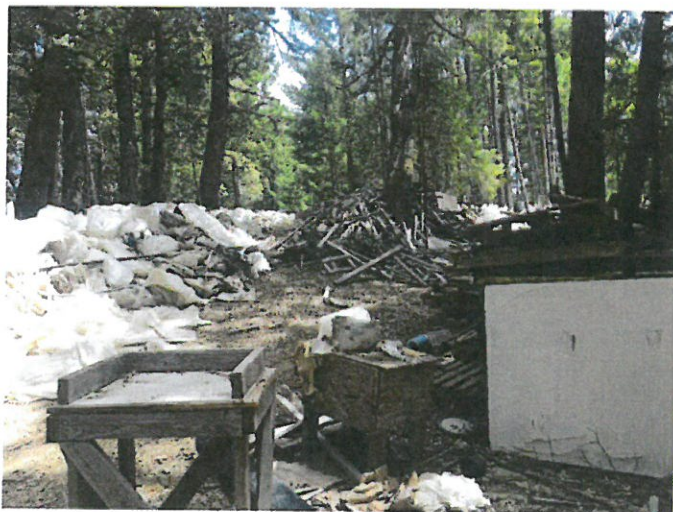
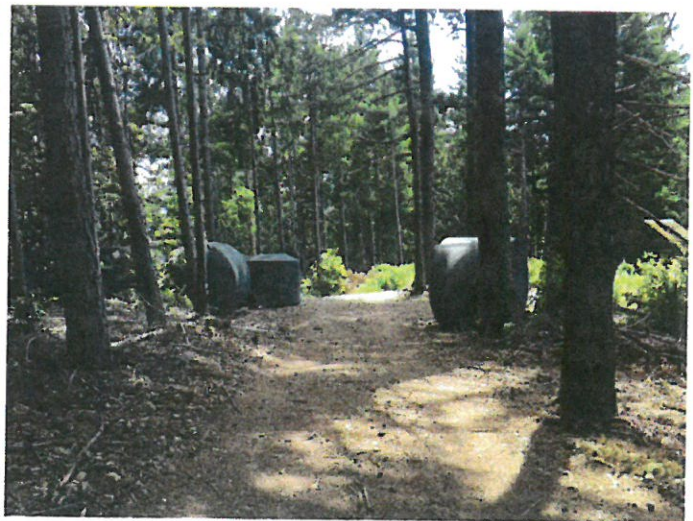
Overview Map 1 also shows locations of scattered water tanks, a sheltered generator, and a Storage/Scrap Pile used in part for cultivation purposes (see Photos 14 and 15)*. These associated areas were also inspected. Though minor tree and vegetation clearing may have occurred to install these structures, the surrounding stand still meets the stocking standards of the Forest Practice Rules. Ultimately, these features do not impede the use of the land for current or future timber growth and harvesting; therefore, they do *not* constitute timberland conversion. The two residences near Cultivation Site 1 are *not* associated with cultivation activities.

Overview Map 1 also shows a water tank(s) used for cultivation purposes (see Photos 15)*. This associated area was also inspected. Though minor tree and vegetation clearing may have occurred to install this structure, the surrounding stand still meets the stocking standards of the Forest Practice Rules. Ultimately, this feature does not impede the use of the land for current or future timber growth and harvesting; therefore, they do *not* constitute timberland conversion.

Photos 14 and 15: View of the Storage/Scrap Pile (left) and view of the Water Storage Tanks north of Cultivation Site 3 (right). These are examples of map features that are fully stocked and do not constitute conversions.

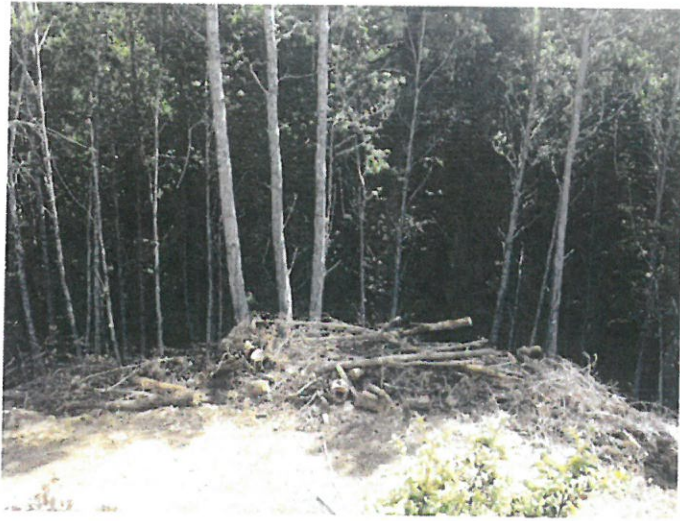
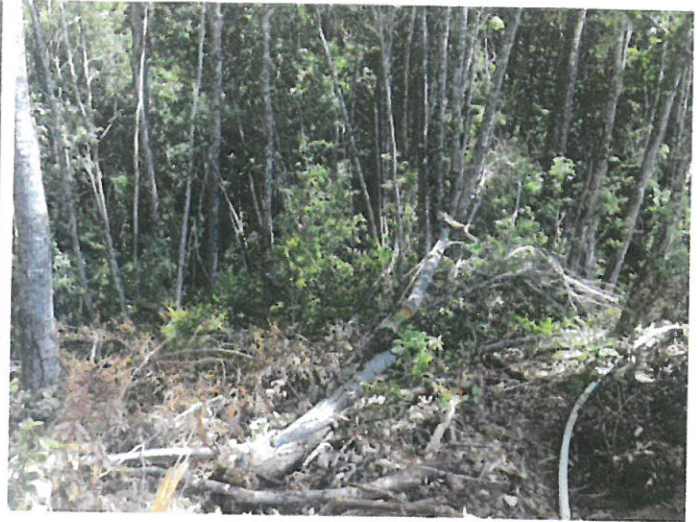
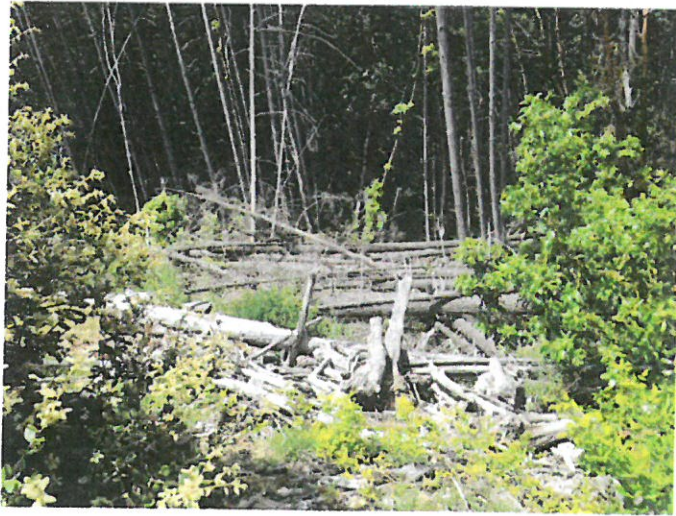
Most of the slash and woody debris generated from the conversion activities has been scattered or piled near the conversion areas (see Photos 16-18). All slash and downed logs should be treated according to the FPRs (Recommendation #1).

Photos 16, 17, and 18: Examples of slash piles and small log decks near the converted sites.

1. Treat all slash piles and log decks as soon as possible using one of the following methods: burying, chipping and spreading, piling and burning, or removal from site.
