TECHNICAL MEMORANDUM

DATE: 6 May 2017
TO: David Manthorne, CDFW
FROM: Joel Monschke, Stillwater Sciences
SUBJECT: APN 221-021-003 Erosion Remediation

I hereby state that all work described in the attached Technical Memorandum for the APN 221-021-003 Erosion Remediation Project follows accepted engineering practice and was completed under my direction. The project proposes to stormproof one agricultural pond, and treat several gullies to decrease sediment delivery to Salmon Creek in Southern Humboldt County.

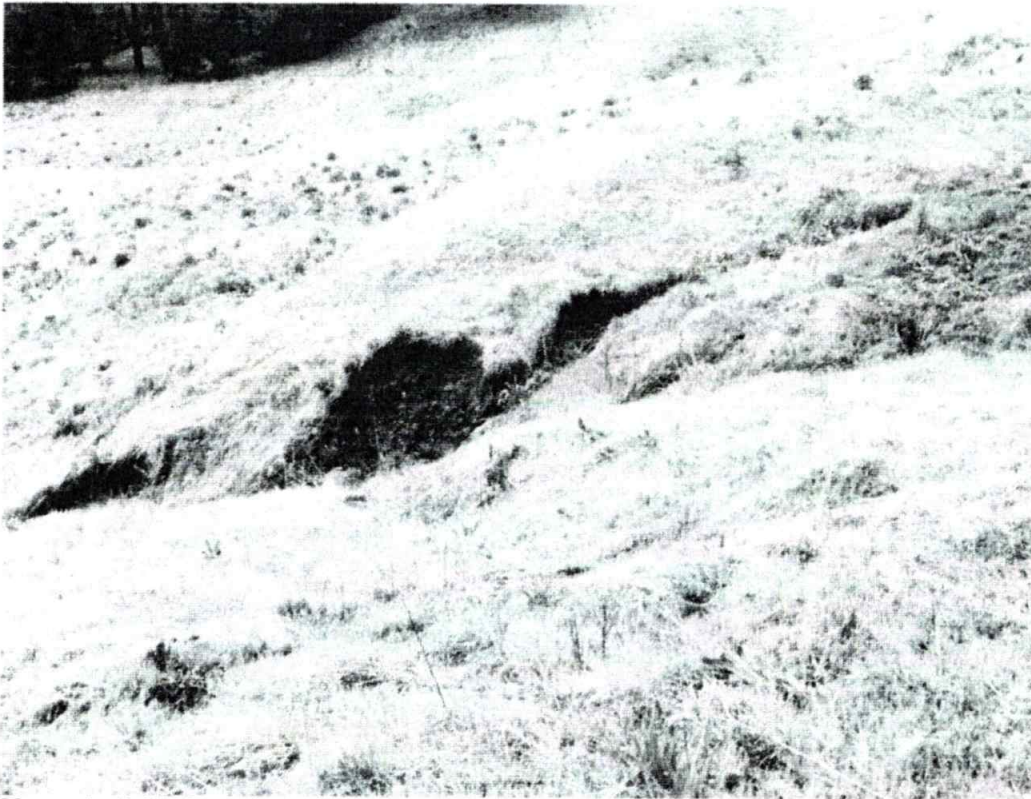
Photo 1. Gully 1 erosion (downslope segment).

There is an actively eroding gully in the southwest portion of the property downslope from the outlet of a 12" diameter ditch relief culvert on the main community road. Armor several headcuts and install additional grade control structures using a total of approximately 30 cubic yards of 0.5–1.0 foot rock (see current conditions in Photos 1 and 2 in Appendix C). Engineer to oversee construction.

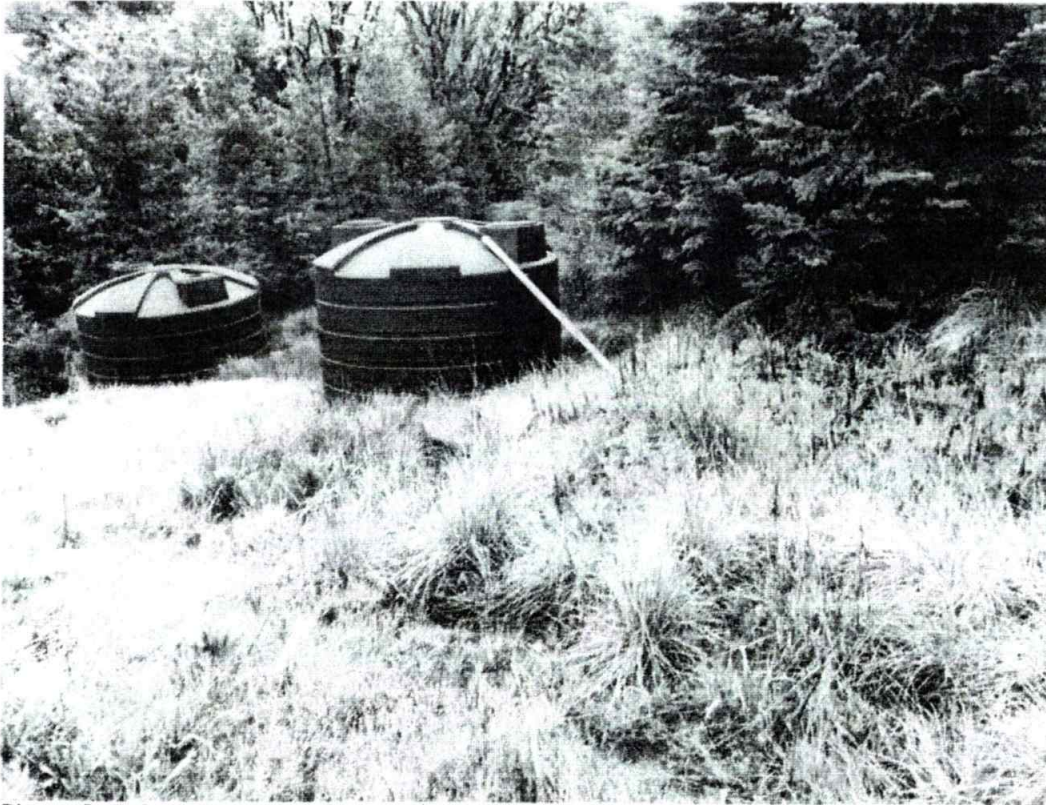
Photo 3. Existing water tanks in wet area at head of watercourse - to be relocated.

Additional gulying is evident in the northern portion of the property along approximately 100 feet of small channel adjacent to the shallow cistern/well (POD1). Work in this area will involve relocation of three water tanks that are located in a wet area at the head of the Class III watercourse (Photo 3, Appendix C), armoring of the channel adjacent to the cistern (Photo 4, Appendix C), and channel armoring and minor excavation of oversteepened banks where the watercourse flows through an old failed pond berm (Photo 5, Appendix C). A total of approximately 30 cubic yards of 0.5–1.0 foot rock will be used. Engineer to oversee construction.

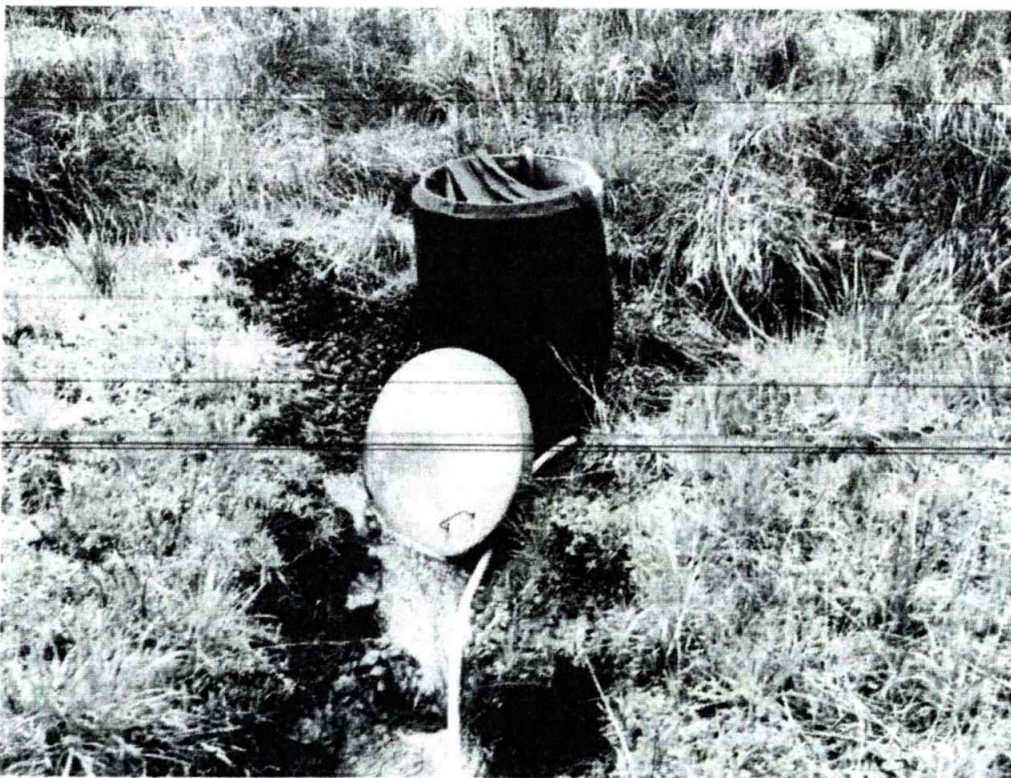
Photo 4. Gully 2 erosion at POD1.

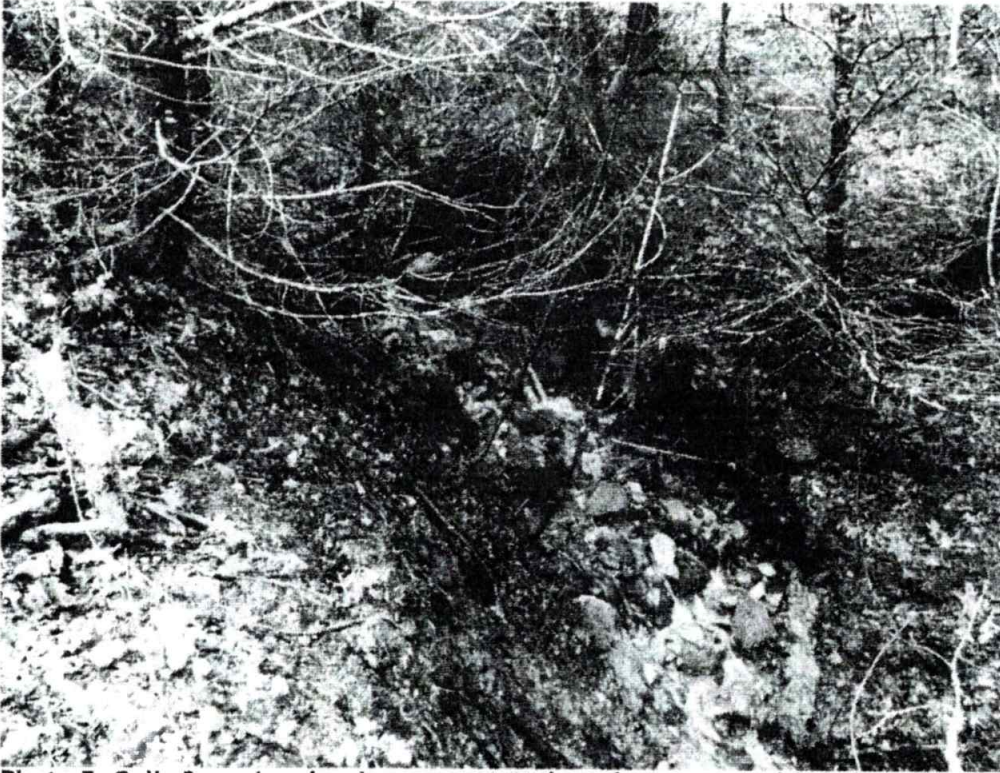
Photo 5. Gully 2 erosion showing segment at downslope extent of failed pond berm.

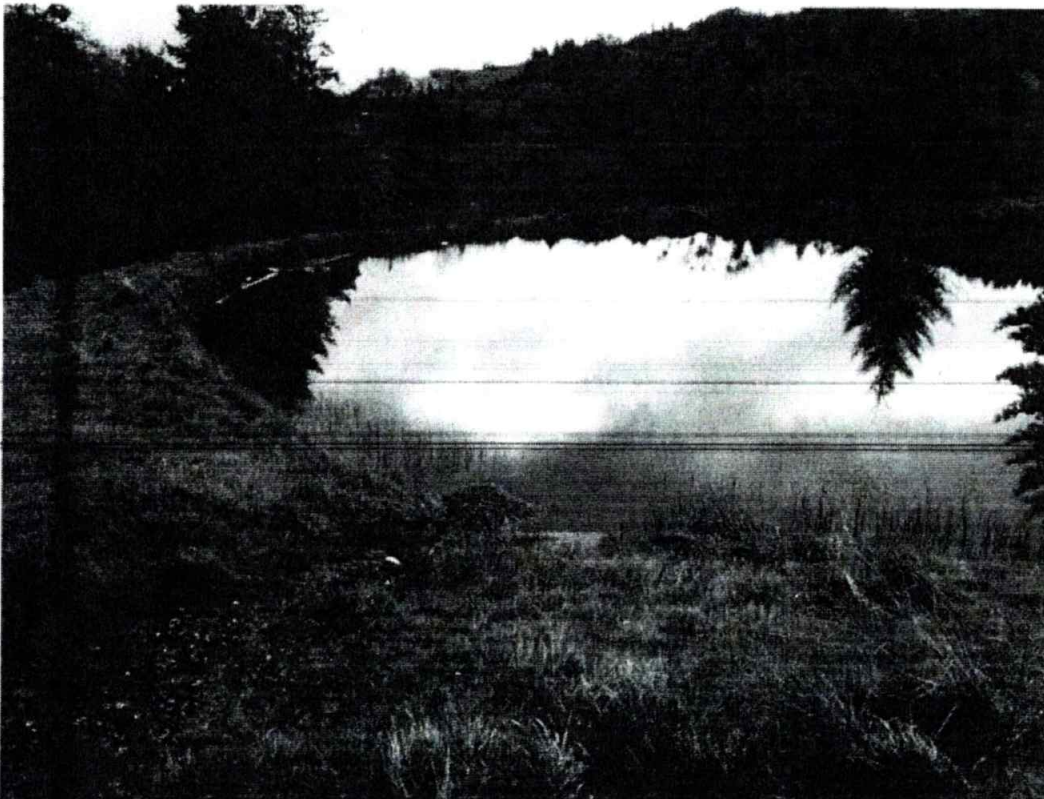
The spillway of the existing pond has been filled by sediment from road runoff and water is currently flowing over the dike. Although there is no evidence of erosion or concentrated flow due to dense vegetation growth, work is needed to construct an armored spillway and provide minimum 2 feet of freeboard. Upgrade pond dike per Sheets 4 and 9 of the Grading Plan in Appendix B.

Photo 6. Existing Pond (POD2).
