Subject: **Honey Honeydew, LLC Special Permit**
Record Number PLN-2018-14300
Assessor's Parcel Number (APN) 107-086-025
41087 Mattole Road, Petrolia

Special permit to correct Code Violation 18-CEU-104 for grading without a permit in the Streamside Management Area (SMA) of the Mattole River on a 40-acre parcel. A restoration plan which specifically addresses violations related to grading without a permit in a stream management area and details the restoration measures recommended to mitigate for that violation has been submitted by the applicant (McKenzie 2020, McGee 2020, and Rinehart 2021). Restoration activities include installation of erosion control materials to reduce erosion, removal of invasive plants, and establishment of native plants to restore site stability and provide functional habitat for flora and fauna in part to potentially qualify the site for licensing future Cannabis cultivation, nursery, and processing activity. Restoration includes a continued Mitigation and Monitoring Plan in the SMA. Grading will occur on existing roads to fix drainage issues. The total area of grading will amount to 20,000 square feet and the volume of grading to occur is calculated to be

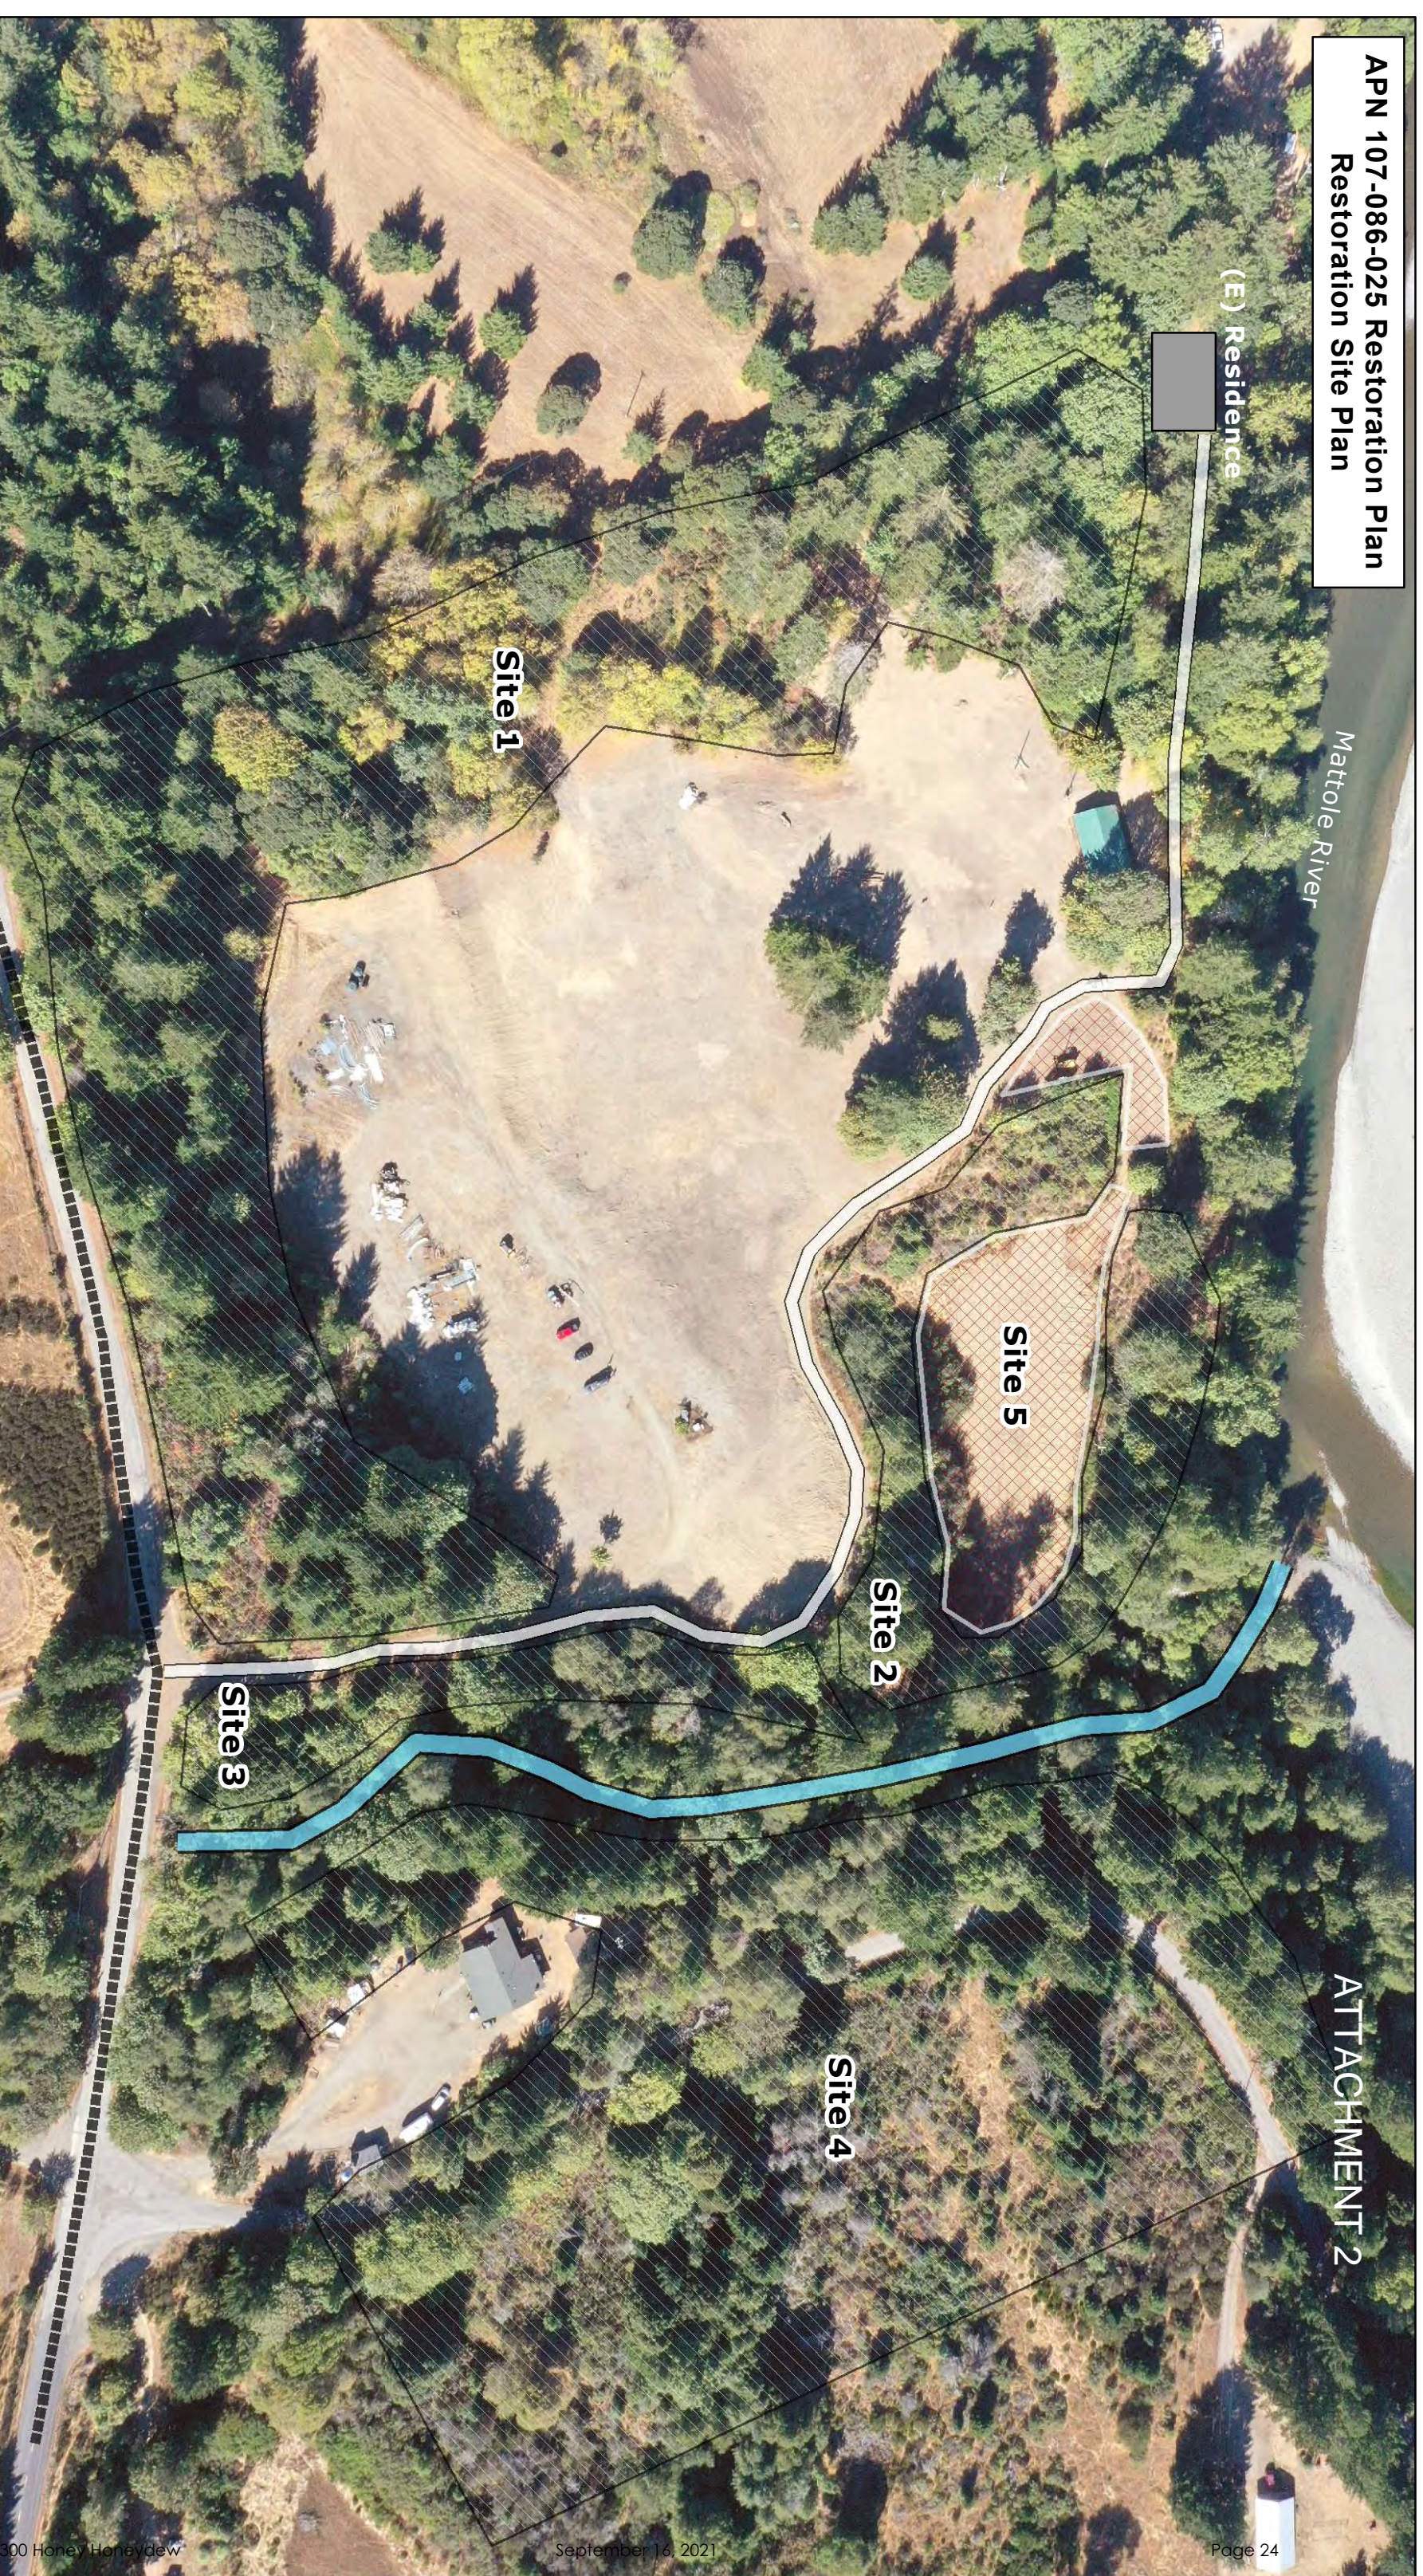
ATTACHMENT 2

1. Site 1- 4: Remove French and Scotch broom in spring before flowering period. Check individual plants for nesting birds. If nest is found, remove plant after nesting period. Pile and burn removed material or dispose at landfill.
2. Site 5: Install native grass and flower seed per quantities detailed in the Restoration Plan. Install seed just prior to fall rain event, harrow or rake in.
3. Site 5: Install rice straw mulch at quantities detailed in Restoration Plan on slopes. Mulch is not required on flat ground.

Attachment 2. Restoration Site Plan

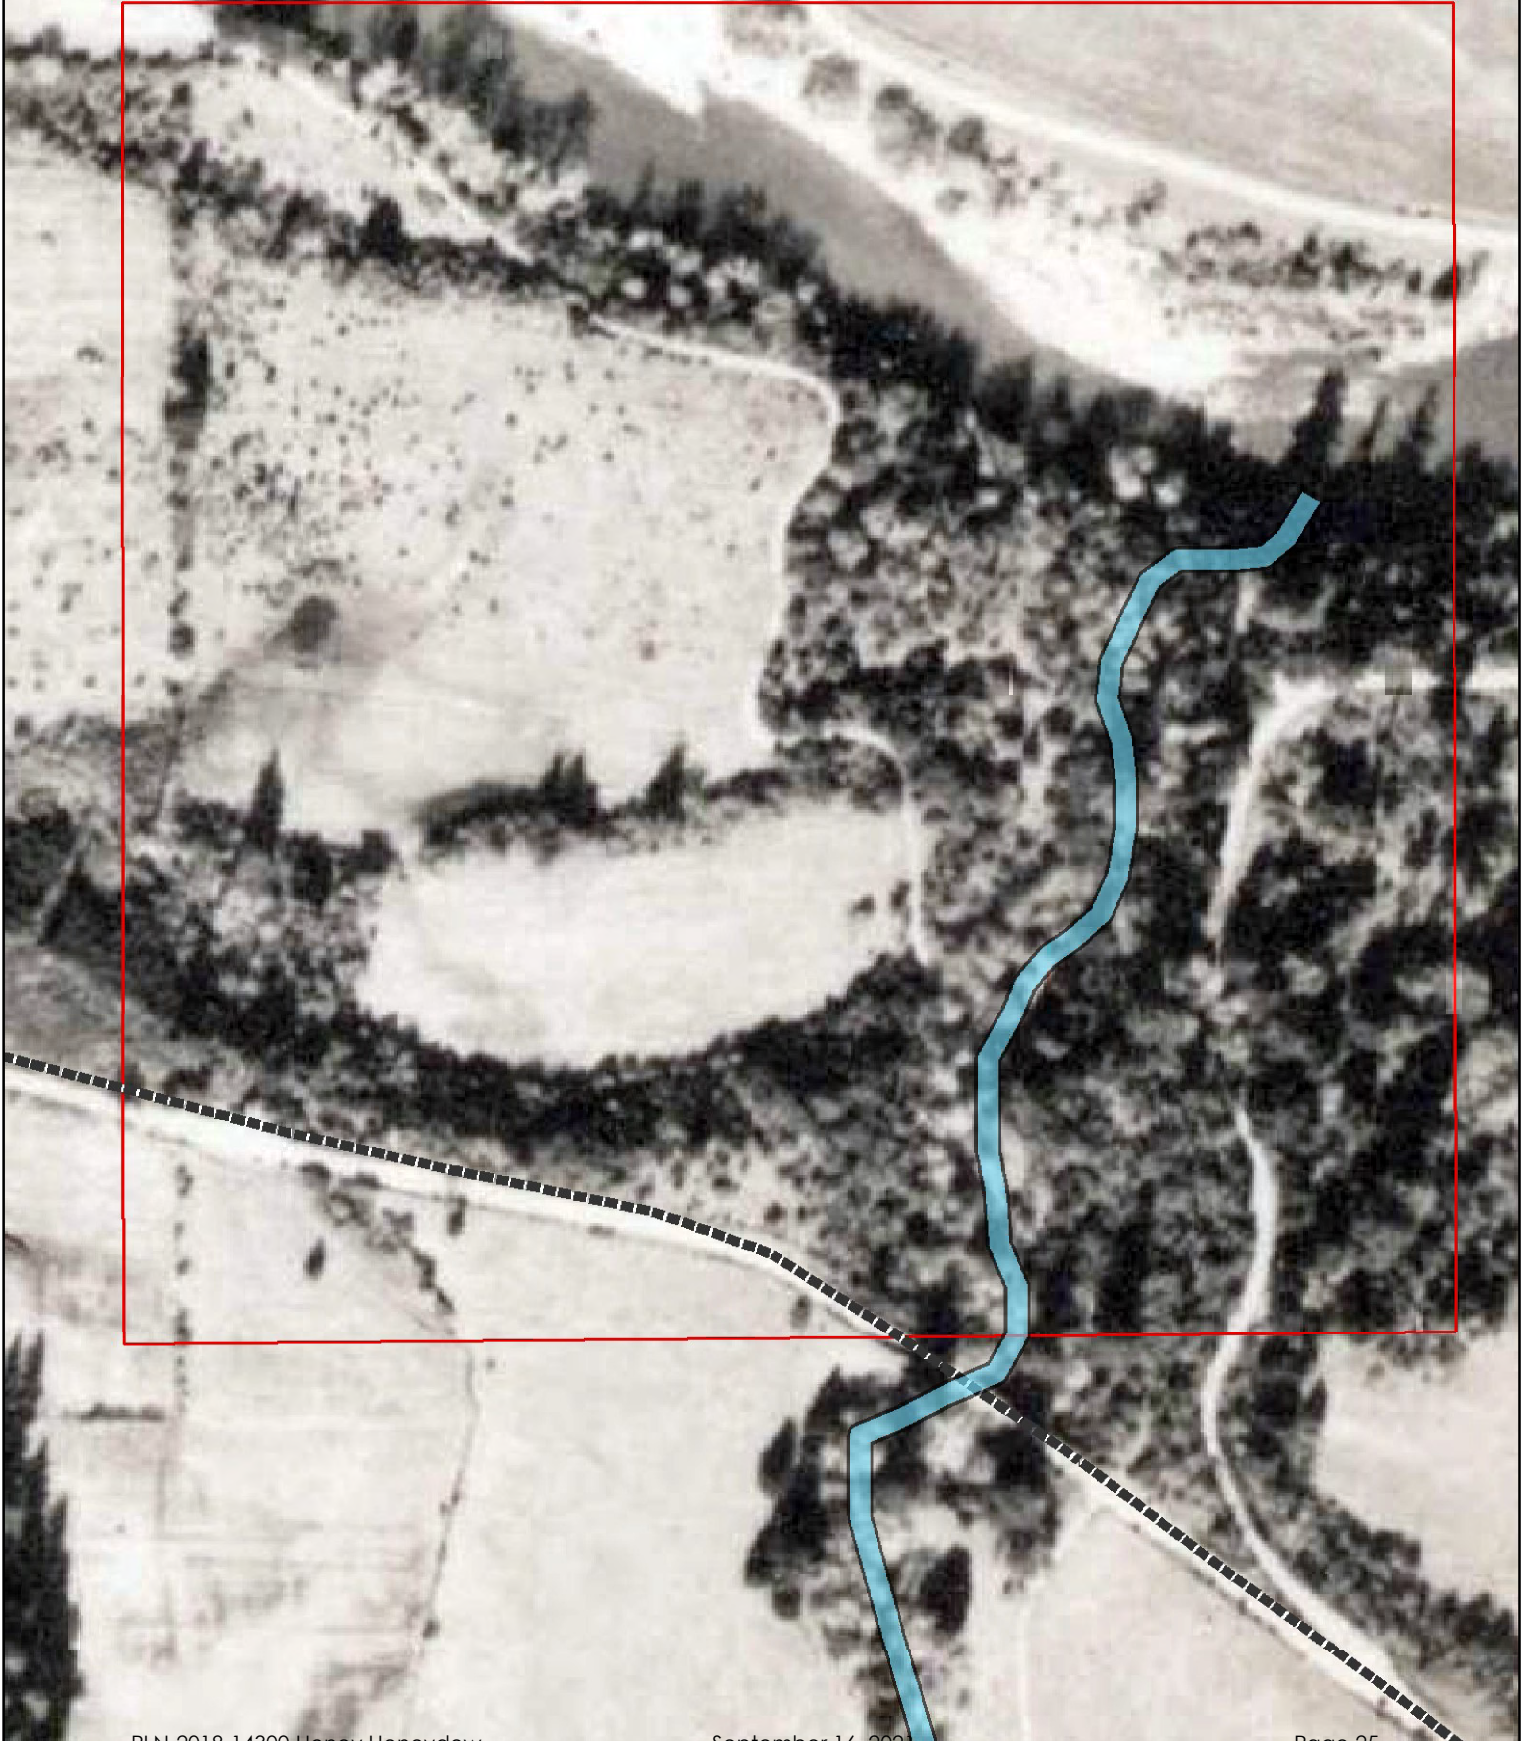
An analysis of the 1942 aerial photo shows that much of the western half of parcel was open in 1942, and was likely cleared prior to that time. Oak woodlands existed on the western edge of the property as they do in current conditions. The open grasslands present on the property in 1942 were likely historical native grasslands. The riparian area along the Mattole River, including the current home site, was more open in 1942 than it is in current conditions. The eastern half of the property was forested and likely dominated by Douglas fir (*Pseudotsuga menziesii* var. *menziesii*), tan oak (*Notholithocarpus densiflores*) and many of these species found on site in current conditions. The main access road on the property existed in 1942.

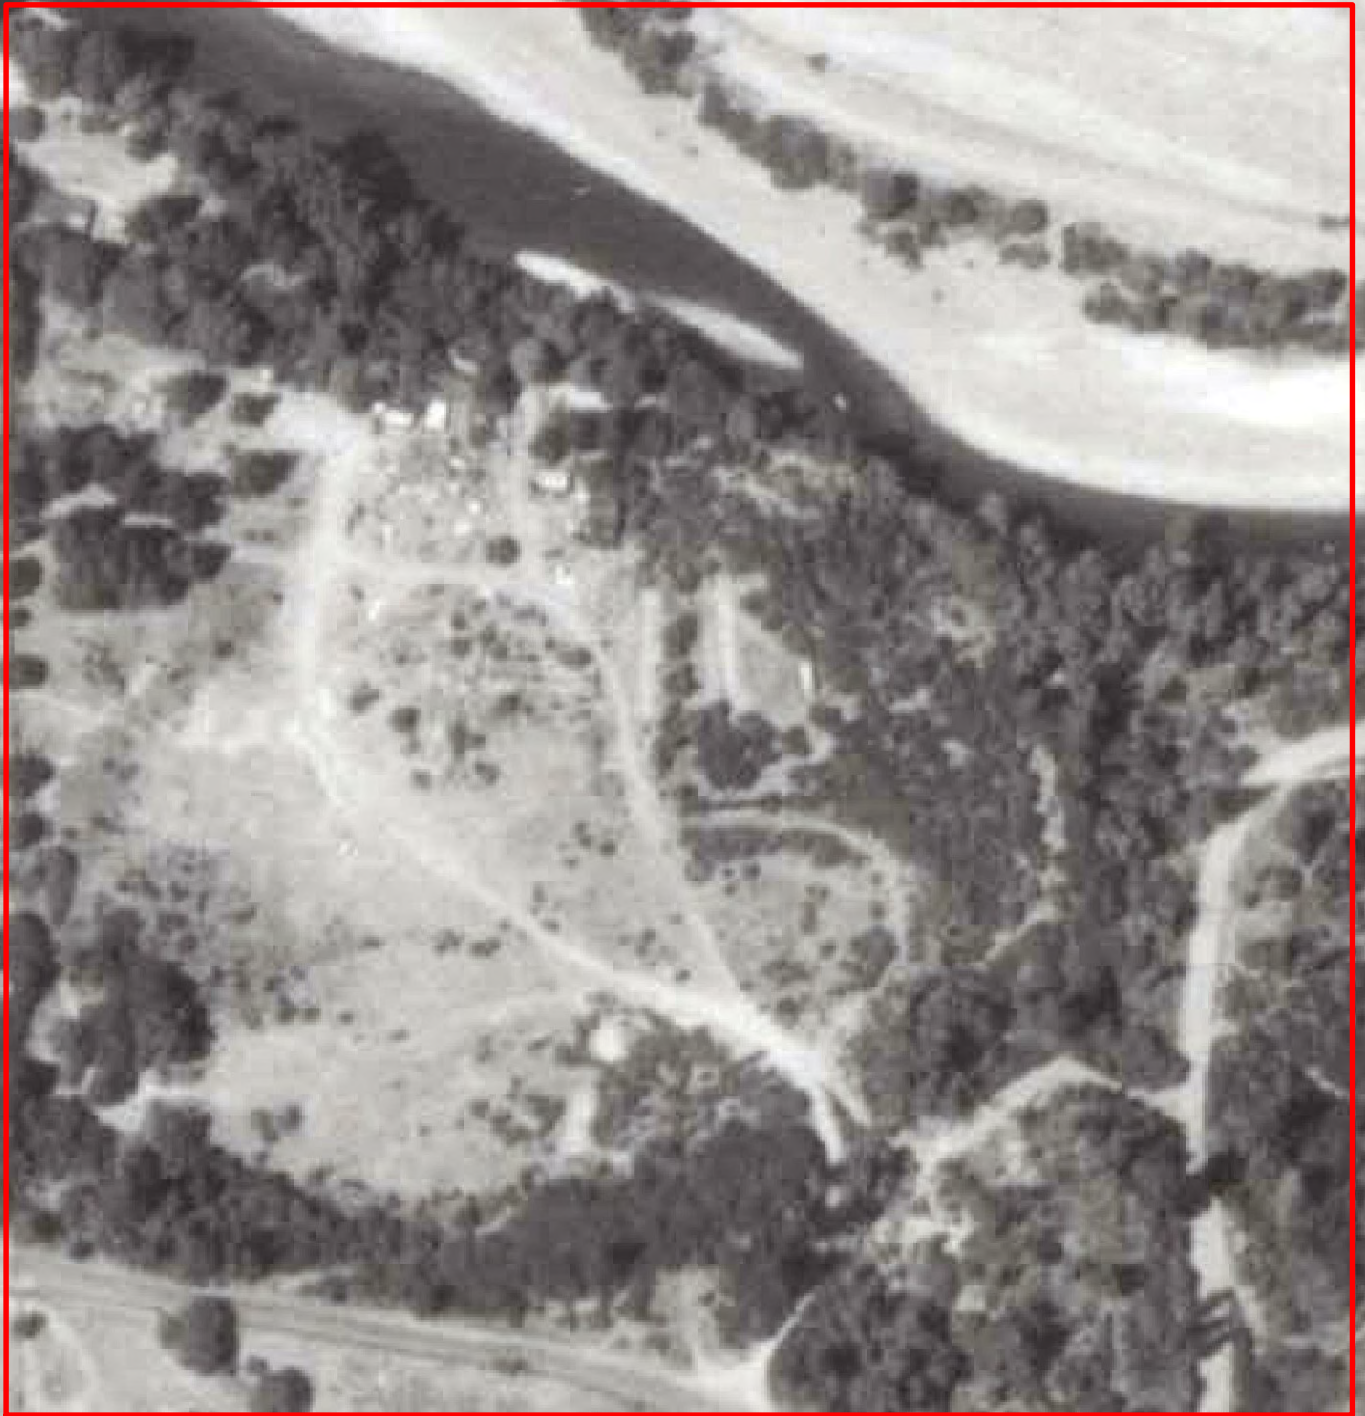
An analysis of the 1965 photo shows that there was timber harvested on the property sometime between 1942 and 1965. Abundant re-growth of riparian and upland forest occurred between 1965 and 2016 as well as establishment and encroachment of Scotch broom (*Cytisus scoparius*) and French broom (*Genista monspessulana*). Between 2016 and 2019, large patches of broom were removed from the property. Air photo analysis can be found in **Attachment 3**.

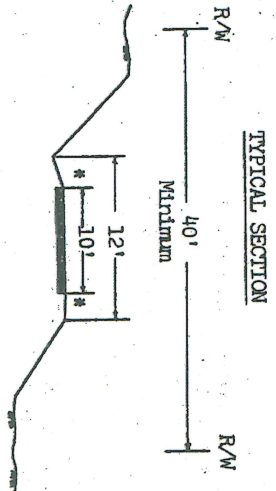
- Traveled Way Width: 10 feet
- Shoulder Width: -0-
- Shoulder Width: 12 feet
- Right of Way Width: Minimum 40 feet for new road or road not previously County maintained. Must be adequate for maintenance. Currently maintained roads may have less than 40 feet right of way. Structural Section: Depends upon engineering analysis of materials and soil by County laboratory. Surface Recommendation: Native earth or gravel. (Seal Coat or A.C. may be used.) Design Period: 5 - 10 years.

Notes: Length limitation - quarter mile.

* Gutter and backup to vary to suit conditions.
