# Report of Vegetation Management Activities

## Table Bluff Landfill Emergency CDP

Record Number PLN-2025-19302

November 13, 2025

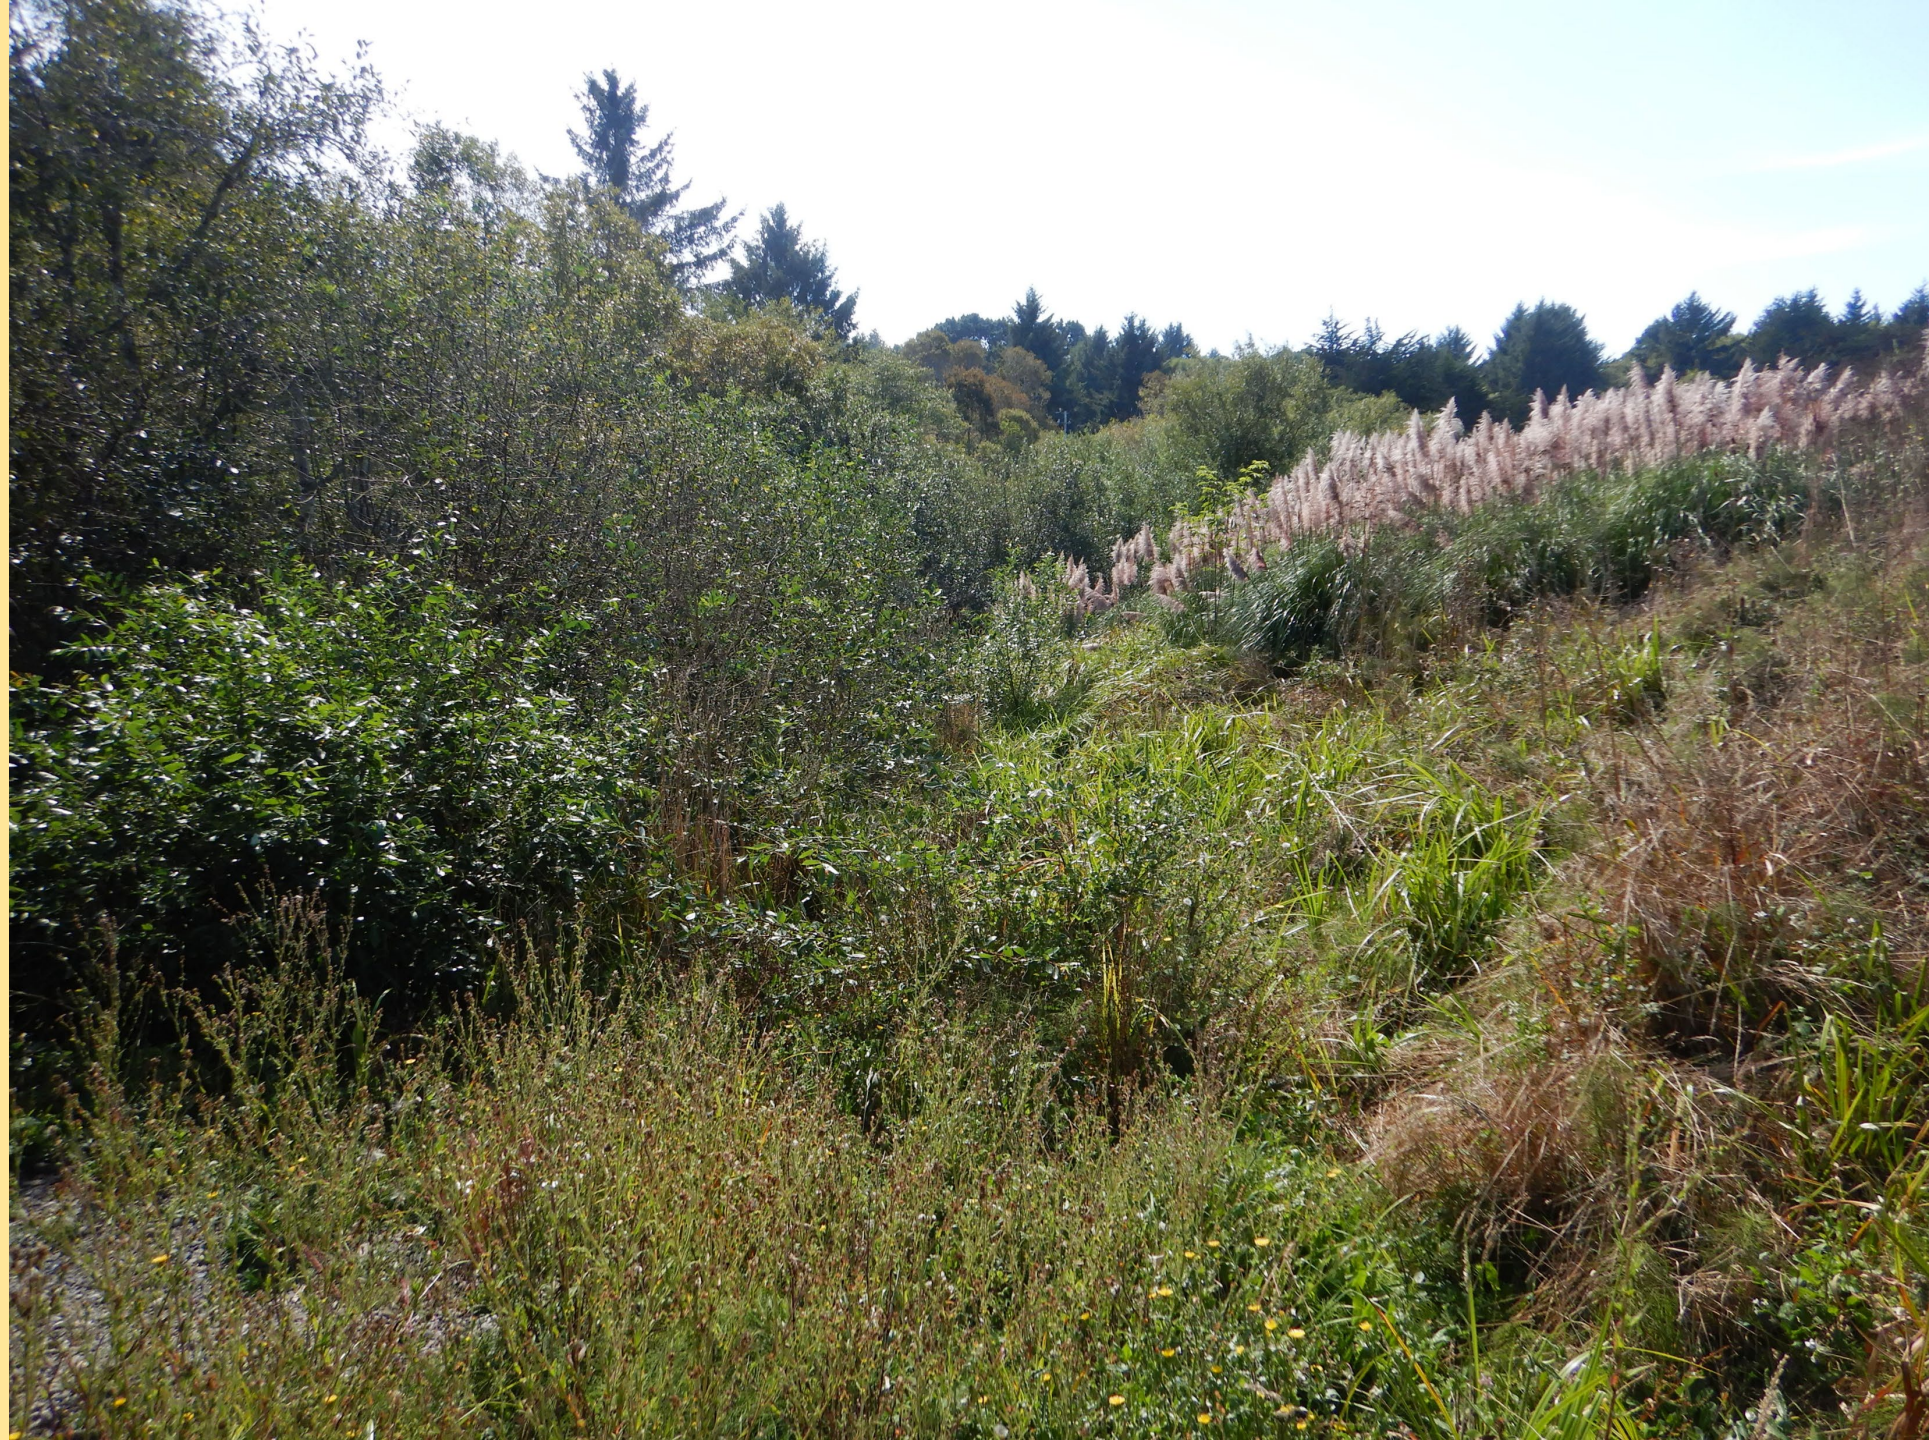
Photo taken on May 10<sup>th</sup>, 2024, prior to any vegetation clearing/work. Picture taken facing south and facing where the Southern Access Road was extended.

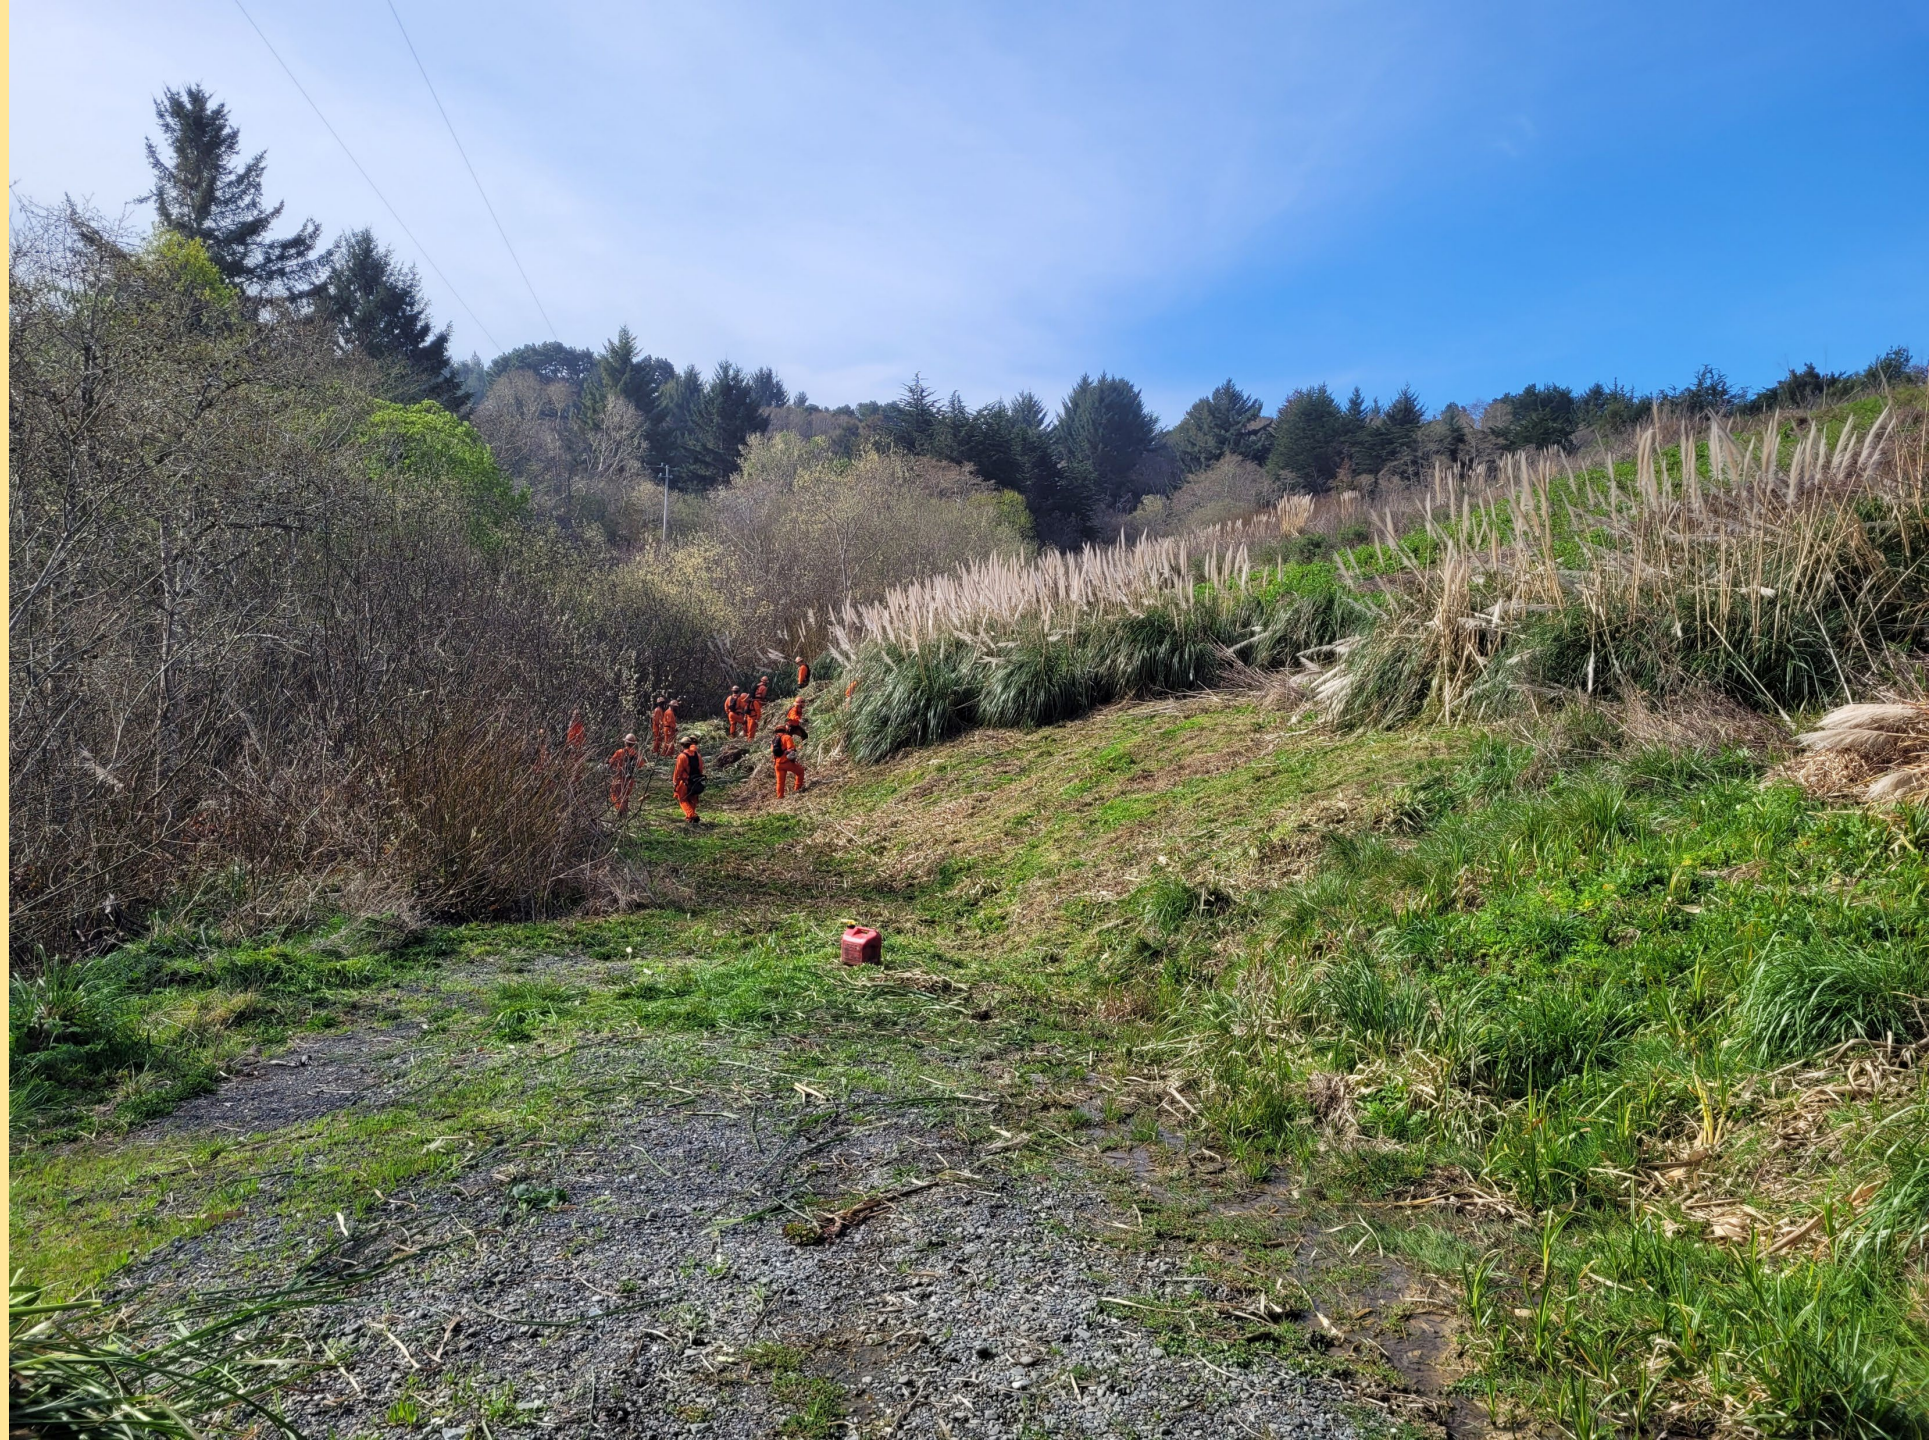
On March 19<sup>th</sup>, 2025, the CalFire inmate crew came on site to conduct vegetation clearing around some features and around the seep area. This photo shows how much the willows have encroached onto the landfill cap.

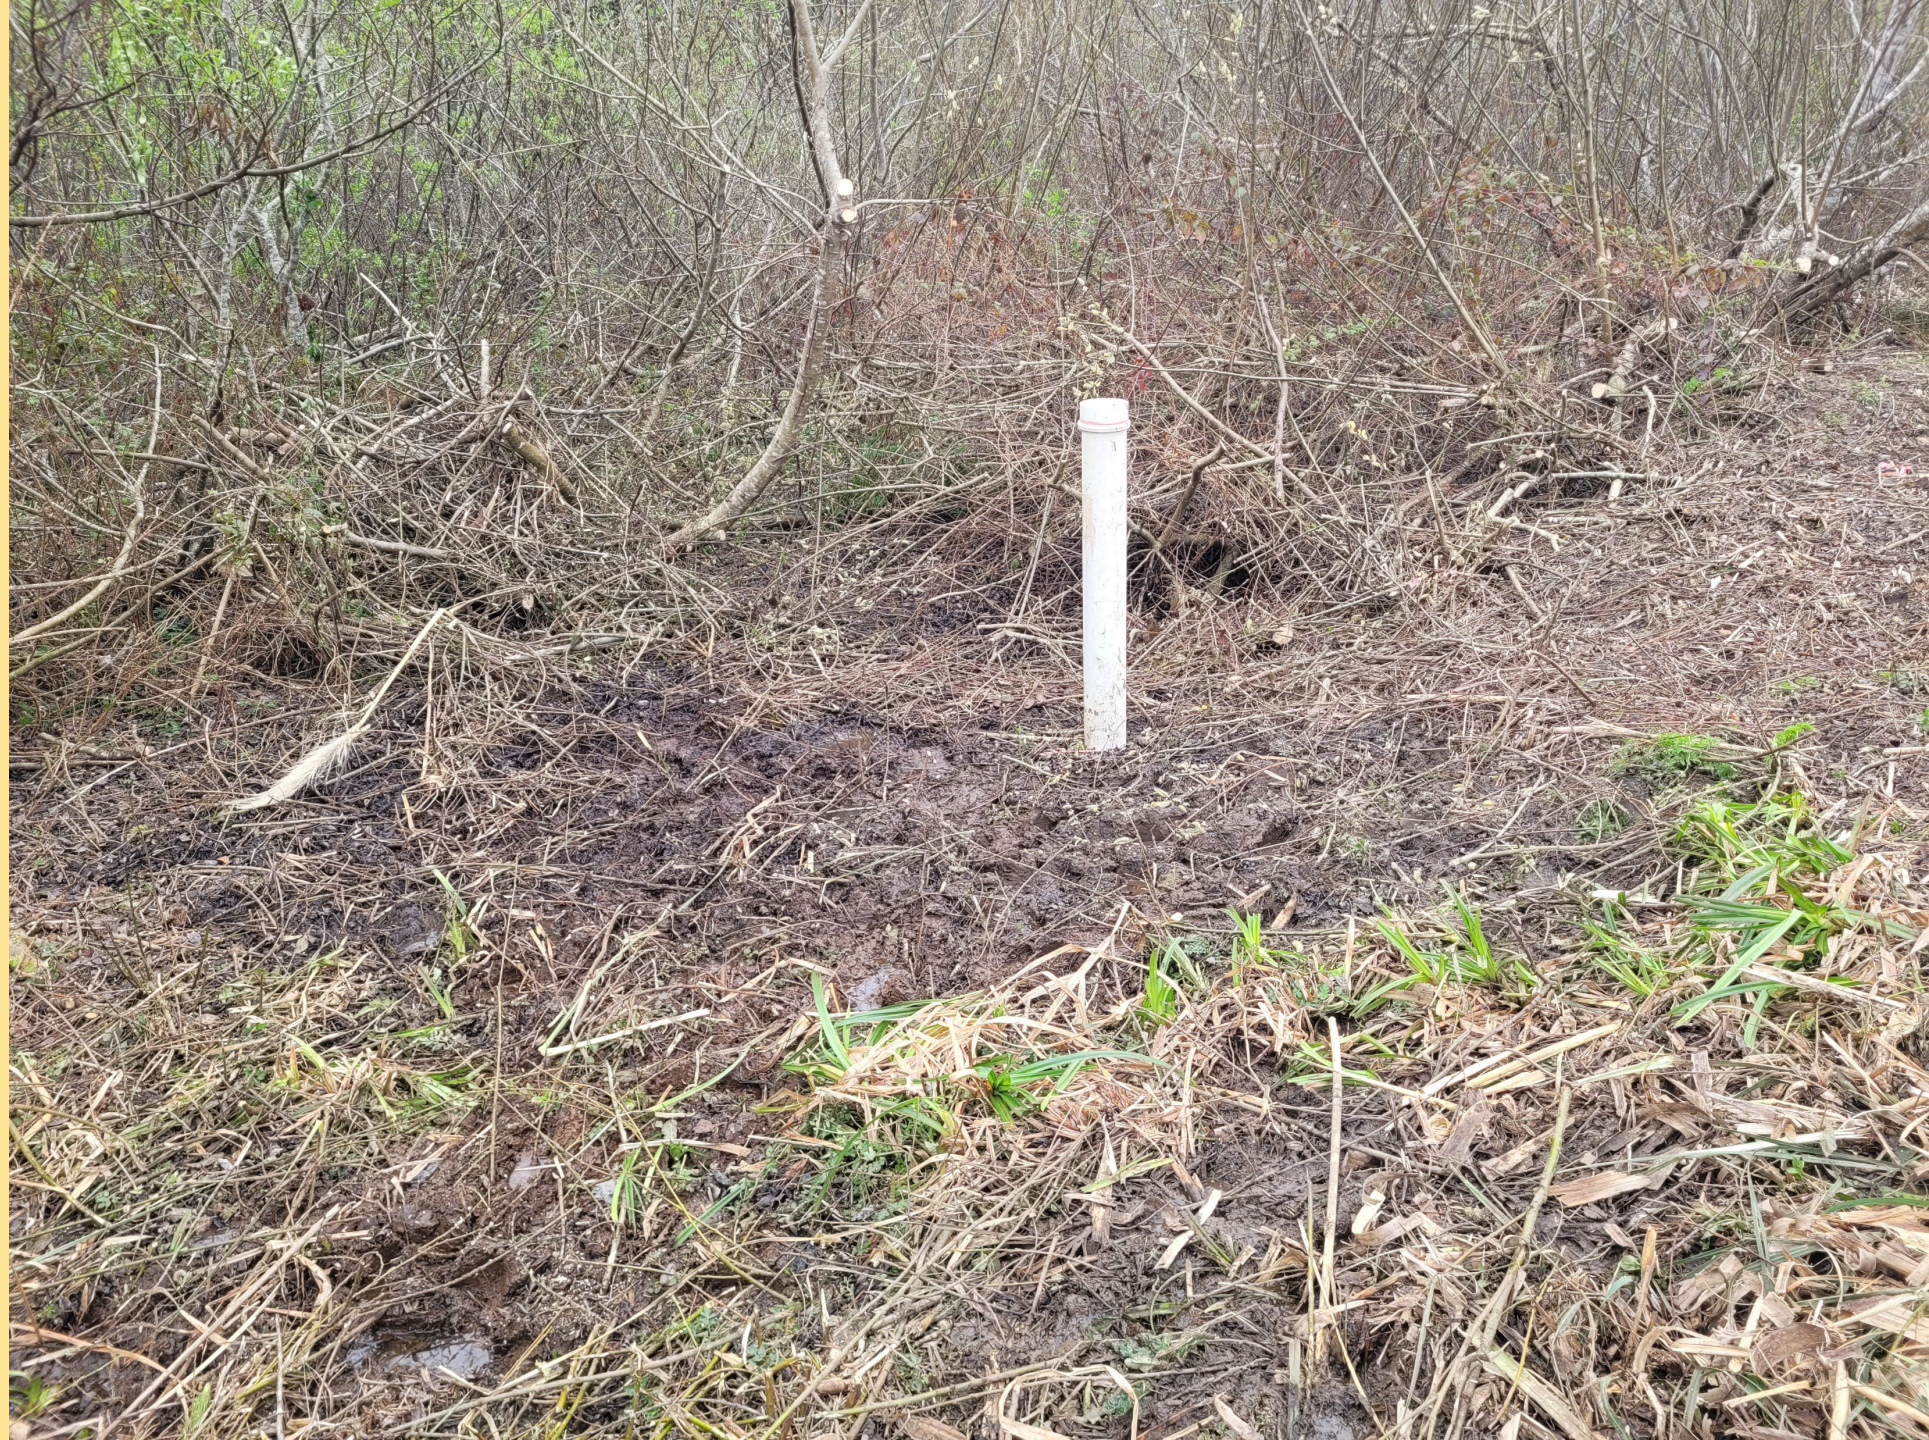
An up-close photo showing how much the willows have encroached onto the cap and hid features like this stand-up pipe. Once construction started for the cap remedial project, we found that the subterranean leachate collection system extends, farther than anticipated, towards the riparian corridor. Removal of the smaller willows to keep roots from potentially breaking pipes that convey the leachate to the leachfield was conducted during the construction phase under the supervision of David Orluck.

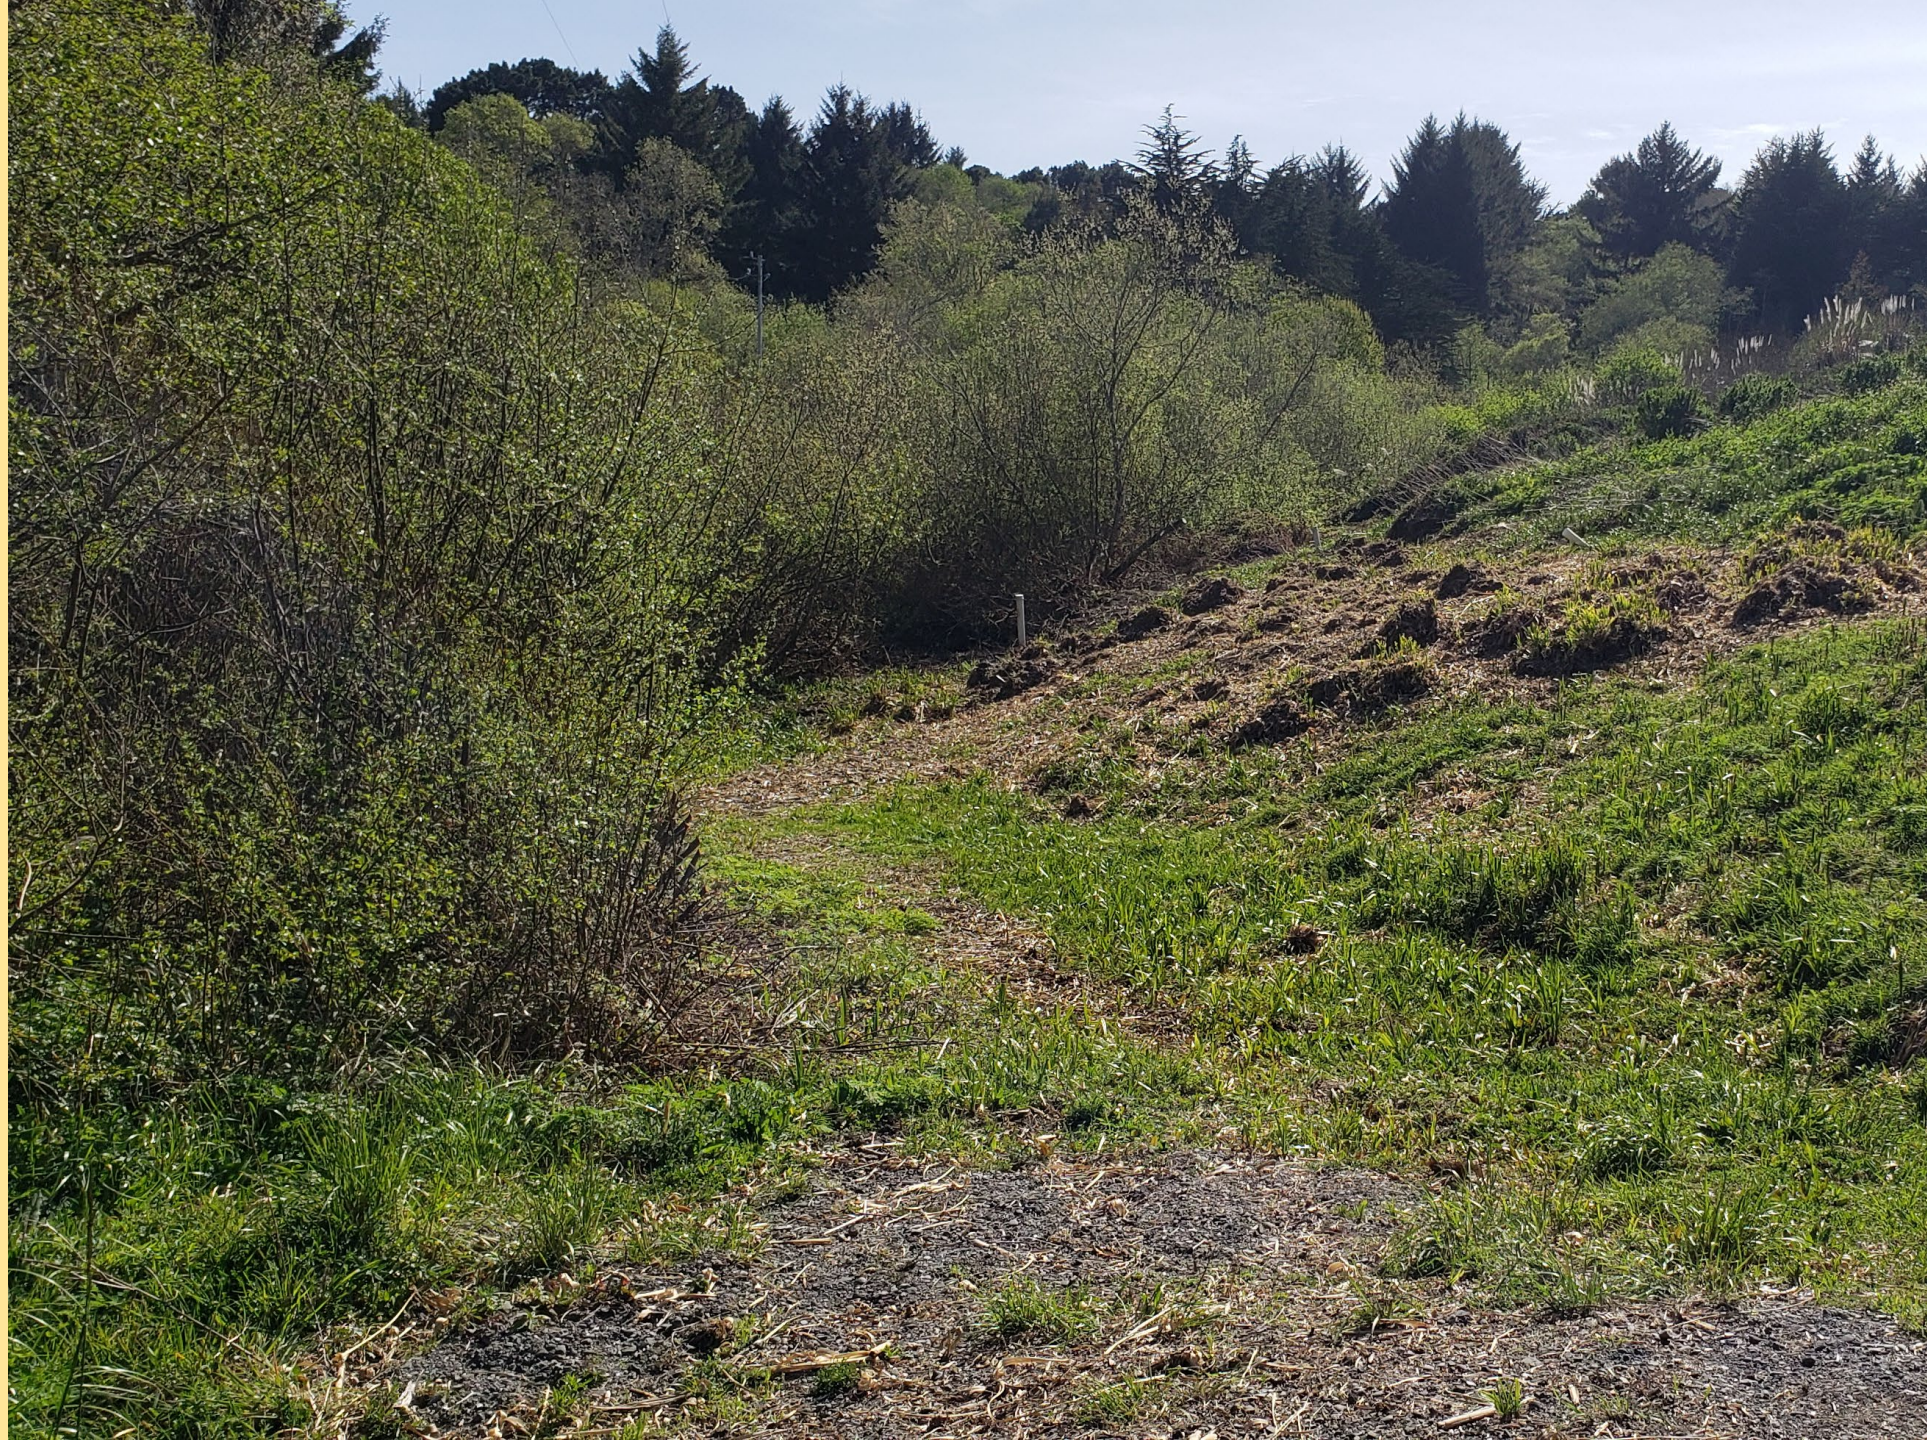
Photo taken on April 4th, 2025, shows the conditions after trimming and removal of some of the willows from along the Southern Access Road.

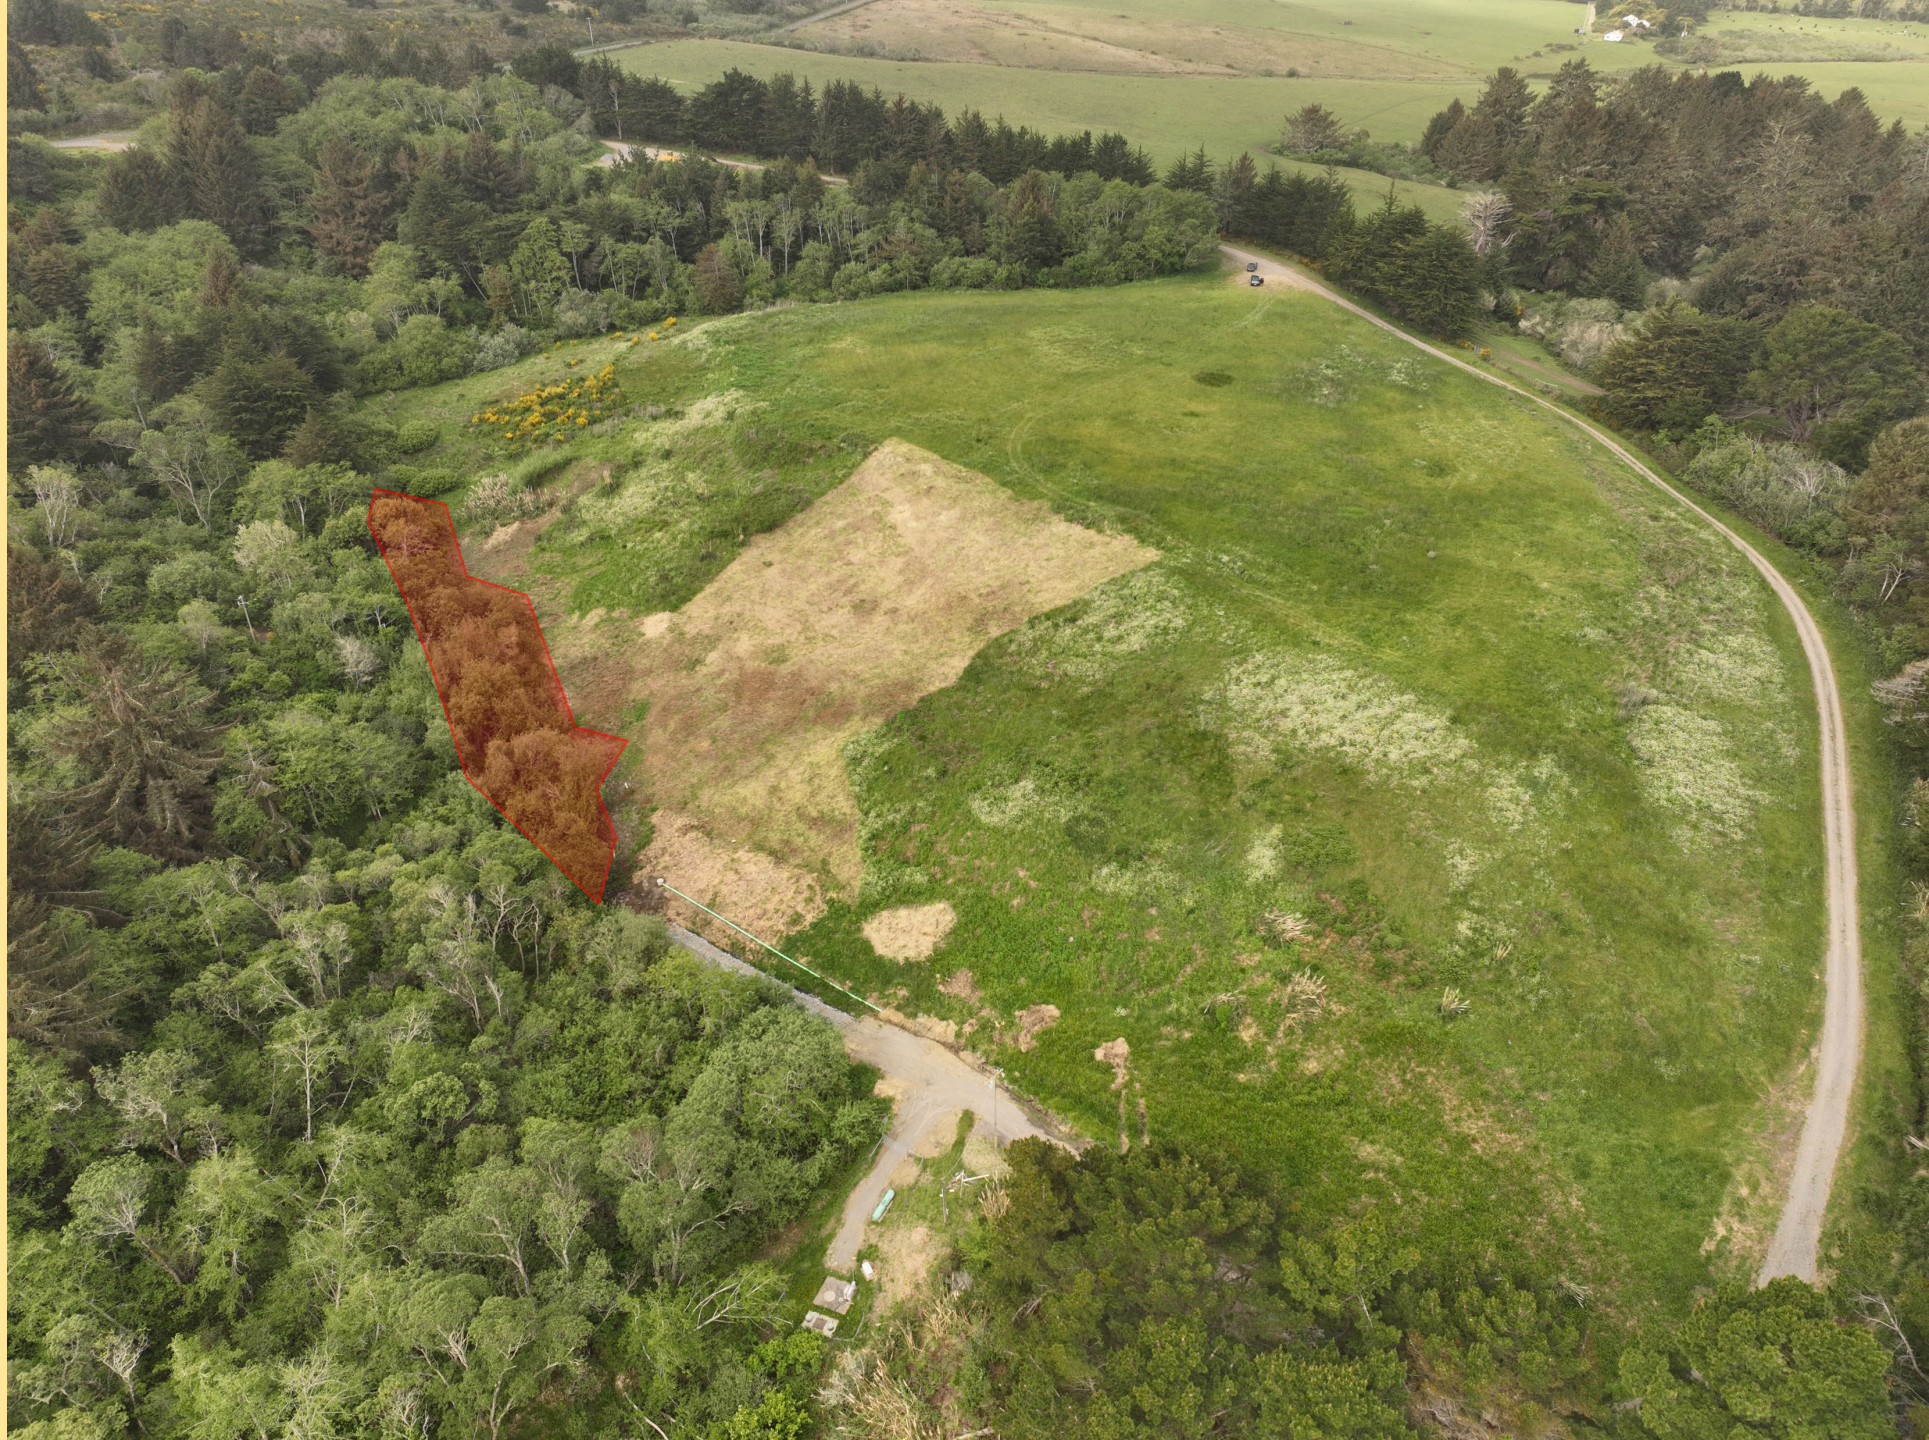
Aerial drone imagery taken on April 29<sup>th</sup>, 2025, show the landfill cap, the Southern Access Road, and the encroaching willows highlighted in red.

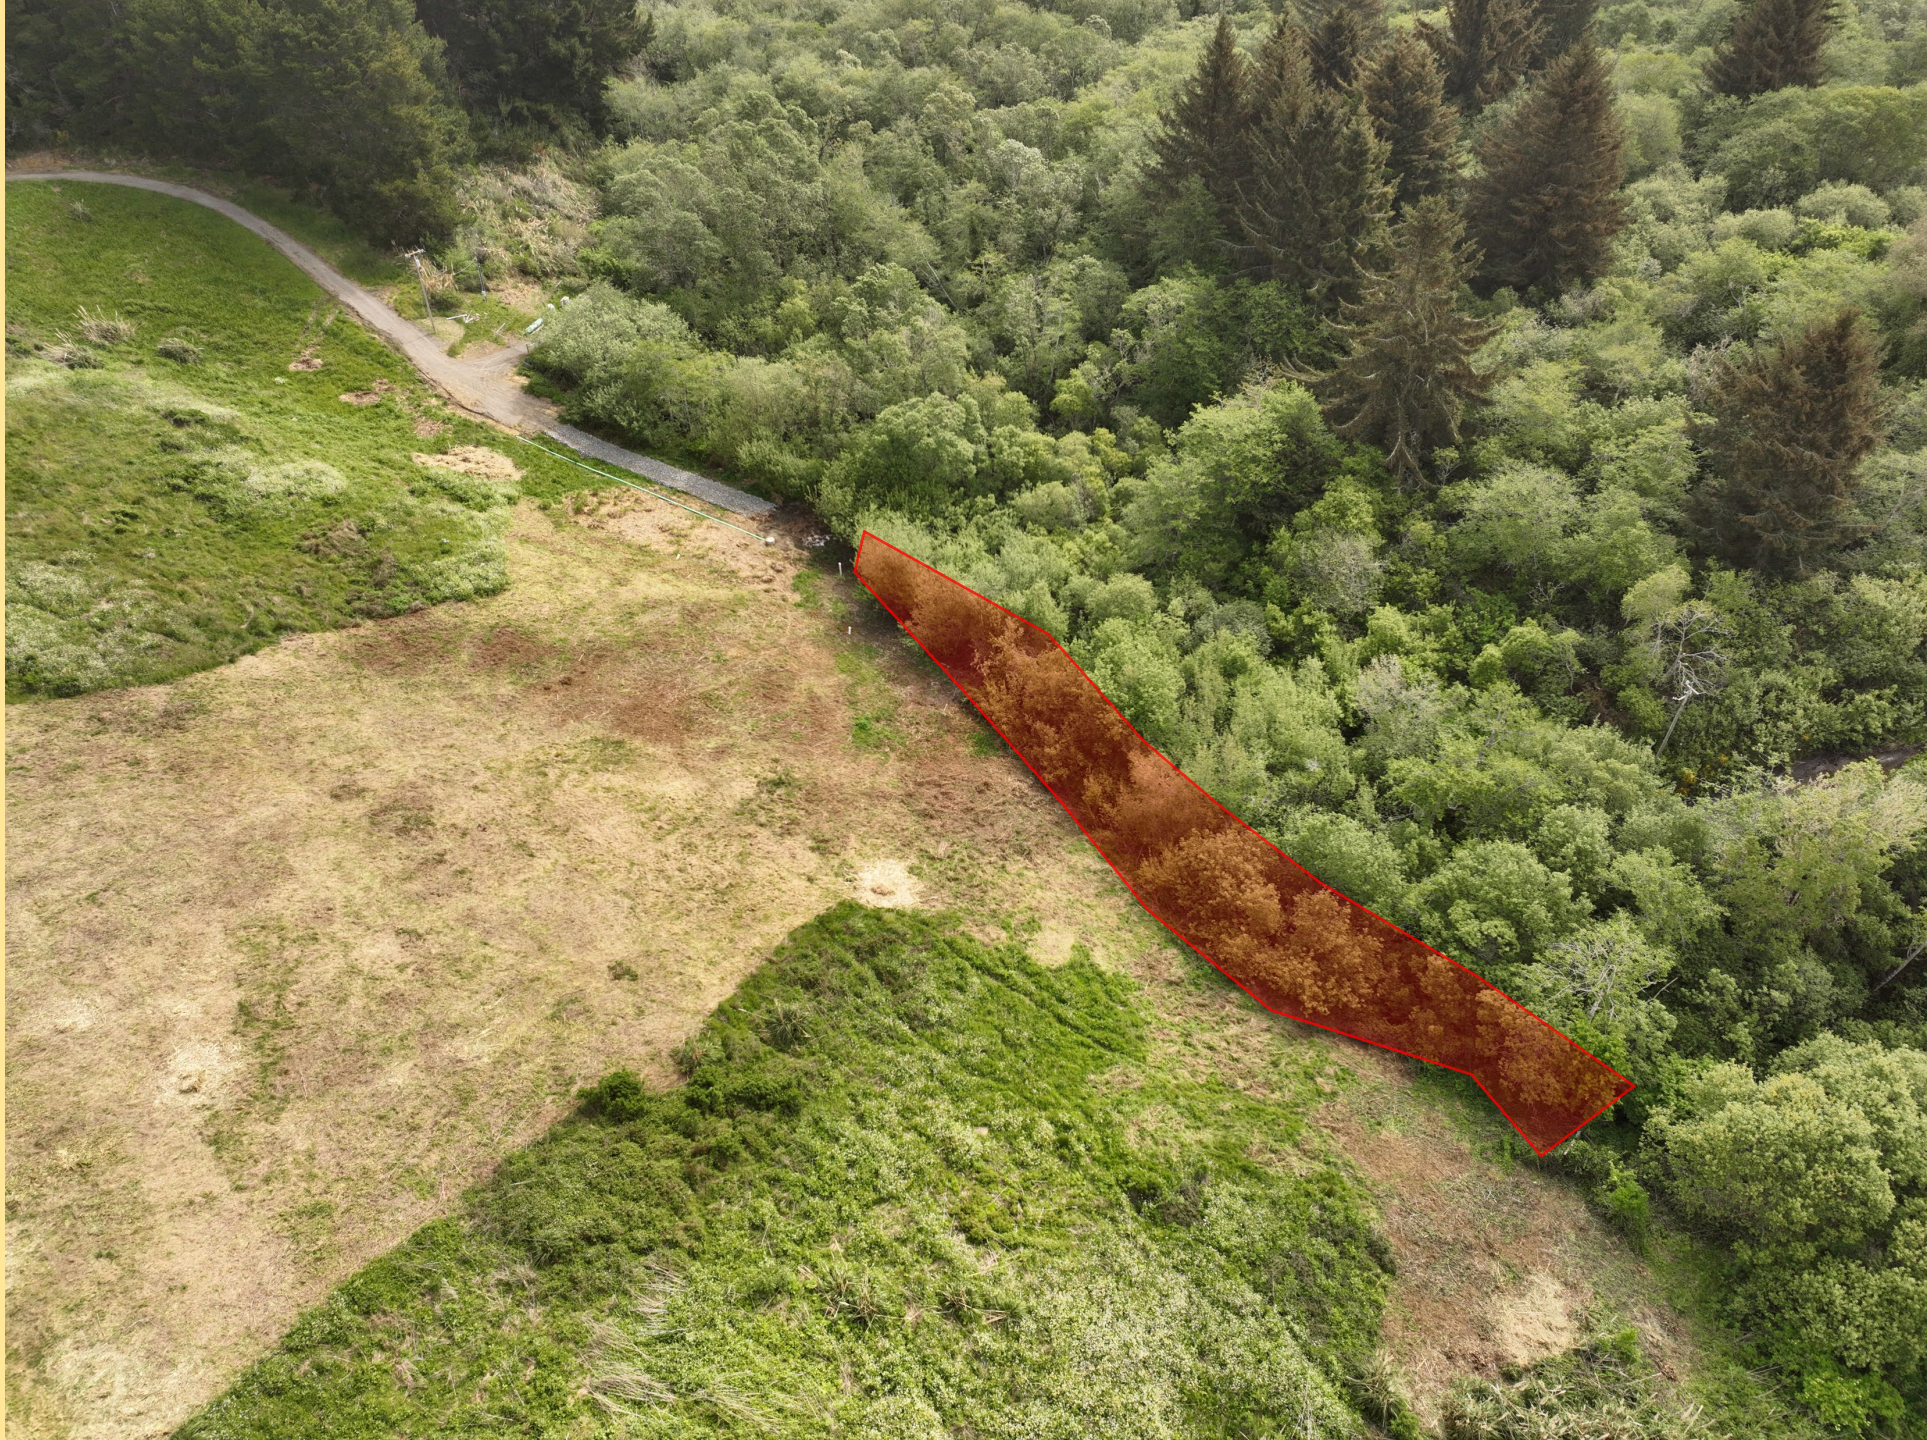
Another aerial drone imagery, showing the encroachment of the willows onto the landfill cap. This area will be addressed by retreating/removing the willows off of the cap in 2026. Encroaching willows shown in red.

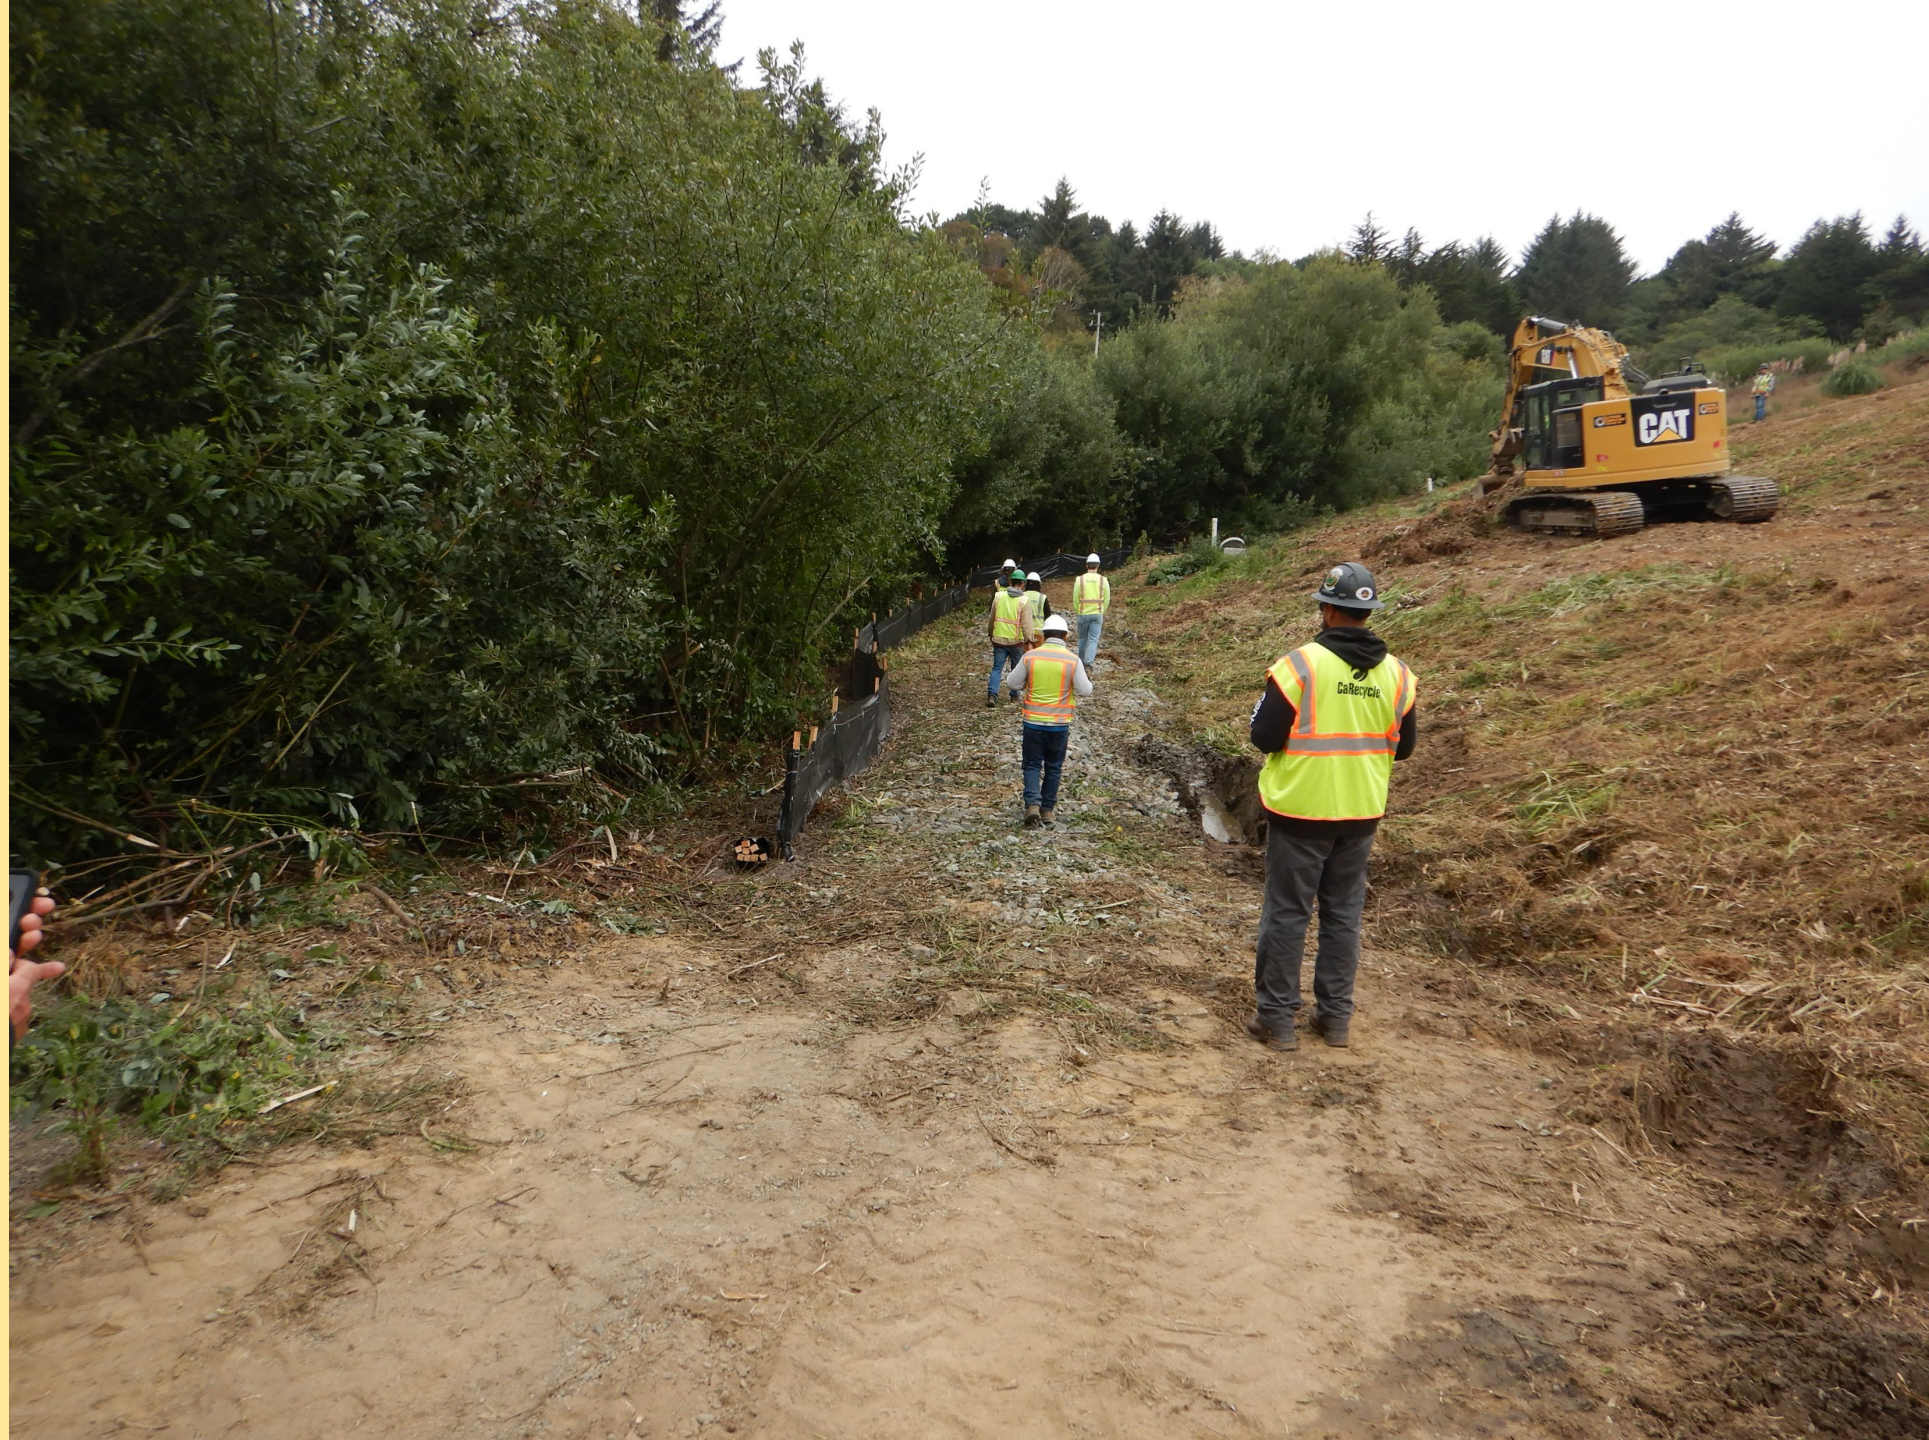
On September 4<sup>th</sup>, 2025, under the supervision of the County's biologist, David Orluck, ERRG (Engineering/Remediation Resources Group, Inc.) began removal of select willows to retreat them from the edge of the landfill cap and to open up access on the soon to be built southern access road. Removal of selected trees were limited to young ones and were either plucked out by the backhoe or limbed/trimmed back by chainsaws.

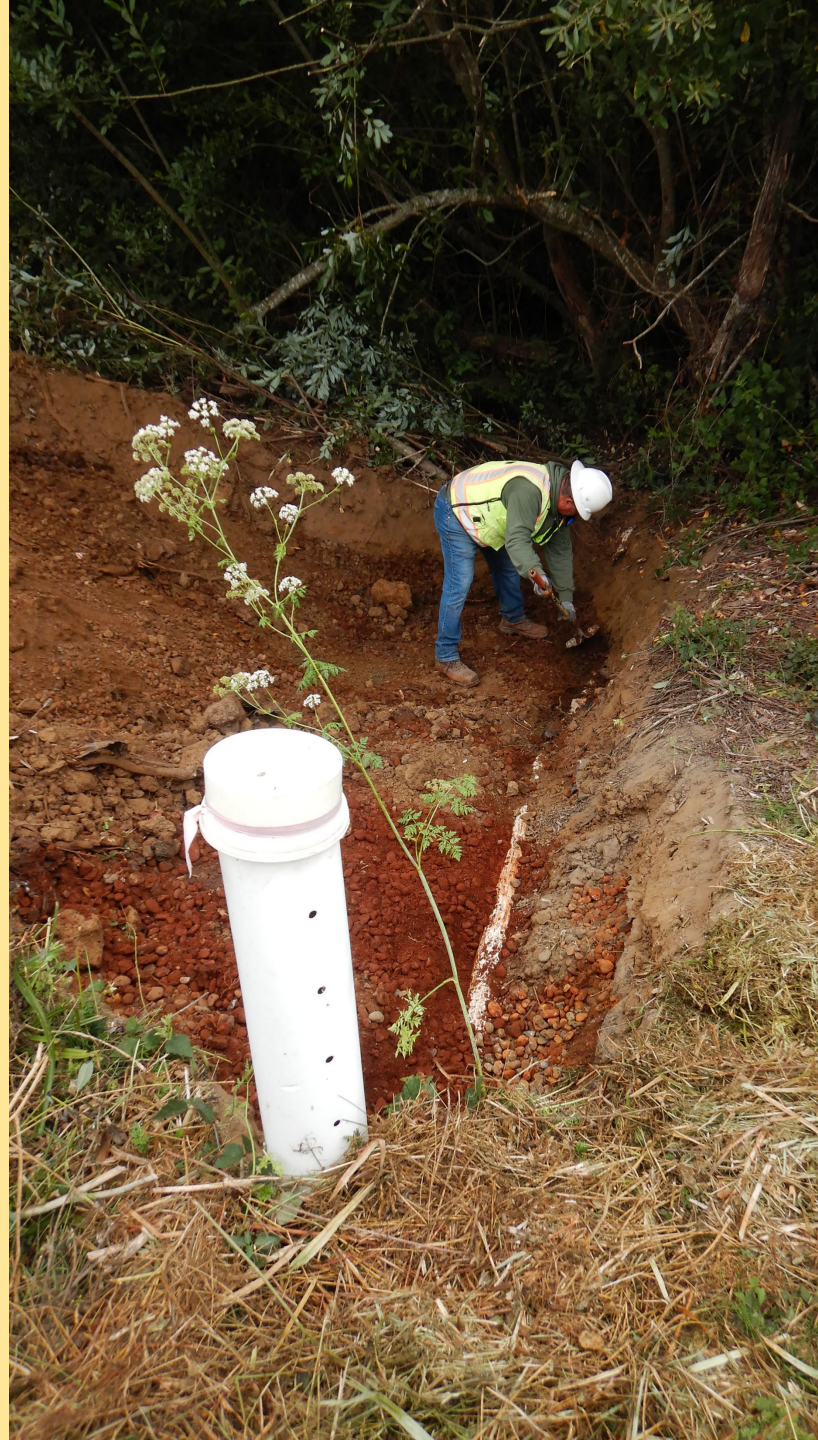
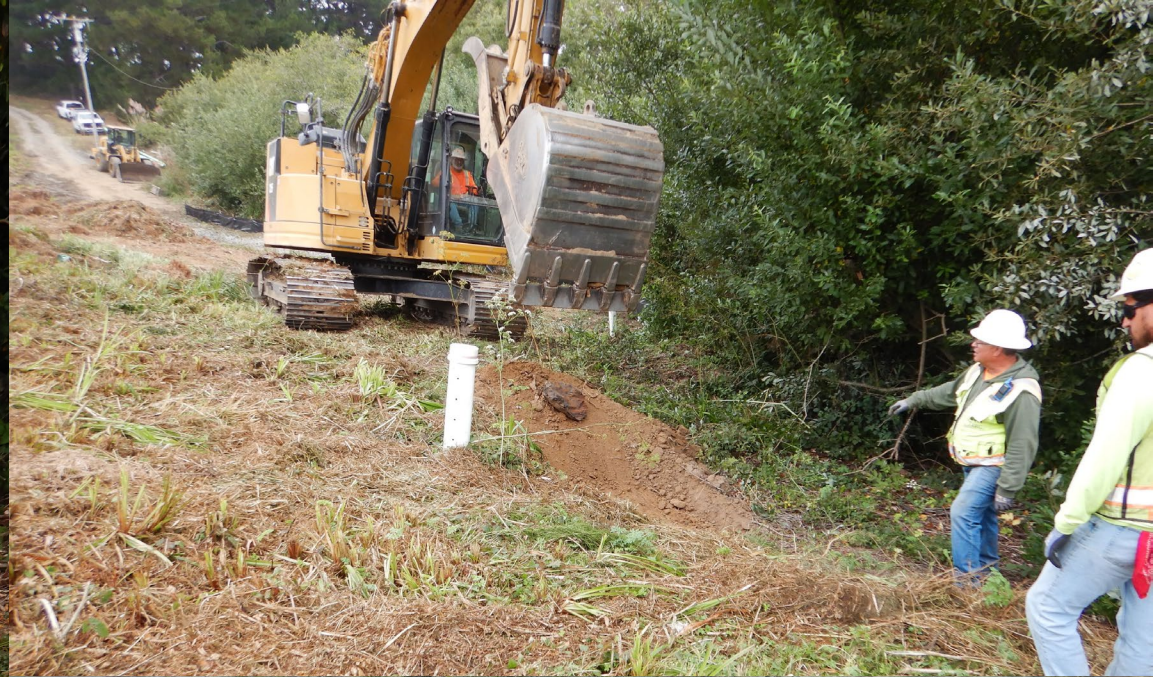
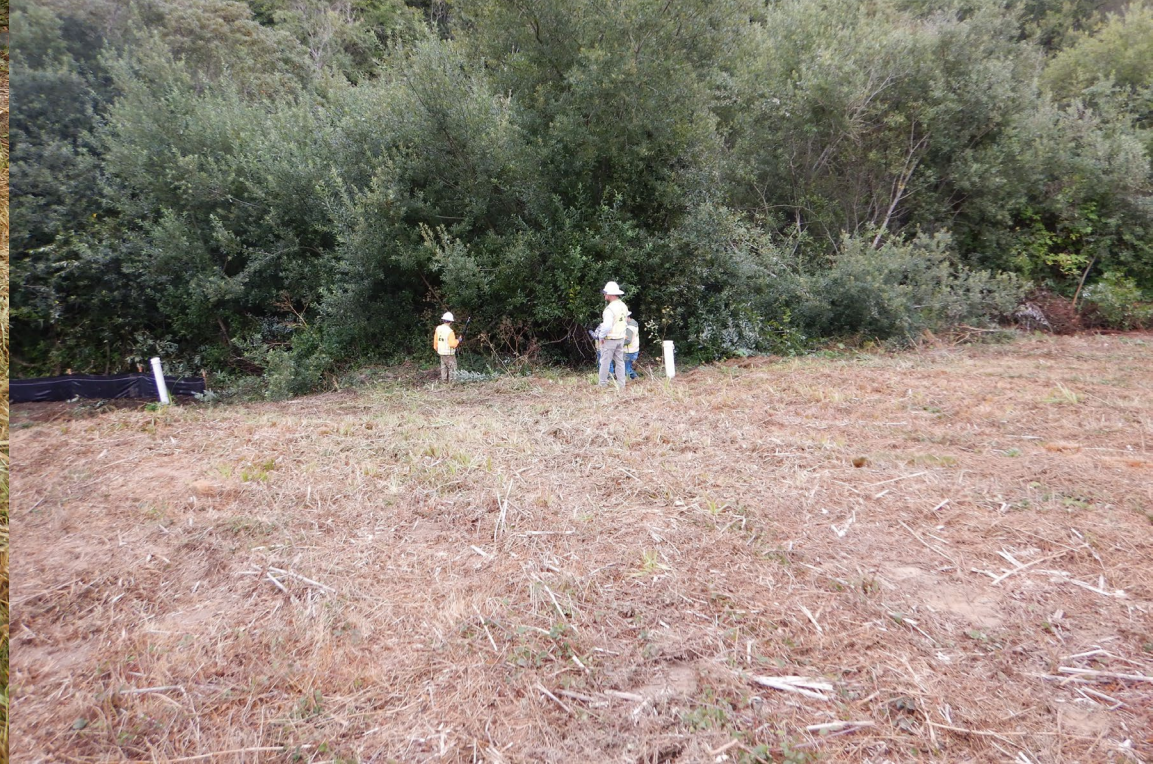
Photos also taken on September 4<sup>th</sup>, 2025, showing how much the willows have grown and expanded onto the cap. The photo on the left shows how far the leachate collection system extends towards the riparian corridor. There is a clear delineation of where the riparian edge of the Southern Access Road stops before it drops in elevation to the mature riparian corridor with mature willows and alders. We used this delineation to know how far to clear the young encroaching willows.
