# Report of Vegetation Management Activities

## Table Bluff Landfill Emergency CDP

Record Number PLN-2025-19302

November 13, 2025

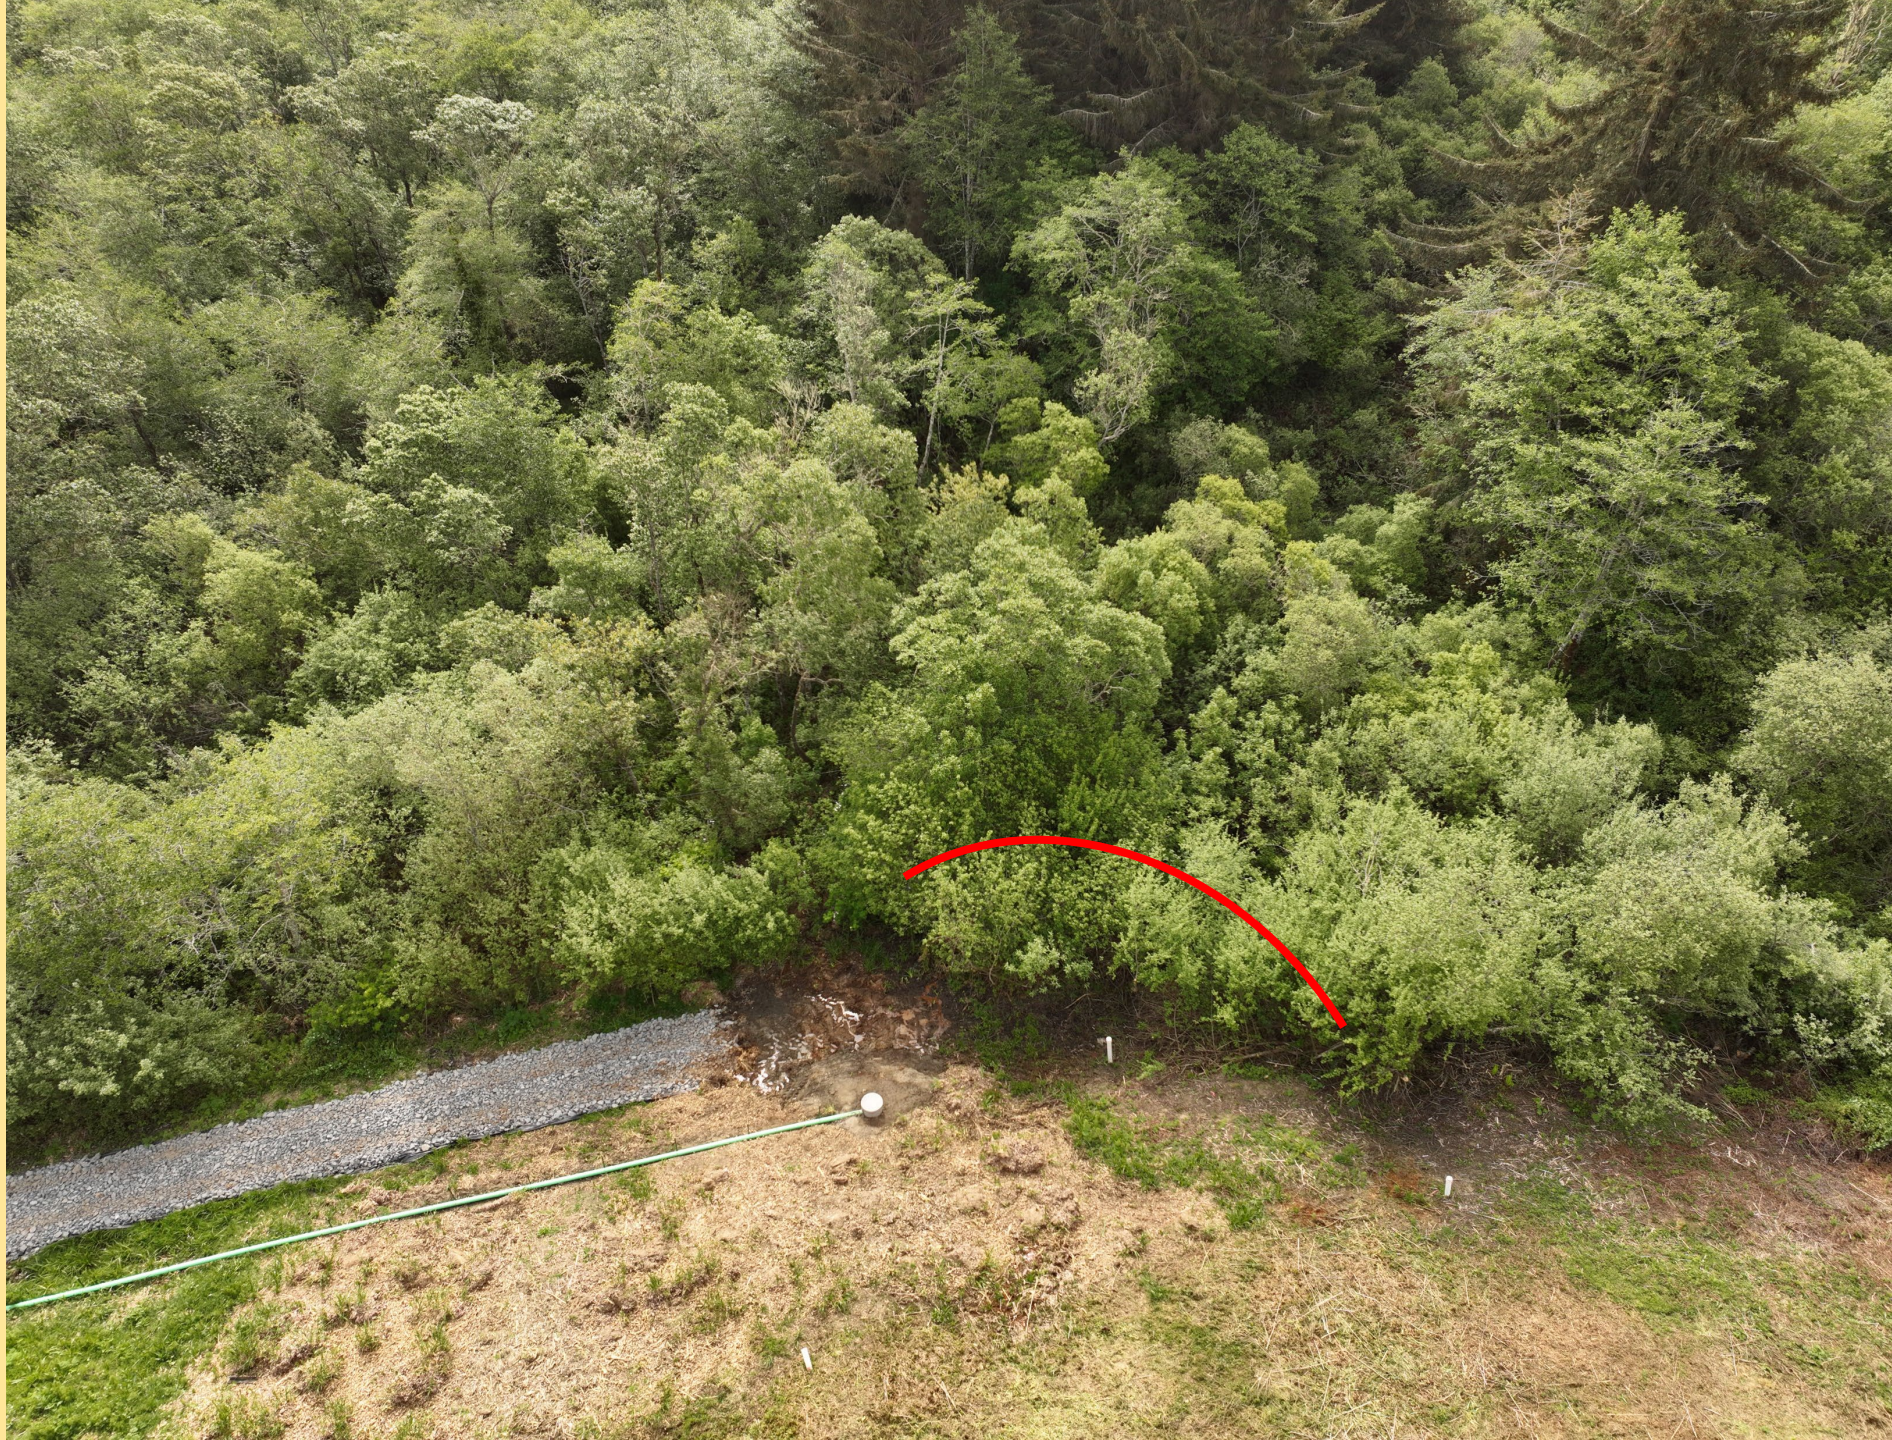
Closer aerial image, of where the Southern Access Road was extended. The red line shows the extent of the willow removal in this area.

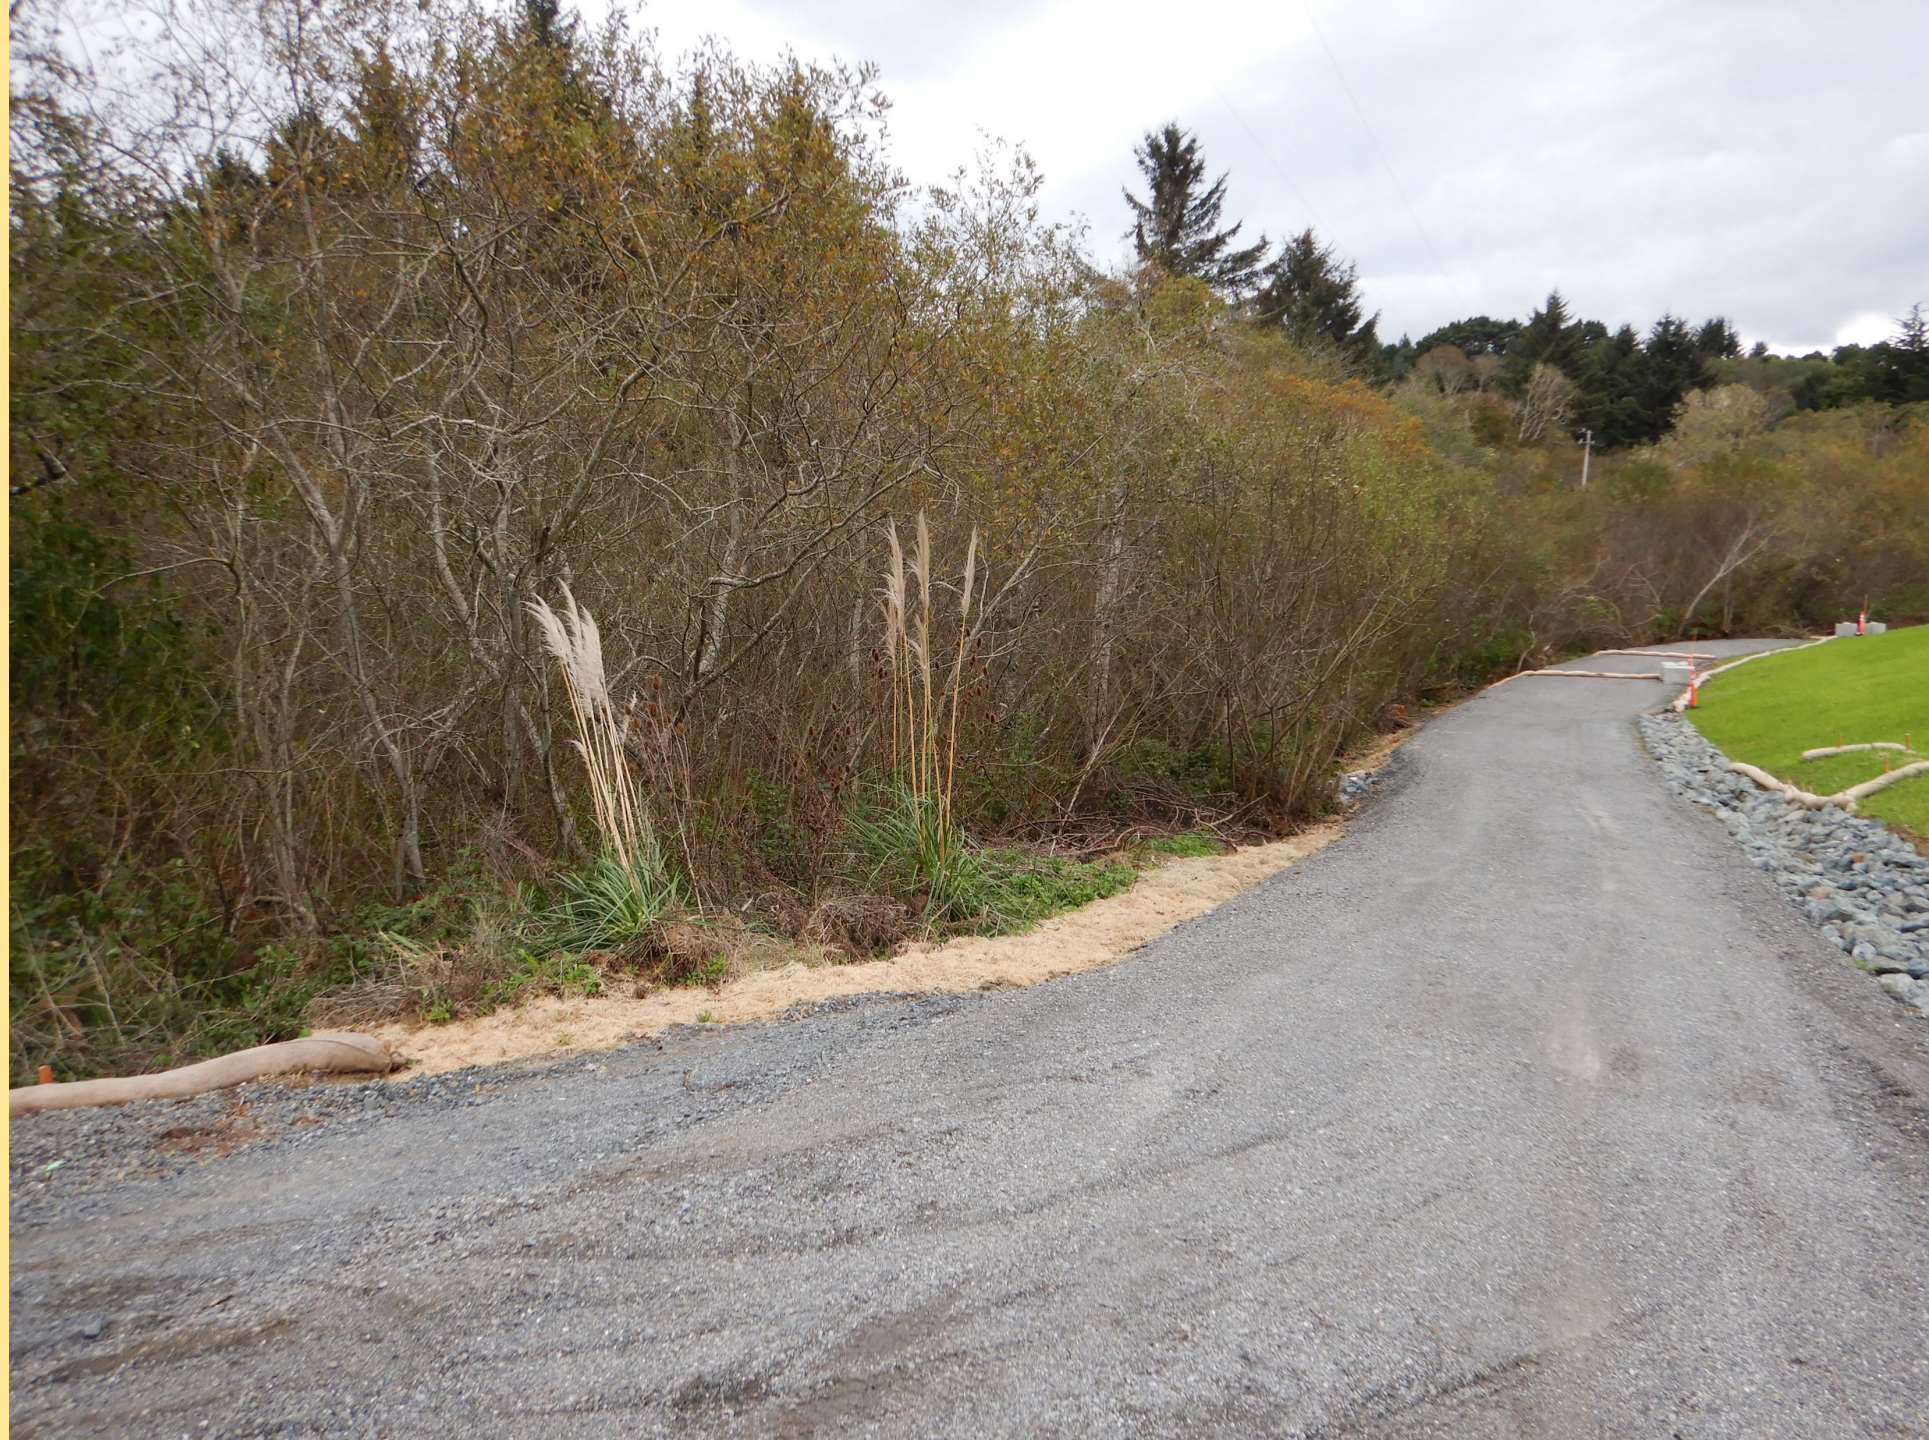
Photo was taken on November 12<sup>th</sup>, 2025, showing the current state of the southern access road. Only limited willow removal was necessary adjacent to the road to give enough clearing for the extension of the Southern Access Road. Several willows were removed towards the end of the Southern Access Road, and the vegetation line was retreated, to keep the woody roots off of the landfill cap and away from the subterranean leachate collection system.

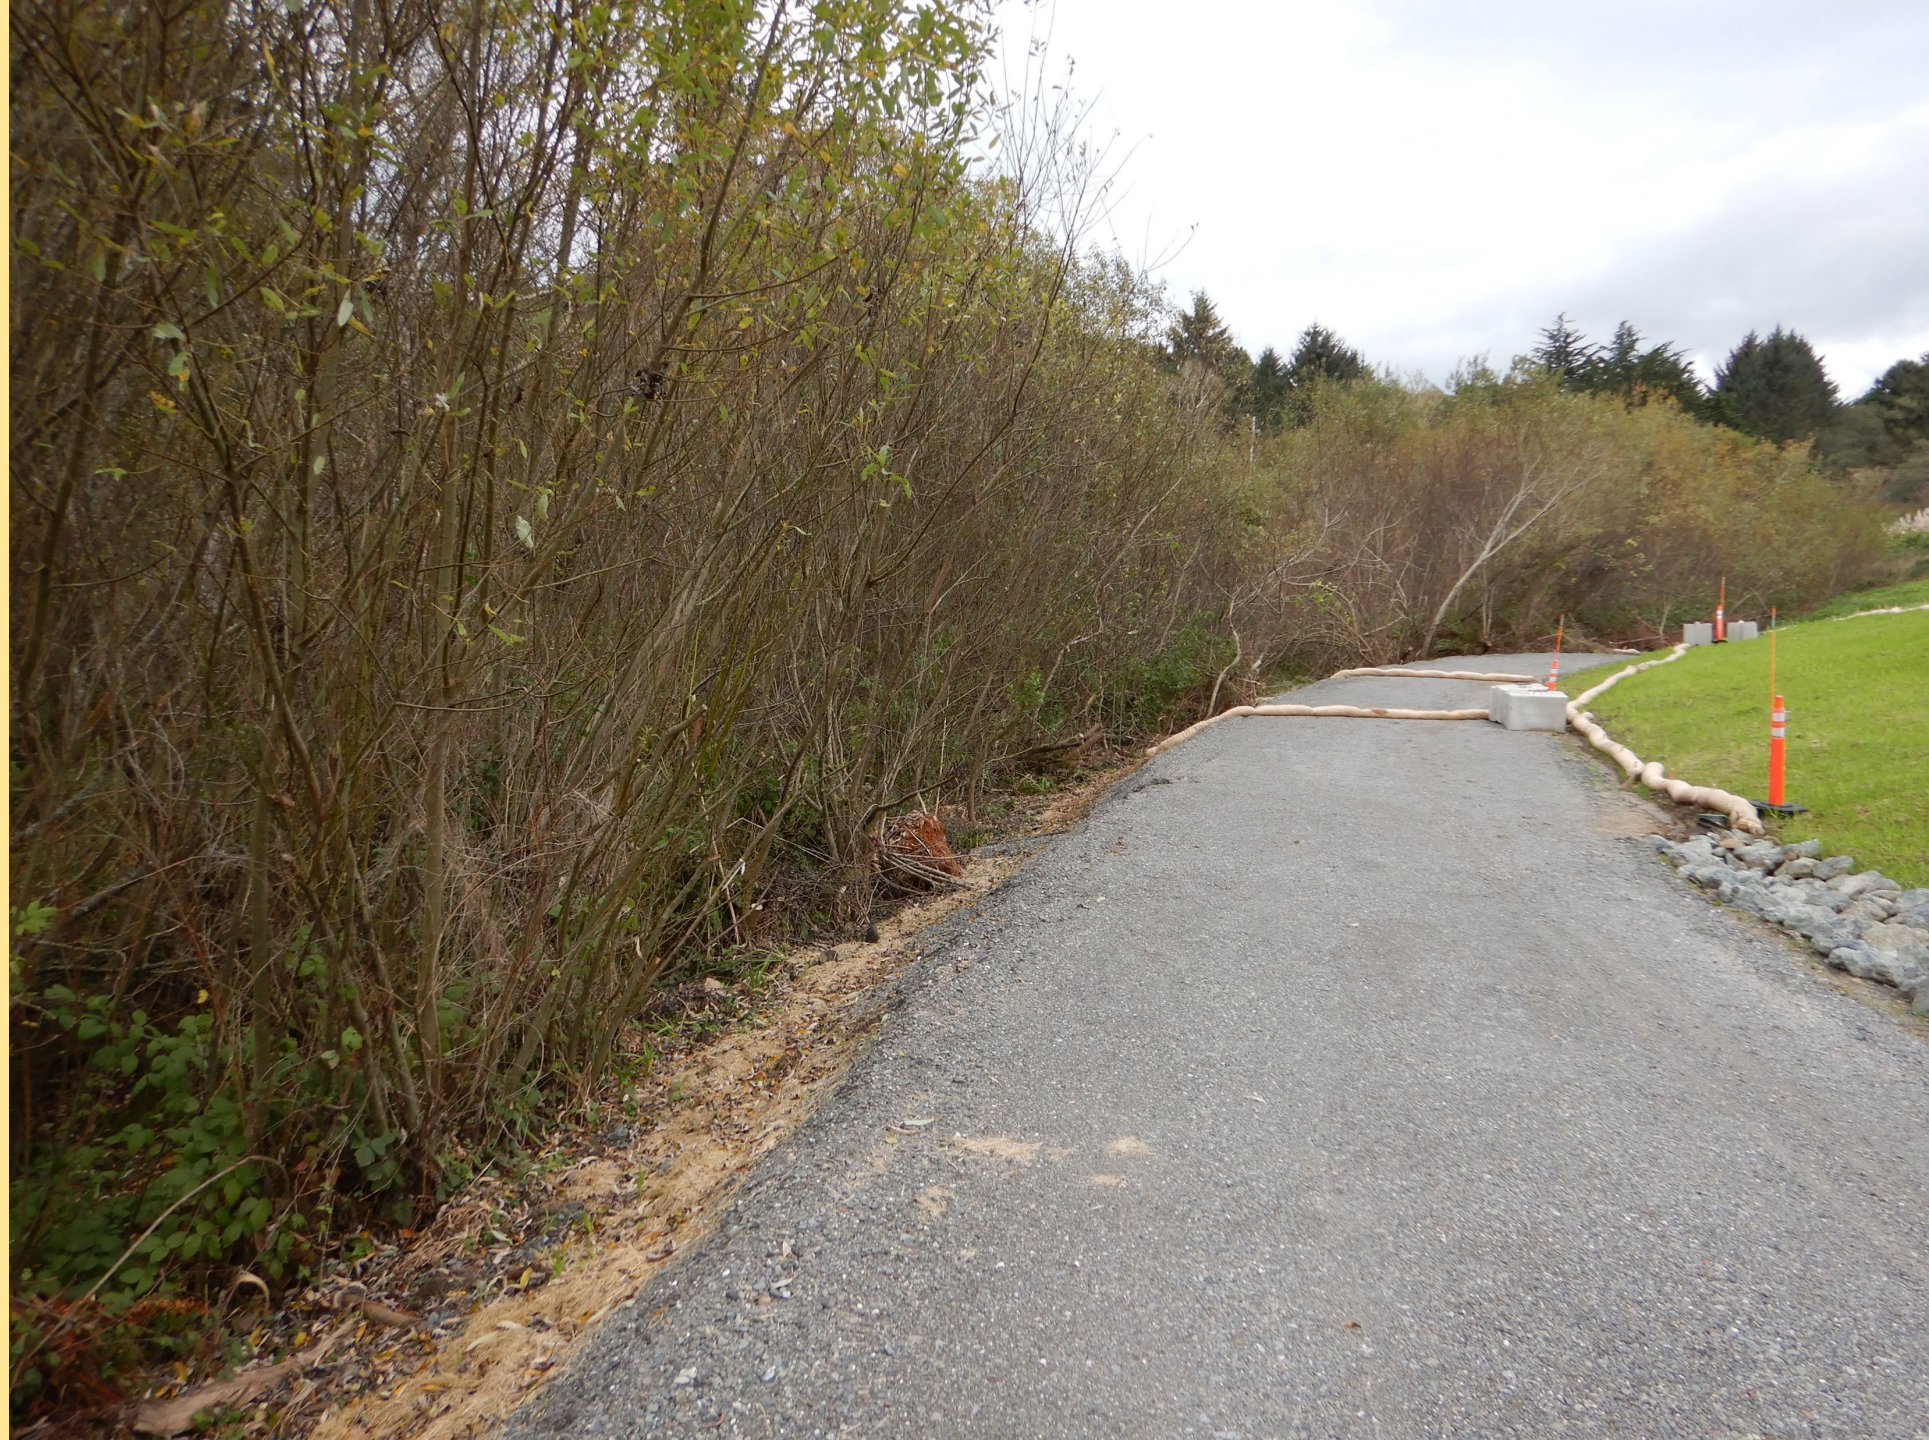
Photo showing the edge of the vegetation line. These willows are growing right before the area drops in elevation to the mature riparian corridor.

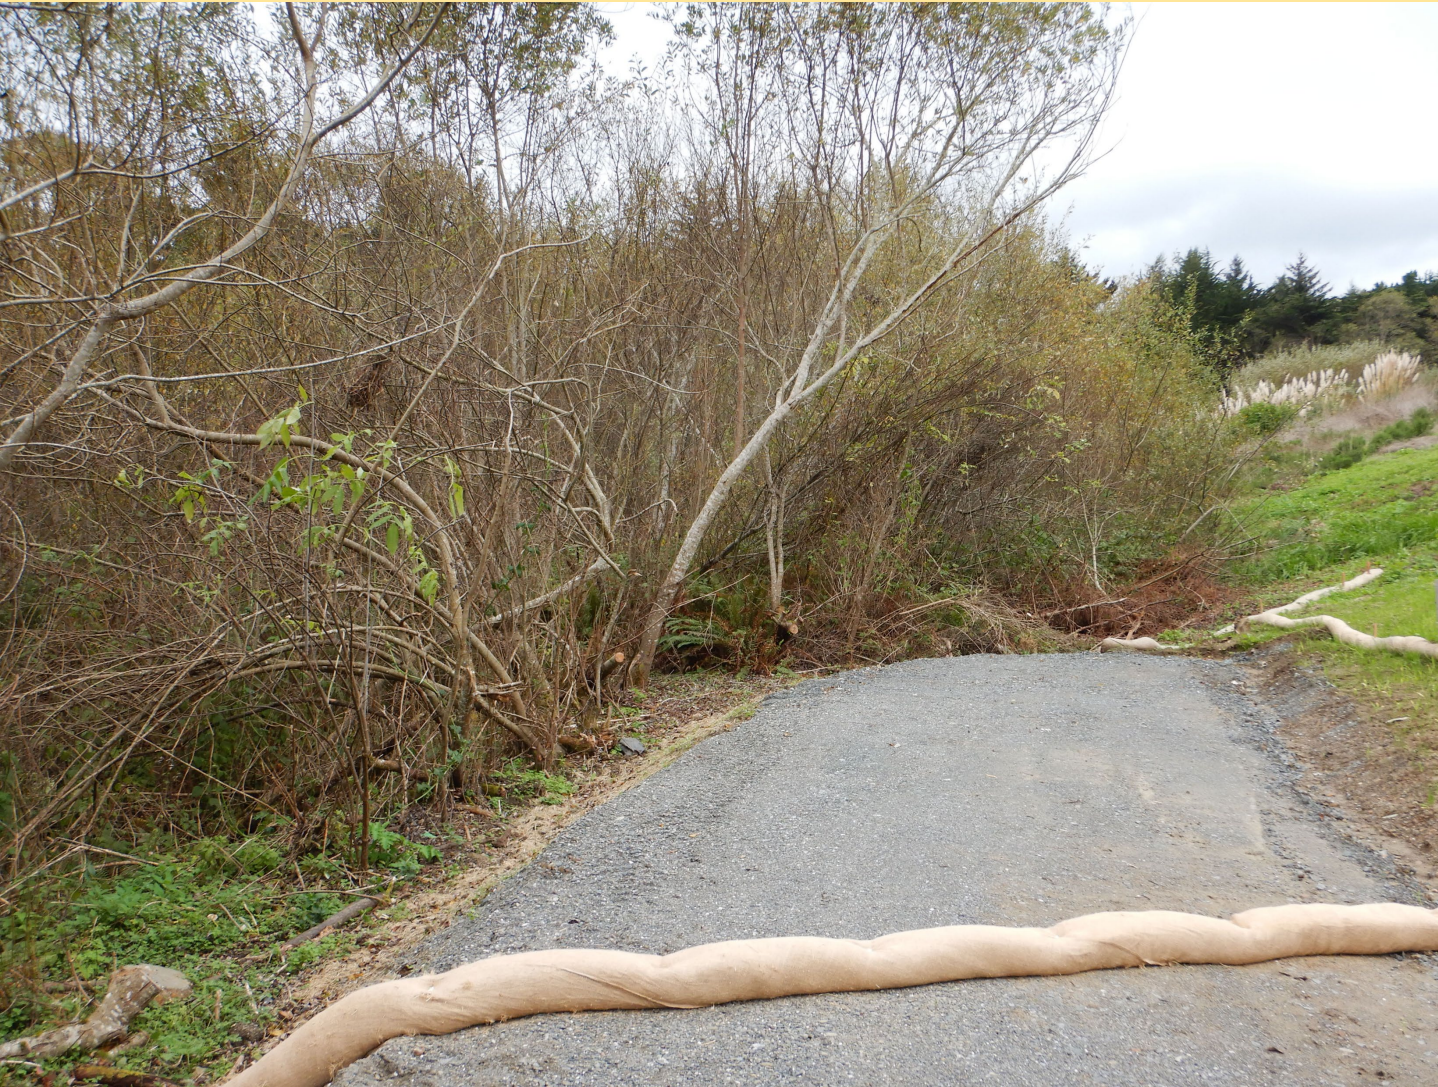
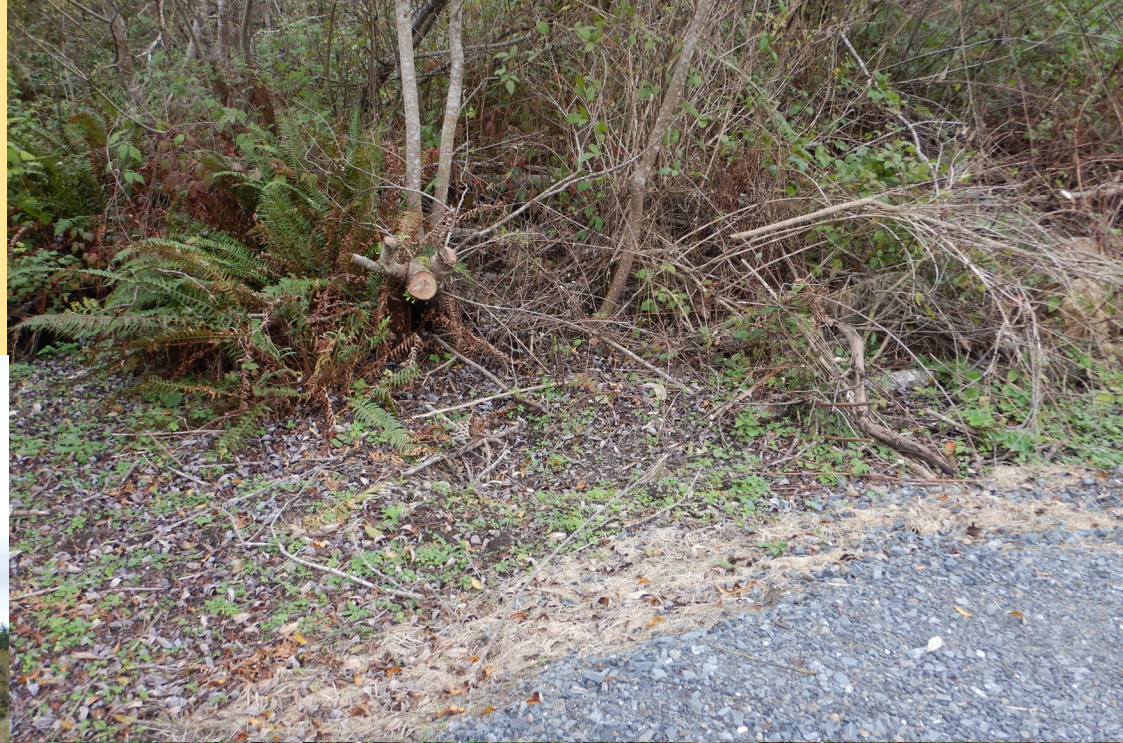
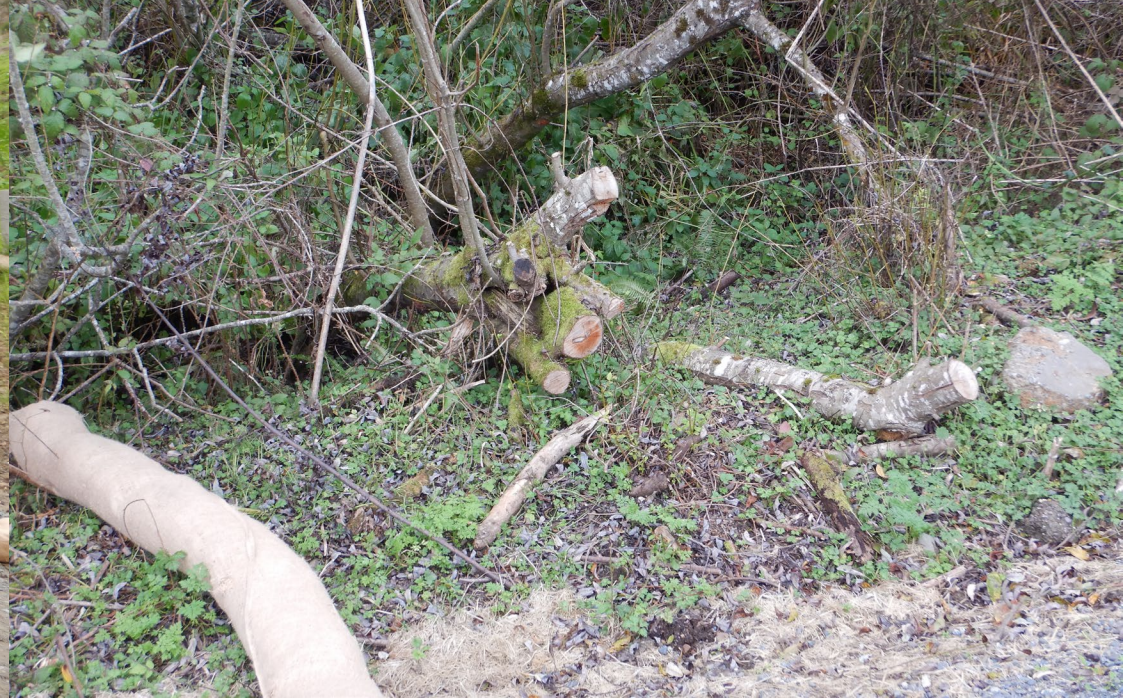
Photos (on the right) showing some of the larger trimmed willows near the end of the Southern Access Road. In addition, the left photo shows how much the willows have encroached onto the cap. Further removal and tree work will need to be conducted this next year.
