# SITE MANAGEMENT PLAN

State Water Resources Control Board Order WQ 2017-0023-DWQ  
*General Waste Discharge Requirements and Waiver of Waste Discharge Requirements for  
Discharges of Waste Associated with Cannabis Cultivation Activities*

## Journey Aquarian

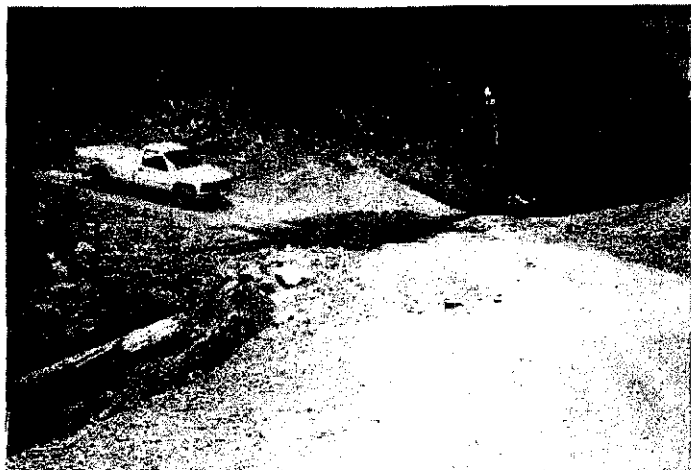
*Figure 1. Wet ford on Class II perennial stream. Clean rock aggregate has been imported for the travelling surface and coarse rock armor protects the outer edge of the road bed. It is important that rock aggregate used in a ford be large enough to resist transport during winter flows. Fords should not be used if high winter flows would cut off access to inspect and maintain drainage structures further out the road. From Weaver and Hagans (1994).*
