HUMBOLDT COUNTY DEPARTMENT OF PUBLIC WORKS
ROAD EVALUATION REPORT

Road Name: Stewart Ranch Rd *(complete a separate form for each road)*

Koffman Realty LLC
APN 216-202-009

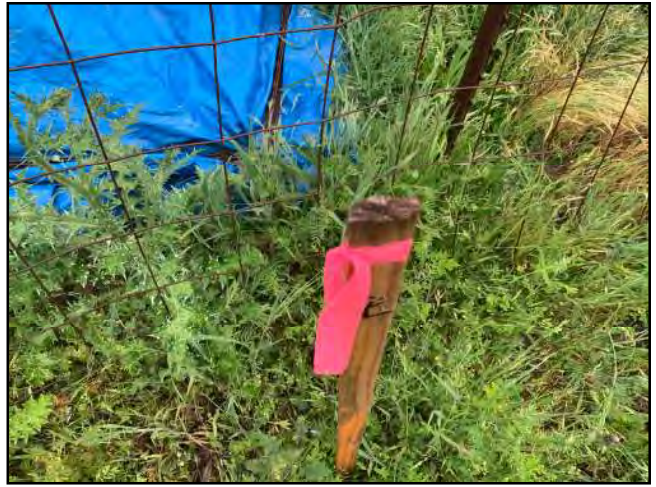
Photo #1 APN 216-202-009 @ Cultivation Area
Looking NE

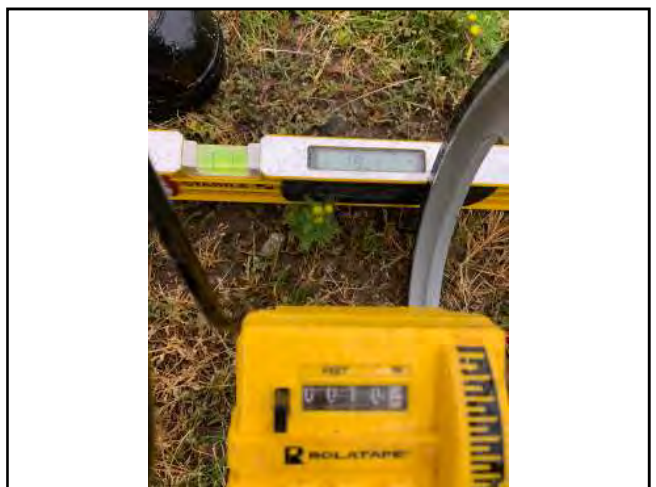
Photo #6 Private Access Rd APN 216-202-009
Width 10'2" Slope 19.1%

Slopes Over 16%: *The Engineer recommends no improvements for photo locations where slopes are over 16%. The traffic benefits to environmental impacts doesn't justify paving or lowering grades. Typically, the steep grades shown at these locations are for short segments of roadway.*

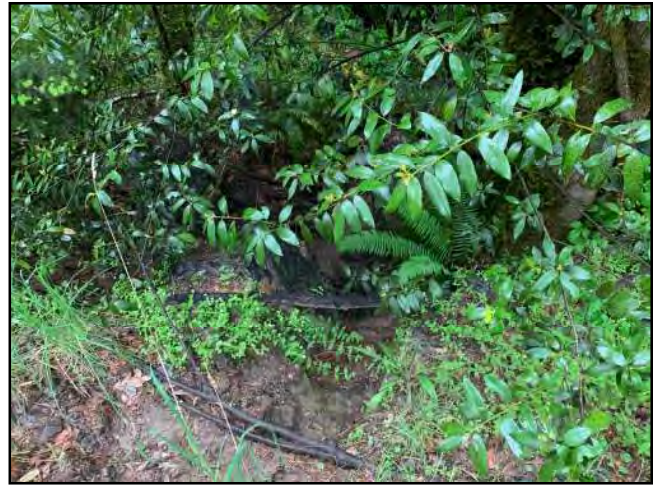
Photo #13 Private Access Rd APN 216-202-009
Looking @ Clogged Culvert In(Size Unknown)

Miscellaneous: *The Engineer recommends that grass be mowed along the roadside, which will expose the turnouts. Then Engineer also recommends that the roadside ditches be cleaned and re-established.*

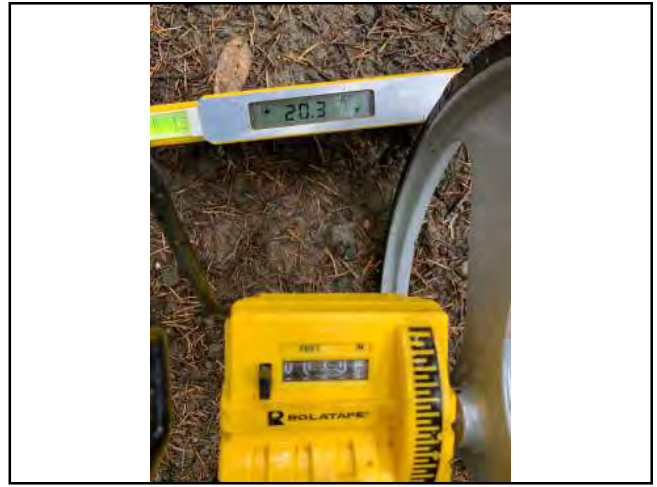
Photo #80 Private Access Rd Width 10'2" Slope 20.3%

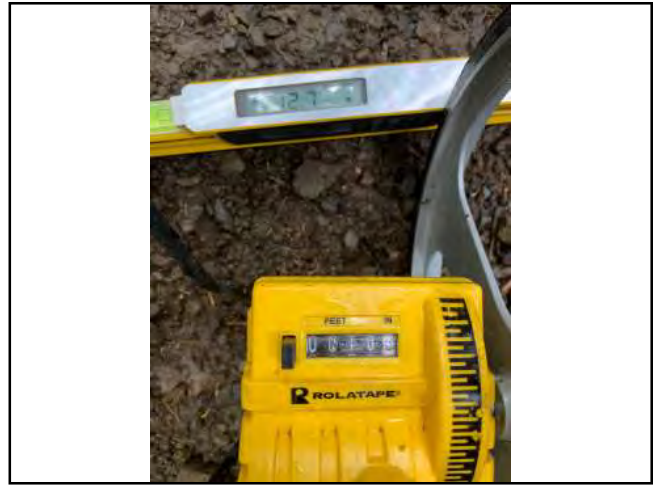
Photo #104 Private Access Rd Width 10'3" Slope 12.7%

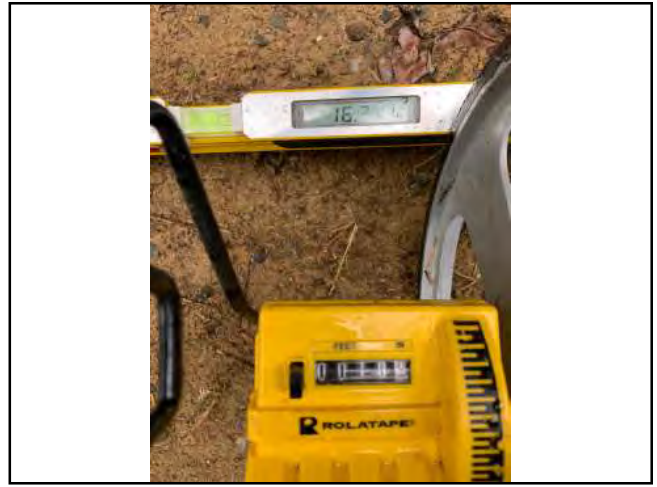
Photo #122 Private Access Rd Width 10'8" Slope 16.3%

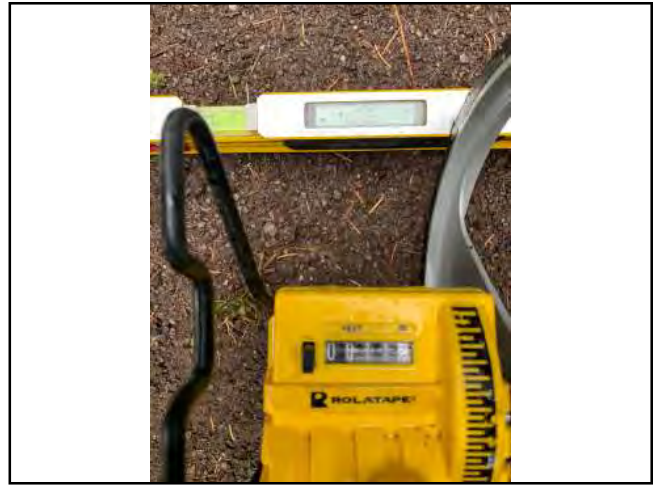
Photo #140 Private Access Rd Width 11'1" Slope 17.6%

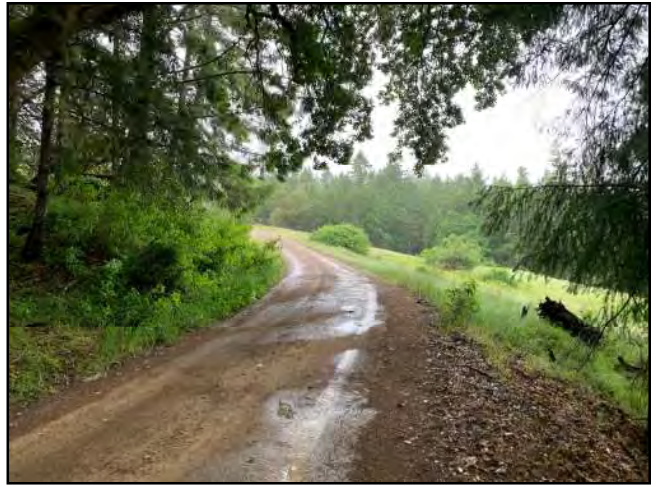
Photo #157 Private Access Rd Looking @ Partially Clogged Culvert In (size Unknown)

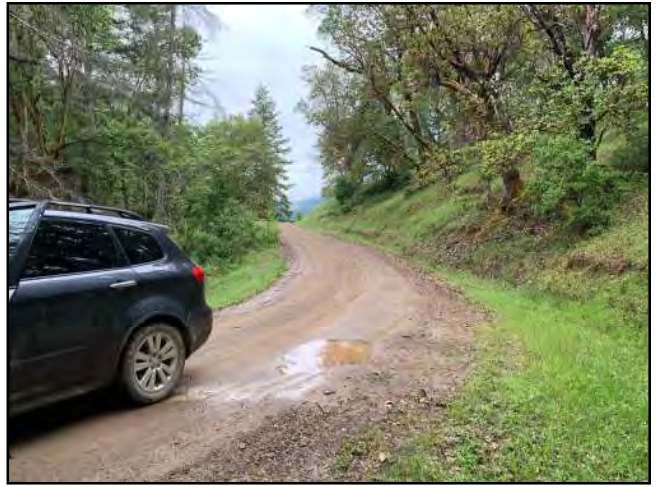
Photo #169 Private Access Rd Looking @ 12" Culvert In

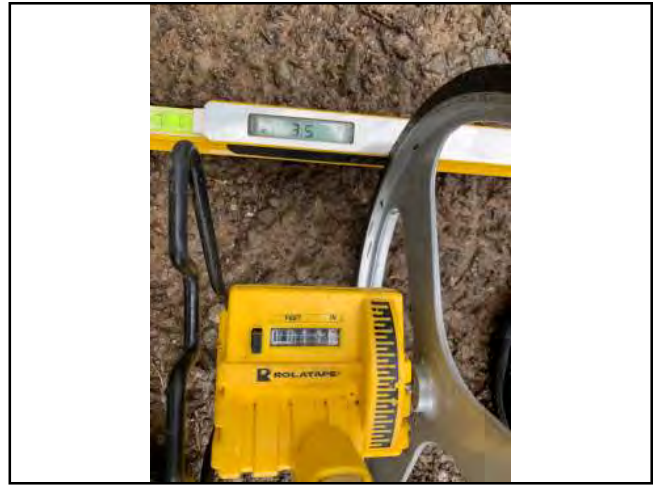
Photo #176 Private Access Rd Width 11'8" Slope 3.5%

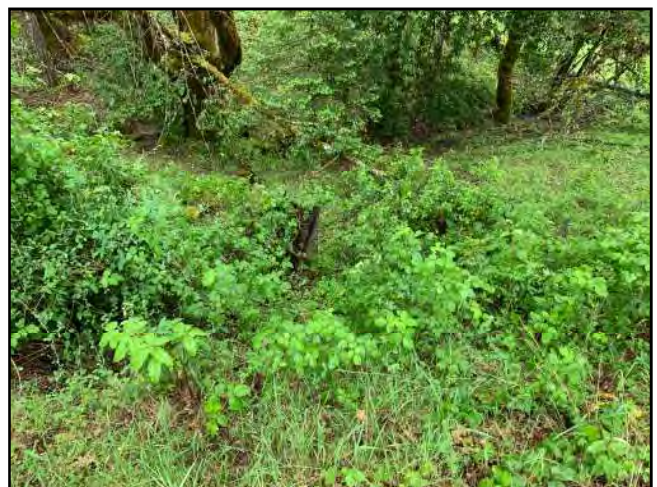
Photo #179 Private Access Rd Looking @ Clogged Culvert In (Size Unknown)

Photo #180 Private Access Rd Looking @ Clogged Culvert Out (Size Unknown)

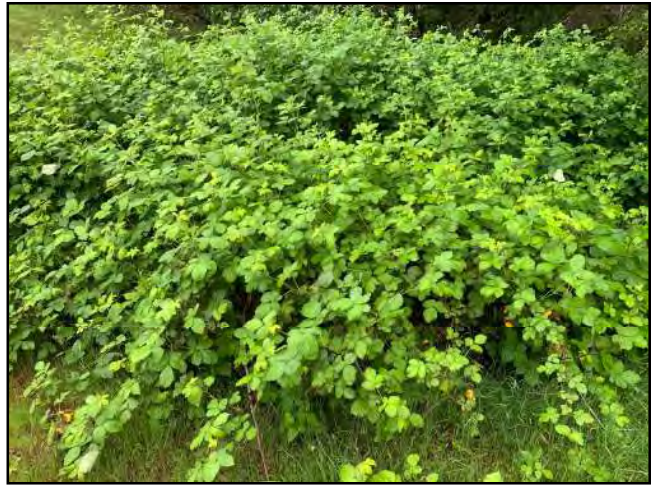
Photo #182 Private Access Rd Looking @ Clogged Culvert In (Size Unknown)

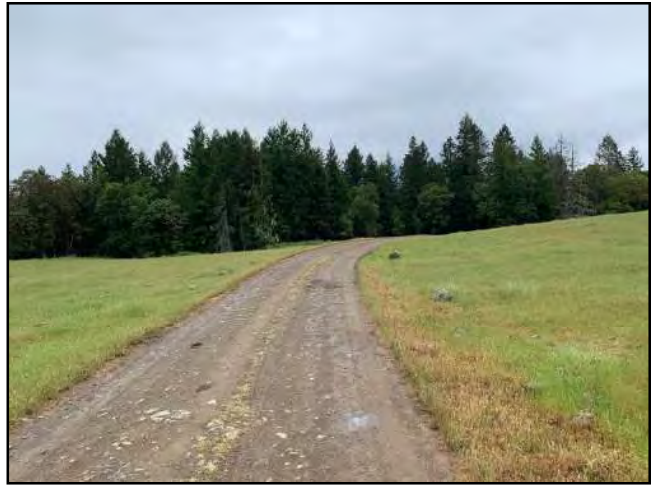
Photo #193 Private Access Rd Looking @ 18”
Culvert Out

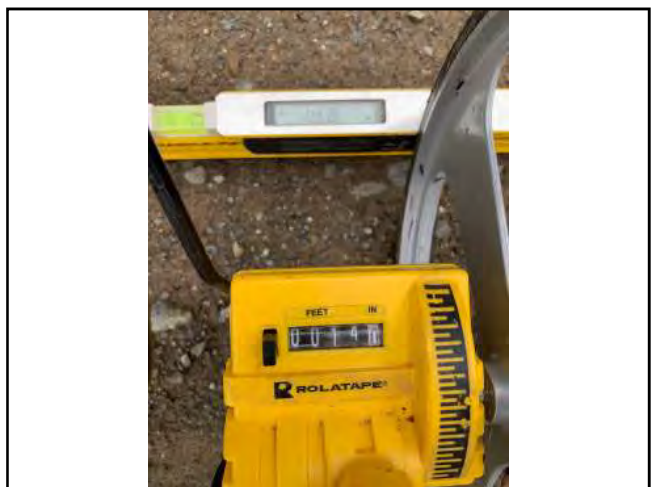
Photo #216 Stewart Ranch Rd Width 14'0" Slope 14.8%

Slopes Over 16%: Slopes Over 16%: The Engineer recommends mitigation measures per Cal-Fire where slopes are over 16%. The suggested mitigation measure is to add a lime slurry to the road base, apply gravel, and a green polymer based dust palliative. For any grades over 20%, the measurements are within the level of tolerance for this work and the traffic benefits to environmental impacts does lowering or raising grades. Typically, the steep grades shown at these locations are for short segments of roadway.

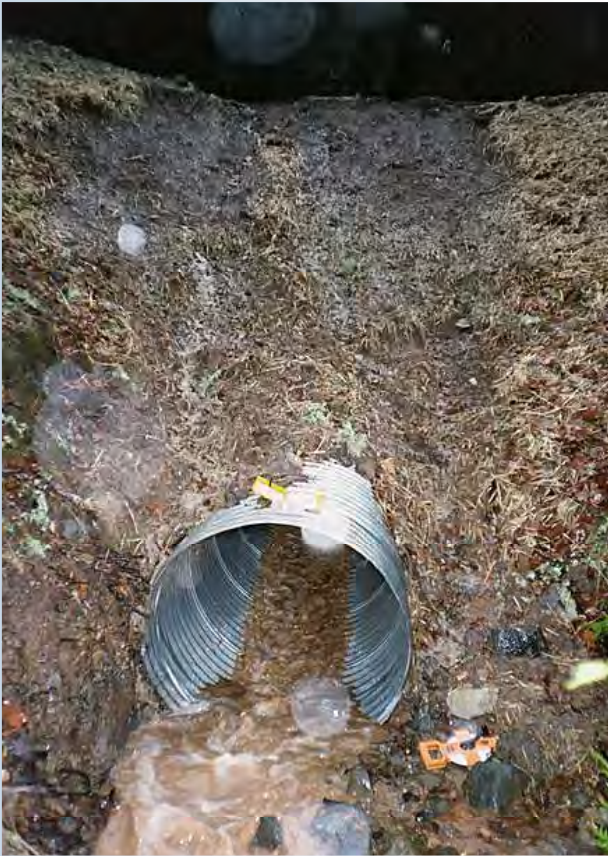
Figure 2. This cross drain delivers sediment from the roadside ditch under the road surface to a nearby stream. The road fill is also eroding. *Photo: Jared Gerstein.*

Rural roads are a major source of sediment that ends up in stream channels (fig. 2). This is especially true for unpaved roads located near streams that are used year-round. Sediment delivered to streams from roads causes streams to run muddy and take a long time to clear after storms. Sediment can end up depositing in pools and adversely affect habitat for fish and other aquatic organisms.

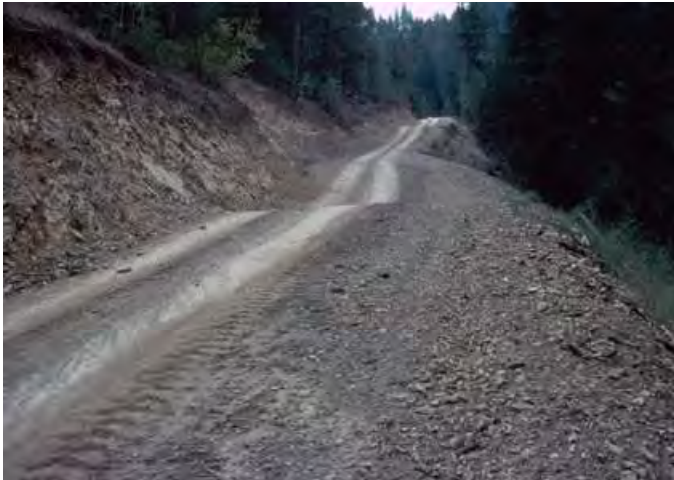
Figure 8. Rolling dips installed to drain an out-sloped road. *Source:* Bill Weaver, Pacific Watershed Associates.

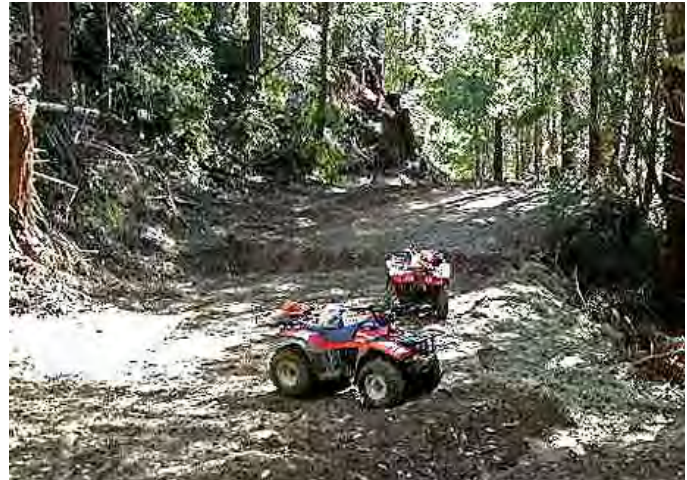
Figure 9. Water bars installed on a road after timber harvesting. *Source:* Angela Wilson, Central Valley Regional Water Quality Control Board.

A *water bar* is a mound of soil and an accompanying ditch on the road surface that interrupts water flow and diverts it off the road surface (fig. 9). It is typically not passable by vehicles and so is not used on permanent roads. A *berm* is a ridge of rock, soil, or asphalt usually found on the outside of a road shoulder to control surface water. It directs runoff to specific locations where water can be discharged without causing erosion. *Armoring* is the placement of a layer of rock on cut or fill slopes or ditches to prevent water from eroding the soil.

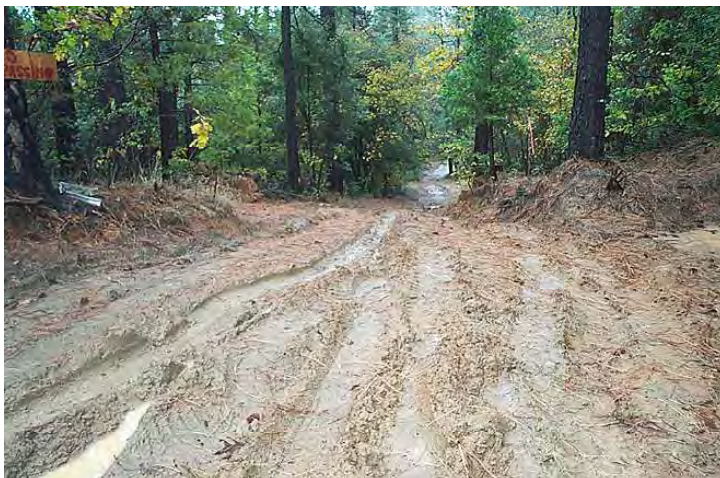
Figure 10. These ruts were created by wet-weather use of an unsurfaced, poorly drained road. *Photo:* Angela Wilson, Central Valley Regional Water Quality Control Board.

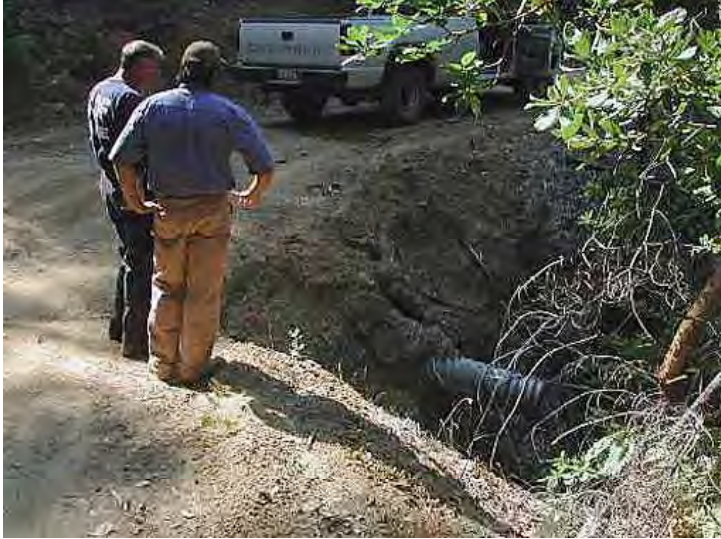
Figure 14. This fill slope erosion was caused by a plugged cross-drain inlet that diverted ditch flow over the road surface. *Photo: Angela Wilson, Central Valley Regional Water Quality Control Board.*

Even properly designed and constructed roads need inspection and maintenance to function well and avoid road and environmental damage. Maintenance should be performed when needed. The longer the delay in needed maintenance, the more damage will occur and the more costly the repairs will be (fig. 14).

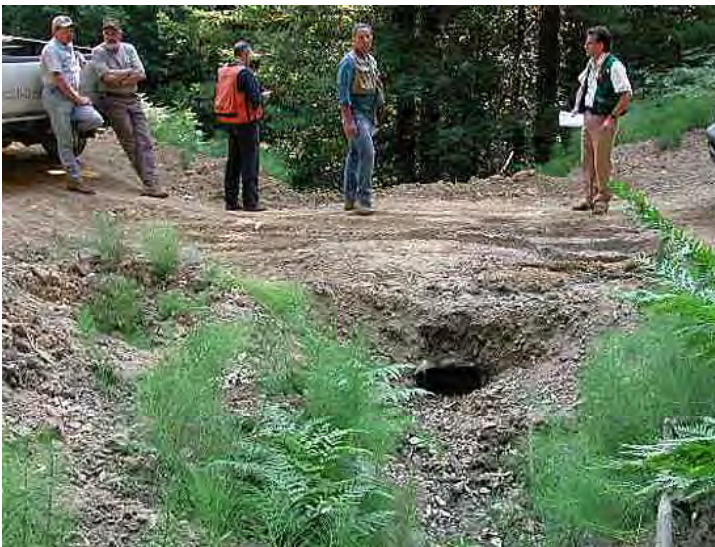
Figure 16. Culvert plugged with sediment at inlet. Photo: Angela Wilson, Central Valley Regional Water Quality Control Board.

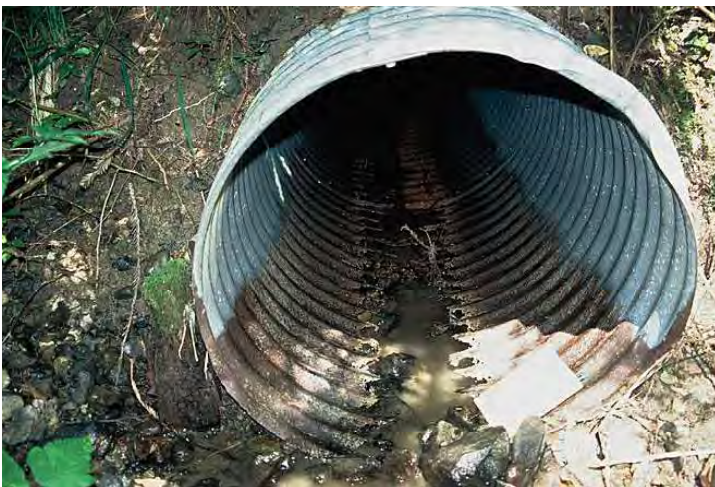
Figure 17. Culvert with rusted bottom and breakage caused by sediment. Photo: Angela Wilson, Central Valley Regional Water Quality Control Board.

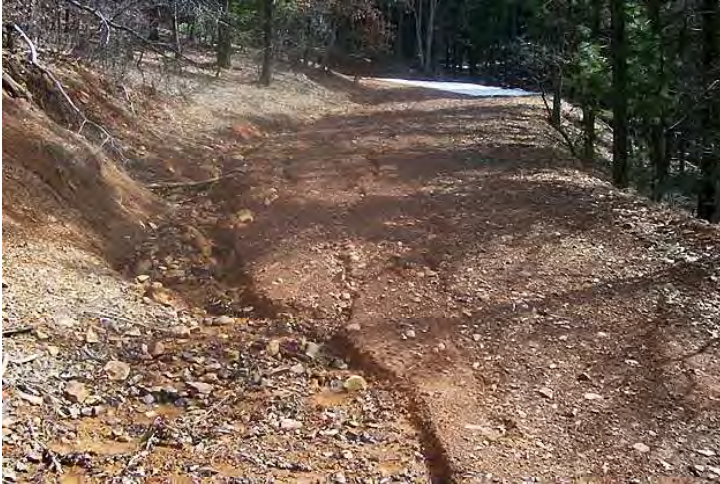
Figure 19. Erosion caused by ditch water leaving the ditch and traveling across the road. *Photo: Susan Kocher.*

One of the liabilities of a ditch system is the possibility of ditches plugging with debris, causing water to flow onto the road surface. Ditch water “captured” by the road surface can cause severe erosion (fig. 19) and even wash out the road completely.

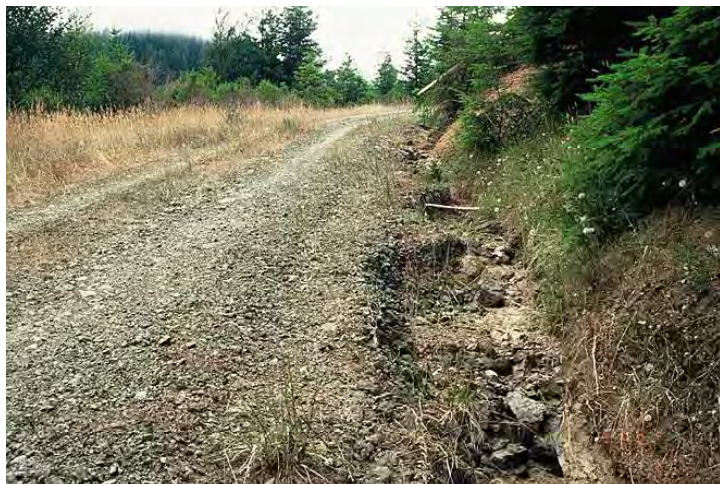
Figure 20. Eroding inboard ditch on an in-sloped road. This is a symptom of inadequate cross drains for conveying ditch flow across the road. *Photo: Richard Harris.*

Another liability of ditch systems can be inadequate cross drains. Without a sufficient number of cross drains or ditch relief culverts, ditch water may become increasingly concentrated, gain erosive power, and cause ditch erosion in larger storms. Deeply incised ditches can be a hazard to driving, especially when they become large enough to accommodate a car tire (fig. 20).

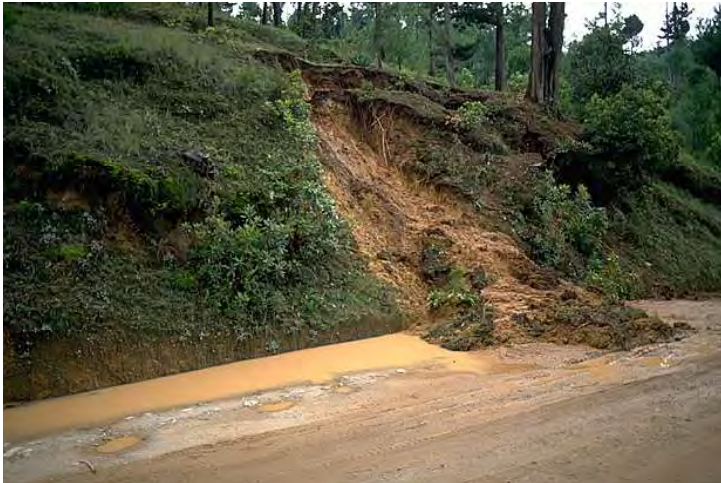
Figure 21. Cut bank failure blocking inboard ditch. Cut bank failures cause operational and maintenance problems, especially when chronic. *Source:* Keller and Sherar 2003.

Ditches may become filled in with sediment, rock, or woody debris (fig. 21). This reduces their

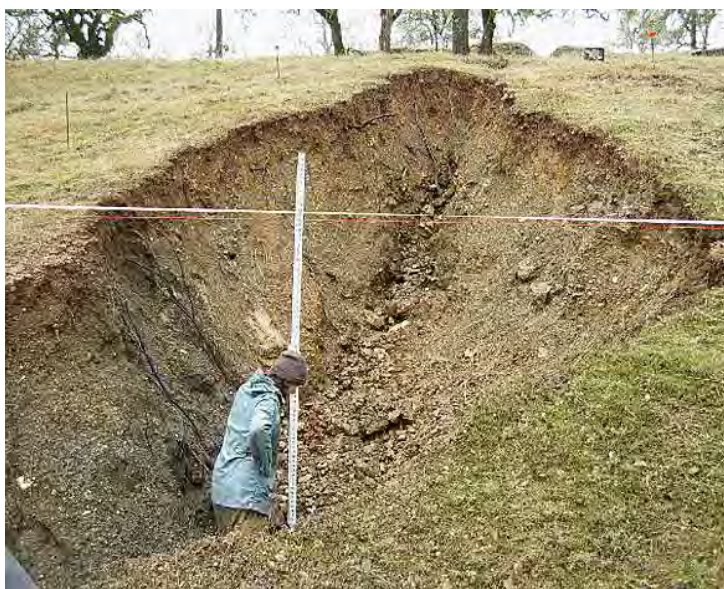
Figure 22. Gully caused by through-cut on road at base of steep road section. *Photo:* Jared Gerstein.

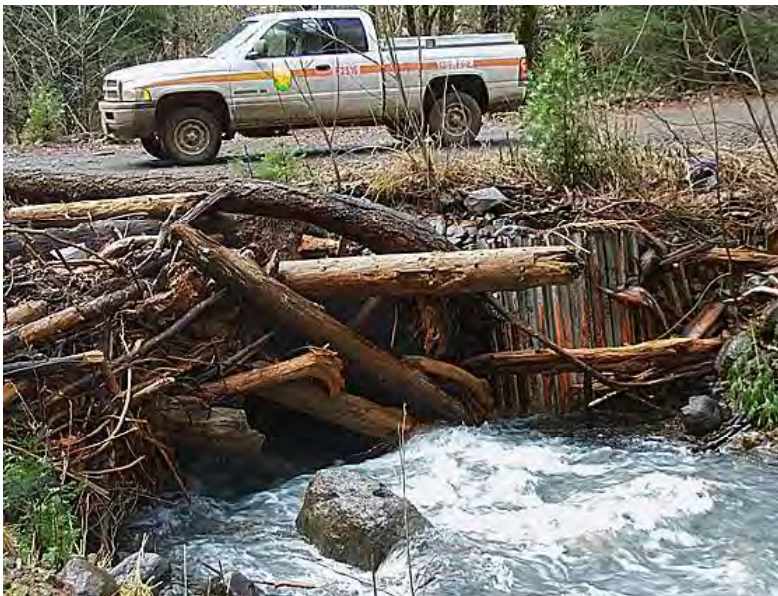
Figure 23. This culvert is nearly plugged by woody debris, endangering the road.
Photo: Angela Wilson, Central Valley Regional Water Quality Control Board.

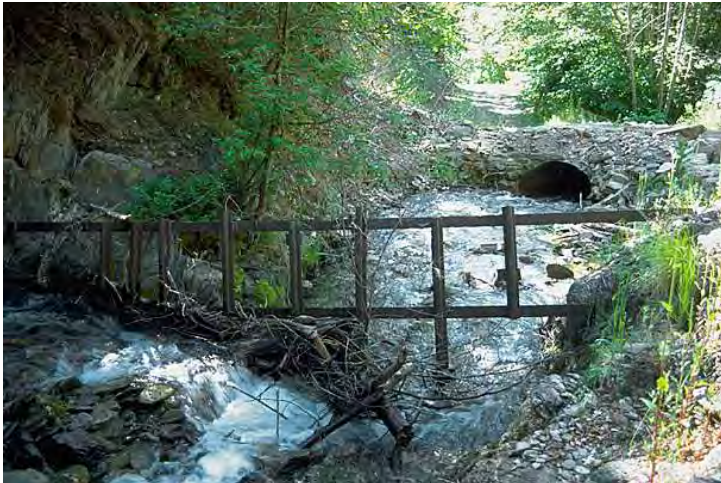
Figure 24. A trash rack installed upstream to protect a culvert from plugging. Source: Keller and Sherar 2003.

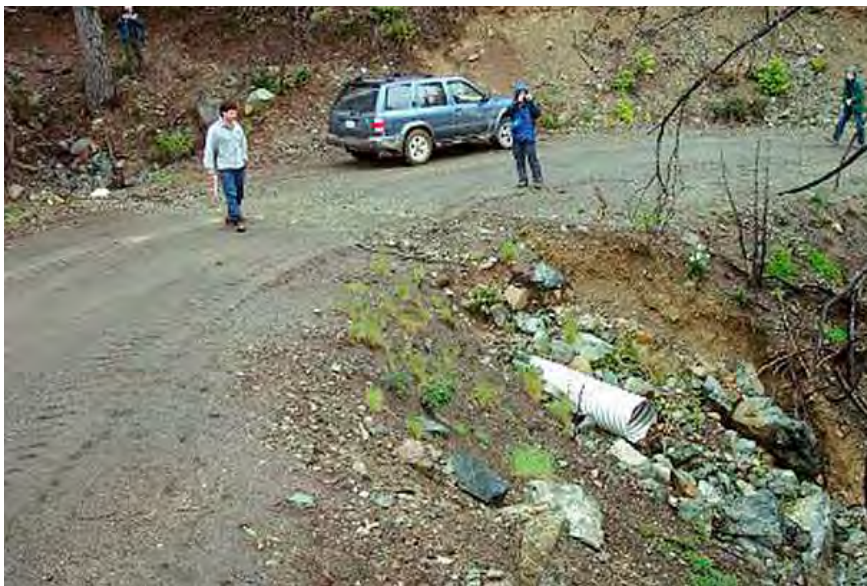
Figure 25. Eroding fill slope and culvert failure due to plugging at inlet and diversion of flow across the road. Photo: Bill Weaver, Pacific Watershed Associates.

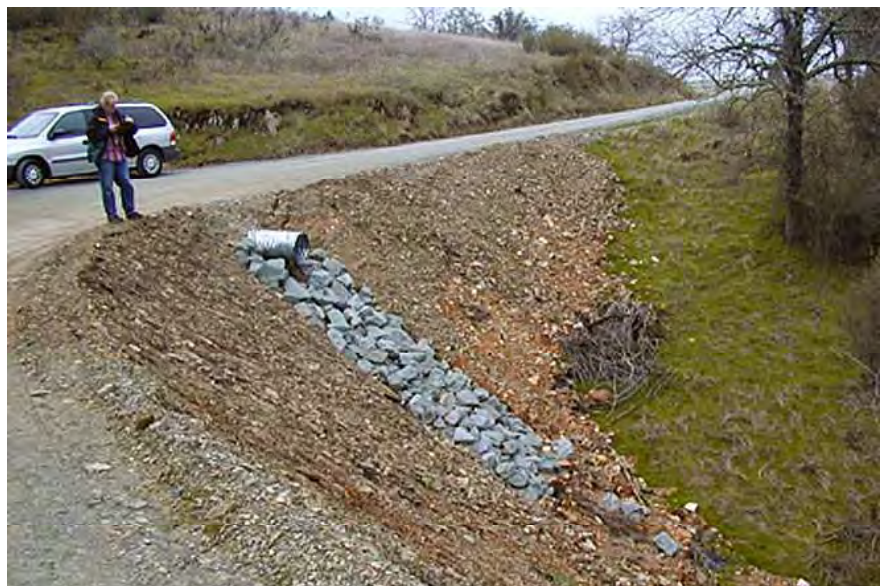
Figure 26. Rock armoring at ditch relief culvert outfall to reduce potential for downstream erosion. Note also the berm around the fill slope to prevent road runoff from eroding it. Also, straw mulch has been placed on the fill slope to reduce erosion. Photo: Jared Gerstein.

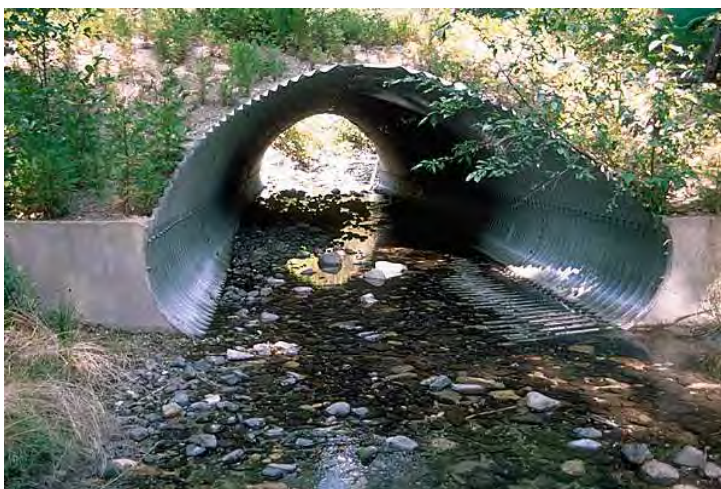
Figure 28. An arched pipe installed on a fish-bearing stream to minimize impacts on fish habitat and migration. *Source:* Keller and Sherar 2003.

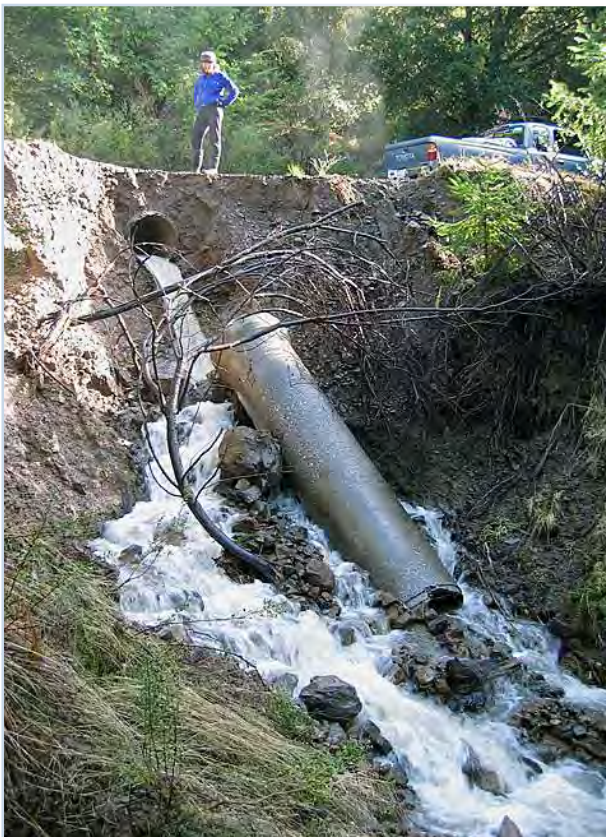
Figure 34. Outlet of a concrete culvert (30 inches in diameter) before the project. The culvert was placed too high in the fill, resulting in a 10-foot drop to the channel at the outlet. This caused erosion of the road fill and stream banks, eventually undermining the outer section of the culvert. *Photo:* Jared Gerstein.

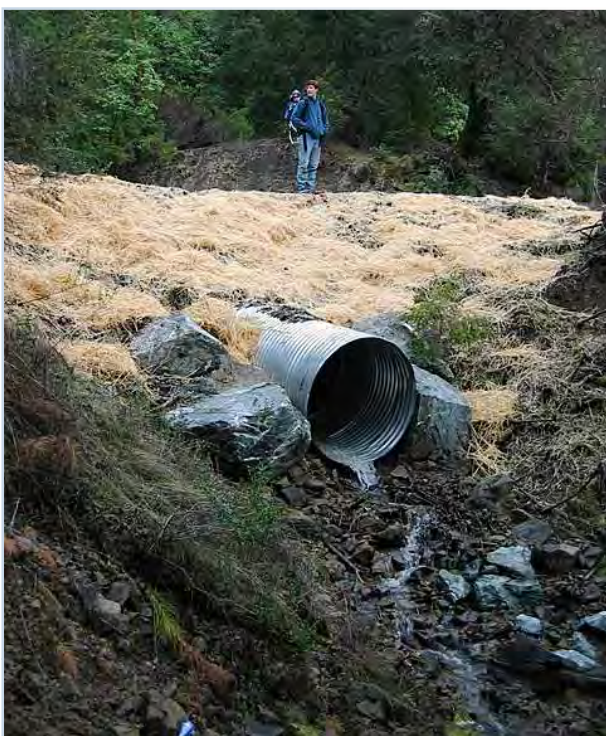
Figure 35. The culvert was replaced with a metal pipe (48 inches in diameter) at the correct slope. The road surface was lowered, reducing the fill volume by 100 cubic yards. The outlet and fill were armored to prevent future diversion. *Photo:* Jared Gerstein.
