**From:** Linda Miller <krazykat745@gmail.com>  
**Sent:** Wednesday, November 20, 2024 4:34 PM  
**To:** Ford, John; Johnson, Cliff; Dorris, Joshua; Madrone, Steve  
**Cc:** Cindy Trobitz-thomas; Jarl Johansen; Heather Trobitz; Claire McAdams; Jim Rydelius; Ethan Luckens; Maria Luckens; Suzanne Wolf  
**Subject:** Public comment RE: Notice of Potential Conditional Use Permit Revocation, CUP-00-27  
**Attachments:** Dec 3rd Public Hearing comments - Linda Miller.docx; Timeline of violations, lawsuits, and enforcement.docx; 2024\_Kernen Construction\_NOV\_Final.pdf; 2225\_kernan\_13267revised.pdf; 021924 inspection memo.pdf

Feb. 19 2024 Inspection Memo

RE: Revocation of Kern Construction Conditional Use Permit – Public Hearing, December 3, 2024

Subject: **Notice of Violation of Water Code Section 13267** Investigative Order R1-2022-0025 (13267 Order or Order) and Industrial General Permit Order No. 2014-0057-DWQ (IGP) for Kernen Construction and **Directive to Apply for Water Quality Certification/Waste Discharge Requirements** for Activities in Waters of the State pursuant to Water Code section 13260.

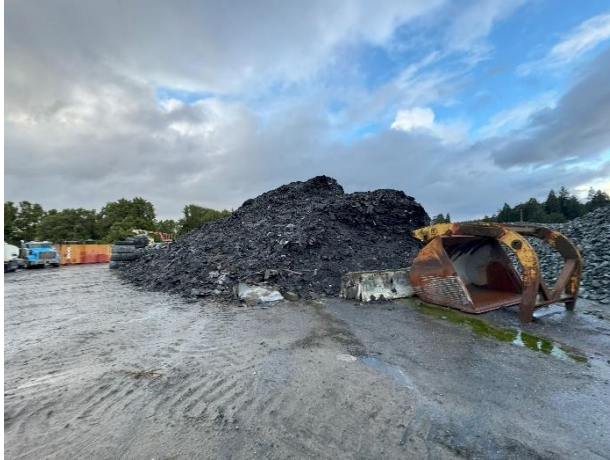
Pictures 1a, 1b – View of uncovered asphaltic roofing waste materials that were exposed to rain located in the Upper Yard. No BMPs are installed to avoid releasing pollutants from the piles or to minimize the exposure to rain. Picture taken by Walt Dragaloski.

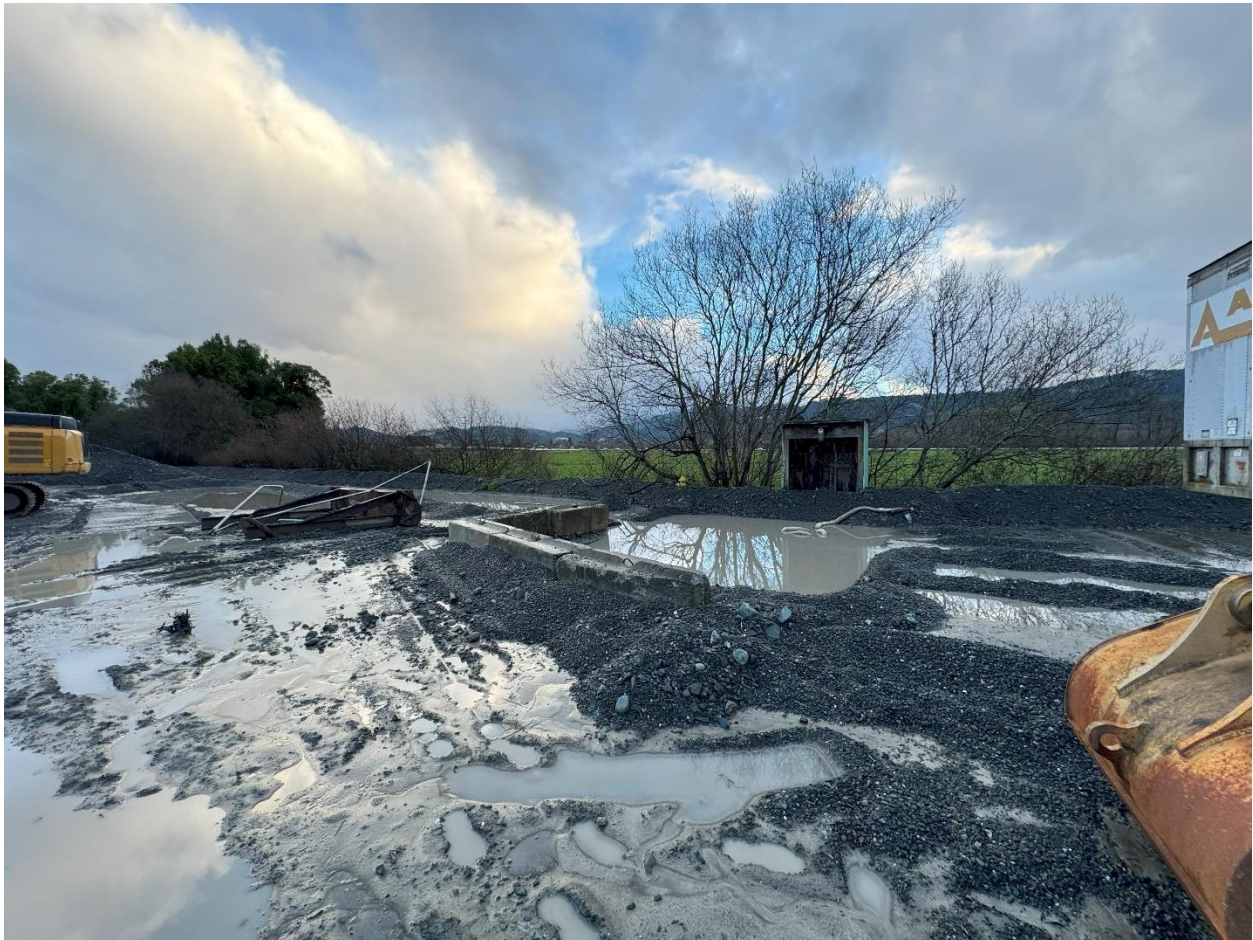
Picture 4 - View of sediment trap at the southern portion of the upper yard. The adjacent upper yard area flows through this sediment trap to the infiltration trench inlet. A thick layer of sediment was observed on the ground within the sediment trap. Additionally, a sheen was observed on the water surface and a black residue stain was visible in this area. This sediment trap drains the turbid water into the infiltration trench. Minimum BMPs were not observed within this area. Picture taken by Walt Dragaloski.

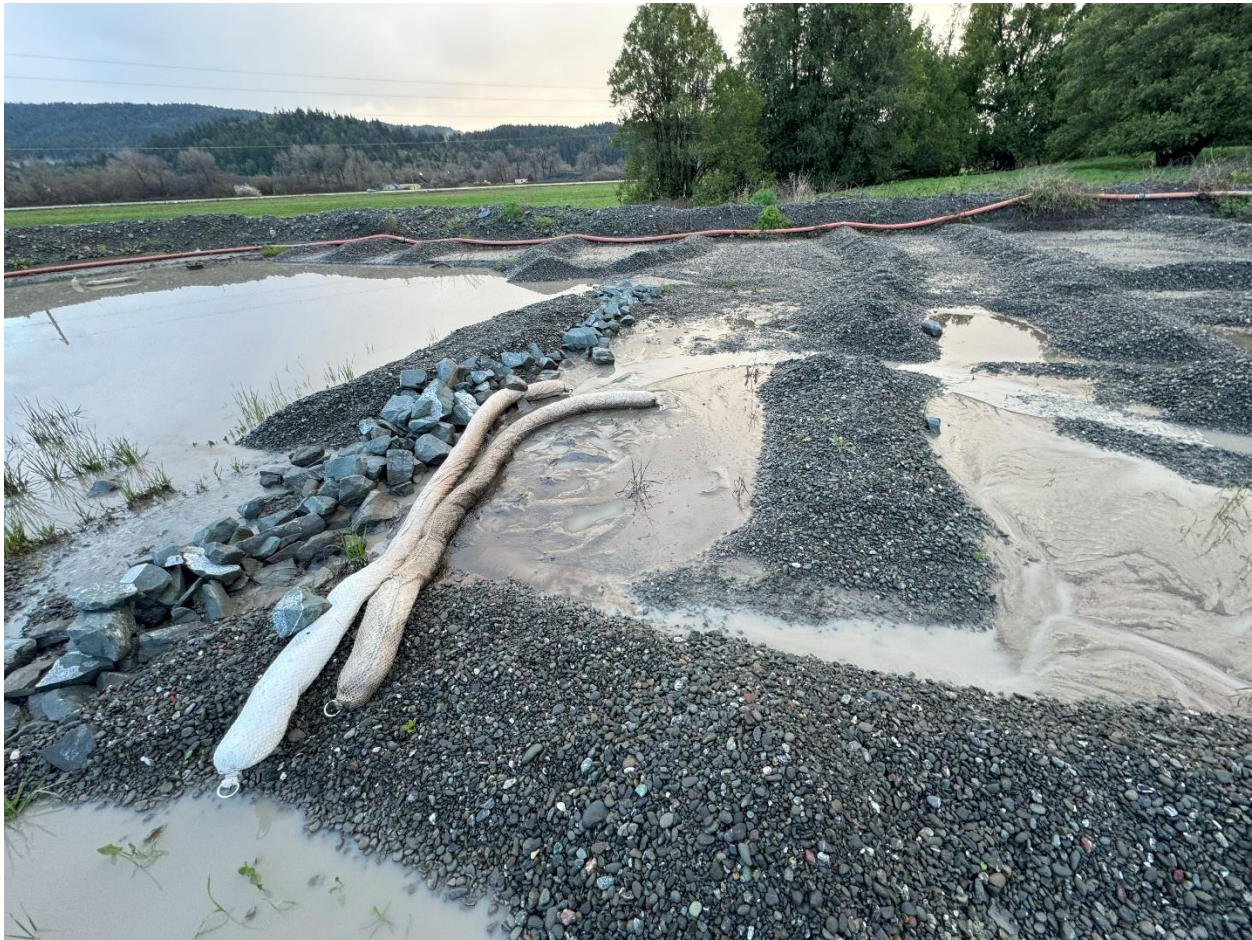
Picture 5 – Looking west at the sediment trap located on the southwest corner of the upper yard. A significant amount of sediment is captured with this non-standard sediment and erosion control BMP. Picture taken by Walt Dragaloski.

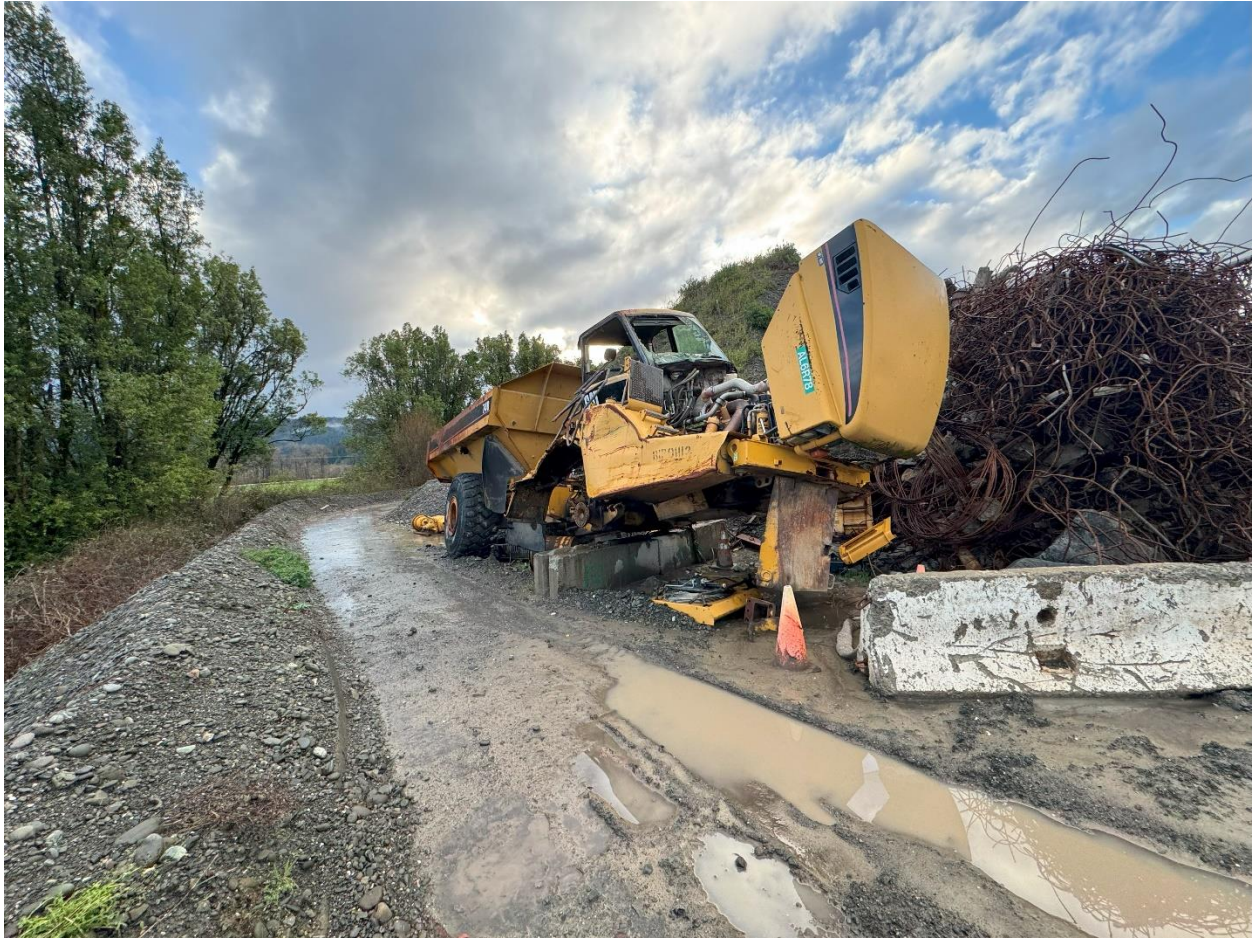
Picture 6 – View of construction waste material and salvaged hauling vehicle. No BMPs are implemented to minimize the exposure of industrial/construction wastes and equipment to rain. Picture taken by Walt Dragaloski.

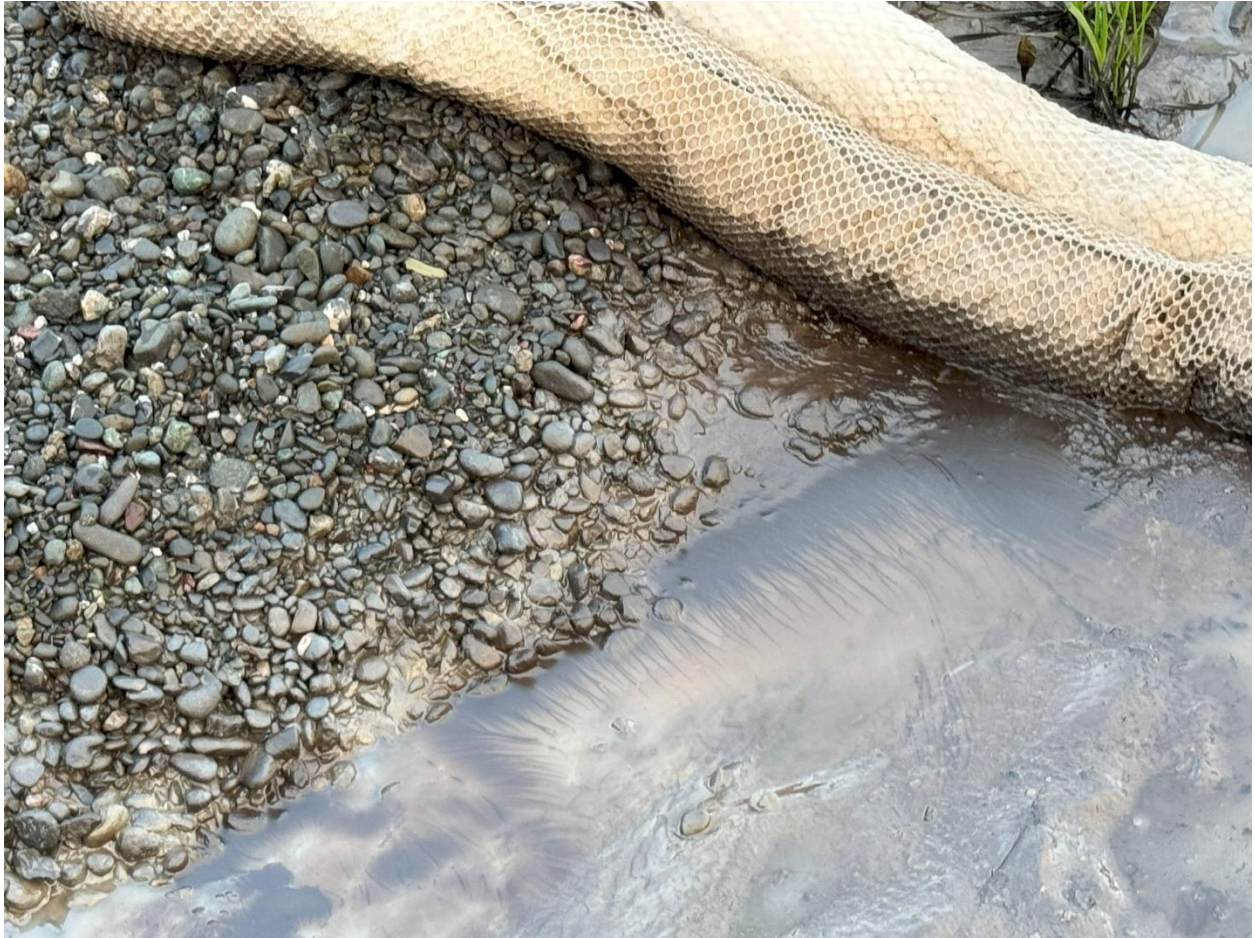
A sheen was observed on the water surface and a black oily residue was observed on the gravel and the absorbent sock within the sediment trap within the upper yard (See picture 7). The IGP requires the Discharger to evaluate the Facility for areas where spills and leaks can likely occur and control these sources of pollutants. The preventative maintenance and spill prevention and response sections of the IGP must be implemented.

Picture 7 - View of an absorbent sock in the sediment trap. A sheen was observed on the water surface and a black oily residue was observed on the gravel and the absorbent sock within the sediment trap. Picture taken by Walt Dragaloski.

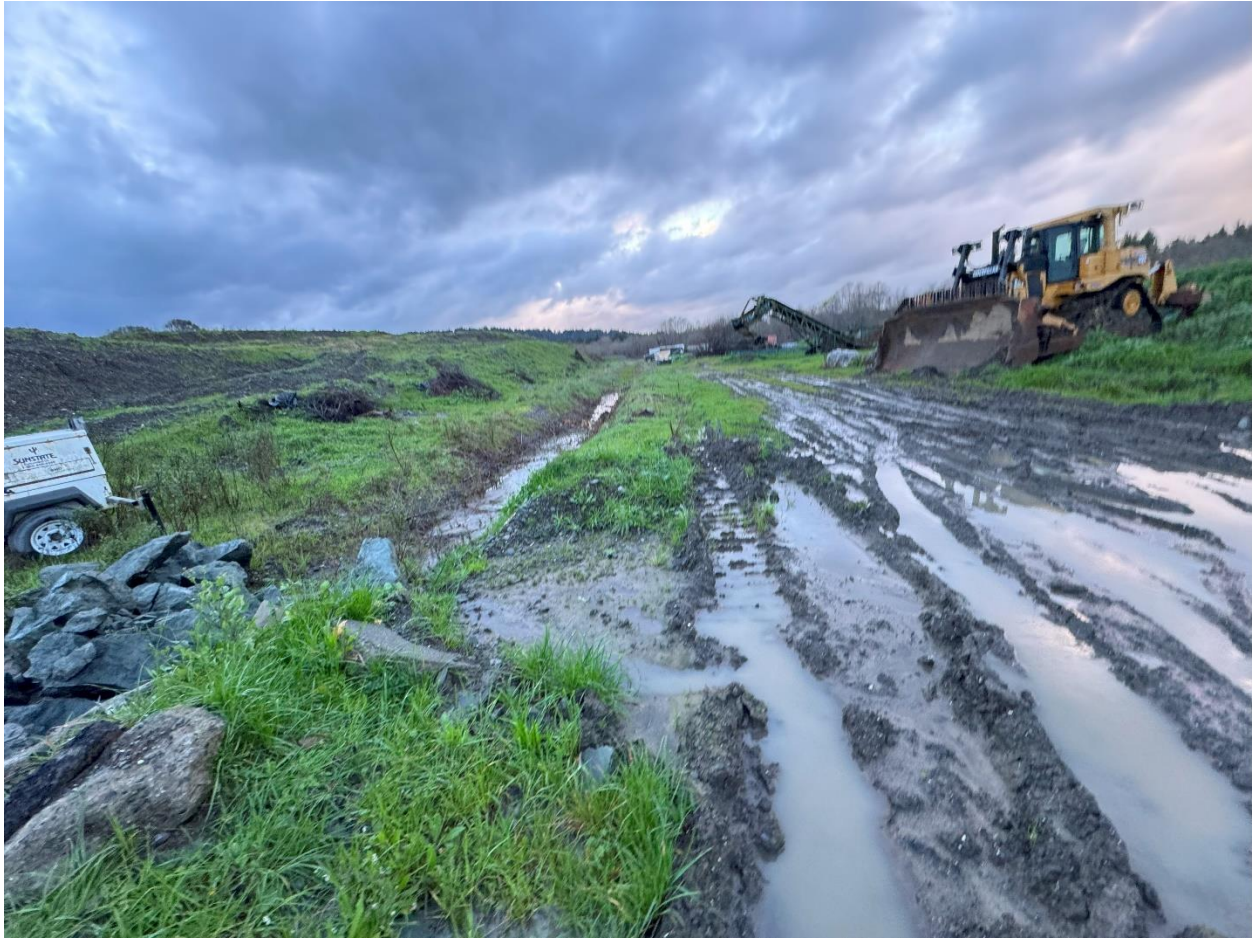
Picture 9 - View of unpaved access road adjacent to an on-site drainage ditch in the lower yard. No sediment and/or erosion control BMPs were observed. Overflow from this ditch discharges into Waters of the State into Noisy Creek or into Waters of the State at an unnamed tributary to Hall Creek. Picture taken by Walt Dragaloski.

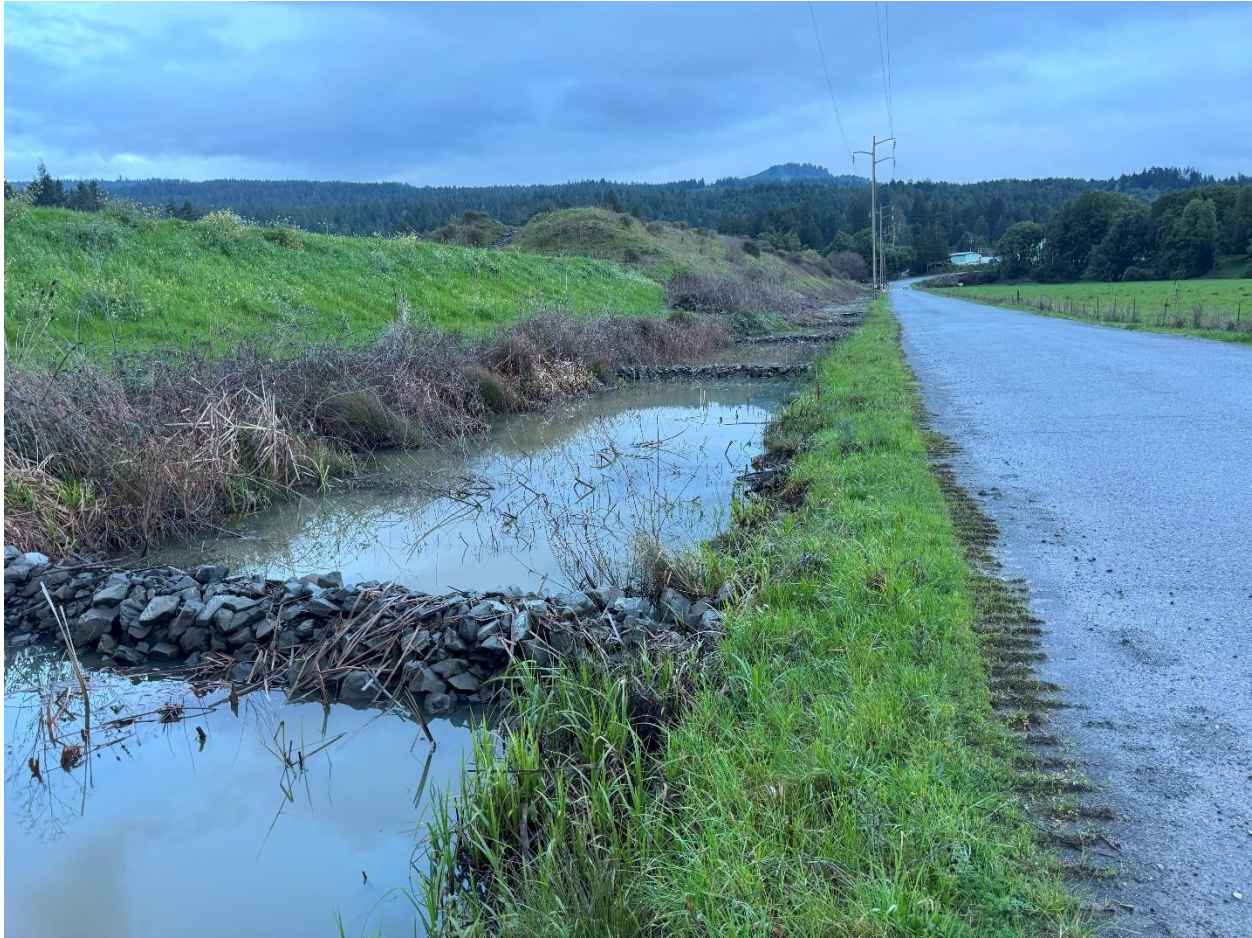
Picture 12 – Looking east at the roadside swale adjacent to the lower yard. These Waters of the State receive runoff from the adjacent stockpile and from the haul roads in the lower yard area. The non-standard rock check dams were installed by the Discharger without obtaining an appropriate permit from the Regional Water Board. Picture taken by Walt Dragaloski.

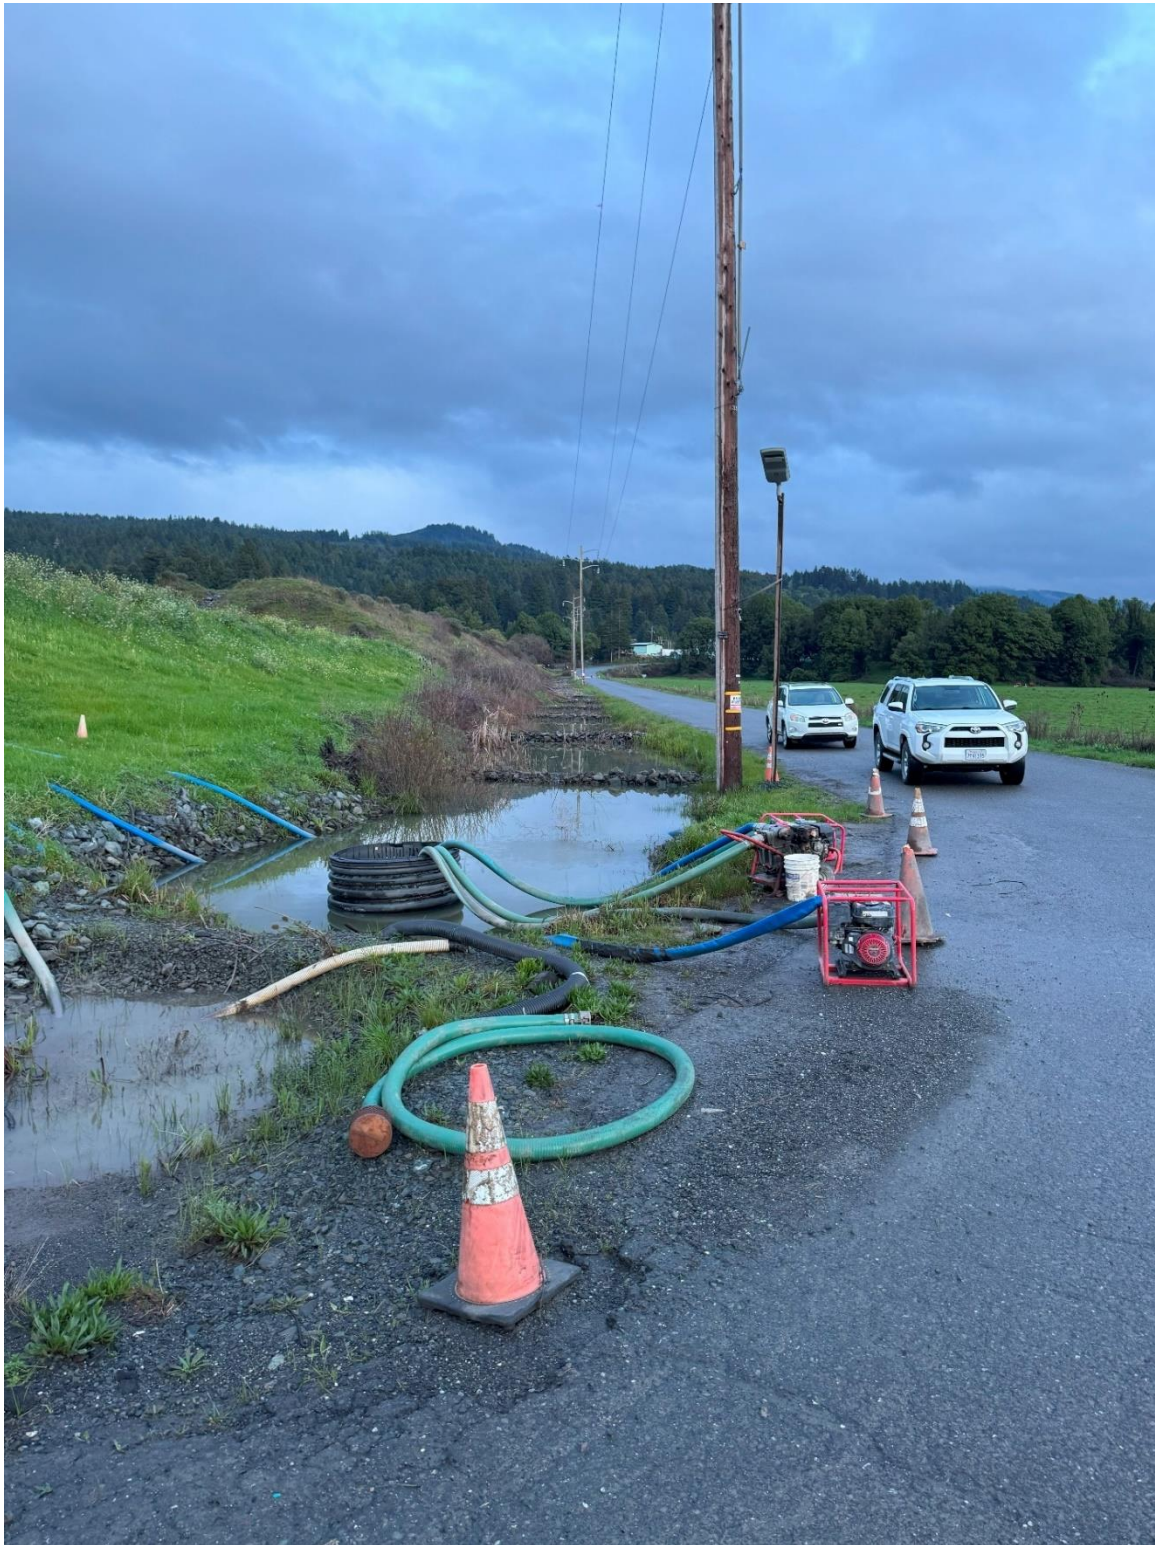
Picture 13 – View of three diesel generators and their pumps observed without required secondary containments. Stormwater is pumped from the swale via the black riser pipe into the newly constructed retention pond. Picture taken by Walt Dragaloski.
