**Sordal 4 Wheel Properties, LLC**  
**Restoration, Invasive Plant Management,**  
**and Monitoring Plan**

APN 210-054-008.

Prepared by  
Stephen Hohman and  
Kelsey McDonald  
2/20/2020

For  
Hohman and Associates  
Hydesville, CA

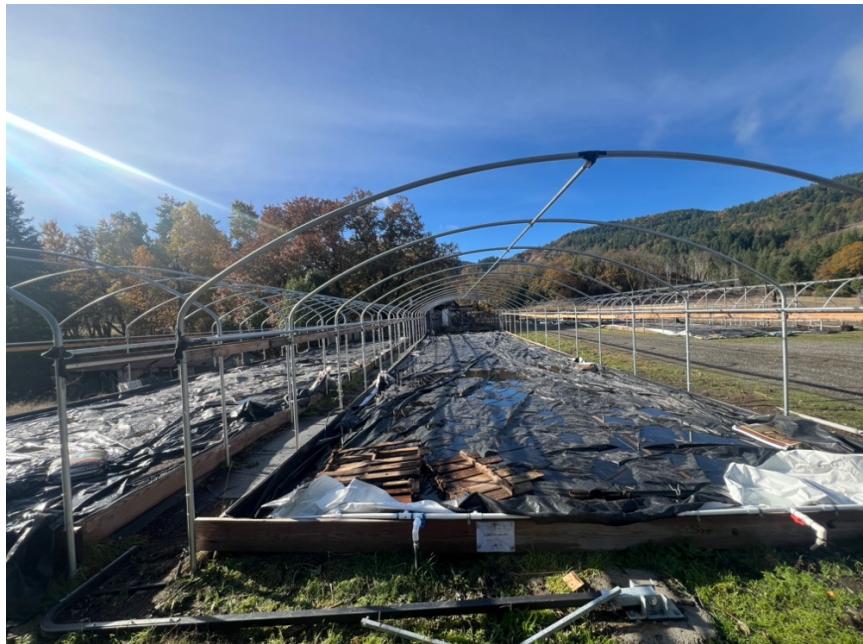
Photo 1. (site E)

The pre-existing and cultivation site is located on 1% slope. This 130' x 170' site was converted for cannabis cultivation by 2012. The site is currently occupied by 4 greenhouses. Surrounding vegetation includes grassland and black oak, with a minor amount of other hardwoods. The proposed move would be to an environmentally superior location, further away from the creek, although site e is not in a riparian zone. This site would benefit from having PG&E rather than small gas generators that produce higher greenhouse gas and noise pollution that disturbs wildlife. Botany, archeology, owl, raptor, wetland surveys have all been done and have no conflict.

- a) Remove green houses and all cultivation related materials from the site.
- b) Maintain all existing vegetation in the surrounding area. No grading required.  
Maintain outsloped log landing.
- c) Straw mulch all bare soil within 100 feet created from the removal process

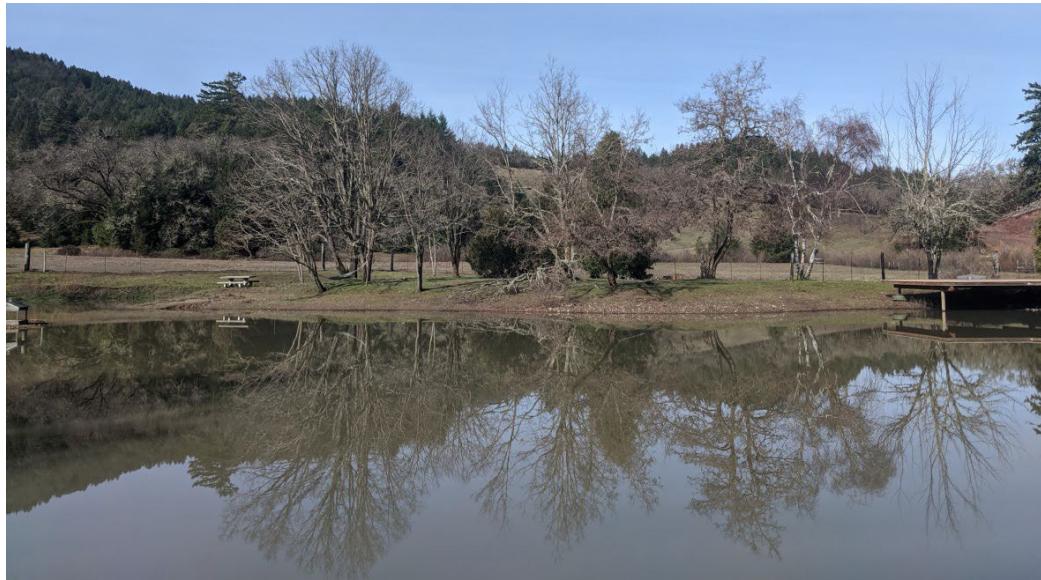
The on-stream pond near the residence is located in open grassland on an altered stream course. Cultivated Port Orford cedar and invasive black locust trees are planted around the pond. Some native willows are naturally recruiting to the edge of the pond, which was mostly bare, with patches of pasture grasses and pennyroyal. The culverts at the inlet and outlets on a class II watercourse are failing and must be replaced (Road Points 5 and 6). The culverts should be replaced according to specifications in the LSAA. The inlet and outlet should be rocked with 12" – 18" diameter rock. The pond shall not be stocked with fish. The pond was evaluated on 1/30/2020. The water clarity was low, but high numbers of invertebrates that indicate high water quality (caddisflies, water boatmen) were present along the edge of the pond. The pond is likely high quality habitat and potential breeding habitat for the western pond turtle and northern red legged frogs. The foothill yellow legged frog also has the potential to use this site. When

surveyed under winter conditions, the pond maintained relatively low temperatures. At 11am on 1/30/20, the stream running into the pond was 49 degrees F, the pond was 50 degrees F, and the shallow water coming out of the pond outlet was elevated to 51 degrees F. With low vegetation cover, the pond has the potential to increase water temperatures substantially during the summer, which may negatively impact habitat quality for native amphibians and sensitive aquatic invertebrates found in the area.

Photo 2. The pond at Site K is on-stream, and native habitat enhancement is recommended.

At least 5 native riparian shade trees such as white alder, California buckeye, bigleaf maple, Oregon ash, or black cottonwood should be planted around the pond edge where they may provide shaded native habitat. Native willows (such as arroyo willow, Sitka willow, or shining Pacific willow) should also be planted in saturated soil approximately every ~10-20 feet around the edge of the pond. Some willows appeared to be naturally recruiting to the pond edge, and these should be supplemented by planting where bare areas remain. Willow cuttings may be sourced onsite or from a local nursery. Areas for recreational access to the pond may be left clear of vegetation. Willows are expected to improve water quality and habitat quality for native amphibians, western pond turtles, songbirds, and waterfowl. Willows should also be planted between the outlet culvert and road along channel leading the away from the pond to improve the quality of water flowing back into the stream channel. Herbaceous native wetland plants such as small-fruited bulrush or spreading rush may also be planted as desired in lieu of willows. The area should be surveyed for invasive American bullfrogs annually according to CDFW guidelines. Amphibian surveys targeting the CESA Candidate foothill yellow-legged frog and other sensitive species are recommended prior to work on the inlet and outlet.

- a) Complete all recommended culvert replacements, earthwork, etc.
- b) Plant native willows along the saturated edge of the pond every ~10-20 feet.

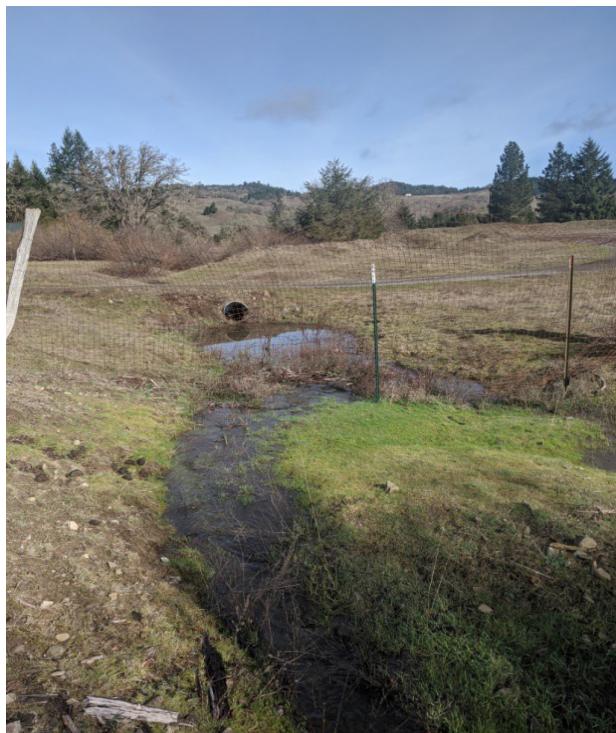
Photo 3. The outlet channel of pond k, should be rocked and revegetated with native willows.

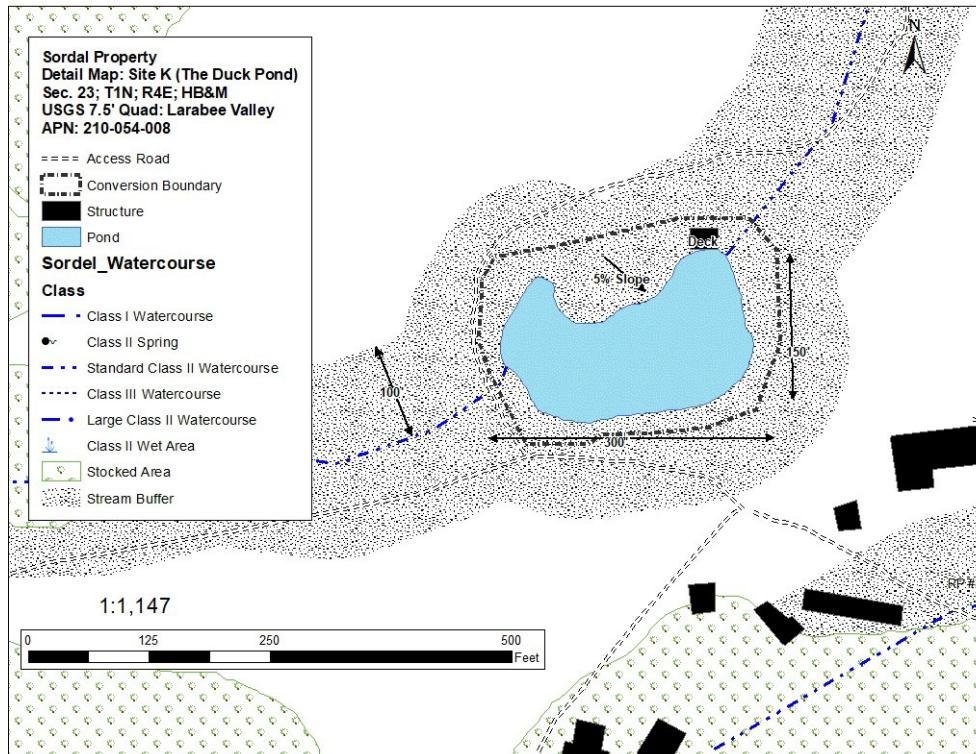
Map 1. The on-stream pond needs work on the inlet and outlet. Native habitat enhancement by planting native trees and willows is recommended.

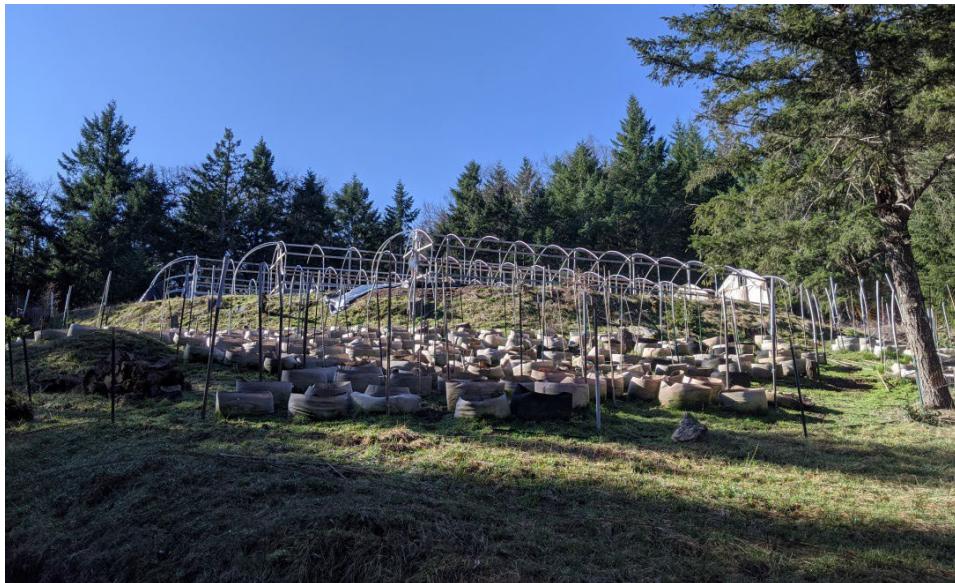
The pre-existing and cultivation site is located on an upland slope within mixed coniferous forest. This 130' x 170' site was converted for cannabis cultivation by 2012. The site is currently occupied by 7 greenhouses and outdoor pots. Surrounding vegetation includes Douglas fir and black oak, with a minor amount of other hardwoods. It is recommended that the cultivation is relocated from the steep forested slope to the open flat grassland closer to Hwy 36. All cultivation materials should be removed. It is recommended that a portion of the site is rocked to be used as an emergency access vehicle turnaround.

Photo 4. Site I includes greenhouses on the graded landing and outdoor cultivation on the surrounding slope. This shall be replaced with an emergency access turnaround and grass seeding sloped banks.

- d) Remove green houses and all cultivation related materials from the site.
- e) Maintain all existing vegetation in the surrounding area. No grading required.  
 Maintain outsloped log landing.
- f) Straw mulch all bare soil within 100 feet created from the removal process

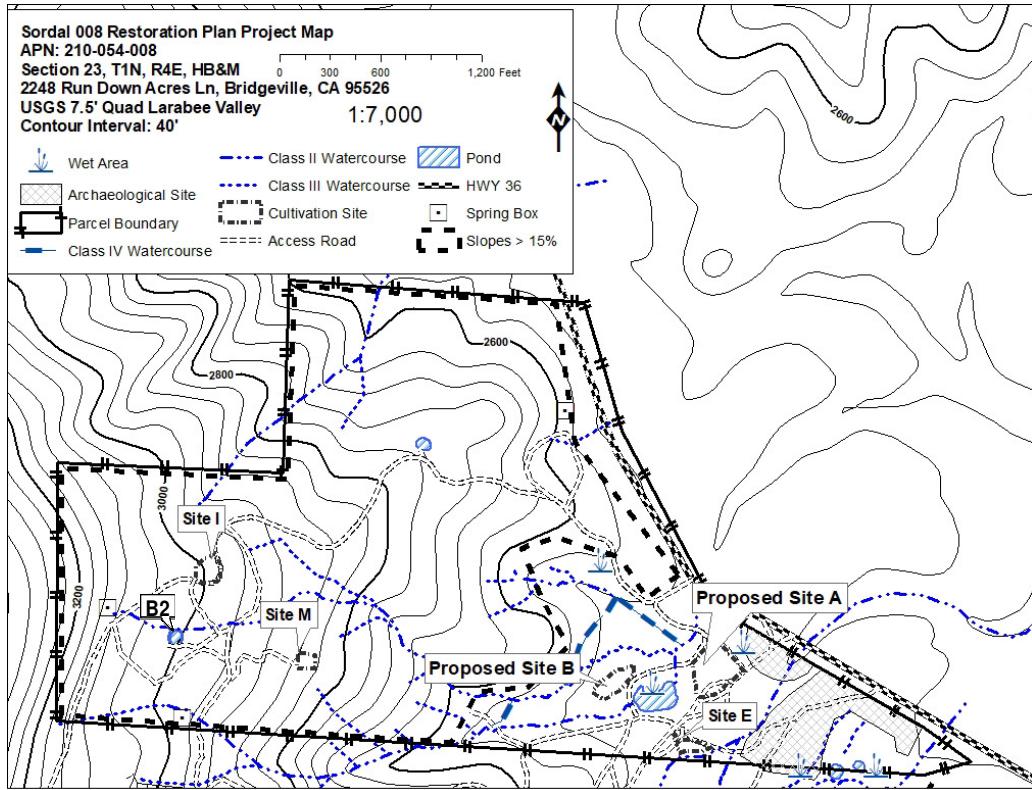
Map 2. The northeastern parcel contains current sites on >15% slopes to be relocated.

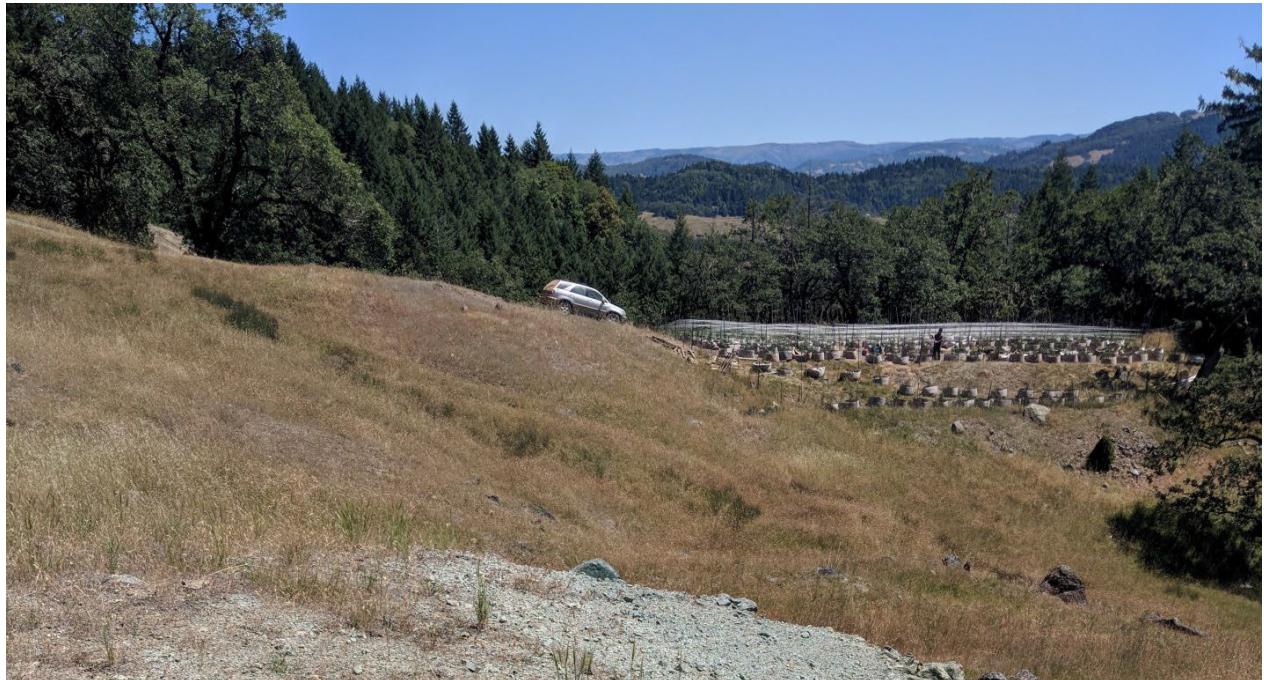
The mid-slope site is located on >15% slope with poor access via steep jeep trails. This 86' x 100' site was first converted for cannabis cultivation around 2012 when aerial imagery shows an outdoor garden was planted. Several greenhouses have occupied the site over the years, but currently no greenhouse is present. The site is located on the edge of oak woodland and a grassy meadow with some serpentine soils. Serpentine soils should be left undisturbed in the remediation process. Surrounding vegetation includes Douglas-fir, and mixed oak woodlands. The road system can only be used seasonally. It is recommended that the site be removed and the flat grass seeded. The road should be water barred, and all cultivation materials should be removed from the slope.

Photo 5. Site M cultivation site should be remediated and restored by planting grass. The nearby serpentine area is characterized by a blue-green tinge, and this area should be avoided.

- Remove all cultivation related materials from the site.
- Maintain all existing vegetation. No grading required. Maintain outsloped flat.
- Straw mulch all disturbed bare soil within 100 feet and seed with a native grass seed mix such as Pacific Coast Seed Native Erosion Control Mix.
