Wetland and Other Waters Delineation Report

Assessor's Parcel Numbers
015-111-006, 008, 012, and 013
Eureka, California

Prepared for:
Jim Paye

December 2021
021184

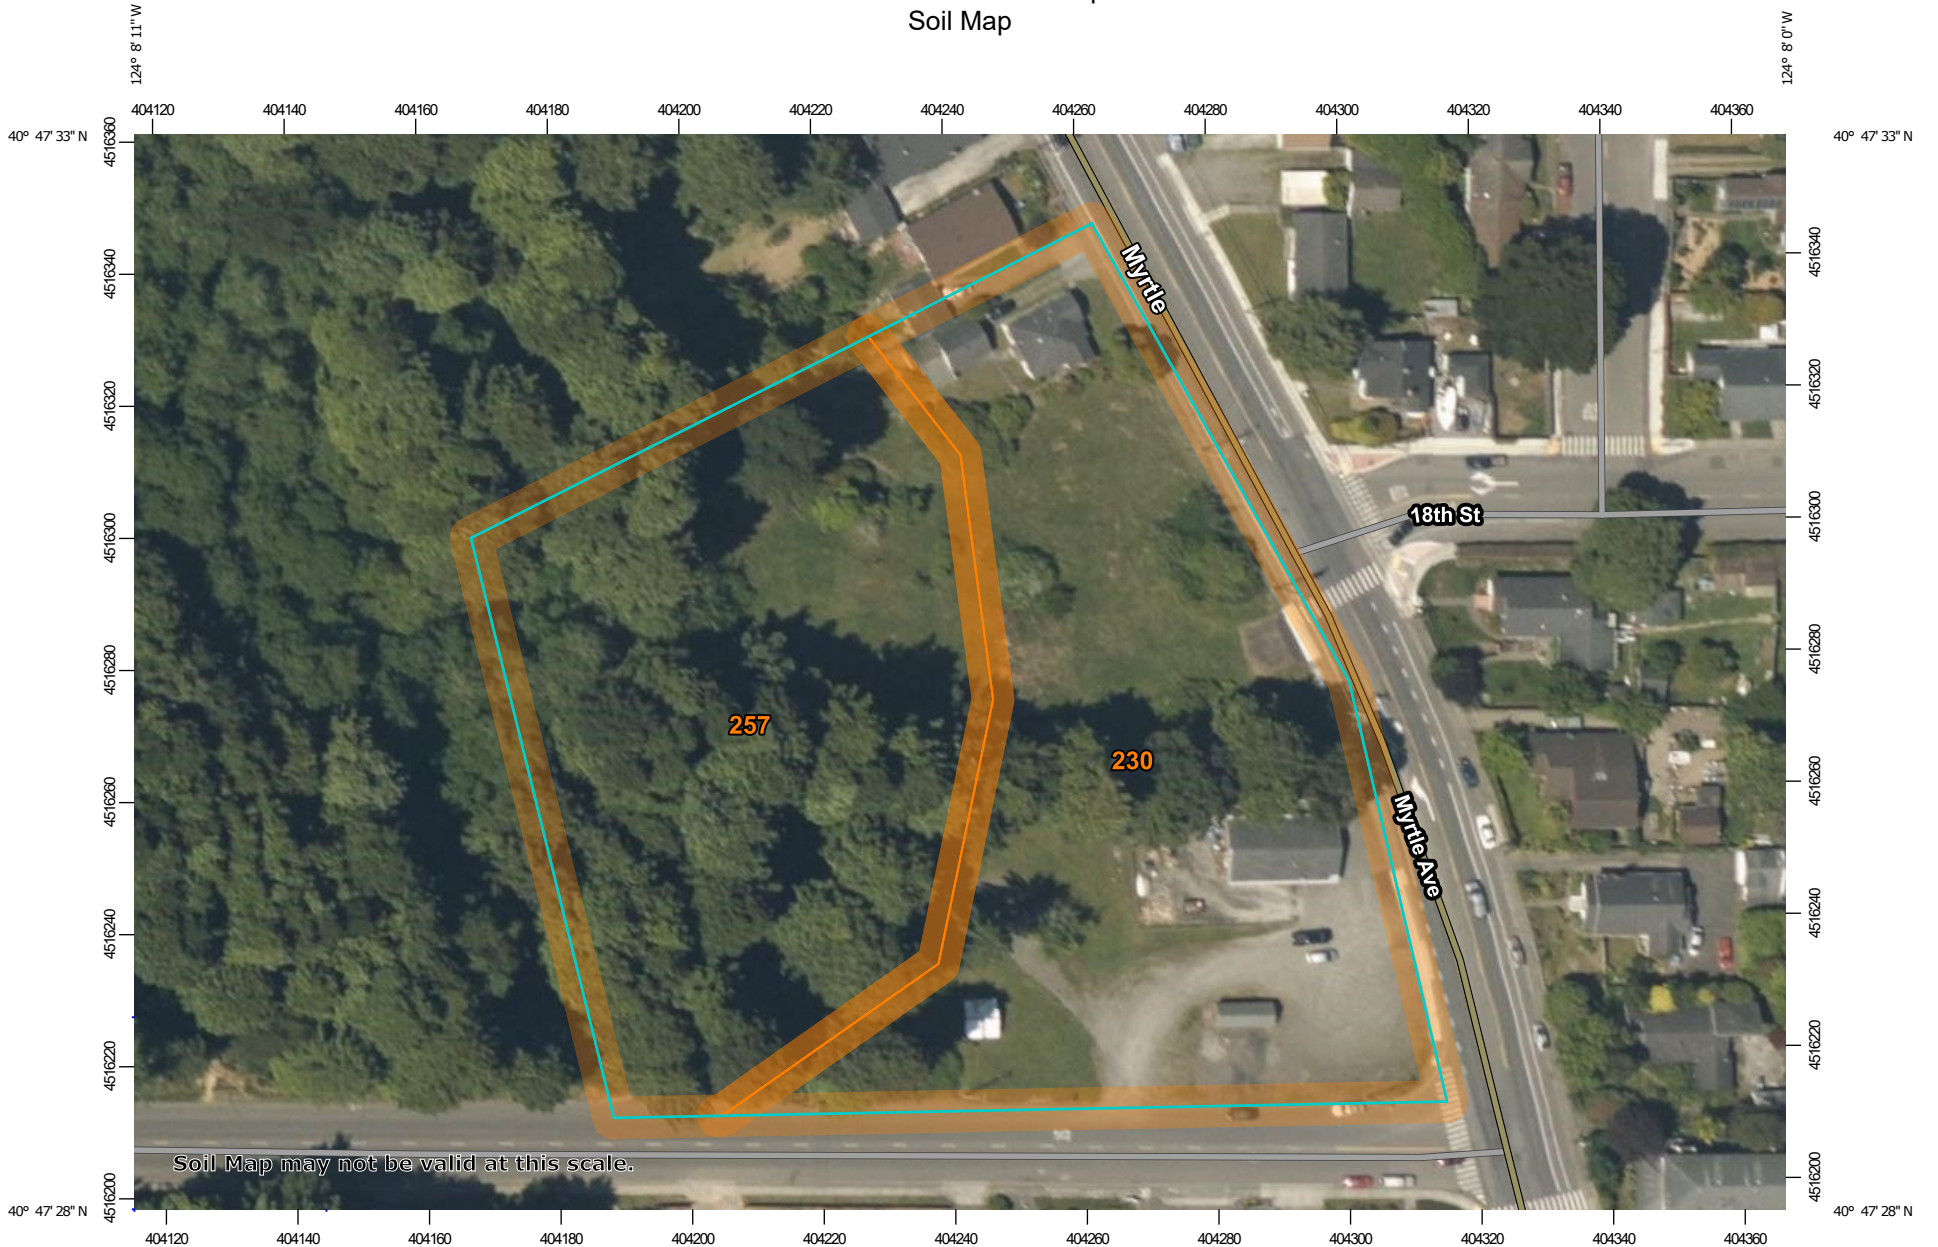
Custom Soil Resource Report Soil Map

The underlying soils in the study area have the USDA-NRCS soil map unit designation 230—Hookton-Tablebluff complex, 2 to 9 percent slopes and 257-Lepoil-Candymountain complex, 2 to 15 percent slopes, as described below (Appendix 2, Soil Map). The site-specific soil description at each exploratory soil TP is included in the wetland determination data forms found in Appendix 3, with photos in Appendix 1.
