Hearing Date: September 15, 2022
To: Humboldt County Zoning Administrator
From: John H. Ford, Director of Planning and Building
Subject: **PL - Van Duzen River Bar Conditional Use Permit/Mining 15-Year Renewal**
Case Number PLN-2021-17243
Assessor's Parcel Numbers 209-201-010 and 206-262-019
Carlotta Area

PL - VAN DUZEN RIVER BAR CONDITIONAL USE PERMIT/MINING 15-YEAR RENEWAL

**PL – VAN DUZEN RIVER BAR
CA MINE ID #91-12-0061
(Humboldt County)
August 2009**

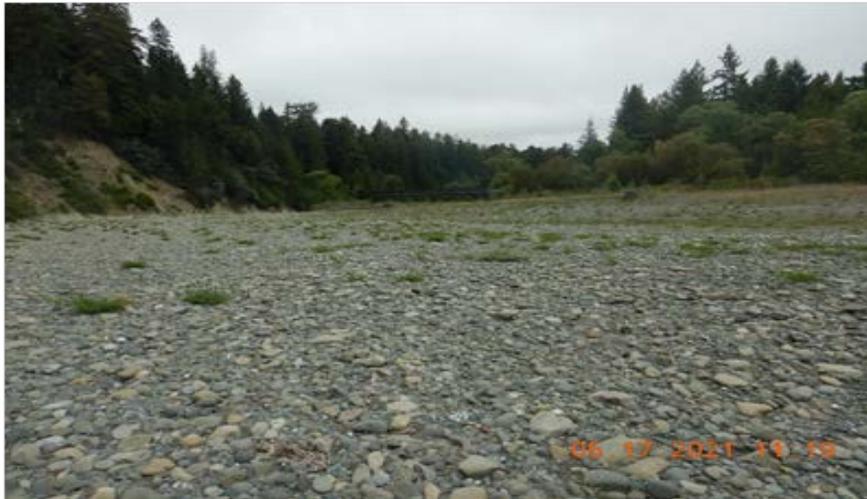
From Gravel Bar Looking Downstream Towards Highway Bridge

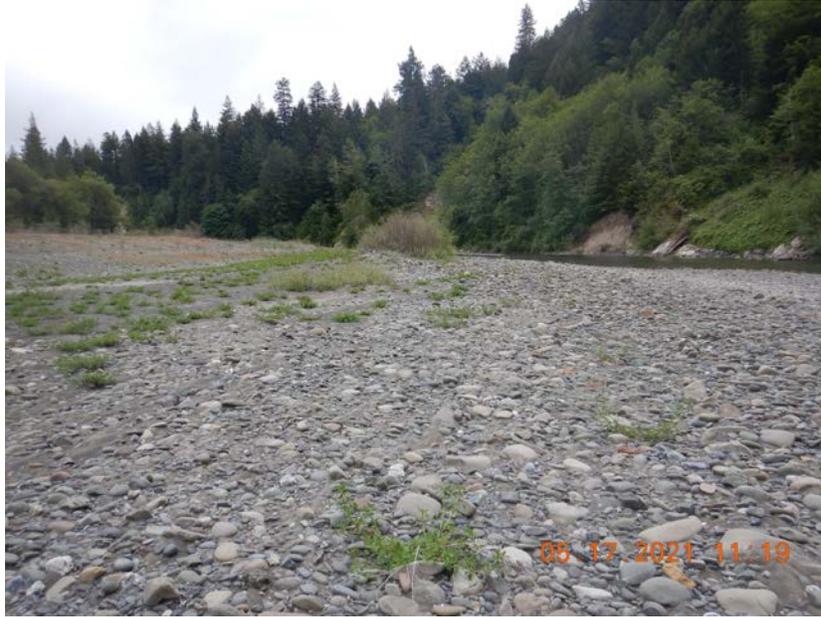
From Van Duzen Bar Looking Upstream

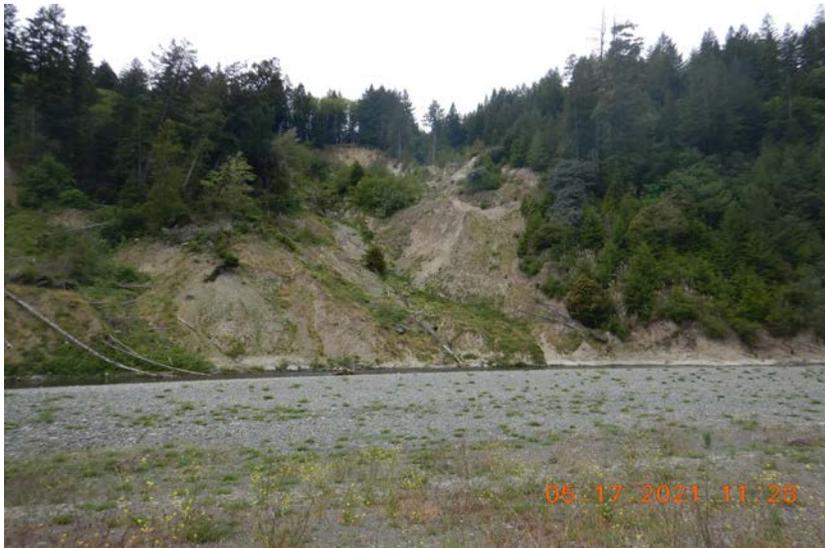
Active Landslide Across from Bar

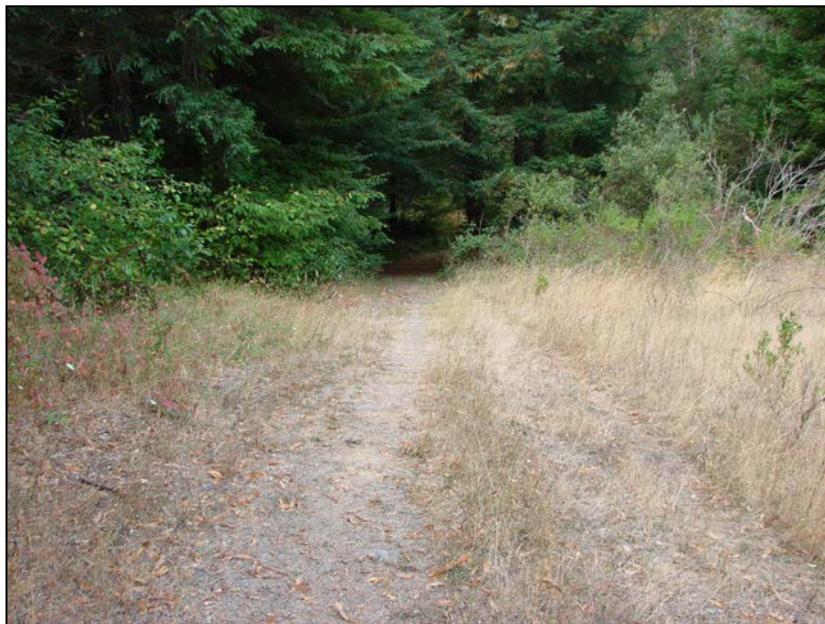
Access/Haul Road to Gravel Bar

Access to the extraction site is via an existing graveled/paved haul road, which enters the gravel bar from the northeast side. A seasonal, temporary haul road is designed to traverse the open gravel bar by the shortest route possible and is further designed to avoid existing areas of riparian vegetation. The topography of the bar will be considered during the design of temporary roads to minimize disturbances associated with cut and fill during construction of these roads.
