Riparian and Stream Assessment
For
Showers Creek
Kneeland, CA

April 26th, 2017

Prepared for:
Timberland Resource Consultants
Fortuna, CA

The proposed project is to install a 74 feet long by 8 feet wide bridge across Showers Creek where a log stringer bridge once existed.

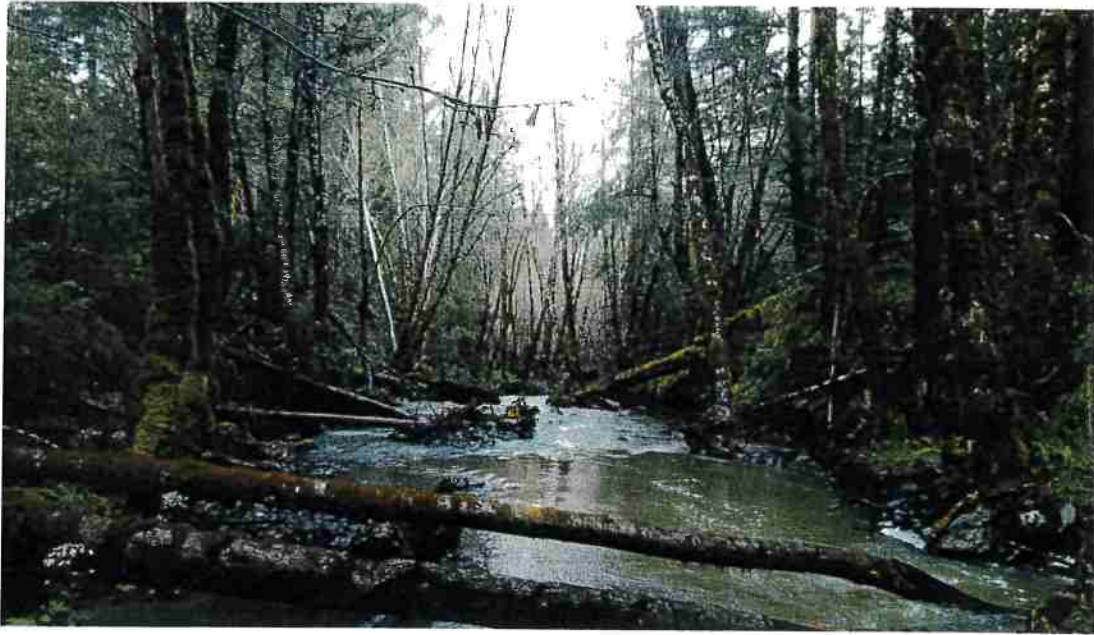
Picture 1: This is a photograph facing downstream towards the proposed bridge location. Photo date: 04/07/2017

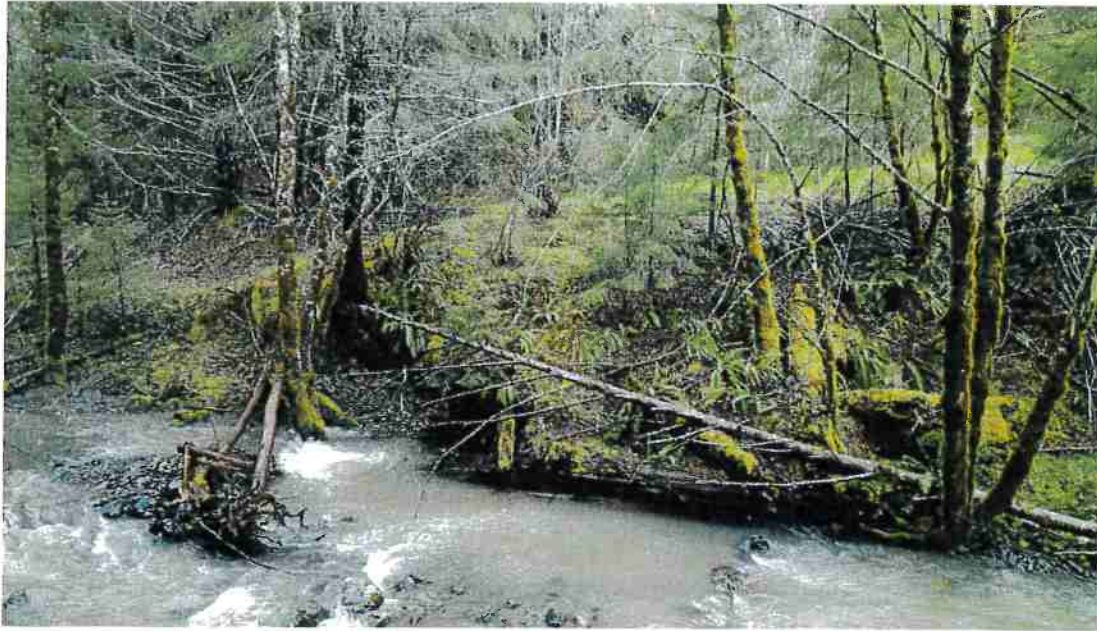
Picture 2: This is a photograph of the western stream bank. Note the log which marks the legacy bridge abutment at the bottom of the bank. Photo date: 04/07/2017

Both approaches will require earth work to remediate their current condition. The western approach will be reconstructed by removing all perched fill from the failed abutment. Old logs remnant from the previous stringer bridge shall be removed. Sound logs may be re-used; otherwise they will be disposed of at the designated spoils site. The eastern approach will have approximately 3' of fill removed from the top. Both stream banks will be contoured to a minimum 1.5:1 slope and rock armored with at least ¼ ton riprap. Riprap shall be built up to a minimum 4' above the stream bed. All materials placed below the high water mark shall not constrict the width of the channel. Abutments shall be constructed of rock, log, or prefabricated materials that will withstand erosion within the watercourse. No native soils will be excavated as a part of this project.

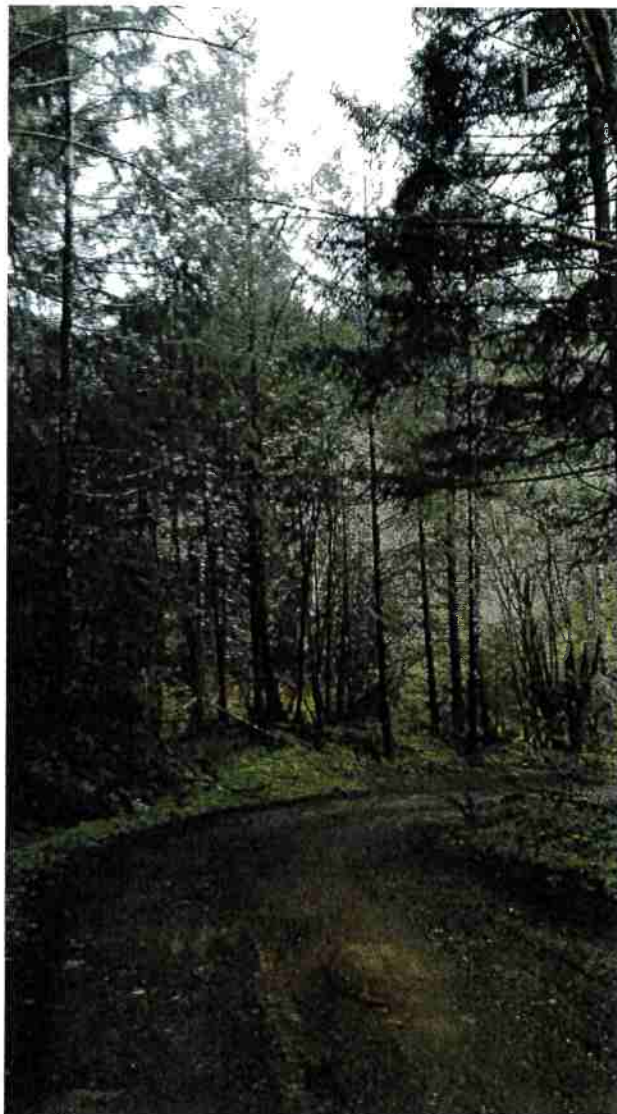
Picture 5: This is a photograph of eastern approach looking towards Showers Creek. This road will continue through the Douglas-fir trees straight to the proposed bridge installation. Photo date: 04/07/2017

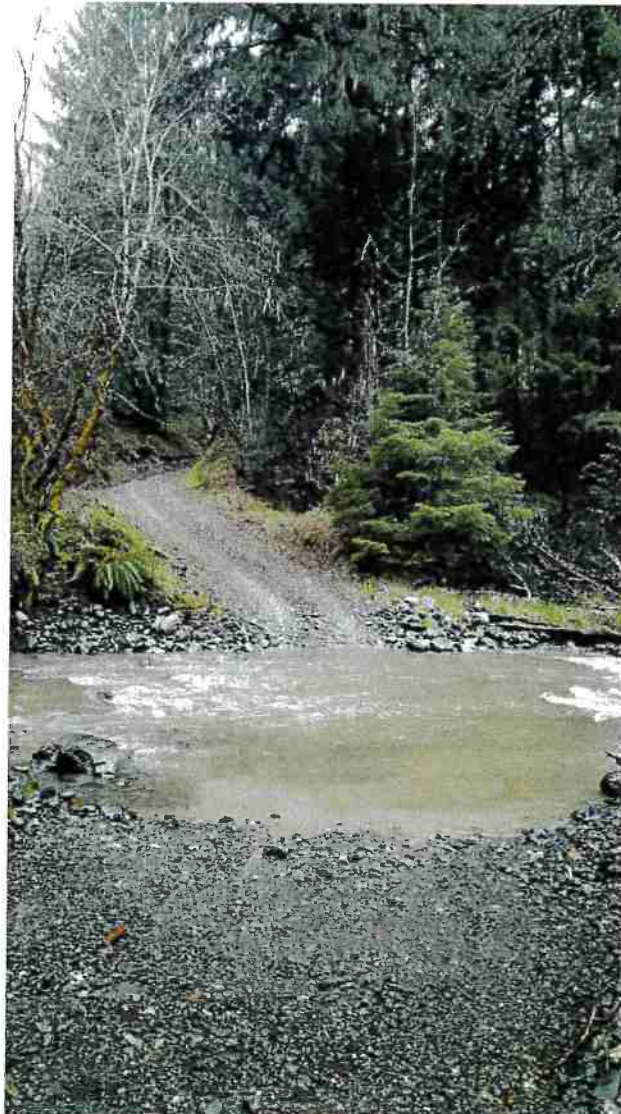
The existing rock ford crossing is used by 15-20 landowners to access a subdivision on the opposing side of Showers Creek. Although the stream bed substrate consists of gravel, cobbles and even some large boulders sediment discharge and an increase in

turbidity was observed with every crossing of a vehicle. The installation of this bridge will mitigate all impacts associated with the use of this ford crossing.

Picture 6: This is a photograph of the existing rock ford crossing downstream of the project area. Turbidity can be seen in the photo from recent vehicle traffic. The completion of the bridge installation will negate the use of this crossing. Photo date: 04/07/2017
