The following is an evaluation of potential timberland conversion on cannabis cultivation sites and associated areas included in Humboldt County Cannabis Permit Application #11543 for APN 221-021-026. An Interim Permit has been issued for 23,250 ft² of existing outdoor of cultivation and 11,000 ft² of existing mixed-light cultivation. Please accept this letter as the RPF's written report required by Humboldt County Code, Ordinance No. 2559 (Commercial Medical Marijuana Land Use), Section 55.4.10 (j), sited below.

Timberland Resource Consultants (TRC) inspected and evaluated the cultivation sites and associated areas contained within the application on August 14, 2018. The RPF exercised due diligence in reviewing all sites and available resources to fully assess potential timberland conversion and consequential impacts. This report evaluates the cultivation sites and associated areas for timber operations only. The scope of this report does not include: all other land alteration (such as grading, construction, and other permit-regulated activities), all property features and sites unrelated to cultivation activities, or any proposed, planned, or absent cultivation-related project s

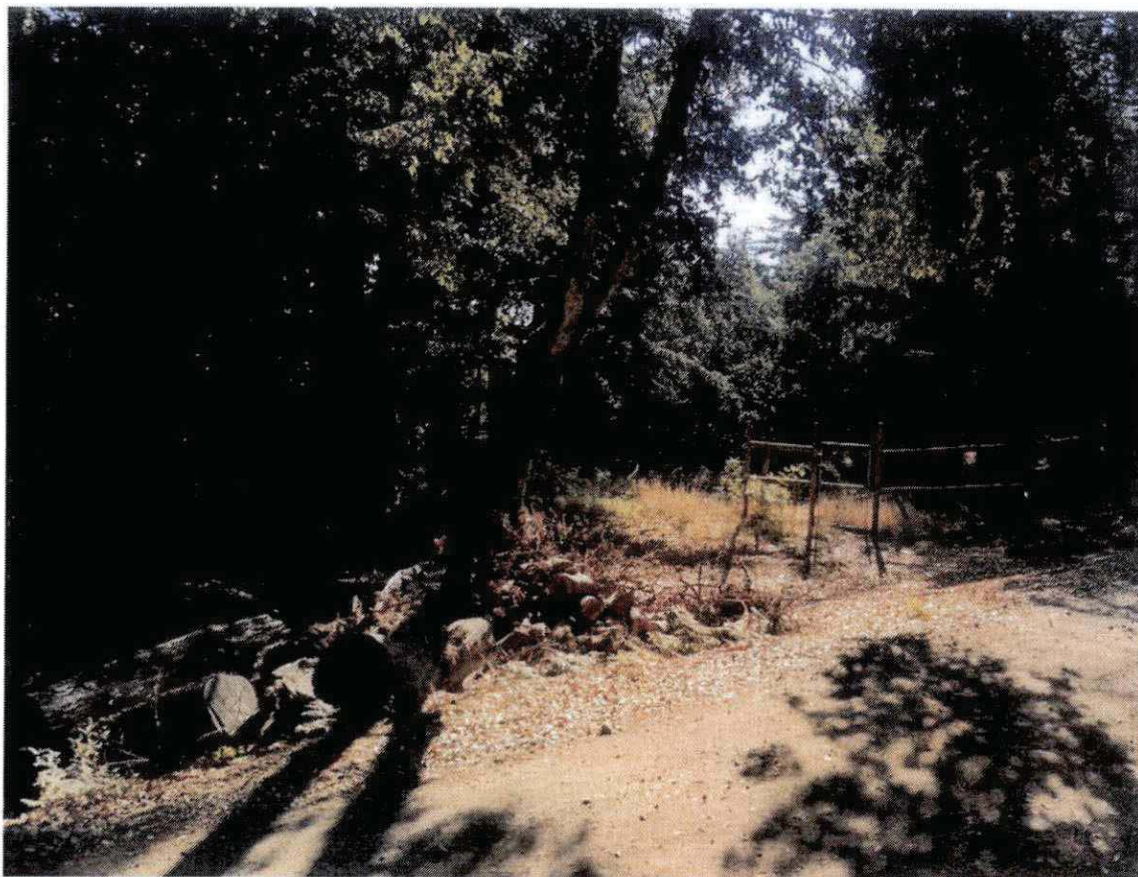
Picture 1: Slash, logs, and woody debris that requires treatment located west of the off-stream pond.
Photo date 8-14-2018.

The RPF identified piles/concentrations of untreated slash, woody debris, and logs from the conversion that require treatment as shown on the attached map. Isolated accumulations of scattered slash and woody debris not shown on the attached map may exist along the perimeter of the converted sites.

Slash and woody debris treatment required at approximately 5 locations as depicted on the attached Conversion Evaluation Map. Isolated accumulations of scattered slash and woody debris not shown on the attached map may exist along the perimeter of the converted sites.

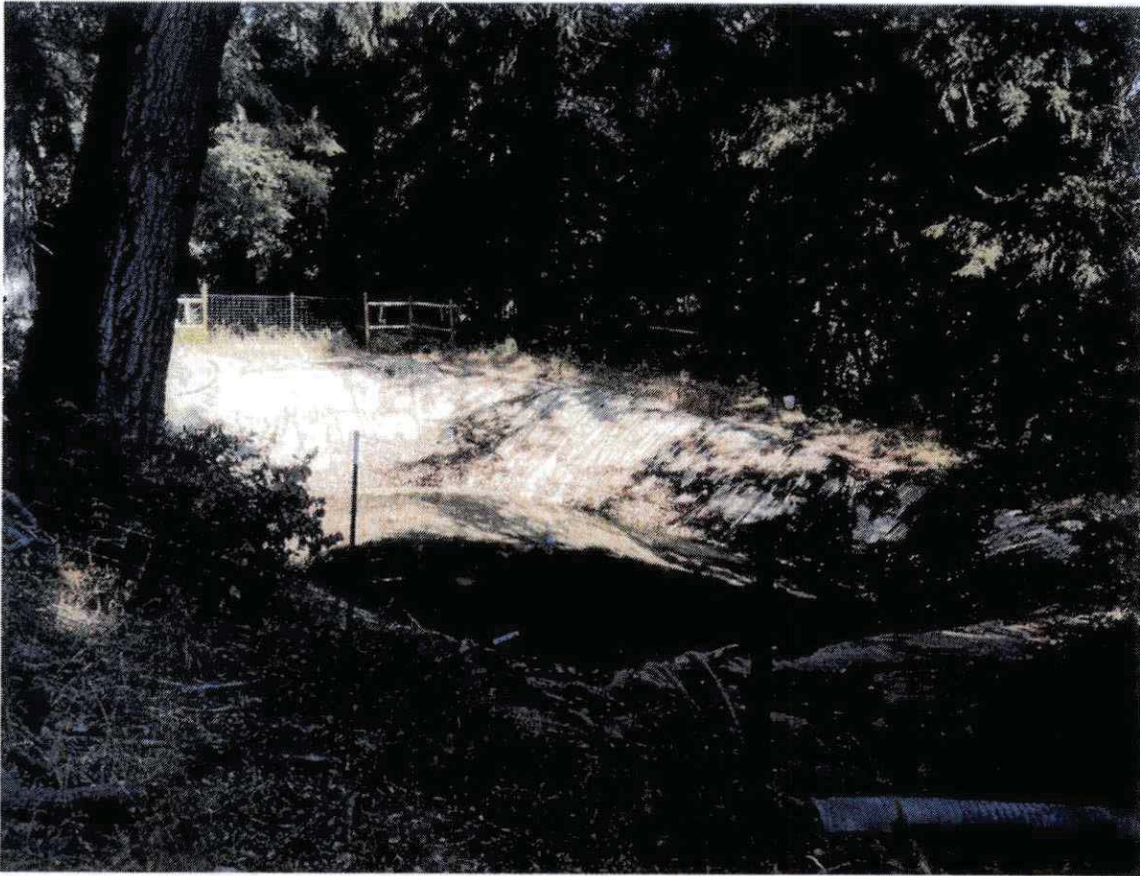
The pond's dimensions are approximately 40-ft by 60-ft with an overall disturbed area of approximately 0.11 acres. Review of historic aerial imagery reveals that the pond was established between 2010 and 2012 and included timber harvesting and grading. Untreated slash, woody debris, and logs from the conversion were observed. The cultivation-related activities observed impede the use of this space for current timber growth and harvesting; in this way, the landowner has effectively converted the single use of this space from timber production to a cannabis cultivation related activity.

Picture 2: Off-stream pond. Photo date 8-14-2018.

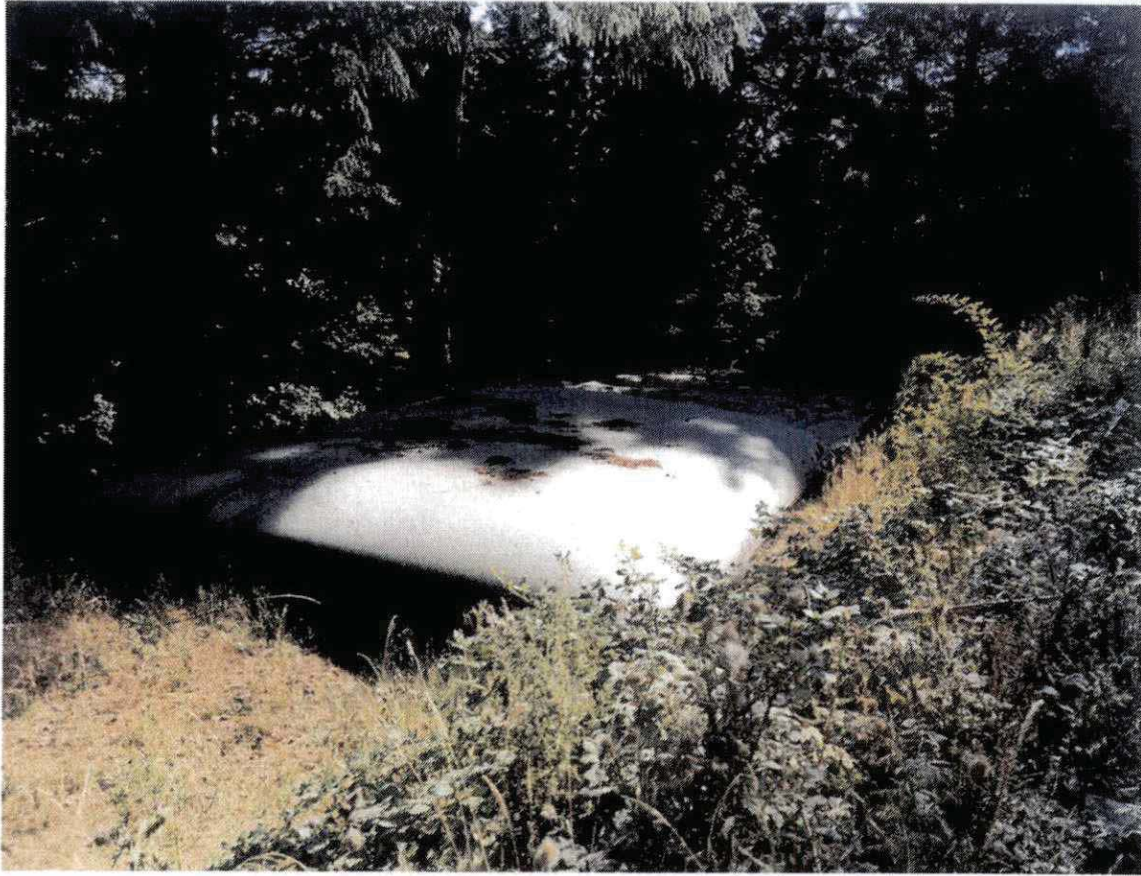
The graded flat's dimensions are approximately 115-ft by 35-ft with an overall disturbed area of approximately 0.12 acres. Review of historic aerial imagery reveals that the graded flat was established between 2014 and 2016 and included timber harvesting and grading. The eastern portion of the bladder site is located within the Class III WLPZ. The cultivation-related activities observed impede the use of this space for current timber growth and harvesting; in this way, the landowner has effectively converted the single use of this space from timber production to a cannabis cultivation related activity.

1. Map Point A: Timberland conversion occurred within the Class III WLPZ in the eastern portion of the Bladder Site. This site shall be decommissioned per the specifications stated in the Applicant's Water Resource Protection Plan and CDFW 1600 Notification, which includes removal of all fill material from the Class III stream channel and buffer zone, and restoration of the stream channel back to its original location, grade, and configuration.

Picture 3: Bladder Site. Photo date 8-14-2018.

Bladder Site: Fill material placed in the Class III watercourse and Class III WLPZ at Map Point A shall be removed per the Water Resource Protection Plan and replanted per the attached Restocking Plan.

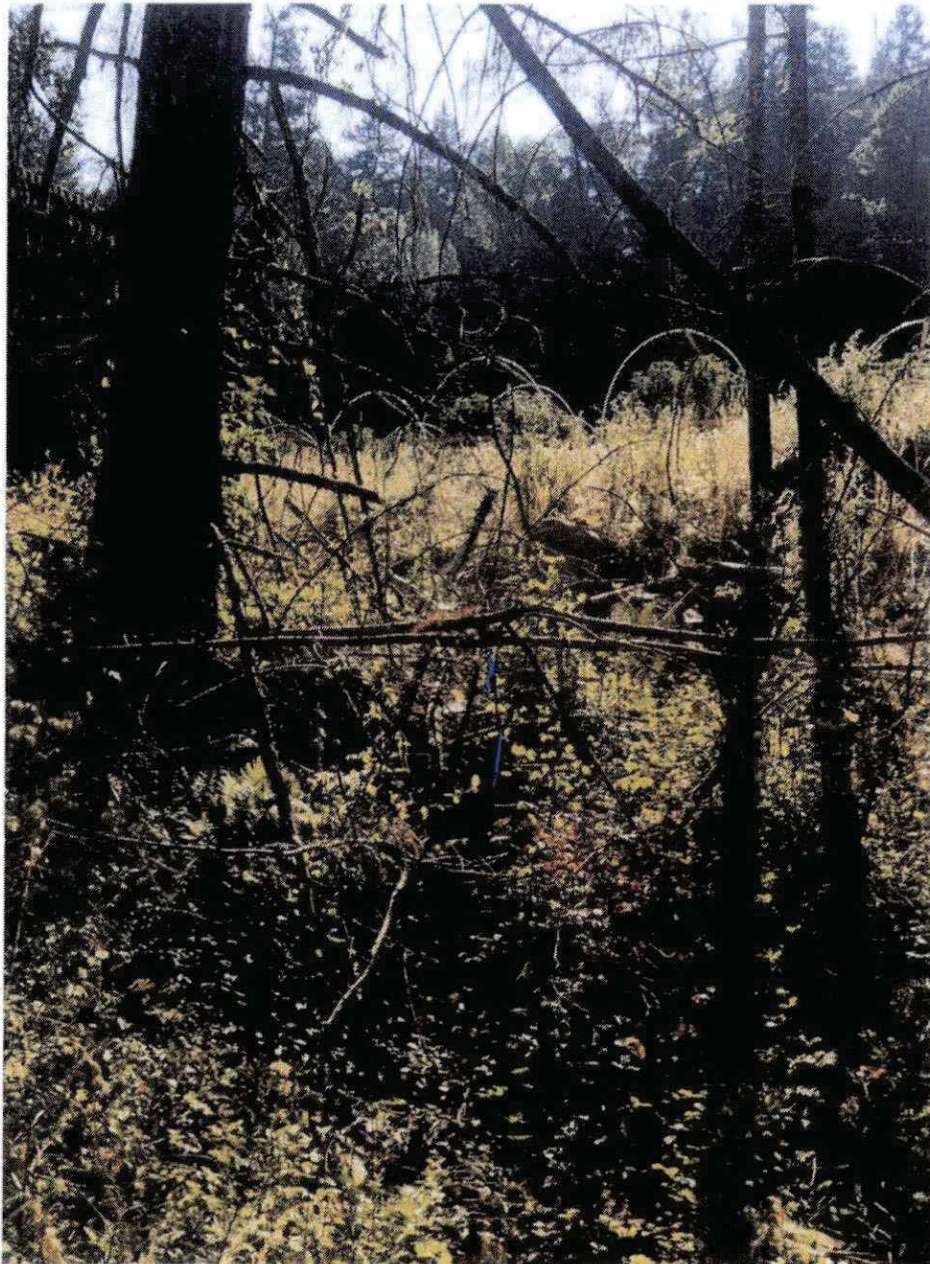
2. Map Point B: Timberland conversion activities resulted in the placement of unstable fill, stumps, logs, and slash into the head of a Class III watercourse located west of Cultivation Site 2 and directly south of the residence. The Water Resource Protection Plan and CDFW 1600 notification requires the removal of all unstable fill material from the Class III buffer zone, and the fill slope shall be pulled back to a maximum slope steepness of 2:1.

Near Map Point B, portions of the fill slope, located to the west of the cultivation site and south of the residence are intermixed with stumps, logs, and woody debris. Treatment of this "unstable fill" requires removal of all buried woody material (stumps, logs, limbs, chunks, etc.) and subsequent treatment per 14CCR 1104.1(a)(2)(D) – Treatment of Slash and Woody Debris. The fill shall be reconstructed and thoroughly compacted in approximately one-foot lifts. The fill shall be no greater than 50 percent (2:1, horizontal to vertical) unless properly engineered. Portions of this unstable fill is perched and side-casted into the head of a Class III watercourse, as previously described, which shall require removal. This requirement shall be addressed with more specificity in the Water Resource Protection Plan and CDFW Notification.

Picture 4: Map Point B. Head of Class III watercourse located west of Cultivation Site 2. Unstable fill, logs, stumps, and slash are buried and intermixed in the perched fill. Photo date 8-14-2018.

Cultivation Site 2: Map Point B: Timberland conversion activities resulted in the placement of unstable fill, stumps, logs, and slash into the head of a Class III watercourse located west of Cultivation Site 2 and directly south of the residence. The Water Resource Protection Plan and CDFW 1600 notification requires the removal of all unstable fill material from the Class III buffer zone and the fill slope shall pulled back to a maximum slope steepness of 2:1. In addition, near Map Point B, storm water runoff is being concentrated and dispersed into the head of two Class III watercourses south of the residence resulting in erosion of the fill material and sediment delivery to downstream watercourses. Corrective action is the proper drainage of the graded flat such that runoff is not concentrated onto the steep and erodible fill material. Lastly, near Map Point B, portions of the fill slope, located to the west of the cultivation site and south of the residence are intermixed with stumps, logs, and woody debris. Treatment of this "unstable fill" requires removal of all buried woody material (stumps, logs, limbs, chunks, etc.) and subsequent treatment per 14CCR 1104.1(a)(2)(D) – Treatment of Slash and Woody Debris. The fill shall be reconstructed and thoroughly compacted in approximately one-foot lifts. The fills shall be no greater than 50 percent (2:1, horizontal to vertical) unless properly engineered.

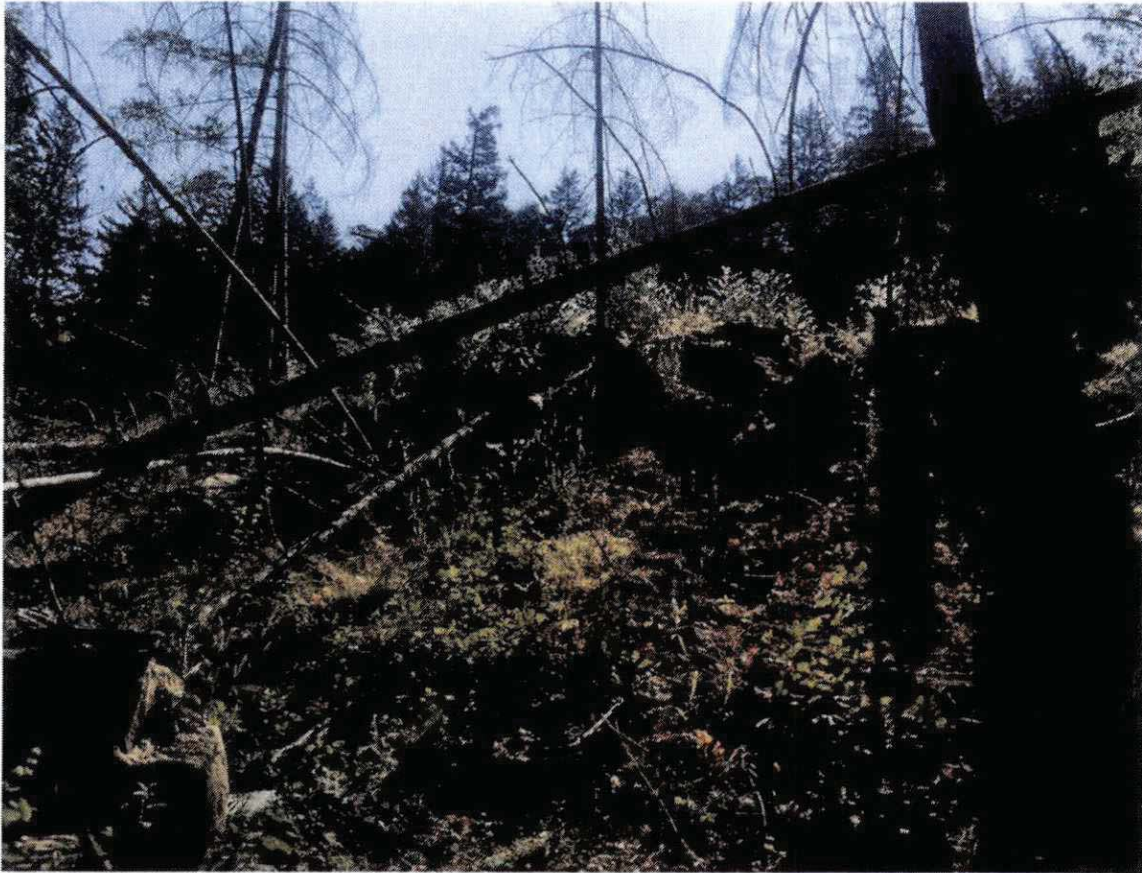
While its recognized that Cultivation Site 2 is not a log landing, construction and maintenance of the graded flat should (at a minimum) meet or exceed similar requirements stated in the Forest Practice Rules for log landings. Compliance with Humboldt County's grading ordinance, Water Board Order, and other regulations would undoubtedly require even higher standards. Therefore, this report shall assess Cultivation Site 2's graded flat to the standards of a log landing. Near Map Point B, storm water runoff is being concentrated and dispersed into the head of two Class III watercourses south of the residence resulting in erosion of the fill material and sediment delivery to downstream watercourses. Corrective action is the proper drainage of the graded flat such that runoff is not concentrated onto the steep and erodible fill material. This requirement shall be addressed with more specificity in the Water Resource Protection Plan and CDFW Notification. The fill material at this location is steep, unconsolidated, and mixed with slash and woody debris. This "unstable fill" needs treatment as further addressed below.

Picture 5: Untreated slash, logs, and woody debris located along the western perimeter of Cultivation Site 2 south of Map Point B. Portions of the fill slope in this area are intermixed with stumps, logs, and woody debris. Treatment of this "unstable fill" requires removal of all buried woody material (stumps, logs, limbs, chunks, etc.). Photo date 8-14-2018.

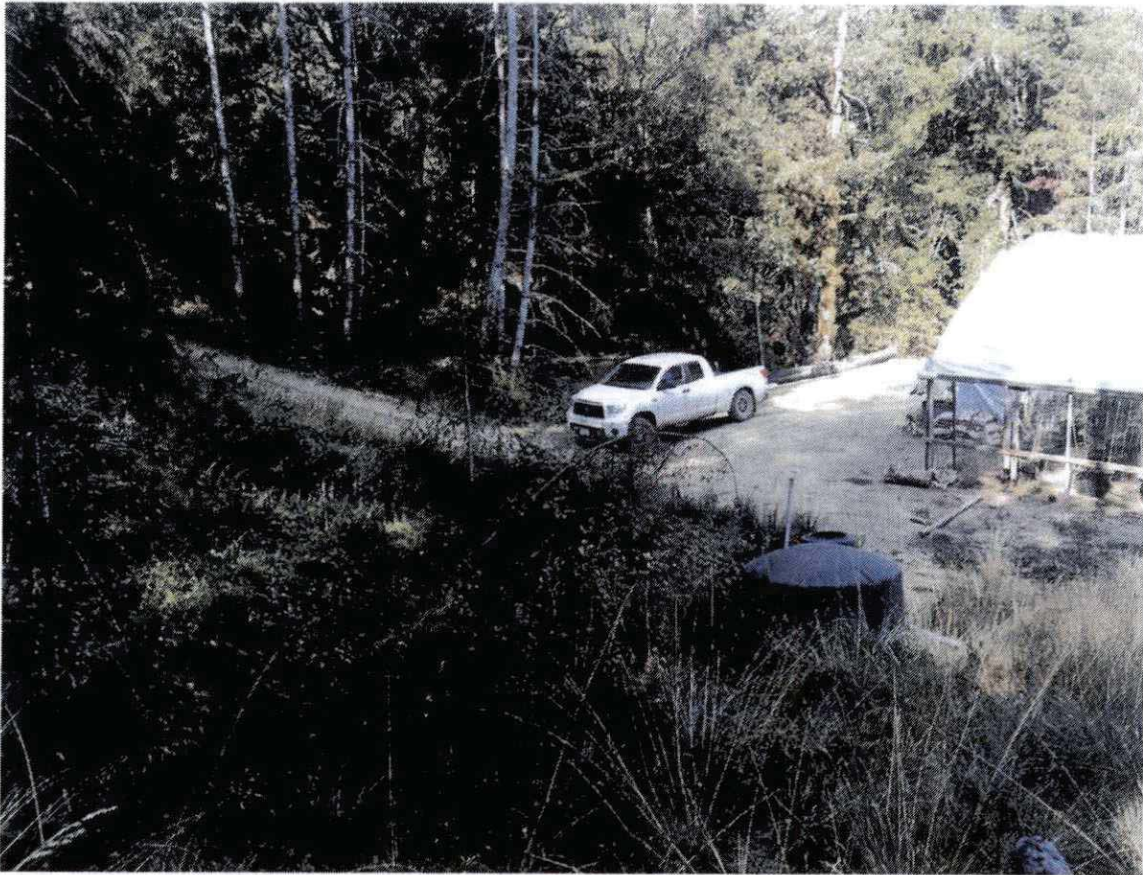
3. Map Point C: Timberland conversion occurred within a Class III watercourse channel at Cultivation Site 3. At this location past grading within the Class III watercourse buffer of 50-feet has resulted in the diversion of this Class III watercourse and the placement of fill in the Class III stream channel. The Water Resource Protection Plan and CDFW 1600 notification requires the decommissioning of Cultivation Site 3, which includes the removal of all fill material from the Class III stream channel and restoration of the stream channel back to its original location, grade, and configuration.

Picture 6: Map Point C. A Class III watercourse has been diverted outside of its natural channel across the road near pickup truck during construction of Cultivation Site 3. Photo date 8-14-2018.

Cultivation Site 3: Map Point C: Timberland conversion occurred within a Class III watercourse channel at Cultivation Site 3. At this location past grading within the Class III watercourse buffer of 50-feet has resulted in the diversion of this Class III watercourse and the placement of fill in the Class III stream channel. The Water Resource Protection Plan and CDFW 1600 notification requires the decommissioning of Cultivation Site 3, which includes the removal of all fill material from the Class III stream channel and restoration of the stream channel back to its original location, grade, and configuration. Following decommissioning, Cultivation Site 3 shall be replanted per the attached Restocking Plan.

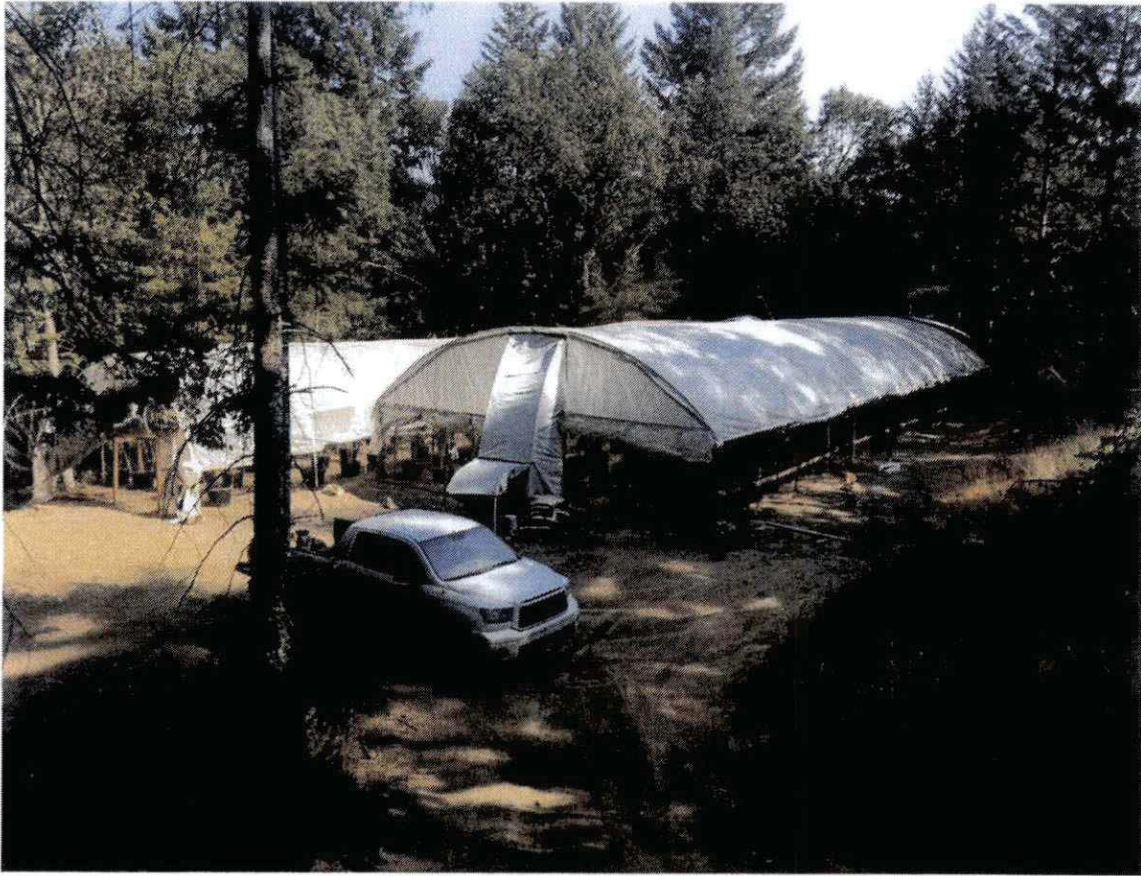
Picture 7: Map Point C. The Class III watercourse's natural alignment passes through the bed of pickup truck or the southern portion of Cultivation Site 3. Photo date 8-14-2018.

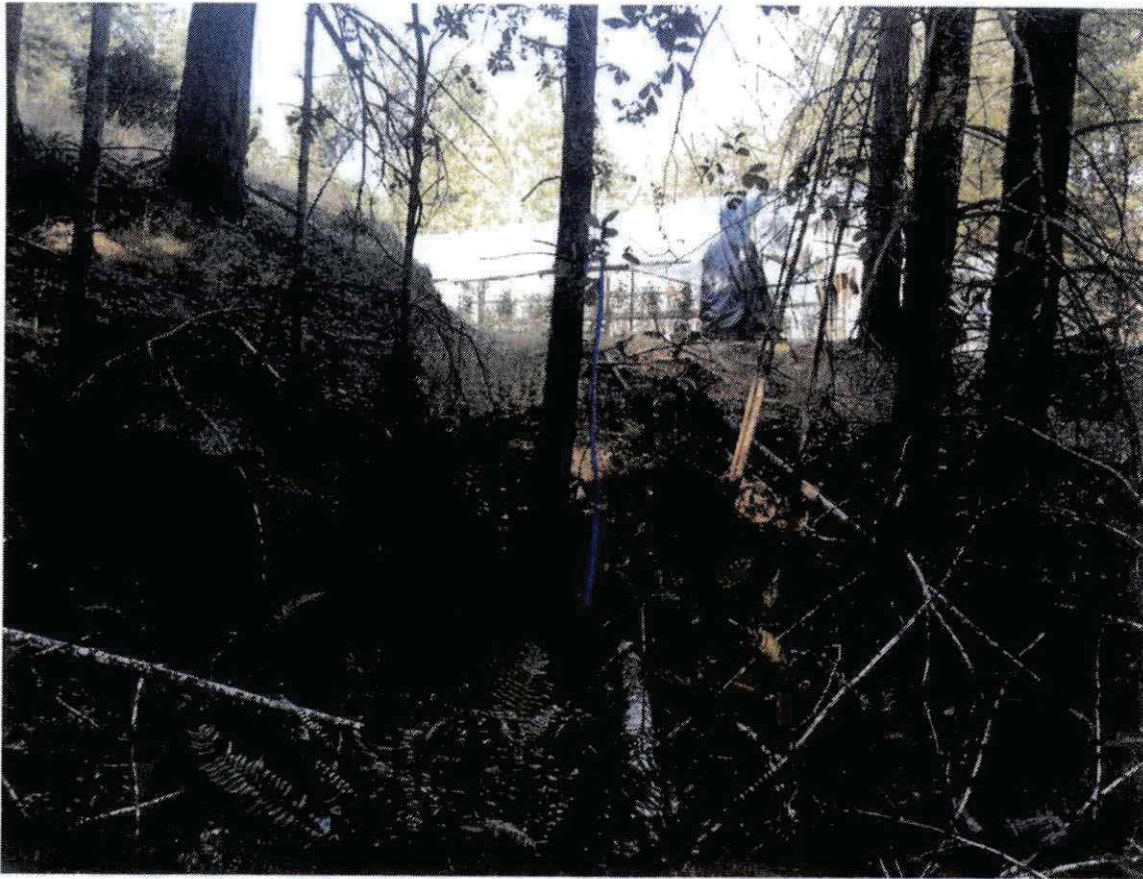
4. Map Point D: Timberland conversion occurred within the Class III WLPZ in the northeastern portion of the Cultivation Site 3, which included the placement of fill material in the Class III WLPZ. Cultivation Site 3 shall be decommissioned per the specifications stated in the Applicant's Water Resource Protection Plan and CDFW 1600 Notification, which shall include the removal of fill material located within the Class III WLPZ.

Picture 8: Map Point D. Class III watercourse is center-lined with blue flagging in foreground. In background is side-casted fill material from the construction of Cultivation Site 3. Photo date 8-14-2018.

Map Point D: Timberland conversion occurred within the Class III WLPZ in the northeastern portion of the Cultivation Site 3. This site shall be decommissioned per the specifications stated in the Applicant's Water Resource Protection Plan and CDFW 1600 Notification, which shall include the removal of fill material located within the Class III WLPZ. Following decommissioning, Cultivation Site 3 shall be replanted per the attached Restocking Plan.

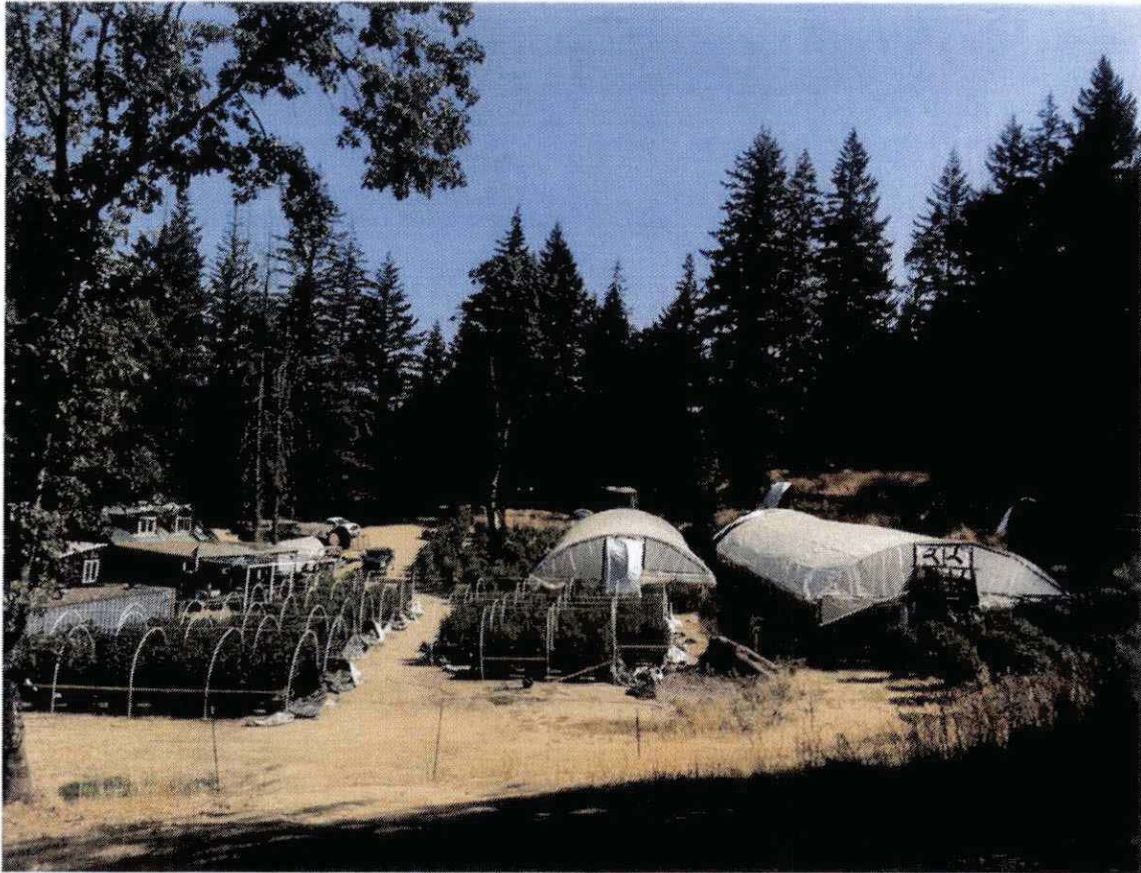
The site is approximately 1.60 acres in size. Review of historic aerial imagery reveals that the cultivation site was established between 2010 and 2012 and included timber harvesting and grading. Unstable fill, slash, and logs have been side-casted into the head of a Class III watercourse within the Class III WLPZ. Storm water runoff from the large graded flat is being concentrated into the head of a Class III watercourse, which is a controllable sediment discharge site. Unstable fill material consisting of uncompacted and perched fill intermixed with slash, logs, stumps, and woody debris occurs on the western edge of the site. The cultivation-related activities observed impede the use of this space for current timber growth and harvesting; in this way, the landowner has effectively converted the single use of this space from timber production to a cannabis cultivation related activity.

Picture 9: Cultivation Site 2. Photo date 8-14-2018.

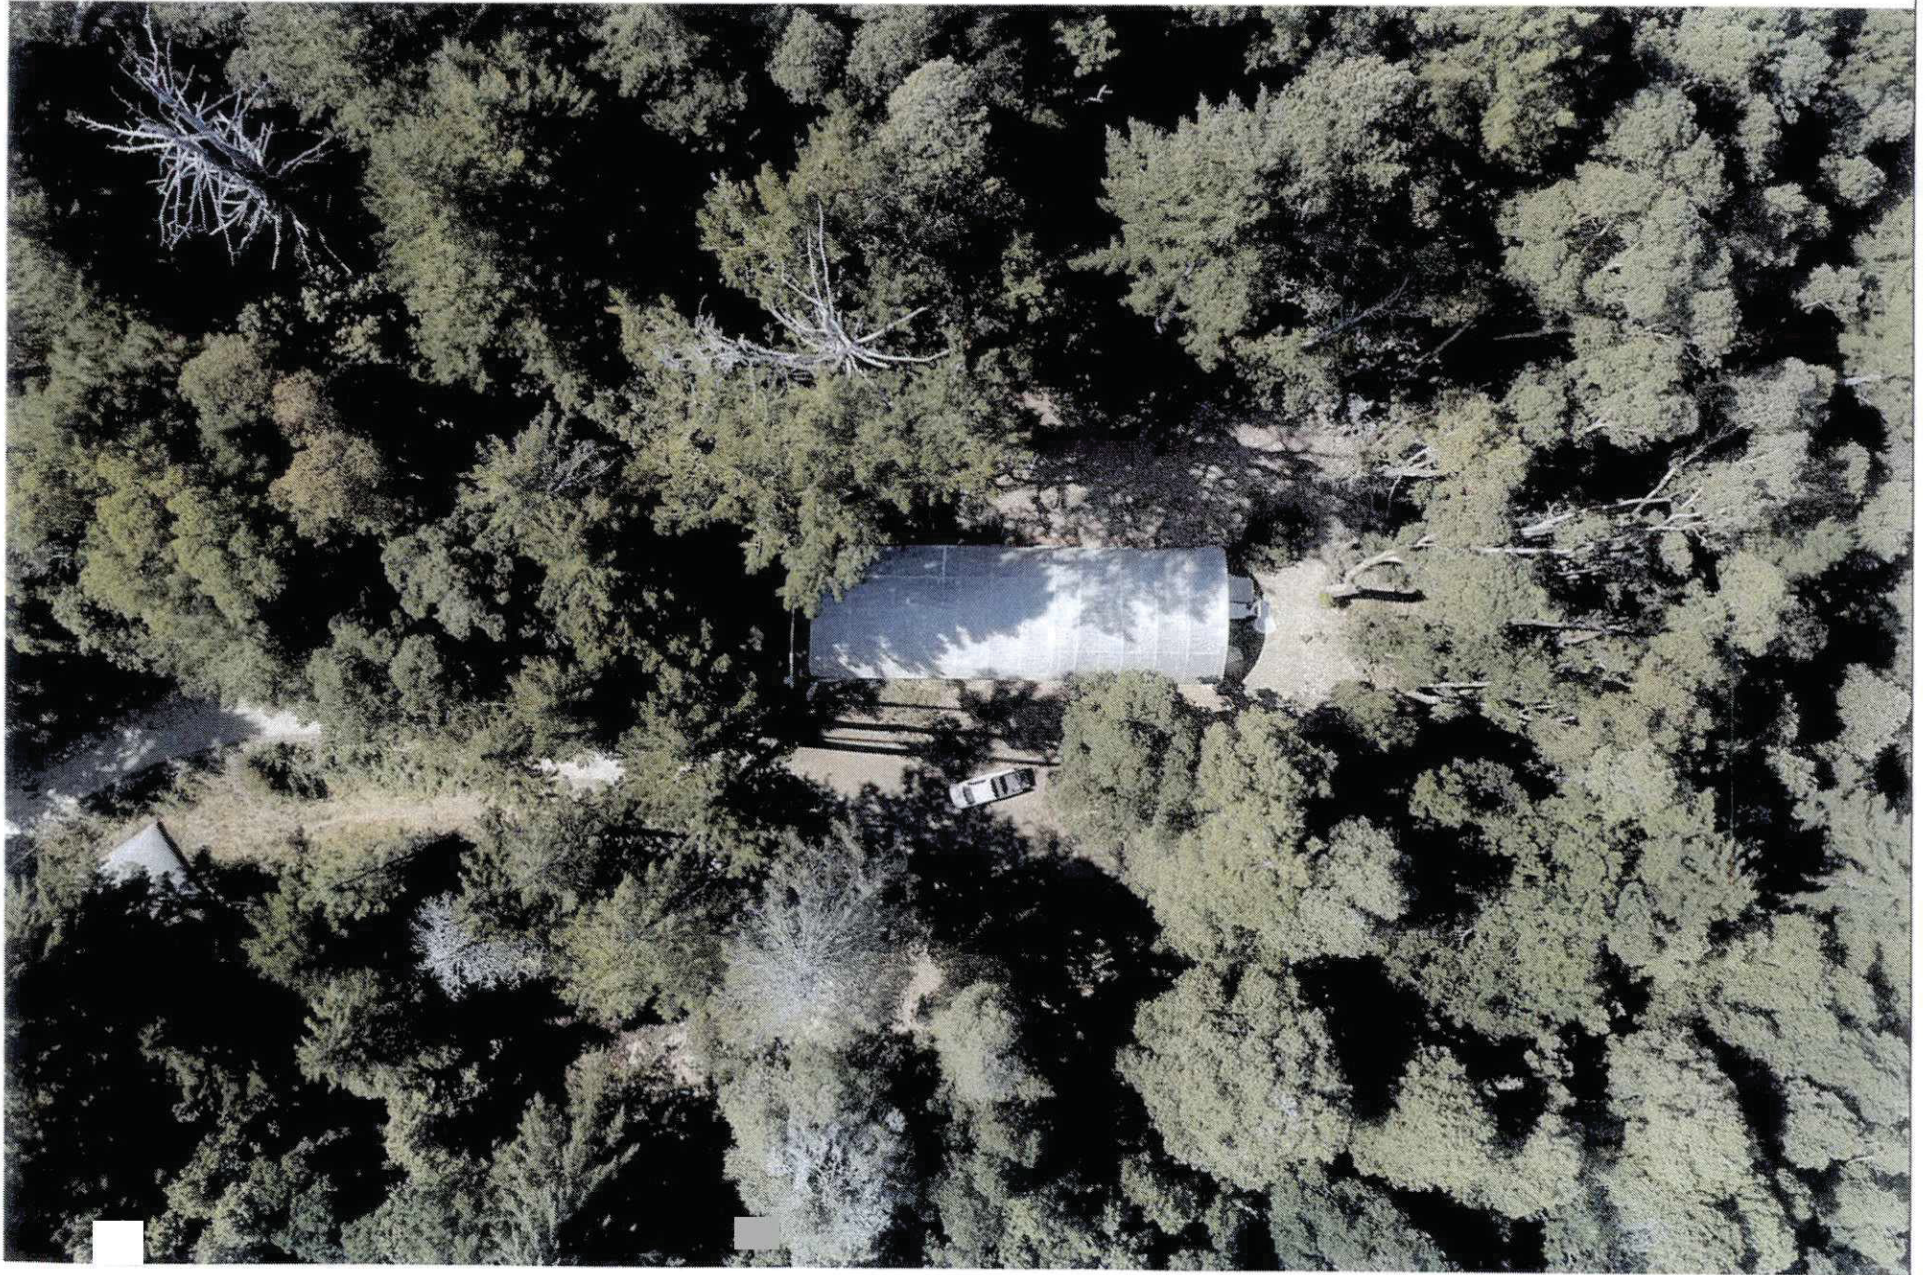
Cultivation Site 1

The site is approximately 200 feet long by 75 feet wide, which equates to 0.34 acres. Review of historic aerial imagery reveals that the cultivation site was established between 2014 and 2016 and included timber harvesting and grading. Untreated slash, woody debris, and logs from the conversion were observed. The cultivation-related activities observed impede the use of this space for current timber growth and harvesting; in this way, the landowner has effectively converted the single use of this space from timber production to a cannabis cultivation related activity.

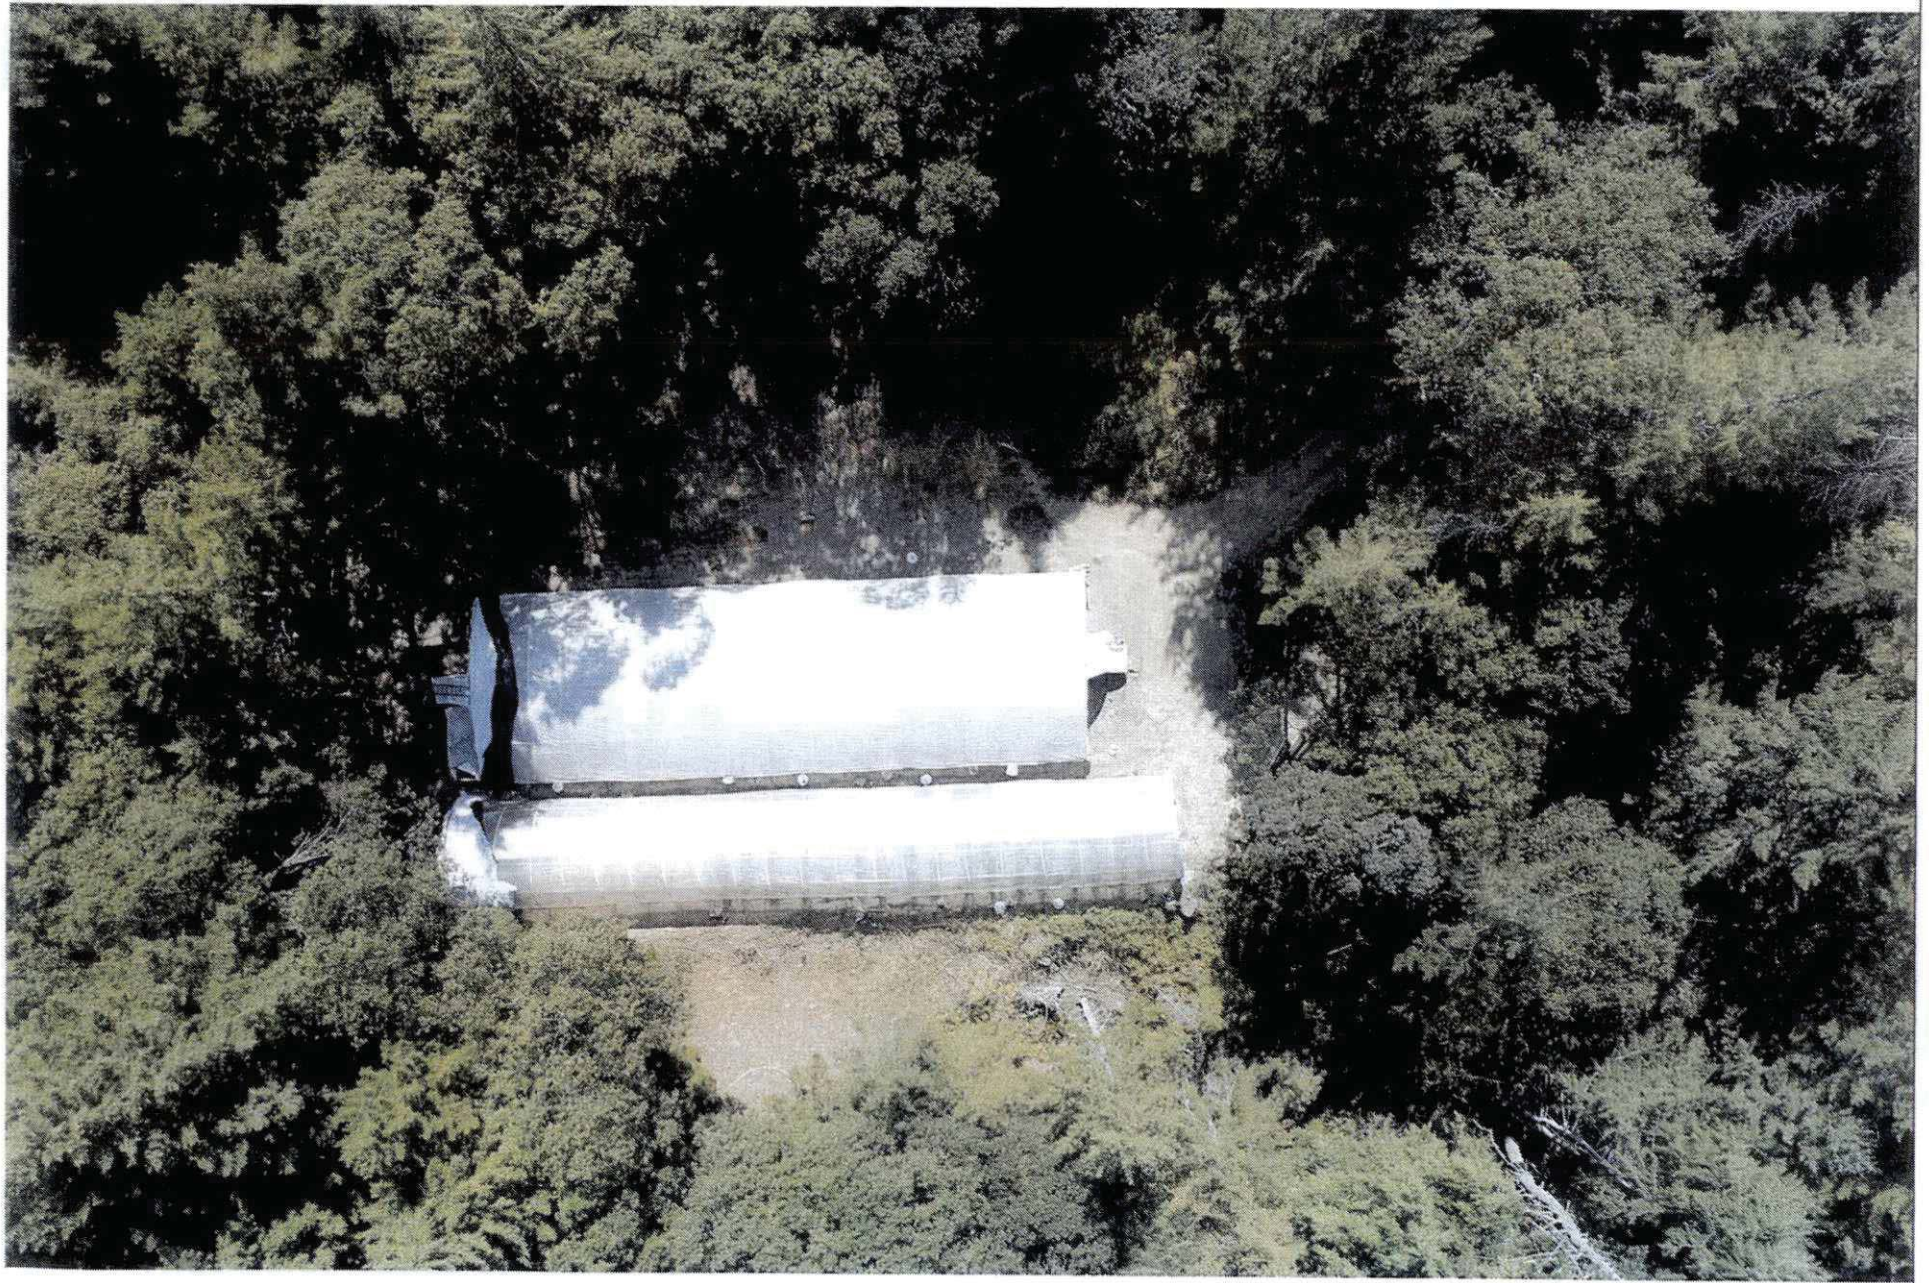
Cultivation Site 3

The site is approximately 0.30 acres in size. Review of historic aerial imagery reveals that the cultivation site was established between 2014 and 2016 and included timber harvesting and grading. Untreated slash, woody debris, and logs from the conversion were observed. The southwestern portion of the graded flat was constructed in a Class III watercourse channel. The northeastern portion of the graded flat's fillslope is located within the Class III WLPZ. The cultivation-related activities observed impede the use of this space for current timber growth and harvesting; in this way, the landowner has effectively converted the single use of this space from timber production to a cannabis cultivation related activity.

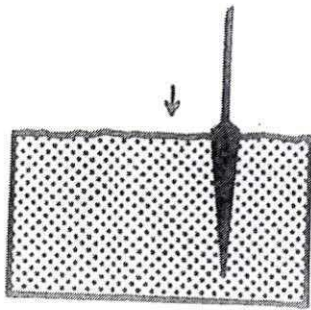
1. Insert flat bar straight down.

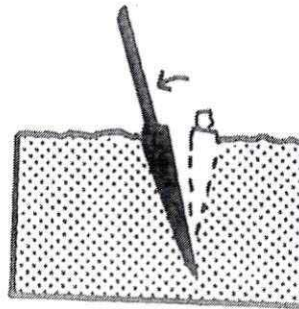
2. Pull flat bar backward to open hole.

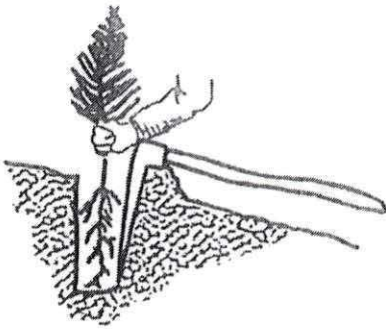
3. Place seedling while using hoe to hold back soil.

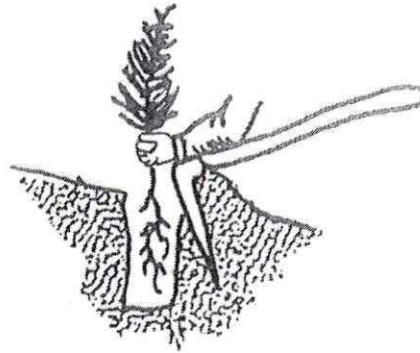
4. Use hoe to pack soil at bottom of hole.

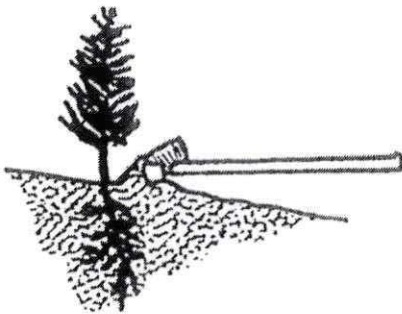
5. Use hoe to pack soil at top hole.

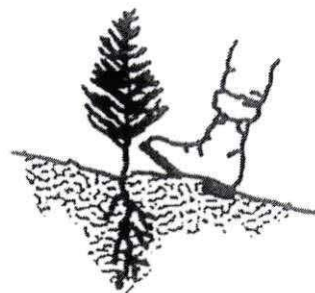
6. Firm soil around seedling with feet.

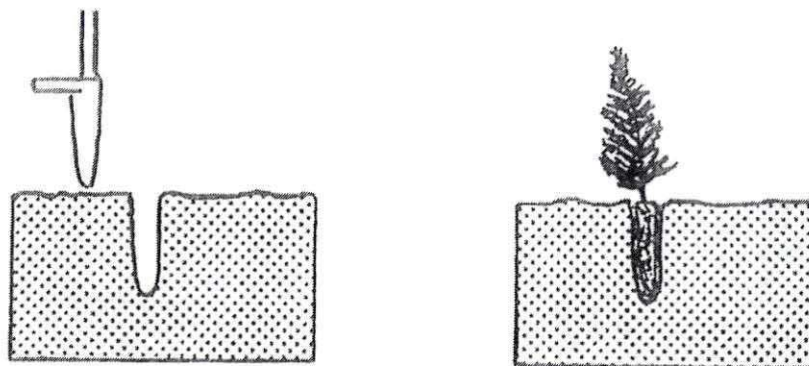
2. Remove plug bar and place seedling in hole.

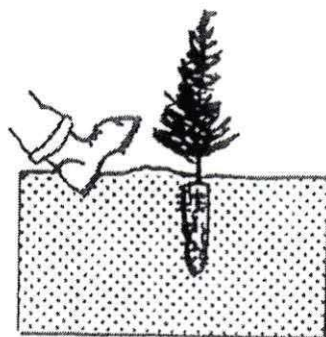
3. Firm soil around seedling with heel of boot.
