# Stansberry Creek Riparian Restoration

- Addendum -

## Restoration and Monitoring Plan for Replacement of Culverts

### Prepared for Safier Family Farms

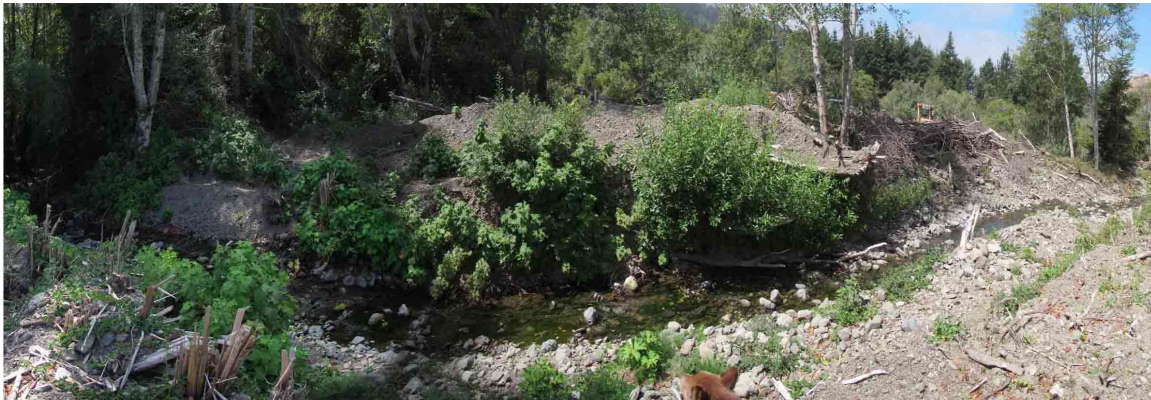
panorama by Thomas Dunklin - July 25, 2019

The progression of natural re-vegetation from 2019, 2021, 2024 are shown in the following panoramas:

Channel and Vegetation Conditions Before (above) and After (below) project implementation

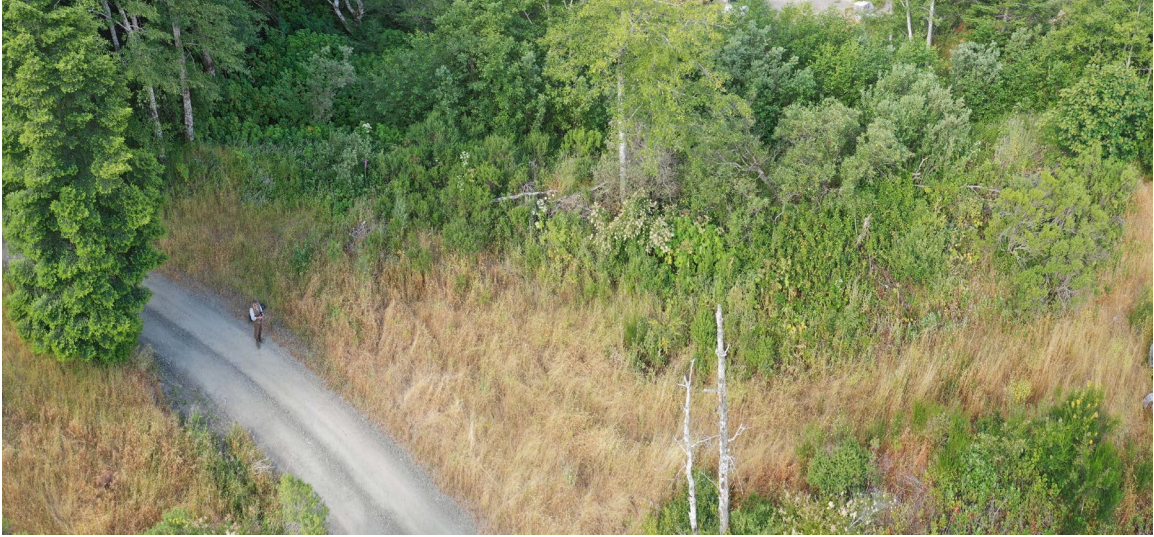
Pano by Thomas Dunklin

Aerial panorama of same project reach on June 20, 2024.

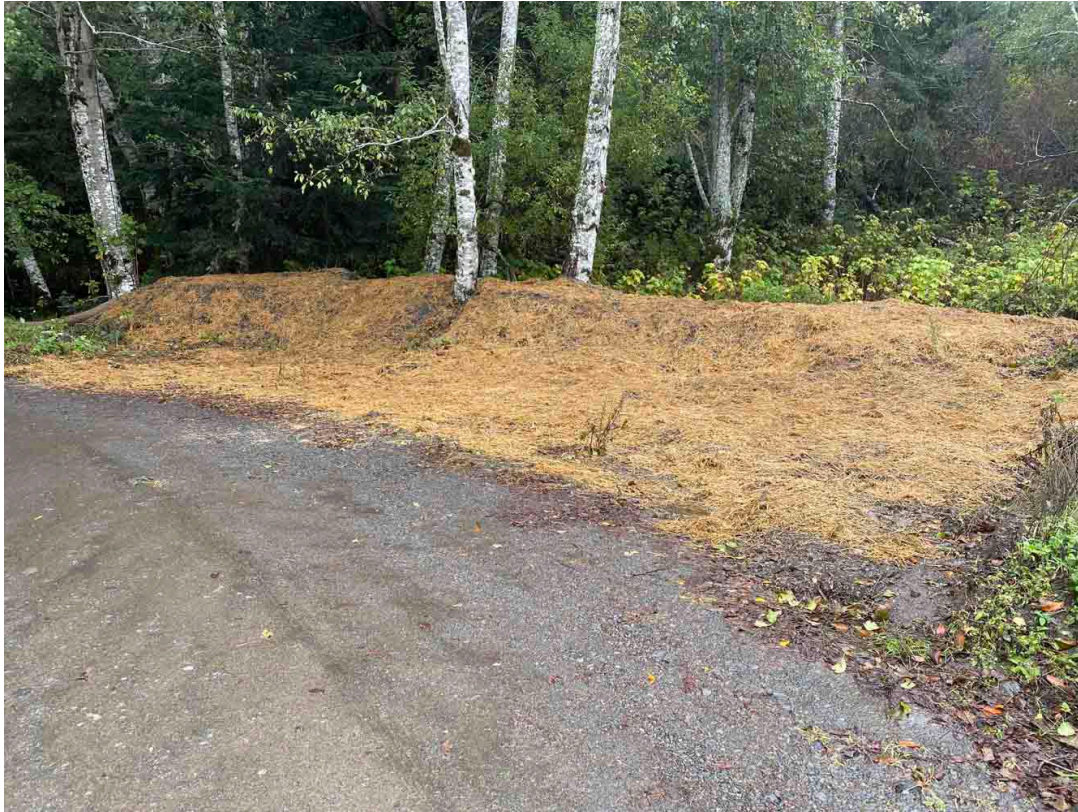
The photo below, taken in early October, 2021 shows the area graded and covered with straw mulch. The area was raised slightly, to prevent further

breaching during high flow/sediment yield events. I have confirmed that no other grading occurred, and that the measurements stated are accurate. (See photo on page 3, for aerial overview of work area). The area to the west of the channel had debris removed and wattles added, but no grading occurred.
