Aquatic Resources Delineation

Homestead Collective Weed Company (APN: 217-401-011)

August 2020

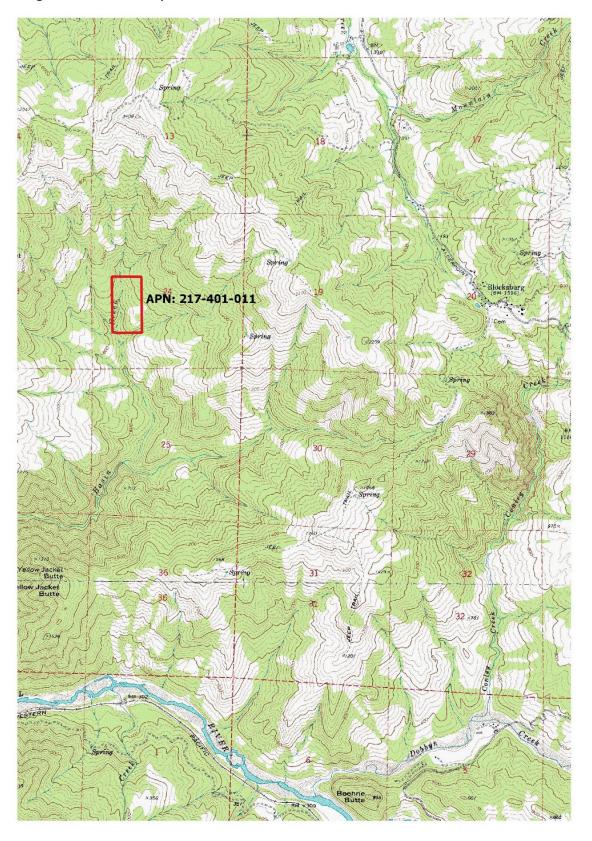
Figure 1. Location Map.

The parcel is located off Homestead Road approximately 2.3 miles west of Blocksburg on the Blocksburg USGS quadrangle (Section 24, T2S, R4E) in Humboldt County (Figure 1).

A 100-foot setback from the pond and 50-foot setbacks from the ephemeral streams are shown in Figure 1. The small wetland is over 130 feet from the cultivation area. Both *Humboldt County General Plan* (Humboldt County (2017) and *Cannabis Cultivation Policy* (State Water Resources Control Board 2019) require 50-foot setbacks from ephemeral watercourses. The pond is constructed, but now includes aquatic habitat that has a connection the adjacent stream. Approximately 368 square feet of the cultivation area is withing 100 feet of the pond. The northeast edge of the cultivation area is approximately 85 feet from the top of the bank of the pond. However, there is a road between the cultivation area and the pond, and the cultivation area is on the west side of the ridge (the pond is on the east side), thus any nitrogen rich runoff or other pollutants would move west towards Basin Creek away from the pond. It is the opinion of the consultant that moving a portion of the cultivation area is not necessary to protect the pond. Basin Creek is over 340 feet from the cultivation area.

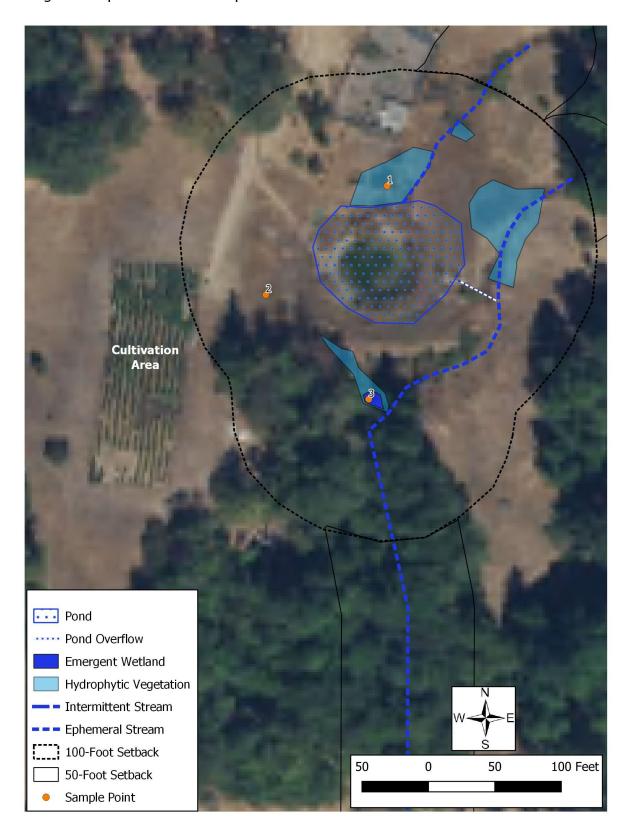
Figure 2. Aquatic Resources Map.

Aquatic features identified in the study area include a small wetland (approximately 100 square feet), two ephemeral streams, and the pond (Figure 2). There are additional areas that have hydrophytic vegetation, but do not meet the three-parameter wetland definition.

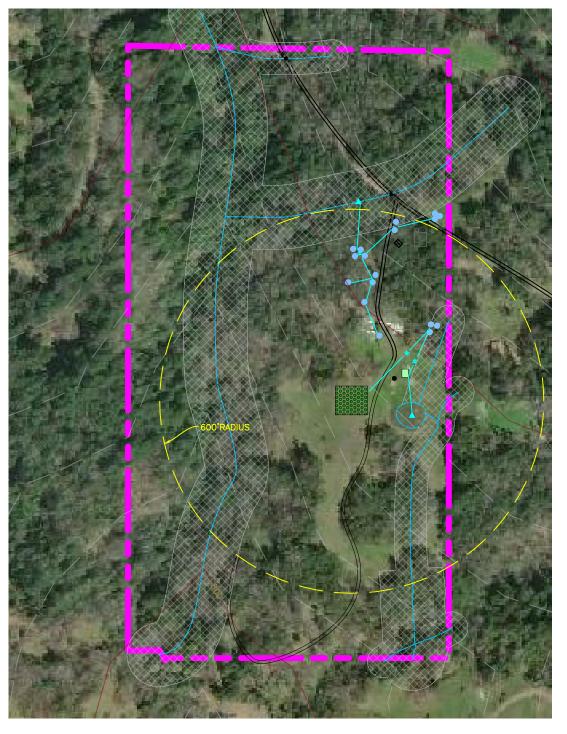
AERIAL MAP

PROPERTY LINES AND BUILDING LOCATIONS ARE APPROXIMATE AND BASED ON AERIAL MAPS AND GPS DATA TAKEN IN THE FIELD.

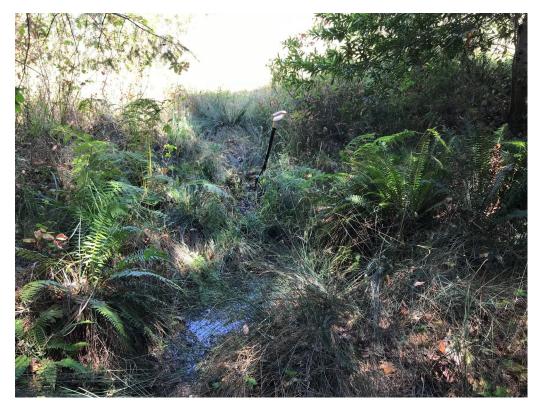
Photo 1. Small wetland near base of the pond levee.

The small wetland is near the base of the pond levee. The wetland has hydrophytic vegetation dominated by spreading rush (*Juncus patens* [FACW]) and poison oak (*Toxicodendron*

diversilobum [FAC]). Other plants include pennyroyal (Mentha pelugium [OBL]), lady fern (Athyrium filix-femina [FAC]), and velvet grass (Holcus lantaus [FAC]). There is a tree canopy over the wetland, but the trees are not rooted in the feature. The soil color was 10yr 4/1 with distinct and prominent 7.5yr 5/6 redox concentrations; this meets hydric soil indicator F3 (Depleted Matrix). The soil was saturated to the surface. There was also shallow surface water in a portion of the feature. Wetland hydrology indicators present included A1 (Surface Water), A2 (High Water Table), and A3 (Saturation). It was not clear if the water is groundwater or water leaking from the pond above.

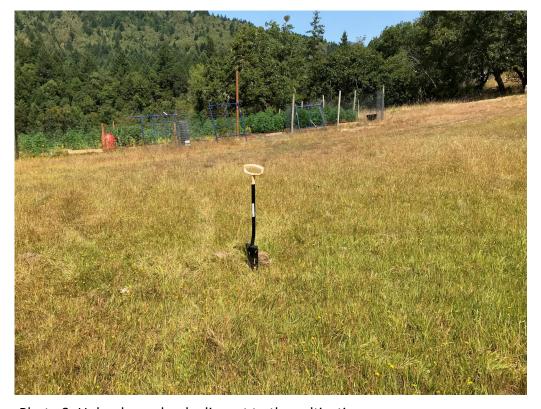
Photo 2. Upland grassland adjacent to the cultivation area.

The adjacent upland habitat includes grasslands and mixed conifer and hardwood stands. The grasslands are dominated by non-native herbaceous plants including sweet vernal grass (Anthoxanthum odoratum [FACW]), rough cat's-ear (Hypochaeris radicata [FACU]), and English

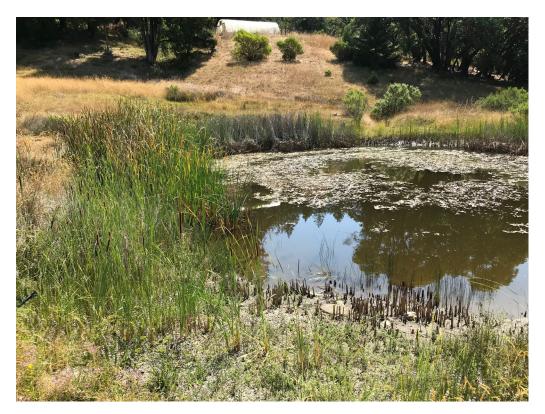
Photo 3. Pond with cattails and pondweed.

The pond had surface water and floating and emergent hydrophytic vegetation. Associated plants include pondweed (*Potamogeton* sp. [OBL]), cattail (*Typha latifolia* [OBL]), water plantain (*Alisma lanceolatum* [OBL]), spike rush (*Eleocharis* sp. [OBL or FACW]), and nutsedge (*Cyperus eragrostis* [FACW]). Google Earth images indicate the pond was constructed between 2006 and 2009. The 2006 image shows the stream channel that feeds the pond continuing south through what is now the pond and converging with the eastern stream, although the confluence is obscured by trees (Appendix D). The area appears to be upland other that the streams, with some associated vegetation, possibly spreading rush or stands of coyote brush, although the resolution of the photo is not adequate to make a definitive determination.

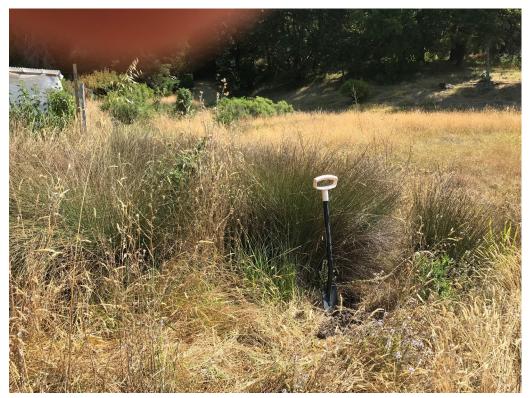
Photo 4. Stand of spreading rush (*Juncus patens*) in area that lacks other wetland indicators.

Approximately 5,008 square feet of area adjacent to the ephemeral streams has hydrophytic vegetation but lacks indicators of hydric soil or wetland hydrology. These areas are generally dominated by spreading rush (*Juncus patens* [FACW]). Other associated plants include pennyroyal (*Mentha pelugium* [OBL]), sweet vernal grass (*Anthoxanthum odoratum* [FACW]), Italian thistle (*Carduus pycnocephalus* [UPL]), and bull thistle (*Cirsium vulgare* [FACU]). The July site visit was in the dry season and lack of wetland indicators like saturated soil was expected. However, the *Regional Supplement to the Corps of Engineers Wetland Delineation Manual Western Mountains, Valleys, and Coast Region (<i>Version 2.0*) (Army Corps 2010) provides many other wetland hydrology indicators that can be used in the dry season. The soil color was 10yr 2/2 with no redox features or other indicators of hydric soil. It is likely these areas are wetter than adjacent areas with non-hydrophytic vegetation during periods with heavy rainfall, but the frequency and duration of soil saturation is not sufficient to create hydric soil, thus these areas do not meet the three-parameter wetland definition.
