Water Resource Protection Plan for APN 221-171-022 WDID# 1B161563CHUM

Humboldt County

Prepared by:
Alicia Heitzman
Natural Resources Management Corporation
1434 3rd Street
Eureka, CA 95501

August 21, 2017

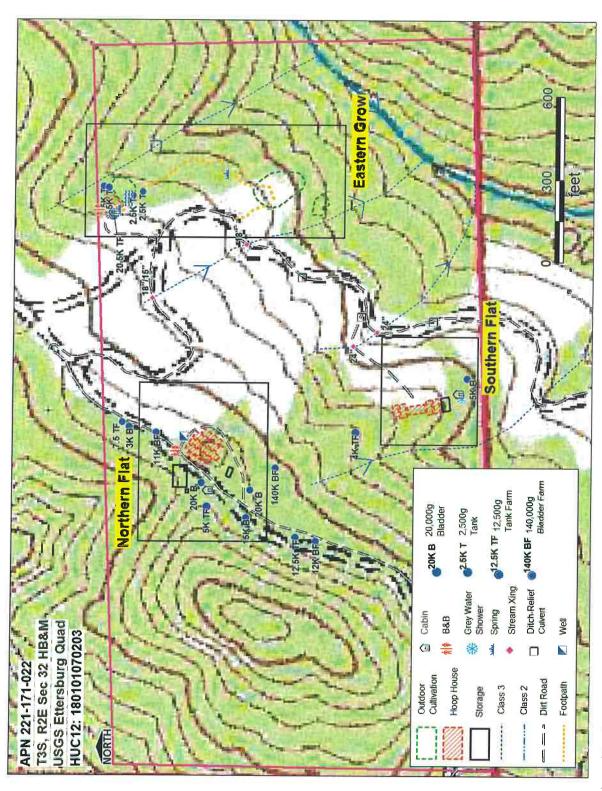
Figure 2. Cultivation areas on parcel 221-171-022

There is a total of ~26,000 square feet of cultivation for the 2017 season. This cultivation is split between two sites: the northern flat and the southern flat. On our initial site visit, in October 2016, there was a third cultivation site near the northeast property corner (picture 10), which was 23,800 square feet. This site was decommissioned for the 2017 cultivation season because of its proximity to a wetland and a portion of the outdoor plants being located on a hillside with a slope greater than 30%.

There are two cultivation flats on this property: the northern flat and the southern flat. The northern flat is made up of five hoop houses: two 20'x80', two 20'x100', and one 20'x120'. There are also five hoop houses on the southern flat: four 20'x50' and one 30'x65'.

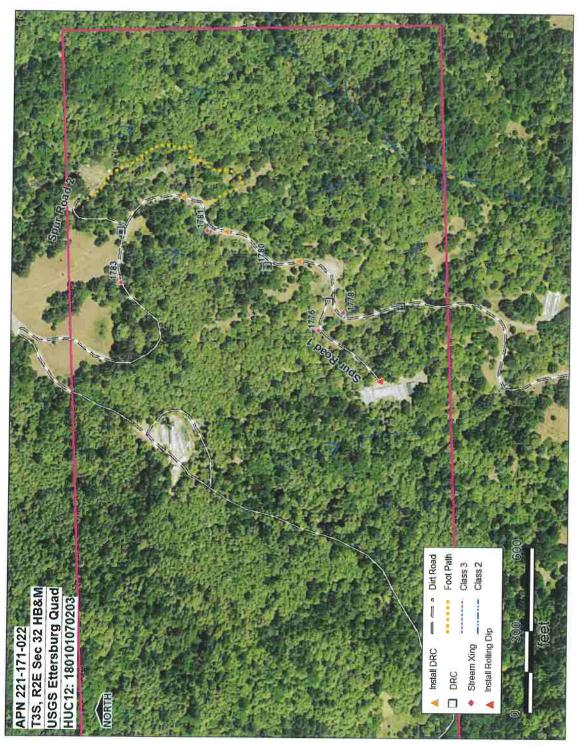
Figure 6. Road treatments required for parcel 221-171-022

Road treatments will consist of the installation of Rolling Dips and Ditch Relief Culverts (See Figure 6). Crooked Prairie Rd. will require treatment to 3 stream crossings on APN 221-171-022 (see Watercourse Crossings). Recommended road treatments for Crooked Prairie Rd, shown in figure 6, are as follows:

- Install DRC between Spur Road and existing DRC at GPS 1780
- Replace DRC at GPS 1780
- Install DRC between DRC at GPS 1780 and Stream Crossing at GPS 1781
- Install DRC between Stream Crossing at GPS 1781 and Thru-Cut road reach downroad of Spur Rd 2

Spur Rd 1 will require a rolling dip installation at the terrace / road transition and improvement to the non-functioning waterbar located uproad of the stream crossing GPS 1776.

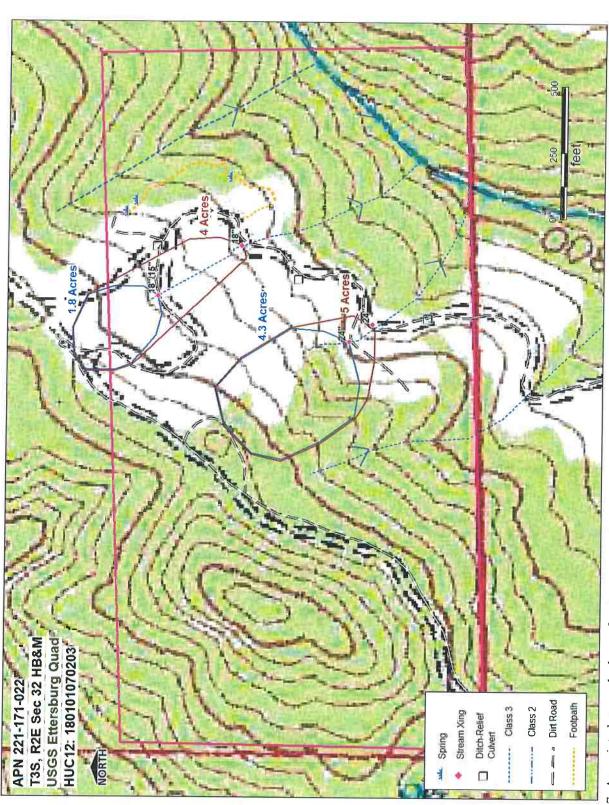
Figure 7. Associated watershed area for stream crossings on parcel 221-171-02

There are four watercourse crossings on this parcel. See Figure 2 & 7.

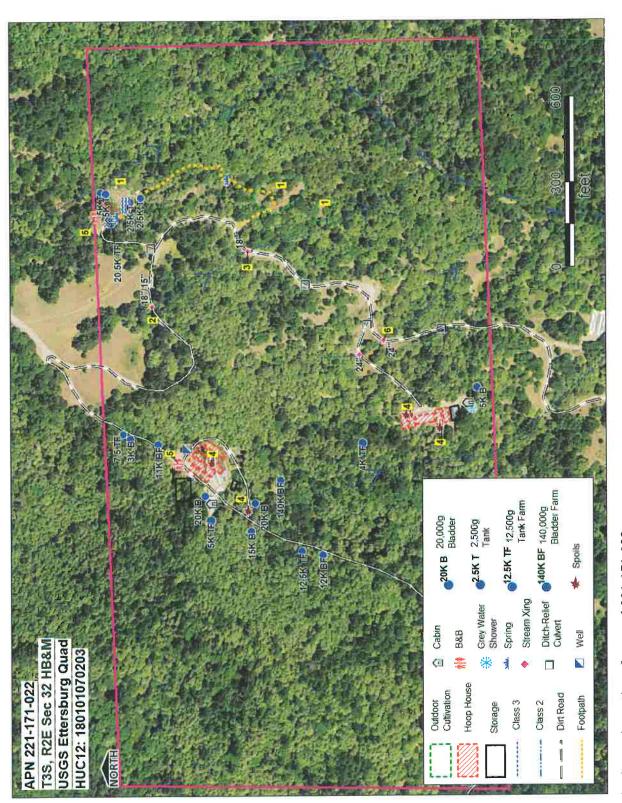
Figure 9. Corrective actions for parcel 221-171-022

Corrective Actions Please refer to Figure 9

- 1) On our initial site visit, in October 2016, there was a third cultivation site near the northeast property corner (picture 10), which was 23,800 square feet. This site was decommissioned for the 2017 cultivation season because of its proximity to a wetland and a portion of the outdoor plants being located on a hillside with a slope greater than 30%. These 23,800 square feet of cultivation will be relocated once a suitable location is secured on the property. By the end of 2018, all cultivation infrastructure will have been removed. We believe the area will revegetate on its own once infrastructure is removed. The area will be checked in the spring of 2018 by a qualified botanist. If additional replanting is deemed necessary it will be prescribed by a qualified botanist and implemented during the winter of 2018.

- 2) This stream crossing (pictures 1-5) is currently a Class 3 stream crossing with a culvert that is two different pipes: an 18" CMP at the inlet and an (approximately) 15" steel casing at the outlet. The inlet is crushed, rusted and partially plugged. Moreover, CulvertQ analysis recommends an 18" culvert to accommodate the predicted discharge associated with a 100-year flood event (Table 1).

- 3) This stream crossing is currently a Class 3 stream crossing with an 18" culvert. According to CulvertQ analysis, this pipe is properly sized to accommodate the predicted discharge associated with a 100-year flood event (Table 1). The culvert inlet, however, was crushed by a grader in late Spring of 2017. Also, the outlet was fitted with a sheet metal downspout that is currently failing and allowing the road to be eroded at the outboard edge. Finally, the stream has been able to divert into the ditch (road-right) in the past.

- 4) On the initial site visit in October 2016, this property had trash piles, spoils, cultivation waste, and uncontained fuel that needed to be addressed. There were also some damages from the harsh winter; a shed was crushed by a falling tree (picture 9). As of May 2017, all of these issues have been addressed and secondary containment has been implemented all over the property.

- 5) The landowner is in the process of getting the necessary permits to build a house with a septic system; until then all outhouses will be serviced regularly and prepared for the winter months when not in use.

- 6) This stream crossing is currently a Class 3 stream crossing with a 24" culvert. According to CulvertQ analysis, this pipe is properly sized to accommodate the predicted discharge associated with a 100-year flood event (Table 1). The culvert inlet, however, has a diversion potential into the dich at the right bank. There is also excessive brush at the inlet increasing the potential for culvert plugging and stream diversion. The outlet is currently a shotgun with a 4-5-foot vertical drop, actively eroding the road fill below the outlet and the left bank downstream. Due to the diversion potential, the brush will be cleared for 10 feet of channel length upstream and around the inlet. Additionally, rock armor will be applied at the inlet to protect the Inboard Edge of Road. Because the CMP is properly sized, the treatment at the outlet will be to attach a 6-foot downspout and apply rock armor at the terminus of the downspout and at the left bank downstream.

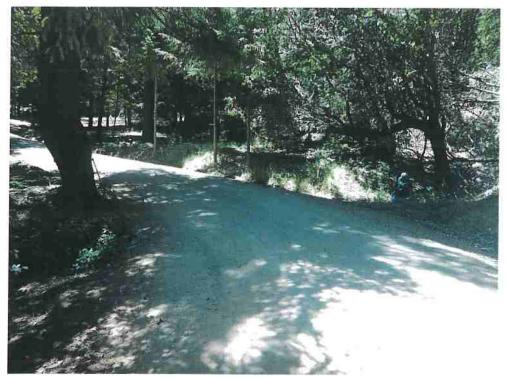
Picture 1. Center line profile of 18"/15" stream crossing

Stream crossing 1783 (pictures 1-5) is currently a Class 3 stream crossing with a culvert that is two different pipes: an 18" CMP at the inlet and an (approximately) 15" steel casing at the outlet. The inlet is crushed, rusted and partially plugged. Moreover, CulvertQ analysis recommends an 18" culvert to accommodate the predicted discharge associated with a 100-year flood event (Table 1).

Due to the poor condition and inadequate capacity of the culvert, the crossing will be upgraded with a new 18-inch diameter corrugated culvert. The existing pipe will be removed and disposed of and the new pipe will be installed at a slightly steeper grade. This excavation will require disturbance to 30 ft. of channel length and 4.5 feet of channel / riparian width, resulting in 135 ft² of areal disturbance. The excavation material is road fill. This project can be completed in 1 working day.

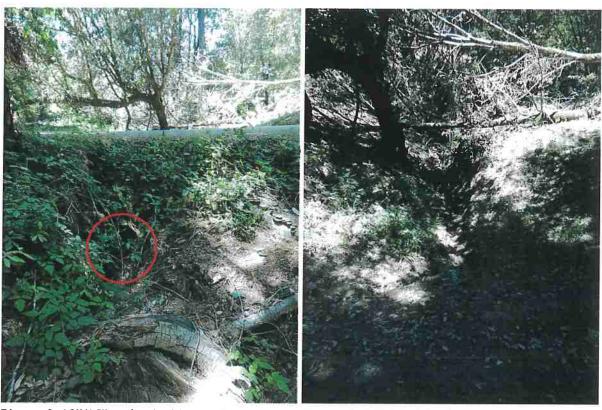
Picture 2. 18"/15" outlet, looking upstream

Picture 3. 18"/15" inlet, looking upstream

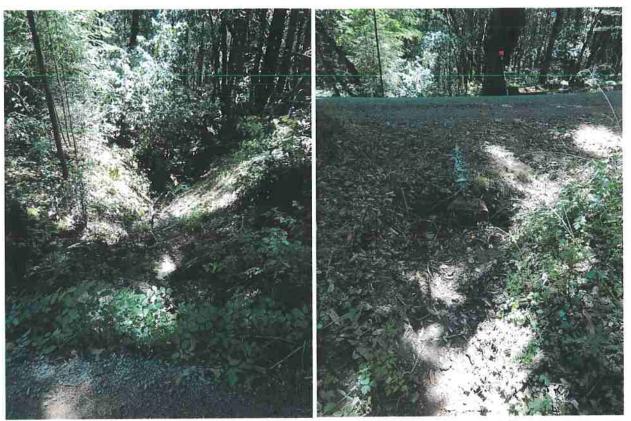
Picture 4. 18"/15" outlet, looking downstream

Picture 5. 18"/15" inlet, crushed, looking downstream

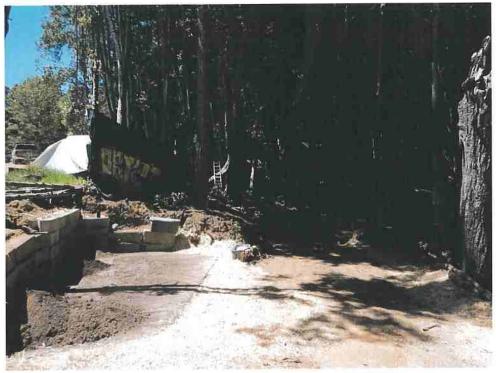
Picture 6. Containment area for all soils (6/14/17)

The only permanent structures are three cabins (picture 7); one on each of the cultivation sites, and a metal storage/drying warehouse on the southern flat. There are no spoils piles that present a hazard to water quality on the property; all loose soil is contained in the largest storage area on the northern flat (picture 6).

Currently, this property is kept in decent shape; spoils are contained properly (picture 6), all generators and pumps are equipped with secondary containment, and all active cultivation areas comply with stream buffers. The eastern cultivation site is in the process of having all infrastructure removed. The landowner is in the process of getting the necessary permits to build a house with a septic system; until then all outhouses will be serviced regularly and prepared for the winter months when not in use.

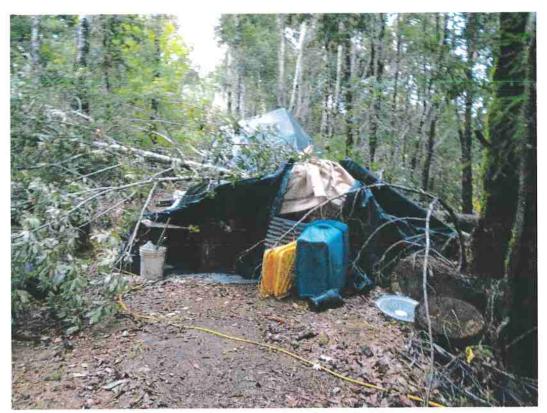
Picture 9. Shed damaged by storm (10/25/16)

On the initial site visit in October 2016, this property had trash piles, spoils, cultivation waste, and uncontained fuel that needed to be addressed. There were also some damages from the harsh winter; a shed was crushed by a falling tree (picture 9). Two outhouses were being used for human waste.

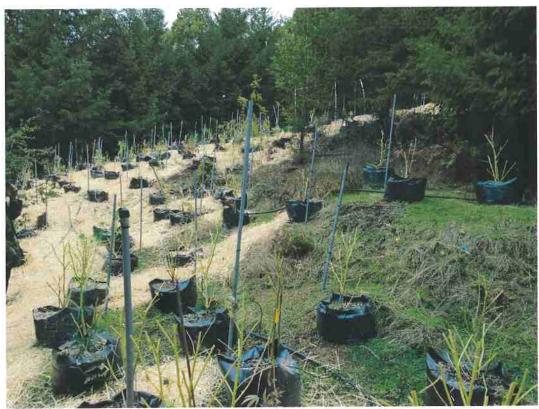
Picture 10. 'Eastern grow' that was discontinued (10/25/16)

On our initial site visit, in October 2016, there was a third cultivation site near the northeast property corner (picture 10), which was 23,800 square feet. This site was decommissioned for the 2017 cultivation season because of its proximity to a wetland and a portion of the outdoor plants being located on a hillside with a slope greater than 30%. These 23,800 square feet of cultivation will be relocated on to the existing flats.
