Aquatic Resources Delineation

APNs 107-103-014 & 107-103-015

May 14, 2020

Prepared for:
Valentin Valkov

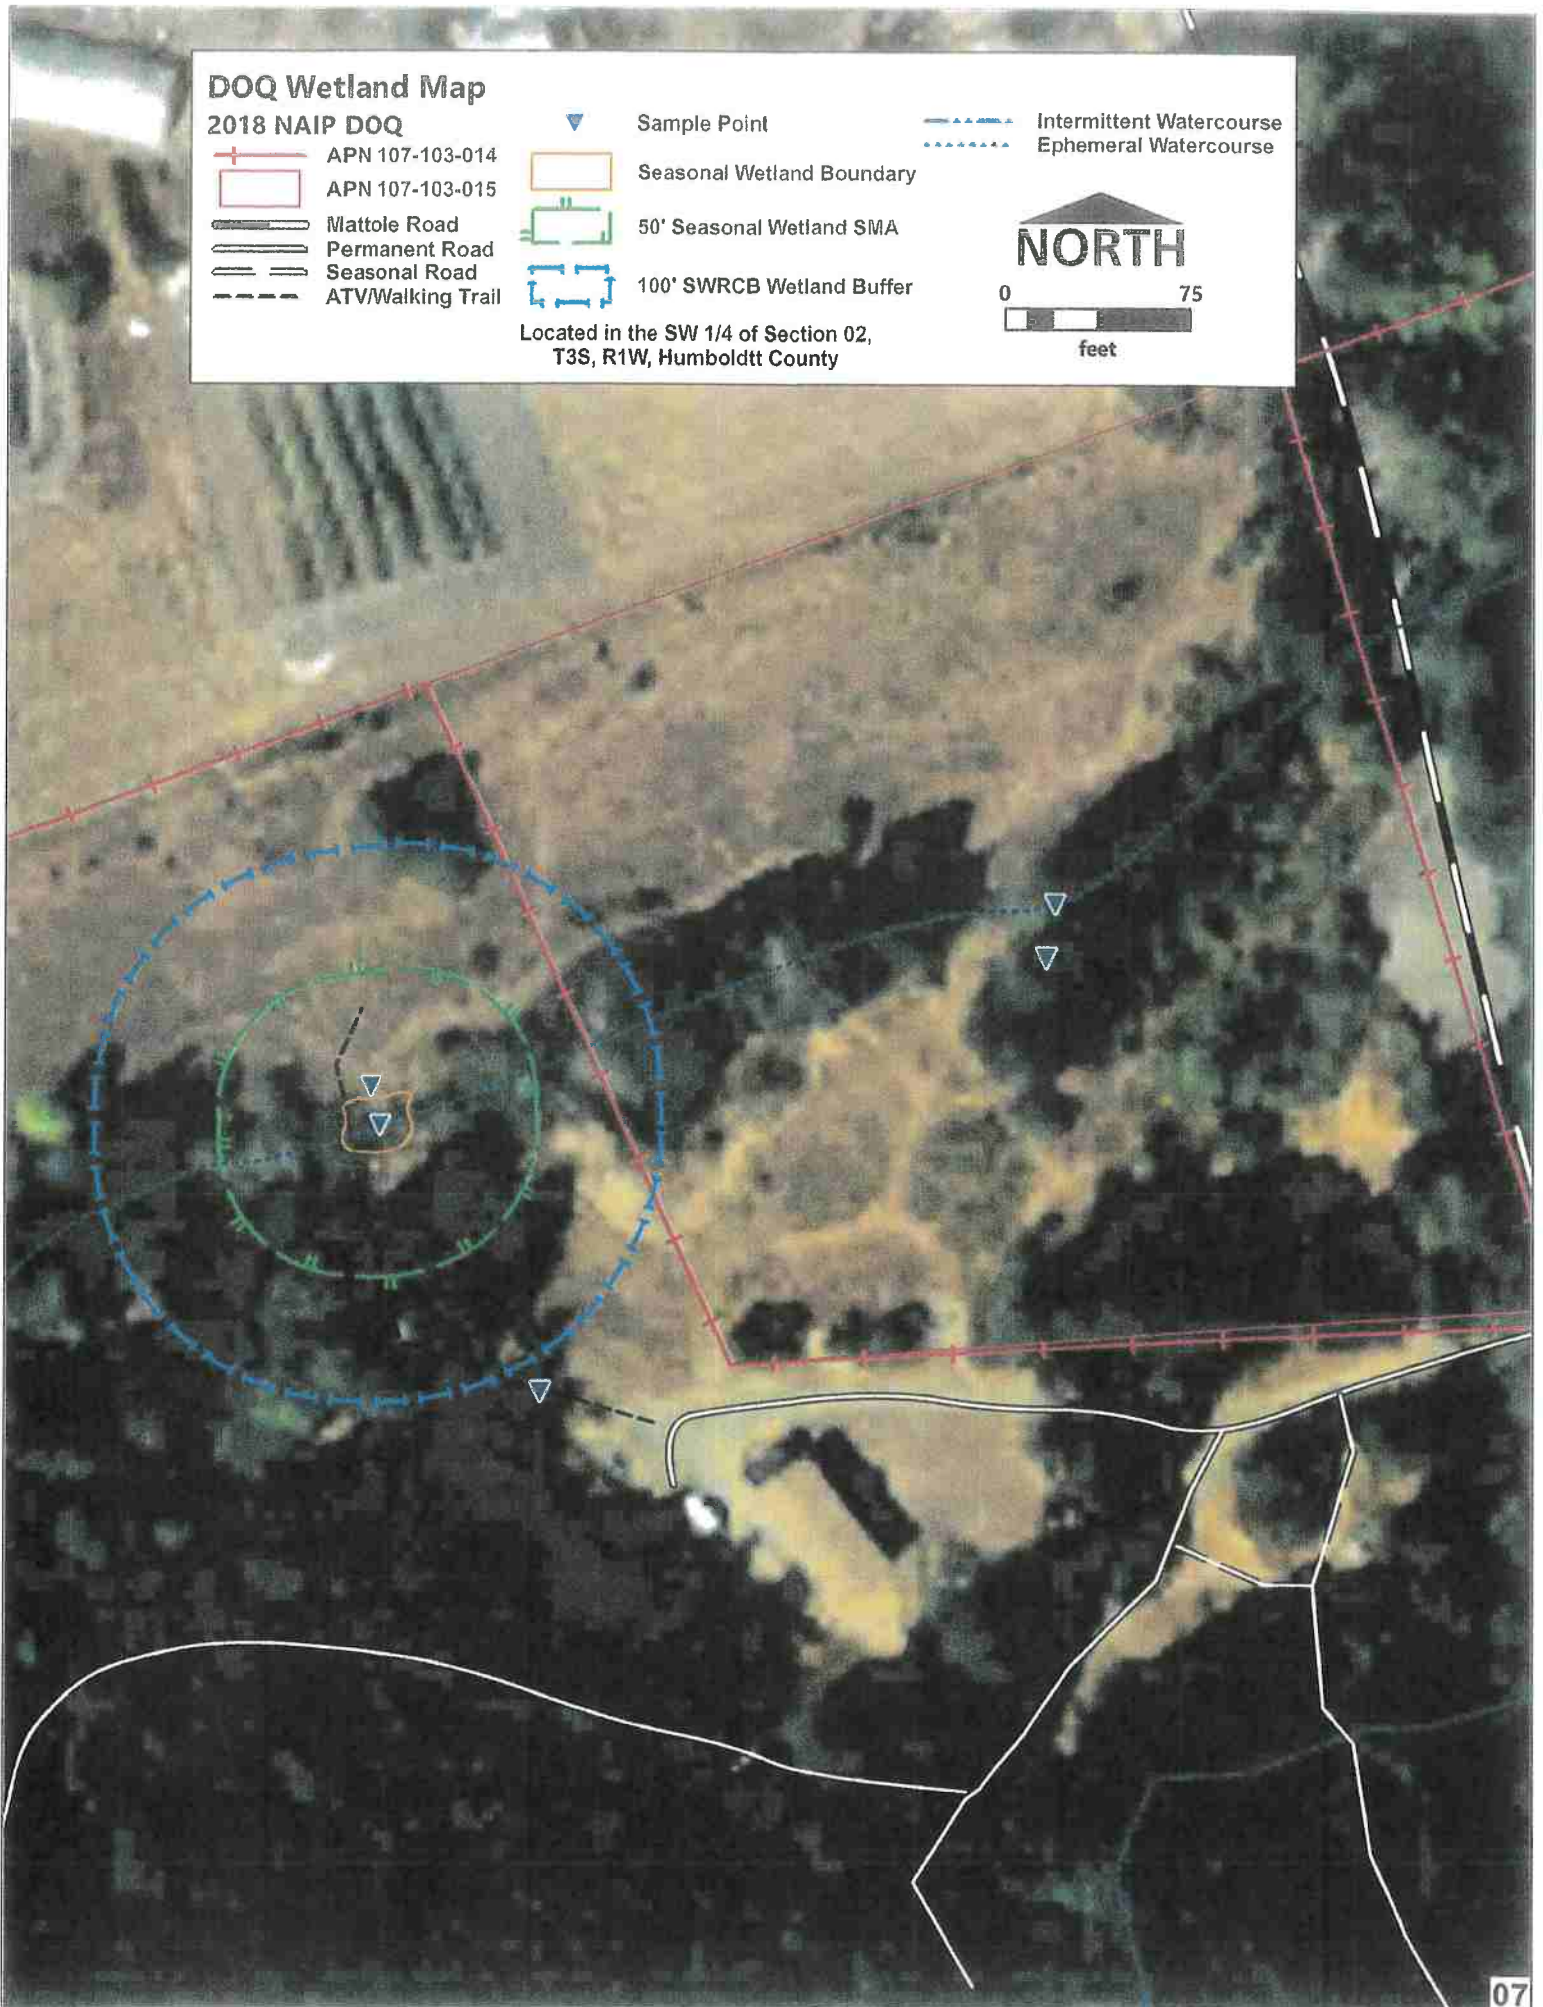
DOQ Wetland Map

Sample Point

Seasonal Wetland Boundary

50' Seasonal Wetland SMA

100' SWRCB Wetland Buffer

Intermittent Watercourse
Ephemeral Watercourse

SP #1 and #2 delineated a suspected wetland in a dispersed community of soft rush located along an ephemeral watercourse. The location is a historic dirt ford crossing that is no longer in use. Historic stream crossing of this location may have resulted in unnatural soil compaction; however the crossing appears to have not been used in the last 10 years. SP #1 occurred within the active channel of the watercourse. This SP identified all three parameters indicative of a wetland. SP #2 occurred in grassland habitat outside of the ephemeral channel. SP #2 identified upland vegetation with soils that displayed very low (1%) densities of iron concentrations and only one secondary hydrology indicator. SP #2 delineated the boundary between wetland and moist soil meadow. Nonnative, facultative grasses were present at all sample points. Dominance of soft rush was used to delineate the boundary between wetland and upland habitats.

SP #3 and #4 assessed a second historic dirt ford crossing on an unnamed ephemeral watercourse approximately 270' downstream of SP #1. SP #3 did test positive for wetland hydrology and hydric soils but failed to display dominant wetland vegetation. Neither of these points met the three parameters that define a wetland.

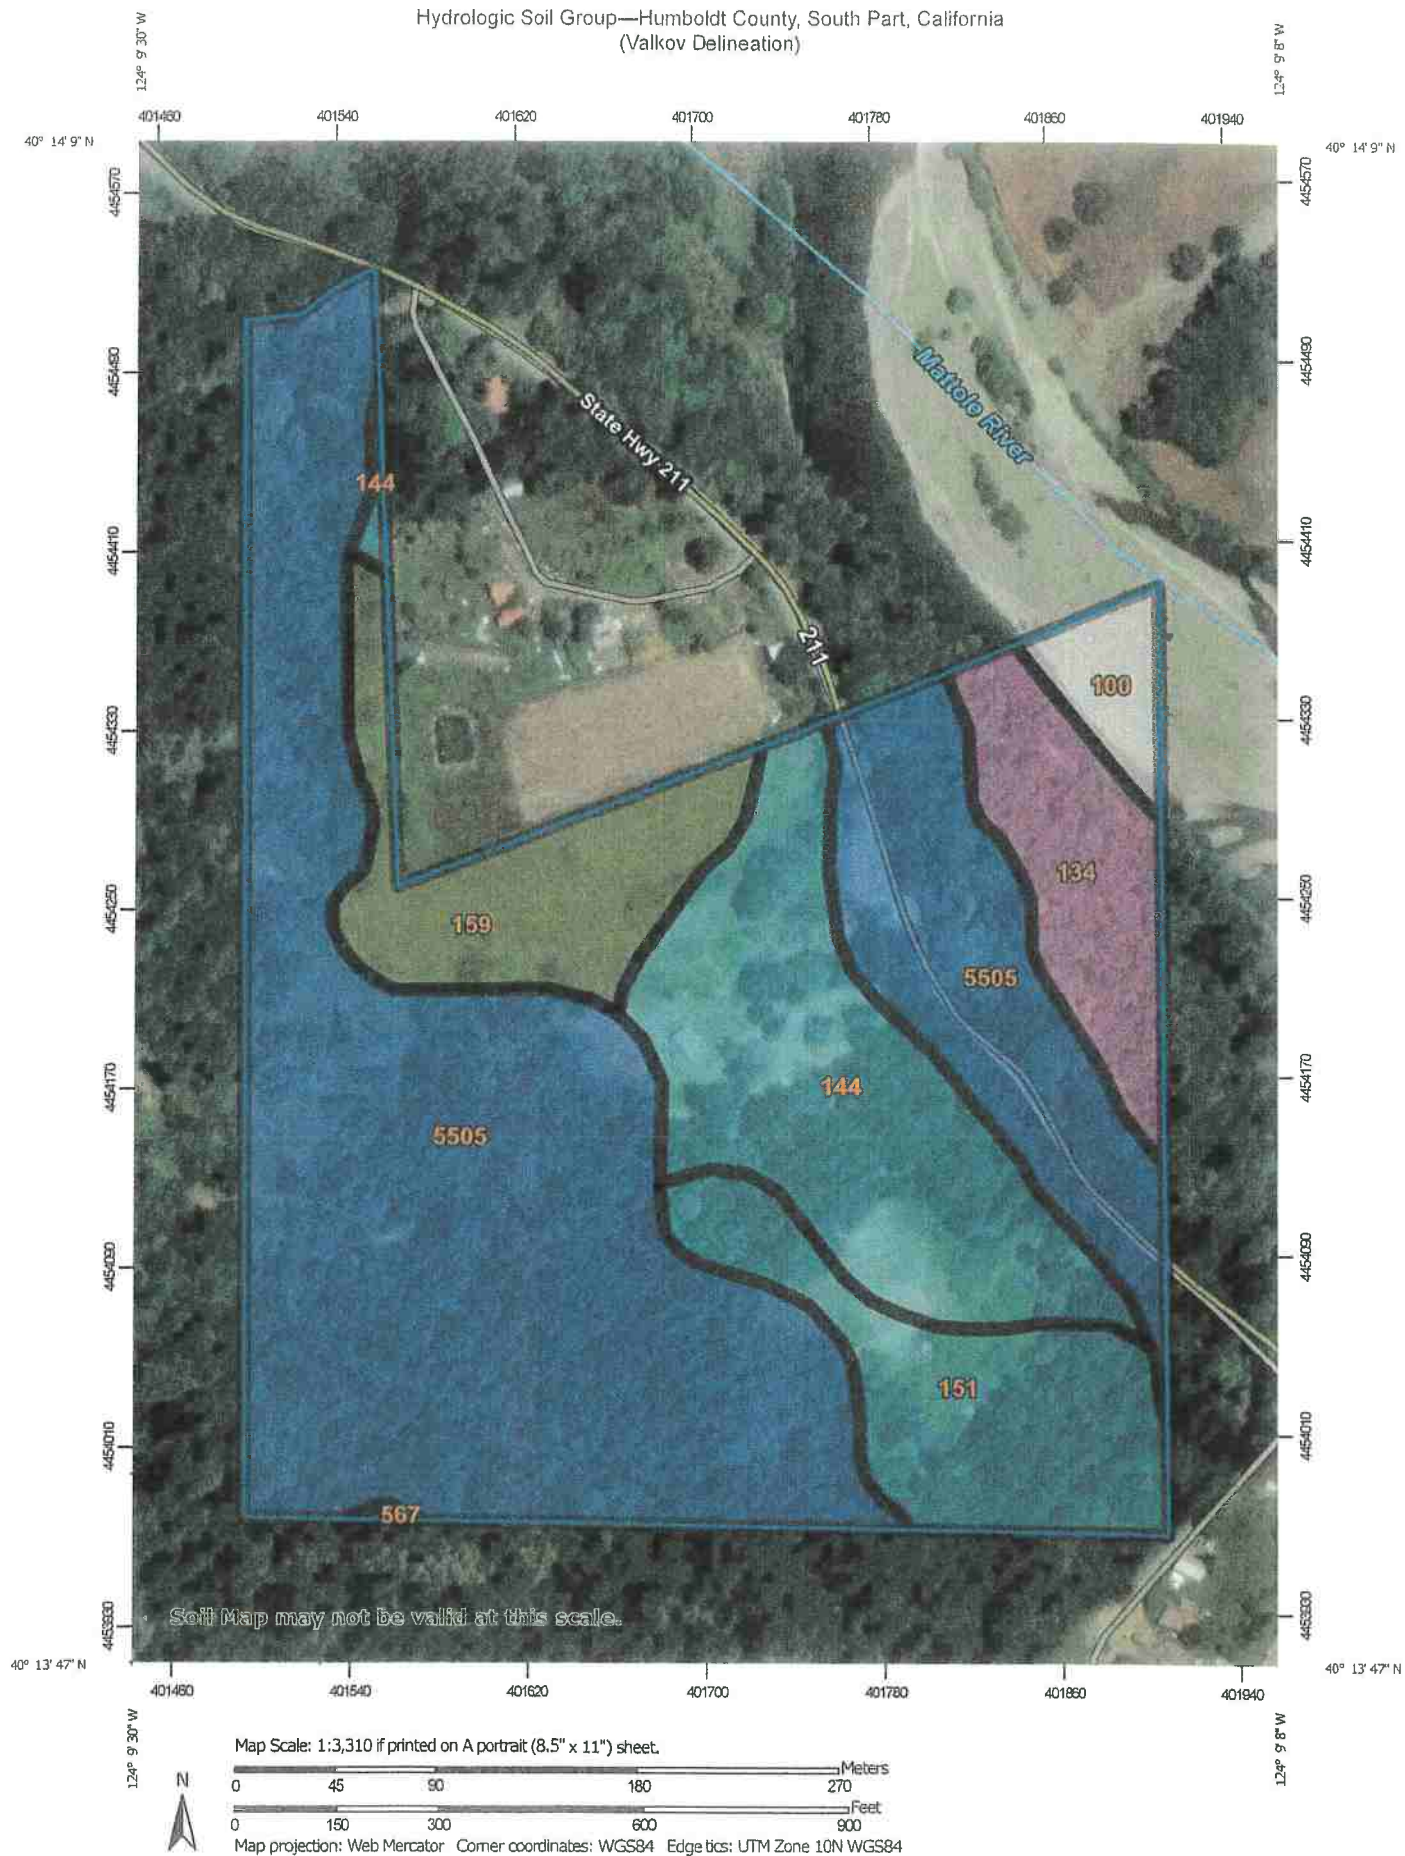
Hydrologic Soil Group—Humboldt County, South Part, California (Valkov Delineation)

Hydrologic Soil Group

| Map unit symbol | Map unit name | Rating | Acres in AOI | Percent of AOI |
|---|--|---|---|---|
| 144 | Garberville-Parkland complex, 0 to 2 percent slopes | C | 6.6 | 16.9% |
| 159 | Grannycreek-Parkland complex, 2 to 5 percent slopes | C/D | 3.3 | 8.5% |

SP #1 and #2 occurred in Grannycreek-Parkland complex while SP #3-#5 occurred within Garberville-Parkland complex. Soils at the sample points generally displayed dark colors with some areas of dark brown shading. Silt clay loam was the dominant soil texture encountered at many sample points. Iron concentrations were the most prominent redox features observed, with some nonhydric soils containing small amounts.
