## TECHNICAL MEMORANDUM

RID# 1 Lot LK, Wetland Assessment and Stream Setback Establishment  
Assessor's Parcel Number 111-118-006

Project No.: 7912.02

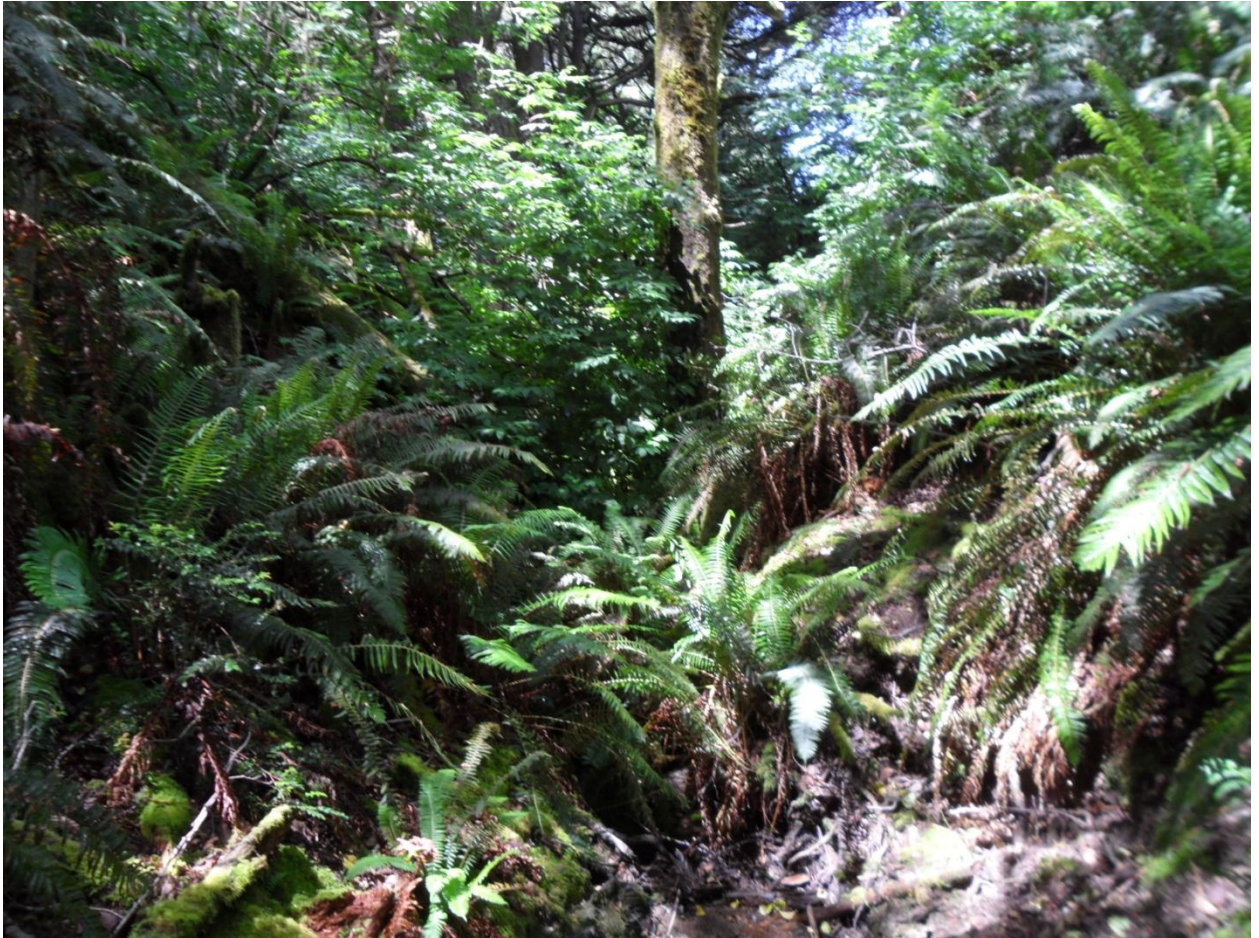
The prominent vegetation occurring at the Project Site is Douglas-fir (*Pseudotsuga menziesii*) forest. Canopy cover is approximately 90 to 100 percent young trees (about 30 years old) up to 24 to 30 inches in diameter at breast height. Forest understory is sparse, with native vegetation represented by widely scattered associated native shrub and herbaceous cover of thimbleberry (*Rubus parviflorus*), red elderberry (*Sambucus racemosa* var. *racemosa*), California blackberry (*Rubus ursinus*), sword fern (*Polystichum munitum*), cow parsnip (*Heracleum maximum*), spring beauty (*Claytonia siberica*), sweet cicely (*Osmorhiza berteroi*), coastal hedge nettle (*Stachys chamissonis*), and bitter-cress (*Cardamine oligosperma*). Ground cover was visually estimated at 20 to 5 percent. Herbaceous forest ground cover was visually estimated at 15 percent, including the horticultural escape, London pride (*Crassula multicaeva*). The forest cover extends all the way to the creek bank from Upper Pacific Drive to the Shelter Cove Golf Course. There is no developed riparian along the upper creek banks (Appendix 1, Figure 2, Appendix 2, Photo 1).

The intermittent creek channel is deeply incised in the upper 550 feet of the Project Site. The creek channel is almost 30 to 40 feet elevation below the upper portion of the parcel at Upper Pacific Road. The creek channel is approximately 10' wide bank to bank, with little or no riparian vegetation establishment. A 100' rag tape was used to measure up from the creek bank using vertical distance slope correction to determine horizontal distance (corrections were applied to slopes of up to 25%). Up to 8 locations opposite the creek channel were measured to 50' horizontal distance upslope towards the clearing and were flagged in the field (50' setback as shown in Figure 2). An additional 100' flag line was also marked in the field (nearly level, where measured tape distance equaled horizontal distance). Because of the isolation of the upper portion of the Project Site from the natural creek processes, and the very limited extent of the on-site riparian habitat (less than 100' in width) and the intermittent nature of the creek, a 50-foot setback from the existing top of bank is more than adequate.

**Photo1: Typical stream channel, note very little riparian development (adjacent upland sword fern/Douglas-fir habitat)**

1. Due to the very low-grade value of the on-site riparian habitat, a 50-foot setback from the existing intermittent creek is more than adequate to protect riparian habitat from degradation.

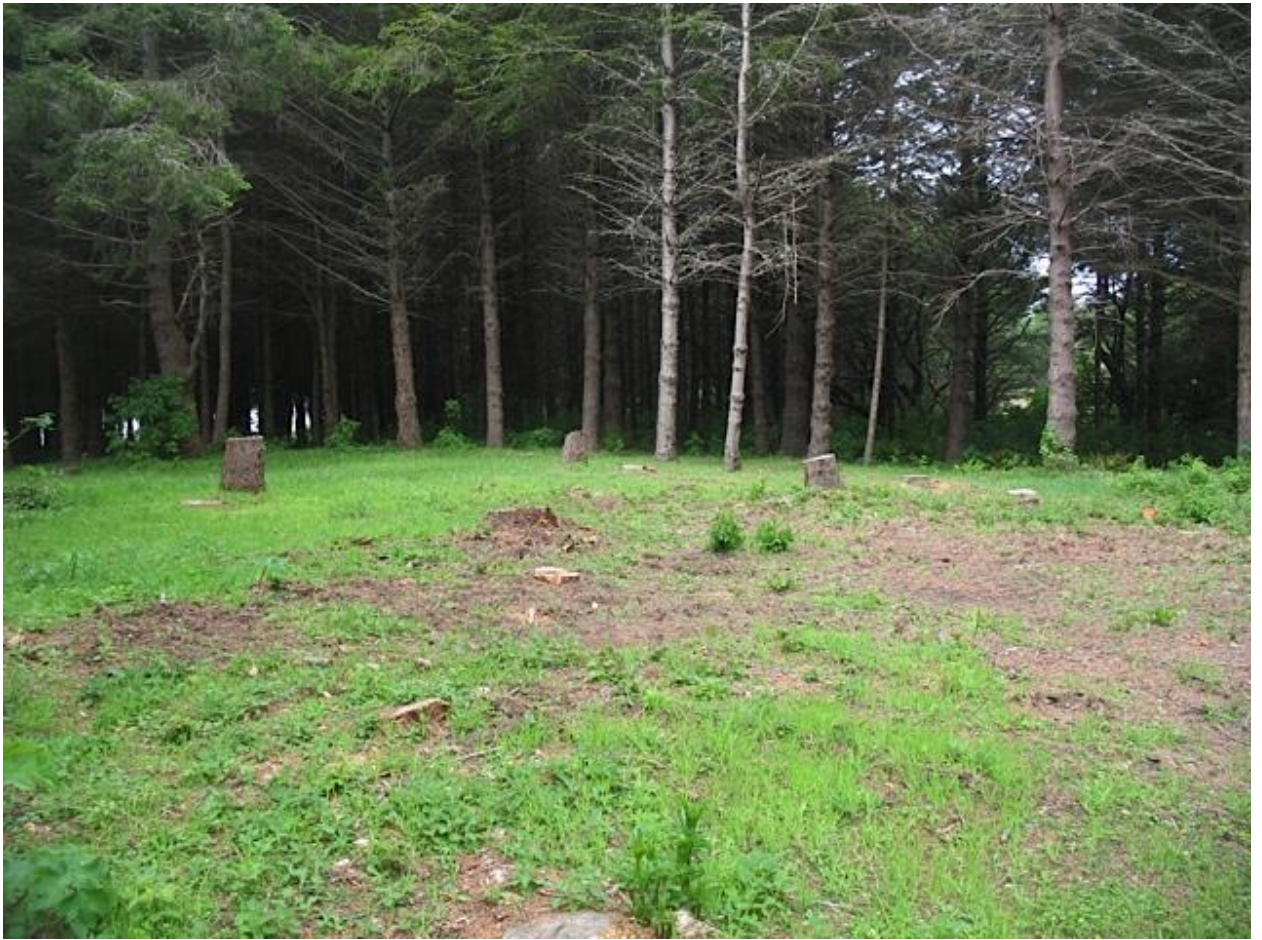
A small clearing of approximately 0.5 acre has been recently established (post August 23, 2012, on Google Earth) on the upper side of the parcel immediately adjacent to Upper Pacific Drive. An effort was made to locate any evidence of seasonal wetlands in the clearing. Signs were searched of dominant hydrophytic vegetation, occurrence of hydric soils or evidence of long standing water or the presence of high groundwater. None of these features, characteristic of coastal wetlands, were located in the cleared area (Appendix 2: Photo 2). The cleared area vegetation is dominated by non-native pasture grasses, including velvet grass (*Holcus lanatus*), sweet vernal grass (*Anthoxanthum odoratum*), tall quaking grass (*Briza maxima*), rescue grass (*Bromus catharticus*), Kentucky bluegrass (*Poa pratensis*), coastal hedge nettle, tall fescue (*Festuca arundinacea*) with associated herbaceous cover of English plantain (*Plantago lanceolata*), English daisy (*Bellis perennis*), wild oats (*Avena barbata*), scarlet pimpernel (*Anagallis arvensis*), bull thistle (*Cirsium vulgare*), California blackberry, bur clover (*Medicago arabica*), dandelion (*Taraxacum officinale*), perennial cat's ear (*Hypochaeris radicata*), bracken fern (*Pteridium aquilinum* var. *pubescens*), sheep sorrel (*Rumex acetocella*), and cut-leaved geranium (*Geranium dissectum*). Ruderal vegetation ground cover coverage was visually estimated at 90 to 100 percent. None of the dominant plant species or clusters of plants were indicators of wetlands. Coastal hedge nettle and California blackberry can occur in wetlands (FACW, Lichvar, et. al. 2014) but each appear to be acting as a weedy natives in this location. A soil pit dug near a coastal hedge nettle population was non-hydric, having only 2" of very dark brown (10YR 2/2) soil at the surface, with dark gray brown (10YR 4/2) soils to 10", yellowish brown (10YR 5/4) soils to 21" and pale brown (10YR 6/3) soils to 28" and having no redoximorphic features throughout the investigated soil column. Additional soil pits were dug throughout the clearing but all soils showed characteristics similar to the original pit, being non-hydric. There were no visible signs of standing water

detected (algal mats, cracking soils, bare soil, drift lines) or evidence of high groundwater (no redoximorphic soil features).

**Photo 2: Upper clearing, with uniform upland grasslands, with no evidence of hydrophytic vegetation**

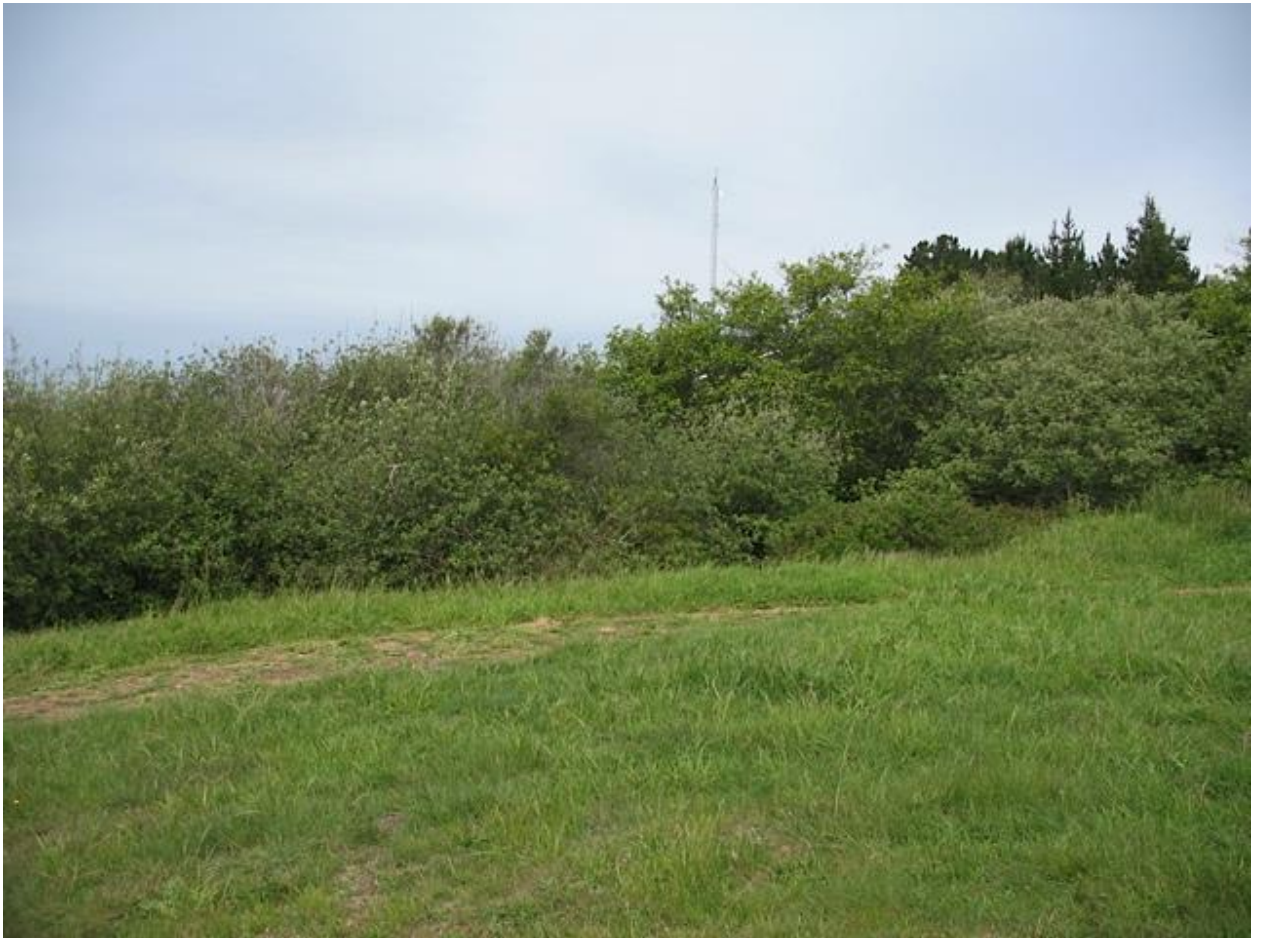
A small patch of riparian habitat (Appendix 1: Figure 2, Appendix 2: Photo 3) occurs at the furthest northwest edge of the property and consists of mature red alder (*Alnus rubra*), Pacific willow (*Salix lasiandra* var. *lasiandra*), and arroyo willow (*Salix lasiolepis*), with scattered understory of Oregon ash (*Fraxinus latifolia*), California blackberry, stinging nettle (*Urtica dioica*), lady fern (*Athyrium filix-femina*) and Italian thistle (*Carduus pycnocephalus*). The riparian vegetation borders the lower end of the intermittent creek. The majority length of the creek is vegetated mostly with Douglas-fir with widely scattered red alder. There is little or no established riparian habitat the length of the creek channel above the willow stand that is associated with the dominant Douglas-fir forest cover.

**Photo 3: Willow riparian established on lower creek channel**
