**SUPPLEMENTAL INFORMATION
No. 1**

Re:	Applicant	Sky High Humboldt, LLC	Item No.: G-1
	Case Number	CUP16-450	
	Assessor Parcel Number	223-271-006

AS-BUILT GRADING, DRAINAGE & EROSION CONTROL PLAN

GRADING, DRAINAGE
& EROSION CONTROL PLAN

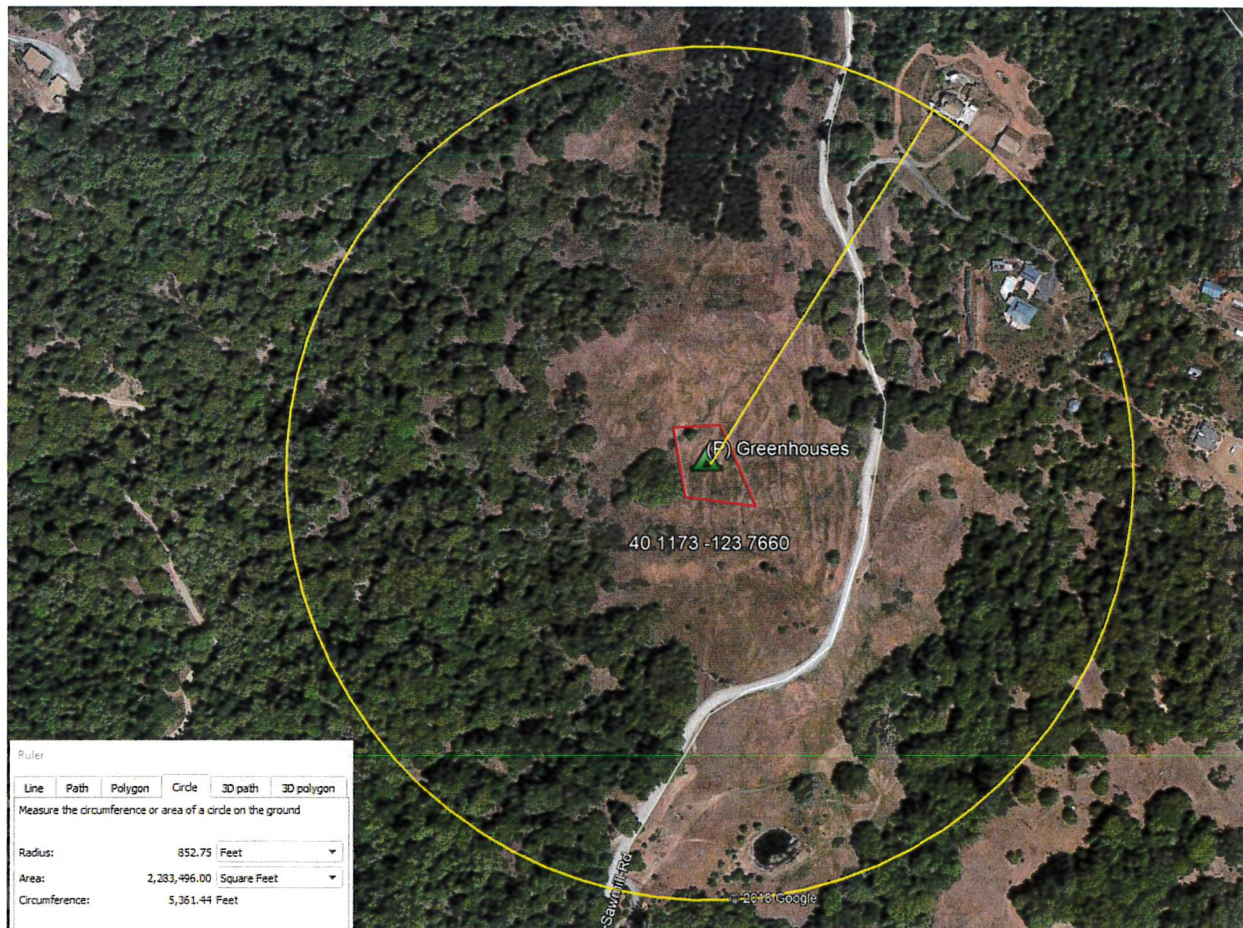
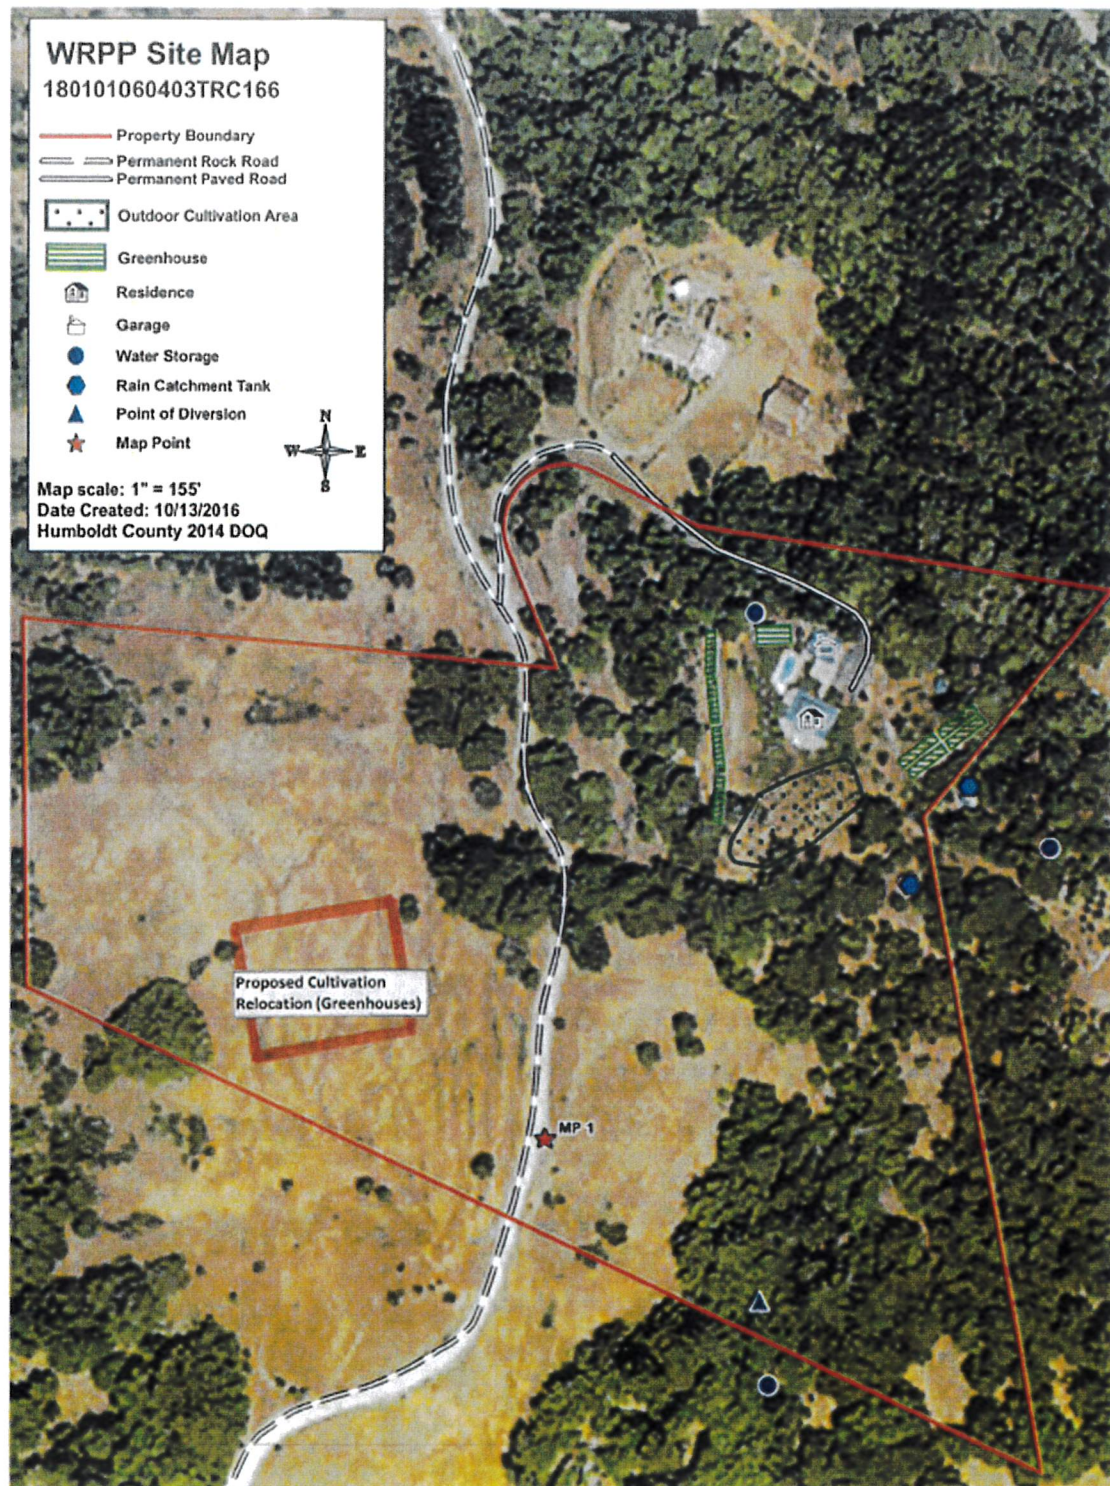
Below: Google Earth image (05/28/2014) showing proposed greenhouse location relative to surrounding features.

Above: The proposed cultivation relocation area outlined starts approximately 240 feet east of the western property line. It is apparent that there are no watercourses or wetlands within 200 feet of the cultivation relocation area.

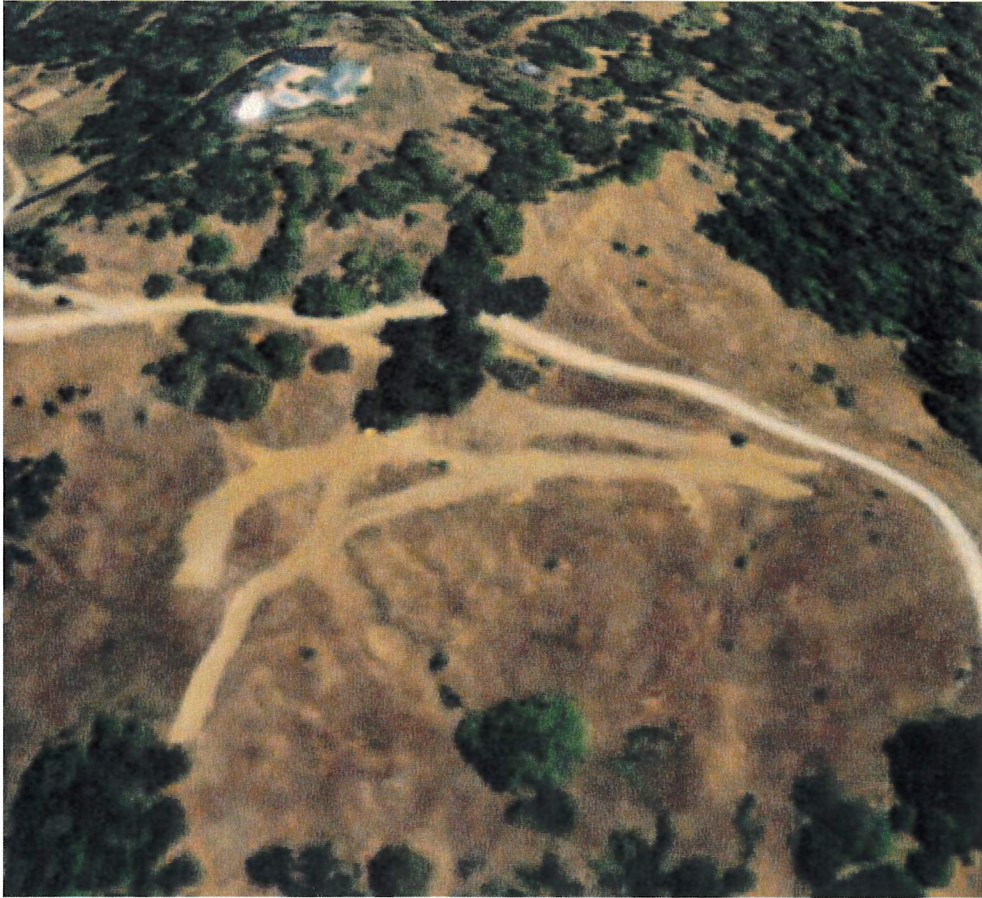
Photo. 2009 Aerial photo of proposed CA with extensive grading. GoogleEarth®

Development of the proposed CA is more environmentally superior because it occurs in a non-native grassland, which already has experienced degradation from historic grading (see map zoom and 2009 aerial imagery). This area provides little cover or forage for wildlife, occurs on a hot and exposed western slope, and was not shown to host wildlife through assessment of remote trail-camera footage and personal observations.
