FINAL REPORT • JANUARY 2018

# Preliminary Delineation of Waters and Wetlands for the Honeydew Ranch Property, Honeydew, California

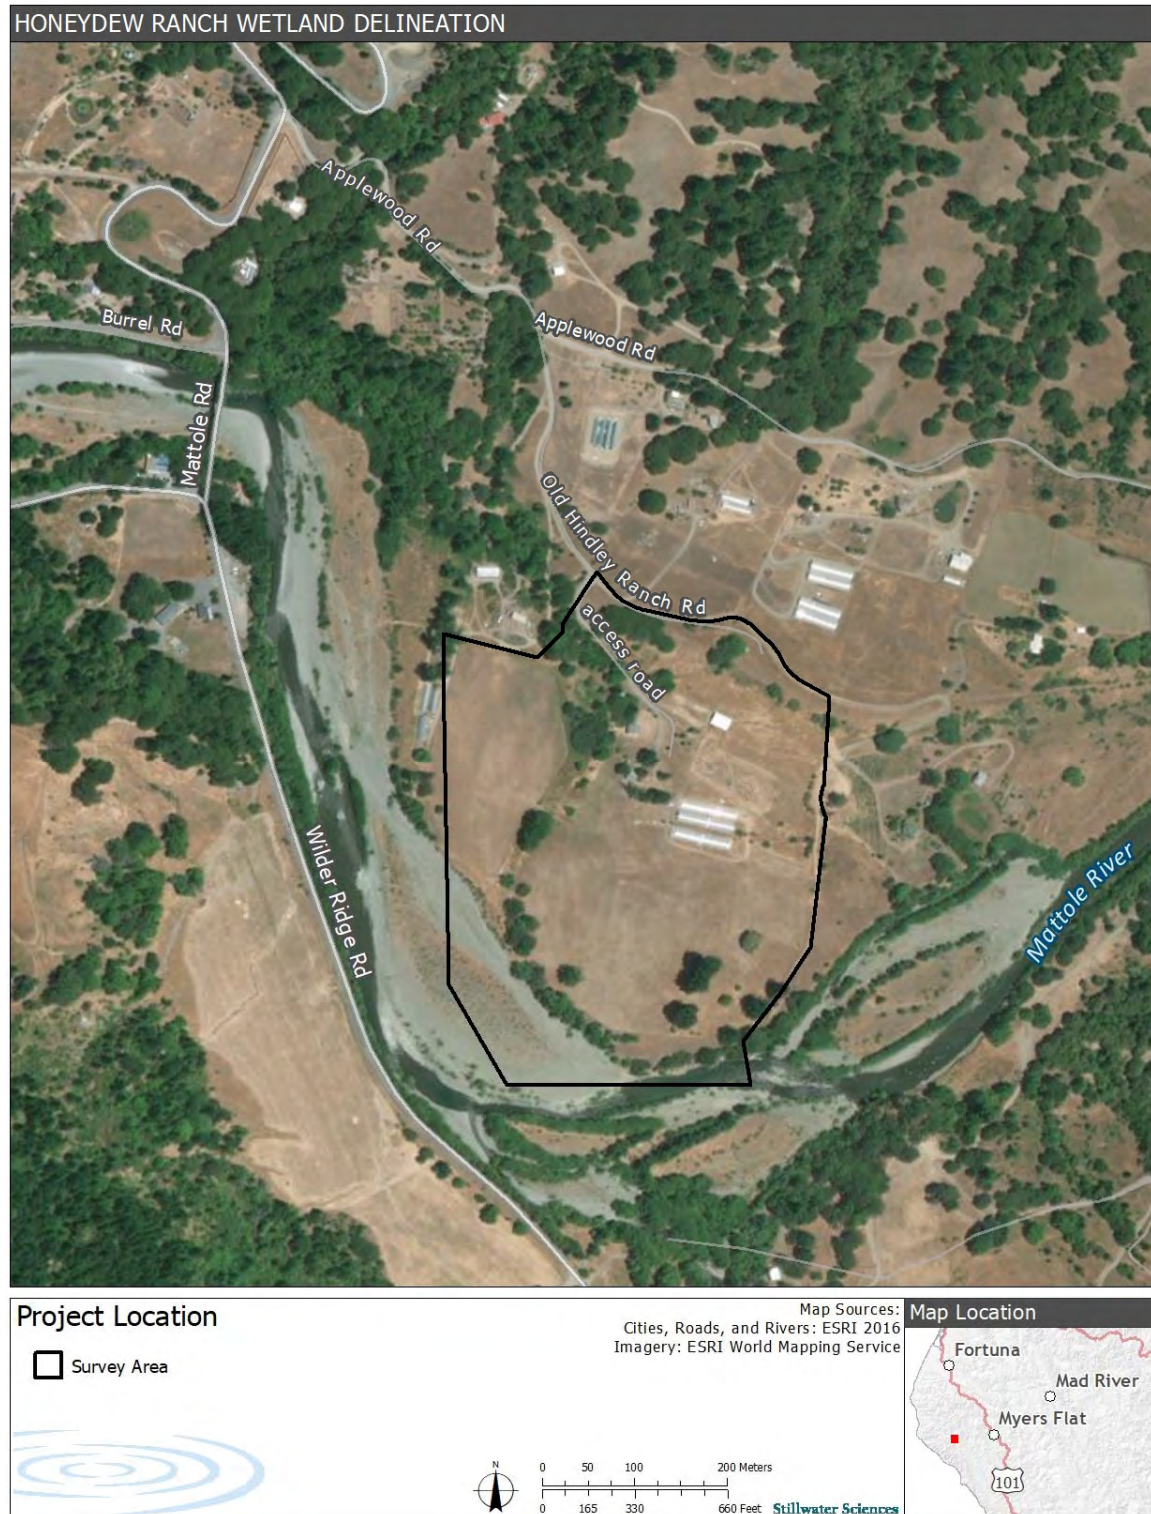
**Figure 1.** Project location and waters and wetland delineation Survey Area.

The property is located in unincorporated Humboldt County in the community of Honeydew, California (Figure 1). The Project is in Section 6 of Township 3 South, Range 1 East of the Honeydew U.S. Geological Survey (USGS) 7.5-minute topographic quadrangle. The property is located at approximately latitude 40.2393° and longitude -124.1165°. The elevation within the property ranges from approximately 219 to 308 feet above mean sea level.

The wetland delineation was performed across the entire 46-acre property (Survey Area) (Figure 1).

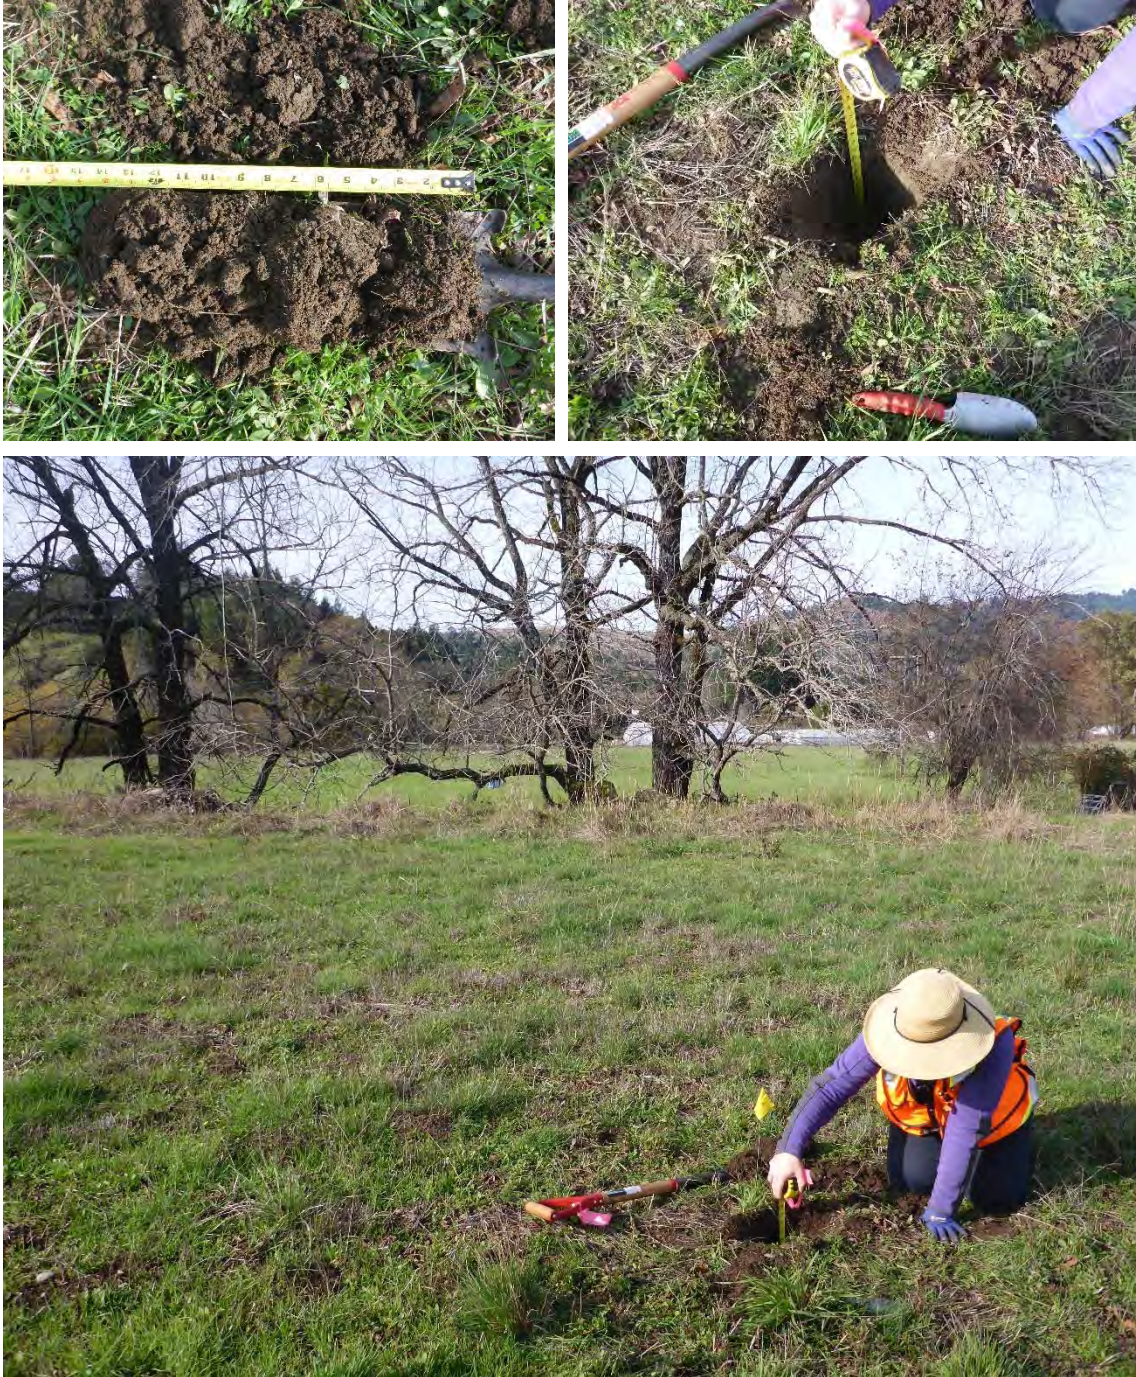
No hydric soil indicators present in soil pit. Some grit in sample. No redoximorphic features observed at sample location.

| Wetland Hydrology Indicators: | | |
|---|---|---|
| Gently sloped alluvial terrace, no primary hydrology indicators observed. | | |

**Figure B-1.** Wetland data point 1U.

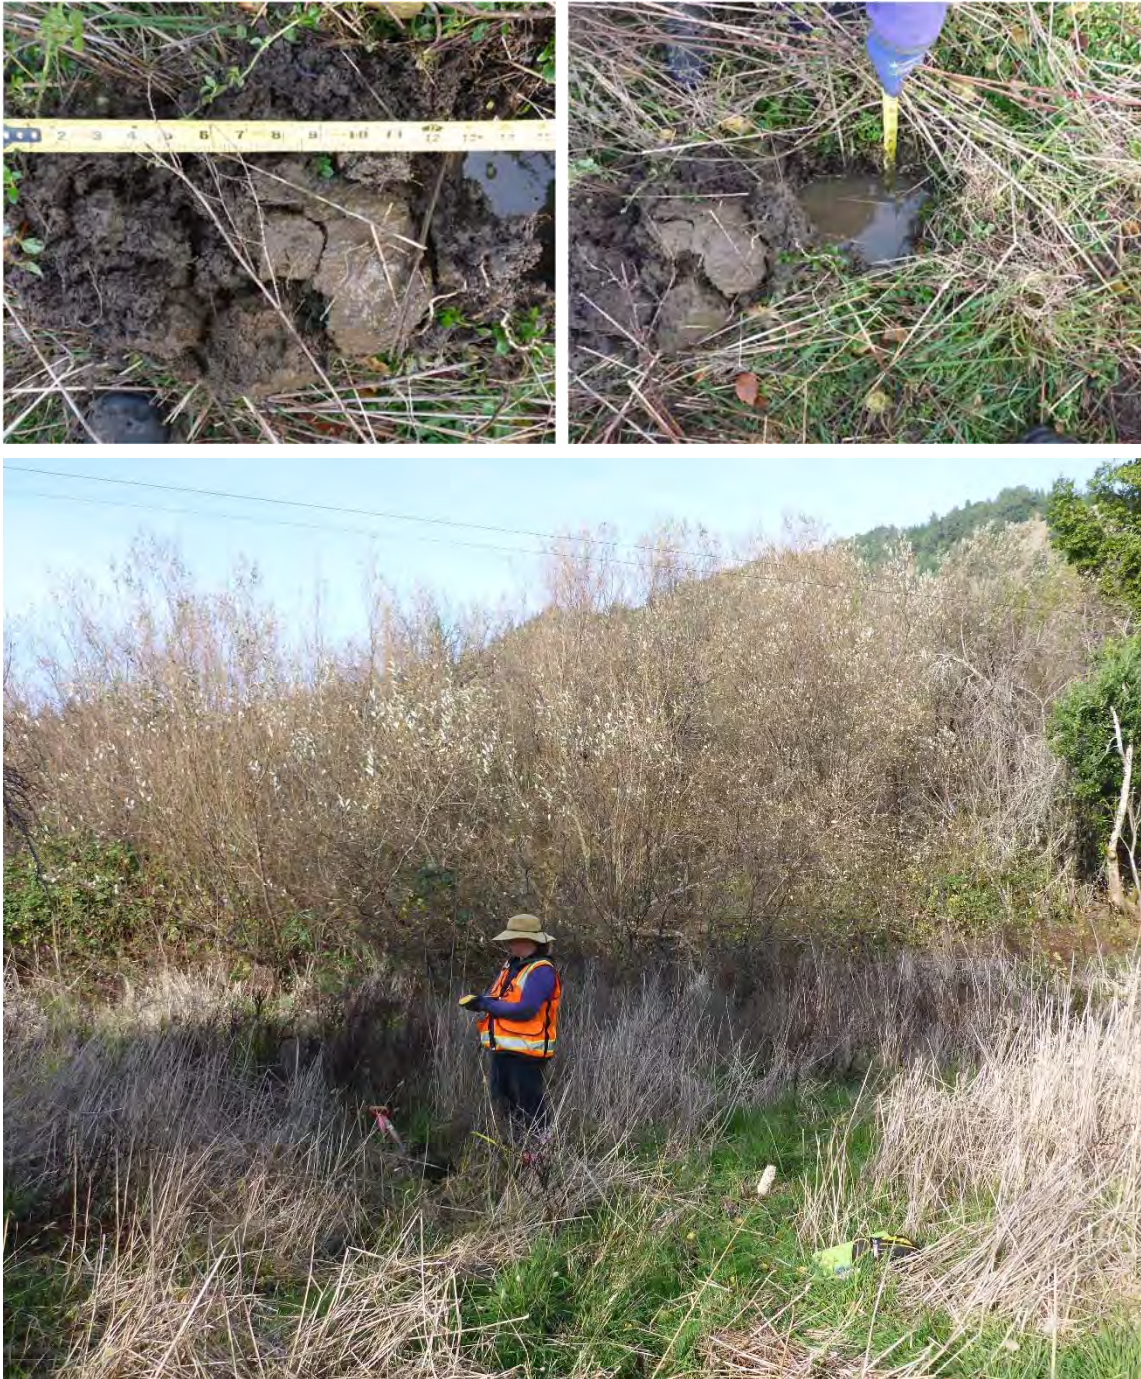
Wetland data points collected in the Pepperwood-Shively complex closely resembled the Pepperwood series and the hydric soil Weott series (NRCS 2017a) with matrix color of 10YR 3/2 and redox concentrations of 10YR 5/6 (Appendix A). Soil samples were considered hydric when a positive primary indicator, such as redox dark surface (F6) and/or redox depressions (F8) were identified (data points 3W and 7W in Appendix A).

Both surface water and a high water table in the soil pit were identified. Several secondary indicators were also observed. Therefore this sampling area is confirmed wetland hydrology.

**Figure B-4.** Wetland data point 3W.

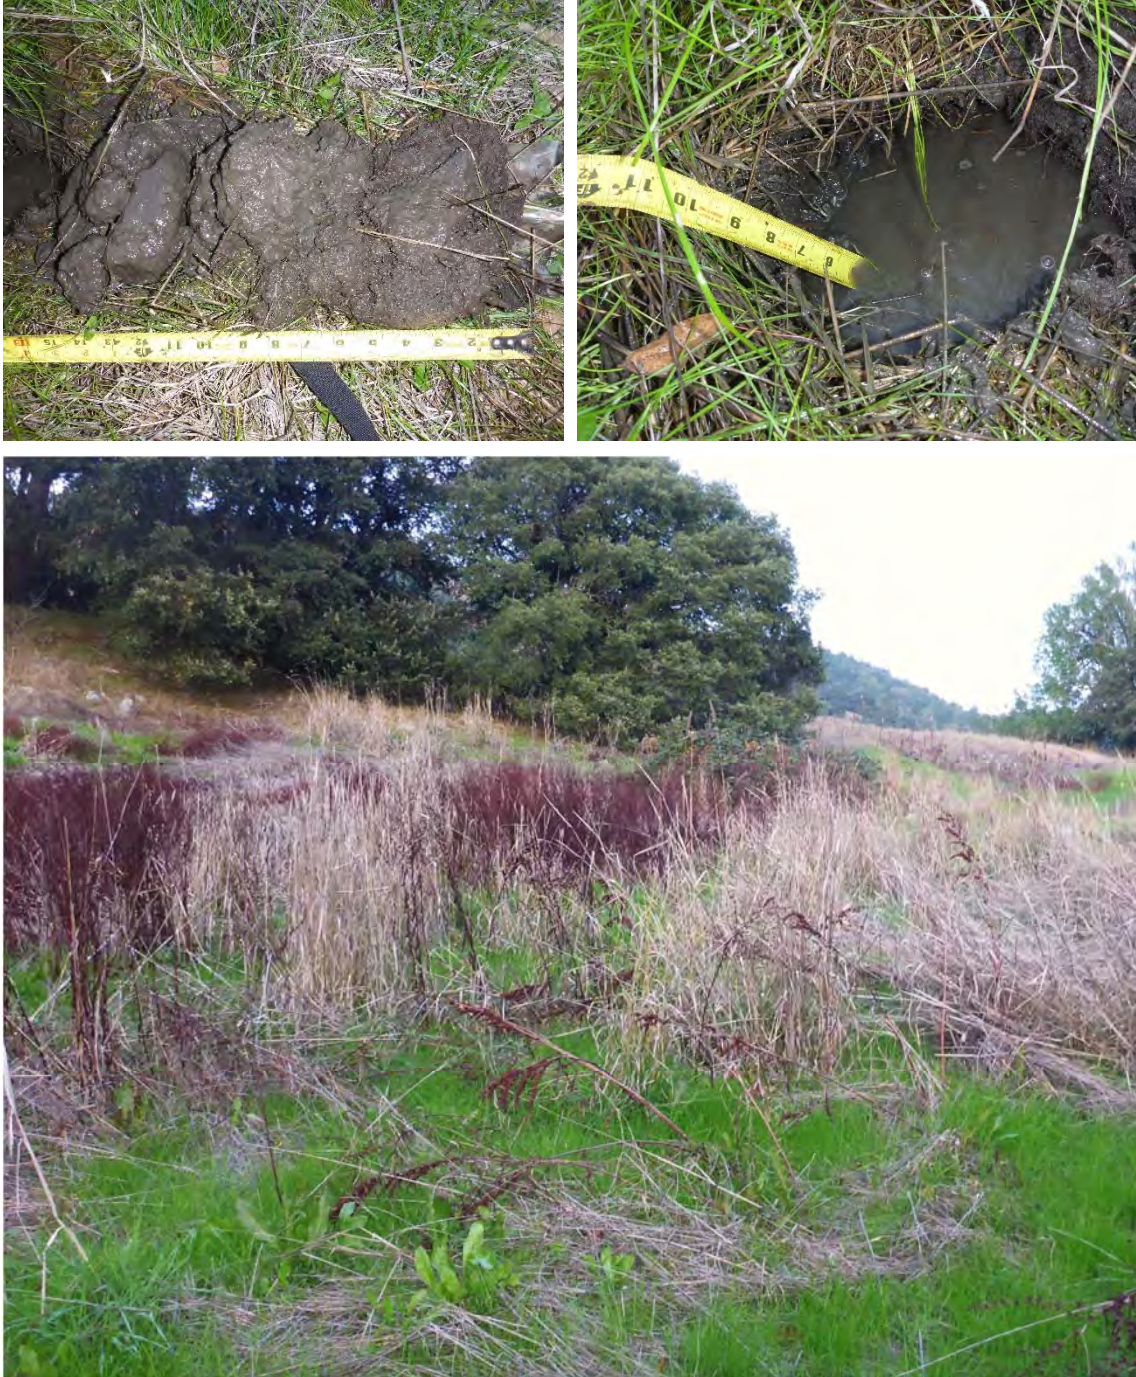
**Figure B-9.** Wetland data point 7W.
