**ASBESTOS SURVEY
LEAD PAINT SCREENING &
LEAD WASTE CHARACTERIZATION
GARBERVILLE DISTRICT SUPERVISOR'S OFFICE
709 & 713 CEDAR STREET
GARBERVILLE, CA**

May 31, 2019

Project # 1900204

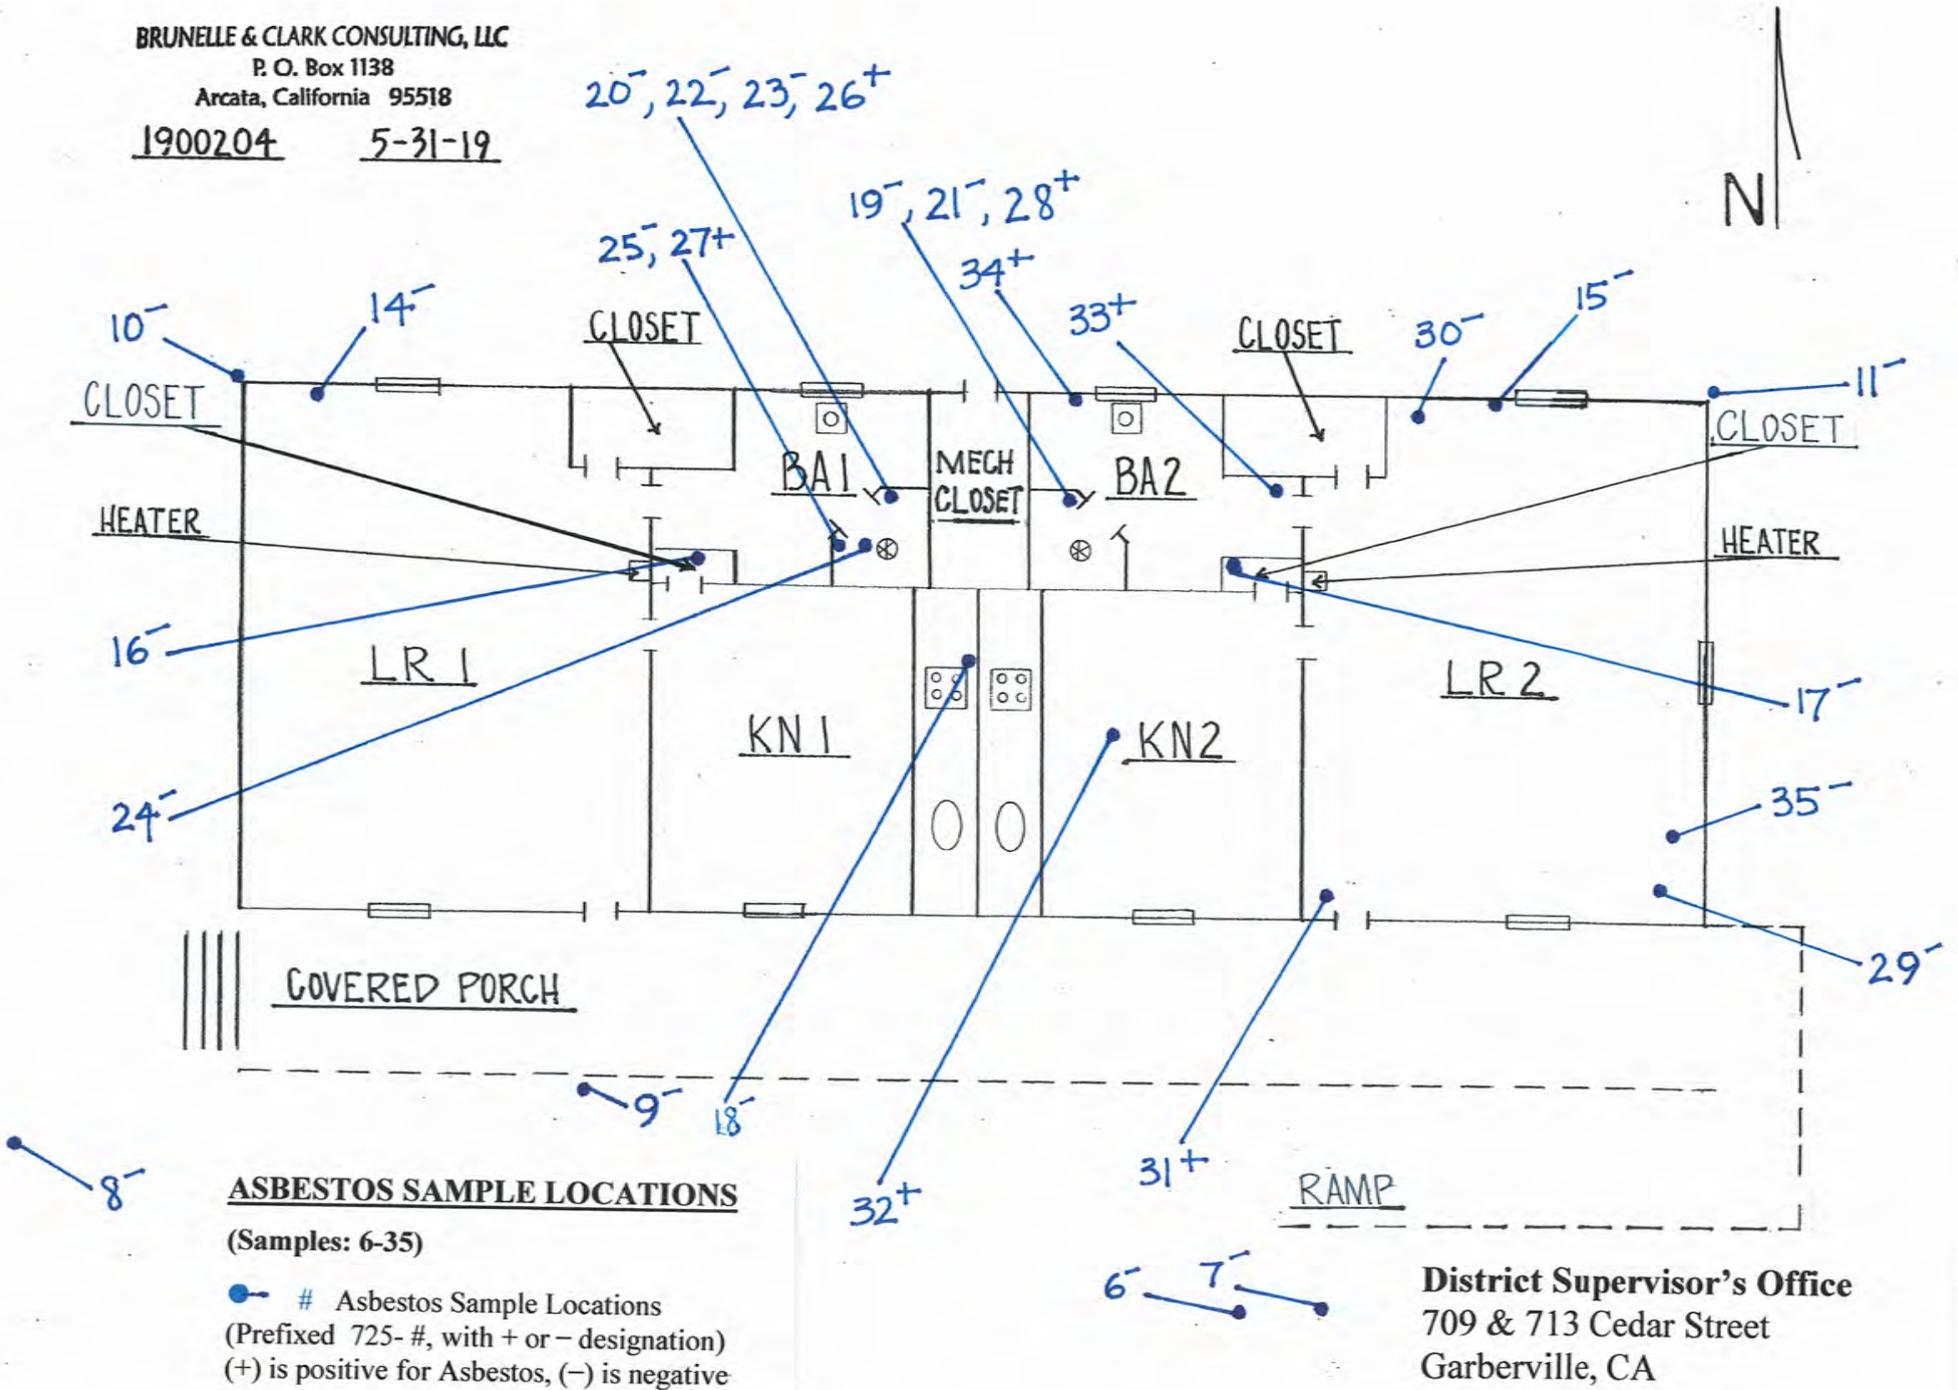
FIG. 1

The Garberville District Supervisor's Office building is a wood framed single story structure, sitting on a post and pier foundation. The exterior is finished with wood siding, and the roof has composition shingle roofing. The interior is divided into two separate units, each with a living room, kitchen, and bathroom. The ceilings of the living rooms and kitchens are finished with textured drywall, and the bathrooms have drywall ceiling and wall finish. The other walls have wood and/or fiberboard panel wall finish. The floors are carpet, and vinyl floor tile. See Figures 1-6 (Appendix A).

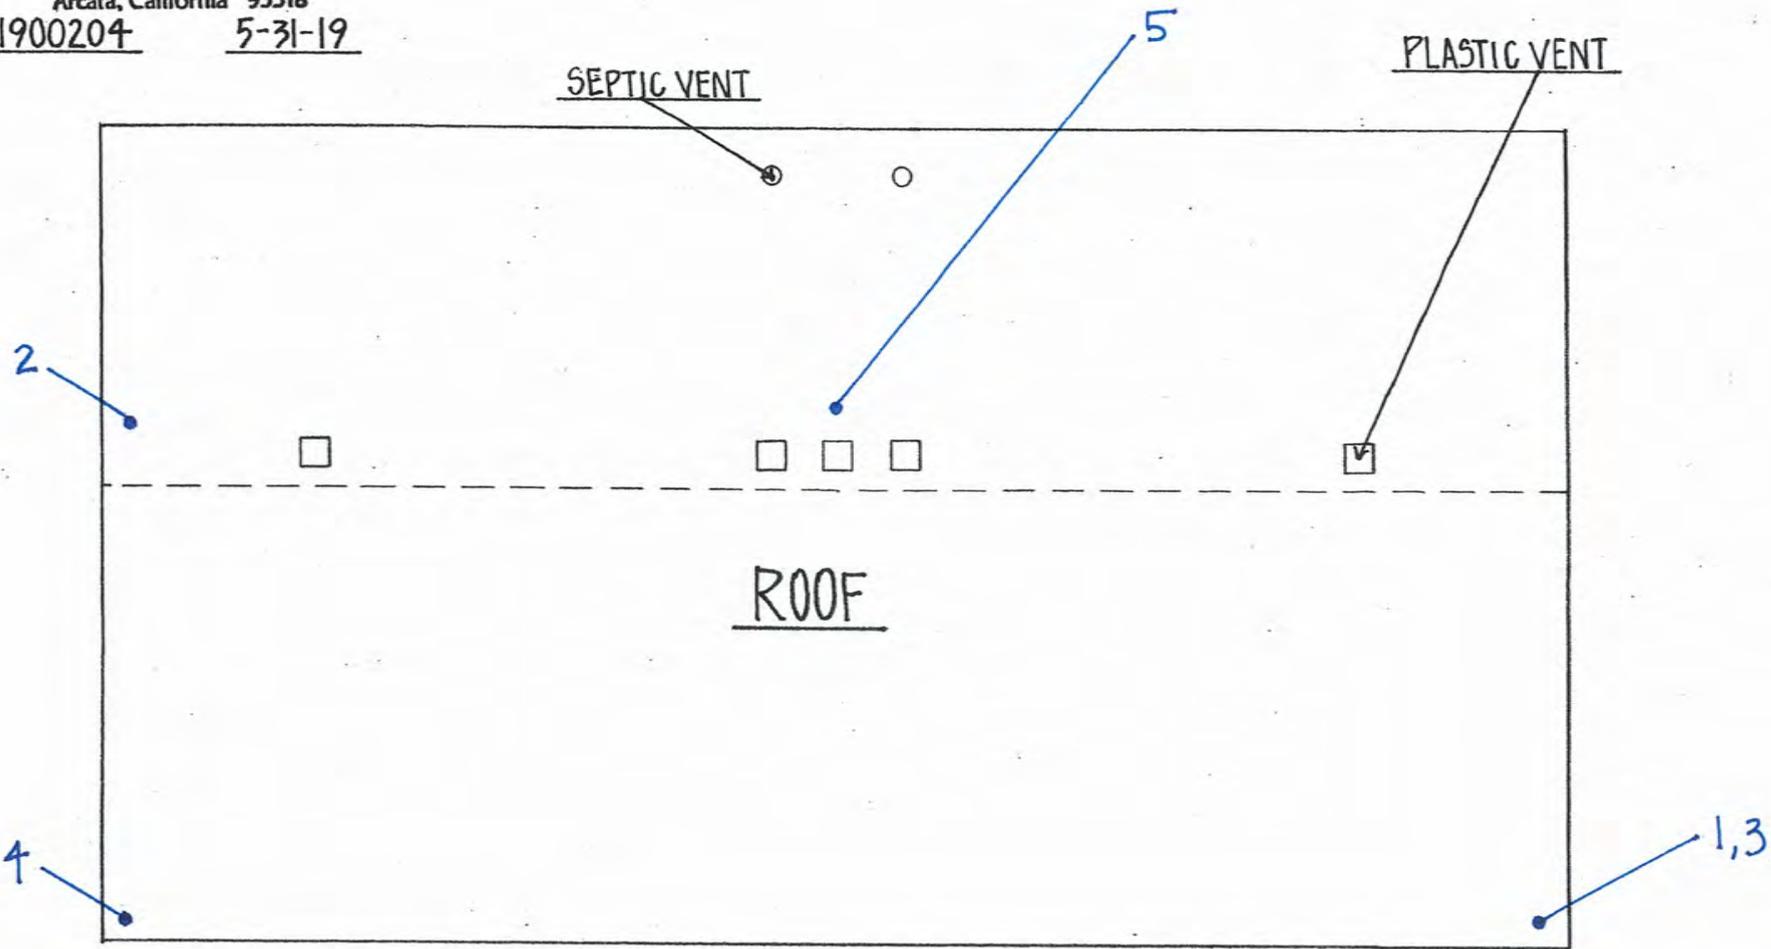
FIG. 3

ASBESTOS SAMPLE LOCATIONS

(Samples: 1-5)

Roof
District Supervisor's Office
709 & 713 Cedar Street
Garberville, CA

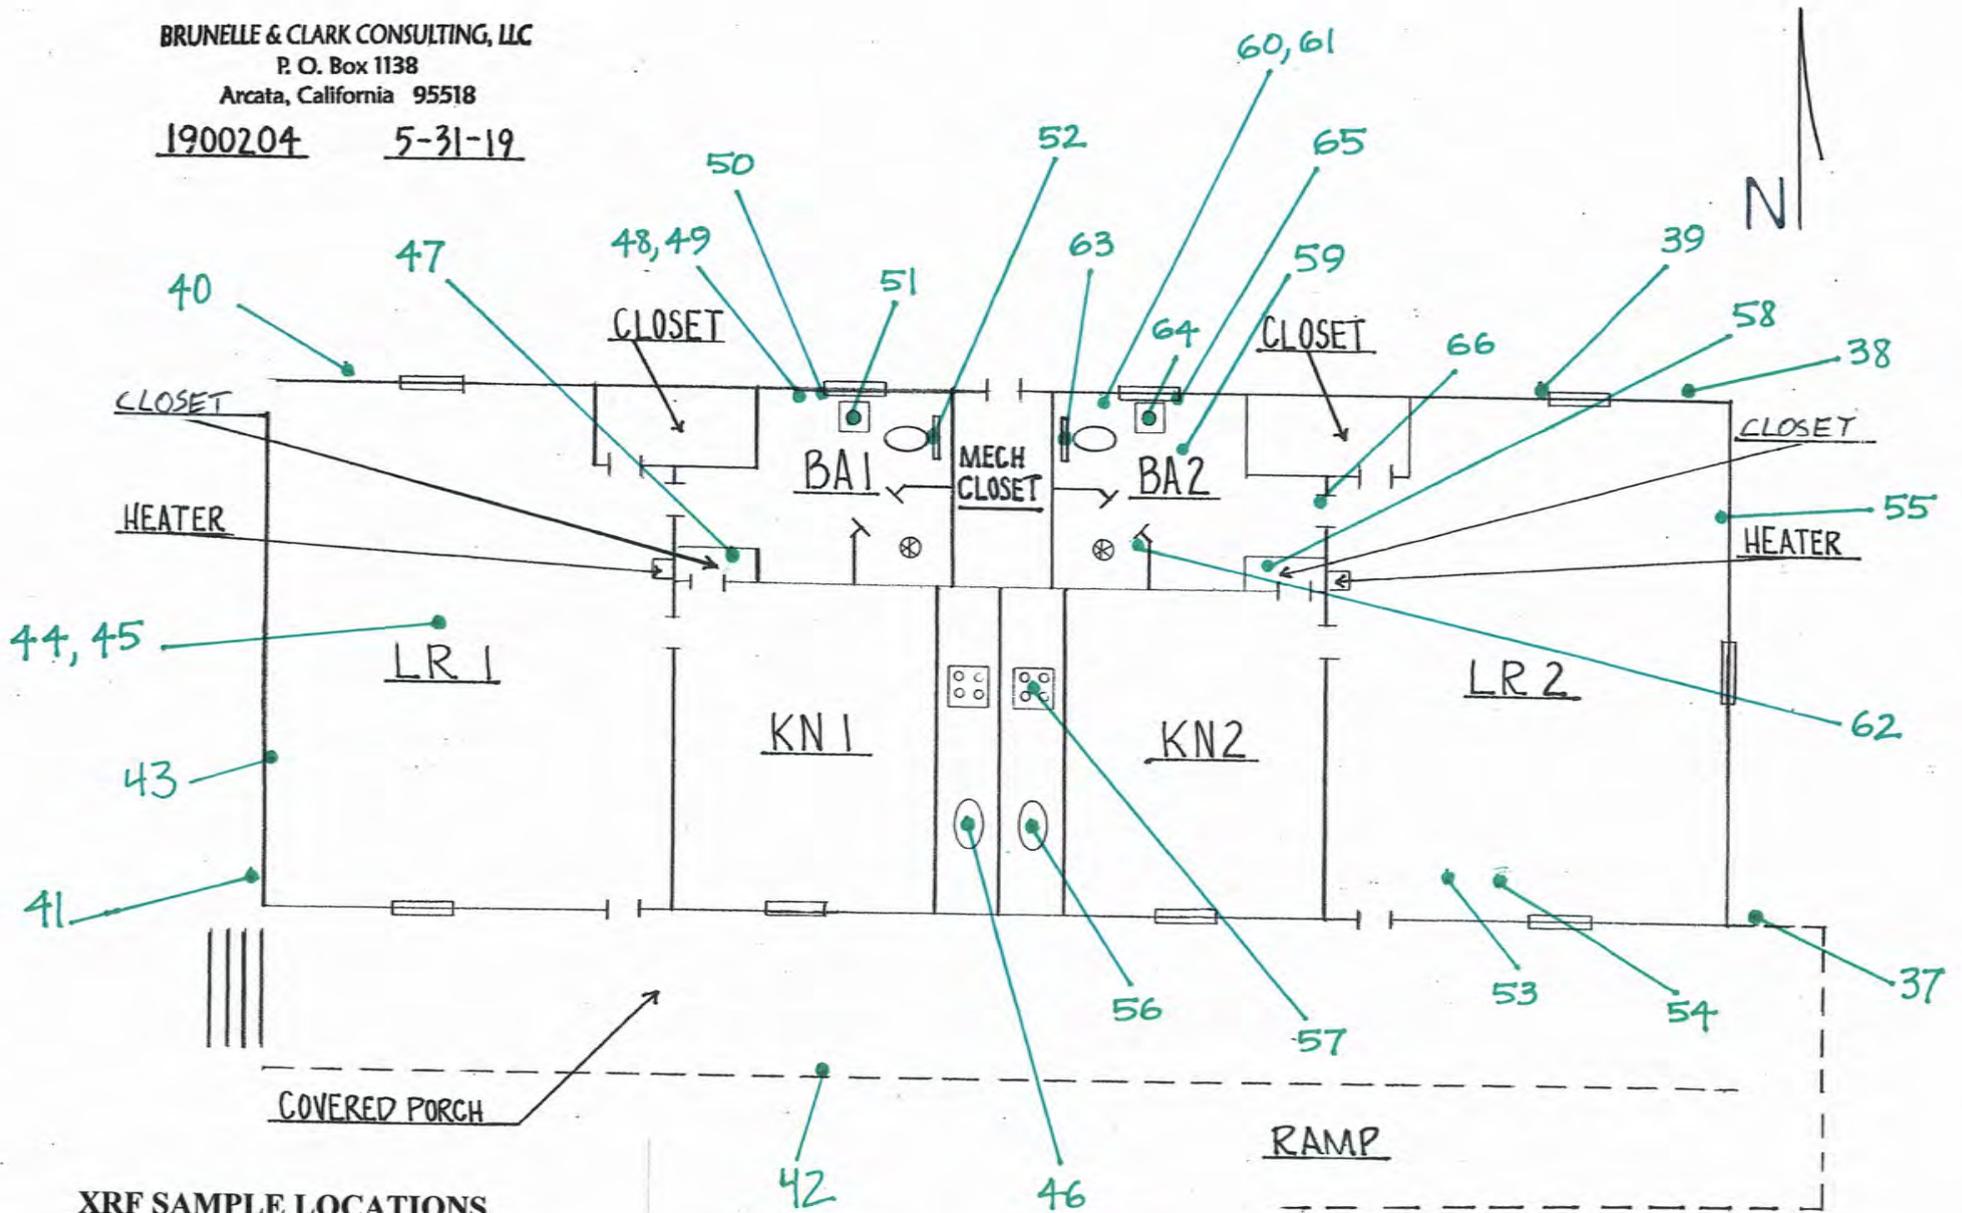
FIG. 4

XRF SAMPLE LOCATIONS

● # XRF Sample Location

By XRF analyses: four (4) sampled components have Lead Based Paint (LBP), ten (10) have LCSC, and sixteen (16) were found to be “negative” for detectable lead. See Table 3, Appendix B for a description of all sampled components, sample locations, and sampling data.

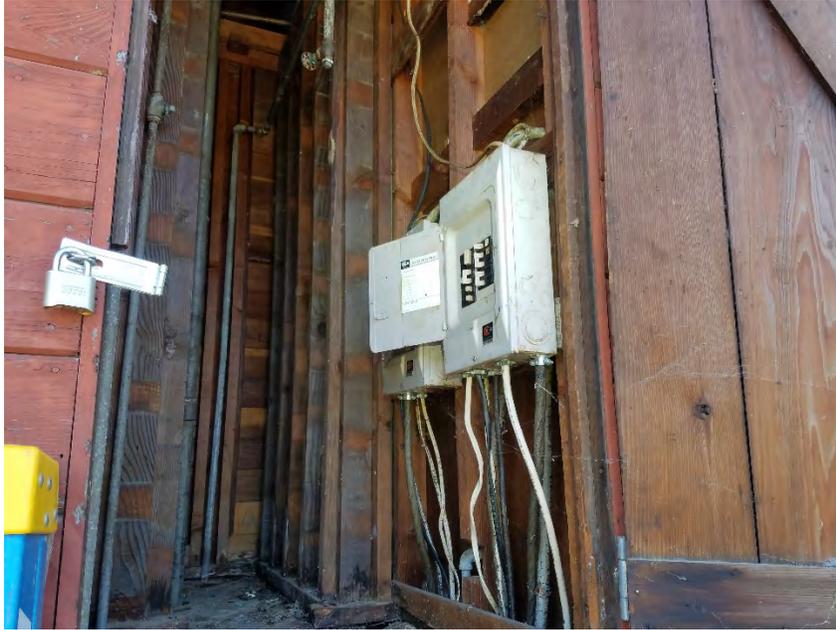
PACM electrical panels & PACM electrical wire insulation, in Mech. Closet

PACM Electrical Panel Heat Shields/Mounting Blocks & Electrical Wire Insulation: The electrical wire insulation, and heat shields/mounting boards commonly found behind fuses and breaker switches in electrical panels/boxes often contain asbestos, and are presumed to contain asbestos herein. Any abatement or disturbance of the PACM materials must be done by a licensed asbestos abatement contractor using Class II methods, with disposal as “non-friable” asbestos waste.

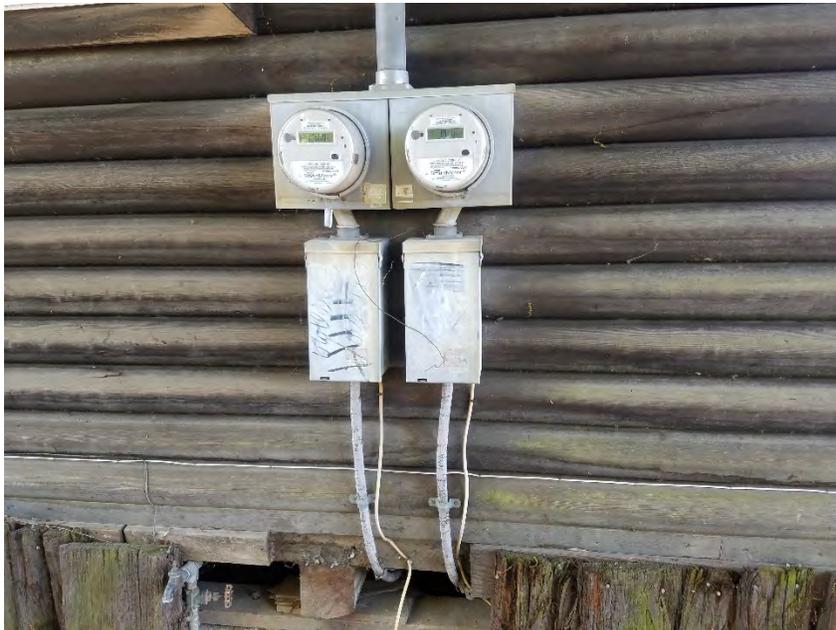
PACM electrical panels & PACM electrical wire insulation, on east exterior of building
