BIOLOGICAL RESOURCES ASSESSMENT

APN 207-086-004
HUMBOLDT COUNTY, CALIFORNIA

PROJECT No HUR007

JANUARY 14, 2020

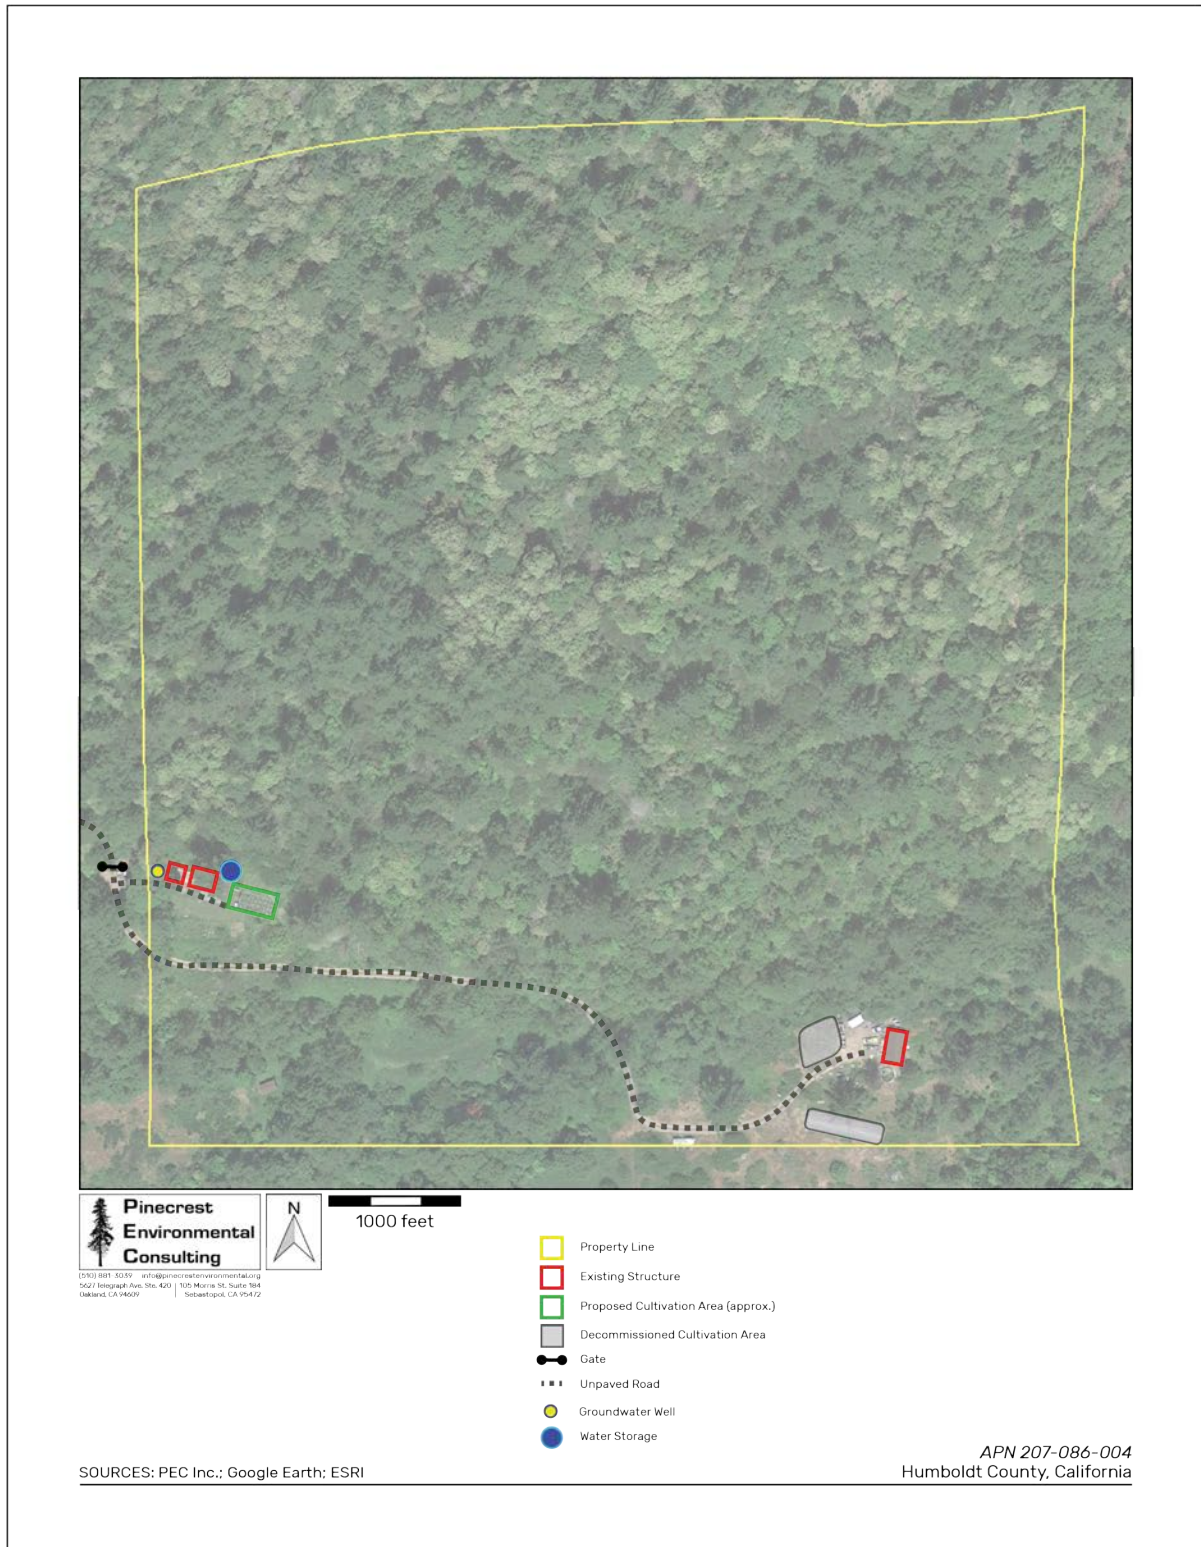
FIGURE 3: SITE SCHEMATIC & WATER FEATURES

The parcel consists of approximately 32 acres of mixed Redwood and Douglas Fir forest on the northern slopes and floodplain forest on the southern flat portion of the parcel (Figure 2). The maximum elevation of the parcel is 916 feet above sea level in the center of the northern parcel boundary, and the minimum elevation is 393 feet above sea level along the southern parcel boundary where it intersects with the floodplain of the Van Duzen River (Figure 3). The topography of the parcel is steeply sloped in the north with grades between 20% and 50%, and moderately sloped in the south with grades between 5% and 15%, as measured by Suunto PM5 handheld clinometer. There are no jurisdictional watercourses onsite (Figure 3). There are also no potential wetlands identified at the time of the survey near the potential cultivation areas, although a protocol-level wetland delineation was not performed. There are no culvert crossings on the property required to reach the cultivation area.

The onsite communities consist of closed-canopy Redwood and Douglas Fir forest in the north, transitioning to moderately sloped successional riparian floodplain forest and old-field grassland in the south (Figure 2). There are no jurisdictional watercourses onsite, however there is a depression that runs along the toe of slope that has some features consistent with a channel, however after examination of aerial photographs it is apparent this is a channel created by historic flooding perhaps during the 1964 flood and does not currently convey flowing water. There were no potential wetlands and no special soil types such as serpentine or hardpan visible at the time of the survey. The specific community descriptions below are organized based on the zones that were surveyed, and the floristic results presented in Appendix B. We have used as guidance the *Manual of California Vegetation* (Sawyer et al. 2009) to guide community classification. Overall, the parcel consists of approximately 75% mixed Redwood and Douglas fir forest, and 15% successional forest, and 10% developed and old-field (Figure 3).

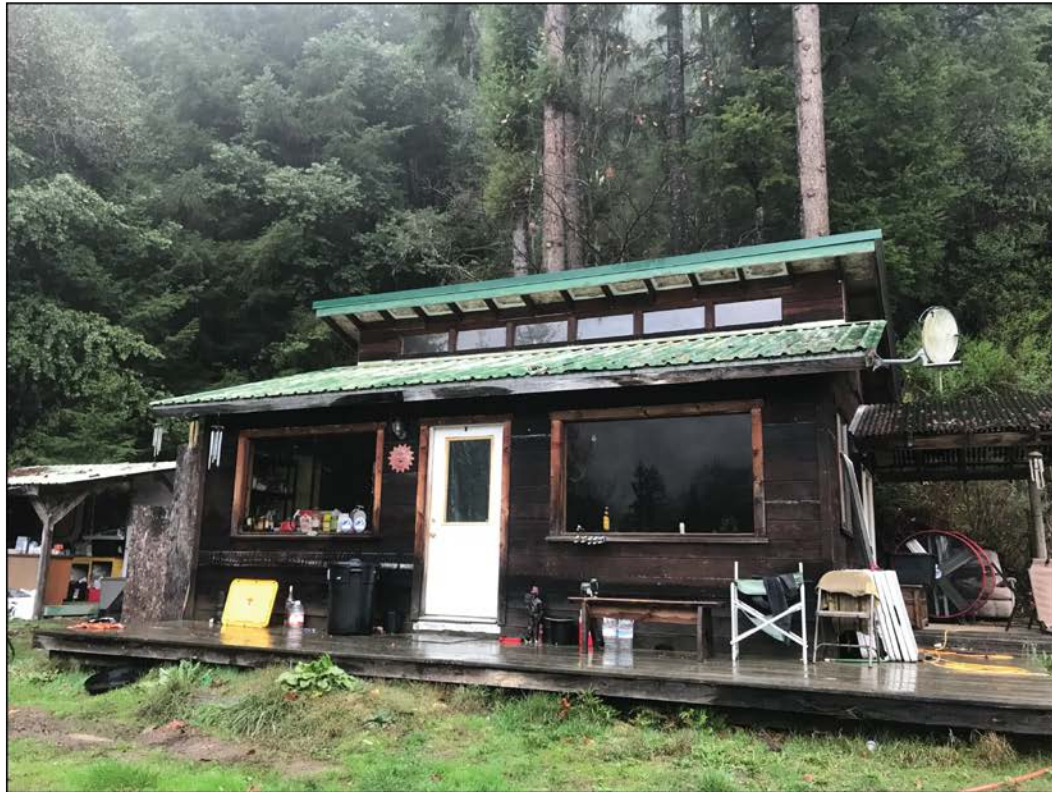
FIGURE 4: PHOTOGRAPH OF RESIDENCE

A metal gate (Figure 7) provides access to the packed earth and gravel access road that is in fair condition (Figure 6). There is one existing permanent residence onsite, and three outbuildings or garages. There is one residence (Figure 4), the proposed current cultivation area that currently contains a dilapidated hoop-house (Figure 9), a well, HDPE water storage tank (Figure 8), and storage shed, all located in the first developed pad you encounter driving east into the property (Figure 3). The residence here also contains a pit type septic system and leach field, as reported to PEC by the resident. Continuing along the access road east you decrease in elevation and after approximately 0.15 miles you reach a second cleared area that contains an outbuilding (Figure 11) and a second cultivation area that is not in use (Figure 10). There are several other trailers and vehicles onsite but no other built structures.
