# Site Management Plan

(Tier 1, High Risk)

**WDID- 1\_12CC404177**

**Humboldt County**

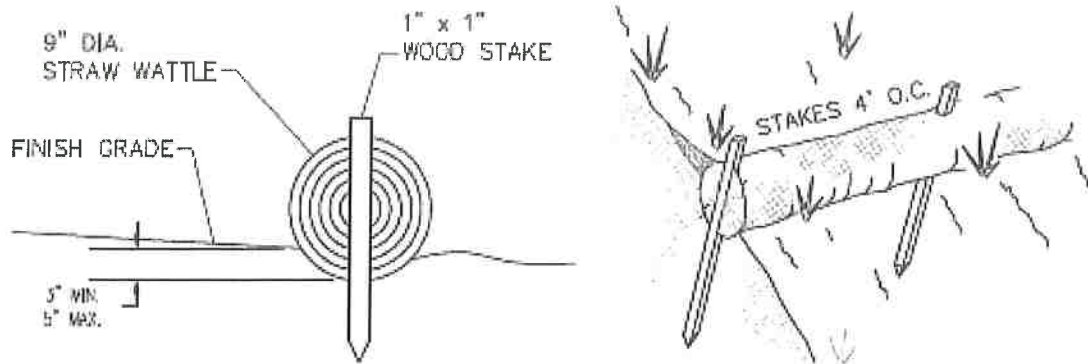
### STRAW WATTLE INSTALLATION DETAIL

1. STRAW WATTLES SHALL BE INSTALLED WITH 18 OR 24 INCH WOOD STAKES AT FOUR FEET ON CENTER. THE ENDS OF ADJACENT STRAW WATTLES SHALL BE ADJUTED TO EACH OTHER SNUGLY OR OVERLAPPED BY SIX INCHES.
2. STRAW ROLL INSTALLATION REQUIRES THE PLACEMENT AND SECURE STAKING OF THE ROLL IN A TRENCH, 3"-5" DEEP. RUNOFF MUST NOT BE ALLOWED TO RUN UNDER OR AROUND THE ROLL.

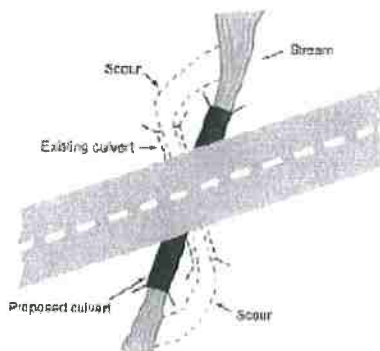
**FIGURE 97.** Culvert alignment should be in relation to the stream and not the road. It is important that the stream enters and leaves the culvert in a relatively straight horizontal alignment so streamflow does not have to turn to enter the inlet or discharge into a bank as it exits. This figure shows a redesigned culvert installation that replaces the bending alignment that previously existed. Channel turns at the inlet increase plugging potential because wood going through the turn will not align with the inlet. Similarly, channel turns at the inlet and outlet are often accompanied by scour against the channel banks (Wisconsin Transportation Information Center, 2004).

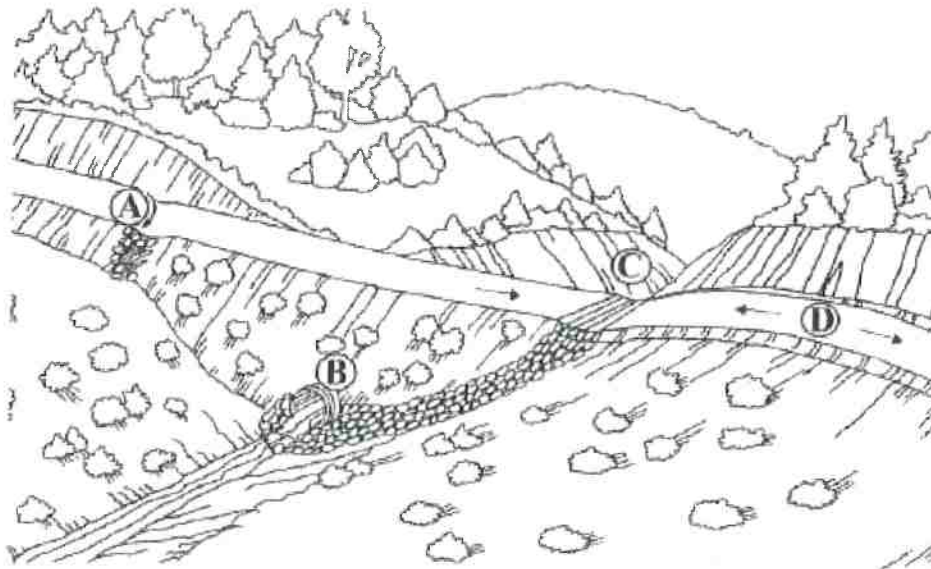
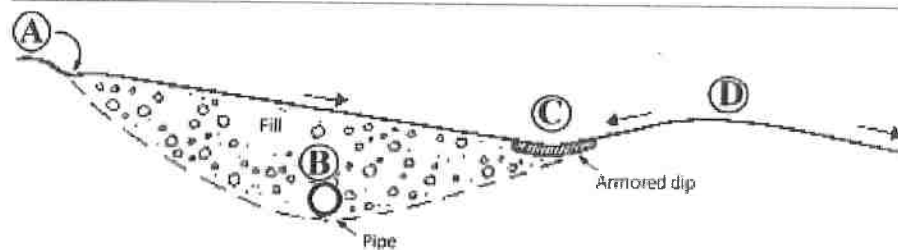
FIGURE 84. Critical dips or dipped crossing fills should be centered near a stream crossing's down-road hingeline, not over the centerline of the crossing where overtopping could cause washout or severe erosion of the fill. If the stream crossing culvert (B) plugs, water will pond behind the fill until reaching the critical dip or low point in the crossing (C) and flowing back down into the natural stream channel. The down-road ditch must be plugged to prevent streamflow from diverting down the ditch line. For extra protection in this sketch, diprap armor has been placed at the critical dip outfall and extending downslope to the stream channel. This is only required or suggested on stream crossings where the culvert is highly likely to plug and the crossing fill overtopped. The dip at the hinge line is usually sufficient to limit erosional damage during an overtopping event. Road surface and ditch runoff is disconnected from the stream crossing by installing a rolling dip and ditch relief culvert just up-road from the crossing (A) (Keller and Sherar, 2003).

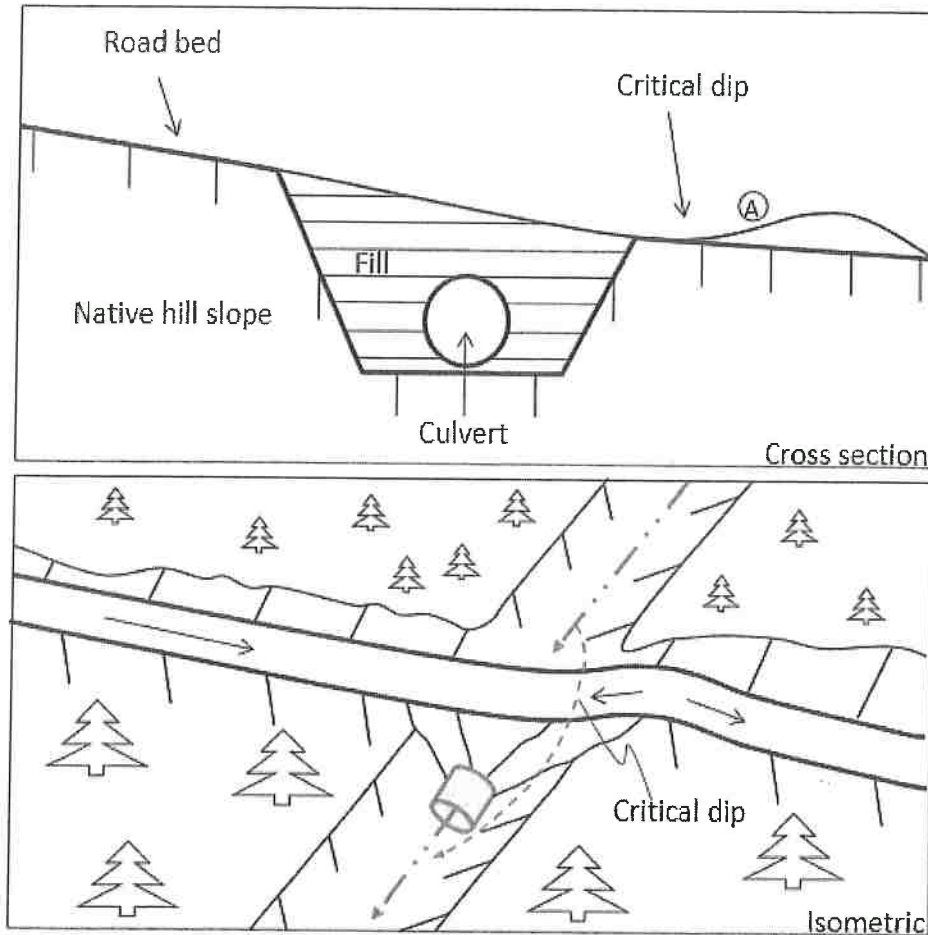
### Typical Critical Dip Design for Stream Crossings with Diversion Potential

1. Critical dip will be constructed on the lower side of crossing.
2. Critical dip will extend from the cutbank to the outside edge of the road surface. Be sure to fill inboard ditch, if present.
3. Critical dip will have a reverse grade (A) from cutbank to outside edge of road to ensure flow will not divert outside of crossing.
4. The rise in the reverse grade will be carried for about 10 to 20 feet and then return to original slope.
5. The transition from axis of bottom, through rising grade, to falling grade, will be in the road distance of at least 15 to 30 feet.
6. Critical dips are usually built perpendicular to the road surface to ensure that flow is directed back into the stream channel.

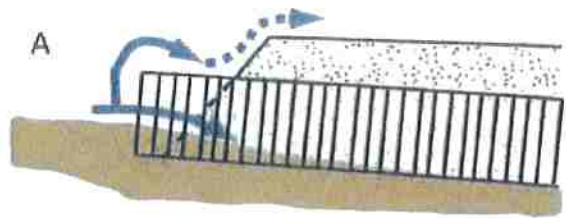
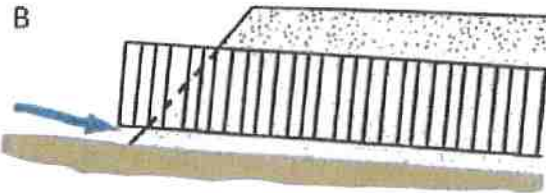
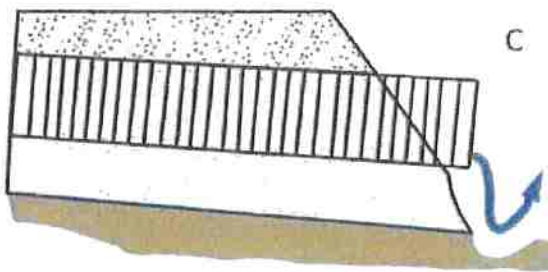
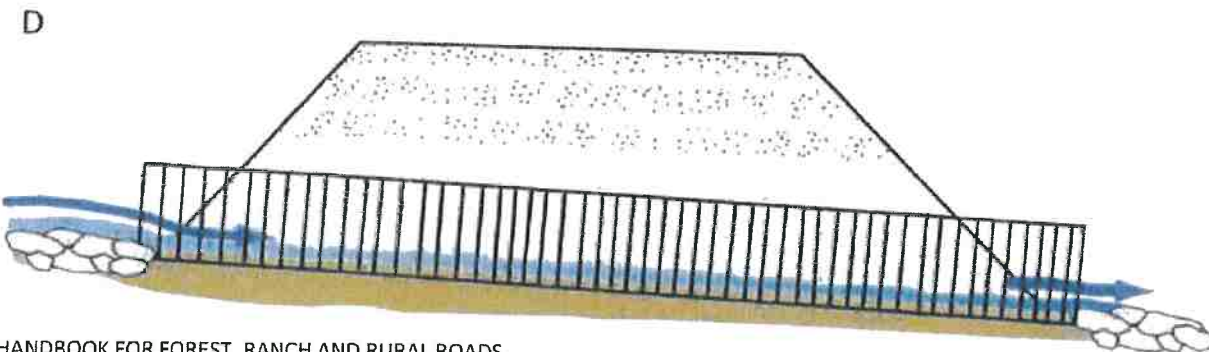
**FIGURE 155.** Proper culvert installation involves correct culvert orientation, setting the pipe slightly below the bed of the original stream, and backfilling and compacting the fill as it is placed over the culvert. Installing the inlet too low in the stream (A) can lead to culvert plugging, yet if set too high (B) flow can undercut the inlet. If the culvert is placed too high in the fill (C), flow at the outfall will erode the fill. Placed correctly (D), the culvert is set slightly below the original stream grade and protected with armor at the inlet and outlet. Culverts installed in fish-bearing stream channels must be inset into the streambed sufficiently (>25% embedded) to have a natural gravel bottom throughout the culvert (Modified from: MDSL, 1991).

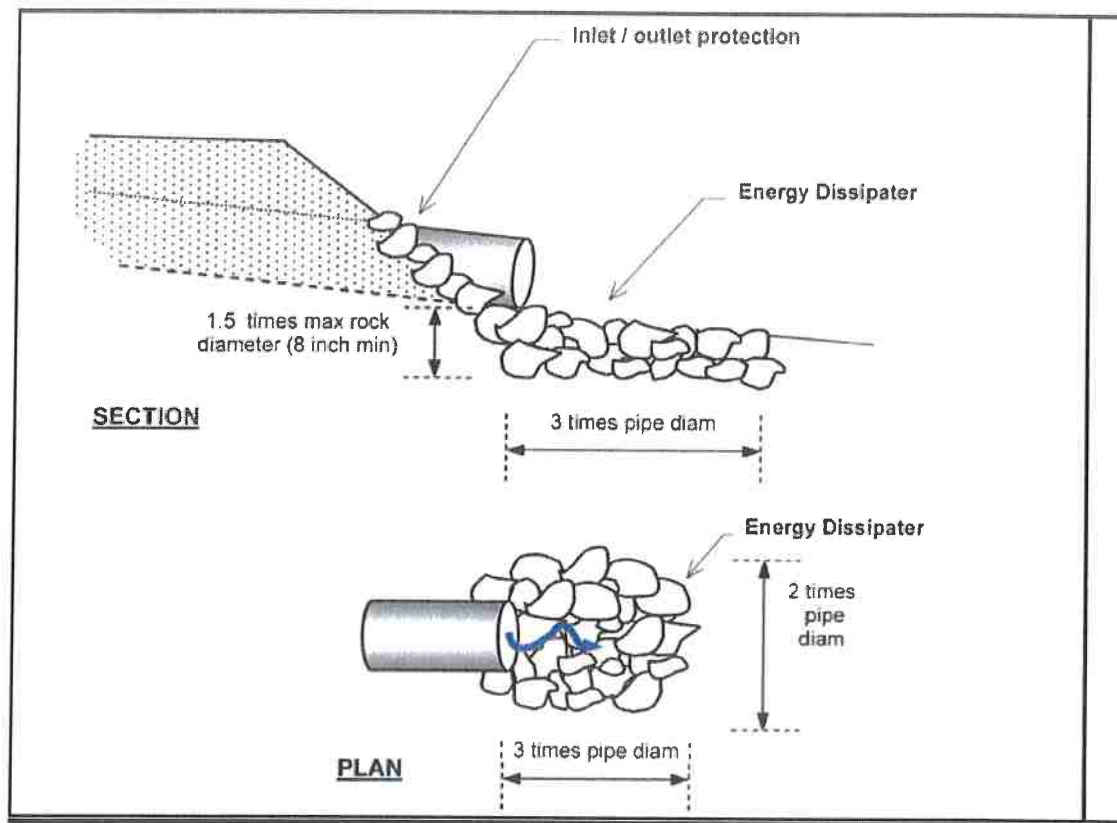
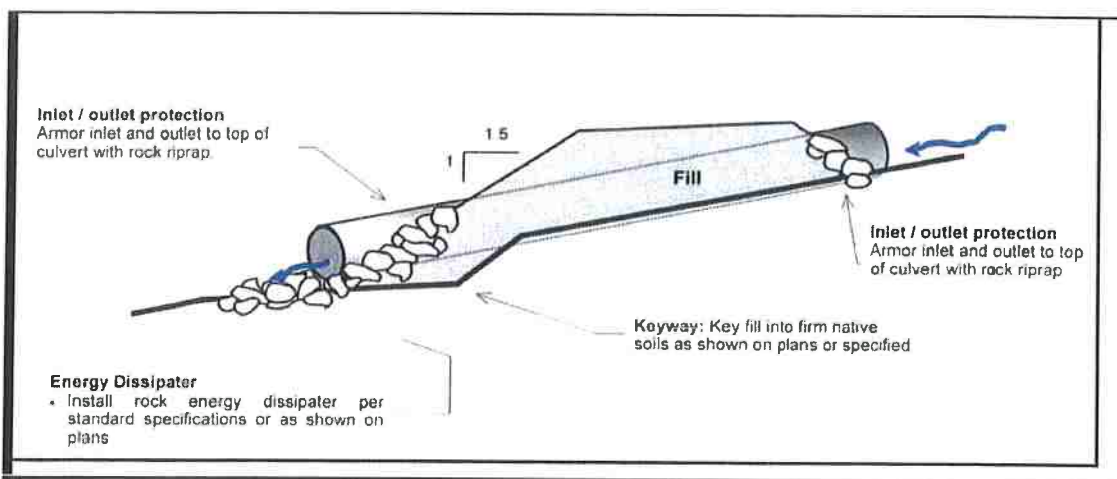
## **BMP: Permanent Culvert Crossing Design (Inlet and Outlet Armoring)**

Riprap installed to protect the inlet and outlet of a stream crossing culvert from erosion or for energy dissipation should be keyed into the natural channel bed and banks to an approximate depth of about 1.5x the maximum rock thickness. Riprap should be placed at least up to the top of the culvert at both the inlet and outlet to protect them from splash erosion and to trap any sediment eroded from the newly constructed fill slope above.

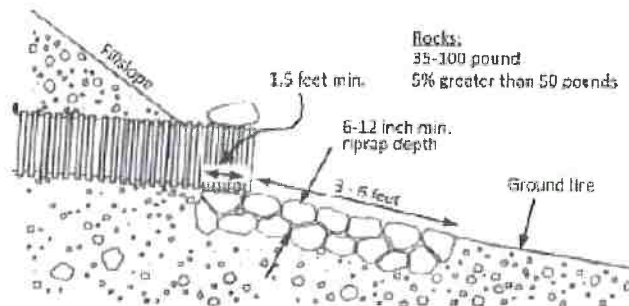
FIGURE 107A. Riprap armor at culvert outlet (Modified from: Keller et al. 2011).

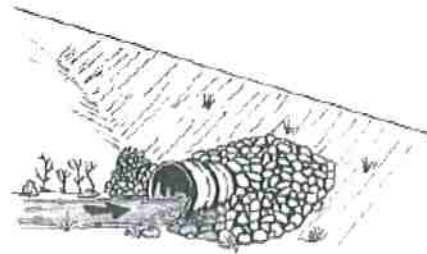
FIGURE 107B. Riprap armor at culvert inlet (Keller and Sharar, 2003).

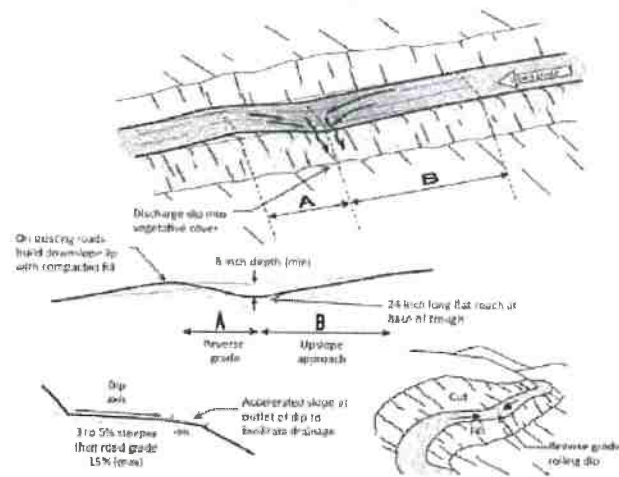
**FIGURE 34.** A classic Type I rolling dip, where the excavated up-road approach (B) to the rolling dip is several percent steeper than the approaching road and extends for 60 to 80 feet to the dip axis. The lower side of the structure reverses grade (A) over approximately 15 feet or more, and then falls down to rejoin the original road grade. The dip must be deep enough that it is not obliterated by normal grading, but not so deep that it is difficult to negotiate or a hazard to normal traffic. The outward cross-slope of the dip axis should be 3% to 5% greater than the up-road grade (B) so it will drain properly. The dip axis should be out-sloped sufficiently to be self-cleaning, without triggering excessive downsloping or sediment deposition in the dip axis (Modified from: Best, 2013).

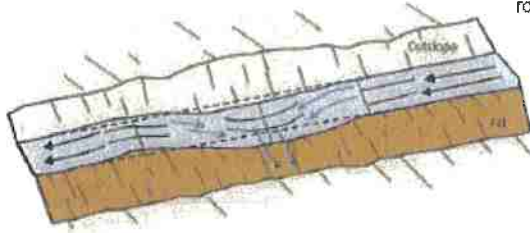
### Type 1 Rolling Dip (Standard)

Type 1 rolling dips are used where road grades are less than about 12-14% and road runoff is not confined by a large through cut or berm. The axis of the dip should be perpendicular to the road alignment and sloped at 3-4% across the road tread. Steep roads will have longer and more abrupt dip dimensions to develop reverse grade through the dip axis. The road tread and/or the dip outlet can be rocked to protect against erosion, if needed.

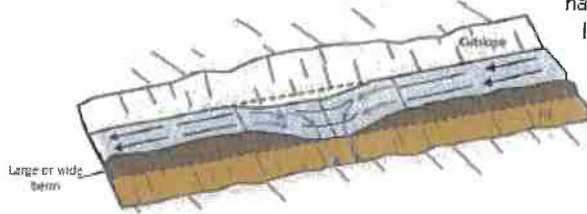
### Type 2 Rolling Dip (Through-cut or thick berm road reaches)

Type 2 rolling dips are constructed on roads up to 12-14% grade where there is a through cut up to 3 feet tall, or a wide or tall berm that otherwise blocks road drainage. The berm or native through cut material should be removed for the length of the dip, or at least through the axis of the dip, to the extent needed to provide for uninterrupted drainage onto the adjacent slope. The berm and slope material can be excavated and endhauled, or the material can be sidecast onto native slopes up to 45%, provided it will not enter a stream.

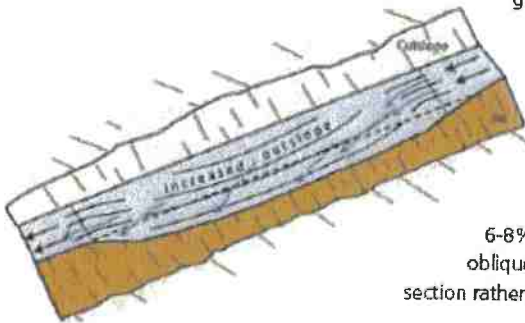
### Type 3 Rolling Dip (Steep road grade)

Type 3 rolling dips are utilized where road grades are steeper than about 12% and it is not feasible to develop a reverse grade that will also allow passage of the design vehicle (steep road grades require more abrupt grade reversals that some vehicles may not be able to traverse without bottoming out).

Instead of relying on the dip's grade reversal to turn runoff off the roadbed, the road is built with an exaggerated outslope of 6-8% across the dip axis. Road runoff is deflected obliquely across the dip axis and is shed off the outsloped section rather than continuing down the steep road grade.

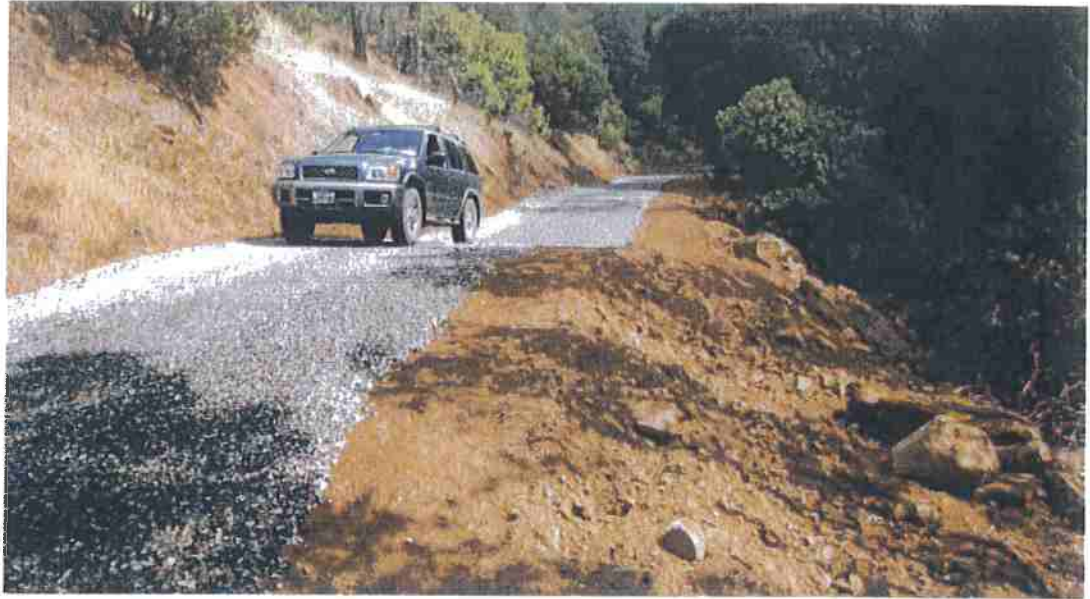
**FIGURE 33A.**

*Rolling dip constructed on a rock surfaced rural road. The rolling dip represents a change-in-grade along the road alignment and acts to discharge water that has collected on, or is flowing down, the road surface. This road was recently converted from a high maintenance, insloped, ditched road to a low maintenance, outsloped road with rolling dips.*

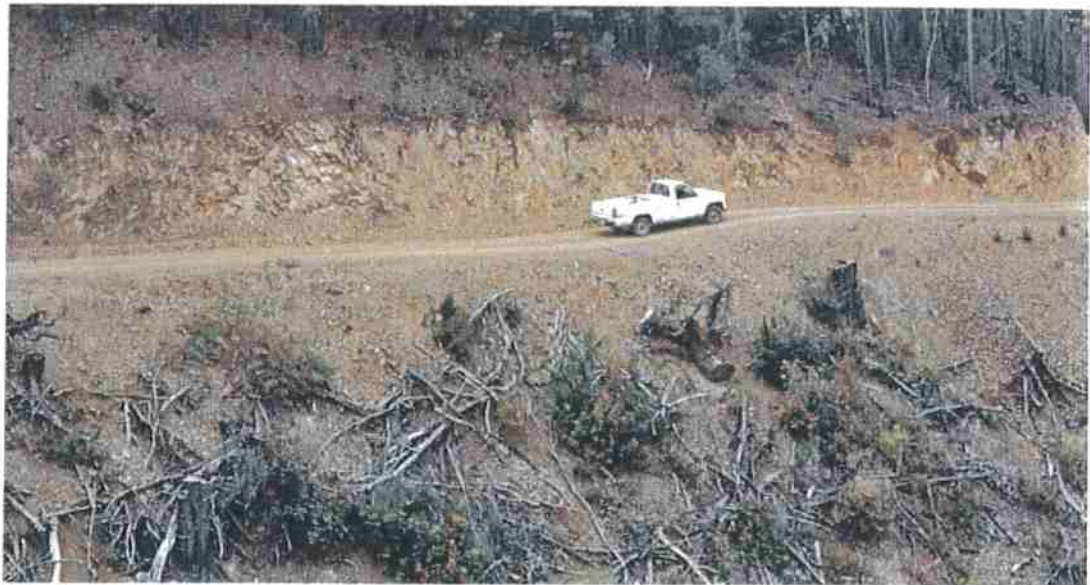
**FIGURE 33B.**

*This side view of an outsloped road shows that the rolling dip does not have to be deep or abrupt to reverse road grade and effectively drain the road surface. This outsloped forest road has rolling dips that allow all traffic types to travel the route without changing speed.*

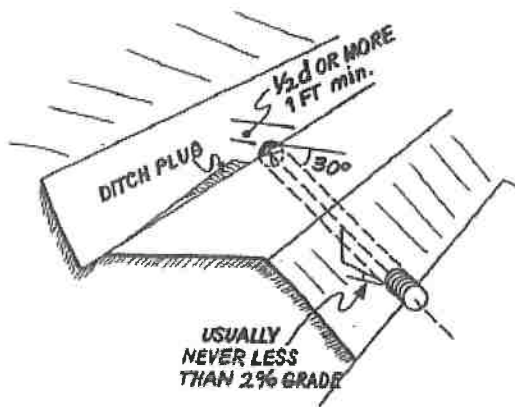
**FIGURE 48.** The elements of a properly installed ditch relief culvert. The culvert is angled at about 30 degrees to the road alignment to help capture flow and prevent culvert plugging or erosion of the inlet area. It is set at the base of the fill (ideally) or with a grade slightly steeper than the grade of the contributing ditch (but never with a grade less than 2 percent) (USDA-SCS, 1983). At a minimum, the grade of the ditch relief culvert should be sufficient to prevent sediment accumulation at the inlet or deposition within the culvert itself (it should be self-cleaning) (USDA-SCS, 1983).

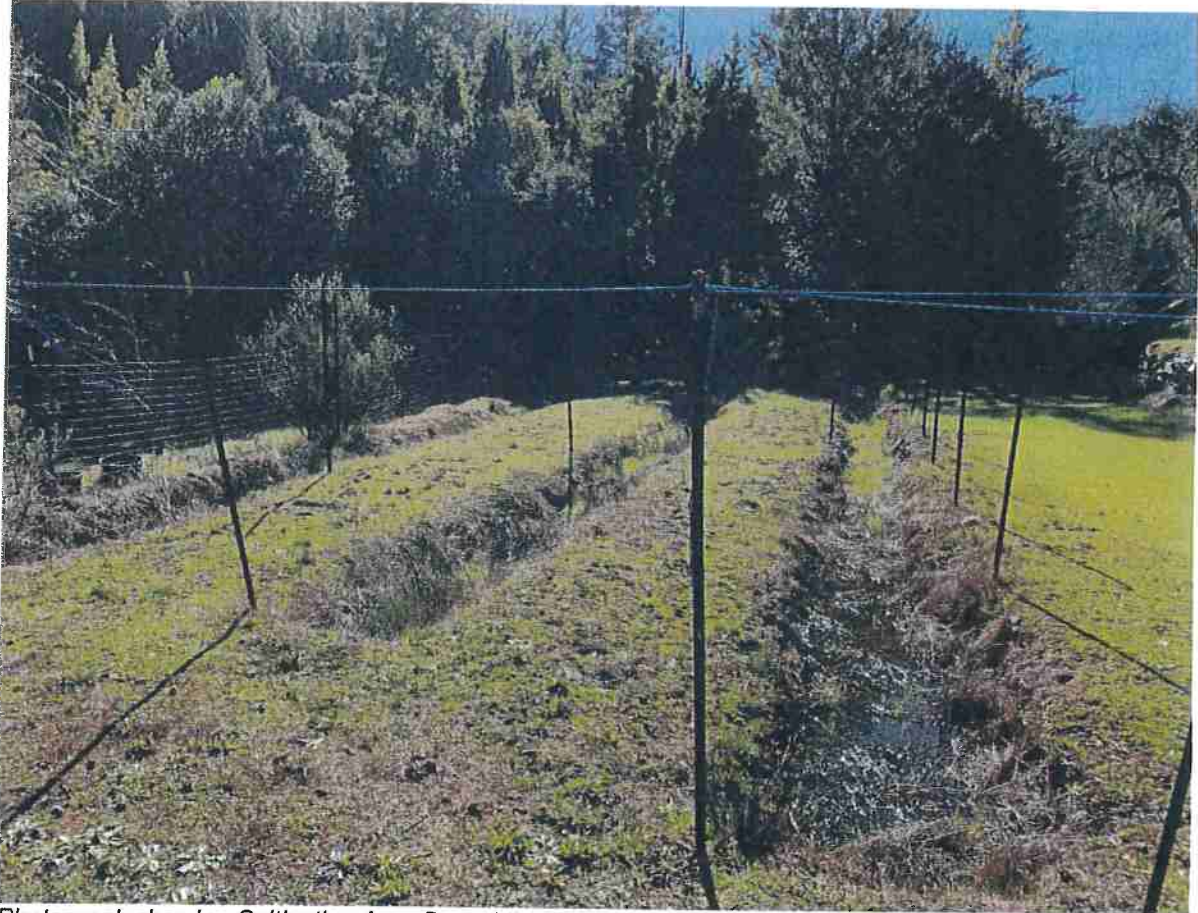
*Photograph showing Cultivation Area D, and the three trenches used for outdoor cultivation purposes.*

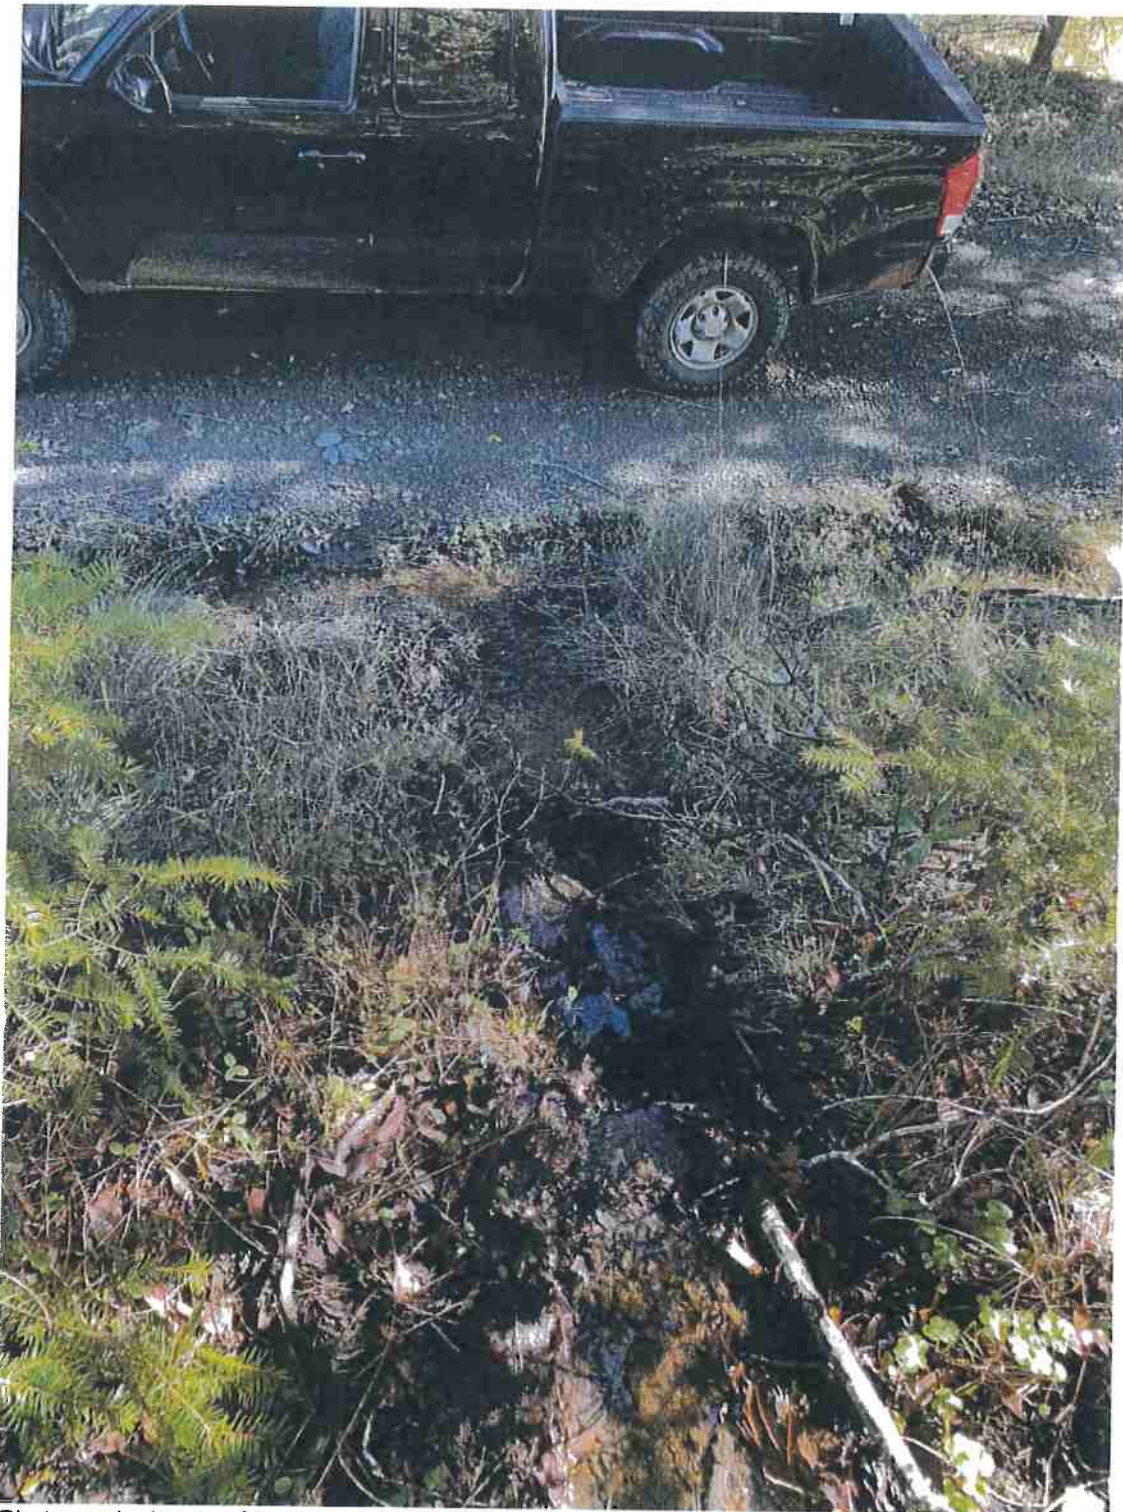
*Photograph showing Site 04 where the watercourse joins an inboard ditch after bypassing a knick point.*

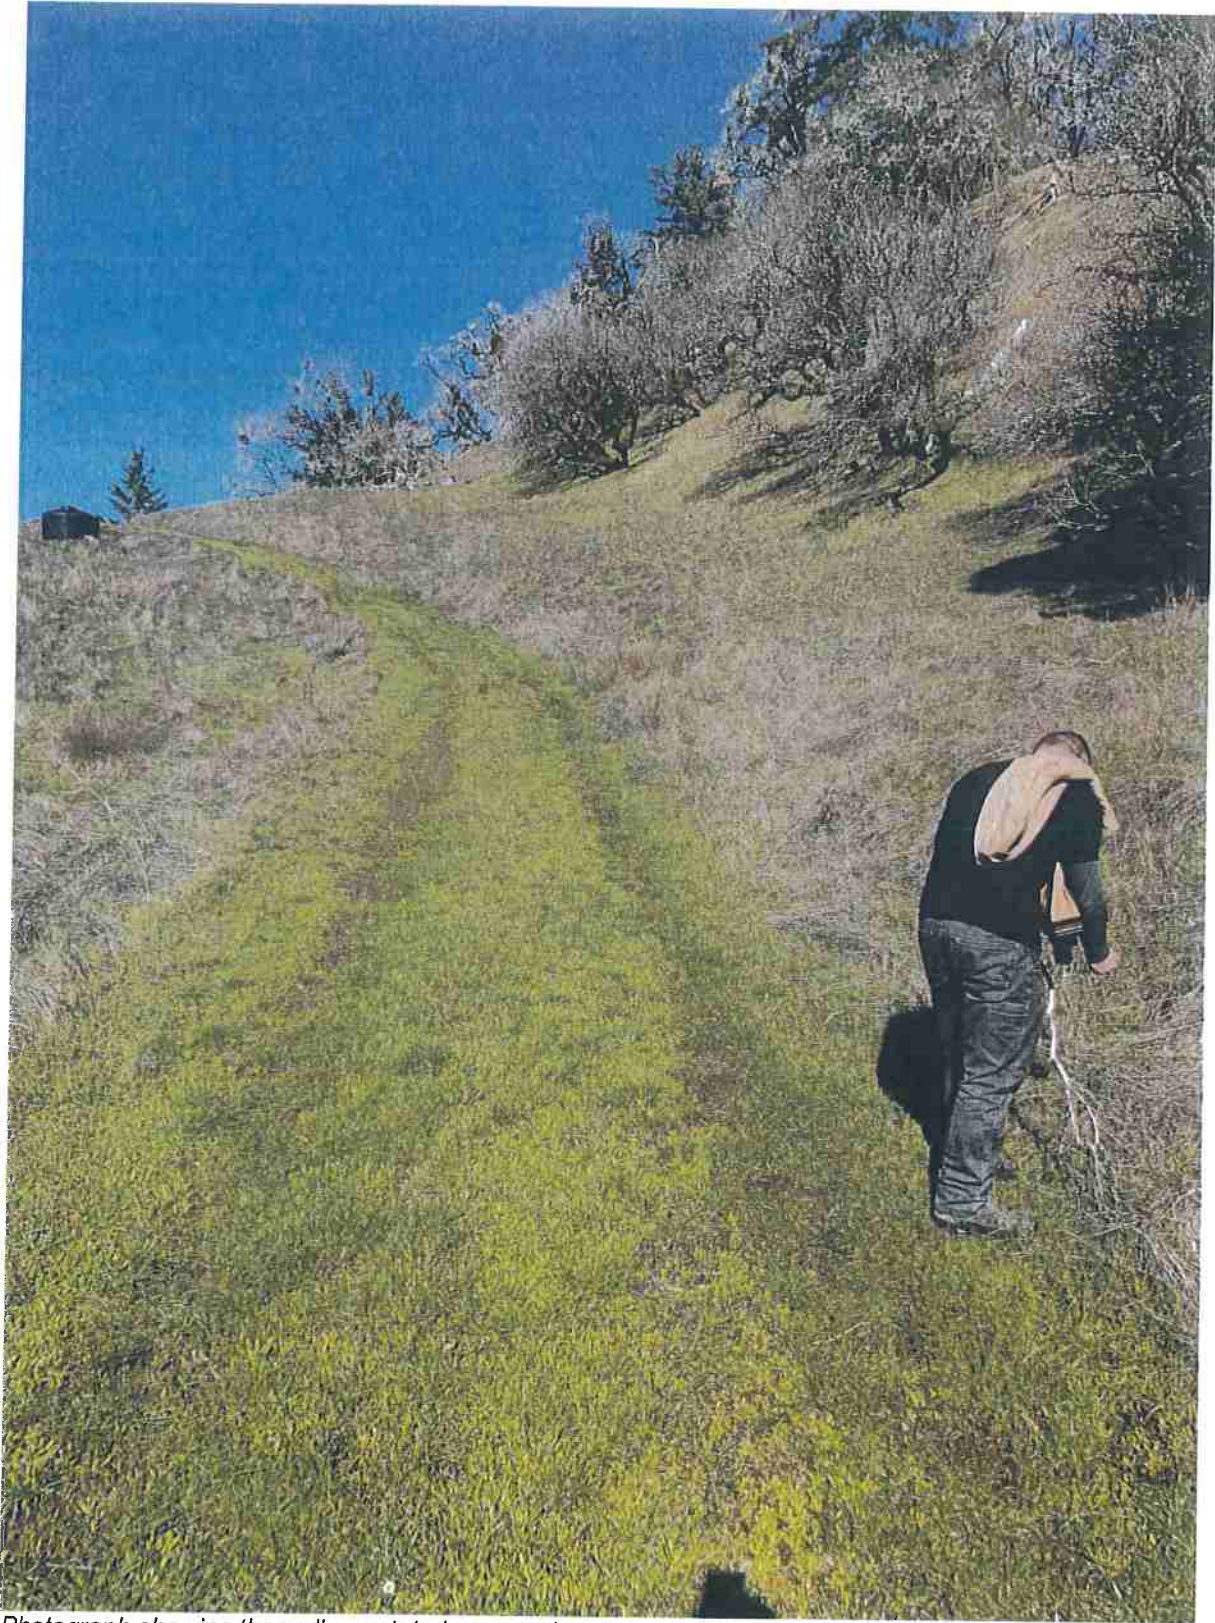
*Photograph showing the well-vegetated seasonal access road on the lower parcel.*
