**Mad River Properties, Inc.**  
2660 Clay Road McKinleyville, CA 95519; (707) 496-0054

**Whyman Less Than Three Acre Conversion Mitigation Plan**

- a. Site Address: Blue Lake CA 95525
- b. Community Area: Blue Lake, CA
- c. Assessor's Parcel No(s): 316-185-008, 316-171-005, and 316-186-006
- d. Parcel Size(s): 40, 40, and 80

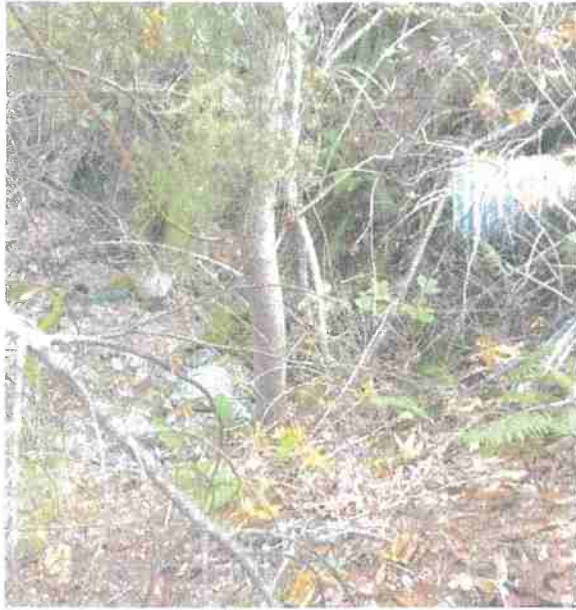
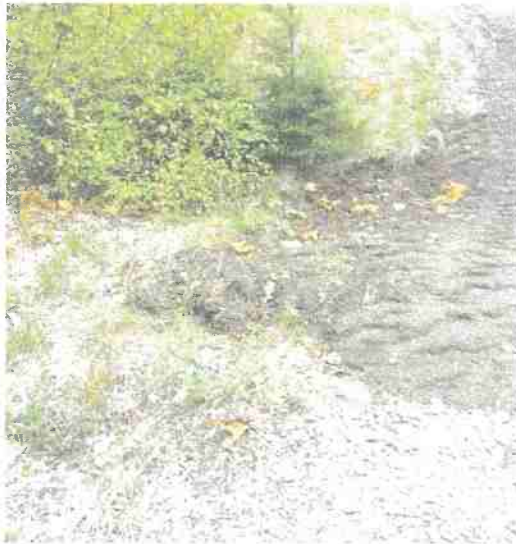
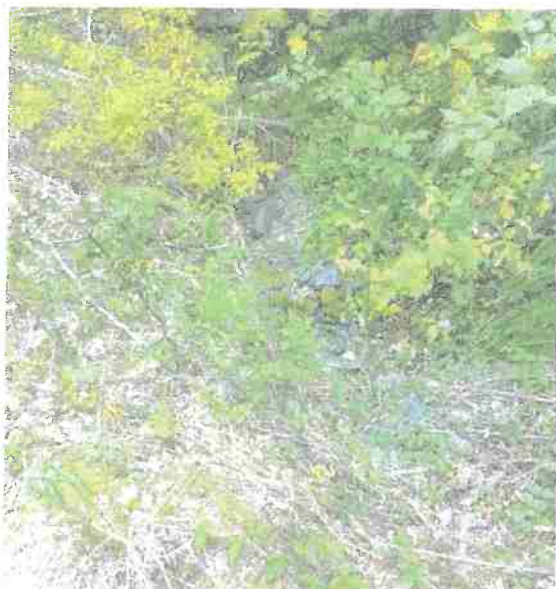
- RP5 Seasonal road system showing signs of overland flow. Install a rocked rolling dip. Line dip with 4-6" diameter rock to prevent surface erosion.
- RP 6 Existing undersized 30" diameter culvert. Replace with 48" diameter culvert, 20' long. Install a critical dip on center and a rocked rolling dip 50' right. Line both dips with 4-6" diameter rock to prevent surface erosion. PWA prepared 1600 document. 40 cubic yds. of erosion potential if left unrepaired. (In 1600 as SC#2)

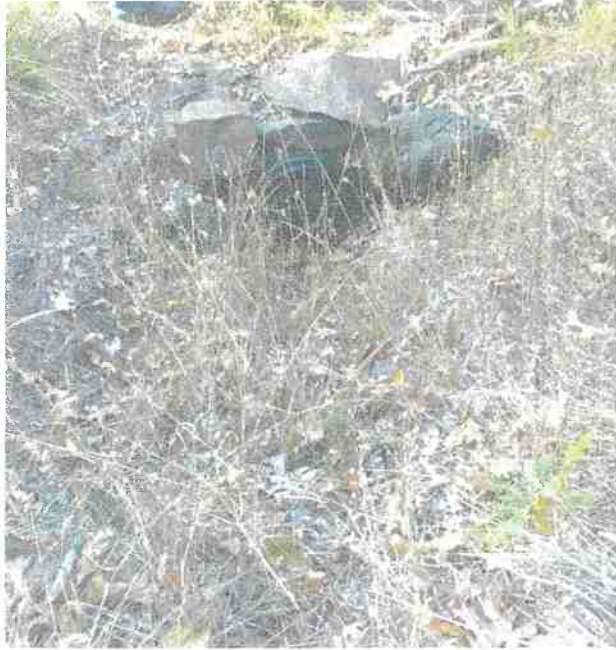
- RP11 Seasonal road system showing signs of overland flow. Install a rocked rolling dip. Line dip with 4-6" diameter rock to prevent surface erosion.
- RP12 Existing 18" diameter culvert. Upgrade to 24" diameter culvert, 30' long. Install a critical dip on center. Line dip with 4-6" diameter rock to prevent surface erosion. No RRD required. PWA prepared 1600 document. 10 cubic yds. of erosion potential if left unrepaired. (In 1600 as SC#3)

RP 12 Upstream view of culvert

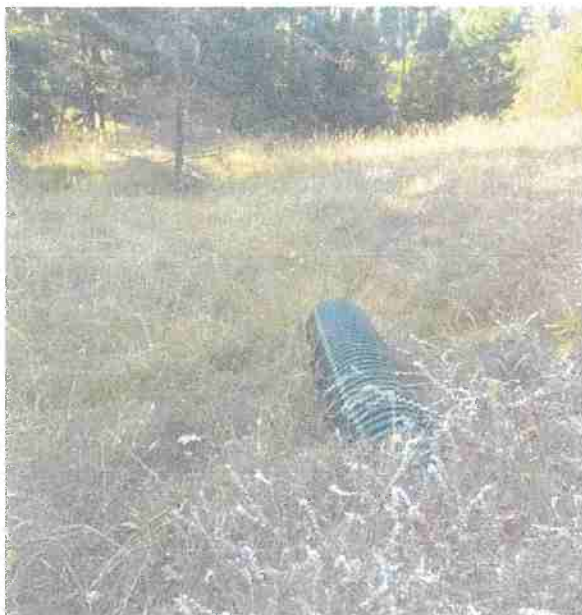
RP 12 Outlet of culvert

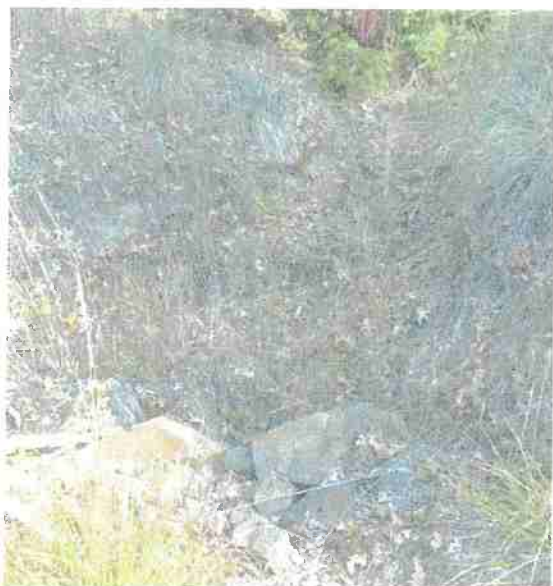
RP 12 Looking north

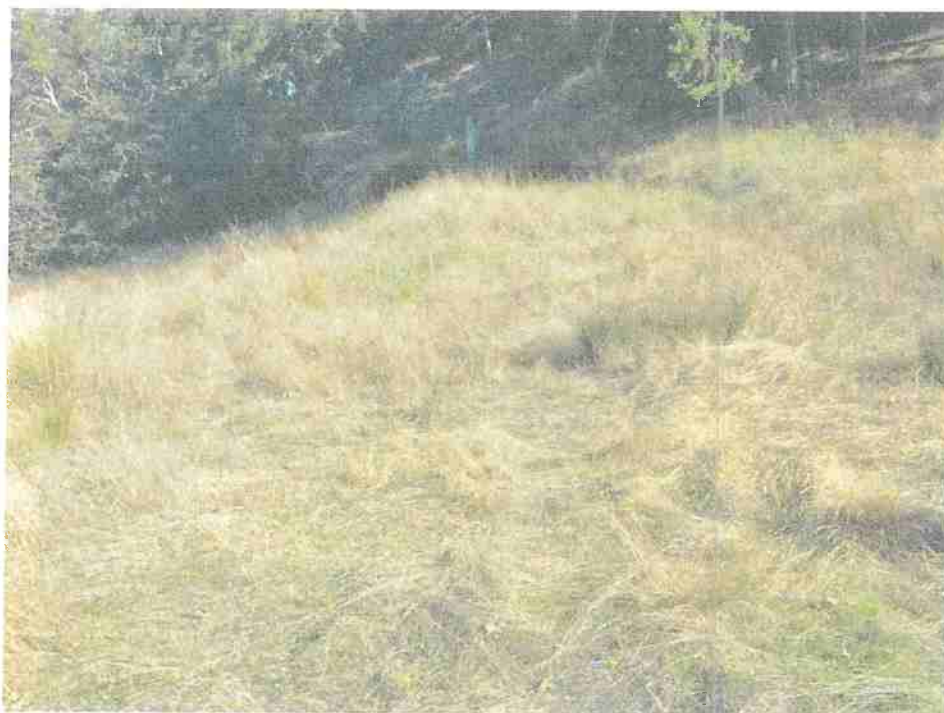
History: The site was first converted with tree clearing in 2015. Aerial images from NAIP show the clearing occurred between 2014 and 2016. The land owner claims that the clearing occurred before December 31, 2015. Currently the site is unoccupied and is now open grassland. No permit was obtained from CALFIRE to convert the area for such use. There are no rare, threatened or endangered animals and plants present within 1000' as per 2019 CNDDDB search. Ownership of at the time of the illegal conversion was Zach Whyman.

Site 1 looking north

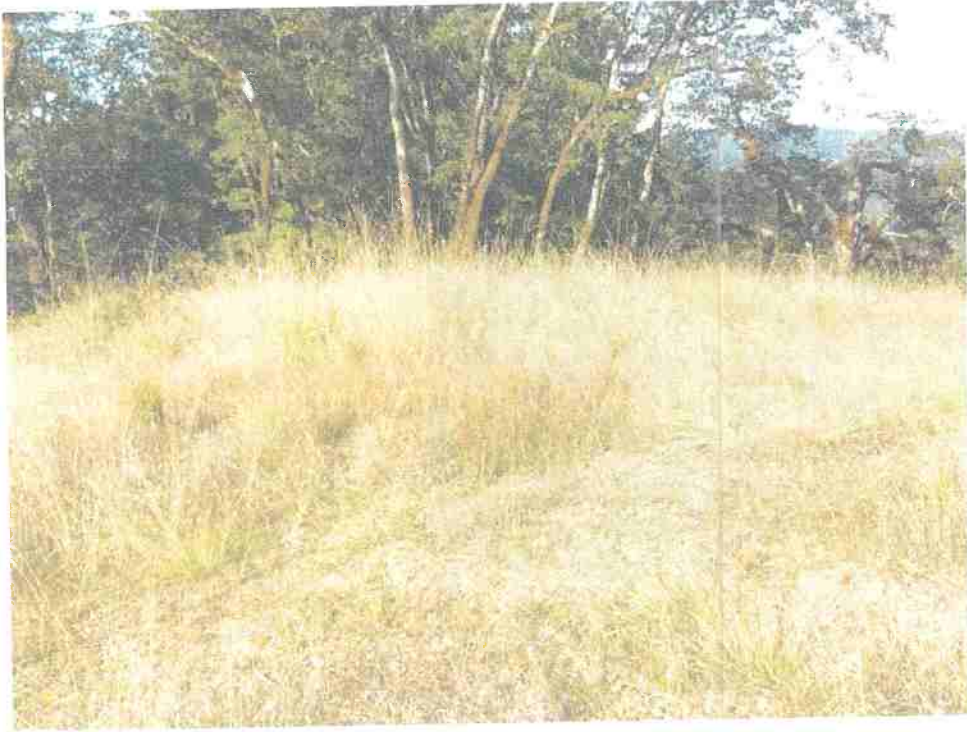
Site 1 looking west

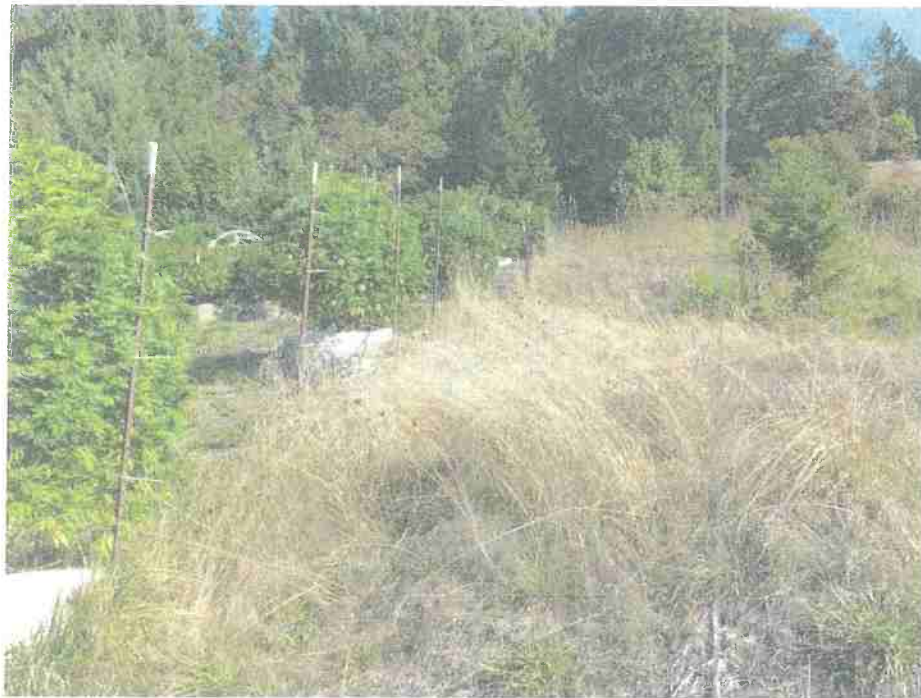
History: The site was first converted to cultivate cannabis with grading and the installation of a structure 1993 and 2004. Currently the site is occupied by an outdoor garden. No permit was obtained from CALFIRE to convert the area for such use at the time. The conversion is within a riparian buffer of a class III watercourse. The closest structure is 13' from the watercourse. It is recommended to relocate the storage shed outside of the 100' buffer per the forestry protection values and county riparian buffer. There is also a larger storage structure within 24' from the class III watercourse. It is recommended to retain the structure since it has a foundation and is more resilient to erosion. There are no rare, threatened or endangered animals and plants present within 1000' as per 2019 CNDDDB search. Ownership of Parcel at the time of the illegal conversion is unknown.

Site2 Looking north

Removal of Quonset Hut proposed

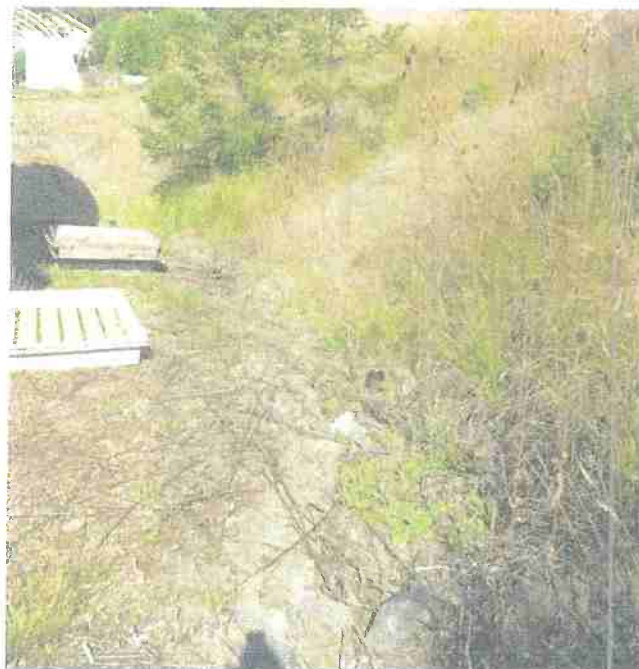
Site 2 French drain behind structure

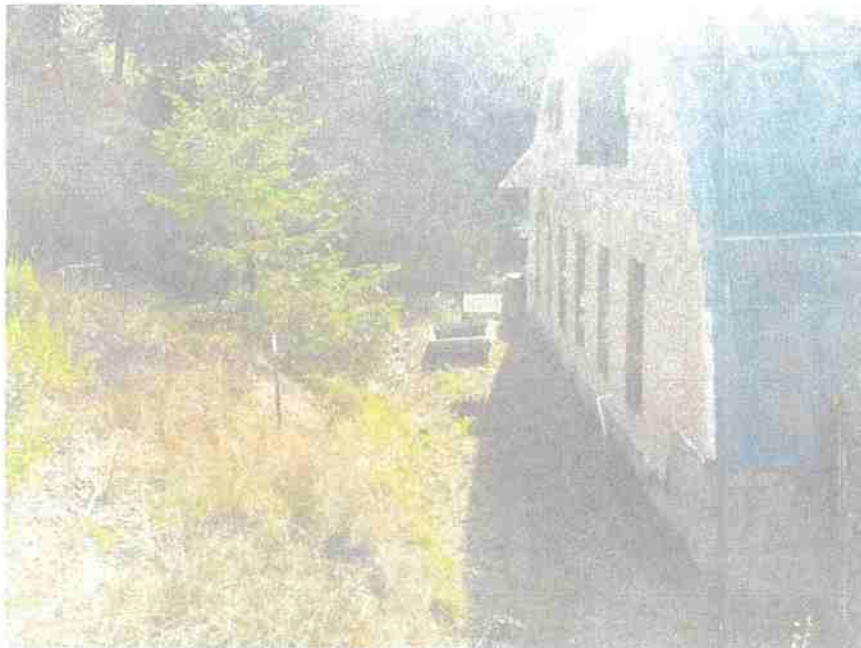
Site 2 structure near stream

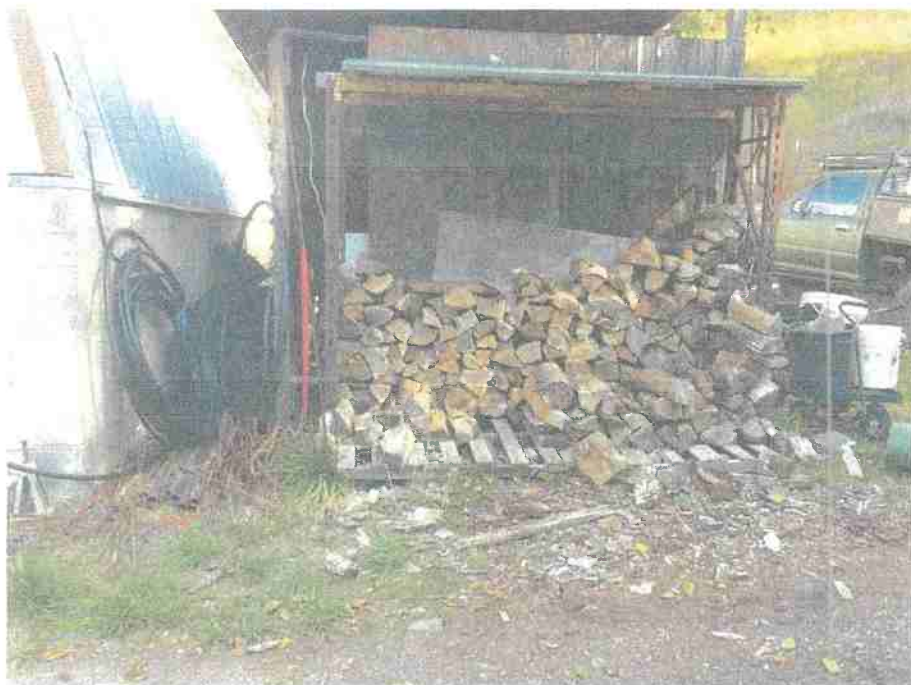
Site 2 storage shed near watercourse

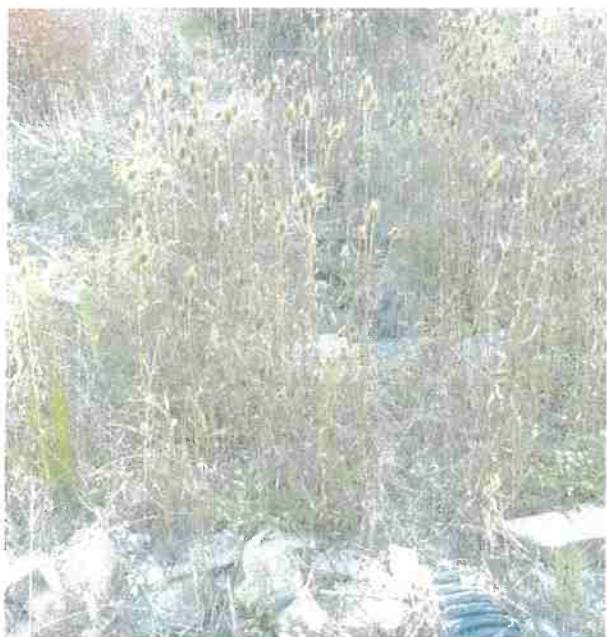
RP 20

- RP20 Existing 18" diameter culvert. Replace with 30" diameter culvert, 60" long. Install a critical dip on center and a rocked rolling dip 50' right. Line both dips with 4-6" diameter rock to prevent surface erosion. PWA prepared 1600 document. 60 cubic yds. of erosion potential if left unrepaired. (In 1600)

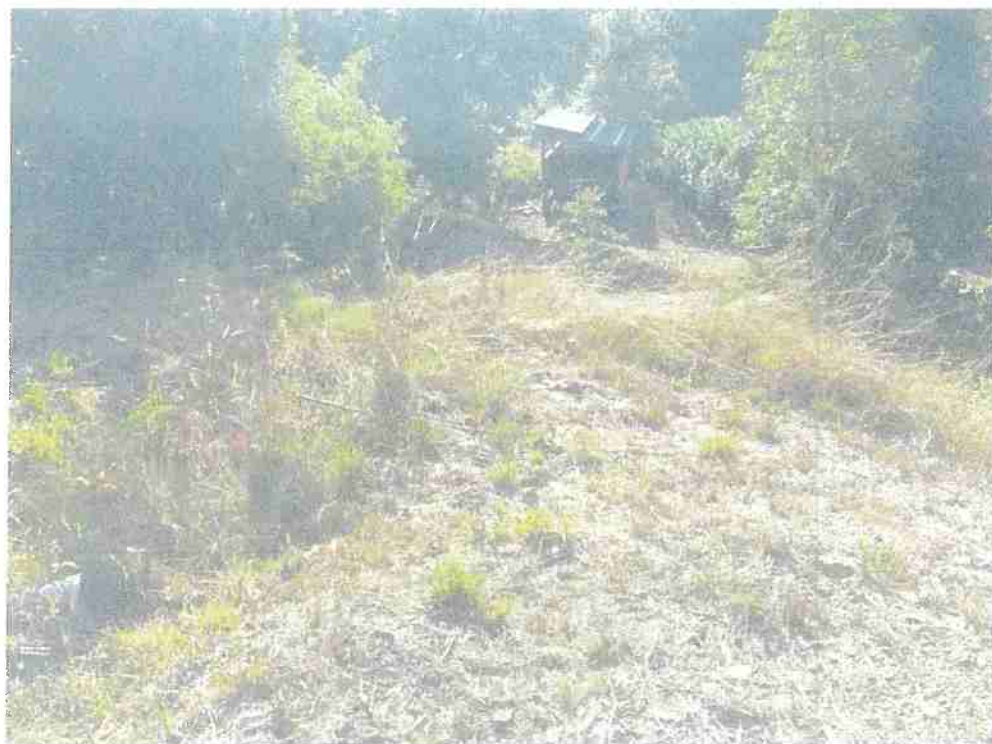
Site 3

History: The site was first converted to cultivate cannabis with grading and the installation of a hoop house #1 between 2006 and 2009. It was expanded to the south in 2010 and 2012 with clearing of trees and the construction of a hoop house #2. Between 2014 and 2016 the hoop house #2 was replaced with an outdoor garden. Currently the site is occupied by a 25' by 100' greenhouses and an outdoor garden to the south. No permit was obtained from CALFIRE to convert the area for such use at the time. There are no rare, threatened or endangered animals and plants present within 1000' as per 2019 CNDDDB search. Ownership of Parcel at the time of the illegal conversion is Zach Whyman.

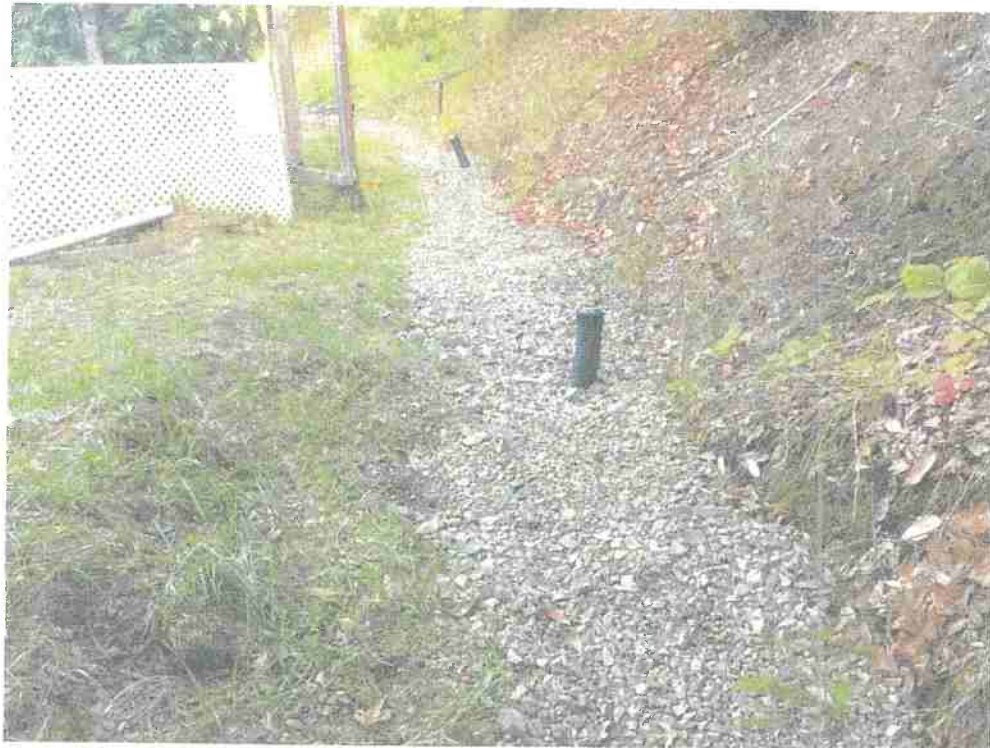
- RP 21 Maintain existing French drain.
- RP22 Seasonal road system showing signs of overland flow. Install a rocked rolling dip. Line dip with 4-6" diameter rock to prevent surface erosion.

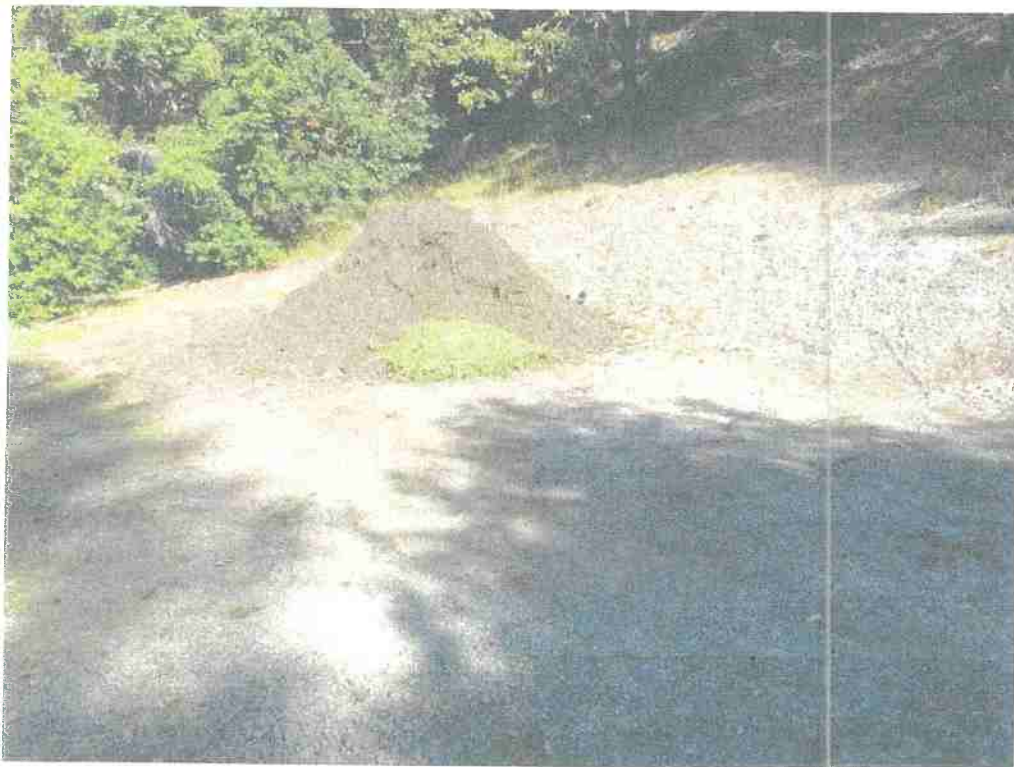
Site 4

History: The site was first converted with the removal of trees, and grading 2014 and 2016. Currently the site is occupied by a Compost pile and agriculture supplies. No permit was obtained from CALFIRE to convert the area for such use at the time. There are no rare, threatened or endangered animals and plants present within 1000' as per 2019 CNDDDB search. Ownership of Parcel at the time of the illegal conversion is Zach Whyman.

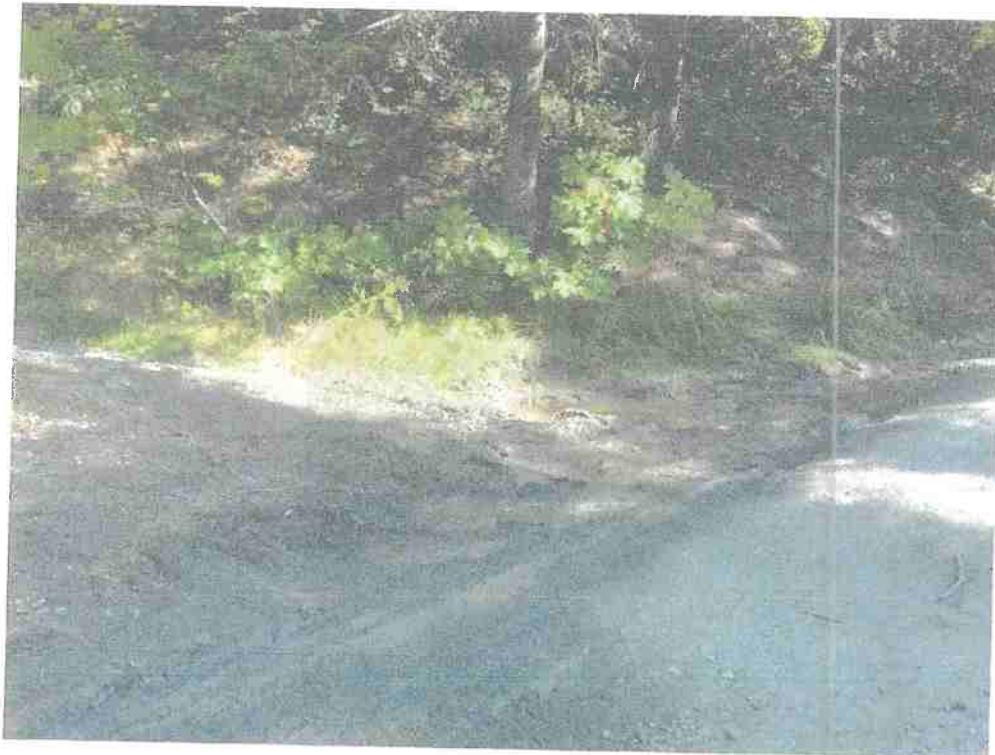
- RP 25 Existing Skid Road showing signs of erosion. Install water break every 50' for the length of current use.
- RP 24 Existing 32" diameter culvert undersized. Replace with 60" diameter culvert. Install a critical dip on center and a rocked rolling dip 50' right. Line both dips with 4-6" diameter rock to prevent surface erosion. PWA prepared 1600 document. 50 cubic yds. of erosion potential if left unrepaired.

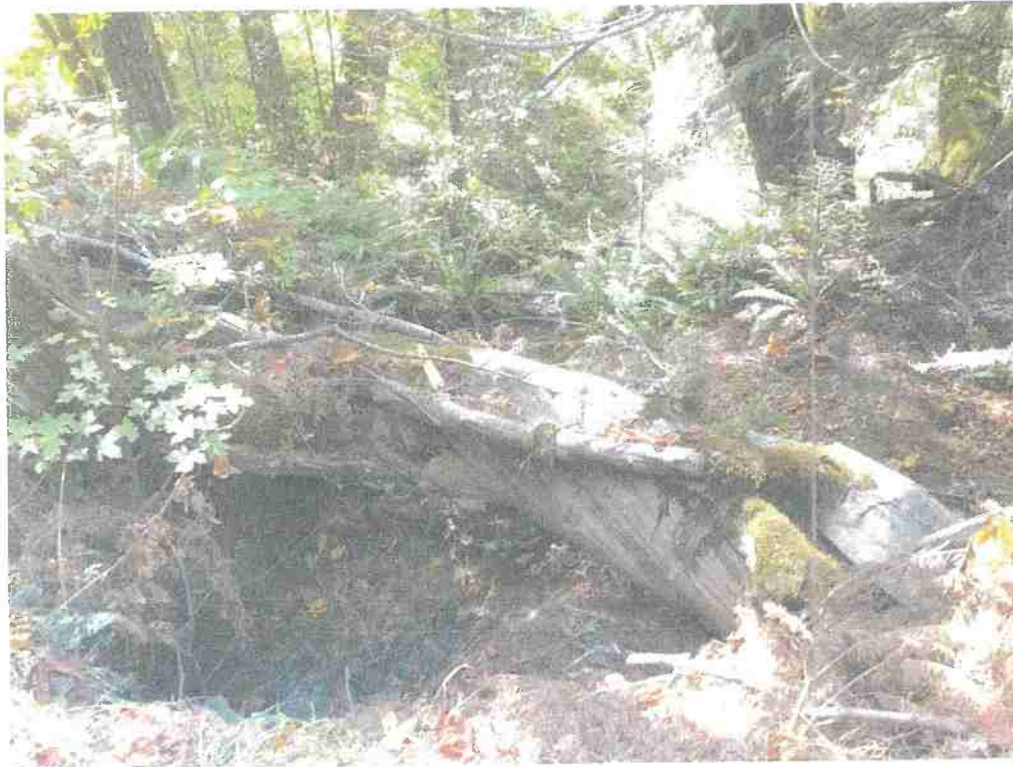
RP 26 outlet

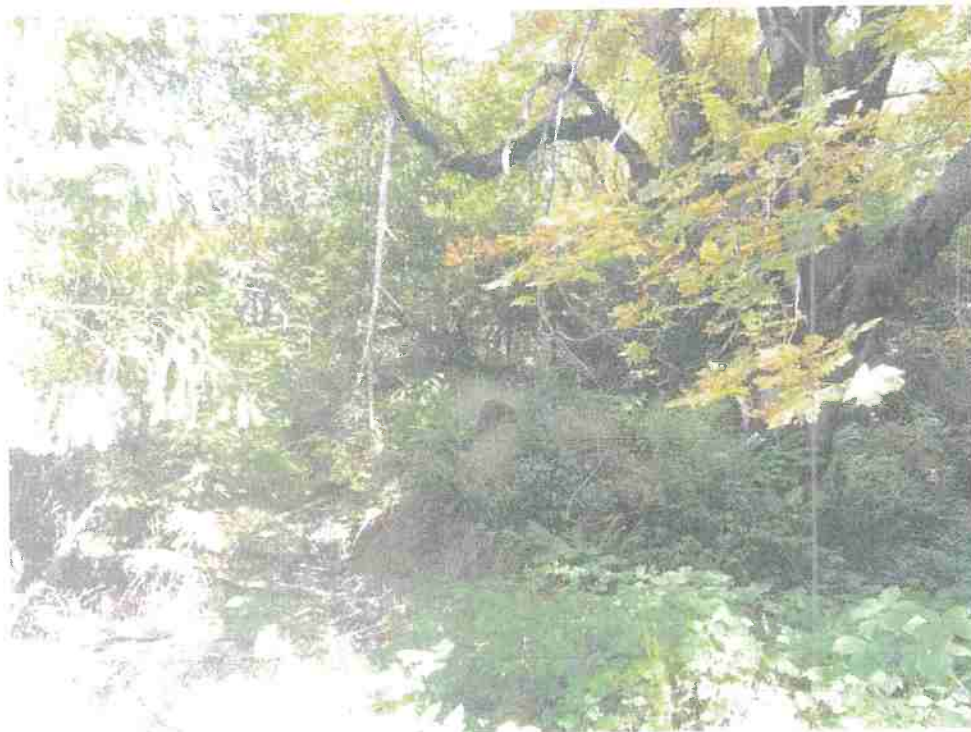
RP 26 inlet
