40 North LLC
271 Evergreen Road, Suite 2, Box 945
Redway, CA 95560

40 North Ranch Less Than Three Acre Conversion Mitigation Plan

- a. Site Address: Dyerville Loop Road, Phillipsville, CA
- b. Community Area: Fruitland CA
- c. Assessor's Parcel No(s): 214-114-010
- d. Parcel Size(s): 195.2 Ac.

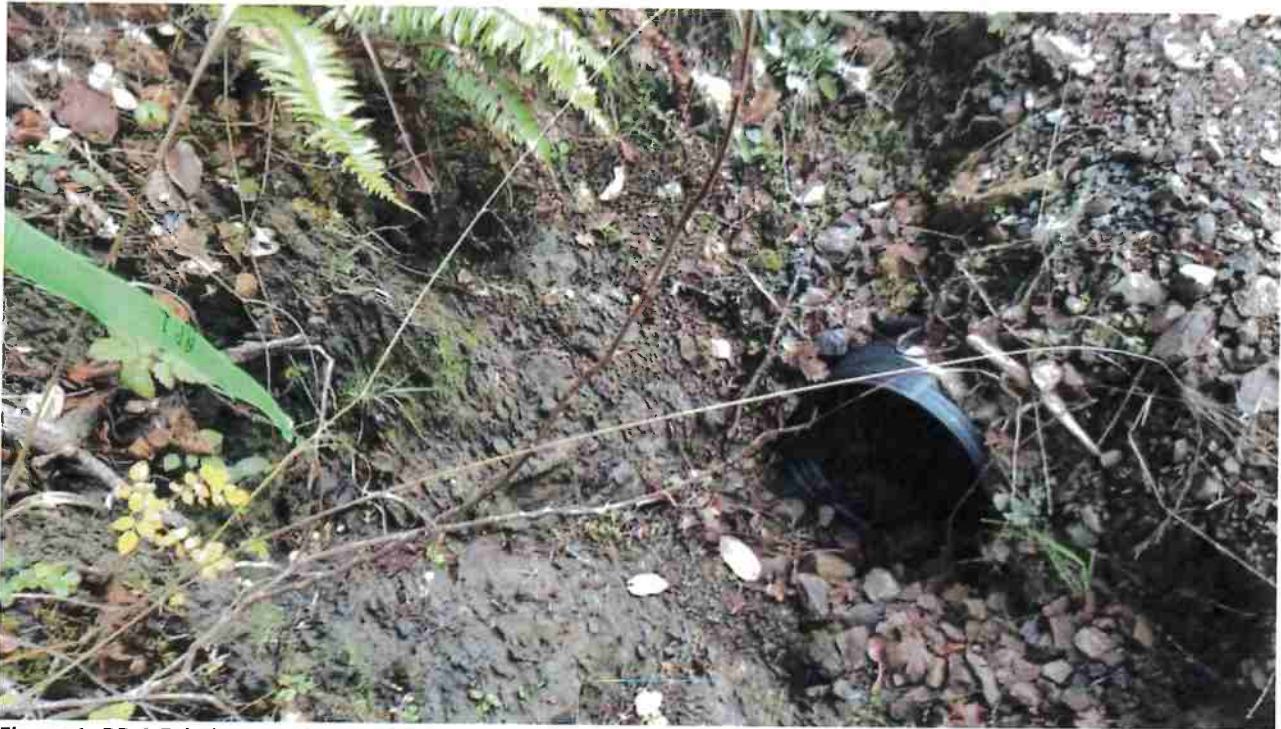
Figure 1: RP-1 Existing Functioning DRC

RP-1 (Site B): Existing functioning 16" ditch relief culvert (DRC). There are no current issues with the DRC monitor and maintain the inlet as necessary. (Monitored by H&A Nov 2019; Work was Completed.)

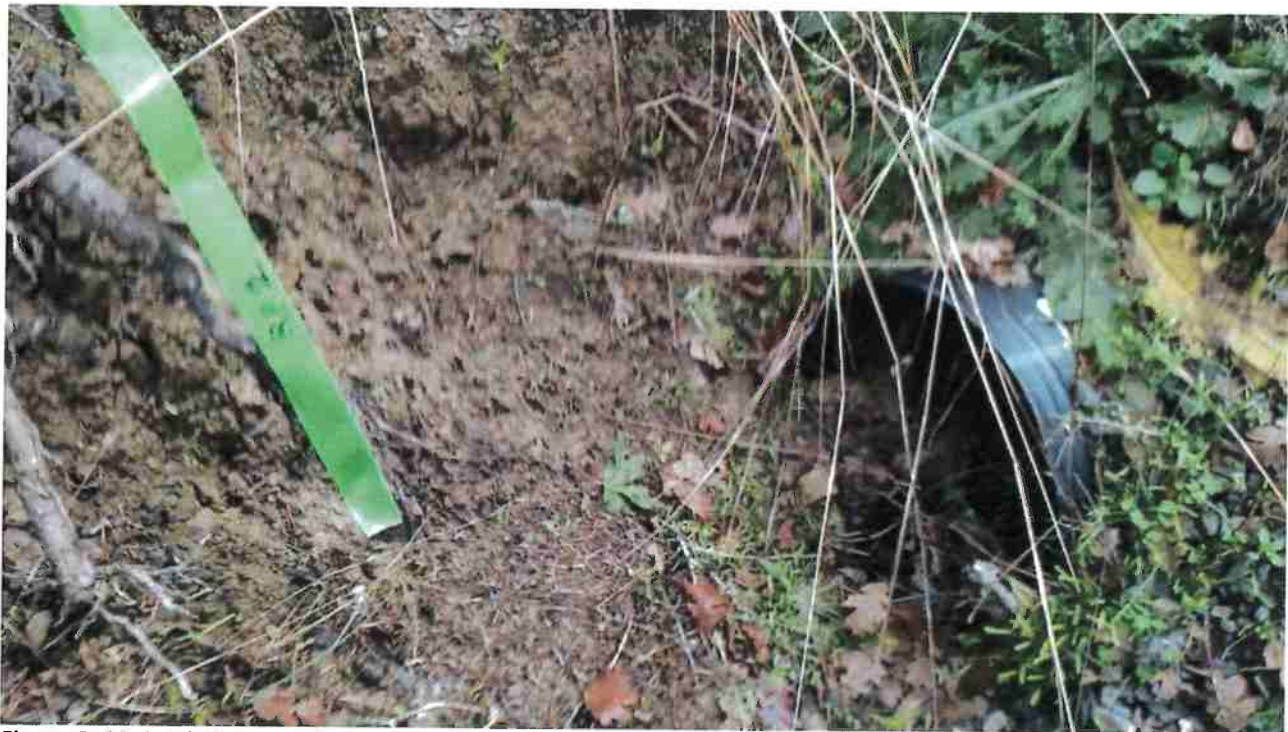
Figure 2: RP-2 Existing Functioning DRC

RP-2 (Site B): Existing functioning 16" ditch relief culvert (DRC). The inlet will need to be cleared of debris. Monitor and maintain the inlet as necessary. (Monitored by H&A Nov 2019; Work was Completed.)

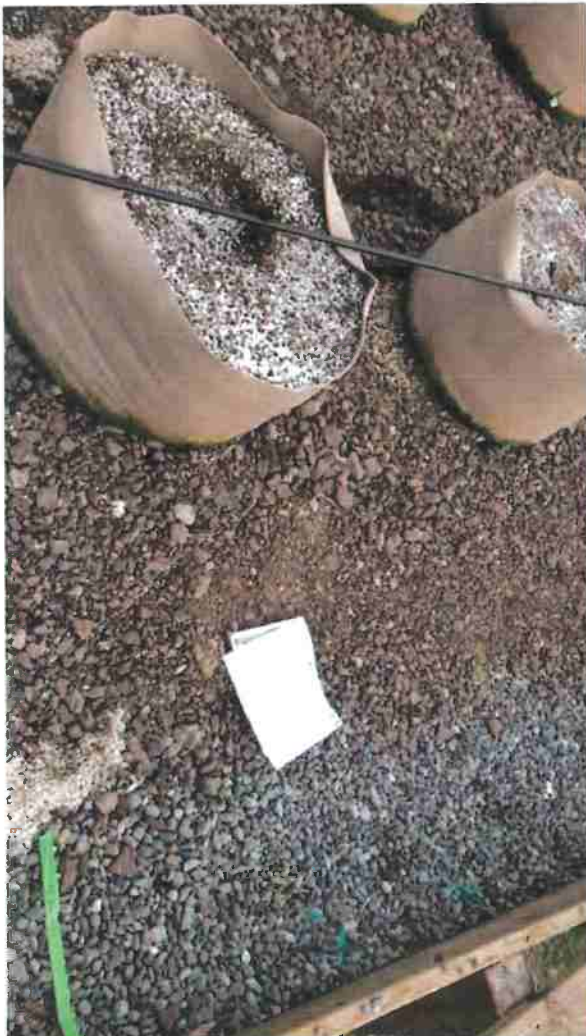
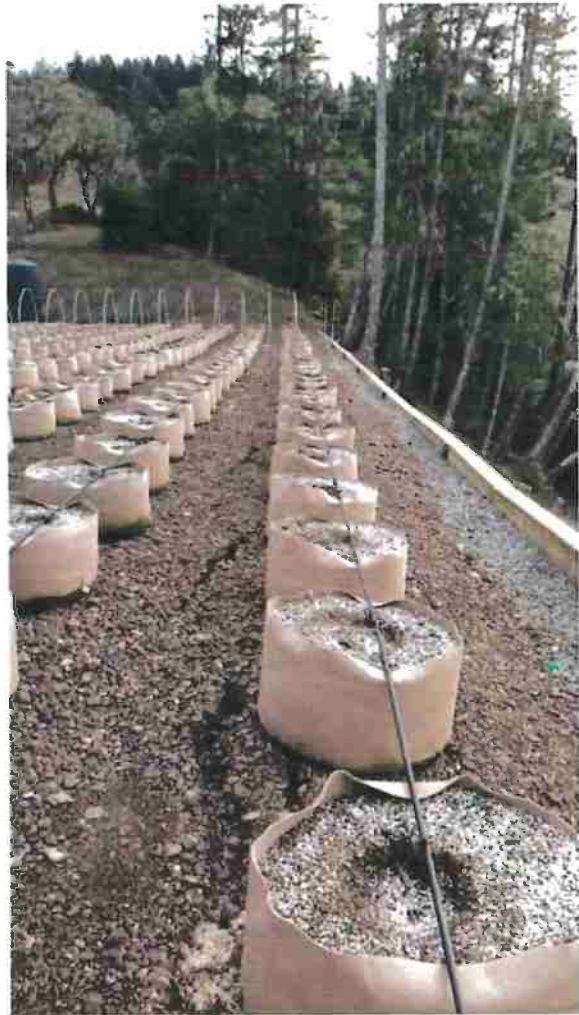
Figures 3 & 3: RP-3 improperly compacted fill slumping against retaining wall.

RP-3 (Site B): Settling fill at the edge of the cultivation site is placing excessive pressure against the retaining wall out. Excavate fill for 60' by 10' and compact in 6" lifts keyed into the slope. Failure of the retaining wall could lead to sediment delivery to the unstable feature below. (Monitored by H&A Nov 2019; Work was Completed.)

RP-B (Site B): The work required at RP-3 was completed the retaining wall was removed and the slope was laidback and fill was recompact. The new fill slope is to be stabilized with wattles, Jute netting and straw mulch.

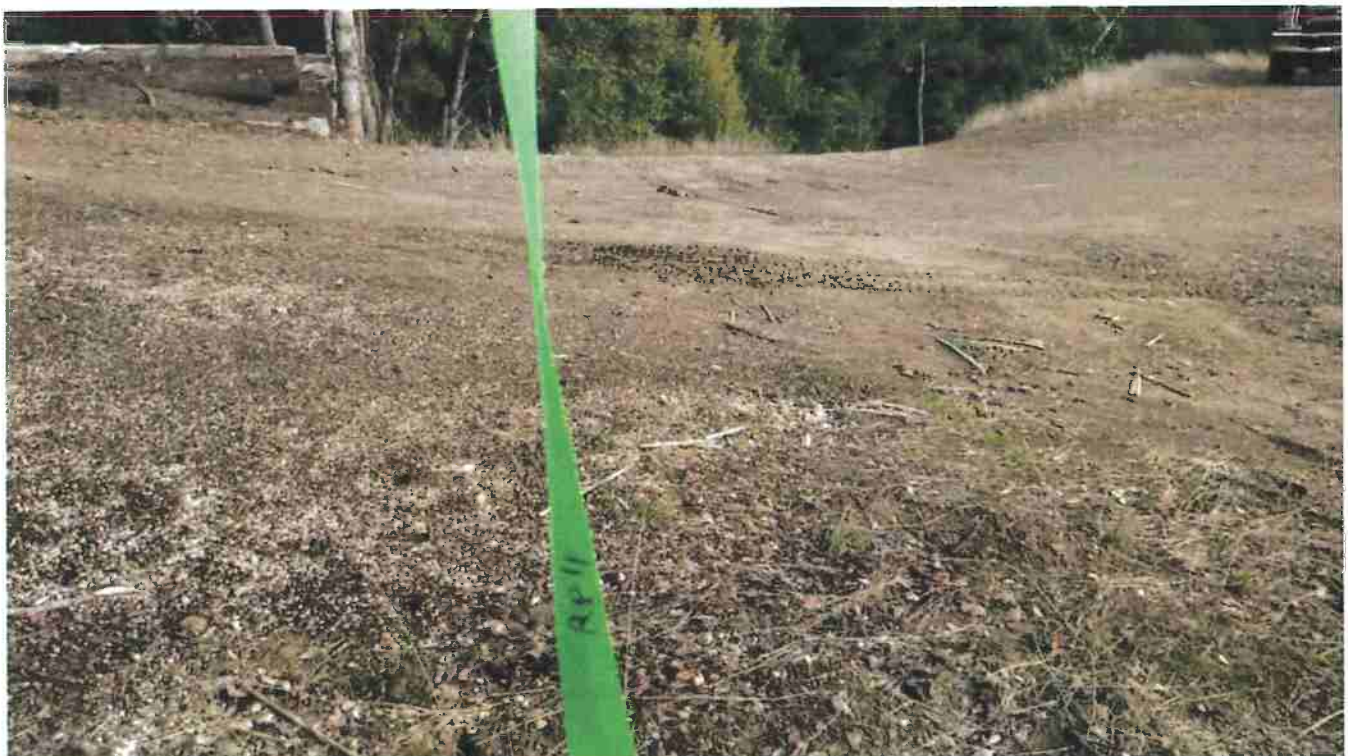
Figure 5: RP-4 Install RRD

RP-4 (Site B): Install a rocked rolling dip. Line dip with 3" to 6" mixed diameter sharp angular rock. (Monitored by H&A Nov 2019; Work was Completed.)

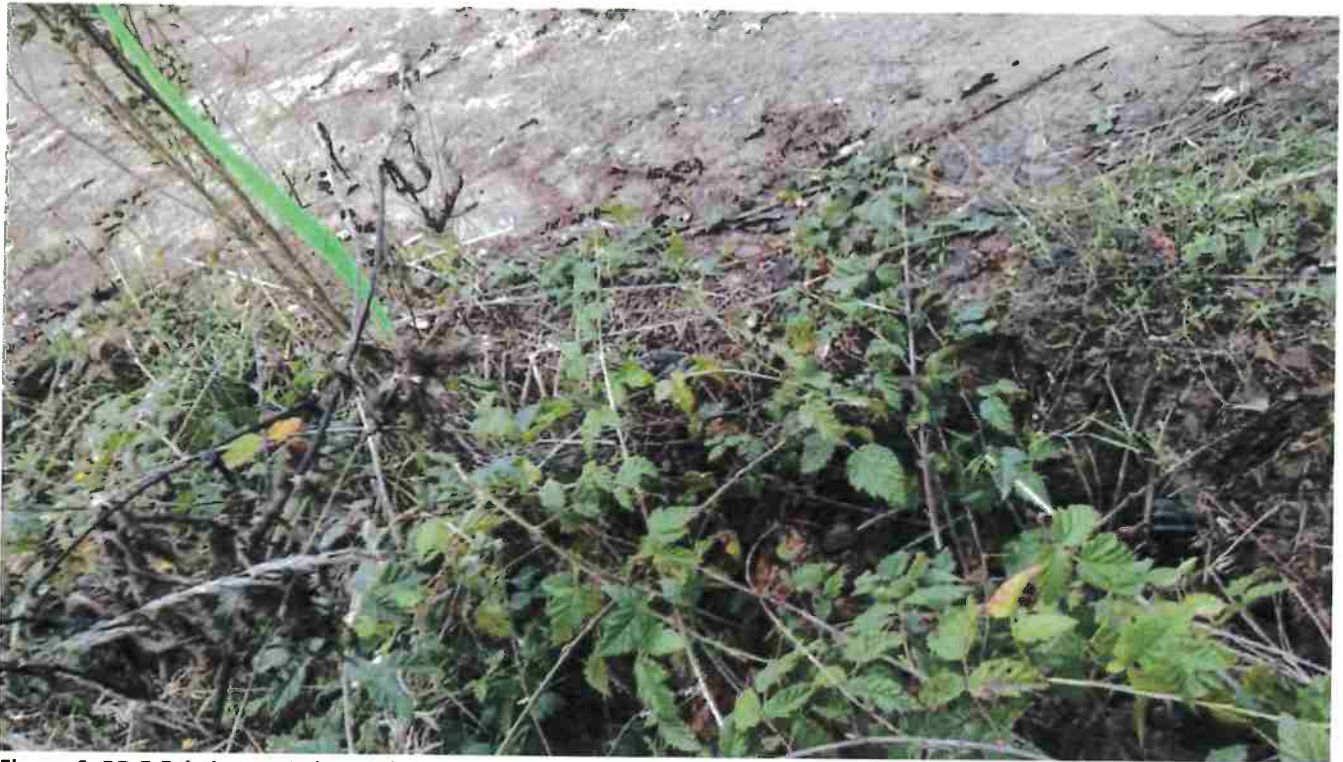
Figure 6: RP-5 Existing DRC clean inlet.

RP-5 (Site B): Existing functioning 16" ditch relief culvert (DRC). The inlet needs to be cleared of debris. Monitor and maintain the inlet as necessary. (Monitored by H&A Nov 2019; Work was Completed.)

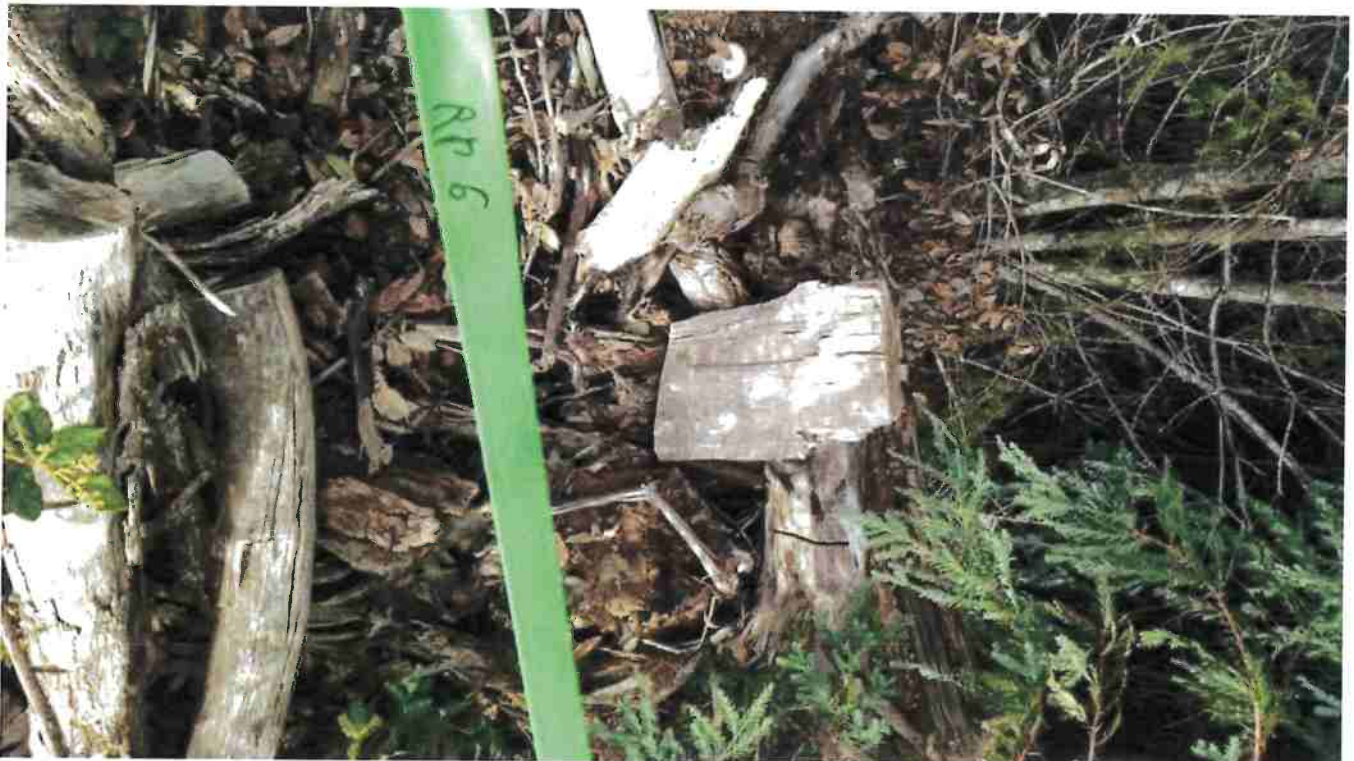
Figure 7: RP-6 Clean up woody debris.

RP-6 (Site B): Woody debris mixed with loose fill caused a slump on the edge of the clearing remove the debris and excavate loose fill back to natural grade as feasible. (Monitored by H&A Nov 2019; Work was Completed.)

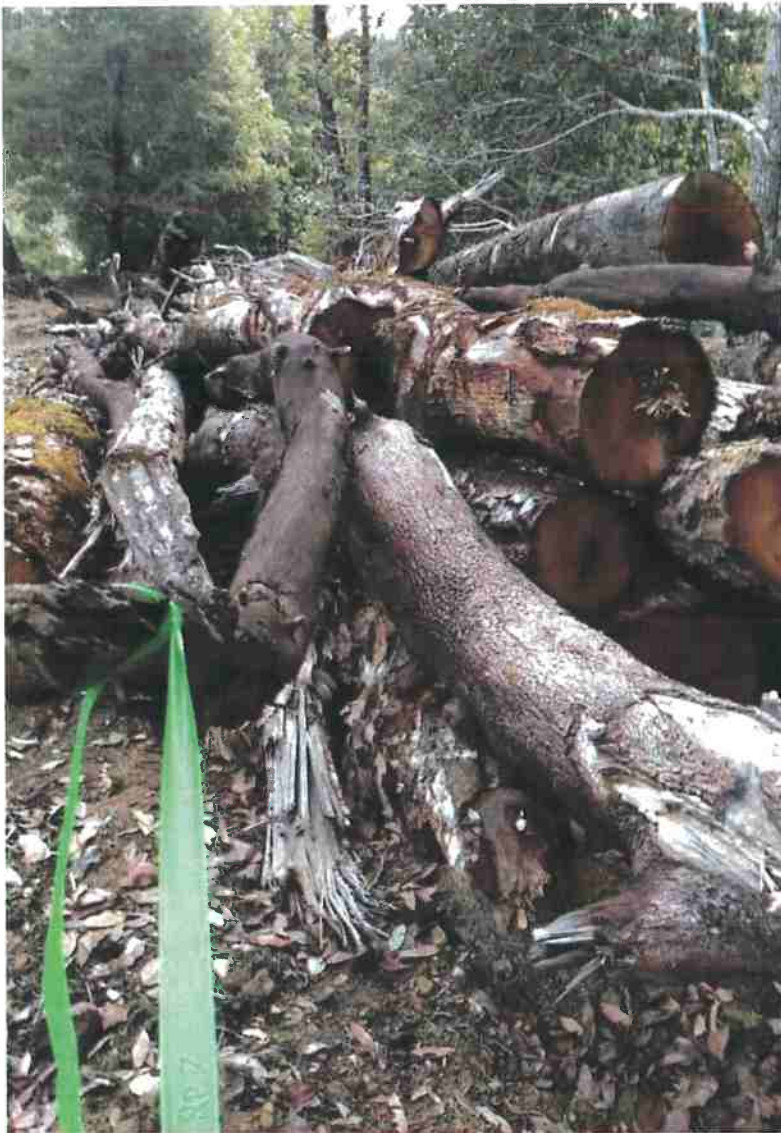
Figure 8: RP-7 Remove logs and woody debris.

RP-7 (Site B): Log and slash pile on the edge of the clearing remove the logs and slash from the site. (Monitored by H&A Nov 2019; Work was Completed.)

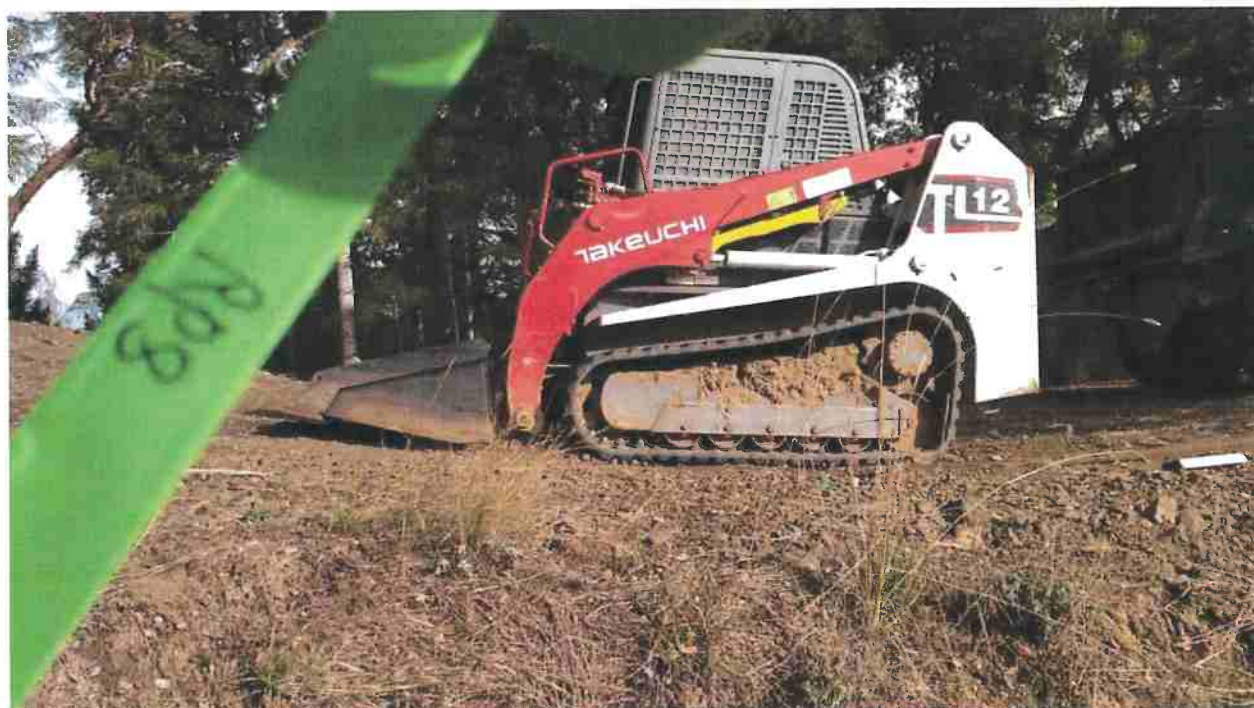
Figure 9: RP-8 Install RRD.

RP-8 (Site B): Install a rocked rolling dip. Line dip with 3" to 6" mixed diameter sharp angular rock. (Monitored by H&A Nov 2019; Work was Completed.)

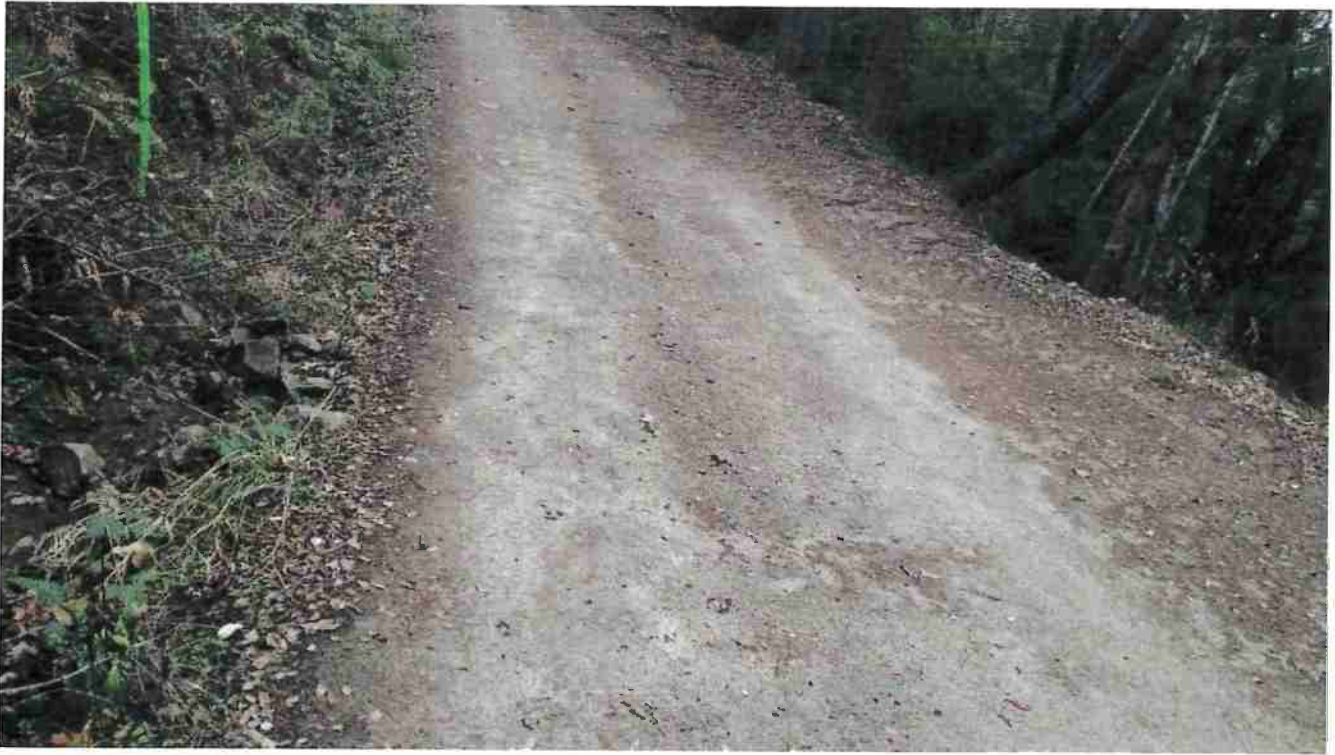
Figure 10: RP-9 Existing DRC to be replaced with 24" DRC.

RP-9 (Site C): Excavate undersized 16" DRC and replace with an oversized 24" DRC installed to the natural grade as feasible. Clear the inside ditch and line with 2" – 4" rock for 40' up either side of the ditch. Monitor and maintain the inlet as necessary.

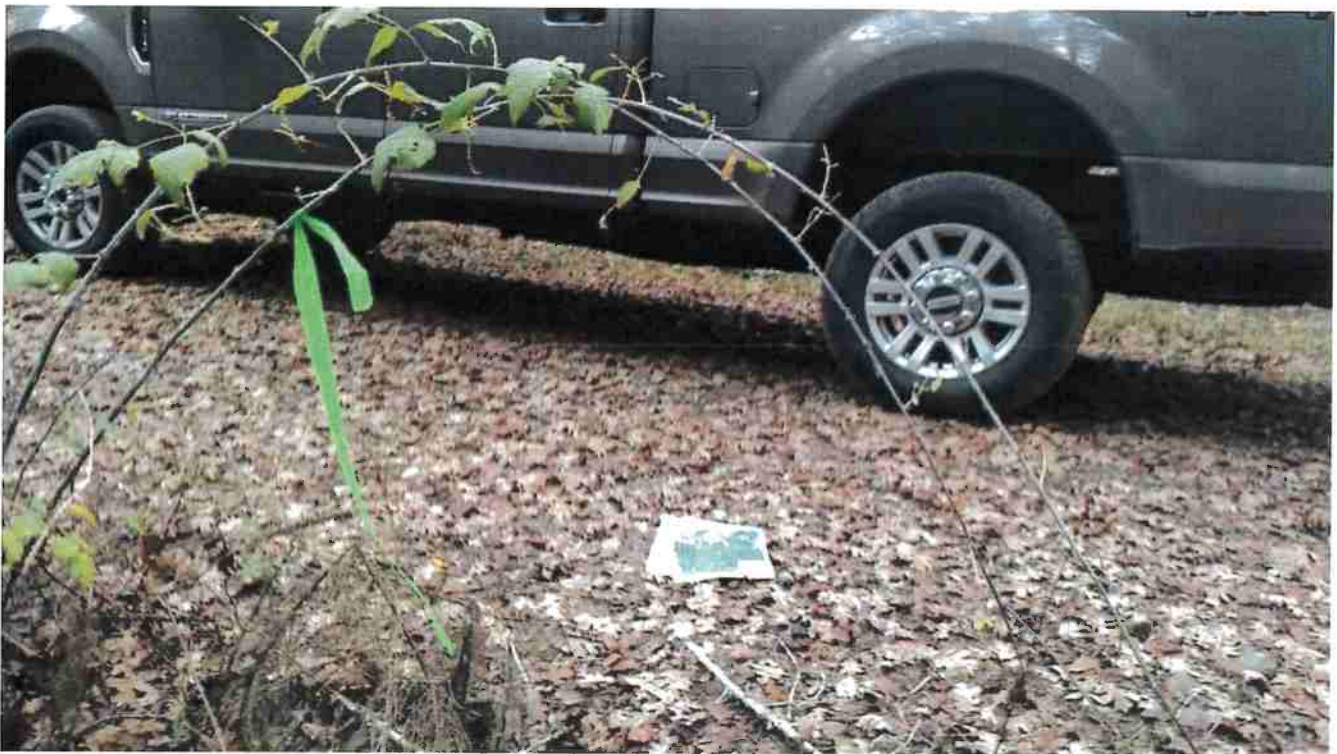
Figure 11: RP-10 Install RRD.

RP-10 (Site C): Install a rocked rolling dip. Line dip with 4" to 8" mixed diameter sharp angular rock. (Monitored by H&A Nov 2019; Work was Completed.)

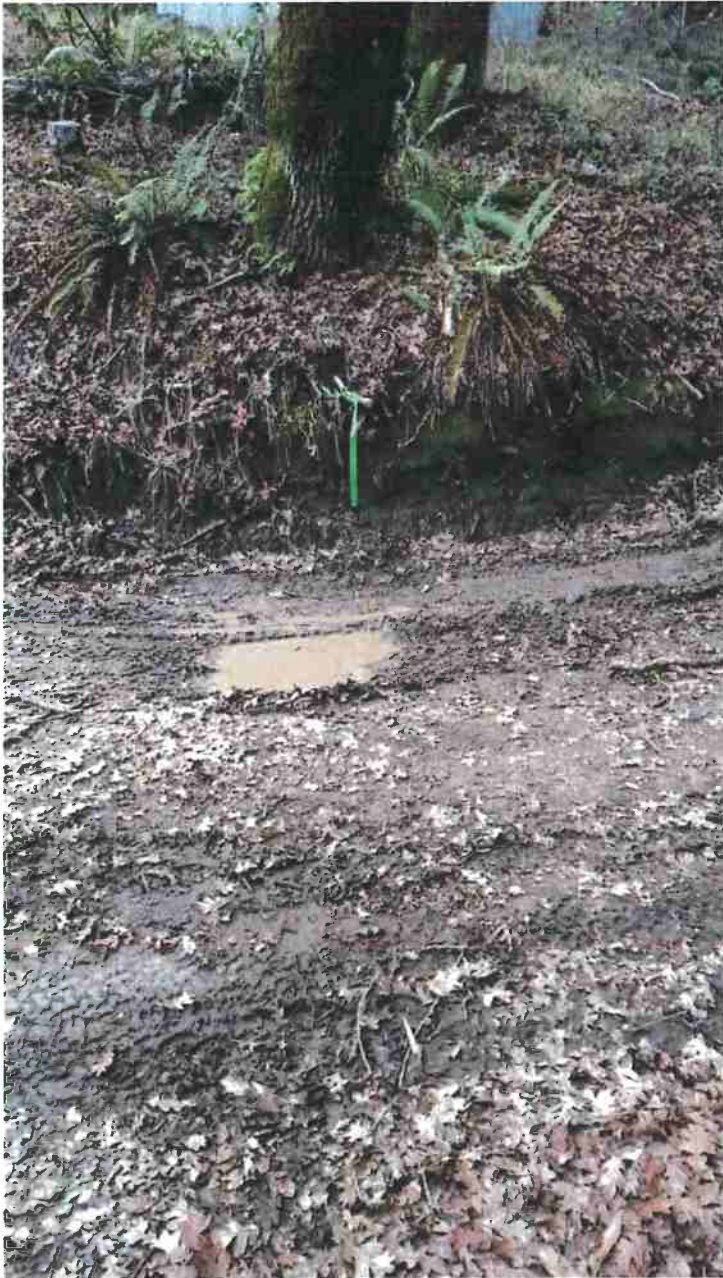
Figure 12: RP-11 Install RRD

RP-11 (Site C): Install a rocked rolling dip. Line dip with 3" to 6" mixed diameter sharp angular rock. (Monitored by H&A Nov 2019; Work was Completed.)

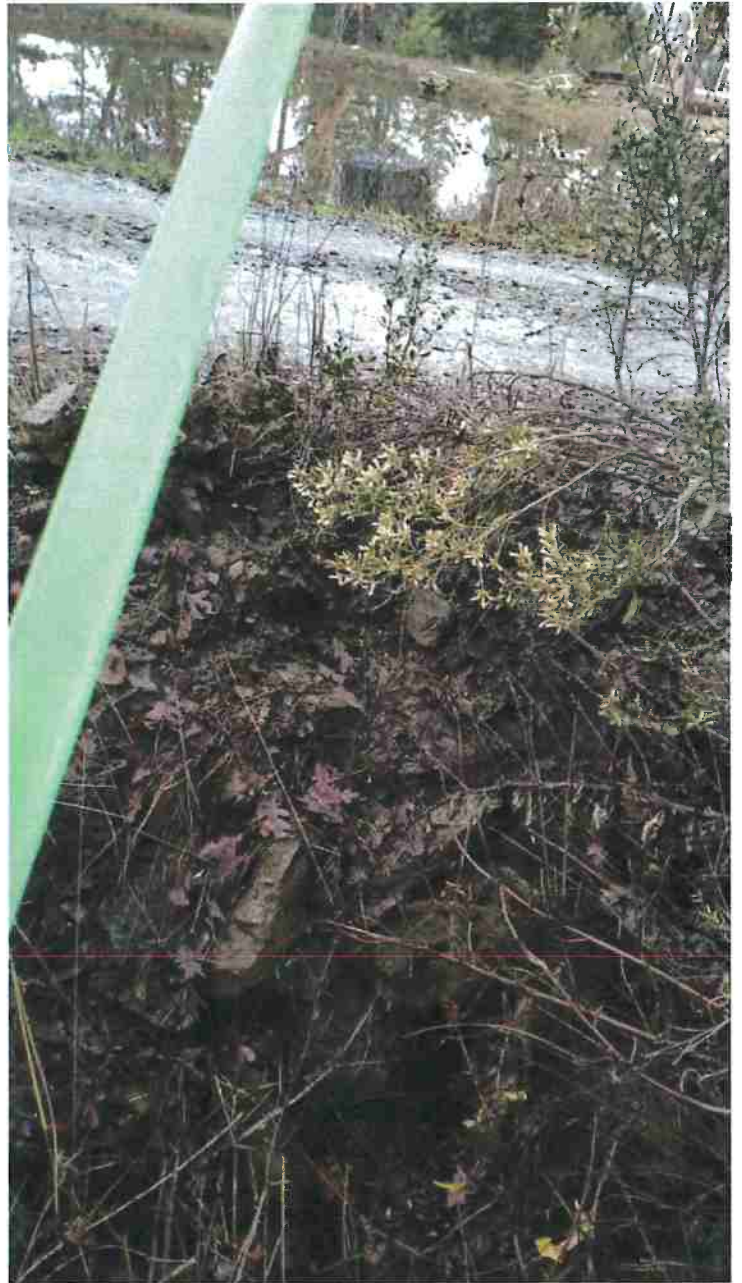
Figure 12: RP-12 Existing DRC enhance rock armoring.

RP-12 (Site C): Existing 16" DRC drains a road side seep. Clear inlet and outlet and install rock armoring on the inlet and outlet using 6" – 18" mixed rock. Install a rocked rolling dip above or just prior to the DRC to capture surface drainage and divert it off the road. Line dip with 3" to 6" mixed diameter sharp angular rock. Monitor and maintain the inlet as necessary. (Monitored by H&A Nov 2019; Work was Completed.)

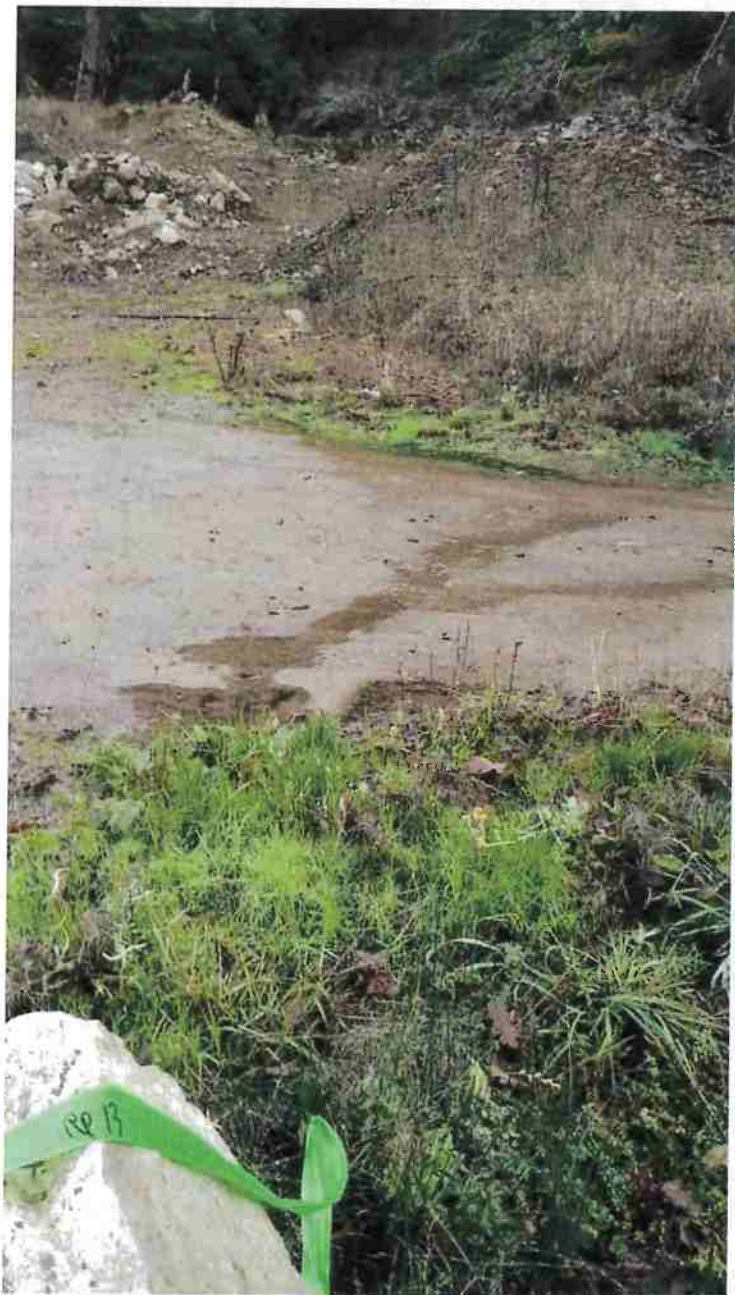
Figure 14: RP-13 Install RRD

RP-13 (Site C): Install a rocked rolling dip. Line dip with 3" to 6" mixed diameter sharp angular rock. (Monitored by H&A Nov 2019; Work was Completed.)

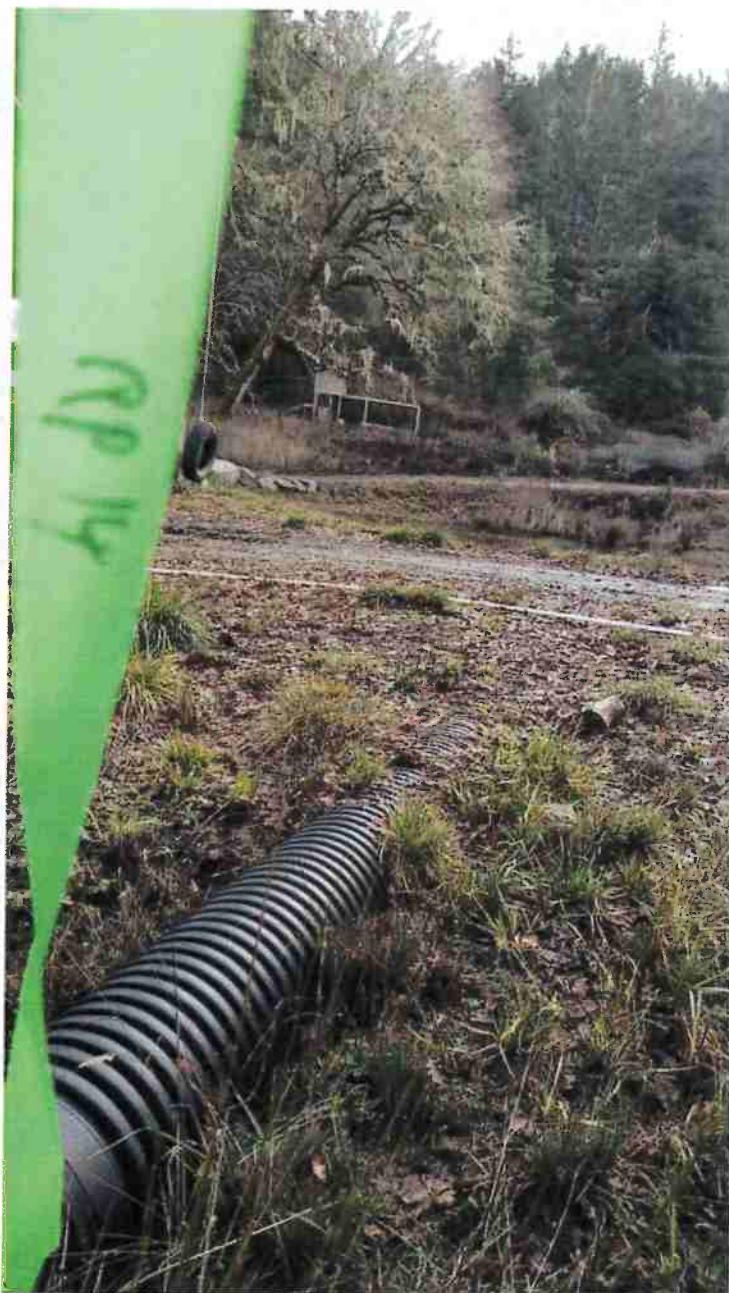
Figure 15: RP-14 Pond overflow enhance rock armoring.

RP-14 (Site C): Existing 12" overflow for the Class IV pond install rock armoring on the inlet and outlet using 6" – 18" mixed rock. Monitor and maintain the inlet as necessary. (Monitored by H&A Nov 2019; Work was Completed.)

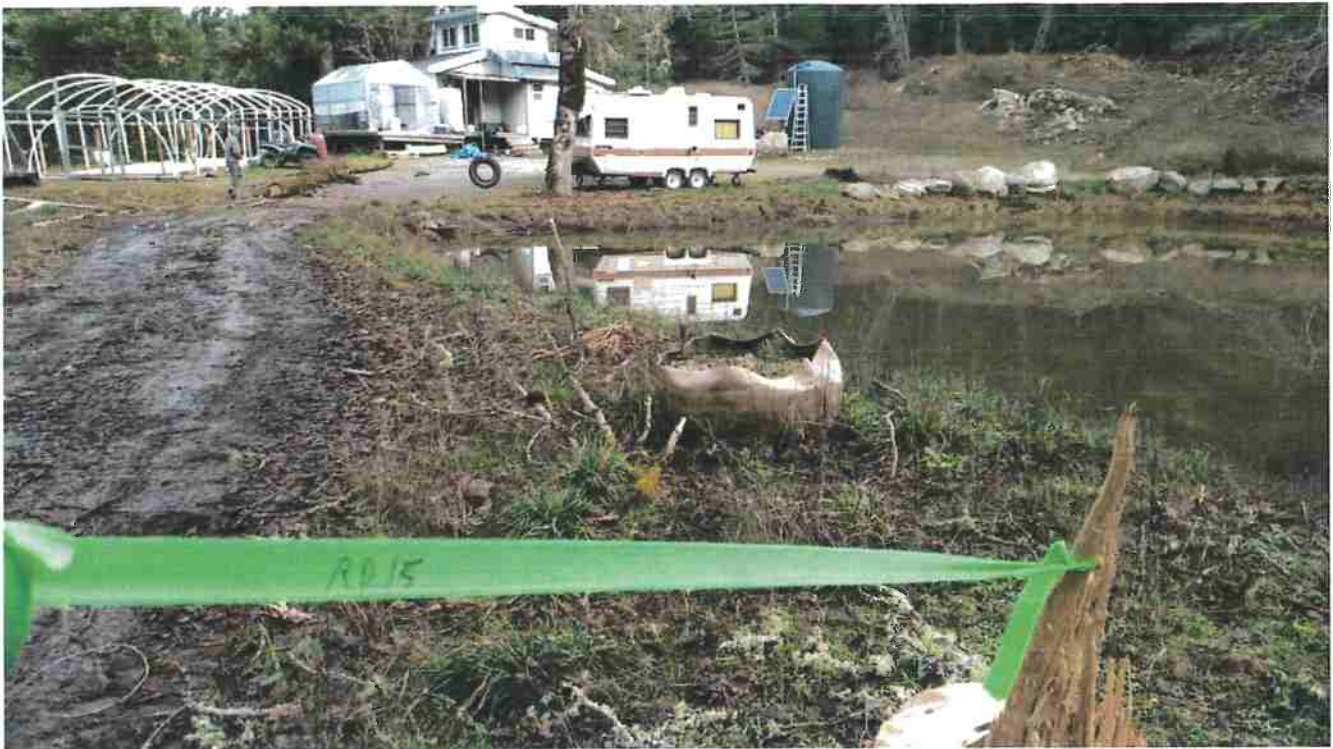
Figure 16: RP-15 Add Additional rock to the road around the pond.

RP-15 (Site C): Install additional rock on the road around the class IV pond within 50' of the pond using ± 2 " crushed rock. (Monitored by H&A Nov 2019; Work was Completed.)

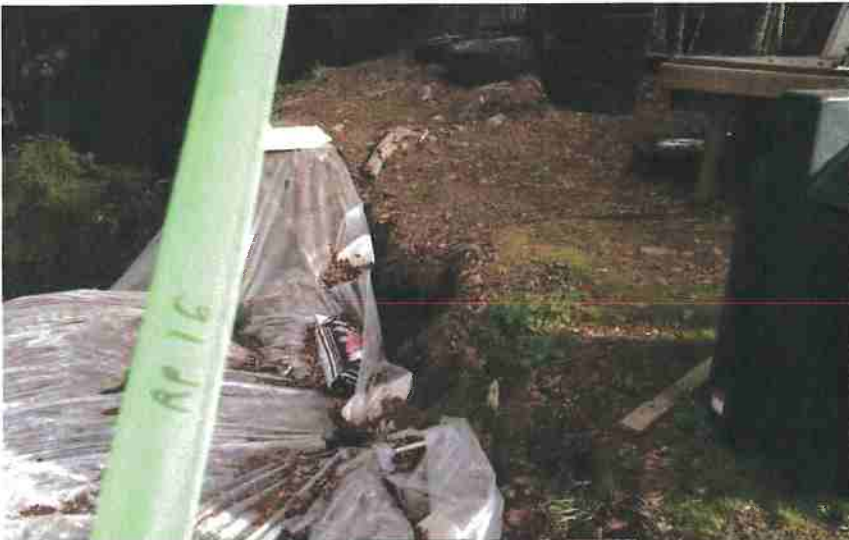
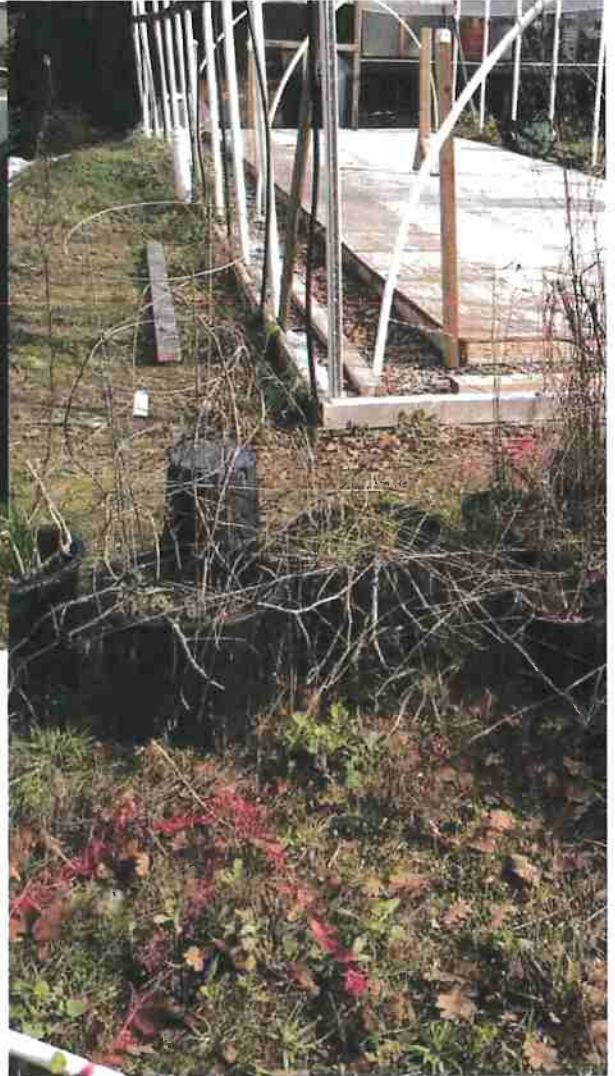
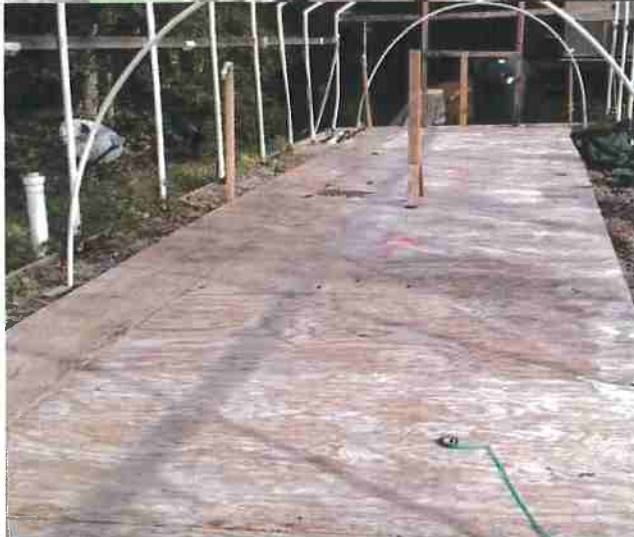
Figures 17, 18 & 19: RP-16 Fill slump failure, excavate and recompact in 6" lifts.

RP-16 (Site C): Fill slump adjacent to an unstable area excavate a $\sim 60'$ X $15'$ section of fill material compact fill in 6" lifts and slope fill back to grade as feasible not to exceed a 1 in 1.5 grade. Use straw mulch and native seed mix to stabilize the fill. (Monitored by H&A Nov 2019; Work was Completed.)

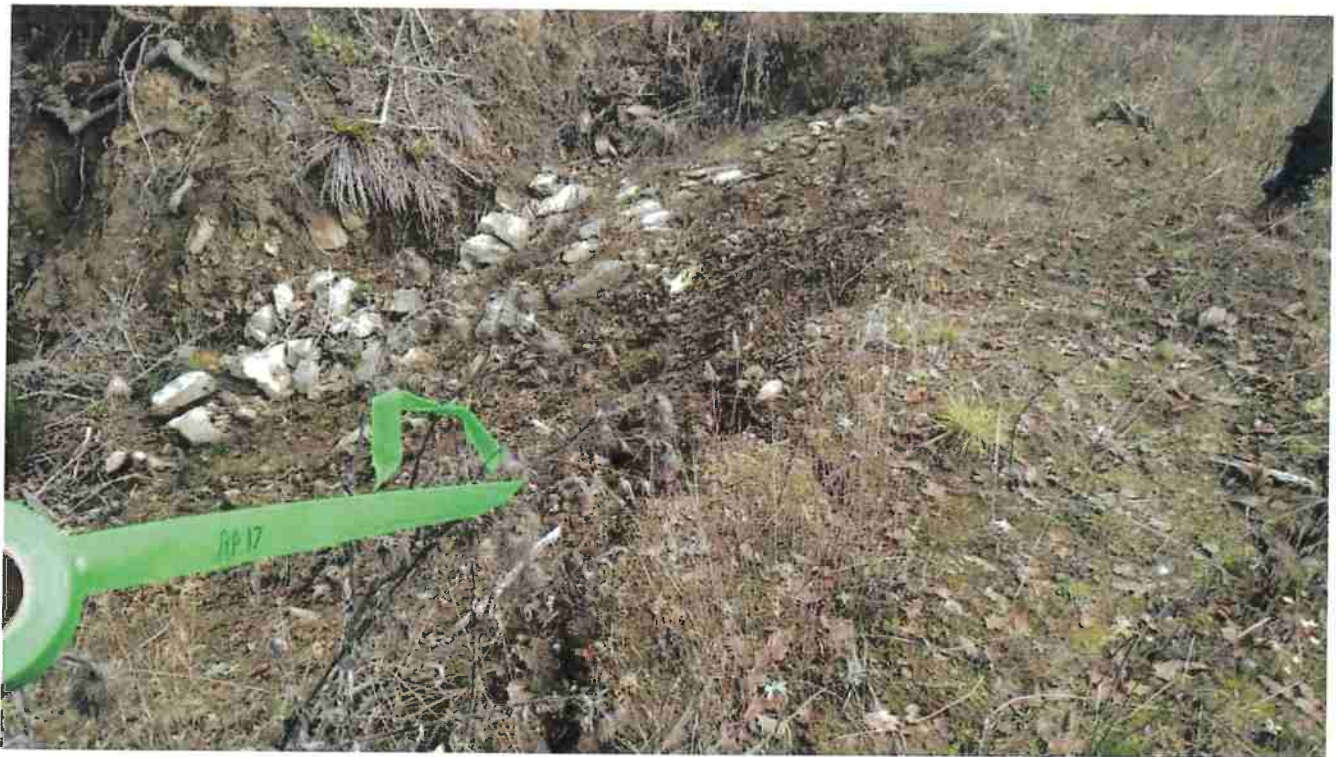
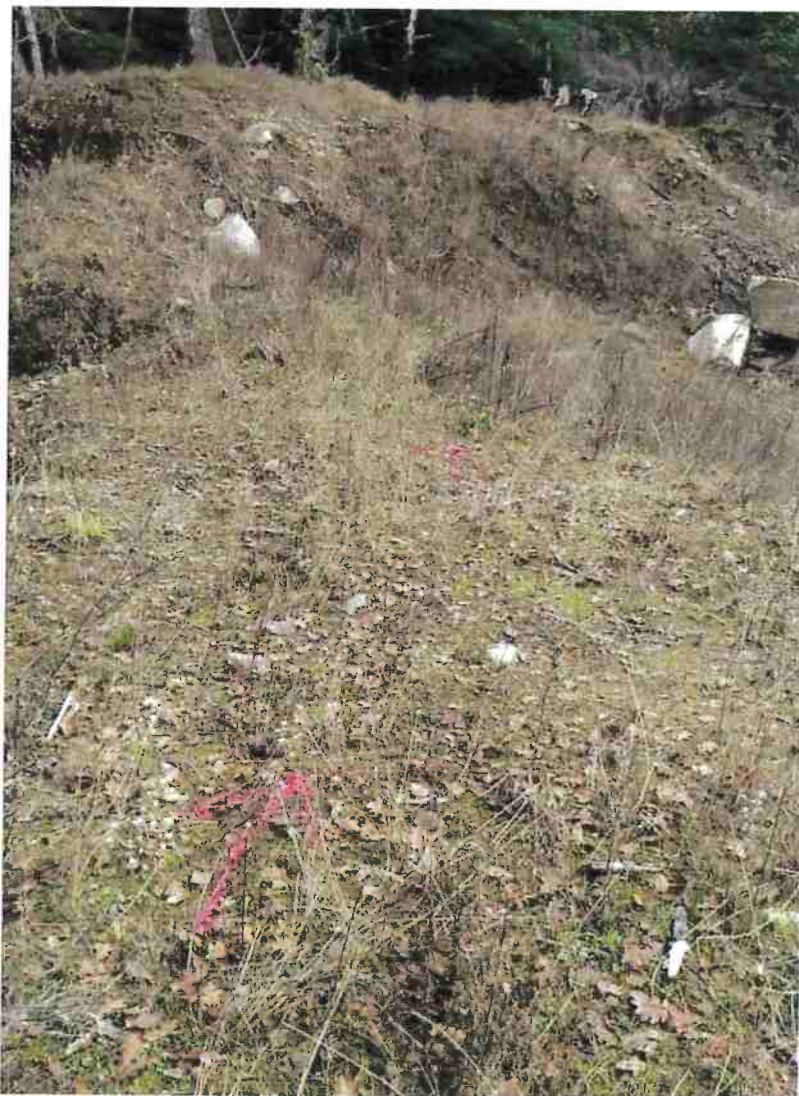
Figures 20 & 21: RP-17 Perched fill excavate lose fill and straw mulch.

RP-17 (Site C): Perched fill on slope leading to class III stream. Pull back loose fill and straw mulch the 40 X 15' area next to the class III stream. Potential of 2 cu yards of erosion. (Monitored by H&A Nov 2019; Work was Completed.)

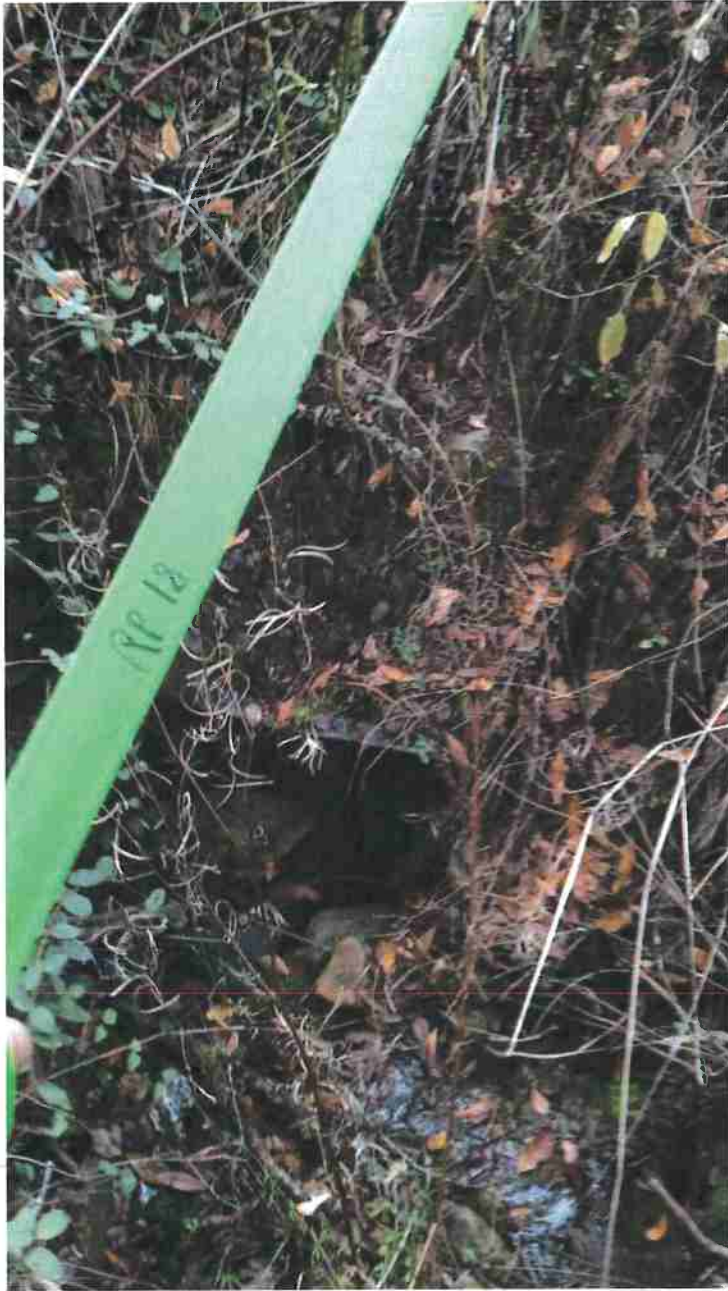
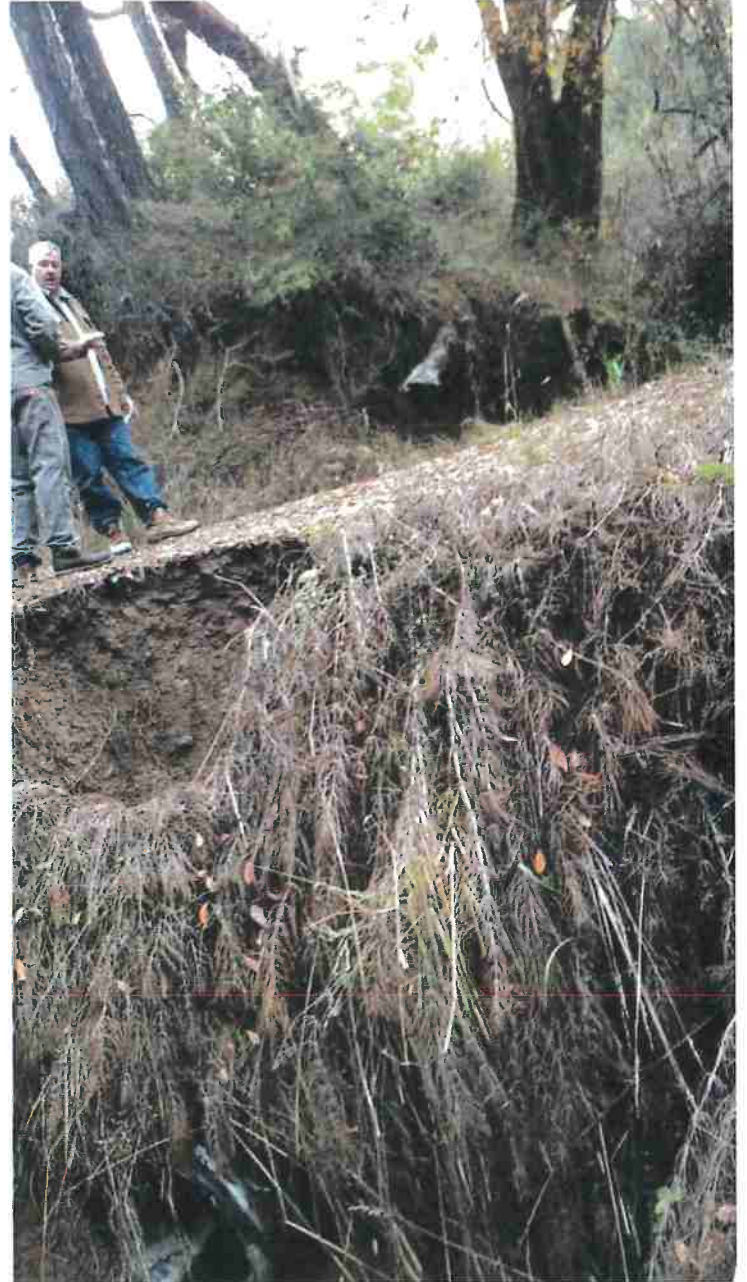
Figures 22 & 23: RP-18 Failing class II stream crossing install new culvert to grade.

RP-18 (Site C): Existing improperly installed and failing 24" diameter culvert on a class II watercourse. Remove the existing culvert and install a 30" X 40' long culvert to stream grade as per attached diagram. Install a critical dip at the center of the hinge line. Rock Armor the inlet and outlet using heavy 1' to 2' mixed sized rock. Install rolling dips 50' left and right of the crossing. The critical dip and rolling dips shall be lined with 4" to 6" diameter sharp angular rock. Rock the entire crossing 100' left and right of the centerline with 2"- 4" crushed rock. Potential of 30 cu yards of erosion. 1600 required.

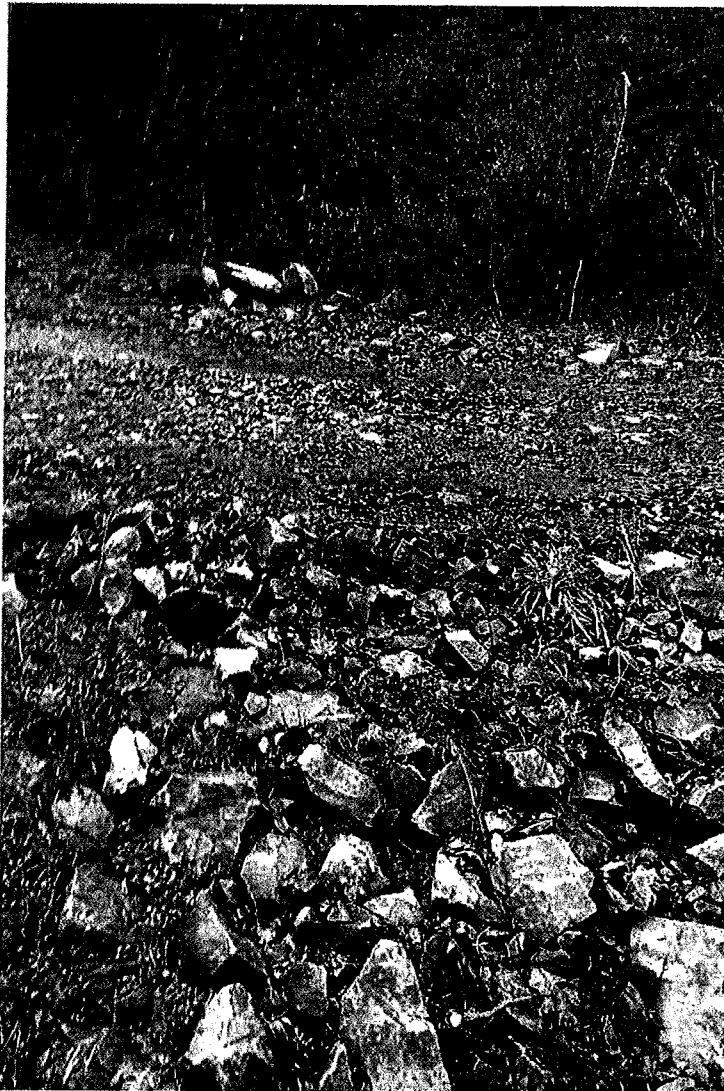
Figure 25: RP-20 Road side seep lower road grade and reinstall the rocked rolling dip.

RP-20 (Site A): Road side seep is drained with a rocked rolling dip. Lower the existing dip to better catch the seep and line the dip with 3" to 6" mixed diameter sharp angular rock. (Monitored by H&A Nov 2019; Work was Completed.)
