40 North LLC
271 Evergreen Road, Suite 2, Box 945
Redway, CA 95560

40 North Ranch Less Than Three Acre Conversion Mitigation Plan

- a. Site Address: Dyerville Loop Road, Phillipsville, CA
- b. Community Area: Fruitland CA
- c. Assessor's Parcel No(s): 214-114-010
- d. Parcel Size(s): 195.2 Ac.

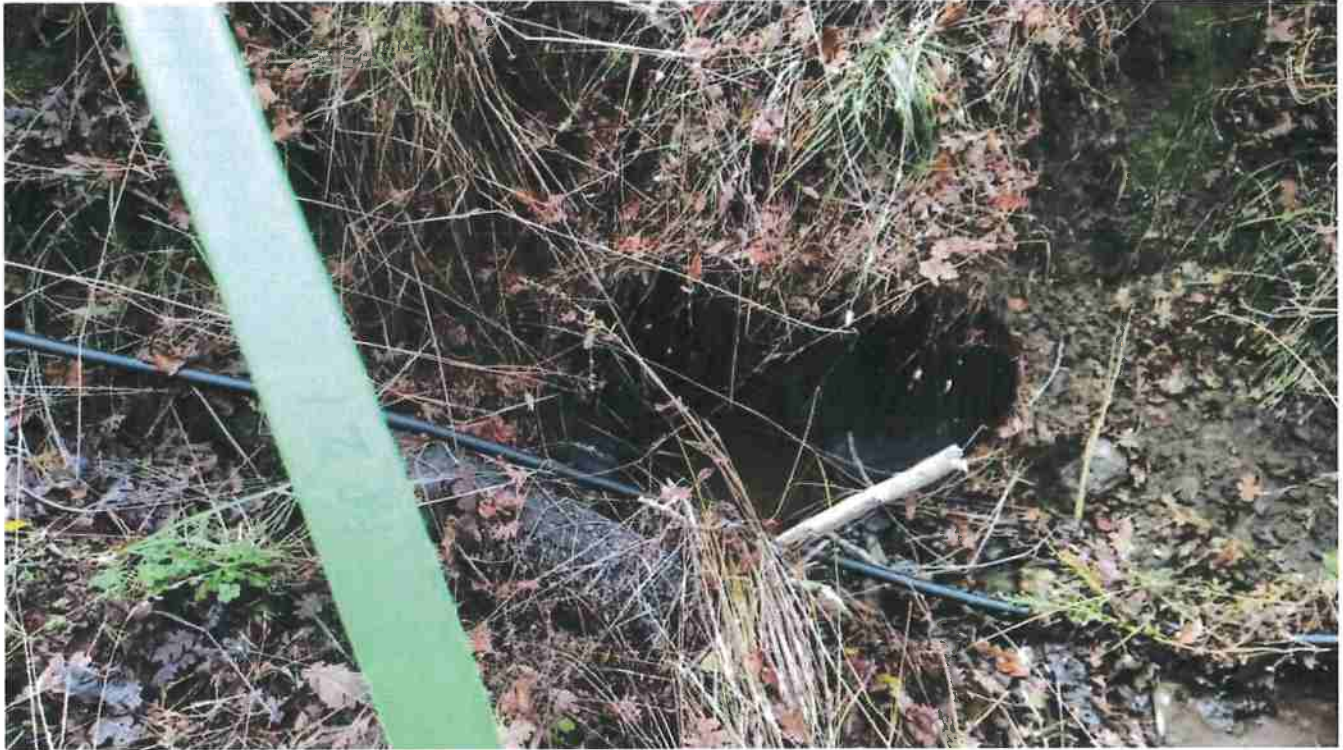
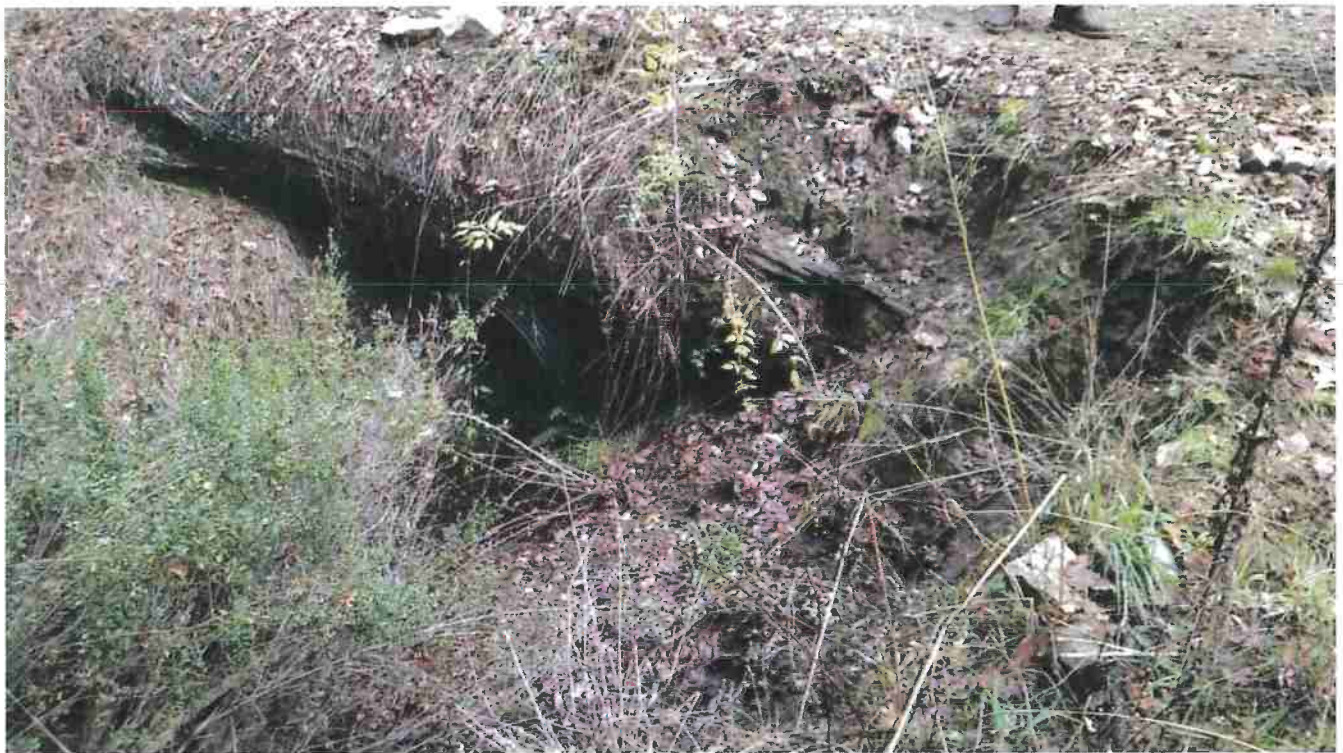
Figures 26 & 27: RP-21 Failing class II stream crossing, install new culvert to grade.

RP-21 (Site A): Existing 36" culvert improperly installed on a class II stream. Install a 36" X 40' long culvert to stream grade as per attached diagram. Install a critical dip at the center of the hinge line and line the dip with 4" - 6" diameter crushed rock. Rock Armor the inlet and outlet using heavy 1' to 2' mixed sized rock. Rock the entire crossing 100' left and right of the centerline with 2"- 4" crushed rock. Potential of 30 cu yards of erosion. 1600 required.

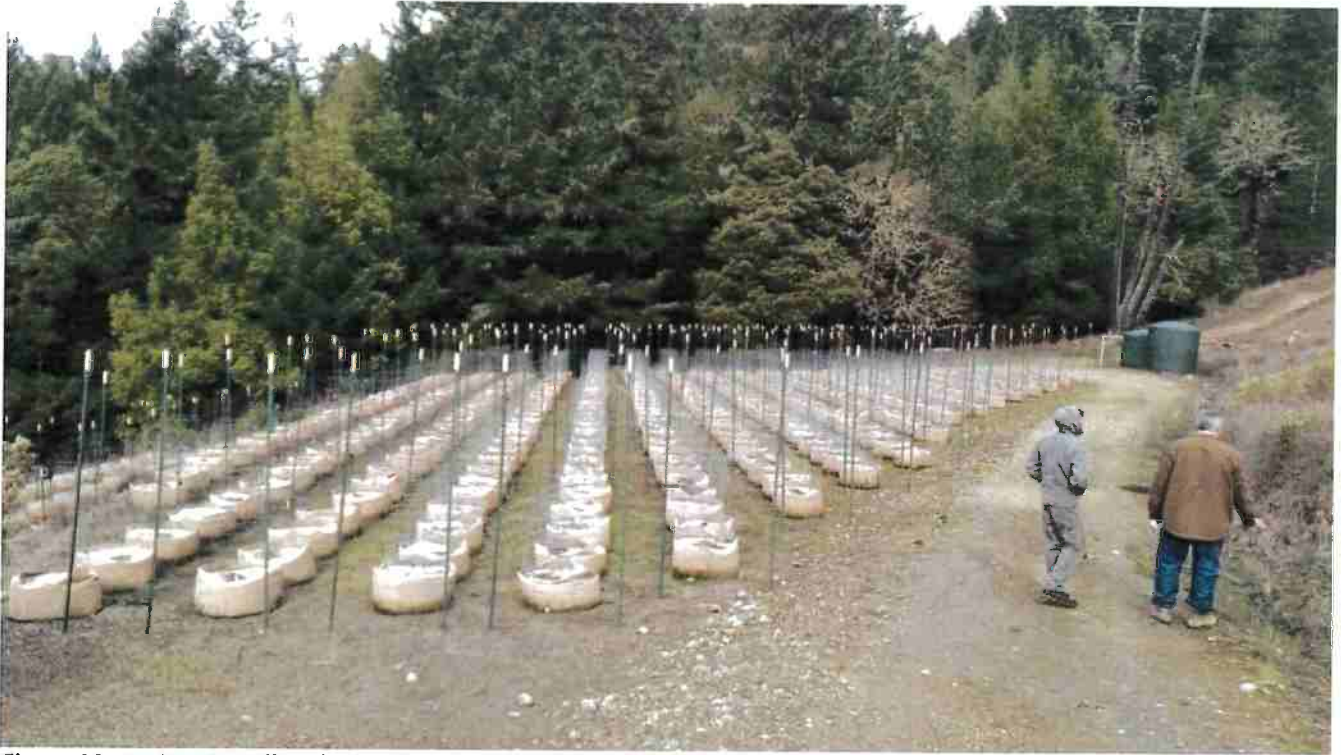
Figure 28: RP-21.5 Install rocked rolling dip.

RP-21.5 (Site A): Install a rocked rolling dip. Line dip with 3" to 6" mixed diameter sharp angular rock.

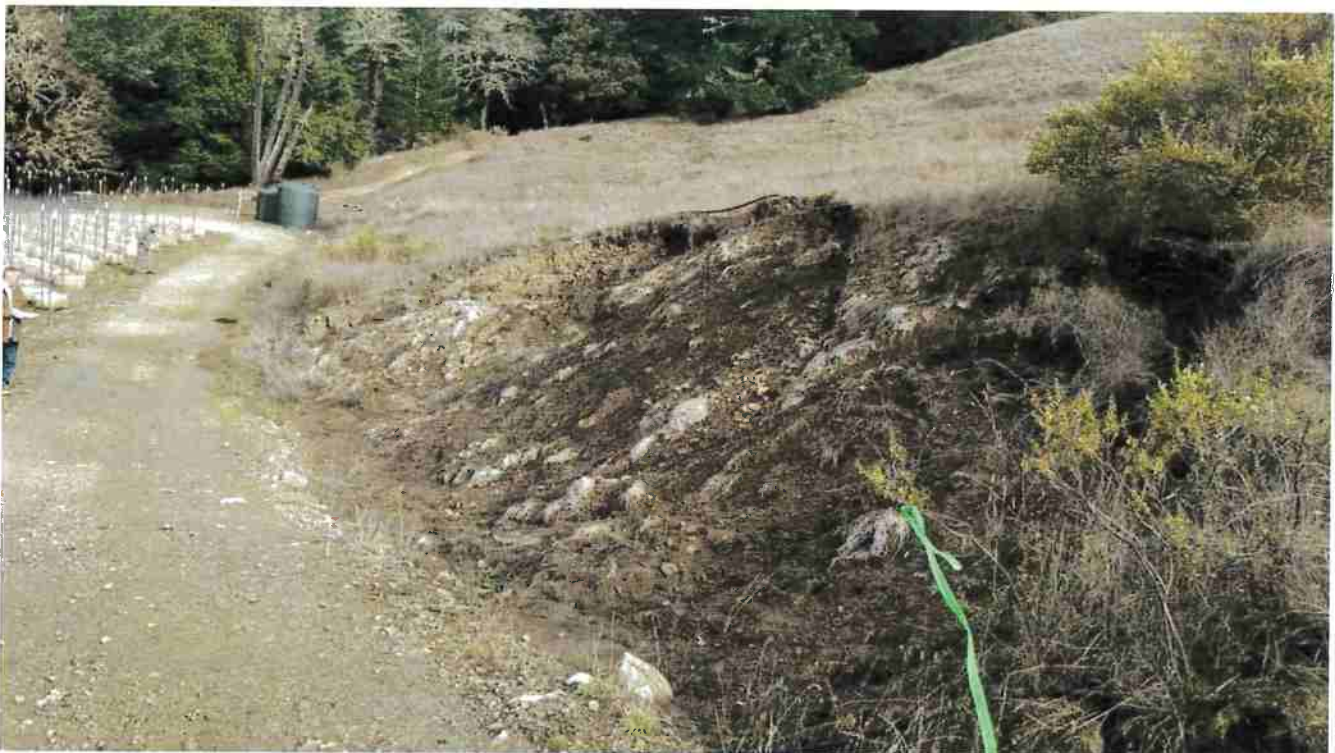
Figure 29: RP-22 Cut bank failure install rock armor.

RP-22 (Site A): Cut Bank slump extends 60' along the road and approximately 18' up slope of the road. Excavate foot of the slump and install 1-2' rock armoring up the slope for 12' or higher. Straw mulch uncovered area above rock armoring. (Monitored by H&A Nov 2019; Work was Completed.)

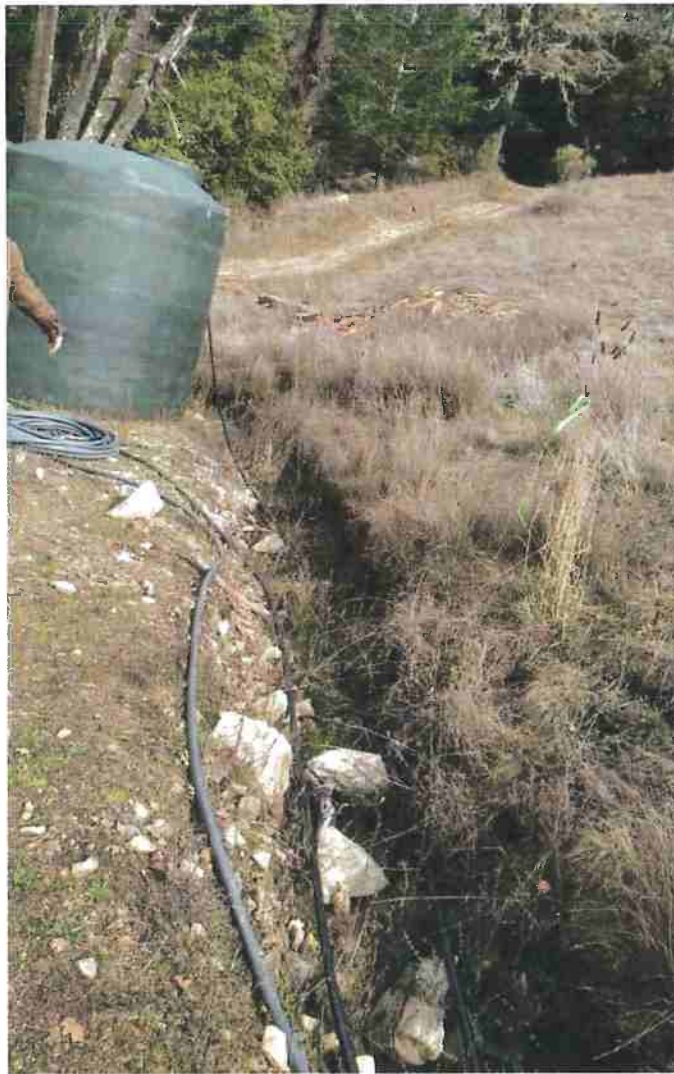
Figure 30: RP-23 Inside ditch needs end lowered.

RP-23 (Site A): Inside ditch is not deep enough to drain. Excavate the last 20' of the ditch down to a level that will allow the ditch to drain freely. Rock line the portion of the ditch with a disturbed bed with 4" to 8" sharp angular rock. (Monitored by H&A Nov 2019; Work was Completed.)

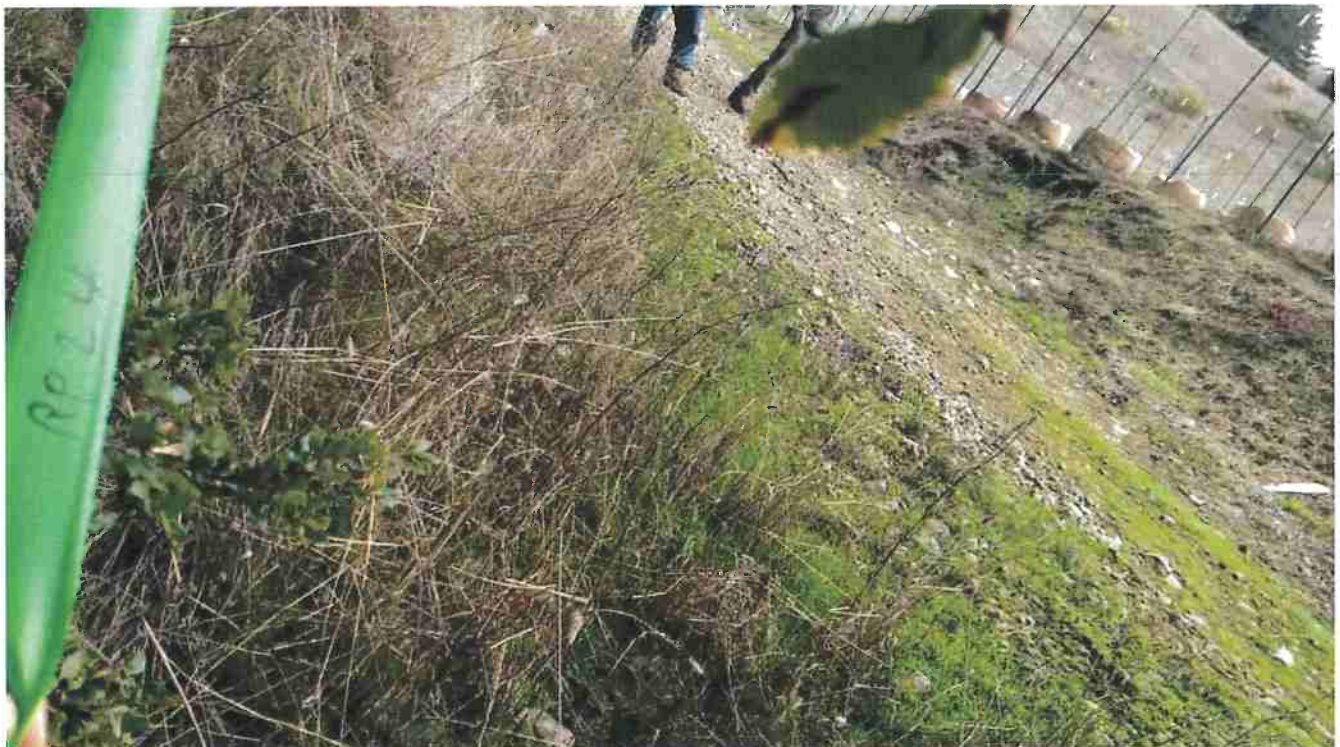
Figure 31: RP-24: Install rocked rolling dip.

RP-24 (Site A): Install a rocked rolling dip. Line dip with 3" to 6" mixed diameter sharp angular rock. (Monitored by H&A Nov 2019; Work was Completed.)

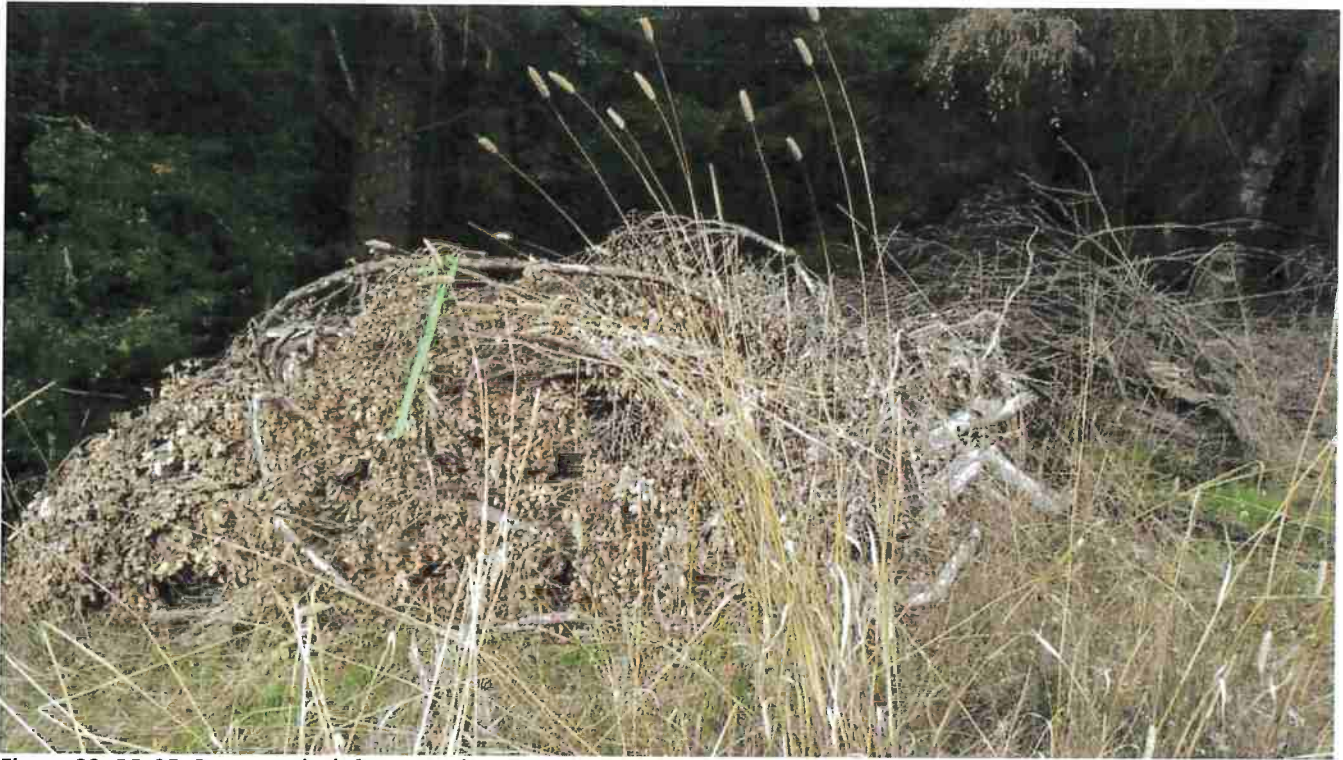
Figure 32: RP-25: Remove slash from site (can be utilized as slash mulch).

RP-25 (Site A): Slash pile on the edge of the clearing; remove the slash from the site (the slash may be used as slash mulch for bare soil stabilization). (Monitored by H&A Nov 2019; Work was Completed.)

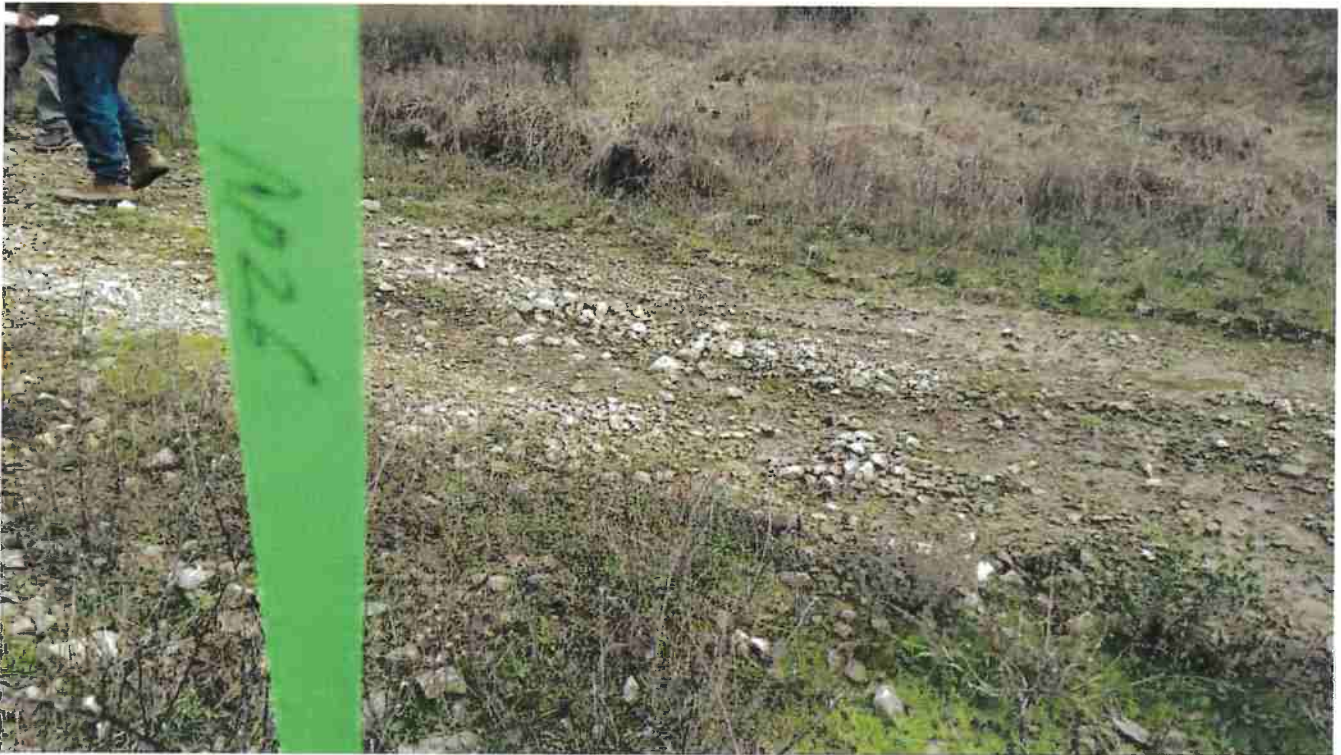
Figure 33: RP-26: Install rocked rolling dip.

RP-26 (Site A): Install a rocked rolling dip. Line dip with 3" to 6" mixed diameter sharp angular rock. (Monitored by H&A Nov 2019; Work was Completed.)

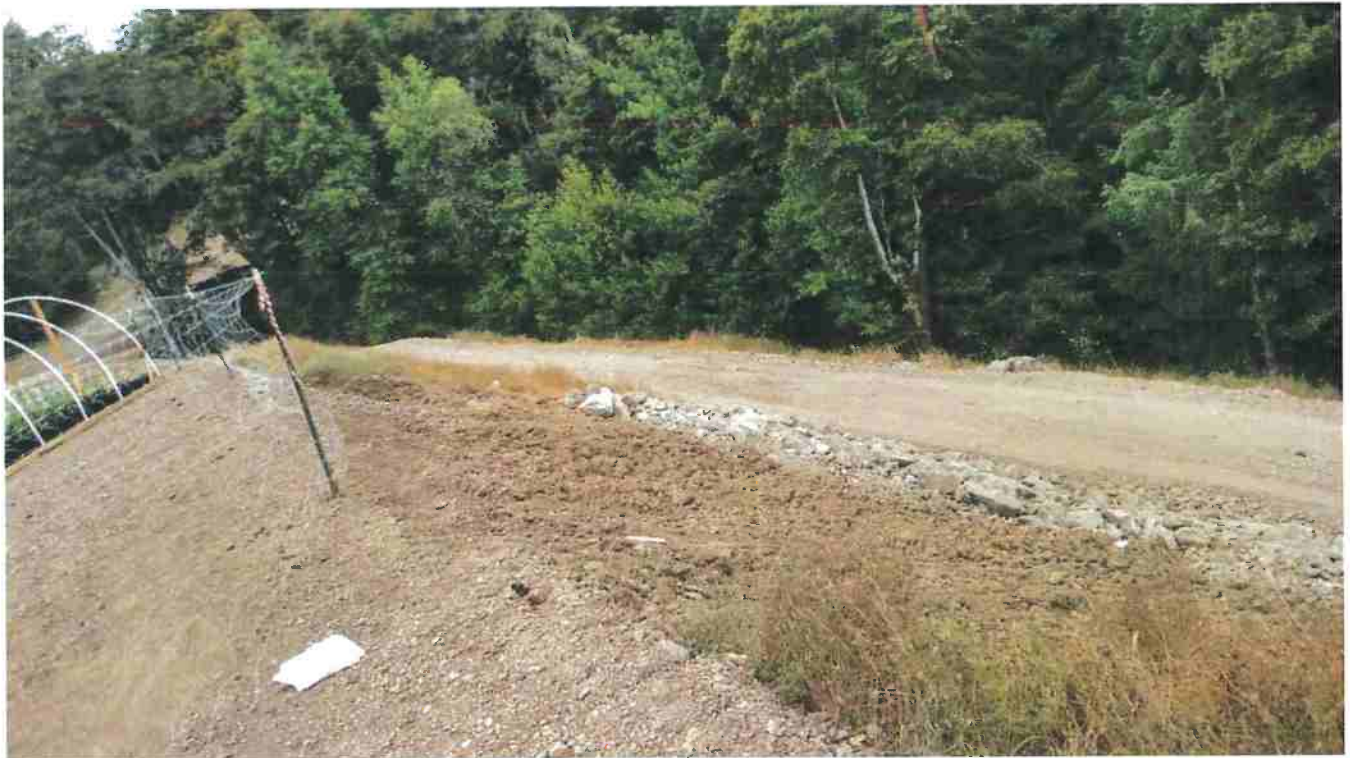
Figure 34: RP-A: Install erosion control.

RP-A (Site B): Rock armoring has been applied to the lower portion of a cut slope to the road below cultivation site B. Further stabilize the remaining disturbed soil by adding wattles, Jute netting, and straw mulch to prevent erosion.

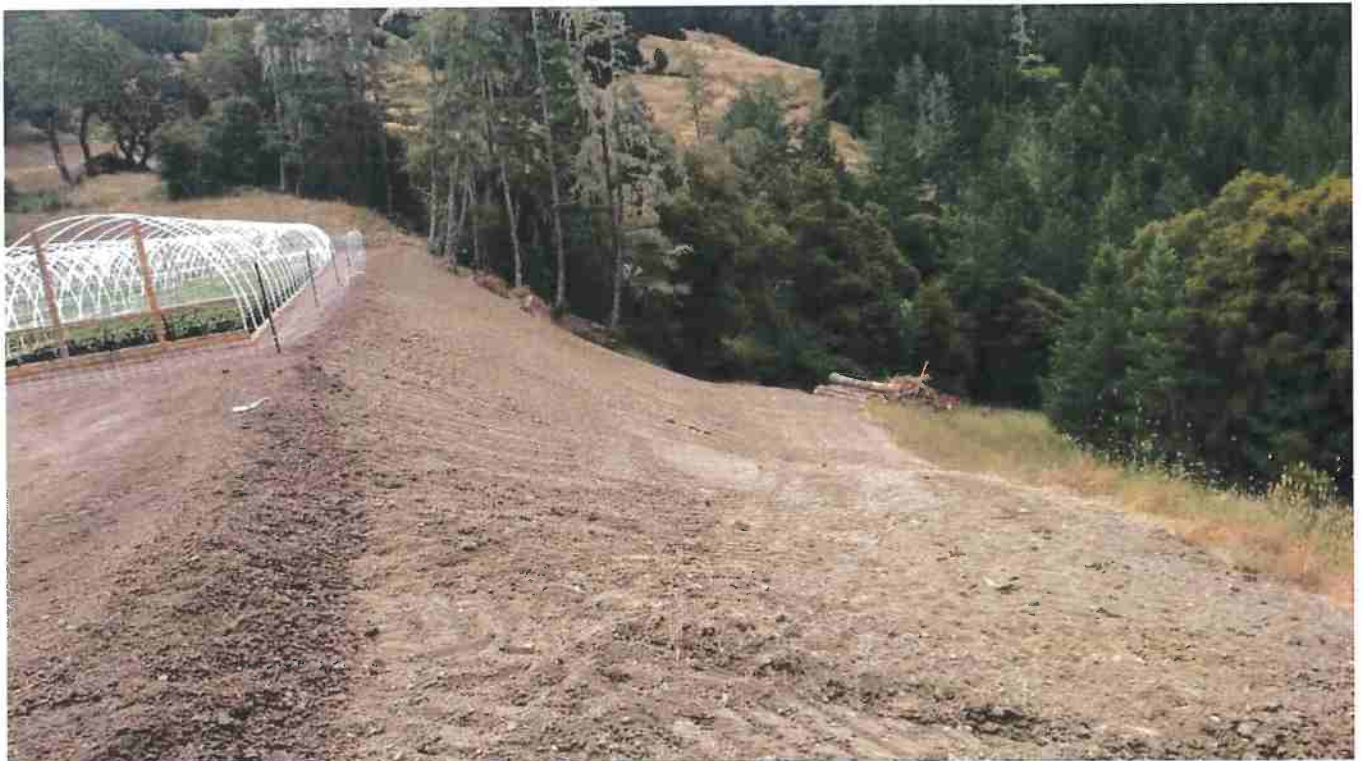
Figure 35: RP-B: Install erosion control.

RP-B (Site B): The work required at RP-3 was completed the retaining wall was removed and the slope was laidback and fill was recompact. The new fill slope is to be stabilized with wattles, Jute netting and straw mulch.

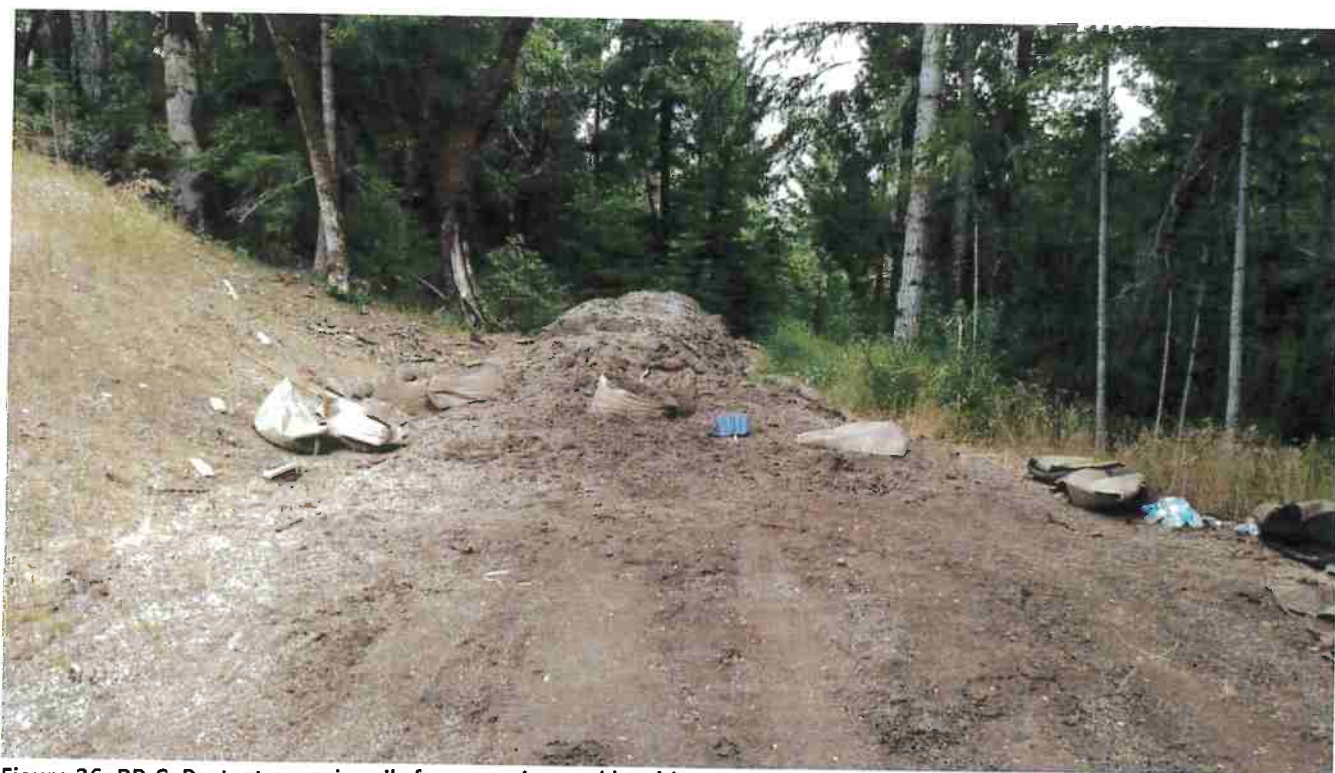
Figure 36: RP-C: Protect organic soils from erosion and leaching.

RP-C (Site B): Potting soil storage area shall be surrounded with wattles and straw mulch. The soil shall be covered to protect it from leaching and eroding prior to the rainy season each year.

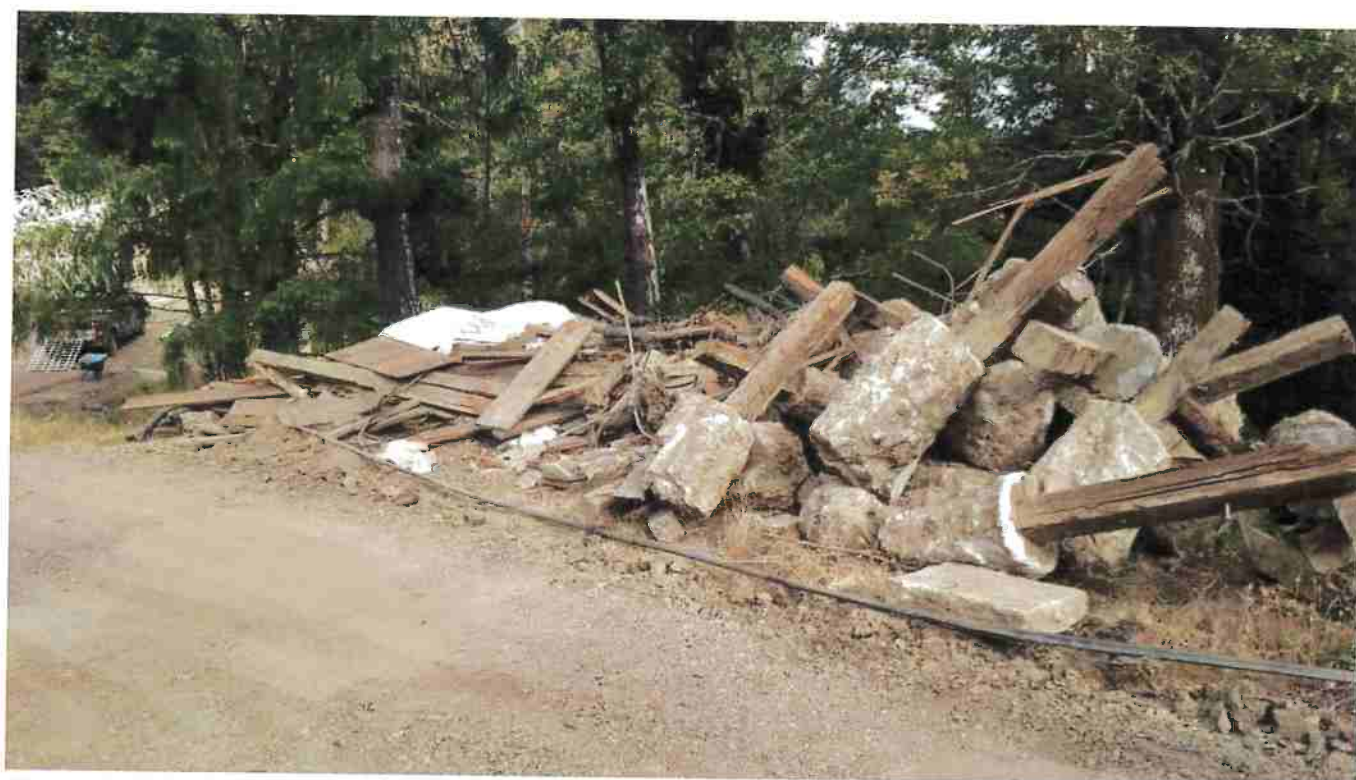
Figure 37: RP-D: Remove demolished retaining wall debris.

RP-D (Site B): Wood and concrete from the demolished retaining wall at RP-3 was temporary stored at RP-D. Remove and properly recycle or dispose of debris.

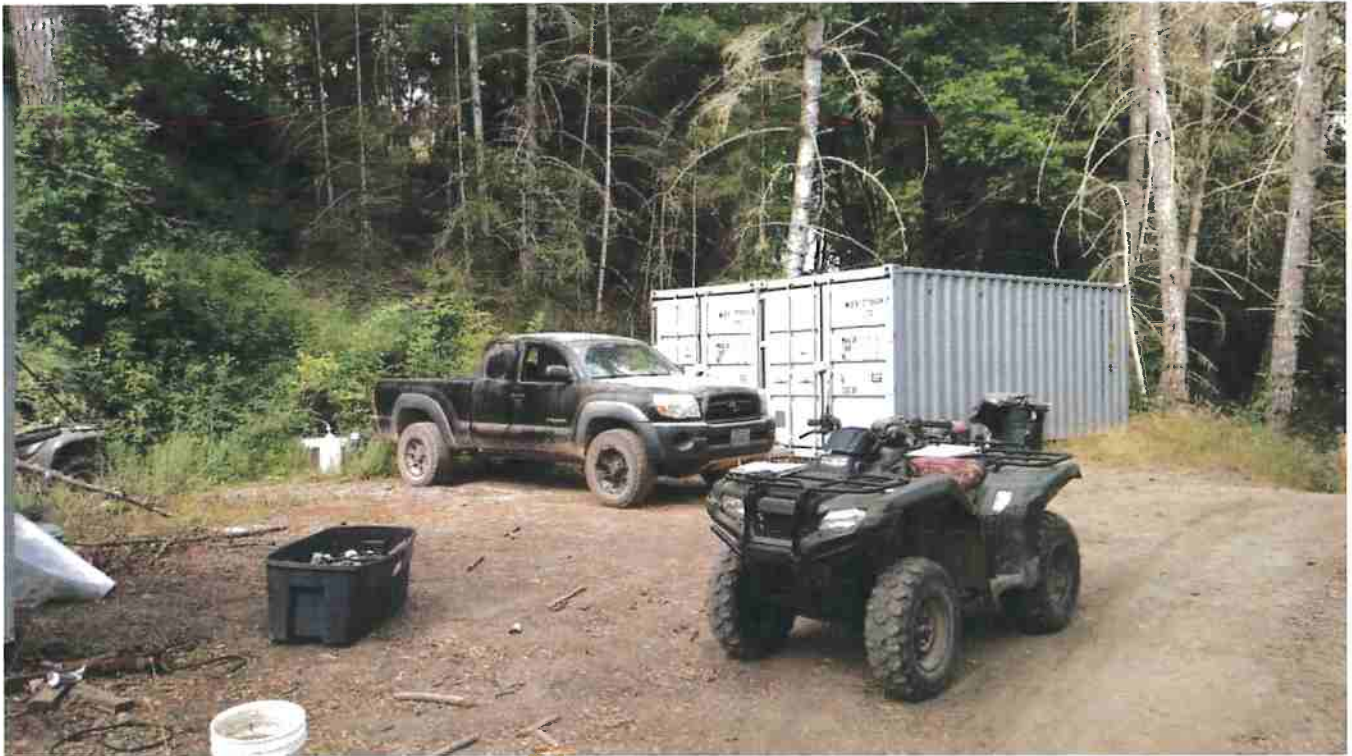
Figure 38: RP-E: Containers to be moved to site specified in the cultivation site maps.

RP-E (Site C): Storage units (shipping containers) shall be moved to the location mapped on the cultivation site maps.

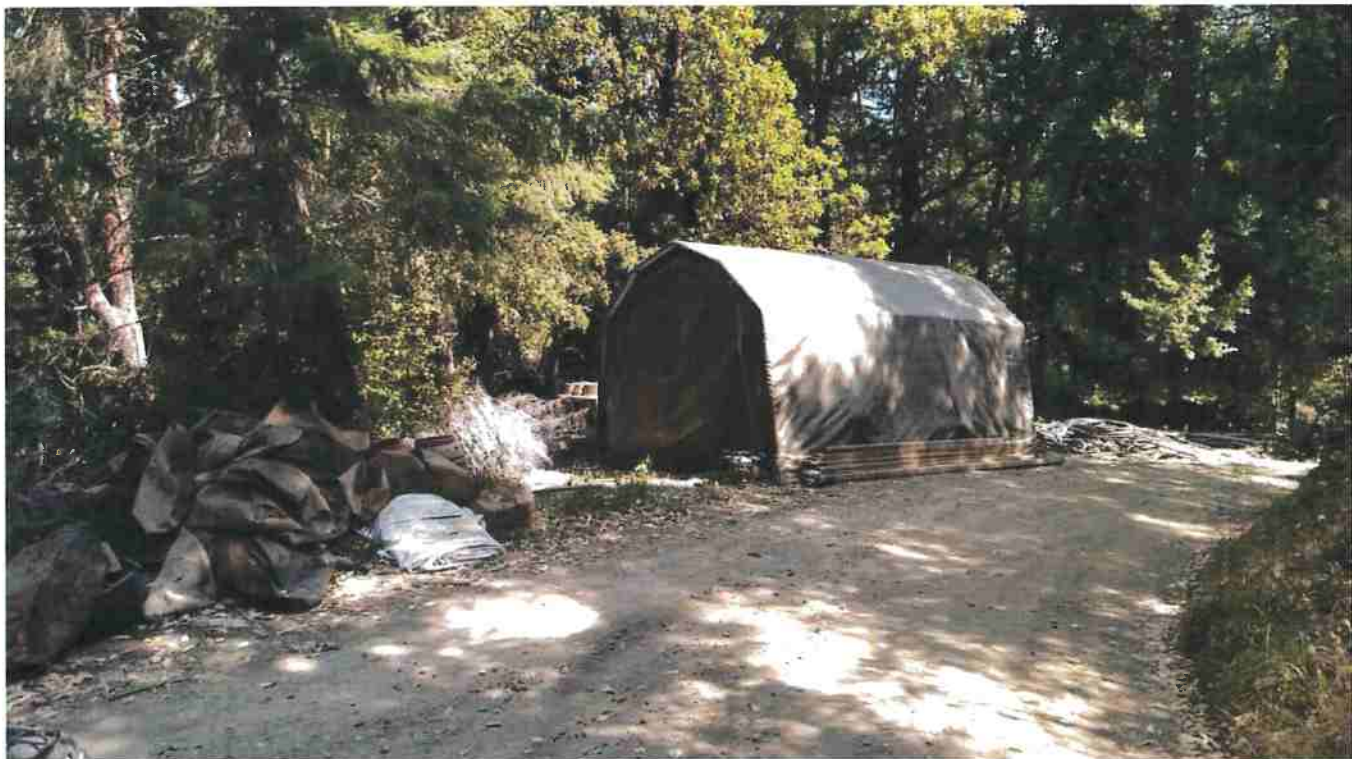
Figure 39: RP-F: All cannabis related items to be moved to site specified in the cultivation site maps.

RP-F (Site C): Storage area all cannabis related items shall be moved to the storage area specified on the cultivation site maps or properly recycled and or disposed of.

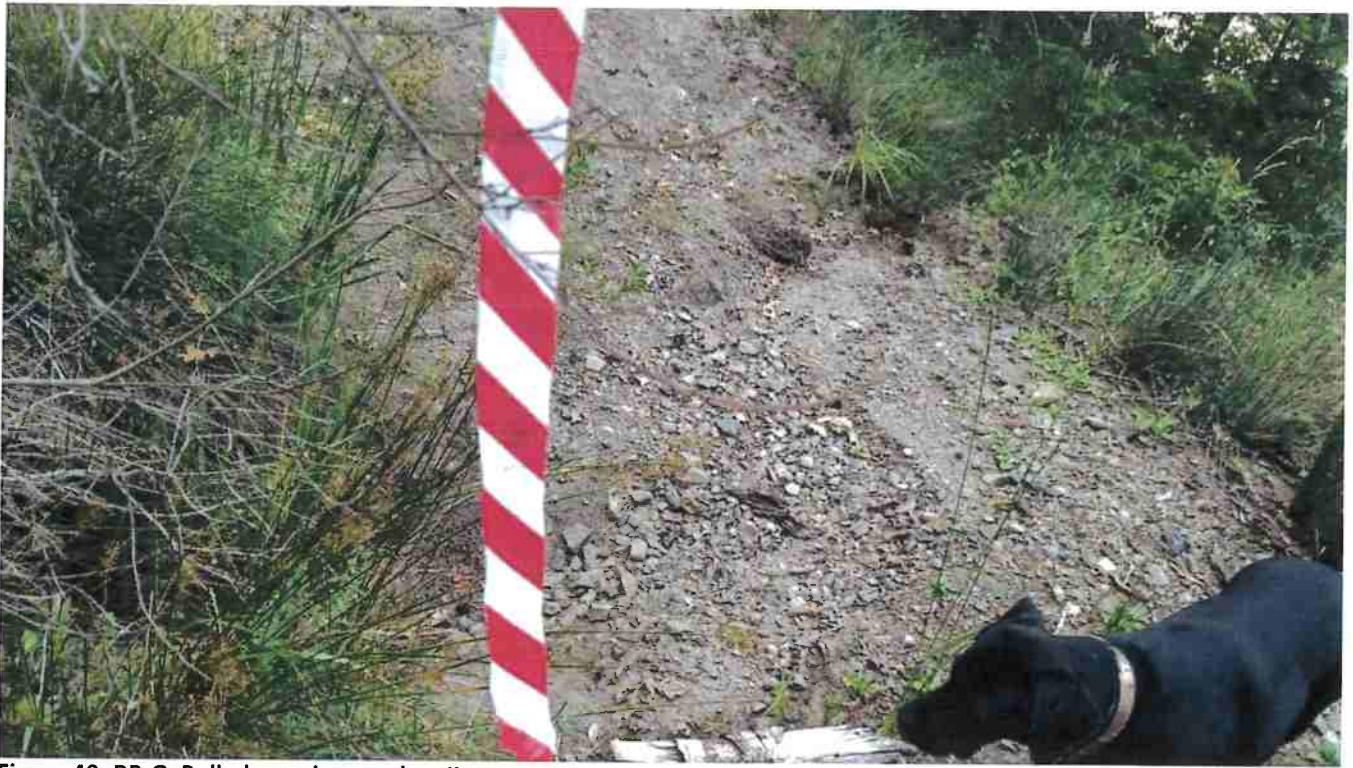
RP-G (Site D & E): Pulled temporary crossing of a seasonal class II stream on a tractor road leading to an old landing site that was utilized for cannabis cultivation in the past. The crossing appears to be stable and the road has been decommissioned. Prior to the winter period install straw mulch on the crossing approaches for 15' on either side of the crossing. Potential of 0.5 cu yards of erosion.

Figure 40: RP-G: Pulled crossing on class II watercourse.

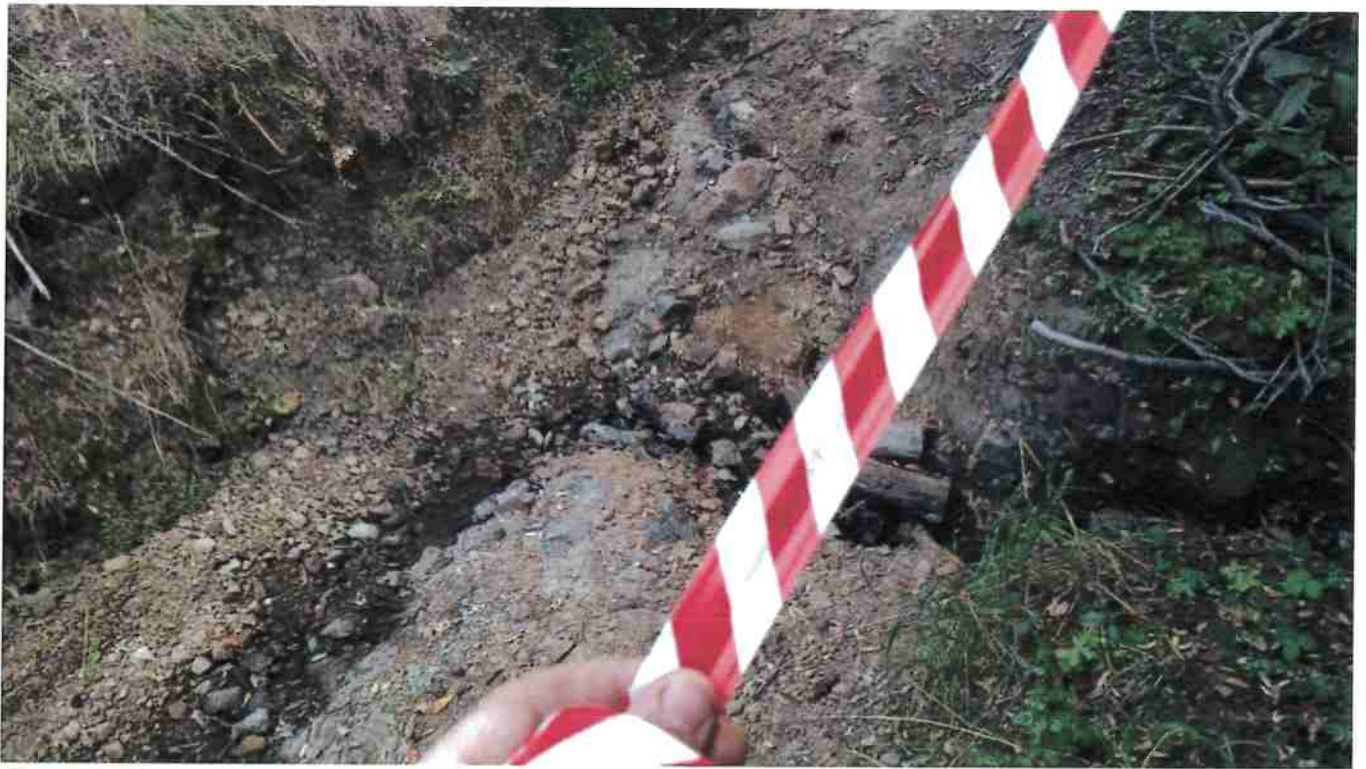
RP-H (Site D & E): Pulled temporary crossing of a seasonal class II stream on a tractor road leading to an old landing site that was utilized for cannabis cultivation in the past. The crossing appears to be stable and the accessing road has been decommissioned. Prior to the winter period install straw mulch on the crossing approaches for 15' on either side of the crossing. Potential of 1 cu yards of erosion.

Figure 41: RP-H: Pulled crossing on class II watercourse.

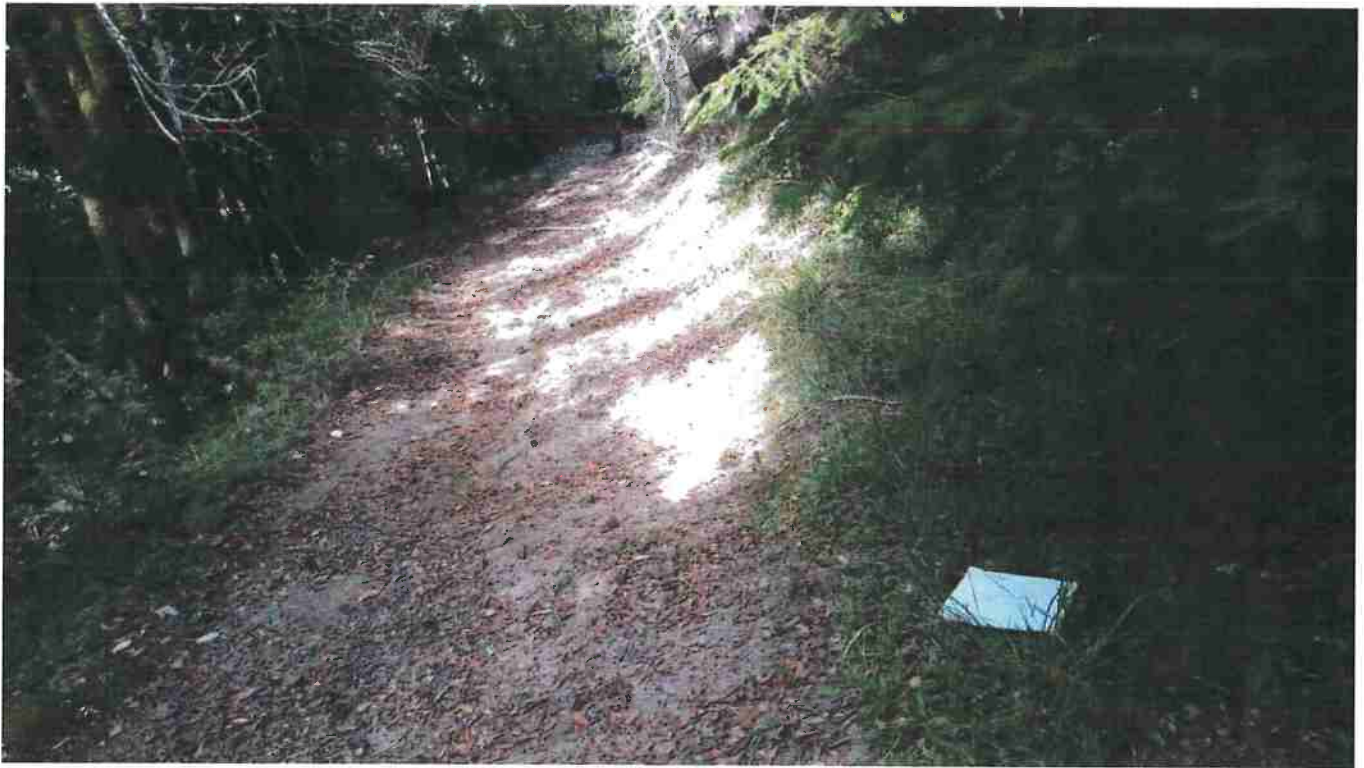
RP-I (Site E): Small class III filled crossing with a small amount of erosion occurring to stabilize the site install straw mulch for 15' on either side of the crossing to reduce sediments entering the stream. Potential of 1 cu yards of erosion.

Figure 42: RP-I: Class III watercourse Crossing.

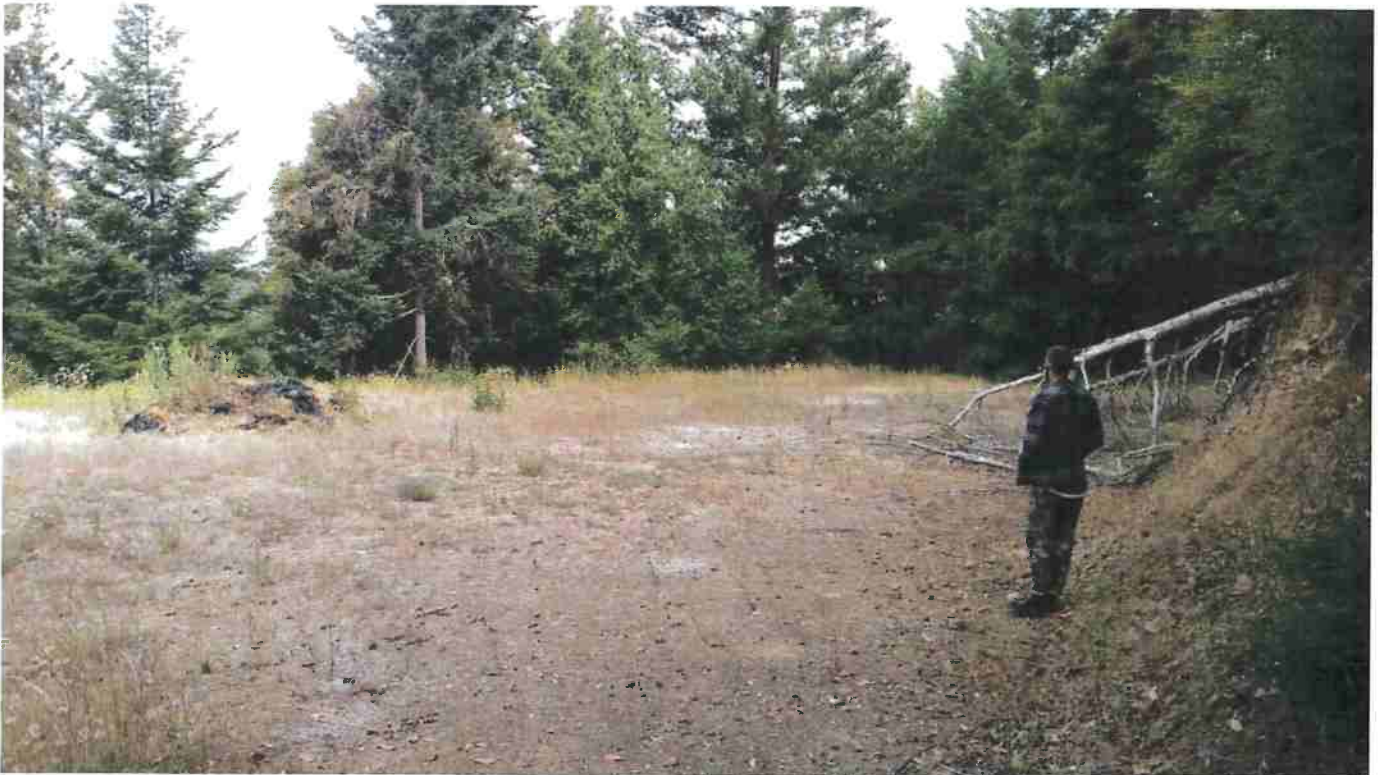
RP-J (Site E): Old landing site that was used to cultivate cannabis in the past but has been decommissioned. The site does not appear to have any erosion or drainage issues and no mitigations are proposed.

Figure 43: RP-J: Old landing that was utilized in the past to cultivate cannabis.

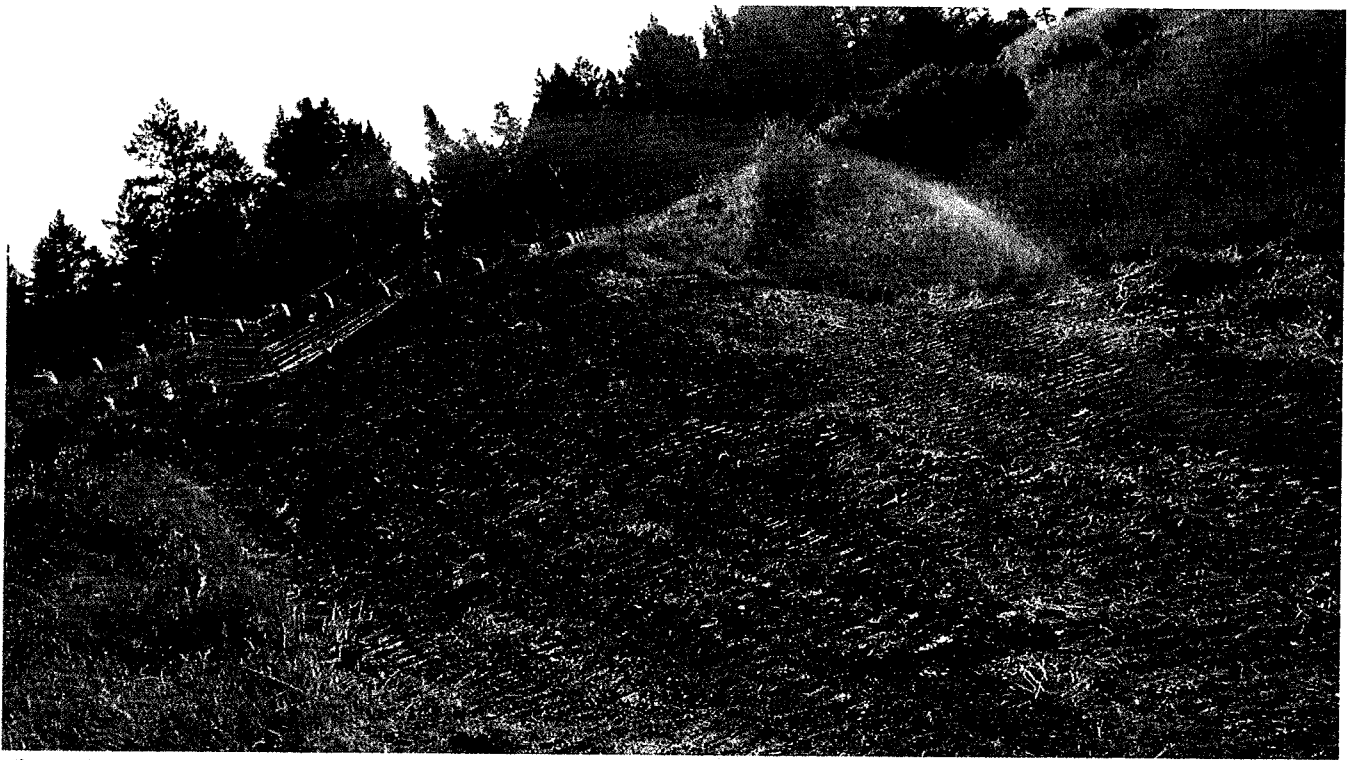
Figure 44: RP-K: Install erosion control.

RP-K (Site A): Regraded slope at cultivation site A. Stabilize the exposed soil with wattles and or jute netting and straw mulch.

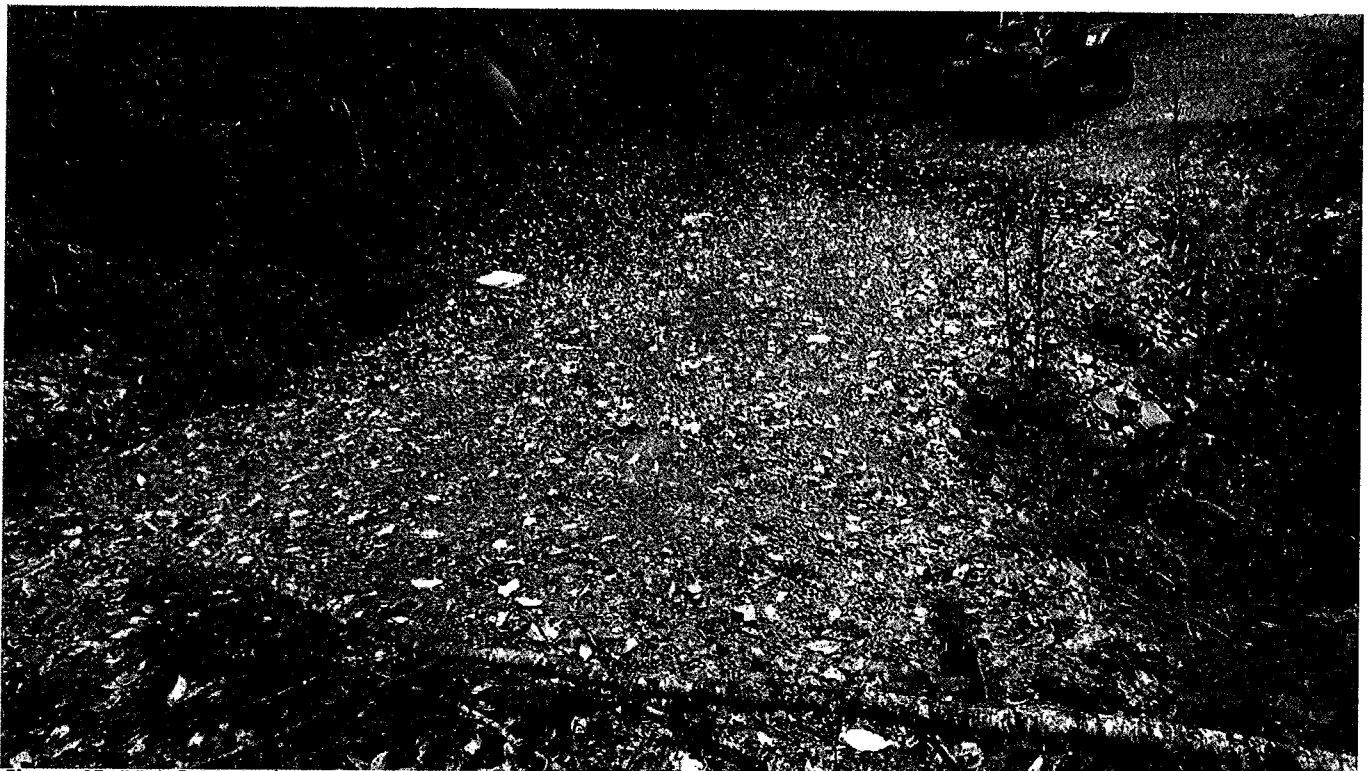
RP-L (Site F): Existing 24" culvert on a class II stream appears to be functioning. The crossing is on a road that leads to a decommissioned cannabis site that was established on an old landing in the past. Monitor and maintain the inlet and outlet. Magnitude and frequency calculations call for a 36" culvert if crossing shows signs of failing replace with a 36" culvert or remove crossing if access is not desired.

RP-M (Site F): Class II rocked ford on a road that leads to a decommissioned cannabis site. The crossing appears to be stable and no erosion issues were observed. Monitor site and add rock 2-4" crushed rock as necessary to prevent erosion.

Figure 45: RP-L & M: A Class II crossings; L is the culvert and M is the rocky ford by the quad.
