40 North LLC
271 Evergreen Road, Suite 2, Box 945
Redway, CA 95560

40 North Ranch Less Than Three Acre Conversion Mitigation Plan

- a. Site Address: Dyerville Loop Road, Phillipsville, CA
- b. Community Area: Fruitland CA
- c. Assessor's Parcel No(s): 214-114-010
- d. Parcel Size(s): 195.2 Ac.

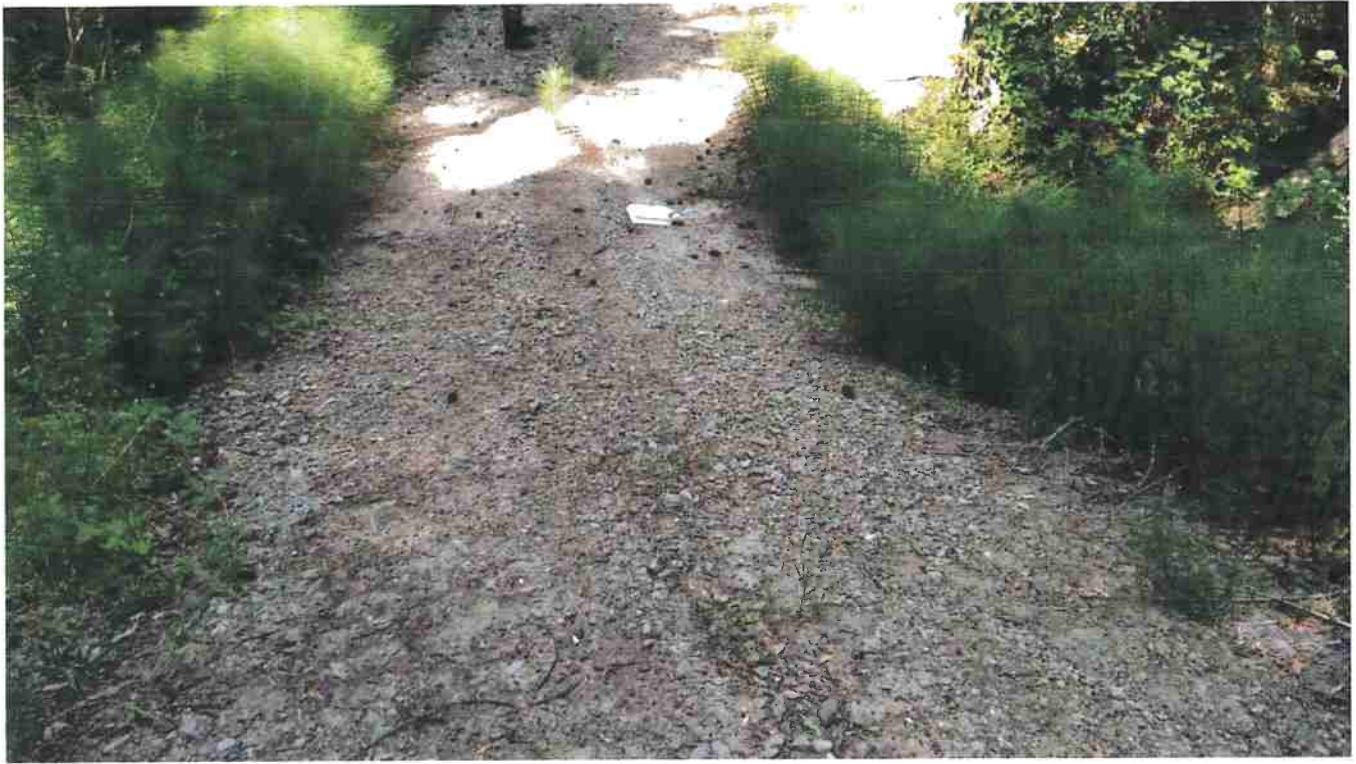
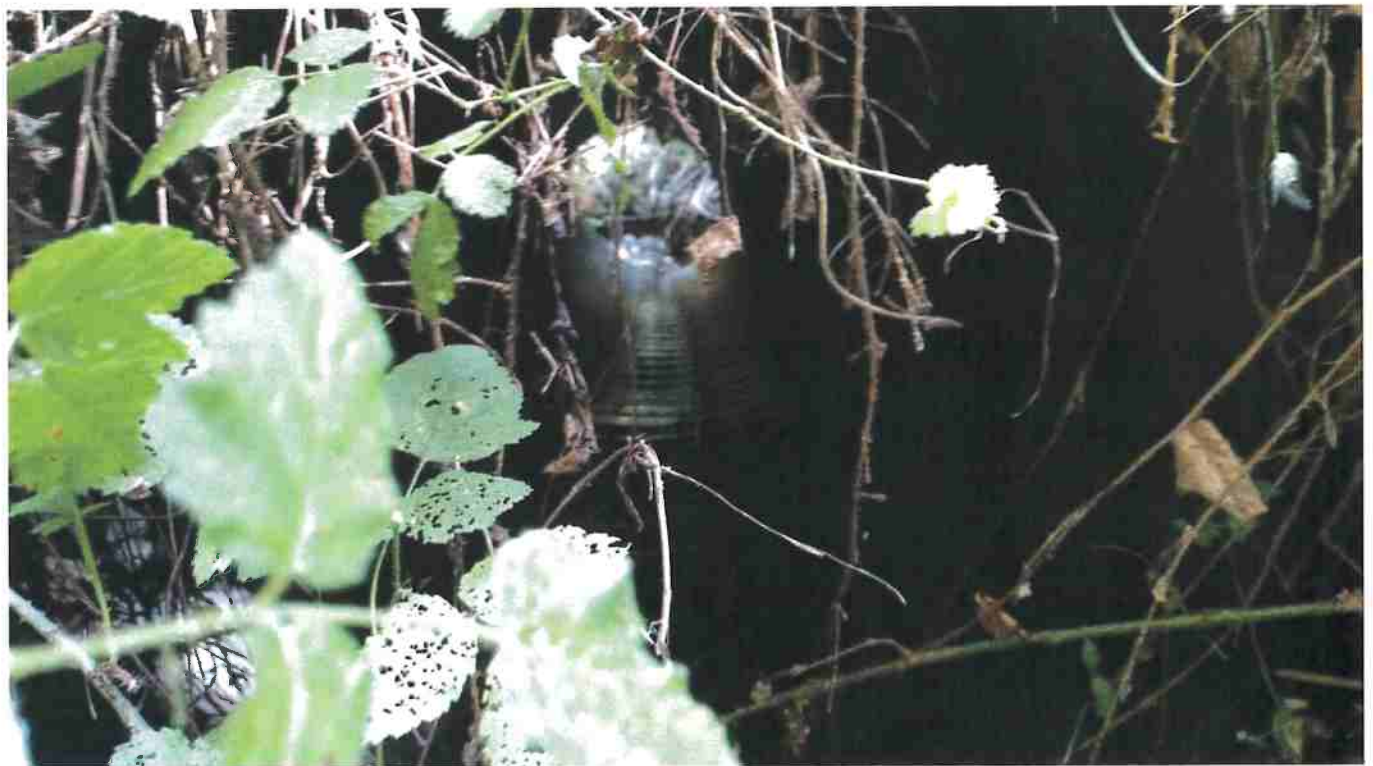
RP-N (Site F): Existing functioning 36" culvert on a class II stream crossing. Monitor and maintain the inlet and outlet to keep clear of debris. If crossing shows signs of failing replace with a new 36" culvert or remove crossing if access is not desired.

Figures 46 & 47: RP-N: A Class II crossings.

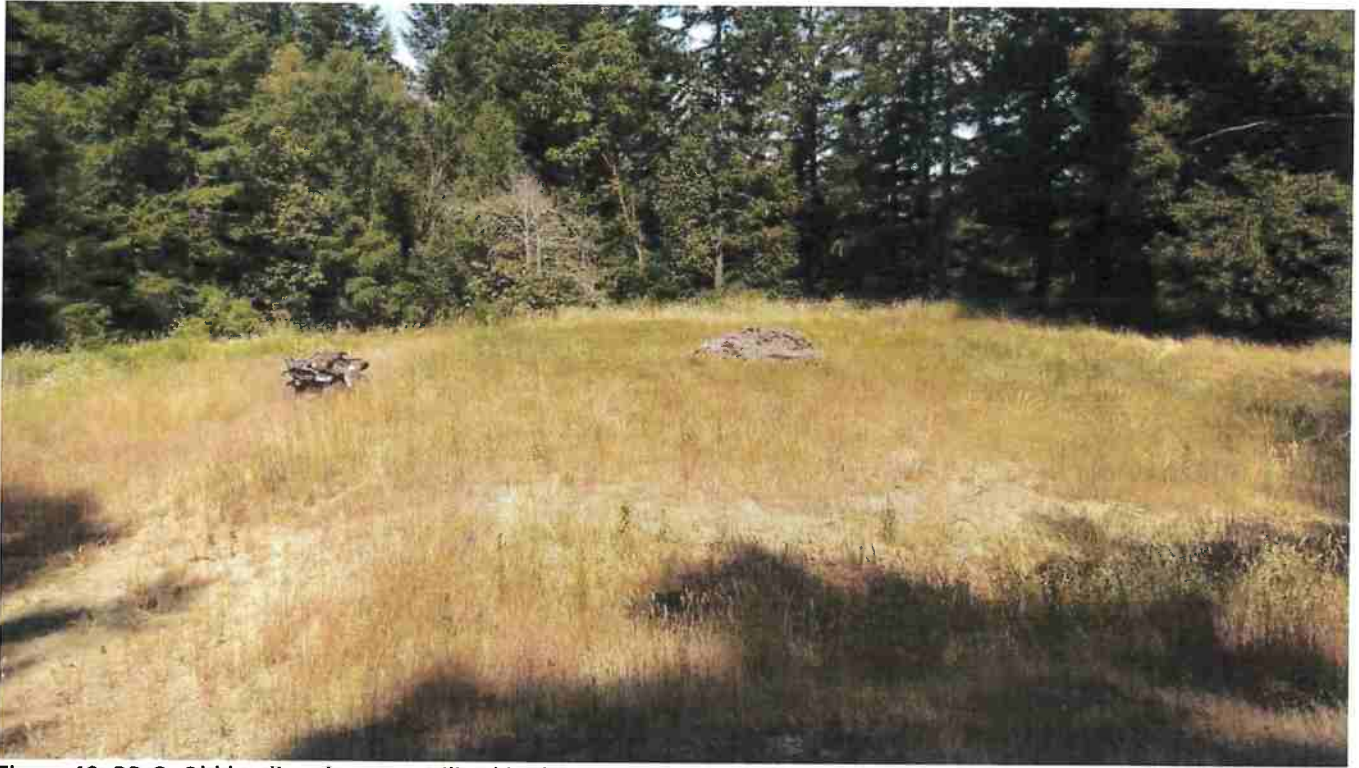
RP-O (Site F): Old WLPZ landing that was utilized in the past for cannabis cultivation the site is not proposed for use and has been decommissioned. There were no erosion issues observed and the site has a heavy grass vegetation cover. No mitigations are proposed for the site.

Figure 48: RP-O: Old landing that was utilized in the past to cultivate cannabis.

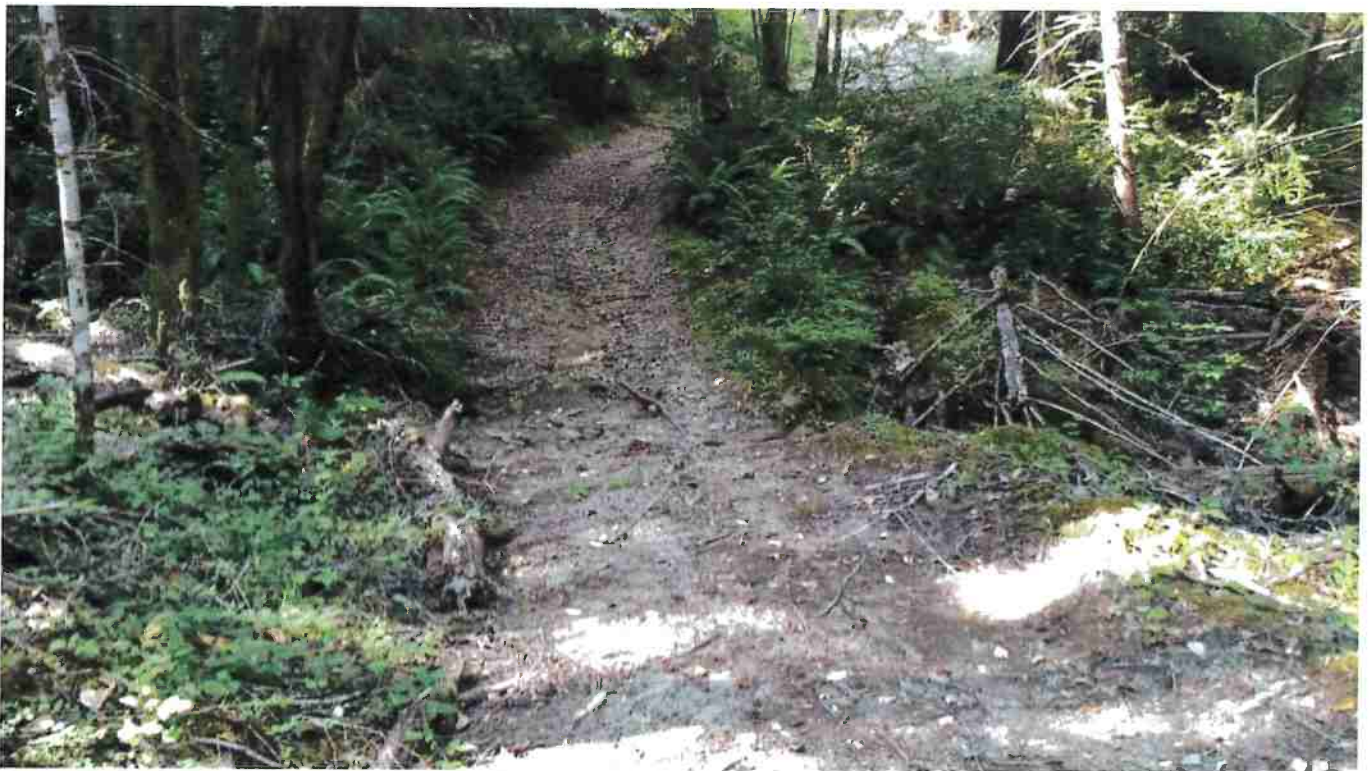
RP-P (Site F): Pulled class II crossing on a tractor road leading to two abandoned drying sheds. The crossing appears to be stable. Prior to the winter period install straw mulch on the crossing approaches for 15' on either side of the crossing to reduce surface erosion. Potential of 0.5 cu yards of erosion.

Figure 49: RP-P: Pulled crossing on class II watercourse.

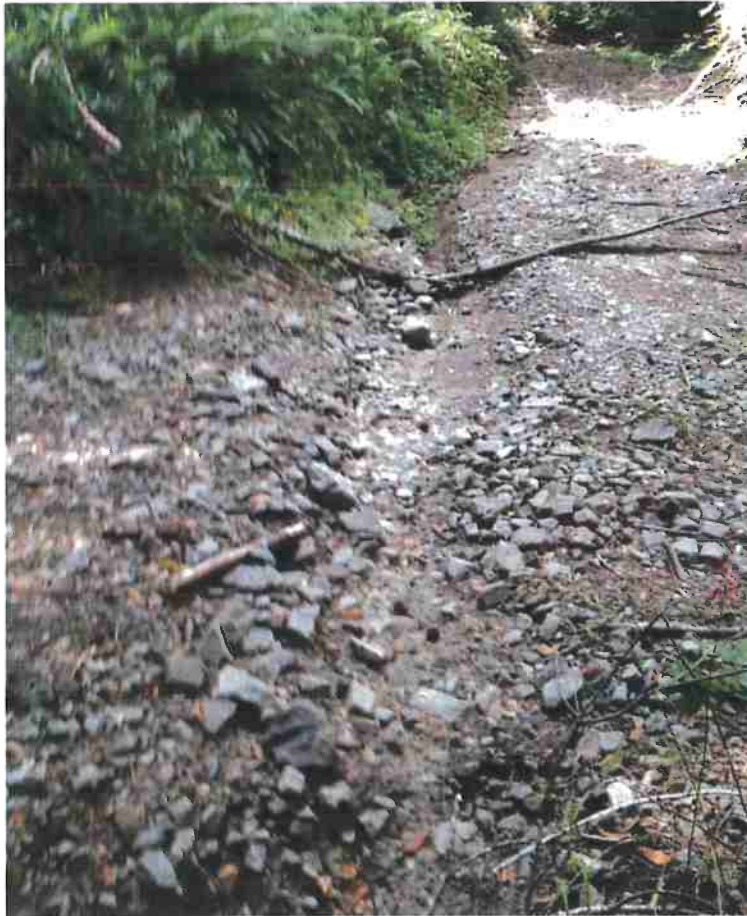
RP-Q (Site F): Pulled class III crossing on a tractor road which forks into a Y adjacent to the crossing. One of the forks leads to two abandoned drying sheds. The crossing appears to be stable. Prior to the winter period install straw mulch on the crossing approaches for 15' on either side of the crossing and up the Y of the old tractor road to reduce surface erosion. Potential of 0.5 cu yards of erosion.

Figure 50: RP-Q: Pulled crossing on class III watercourse.

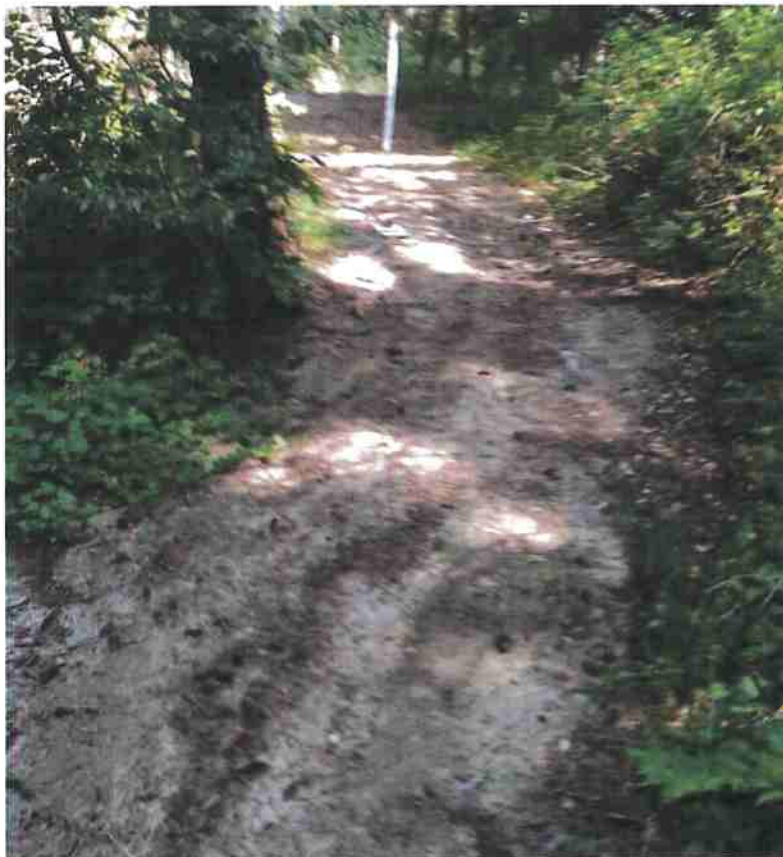
RP-R (Site F): Old WLPZ tractor road leading to two abandoned drying sheds. Monitor and add straw mulch as necessary to reduce surface erosion. Potential of 2 cu yards of erosion.

Figure 51: RP-R: WLPZ tractor road.

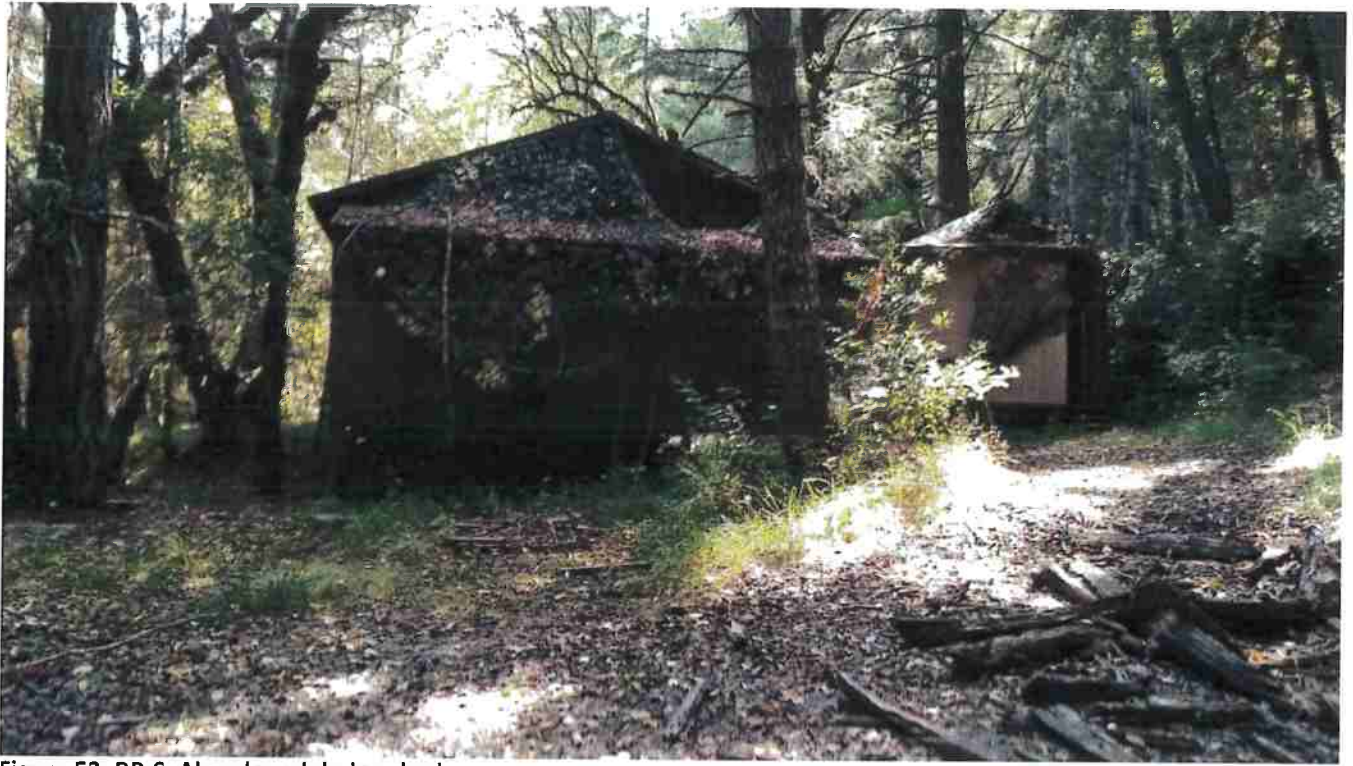
RP-S (Site F): When past cannabis cultivation occurred at RP-J and K two drying sheds were constructed at RP-S. The two sheds are within the class II WLPZ buffer however all cannabis related materials have been removed from the site and no use is proposed under the current cannabis cultivation plan. The sheds currently appear to be stable and there were no issues to water quality observed on the site. The proposed recommendation is to leave the site as is since bringing in the required equipment to demolish the structures could cause damage to the watercourses.

Figure 52: RP-S: Abandoned drying sheds.

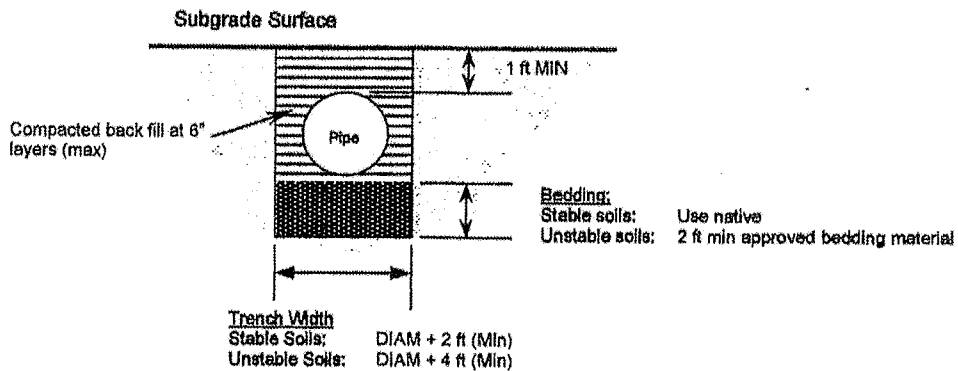
**PERMANENT WATERCOURSE
CROSSING STANDARD PLAN**

- The culvert bed shall be clean and free of large woody debris and large rocks.
- Unsuitable foundation material (highly plastic material - "blue goo") shall be excavated below the invert elevation of the culvert to an approximate depth of 2 feet and a width of at least the culvert diameter plus 4 feet.
- Unsuitable material shall be replaced with selected granular foundation material and compacted to obtain a uniform foundation.
- Select mineral soil shall be used for culvert backfill. The back fill shall be free of lumps, chunks, highly plastic material, and organic material.
- No rocks greater than 3" in any dimension placed closer than 1 foot to the culvert.
- Back fill shall be compacted to a degree greater than the surrounding soils. Soil moisture shall be adequate to achieve suitable compaction.
- See Text for more detail.

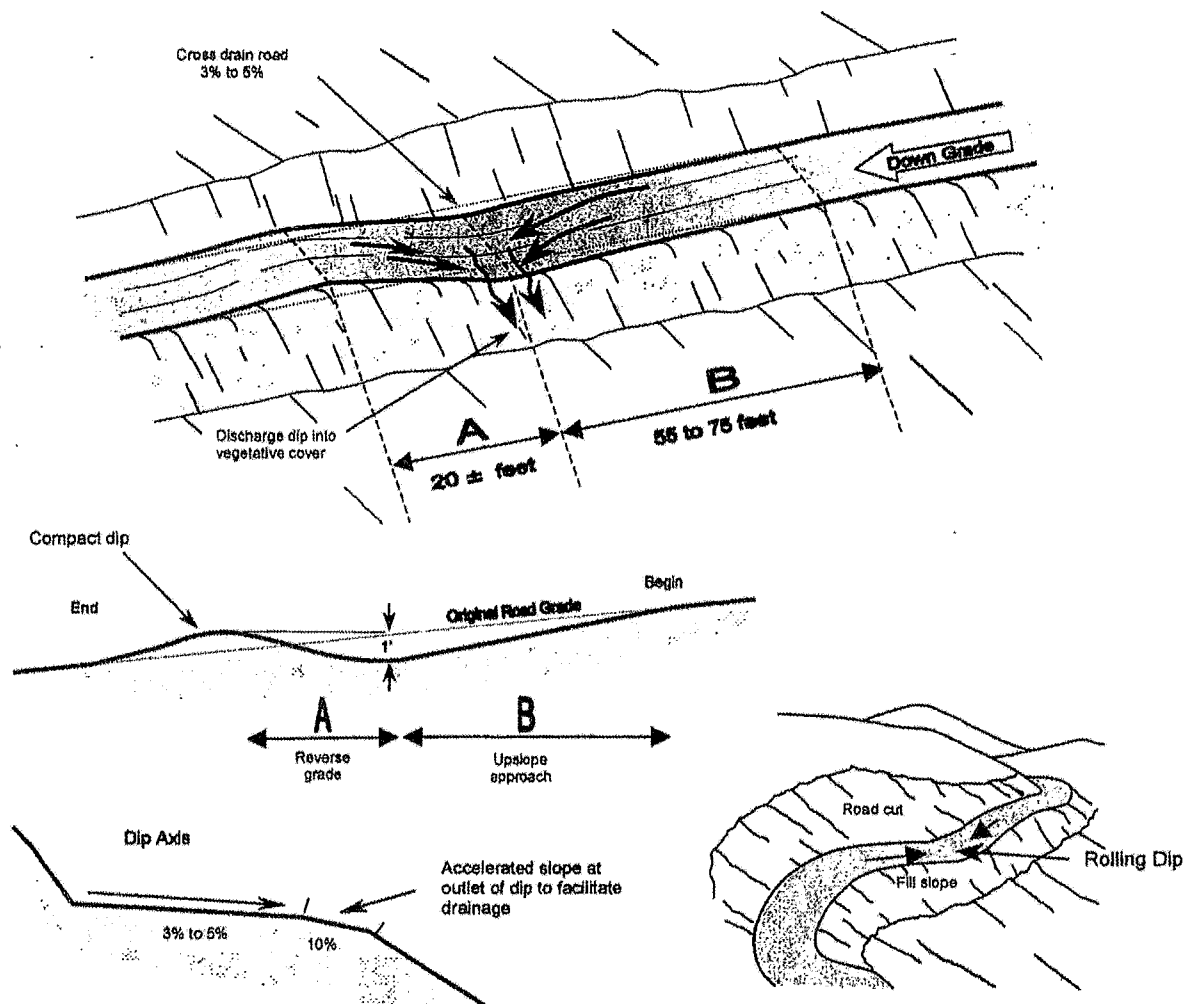
ROLLING DIP DIMENSIONS					
		MAIN LINE ROAD		SECONDARY ROAD	
Road Grade (%)	Depth of trough Depth below downslope crest (ft)	A: Reverse grade (Distance from trough to downroad crest (ft))	B: Upslope Approach (Distance from up-road start of rolling dip to trough (ft))	A: Reverse grade (Distance from trough to downroad crest (ft))	B: Upslope Approach (Distance from up-road start of rolling dip to trough (ft))
<6	1.0	20	65	15	55
6 - 8	1.0	20	75	15	65
