BOTANICAL AND AQUATIC RESOURCES SURVEY

522 Brown Road (APN: 211-374-013)

March 2020

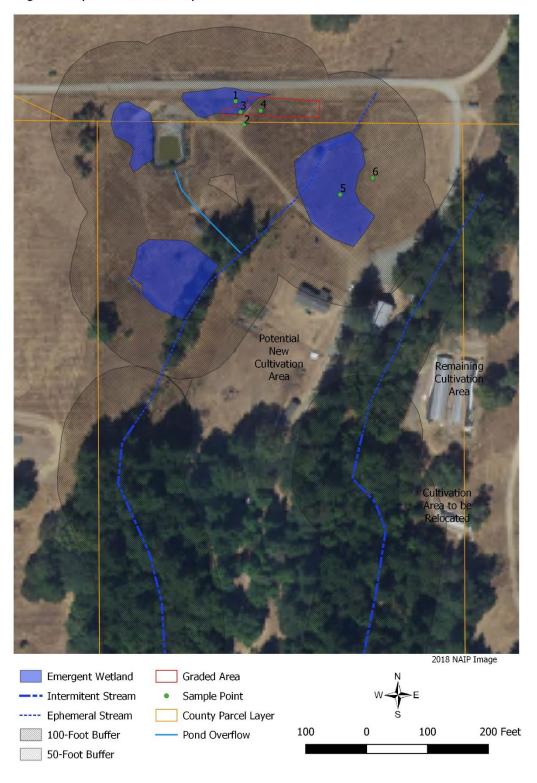
Figure 2. Aquatic Resources Map.

The wetland boundary in the graded area was delineated based on the adjacent vegetation and soil on the flat. The northern and western parts of the wetland feature were still intact, making it possible to locate the wetland boundary along the west and north sides of the graded area. There are no wetland indicators on the south side of the graded area, indicating the wetland

did not extent south of it. The boundary on the graded area was established based on presence or absence of hydric soil under the gravel (Sample Points 3 & 4). A recent Google Earth image was also evaluated. The wetland is visible in the photo, but it is difficult to see the precise boundary (Appendix F). It does appear most of the graded area was upland.

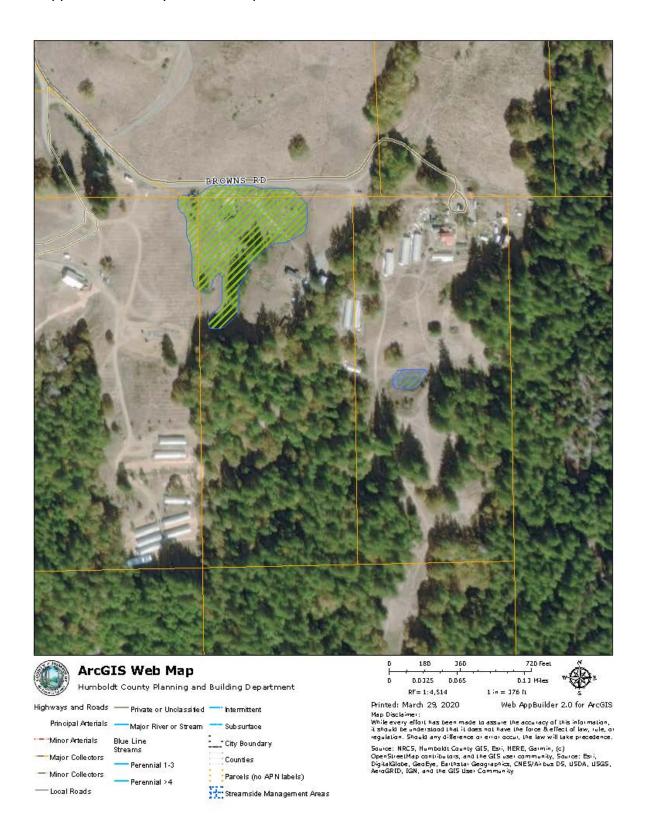
Appendix F. Google Earth Image of the Graded Area Before Disturbance.

Approximately 3,914 square feet was recently graded along the northern property line. Most of the area is in upland, however an estimated 572 square feet is within emergent wetland. The graded soil appears to have been moved elsewhere, thus there does not appear to be any wetland fill (other than a thin layer of gravel), only disturbance to soil and vegetation. All of the graded area is within the wetland and stream setbacks and should be restored to its original condition. Currently the flats are compacted on the surface and there is a layer of gravel. Although this likely helps with stabilization, it may make it more difficult for plants to establish on the flats. Additionally, the topsoil with the seedbank has been removed which could also slow revegetation. The following is recommended:

An approximately 3,914 square foot area was graded along the northern edge of the parcel that impacted approximately 572 square feet to emergent wetland. It is recommended the layer of gravel be removed and the area be restored to its original topography and that erosion control and revegetation be implemented.

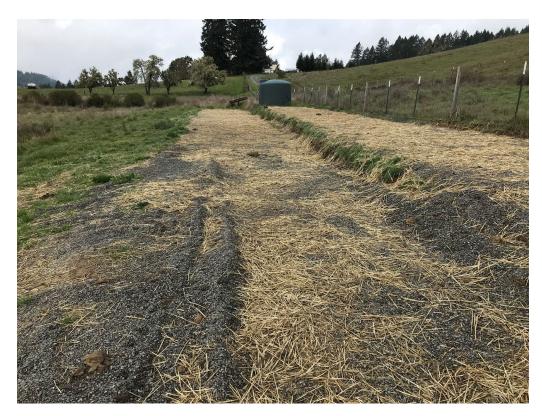
Photo 1. Recently graded area along Brown Road.

It is also recommended a qualified geologist or engineer be consulted and that and that the County and other agencies be contacted to determine the permitting requirements for the project.

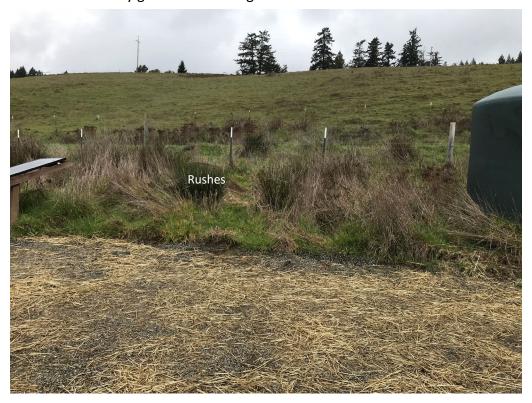
The vegetation is hydrophytic. Dominant plants include rushes (*Juncus effusus* and *J. patens* [FACW]), pennyroyal (*Mentha pulegium* [OBL]), nut-grass (*Cyperus eragrostis* [FACW]), and velvet grass (*Holcus lanatus* [FAC]).

Photo 2. Emergent wetland direct adjacent to graded area.

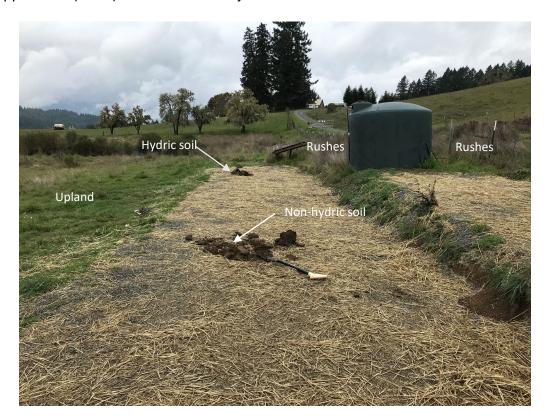
Photo 3. Soil pits on graded flat and adjacent vegetation.

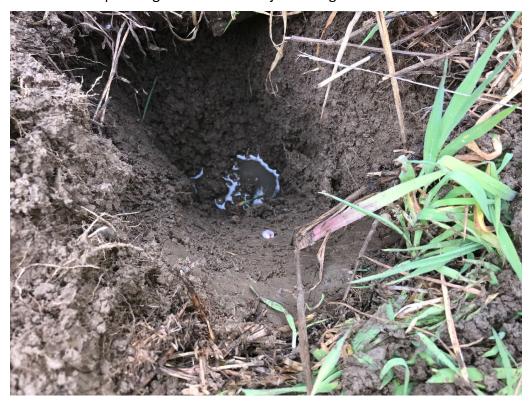
Photo 4. Groundwater in Sample Point 1.

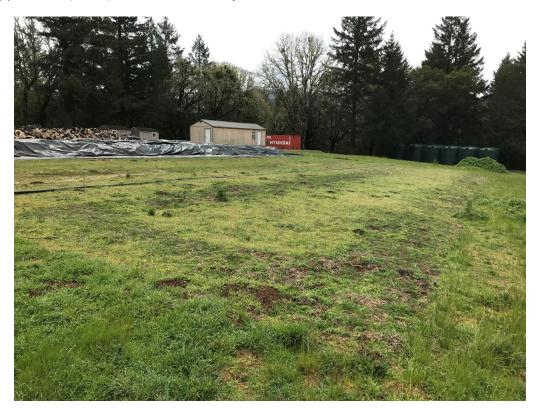
No special status plants or natural communities were observed. The new proposed cultivation site is disturbed grassland dominated by non-native grasses and other herbaceous plants and is poor habitat for most rare plants. It is recommended the pampas grass at the existing cultivation site be removed to prevent further spread of this highly invasive species.

Photo 5. New cultivation area, looking southeast.

Relocating the cultivation area out of the stream buffer will be environmental beneficial because it is currently too close to the creek and could damage aquatic resources through erosion and pollution. The existing cultivation area is on a slope and is potentially subject to erosion resulting in delivery of sediment and nitrogen rich runoff to the watershed. The new location is on a flat directly adjacent to the residence in a disturbed area outside the stream and wetland setbacks. Additionally, the new cultivation area is closer to the residence and other structures and will likely concentrate human activities to that area which could reduce noise and disturbance to wildlife elsewhere on parcel.

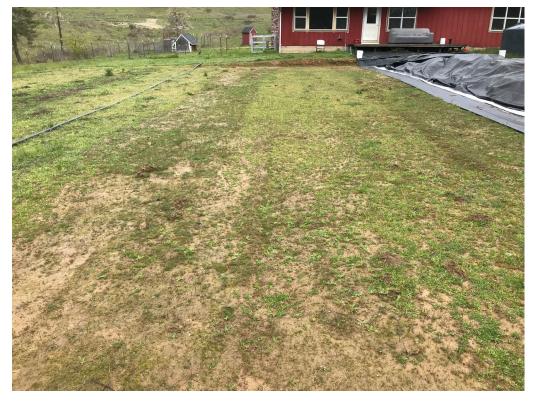
Photo 6. New cultivation area, looking north.
