**Peakview**  
**SITE MANAGEMENT PLAN**

**APNs:**  
**216-082-002**  
**216-082-006**  
**WDID #: 1\_12CC417448**

**Project Name:** Peakview

## **Purpose**

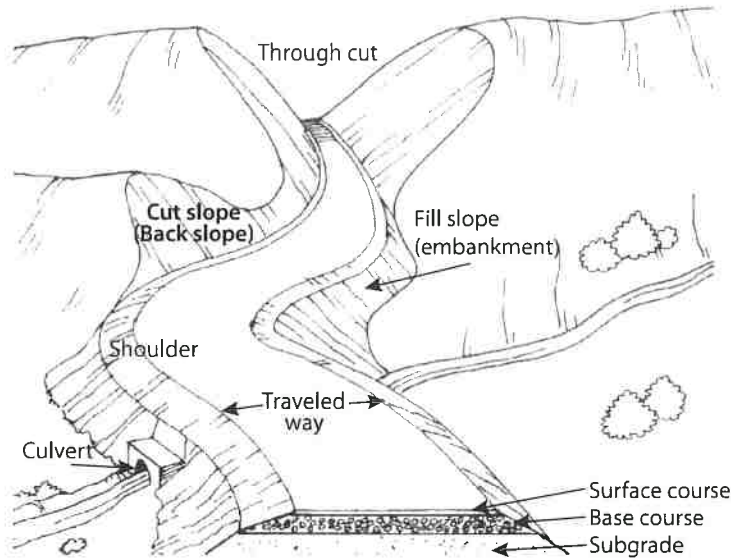
Figure 5. Components of a road. Source: Keller and Sherar 2003.

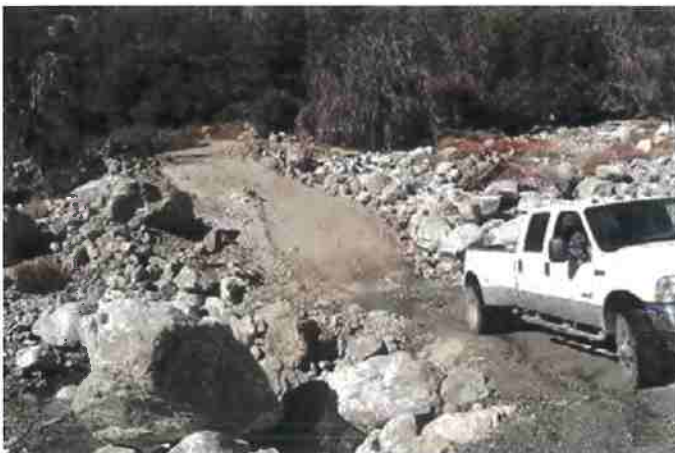
Figure 6. Low-water crossing on a perennial stream, San Bernardino County. Photo: Richard Harris.

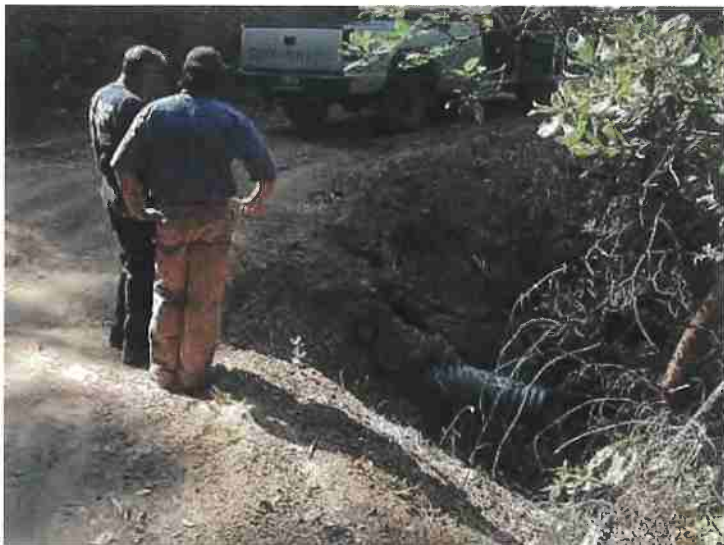
**Figure 14.** This fill slope erosion was caused by a plugged cross-drain inlet that diverted ditch flow over the road surface. Photo: Angela Wilson, Central Valley Regional Water Quality Control Board.

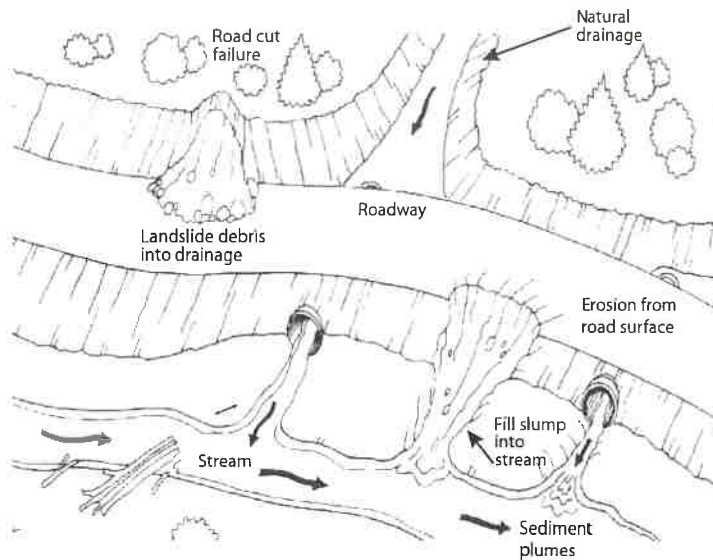
**Figure 15.** Road system problems to look for during a road inspection.  
Source: Keller and Sherar 2003.

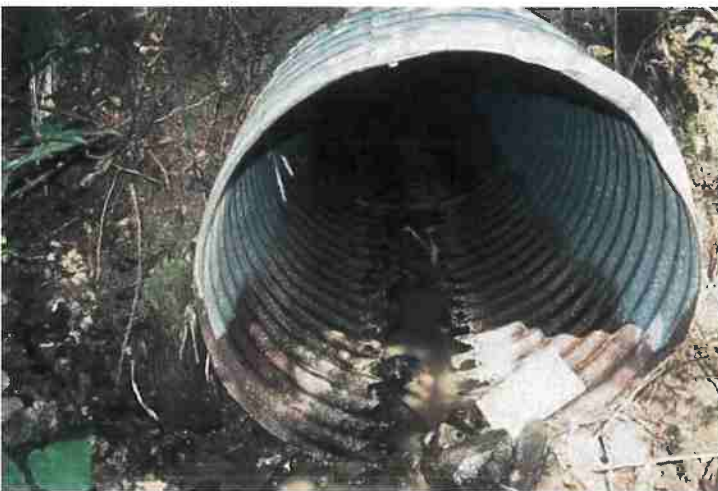
**Figure 17.** Culvert with rusted bottom and breakage caused by sediment. Photo: Angela Wilson, Central Valley Regional Water Quality Control Board.

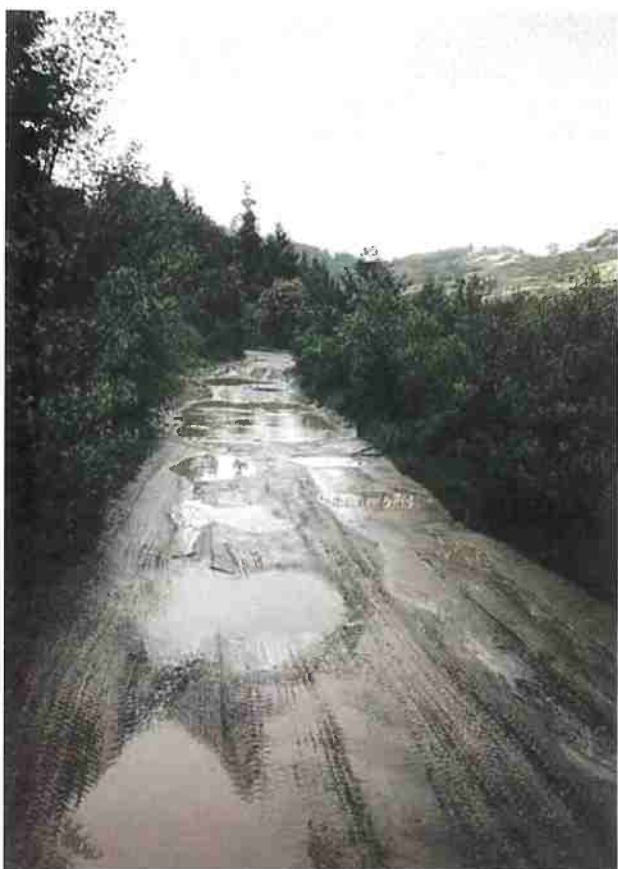
**Figure 18.** Water collecting on a forest road because of poor drainage. Photo: Jared Gerstein.

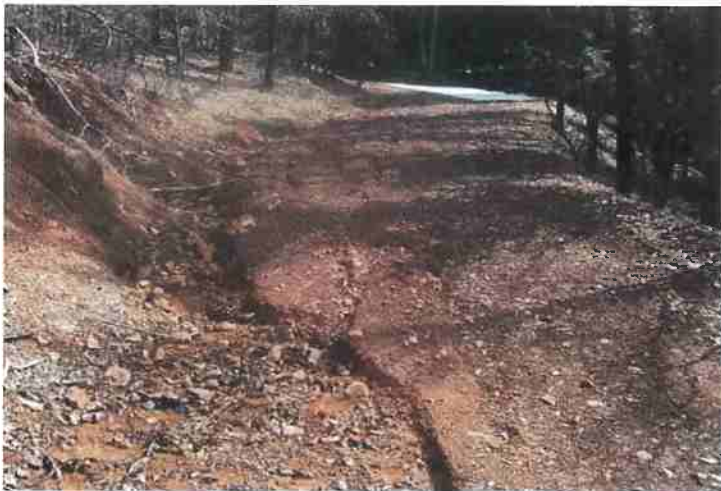
Water may flow out of a ditch onto a road when the capacity of the ditch is exceeded. This occurs when the volume of runoff exceeds the ditch capacity or, more commonly, when a ditch relief culvert is plugged with debris. In the latter instance, the plugged cul-

**Figure 19.** Erosion caused by ditch water leaving the ditch and traveling across the road. Photo: Susan Kocher.

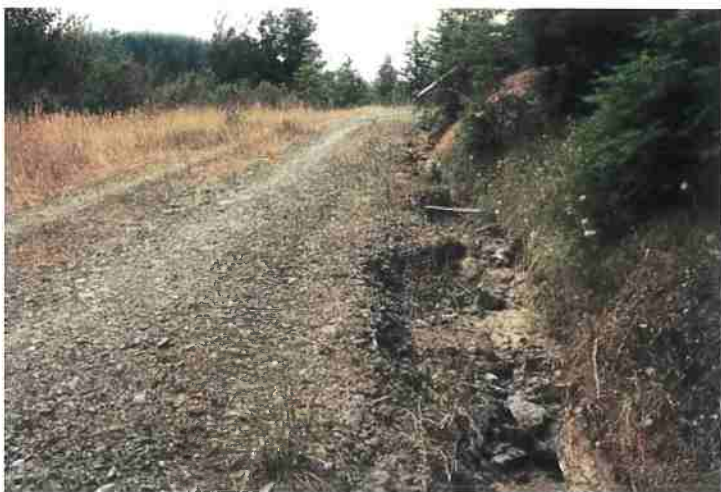
Ditches incise when they carry too much flow for their design capacity and they erode rather than spill water out onto the road. Too much flow in the ditch occurs because there are not enough ditch relief structures and/or because there are sources of water other than road runoff contributing to ditch flow. Examine the ditch system to see if the ditch has captured the flow from a stream channel or spring and diverted it down the ditch. If not, the most likely problem is too few ditch relief culverts or cross drains.

**Figure 20.** Eroding inboard ditch on an in-sloped road. This is a symptom of inadequate cross drains for conveying ditch flow across the road. Photo: Richard Harris.

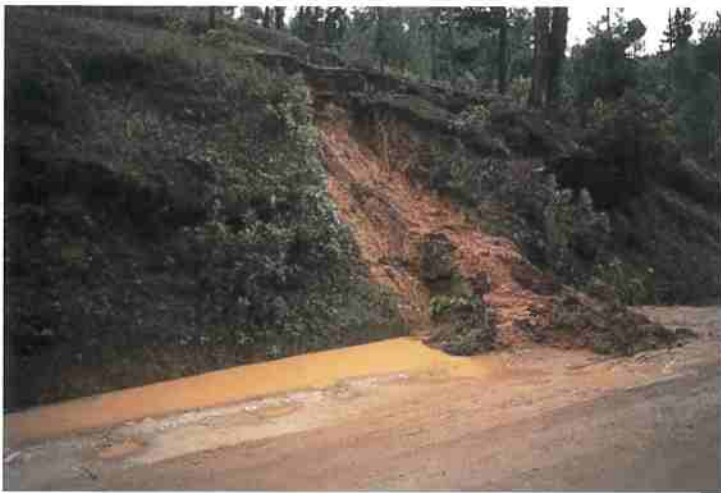
Ditches may become filled in with sediment, rock, or woody debris (fig. 21). This reduces their

**Figure 21.** Cut bank failure blocking inboard ditch. Cut bank failures cause operational and maintenance problems, especially when chronic. Source: Keller and Sherar 2003.

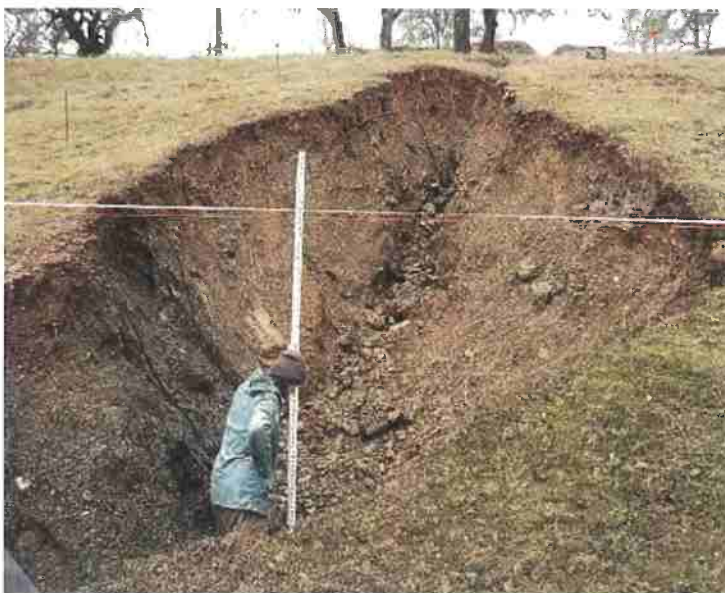
Gullies are caused when increased or concentrated flow from the road system flows onto erosive soil. Most often, gullies originate from a road system's drainage features. They can be identified by their bare dirt banks and occurrence in places where natural streams do not occur, such as smooth hillslopes or ridges (fig. 22). Gullies may or may not threaten the roadbed itself, but they are always a significant source of sediment and thus a detriment to streams.

**Figure 22.** Gully caused by through-cut on road at base of steep road section. Photo: Jared Gerstein.

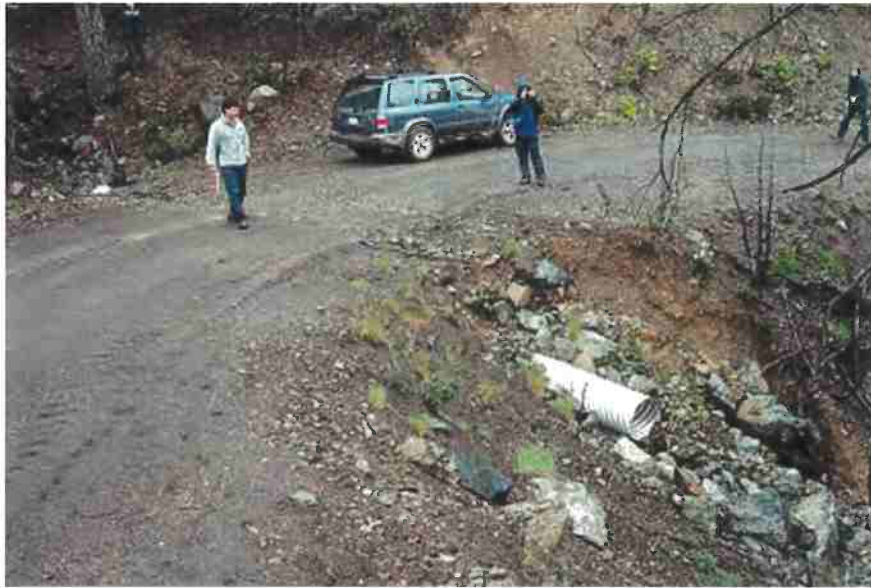
**Figure 25.** Eroding fill slope and culvert failure due to plugging at inlet and diversion of flow across the road. Photo: Bill Weaver, Pacific Watershed Associates.

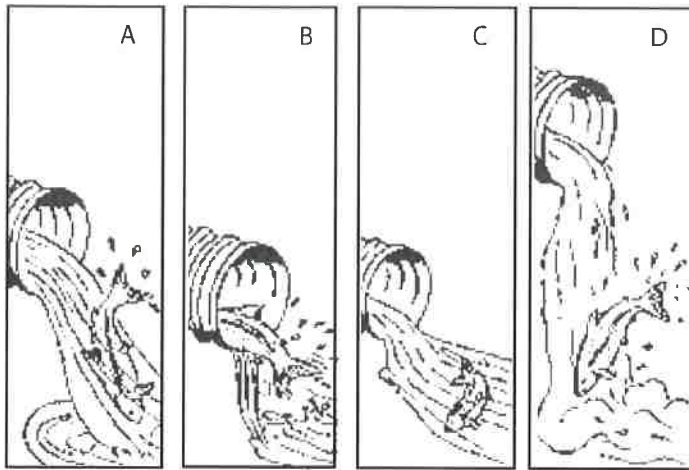
**Figure 27.** Barriers to fish migration caused by culverts. *Source:* Keller and Sherar 2003.

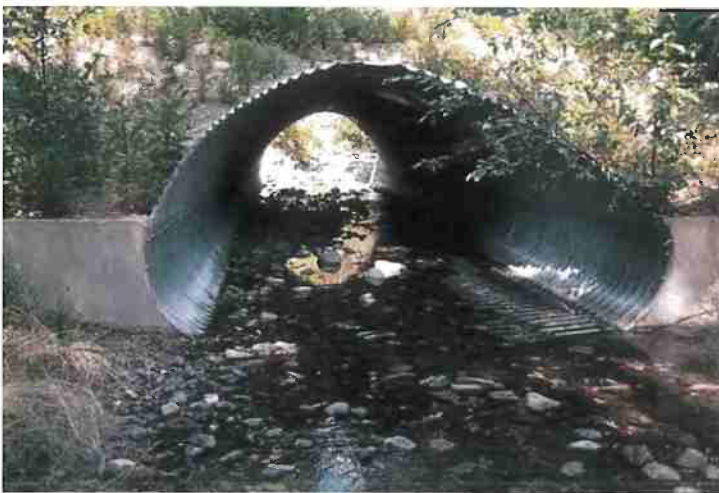
**Figure 28.** An arched pipe installed on a fish-bearing stream to minimize impacts on fish habitat and migration. *Source:* Keller and Sherar 2003.

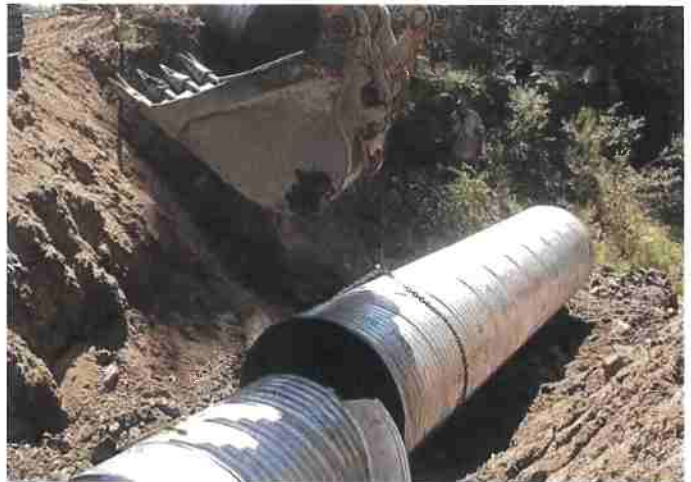
**Figure 30.** Installation of a new culvert after the old one was excavated. Photo: Jared Gerstein.

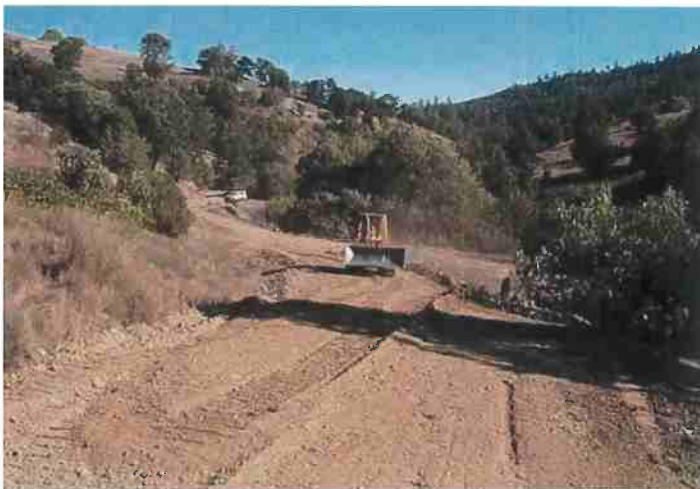
**Figure 31.** Bulldozer reshaping road surface to out-sloped condition to improve drainage. Photo: Jared Gerstein.

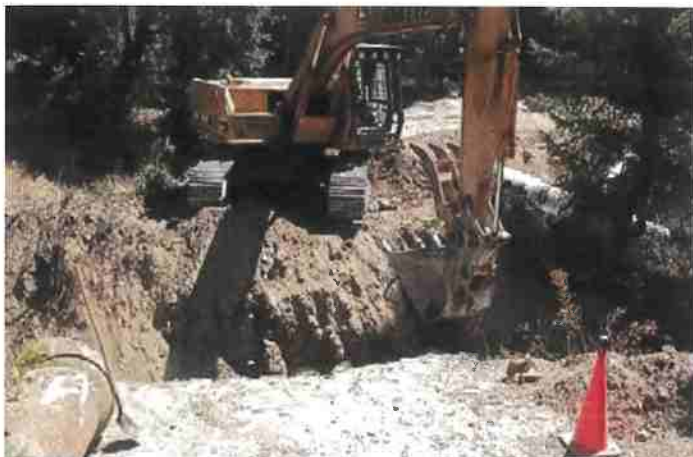
Figure 32. Excavator removing a crossing, including culvert and fill.  
Photo: Jared Gerstein.

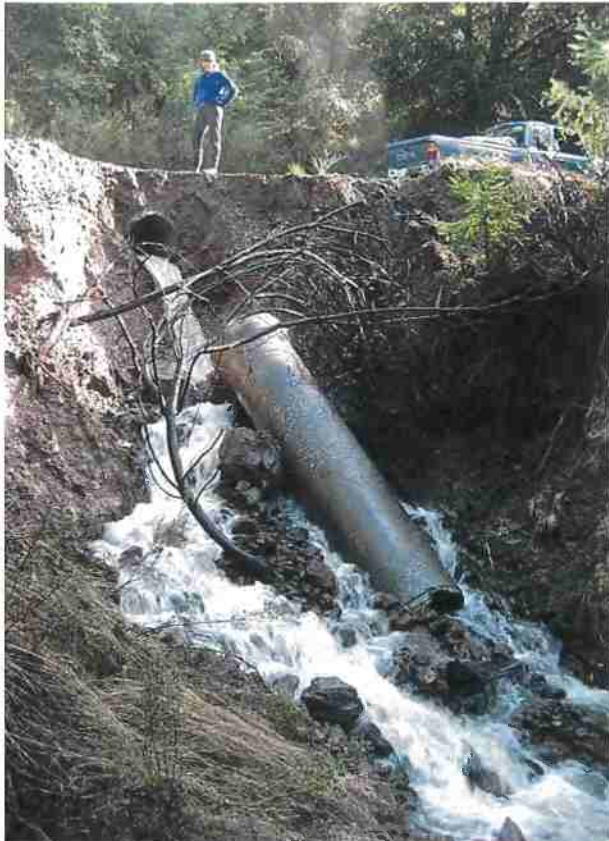
**Figure 34.** Outlet of a concrete culvert (30 inches in diameter) before the project. The culvert was placed too high in the fill, resulting in a 10-foot drop to the channel at the outlet. This caused erosion of the road fill and stream banks, eventually undermining the outer section of the culvert. Photo: Jared Gerstein.

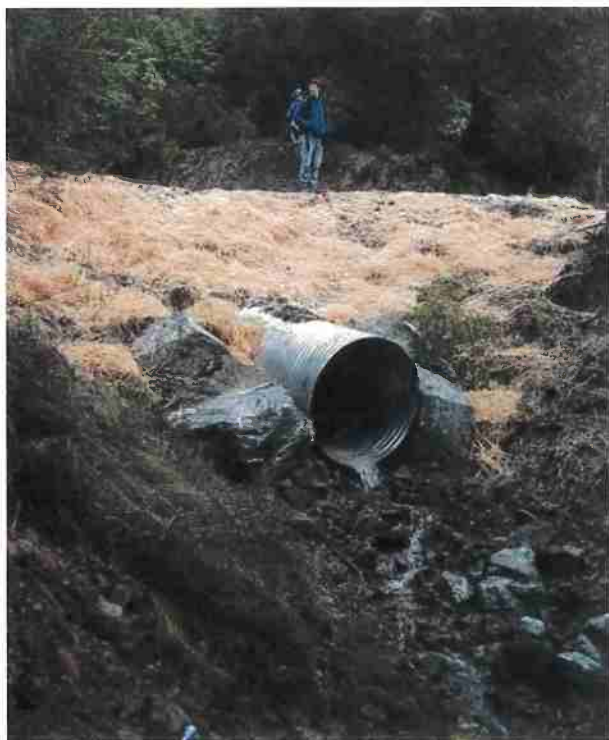
**Figure 35.** The culvert was replaced with a metal pipe (48 inches in diameter) at the correct slope. The road surface was lowered, reducing the fill volume by 100 cubic yards. The outlet and fill were armored to prevent future diversion. Photo: Jared Gerstein.

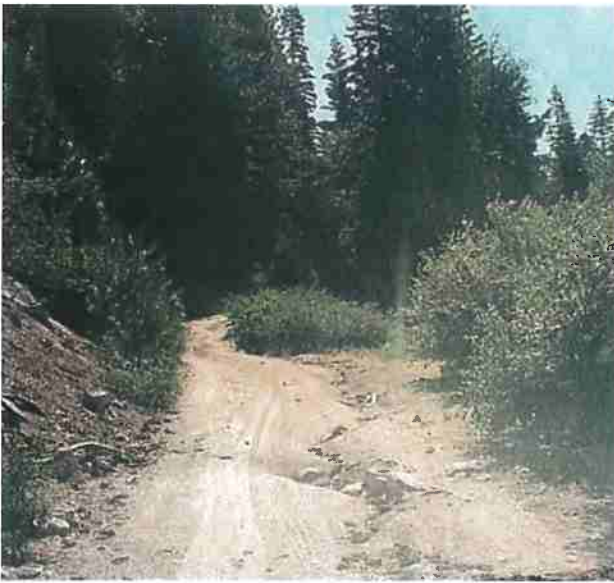
**Figure 37.** Pinchard Creek road with rilling along the road surface before the project, 2002. Photo: Joe Hoffman, Plumas National Forest.

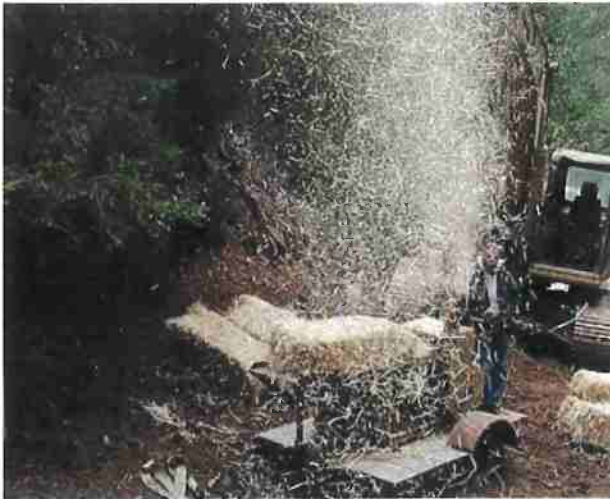
**Figure 40.** Using a portable blower to spread straw mulch on a disturbed road site. *Photo:* Julie Bawcom, California Geological Survey.
