From: David Nicoletti PE QSD\QSP
DTN Engineering & Consulting
2731 K Street Unit A
Eureka, CA 95501
Email: dnicoletti@dtngineering.com

Subject: Roadway Evaluation for Cobb Road from Rattlesnake Bridge to APN 208-341-016

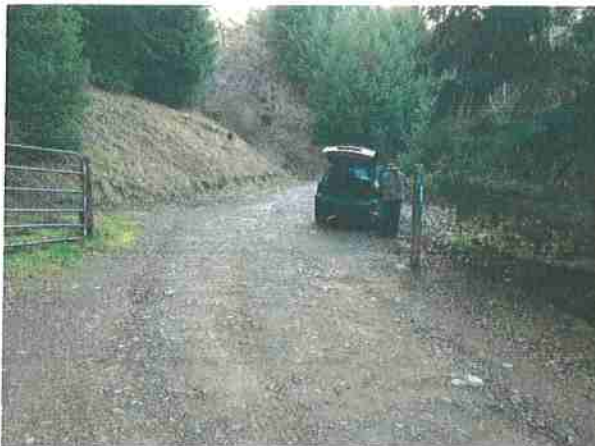
The road evaluation begins at the gated entrance to Cobb Rd and the intersection of Rattlesnake Bridge (Pictures 1-2). At this location Cobb Rd. is within the SMA and an unidentified culvert conveys water under Cobb Rd. The roadway at this location is 16 feet wide and the grade abruptly increases to approximately 8% past the gate. As Cobb Rd proceeds to the southeasterly direction the first culvert is encountered (Picture 3). The culvert is an 18 inch CMP culvert in poor condition that is supplied by a drainage way. This culvert has previously been blocked due to sediment traveling downslope from the unstabilized PG&E easement.

Picture #1 Gate @ Cobb Rd & Rattlesnake Bridge looking E.

At this specific location it is recommended to replace the existing culvert with a new minimum 18 inch culvert and construct an approved turnout in accordance with the Humboldt County Ordinance for California Fire Safe Regulation. In order to prevent this culvert from clogging in the future, stabilize the PG&E easement, create a little ponded rocky area at the inlet of the culvert for sediment to settle out, and possibly increase the culvert diameter to 24 inches. Reestablishment of the existing roadside ditches are also recommended.

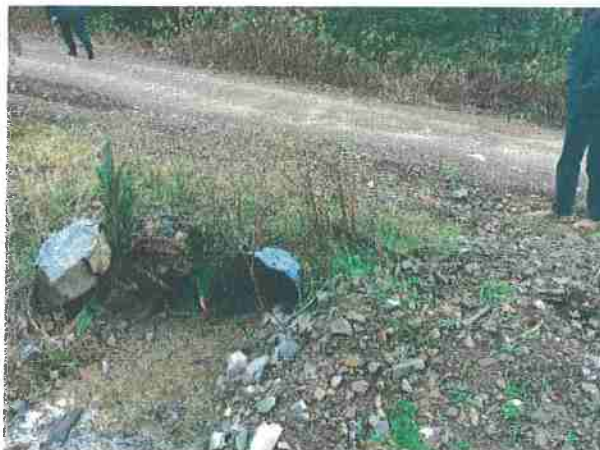
Picture #3 Cobb Rd at Curve in Picture #2 looking @ 12" CMP

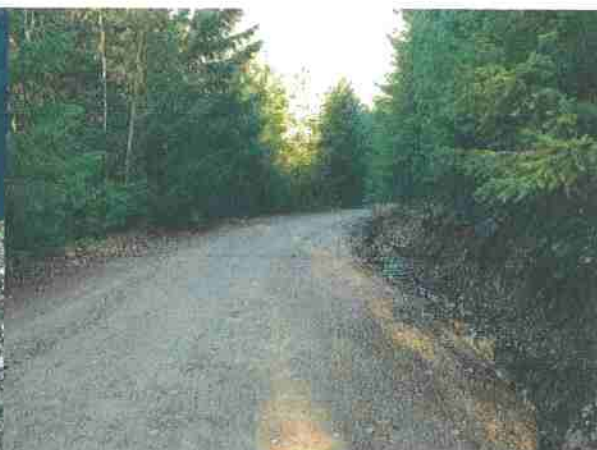
Picture #4 Cobb Rd @ curve looking NW

At this specific location it is recommended to replace the existing culvert with a new minimum 18 inch culvert. In order to prevent this culvert from clogging in the future, stabilize the PG&E easement, create a little ponded rocked area at the inlet of the culvert for sediment to settle out, and possibly increase the culvert diameter to 24 inches. Also, construct turnouts in accordance with the Humboldt County Ordinance for California Fire Safe Regulation at the curve. Reestablishment of the existing roadside ditches are also recommended.

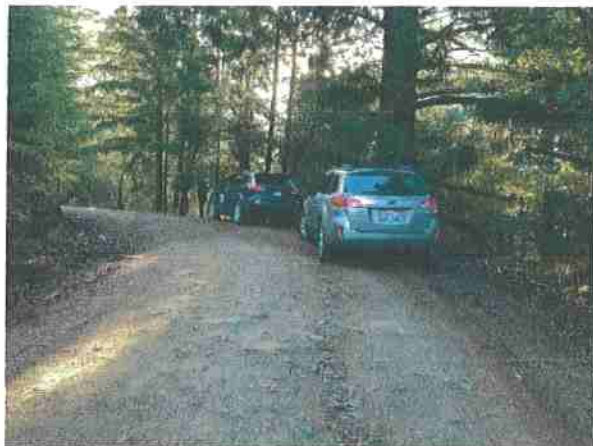
Picture #5 Cobb Rd @ curve in Picture #4 looking SE

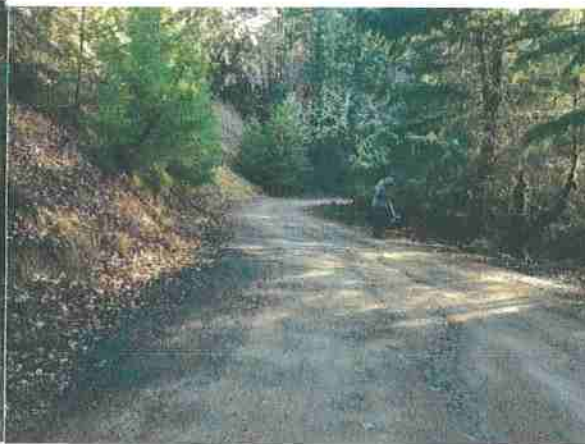
Proceeding southeasterly up grade at approximately 8%, the first curve in the roadway is encountered (Pictures 4 & 5). As shown (Picture 5), there is sufficient space for two vehicles to pass, but as with the case of all pull outs at curves evaluated on Cobb Rd, they aren't in accordance with the Humboldt County Ordinance for California Fire Safe Regulation for turnouts (Exhibit D). The width

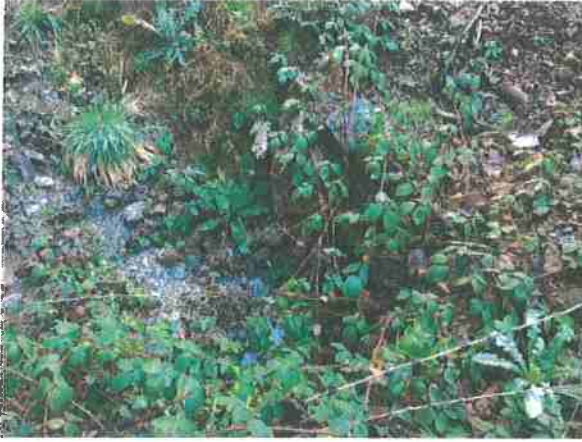
Proceeding southeasterly, the next curve is encountered (Picture 6) and as shown in the picture there are no turnouts, preventing the safe passage of two vehicles. At this location a 12 inch culvert exists, but at one point it was blocked and water cascaded over the road and over the downslope side of the hill (Picture 8). On the Google Earth image, the water overtopping the road is shown as well. Also, on the Google Earth image a drainageway is developing to the north, due to the clearing in the PG&E easement above the road.

Picture #6 Cobb Rd looking E. @ curve

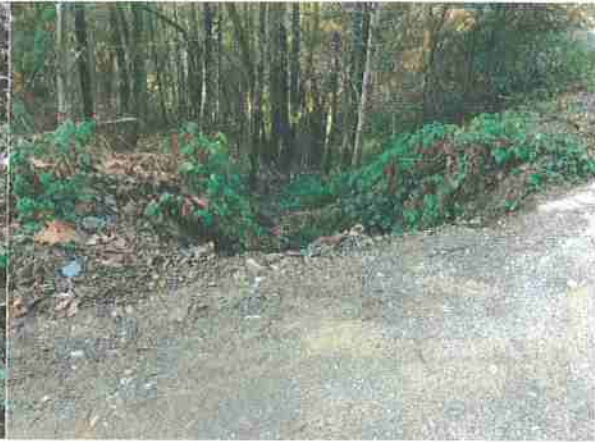
Picture #8 road washout due to culvert being clogged.

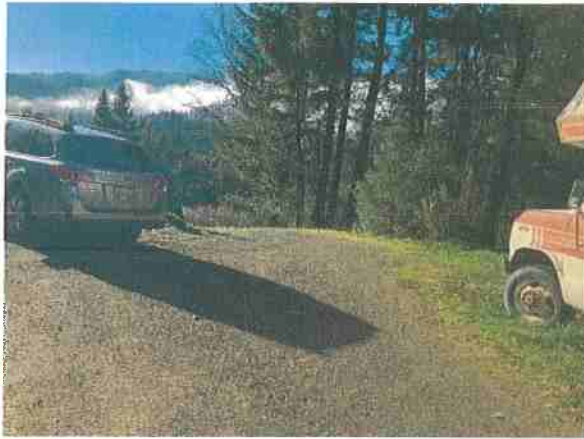
Picture #9 Cobb Rd @ unsafe driveway

At this specific location it is recommended to improve the existing driveway for compliance with Humboldt County Standards for Commercial Rural Driveway. It is

also recommended to stabilize the sloughing of the north road embankment with engineered fill and appropriate slope armoring.

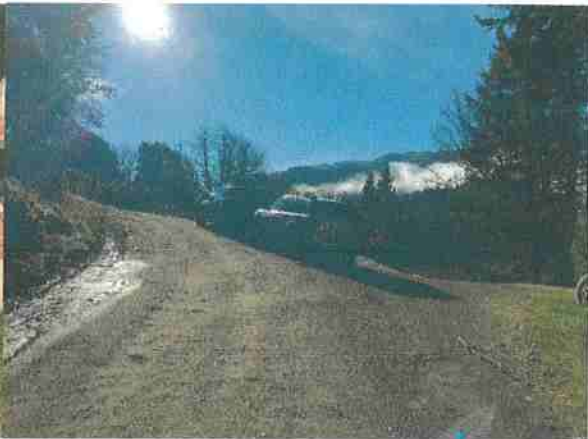
Picture #10 Cobb Rd looking SE towards curve & drive in #9

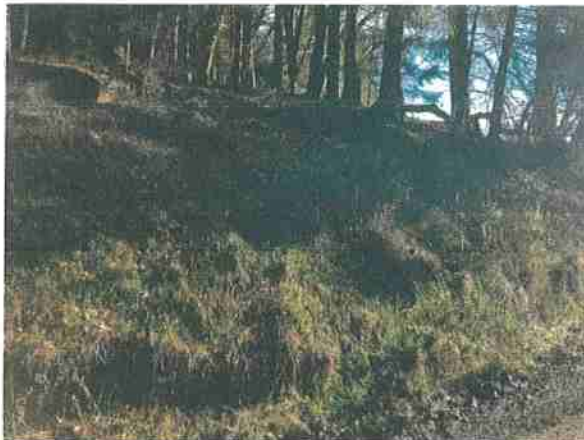
Continuing southeasterly, the first driveway is encountered (Picture 9), and just passed that driveway (Picture 10), a curve is encountered with a slope of approximately 7% upslope from the driveway. The driveway as shown (Picture 9), is steep as it intersects Cobb Rd without appropriate SSD in accordance with Humboldt County Standards for Commercial Rural Driveway (Exhibit D). Looking northeasterly (Picture 11), the upslope side of the road embankment is sloughing and as described below in sections Pictures 12-14 & 57-59, the unstabilized graded flats above the roadway on APN #208-341-011, are creating erosion and runoff coming down the hillside. The erosion is also impacting and on the inside edge of the roadway curve the runoff is eroding the toe of the slope as shown (Picture 11), causing sloughing of the hillside. The grade upslope is approximately 7%. At the drive the width of the roadway and flat area is approximately 18 feet narrowing down to 14 feet (Picture 10). At either end of the curve the roadway narrows down to 11.5 feet.

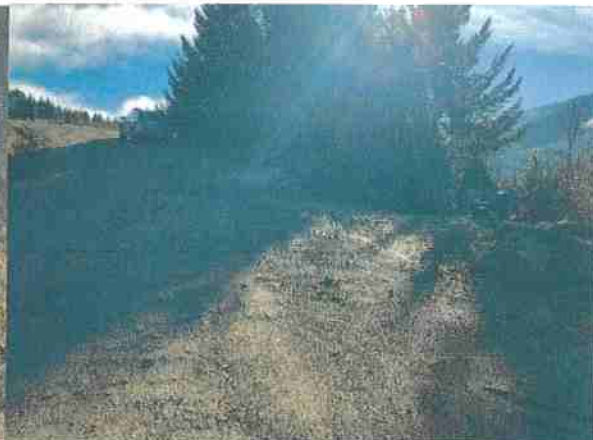
Picture #11 Cobb Rd looking NE @ sloughing of embankment

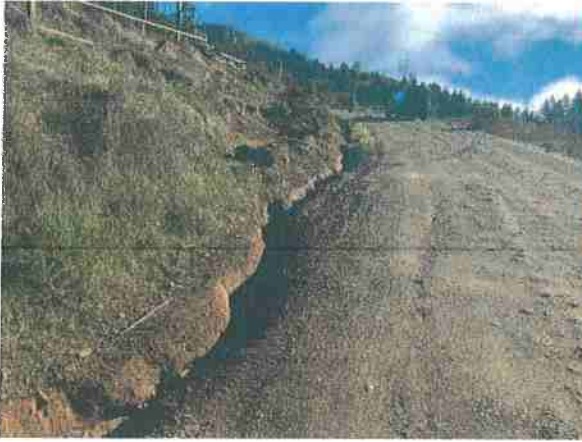
Continuing southeasterly, coming upon the horseshoe curve at APN #208-341-011 (Picture 12), which depicts the second driveway encountered. This driveway as shown also does not meet Humboldt County Standards for Commercial Rural Driveway for SSD at driveways intersecting roadways. The roadway width around the horseshoe curve expands from 12 feet at the beginning of the curve travelling southeasterly. Significant drainage is entering the roadway from the graded flat on APN #208-341-011 and is eroding the inside toe of the slope creating erosion issues, sloughing of the hillside as described in section Pictures 9-11, and the blocked culvert described in section Pictures 57-59. The roadway around the curve expands to approximately 18 feet wide with a driveway that appears to be in conformance with Humboldt County Standards for Commercial Rural Driveway is encountered with a sufficient turnout space exists allowing two vehicles to pass at the same time. After the driveway the roadway narrows in width back to approximately 12 feet with a grade of 6% approaching the next curve (Picture 22). Looking northwesterly (Picture 17) the next curve is encountered and a pull out does exist for a car to pull out, but it is placed on the opposite side of travel as the curve is approached.

Picture #12 Cobb Rd looking SE @ curve & driveway

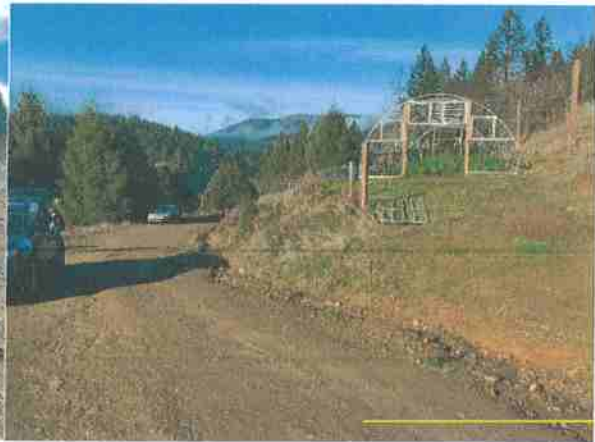
Picture #14 Cobb Rd looking SW towards curve.

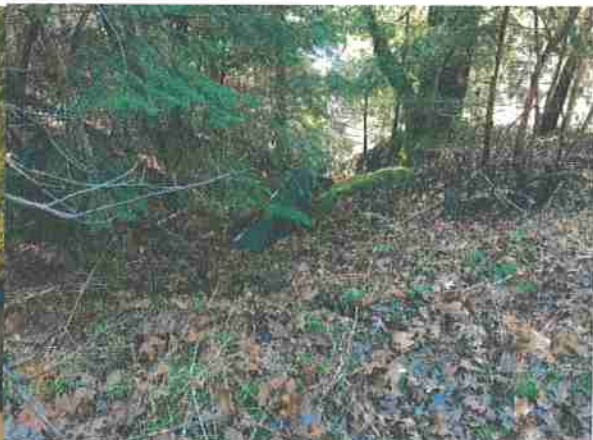
Picture #17 Cobb Rd looking NW towards curve

At the specific location shown (Picture 17) it is recommended to construct a turnout on the north side of the roadway in compliance with Humboldt County Ordinance for California Fire Safe Regulation. A large part of the erosion and drainage issues identified in sections Pictures 9-11, Pictures 57-59, and Pictures 12-17, have been created by APN #208-341-011 due to clearing and grading for flats without proper slope stabilization. Reestablishment of the existing roadside ditches are also recommended.

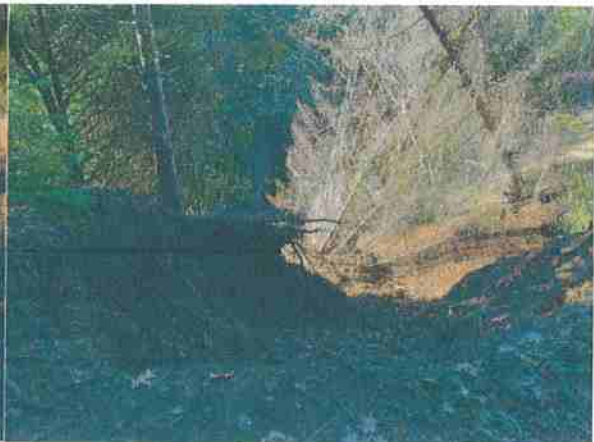
Picture #20 On PG&E esmt looking SW @ erosion.

At this location it is recommended to coordinate with PG&E regarding to legal responsibility for maintaining environmental control over the easement. Also, it is recommended to replace the existing culvert with a new minimum 18inch culvert.

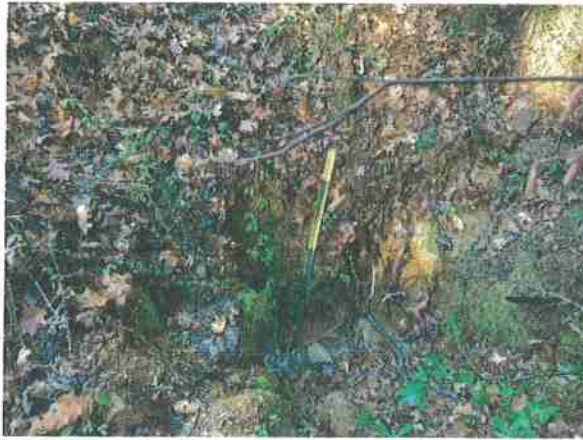
This section evaluates part of the PG&E easement clearing along with a water tank placed on the edge of a slope, along with drainage and erosion issues. The tank is shown looking downslope, Picture 25 in section Picture 22-25 below. Erosion is occurring (Pictures 19 & 20) due to un-stabilized slopes that have been created by the clearing of the PG&E easement. A 12 inch culvert that appears partially blocked (Pictures 18 & 21) on the intake side exists. There is a steel delineator marking the inlet of the 12 inch culvert (Picture 21).

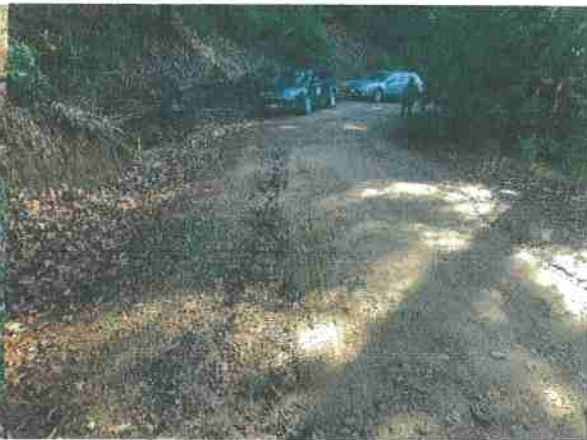
Picture #21 On PG&E esmt looking NE @ outlet from Cobb Rd

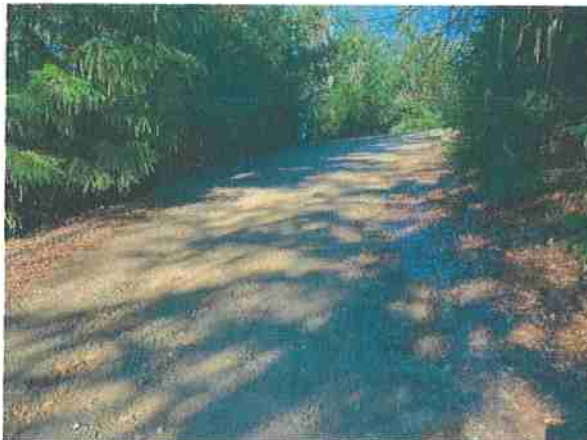
Continuing northwesterly, the next curve and culvert location is encountered (Pictures 22-25). As depicted (Picture 22) there is a narrow turnout allowing two vehicles to pass around the curve. Additionally, there is erosion and drainage occurring downhill due to the 12 inch culvert being blocked in the past as well as the ditch on either side of the road being congested with debris. The roadway before and after the curve is approximately 12 feet with clogged ditches on either side of the traveled way. The slope of the road is approximately 8%.

Picture #22 Cobb Rd SE towards curve

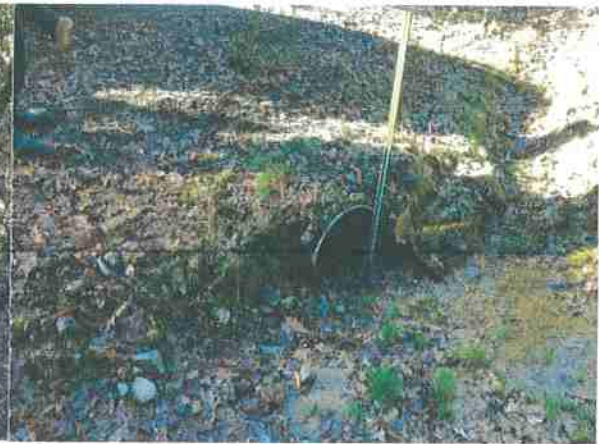
Picture #26 Cobb Rd inlet of 12" culvert in Picture 27.

At this specific location it is recommended to replace the existing culvert with a new minimum 18inch culvert and construct a turnout at the curve in accordance with the Humboldt County Ordinance for California Fire Safe Regulation. Reestablishment of the existing roadside ditches are also recommended.

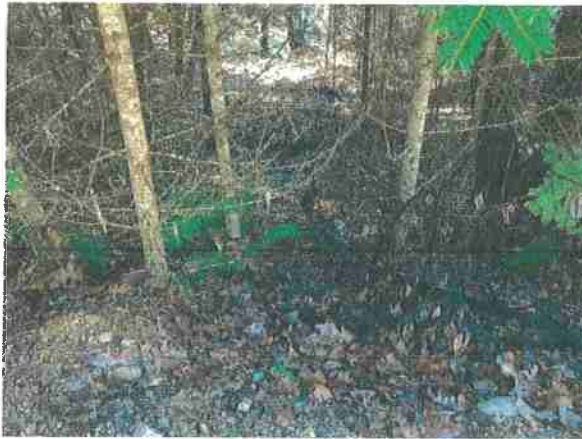
Continuing around the next horseshoe curve, a 12 inch culvert is encountered (Pictures 26 & 27). This culvert is discharging at a steep slope down hill (Picture 27) and without armoring the drainage is causing erosion. The roadway here is approximately 12 feet wide and the grade approaches 5% approaching the next curve.

At this specific location it is recommended to replace the existing culvert with a new minimum 18inch culvert.

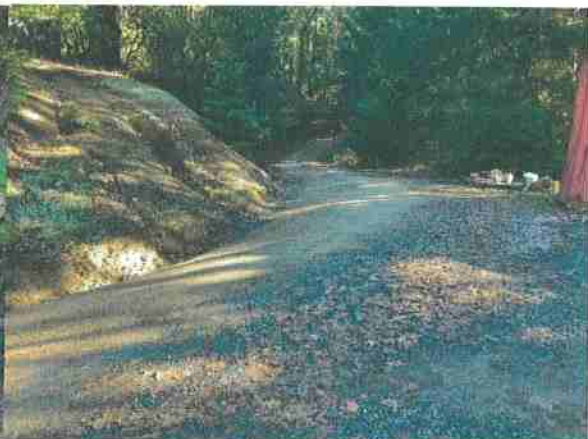
Picture #27 Cobb Rd outlet & erosion from culvert @ Picture 26

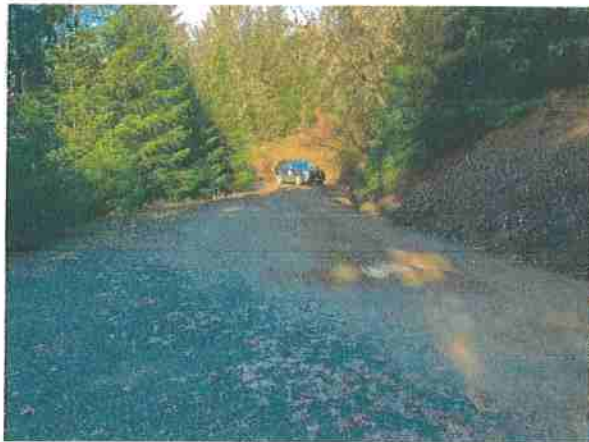
Continuing northeasterly around the next curve, another driveway is encountered at the midpoint of the curve, and the driveway appears to meet Humboldt County Standards for Commercial Rural Driveway. The roadway at this location is 18 feet wide sloping gently, allowing two vehicles to pass.. The width of the roadway before and after the curve are 12 feet with a 5% grade approaching (Picture 28) and a 3% slope departing the curve (Picture 29). A 12 inch culvert exists (Pictures 30 & 31).

Picture #28 Cobb Rd looking E towards curve

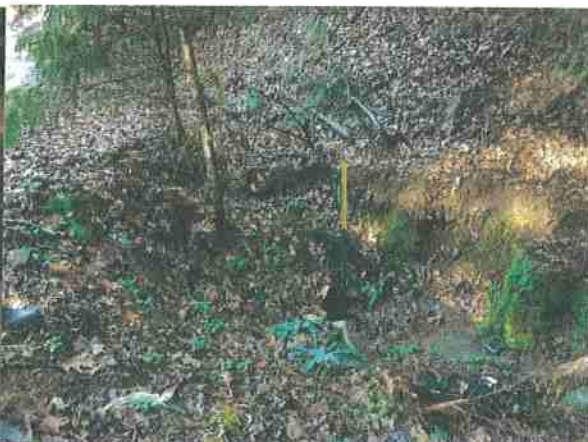
Picture #29 Cobb Rd looking NW towards curve

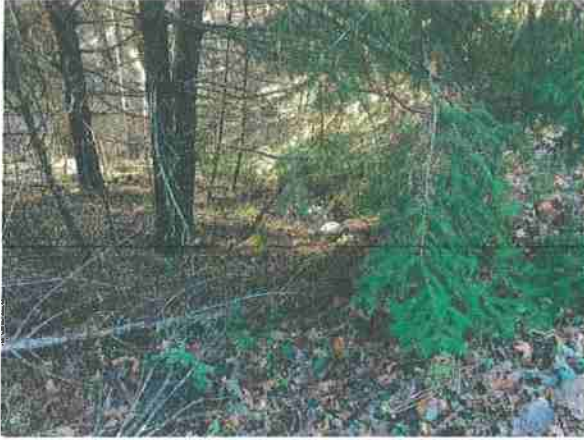
Picture #30 Cobb Rd 12" culvert inlet

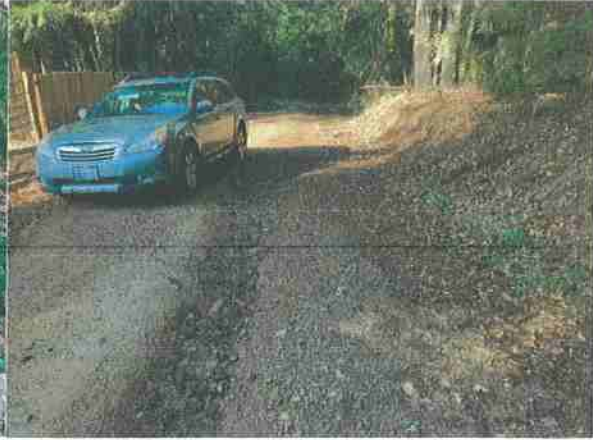
Picture #31 Cobb Rd 12" culvert outlet

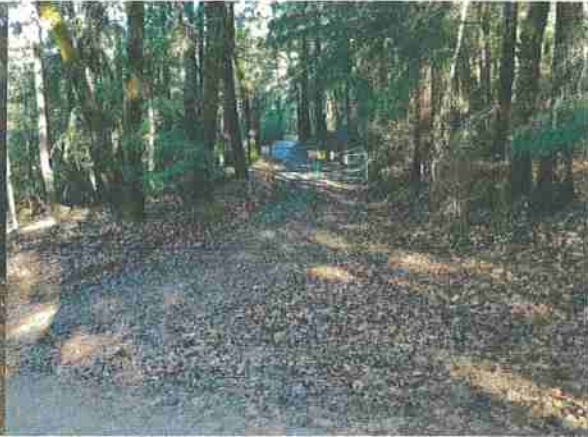
At this location a gated drive (Picture 33), exists on the southside of the roadway and the northside of the roadway (Picture 34), exists a drive that is steep and carrying drainage and erosion onto Cobb Rd. The roadway width at this location is 12 feet at a 3% grade and erosion is occurring along the north side of the road, eroding the toe of the slope creating a potential sloughing situation on the hillside.

Picture #33 Cobb Rd looking @ driveway

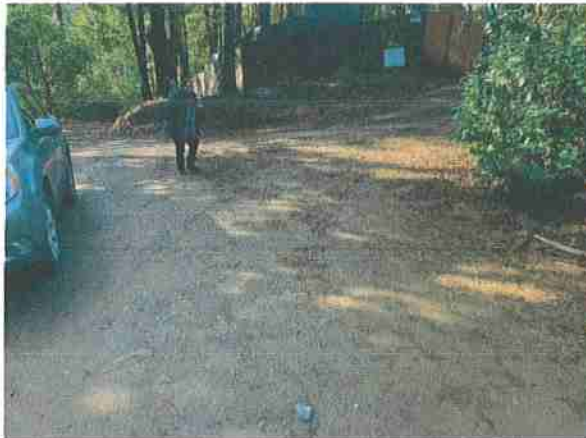
Picture #34 Cobb Rd looking N. @ driveway w/ erosion

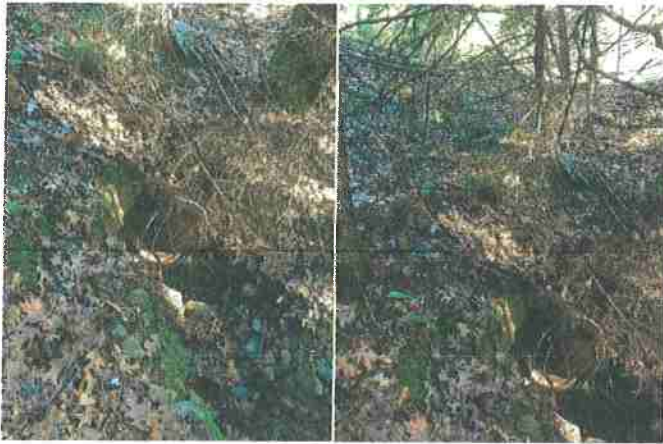
Picture #43 Cobb Rd inlet of 12" culvert Picture #44 Cobb Rd outlet from culverts in Pictures 42 & 43.

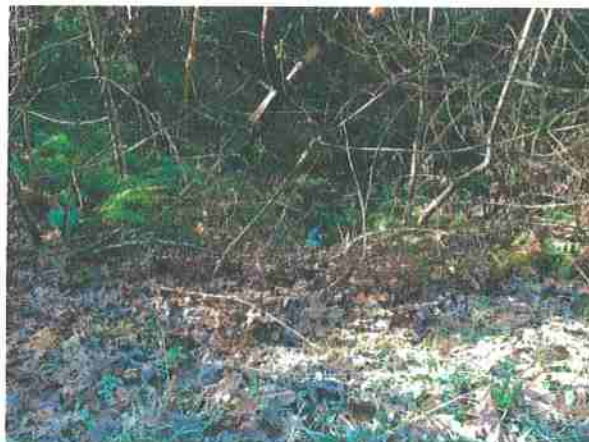
Picture #46 Cobb Rd looking at 12" crushed CMP inlet

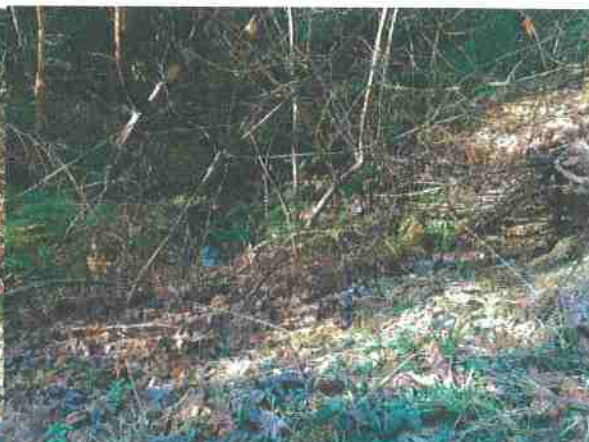
Picture #47 Cobb Rd outlet of 12" culvert in Picture 46

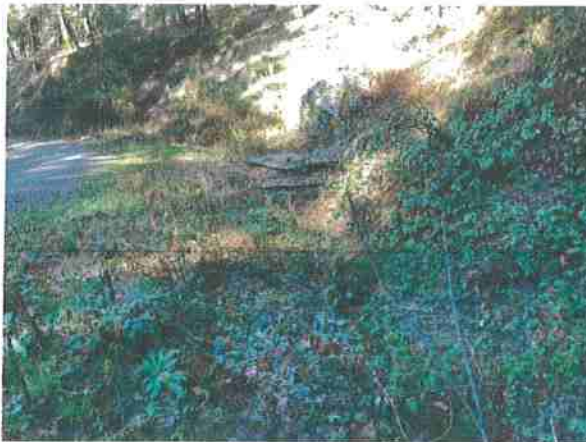
Picture #49 Cobb Rd @ double 12" culvert w/ dam in middle

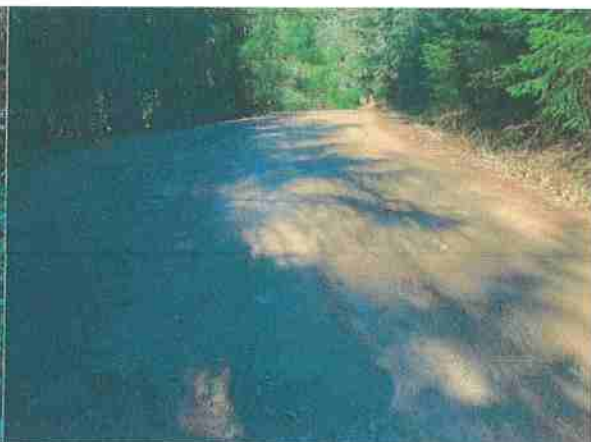
Picture #50 Cobb Rd looking SW towards curve.

At this specific location it is recommended to construct a turnout at the curve in accordance with the Humboldt County Ordinance for California Fire Safe Regulation and to reestablish the roadside ditches are also recommended.

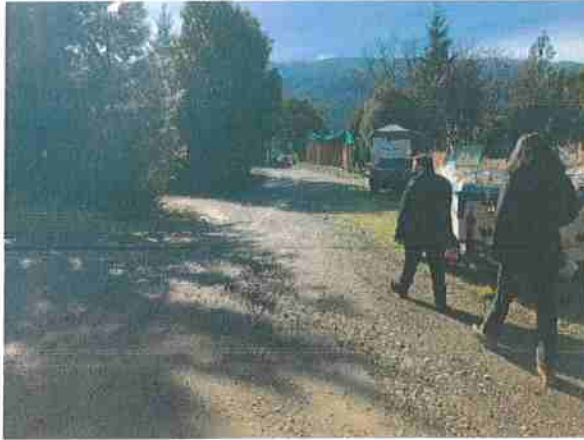
Picture #55 Cobb Rd looking SE @ road end

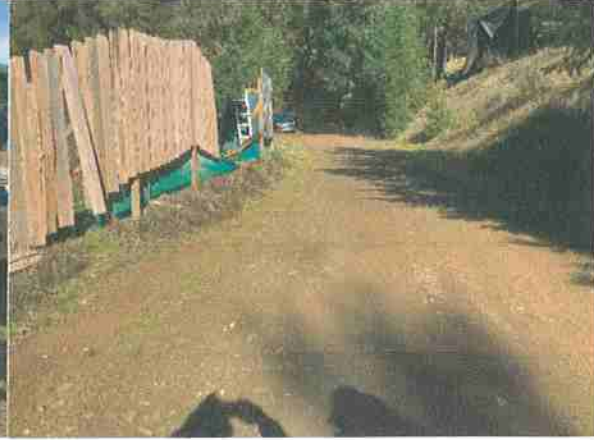
Picture #56 Cobb Rd at road end looking NW.

It is recommended to construct a turnaround in accordance with the Humboldt County Ordinance for California Fire Safe Regulation. Reestablishment of the existing roadside ditches are also recommended.

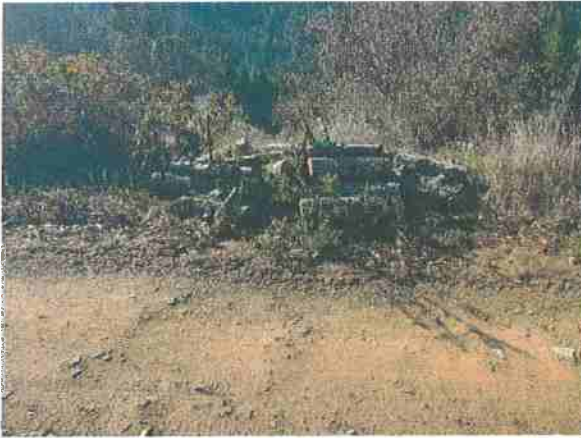
Picture #57 Cobb Rd @ outlet of culvert where water tops road

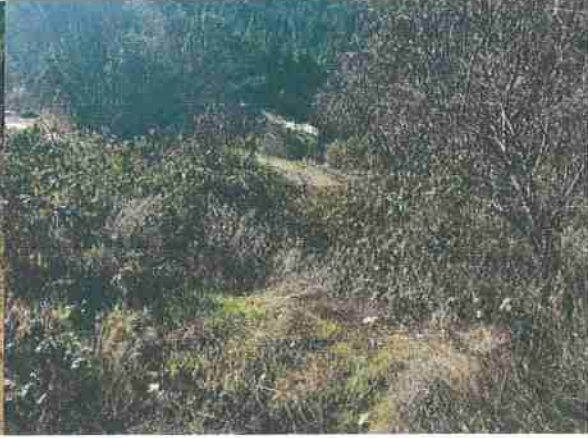
Picture #58 Cobb Rd outlet of culvert in Picture 57

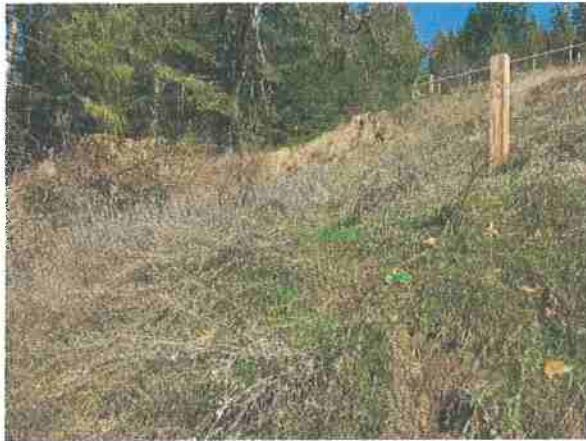
Picture #59 Looking uNW @ erosion @ outlet of culvert in Picture 58

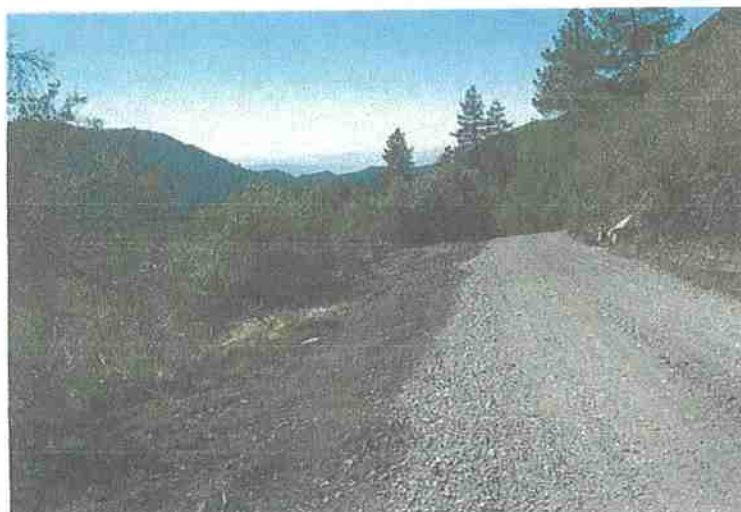
Figure 1. Low-volume road that has been newly gravelled and out-sloped, San Bernardino County. Photo: Richard Harris.

Many thousands of miles of privately maintained rural roads extend throughout California, and they are used for resource management as well as residential and recreational access by over 500,000 landowners (fig. 1). The California Department of Forestry and Fire Protection (CAL FIRE) estimates that another 2.7 million acres of forest and rangeland will be developed over the next 40 years, requiring the construction of thousands of miles of new roads (CAL FIRE 2003). Poorly located, designed, or maintained roads are the primary cause of water quality degradation in rural watersheds.

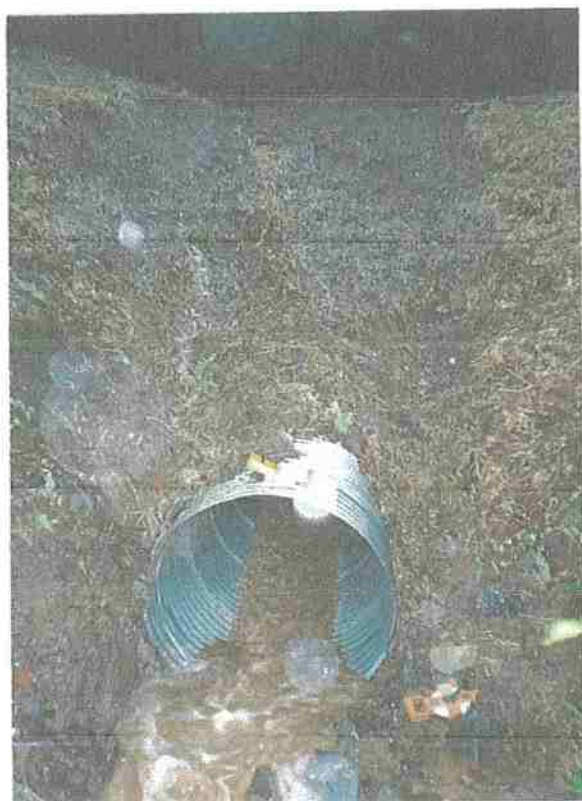
Figure 2. This cross drain delivers sediment from the roadside ditch under the road surface to a nearby stream. The road fill is also eroding. Photo: Jared Gerstein.

Rural roads are a major source of sediment that ends up in stream channels (fig. 2). This is especially true for unpaved roads located near streams that are used year-round. Sediment delivered to streams from roads causes streams to run muddy and take a long time to clear after storms. Sediment can end up depositing in pools and adversely affect habitat for fish and other aquatic organisms.

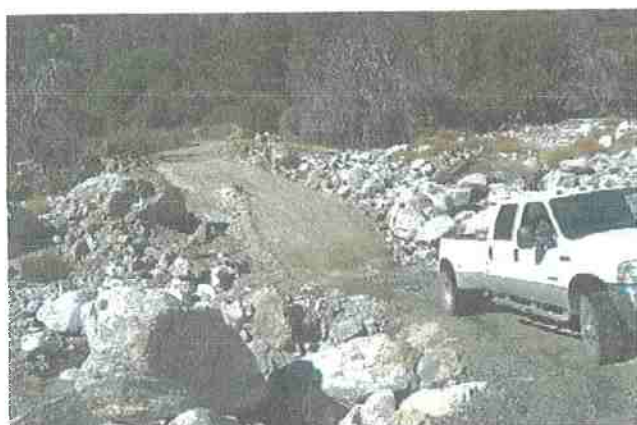
Figure 6. Low-water crossing on a perennial stream, San Bernardino County. Photo: Richard Harris.

Besides culverts, common stream-crossing structures include bridges and low-water crossings or fords. *Bridges* usually cause fewer environmental impacts than culverts because they may not alter the natural channel form or require placement of fill in the channel. However, they are often more expensive to install than culverts. *Low-water fords* involve modifying and sometimes hardening a swale or stream channel to allow vehicles to drive through during low-flow periods (figs. 6 and 7). Less fill is introduced to the stream channel; however, vehicles driving through may input sediment to the stream continuously. Fords are typically impassable during high flows and so are rarely suitable for permanent roads.

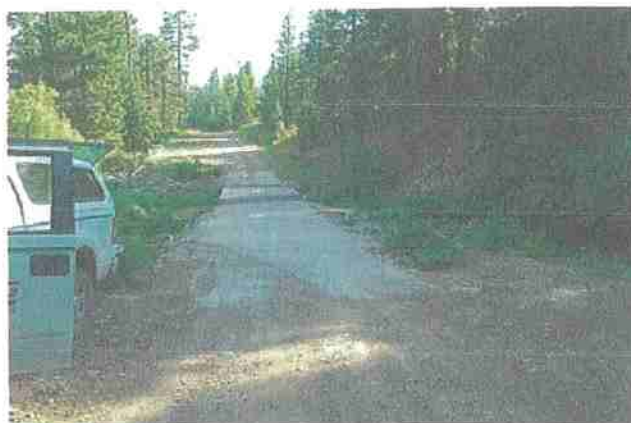
Figure 7. Concreted low-water crossing placed on bedrock outcrop in intermittent stream. Photo: Angela Wilson, Central Valley Regional Water Quality Control Board.

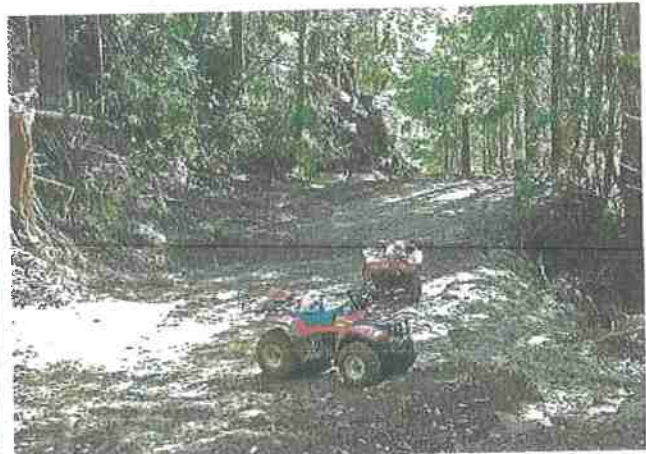
Figure 9. Water bars installed on a road after timber harvesting. Source: Angela Wilson, Central Valley Regional Water Quality Control Board.

A *water bar* is a mound of soil and an accompanying ditch on the road surface that interrupts water flow and diverts it off the road surface (fig. 9). It is typically not passable by vehicles and so is not used on permanent roads. A *berm* is a ridge of rock, soil, or asphalt usually found on the outside of a road shoulder to control surface water. It directs runoff to specific locations where water can be discharged without causing erosion. *Armoring* is the placement of a layer of rock on cut or fill slopes or ditches to prevent water from eroding the soil.

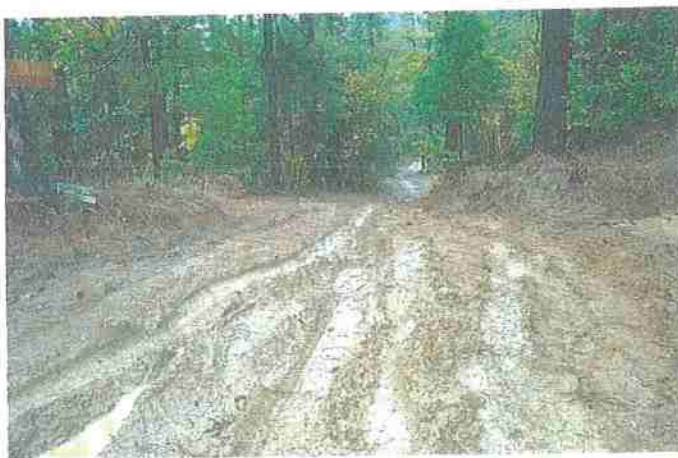
Figure 10. These ruts were created by wet-weather use of an unsurfaced, poorly drained road. Photo: Angela Wilson, Central Valley Regional Water Quality Control Board.

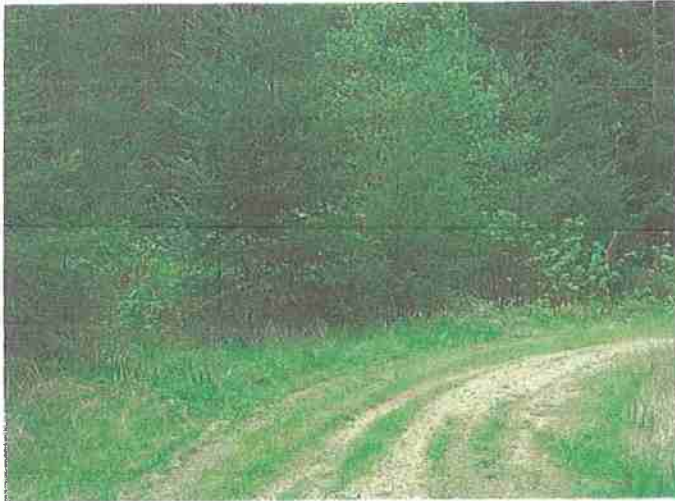
Figure 12. Grass cover on the surface of a road used for dry-season access.
Source: Julie Bawcom, California Geological Survey.

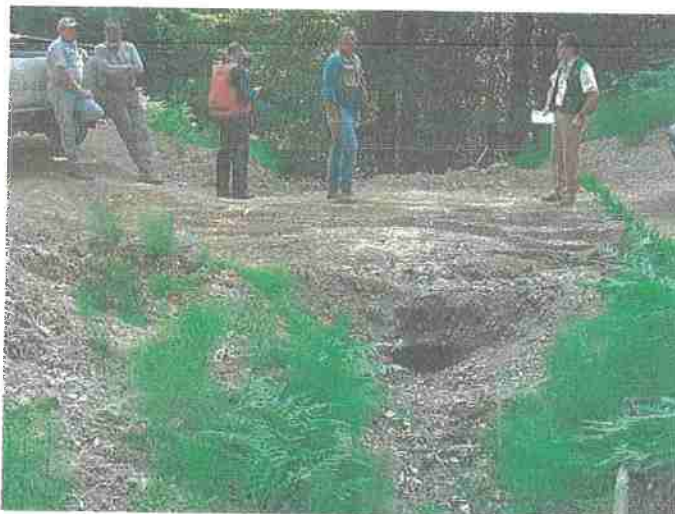
Figure 16. Culvert plugged with sediment at inlet. Photo: Angela Wilson, Central Valley Regional Water Quality Control Board.

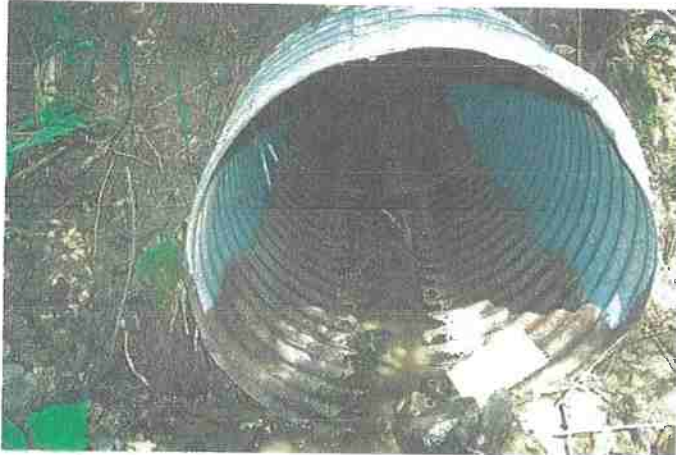
Figure 17. Culvert with rusted bottom and breakage caused by sediment. Photo: Angela Wilson, Central Valley Regional Water Quality Control Board.

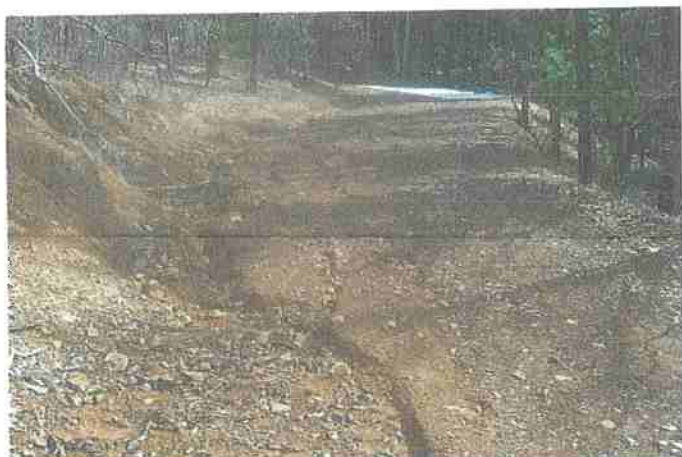
Figure 19. Erosion caused by ditch water leaving the ditch and traveling across the road. Photo: Susan Kocher.

Water may flow out of a ditch onto a road when the capacity of the ditch is exceeded. This occurs when the volume of runoff exceeds the ditch capacity or, more commonly, when a ditch relief culvert is plugged with debris. In the latter instance, the plugged cul-

vert may be located at the point where water flows onto the road or it may be uphill from there. Once the plugged culvert is located, examine its size and alignment. If a culvert plugs regularly, especially with sediment, there may be a design problem. If the culvert is less than 18 inches in diameter, it may be too small. If the culvert is installed at too sharp of an angle at the inlet, ditch water may not be directed into the culvert at high flow. If the cross-drain grade is too flat, sediment may settle out in the culvert rather than passing through it, causing blockage.

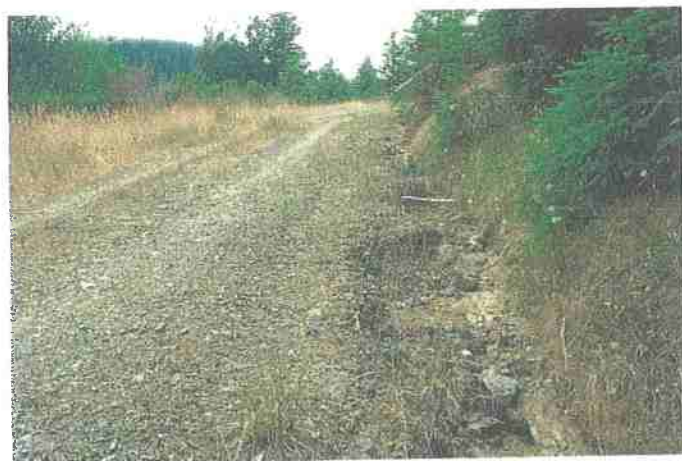
Figure 20. Eroding inboard ditch on an in-sloped road. This is a symptom of inadequate cross drains for conveying ditch flow across the road. Photo: Richard Harris.

Ditches incise when they carry too much flow for their design capacity and they erode rather than spill water out onto the road. Too much flow in the ditch occurs because there are not enough ditch relief structures and/or because there are sources of water other than road runoff contributing to ditch flow. Examine the ditch system to see if the ditch has captured the flow from a stream channel or spring and diverted it down the ditch. If not, the most likely problem is too few ditch relief culverts or cross drains.

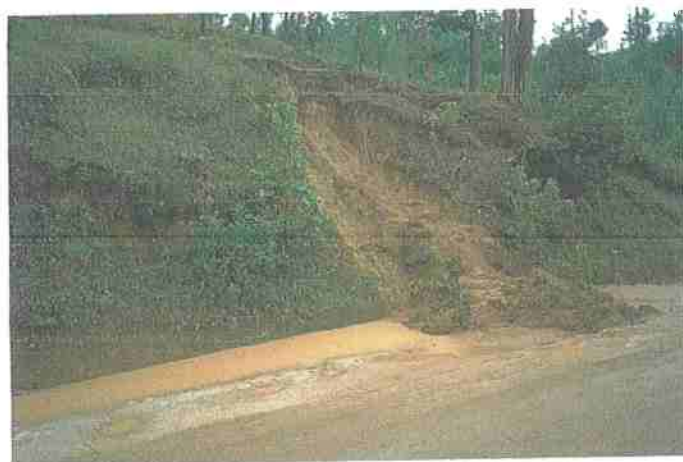
Figure 21. Cut bank failure blocking inboard ditch. Cut bank failures cause operational and maintenance problems, especially when chronic. Source: Keller and Sherar 2003.

Ditches may become filled in with sediment, rock, or woody debris (fig. 21). This reduces their

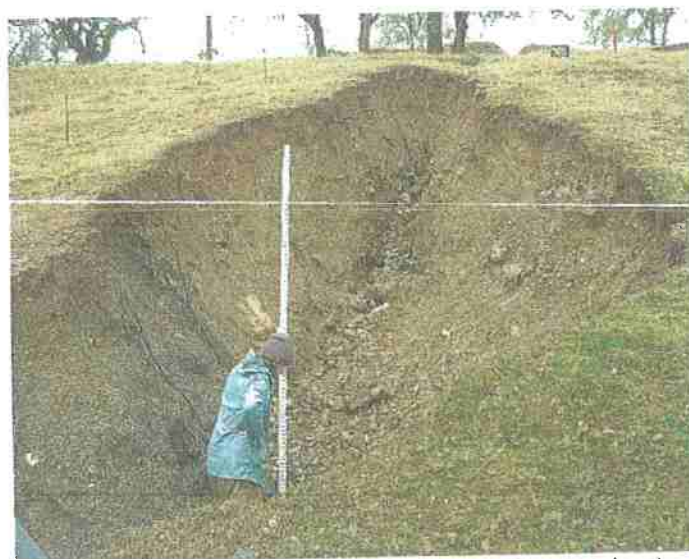
Figure 22. Gully caused by through-cut on road at base of steep road section. Photo: Jared Gerstein.

Gullies are caused when increased or concentrated flow from the road system flows onto erosive soil. Most often, gullies originate from a road system's drainage features. They can be identified by their bare dirt banks and occurrence in places where natural streams do not occur, such as smooth hillslopes or ridges (fig. 22). Gullies may or may not threaten the roadbed itself, but they are always a significant source of sediment and thus a detriment to streams.

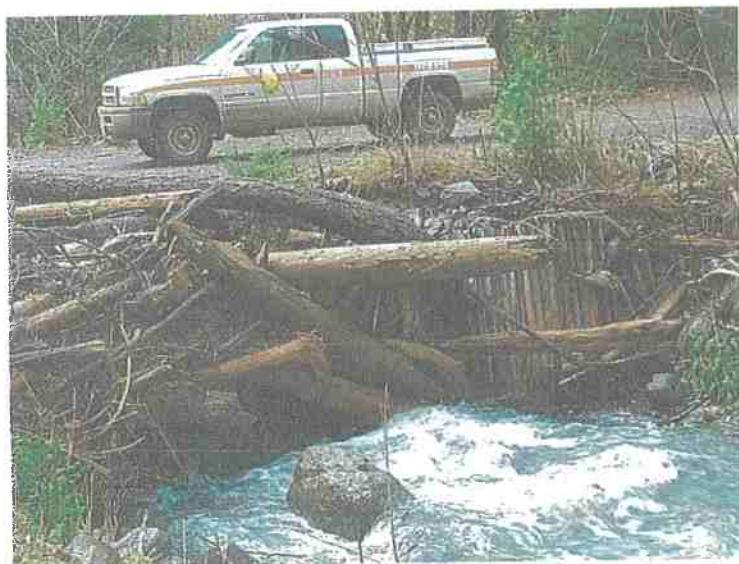
Figure 23. This culvert is nearly plugged by woody debris, endangering the road.
Photo: Angela Wilson, Central Valley Regional Water Quality Control Board.

Culverts that convey streams under roads must be large enough to transport the flow plus the tree branches, sediment, and rocks that often accompany the flow during large rain storms (fig. 23). Stream culverts may plug when debris blocks the inlet, allowing water to overtop the crossing and possibly wash out the crossing and road altogether.

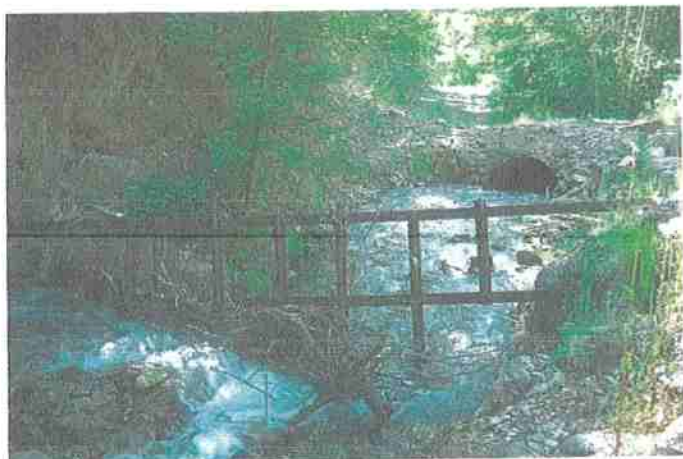
Figure 24. A trash rack installed upstream to protect a culvert from plugging. Source: Keller and Sherar 2003.

The ideal treatment for an undersized culvert is replacement with a larger one, capable of carrying flow and debris. Appropriately sizing a culvert for the stream and watershed it drains is a fairly technical task and should be done by a knowledgeable professional (Cafferata et al. 2004). In some relatively simple cases, it may be feasible to install trash and debris racks upstream from the culvert to capture and retain the debris so that it does not flow into the culvert (fig. 24). This, however, should be discouraged on fish-bearing watercourses because debris accumulations may become a barrier to migrating fish. Remember that debris racks need to be cleaned regularly to continue to function.

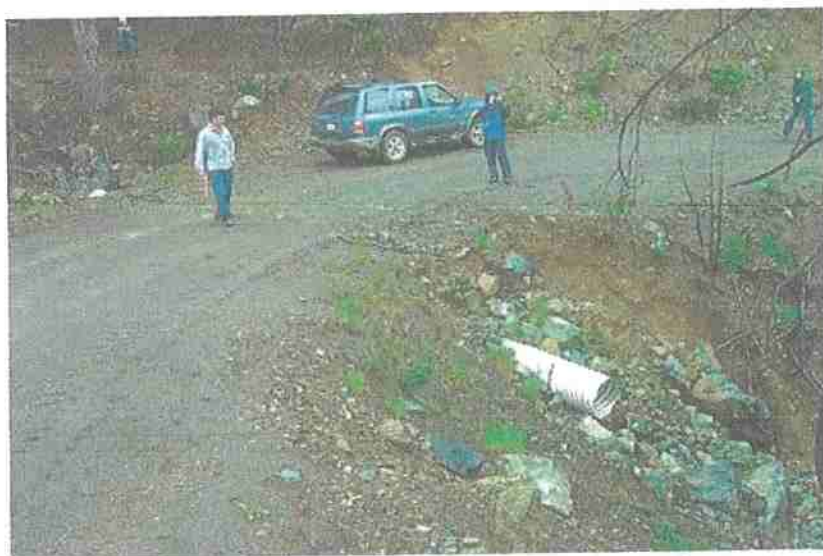
Figure 25. Eroding fill slope and culvert failure due to plugging at inlet and diversion of flow across the road. Photo: Bill Weaver, Pacific Watershed Associates.

of fill in the channel above and below the culvert, and then building the road base on that fill. The fill over the culvert may erode, narrowing the traveled way (fig. 25).

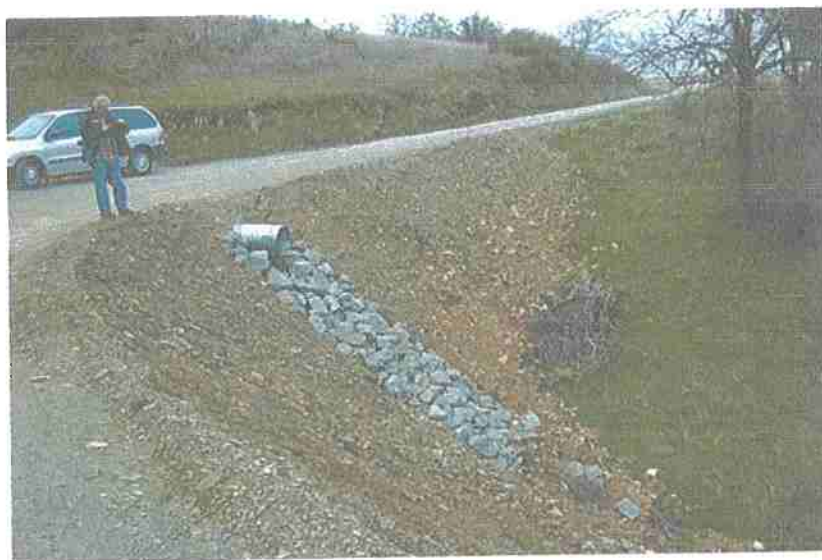
Figure 26. Rock armoring at ditch relief culvert outfall to reduce potential for downstream erosion. Note also the berm around the fill slope to prevent road runoff from eroding it. Also, straw mulch has been placed on the fill slope to reduce erosion. Photo: Jared Gerstein.

The most thorough solution to shotgun culverts is to replace them with longer pipes that are placed at the grade of the natural stream channel rather than high in the fill above the stream. Alternatively, a downspout or rock armor can be added below the outlet if erosion has not been too severe (fig. 26).

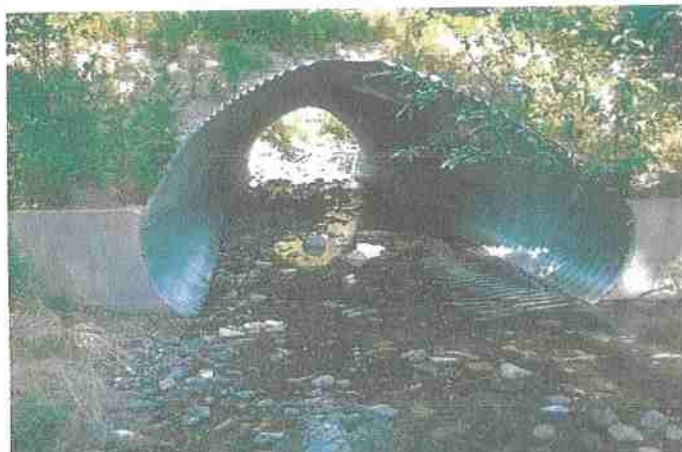
Figure 28. An arched pipe installed on a fish-bearing stream to minimize impacts on fish habitat and migration. Source: Keller and Sherar 2003.

Replacement of problem culverts with bridges and arched culverts of adequate size is preferred because they modify the channel less and so avoid many problems that can block migration (fig. 28). Appropriate assistance should be sought in designing and constructing crossings where migrating fish must be accommodated. Contact your local Department of Fish and Game office. In some cases, passage through existing culverts may be improved by installing baffles or weirs to slow and funnel stream water. In other cases, the upstream and/or downstream channels may be modified to create resting pools and reduce the jump height.

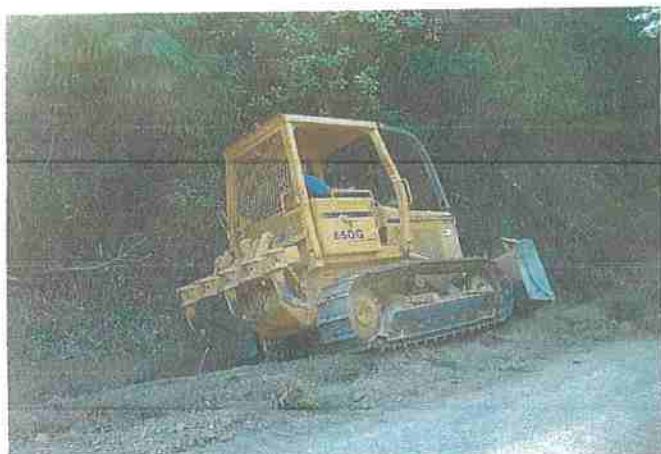
Figure 29. Bulldozer clearing out a road ditch. Photo: Jared Gerstein.

maintenance needs. Simple tasks such as culvert and ditch clearing can be performed by most landowners (fig. 29). More complex tasks, such as roadside brushing, remedial grading repair, or installation of culverts (fig. 30), will probably require outside assistance. Keeping good maintenance records can help landowners evaluate the cost of correcting on-going problems and judge whether road upgrading projects would be cost effective. It is also essential for tax purposes.

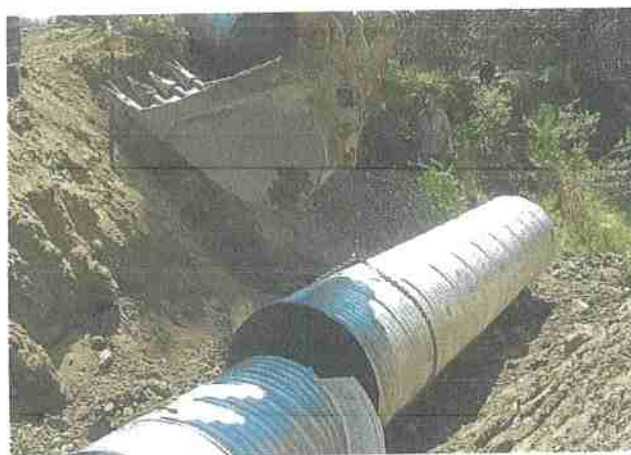
Figure 30. Installation of a new culvert after the old one was excavated. Photo: Jared Gerstein.
