From: David Nicoletti PE QSD\QSP
DTN Engineering & Consulting
2731 K Street Unit A
Eureka, CA 95501
Email: dnicoletti@dtngineering.com

Subject: Roadway Evaluation for Cobb Road from Rattlesnake Bridge to APN 208-341-016

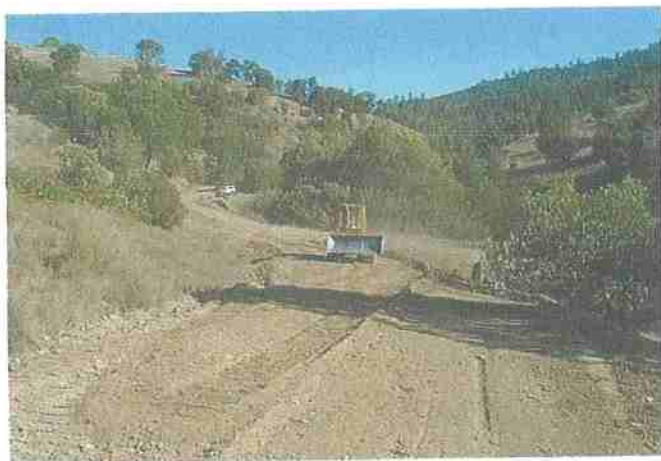
Figure 31. Bulldozer reshaping road surface to out-sloped condition to improve drainage. Photo: Jared Gerstein.

A variety of heavy equipment may be used when constructing or maintaining a road. *Bulldozers* are often used to make road cuts, shape the road, and develop the subgrade (fig. 31). *Excavators* can be used to replace crossings and develop new road alignments (fig. 32). *Backhoes* have many uses, including replacing small crossings, loading rock, and road shaping. *Graders* are used for final road shaping, spreading surface rock, and smoothing the surface (fig. 33). *Dump trucks* are used to transport rock to the construction site and to haul away any excess cut materials (fig. 33). *Rollers* are specialized to roll over the road surface and compact rock and road materials.

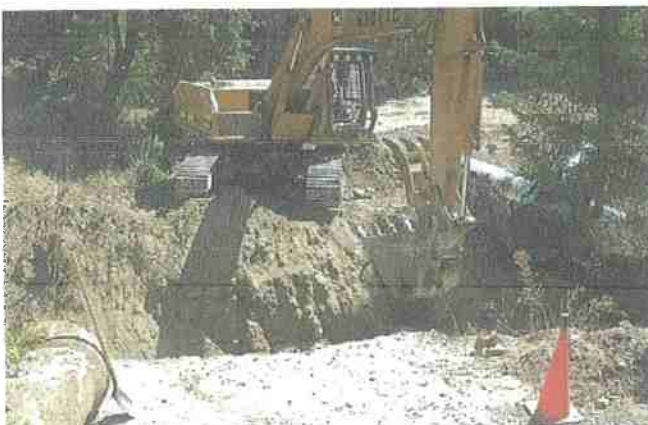
Figure 32. Excavator removing a crossing, including culvert and fill.
Photo: Jared Gerstein.

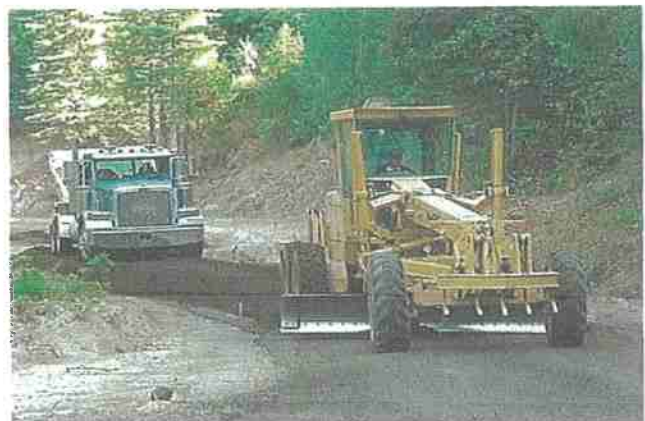
Figure 33. A grader spreading the gravel on the road surface placed by a dump truck. Source: Joe Hoffman, Plumas National Forest.

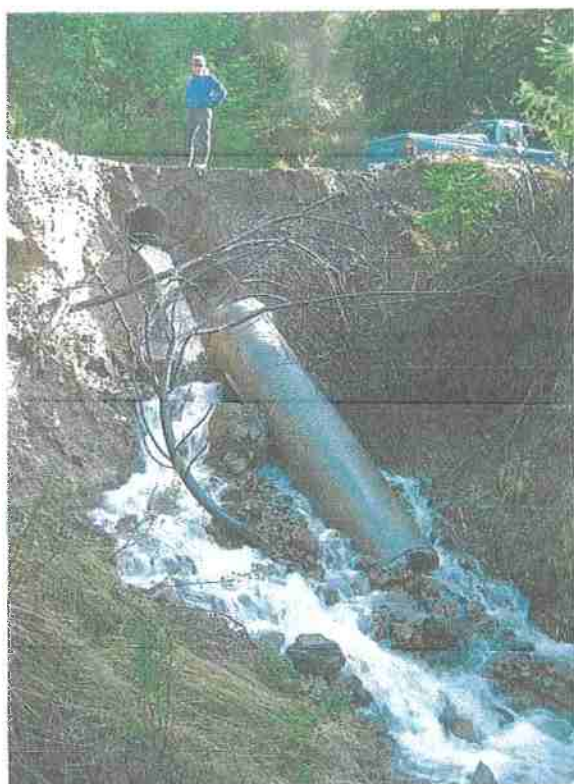
Figure 34. Outlet of a concrete culvert (30 inches in diameter) before the project. The culvert was placed too high in the fill, resulting in a 10-foot drop to the channel at the outlet. This caused erosion of the road fill and stream banks, eventually undermining the outer section of the culvert. Photo: Jared Gerstein.

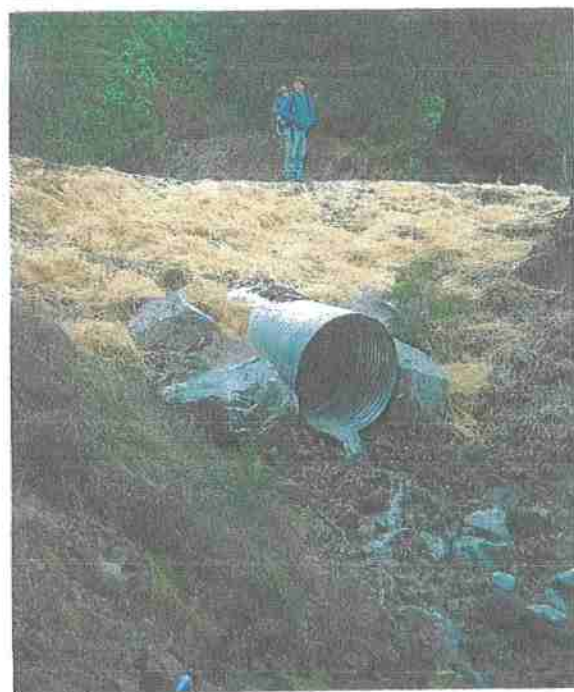
Figure 35. The culvert was replaced with a metal pipe (48 inches in diameter) at the correct slope. The road surface was lowered, reducing the fill volume by 100 cubic yards. The outlet and fill were armored to prevent future diversion. Photo: Jared Gerstein.

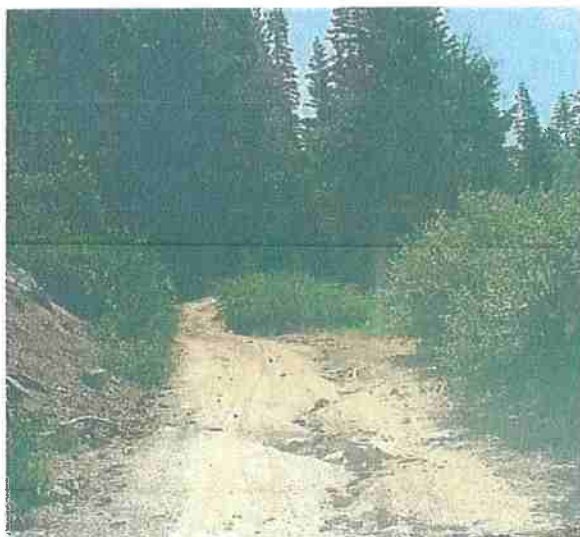
The U.S. Forest Service partnered with Sierra Pacific Industries and Plumas County to upgrade a section of national forest road with serious erosion problems. The road's native surface was very erosive and lacked drainage structures. The surface was heavily rutted with rills over 2 inches deep and over 20 feet long (fig. 37). Road cut banks were unstable and eroding with more than 5 cubic yards of material moved, 40 percent of which was delivered to the stream channel. Roadside ditches were overloaded and degrading. One stream-crossing culvert entrance was more than 30 percent blocked with sediment and debris.

Figure 37. Pinchard Creek road with rilling along the road surface before the project, 2002. Photo: Joe Hoffman, Plumas National Forest.

The project involved out-sloping the road surface, covering it with crushed rock, and installing drainage dips (fig. 38). Two years after the completion of the project, no surface ruts or road bank erosion has occurred, roadside drainage ditches are stable with little or no sediment delivery to the stream, and culvert entrances remain clear (fig. 39). The cost of the project was \$221,603, with 35 percent from National Forest road maintenance funds, 9 percent from Sierra Pacific Industries, and 56 percent from the Plumas County Resource Advisory Committee.

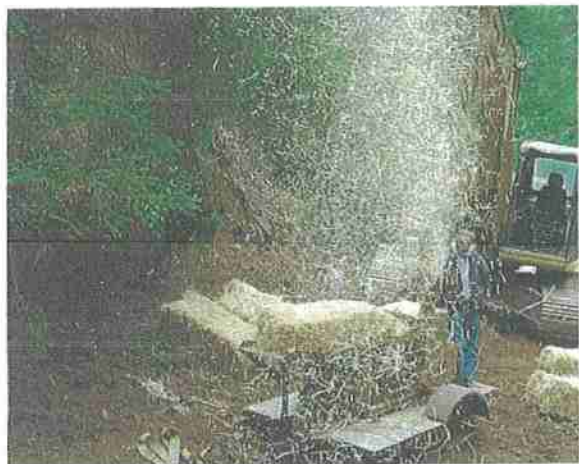
Figure 40. Using a portable blower to spread straw mulch on a disturbed road site. Photo: Julie Bawcom, California Geological Survey.

- Minimize grading and soil disturbance.
- Develop an erosion control plan that includes measures on cut-and-fill slopes, drainage outlets, and disturbed areas (fig. 40).
- Avoid construction and soil disturbance in the winter.
- If construction does occur in the rainy season, ensure that the site has been storm proofed with erosion control measures when rains are forecast.
- Avoid incorporating logs or brush in the fill slope.
- Haul away excess sediment generated rather than side cast it onto the slope.
- Locate any stockpiled sediment in areas where it can be protected from erosion and will not deliver sediment to streams.
- Do not service or fuel heavy equipment where spills could enter a watercourse.

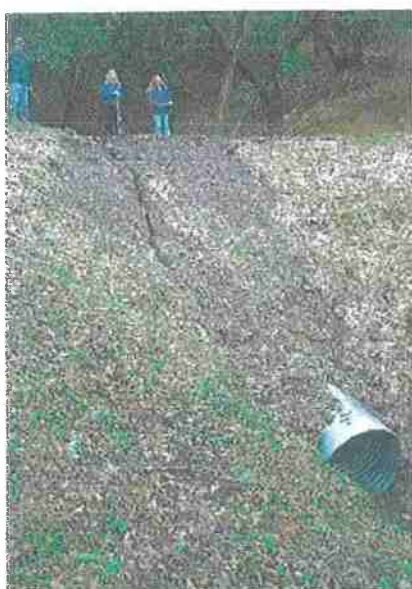
Figure 41. Fill surface erosion occurring after a road upgrading project. Photo: Bill Weaver, Pacific Watershed Associates.

No matter how well planned and executed a road project has been, winter rains and traffic will lead to some adjustment of the final as-built condition during the first winter after improvements are made. Assuming that the road is in otherwise stable terrain, the adjustments will usually be minor and easily corrected. Adjustments may include some erosion of cut-and-fill slopes or culvert inlets and outlets (fig. 41). Road inspections should be done frequently during the new road's first winter season to identify any emerging problems for remediation. Developing problems may be averted with timely action. Plan for follow-up maintenance and put aside funds to perform the maintenance.
