Pratt Mountain, LLC

Road System Assessment Report

Record No.: PLN-2019-16117

APN: 216-133-013

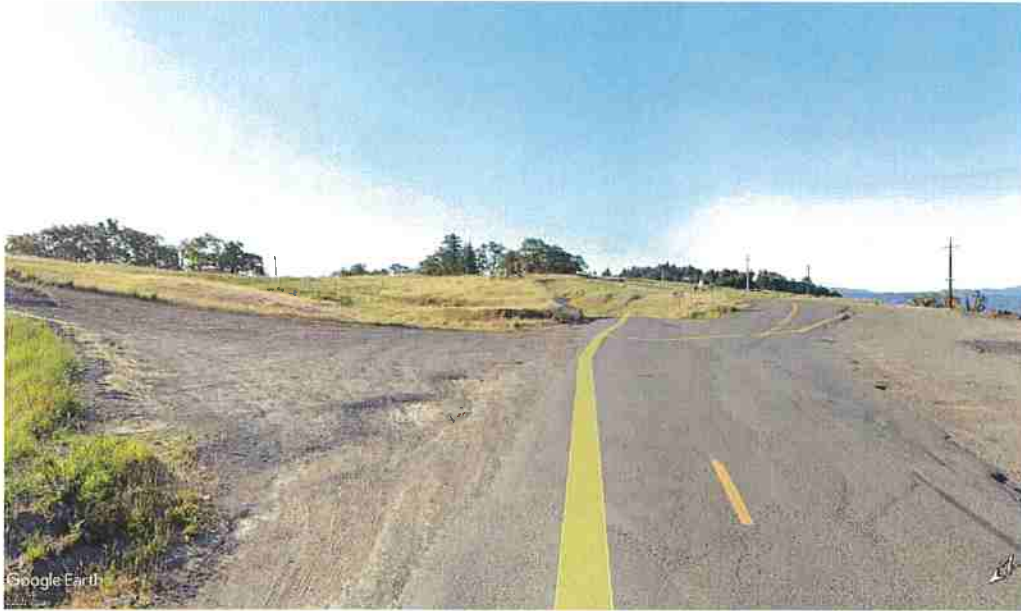
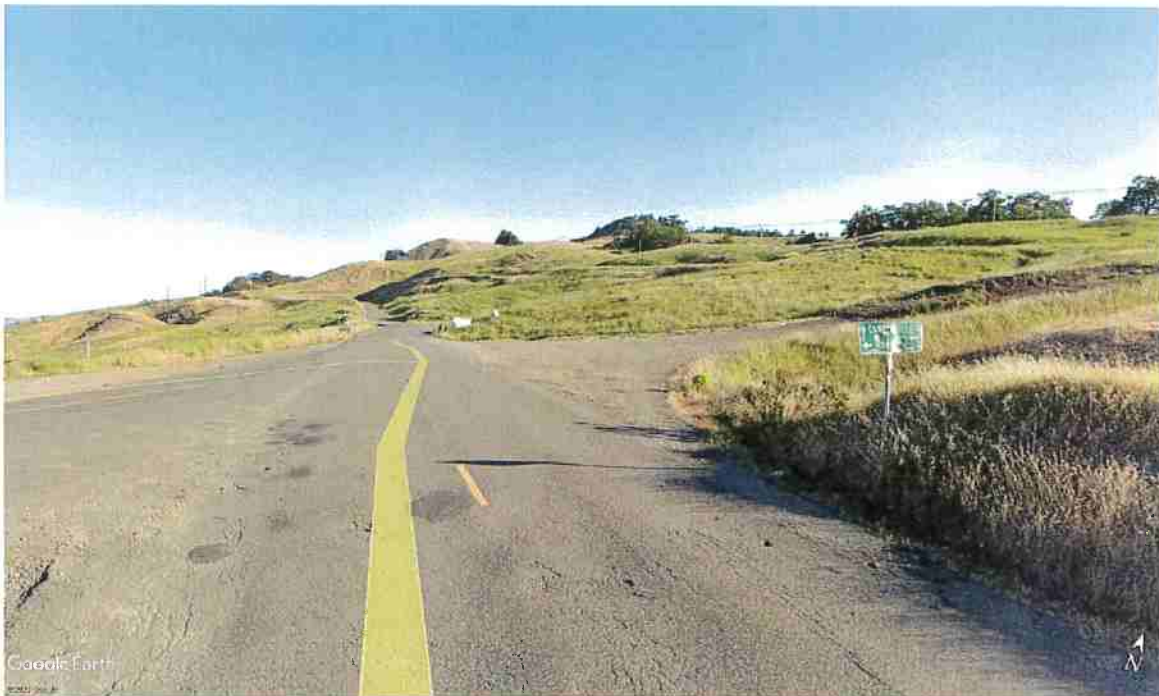
Figure 1: RP 1. Intersection of Alderpoint Rd and Private Drive. Image obtained from Google Earth. Image taken facing south-east on Alderpoint Rd.

Figure 2: RP 1. Intersection of Alderpoint Rd and Private Drive. Image obtained from Google Earth. Image taken facing south-east on Alderpoint Rd.

RP #	Figure(s)	Measured Roadway Width (ft.)	Lat., Long.	Description	Recommendation
1	1-2	25+	40.100785°, -123.686826°	Intersection of Alderpoint Rd and Private Drive. No sight distance restrictions.	Maintain existing roadway width and sight distance.
2	3-4	16	40.101917°, -123.686427°	Gate 14' in width. No sight distance restrictions.	Maintain existing roadway width and sight distance.
3	5-7	18	40.104319°, -123.688589°	Inboard ditch and location of lead-out ditch. Some riling on road surface just after lead-out ditch. Lead-out ditch discharges onto a vegetated, stable hillside.	Improve inboard ditch and roadway to allow water to drain off roadway.
4	8-9	18	40.105457°, -123.689189°	Inboard ditch and location of lead-out ditch. Lead-out ditch discharges onto a stable, vegetated hillside.	Maintain existing roadway width, inboard ditch and lead-out ditch.
5	10-12	18	40.105597°, -123.689900°	Inboard ditch and location of lead-out ditch. Lead-out ditch discharges onto a stable, vegetated hillside.	Maintain existing roadway width, inboard ditch and lead-out ditch.

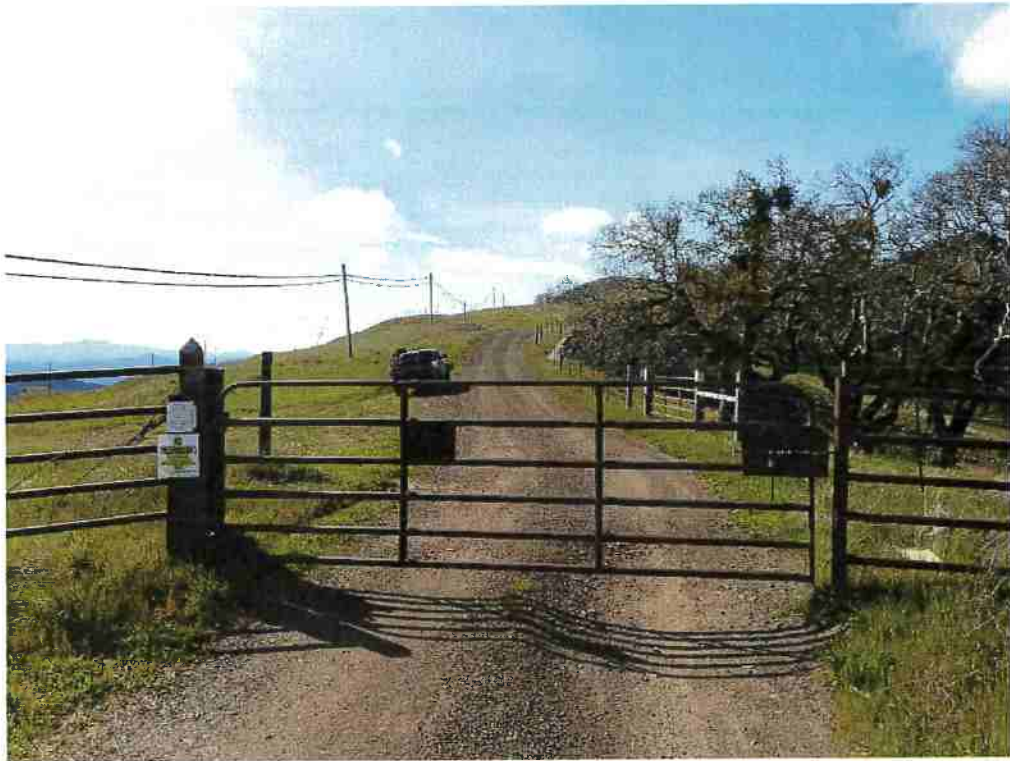
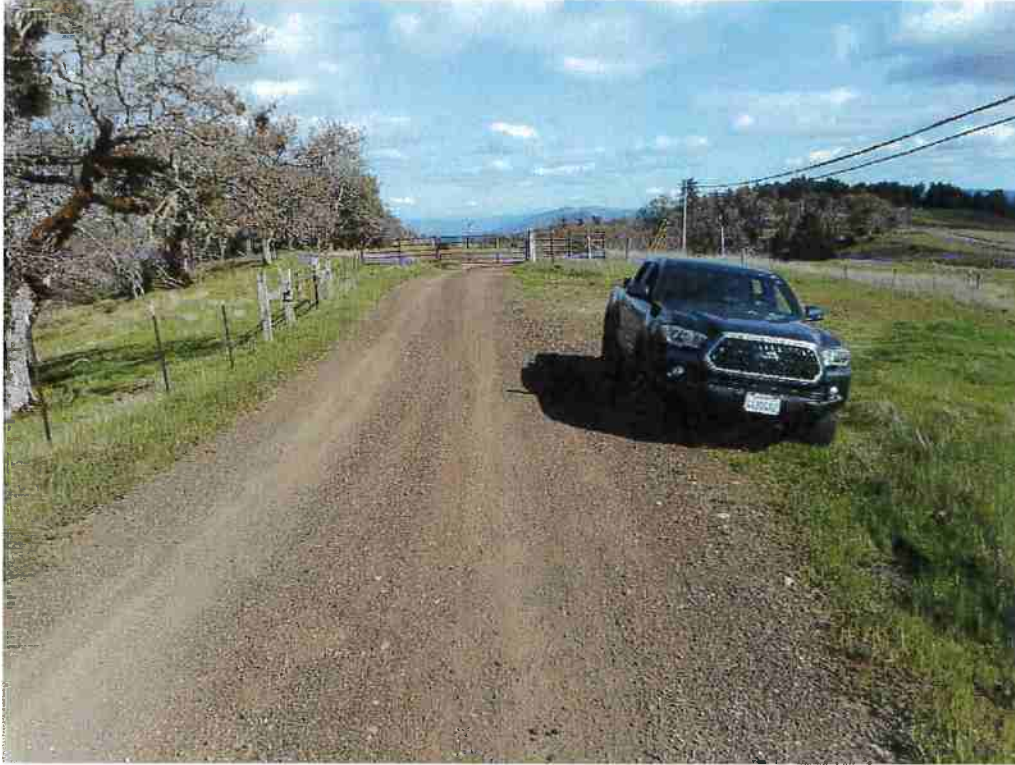
Figure 3; RP 2. Gate 14' in width. Photo taking facing north.

Figure 4: RP 2. Gate 14' in width. Vehicle traveling north. Photo taking facing south.

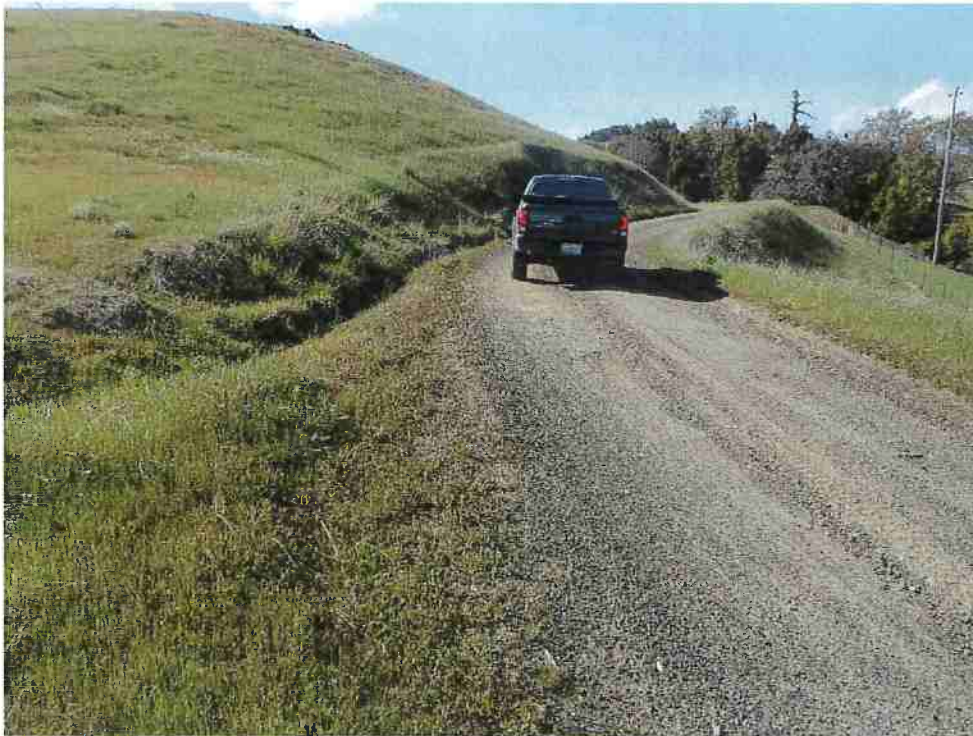
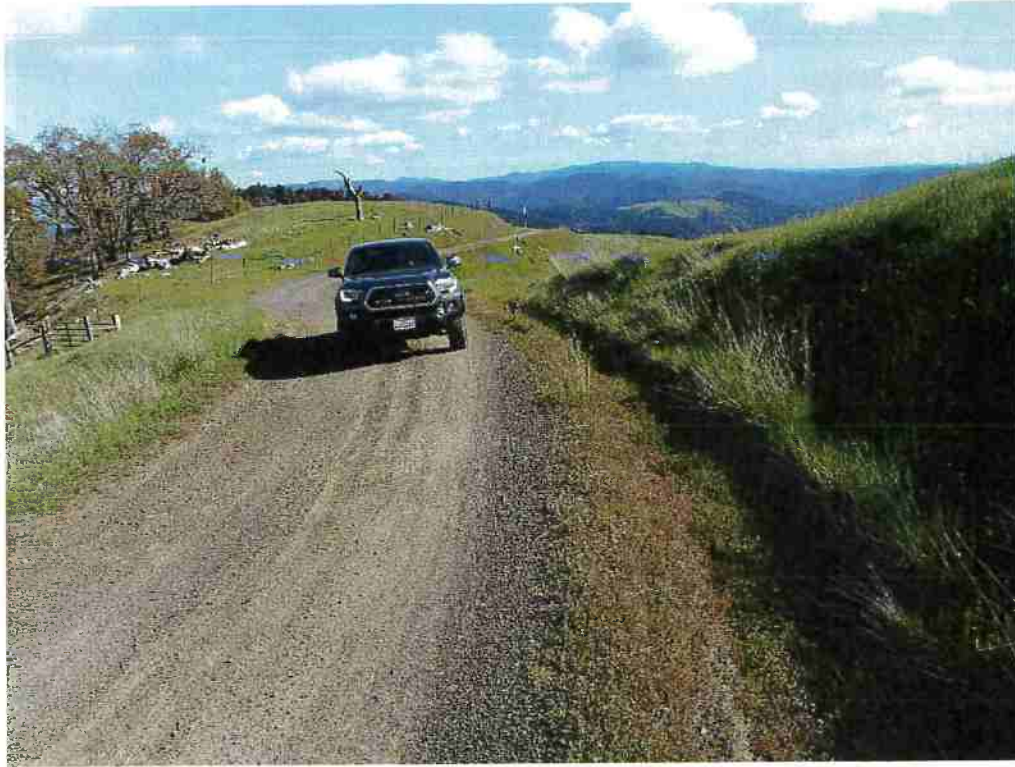
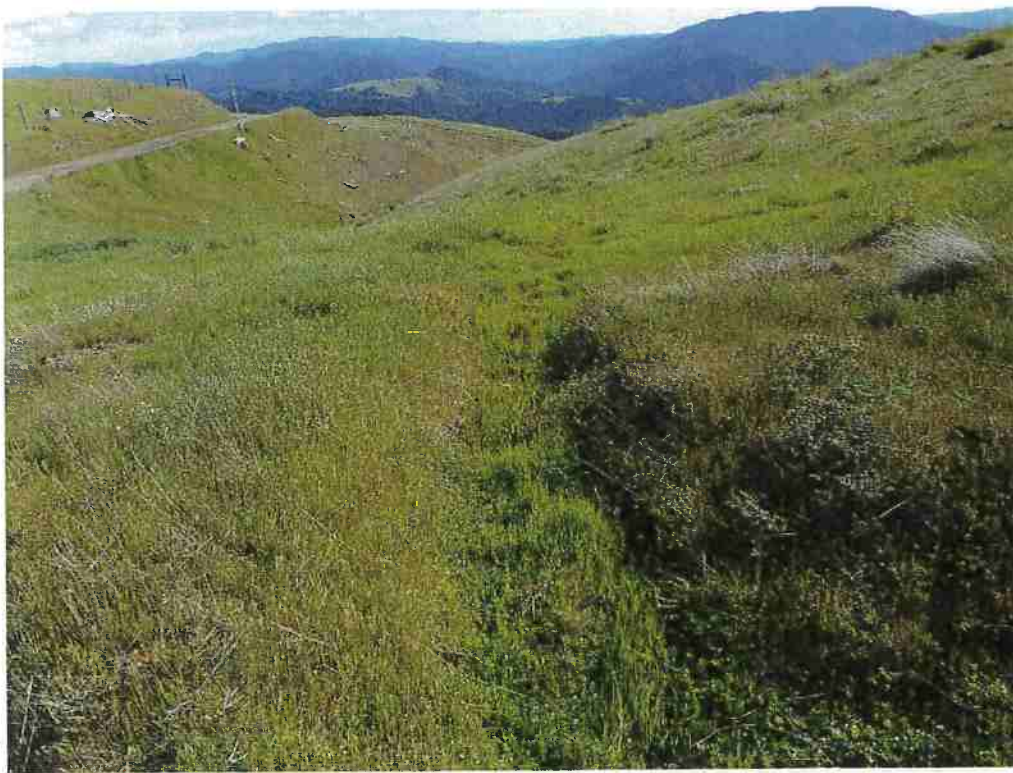
Figure 5: RP 3. Inboard ditch and location of lead-out ditch. Vehicle traveling north. Photo taking facing north.

Figure 6: RP 3. Inboard ditch and location of lead-out ditch. Vehicle traveling north. Photo taking facing south.

Figure 7: RP 3. Lead-out ditch discharging on stable, vegetated hillside. Photo taken facing west.

RP #	Figure(s)	Lat., Long.	Description	Recommendation
3	5-7	40.104319°, -123.688589°	Inboard ditch and location of lead-out ditch. Some riling on road surface just after lead-out ditch. Lead-out ditch discharges onto a vegetated, stable hillside.	Improve inboard ditch and out slope roadway to allow water to appropriately drain off roadway.
4	8-9	40.105457°, -123.689189°	Inboard ditch and location of lead-out ditch. Lead-out ditch discharges onto a stable, vegetated hillside.	Maintain existing roadway width, inboard ditch and lead-out ditch.
5	10-12	40.105597°, -123.689900°	Inboard ditch and location of lead-out ditch. Lead-out ditch discharges onto a stable, vegetated hillside.	Maintain existing roadway width, inboard ditch and lead-out ditch.
6	13-15	40.107572°, -123.690060°	Rutting on west side of roadway for approximately 75' in length. Inboard ditch and lead-out ditch located on the left side of roadway. Inadequate culvert crossing at RP 7 is causing runoff to travel down roadway.	Improve section of roadway to allow water to appropriately drain off road. Maintain existing roadway width, inboard ditch and lead-out ditch.

RP 3, RP 6 and RP 7 have the potential to discharge sediment which can pose a threat to water quality. Recommendations for these RPs include improving inboard ditches and a drainage relive culvert to allow the conveyance of stormwater and to minimize sediment transport. These recommendations are further described in Table 3. There are no road related landslides, slope failures or major erosion issues within the road system.

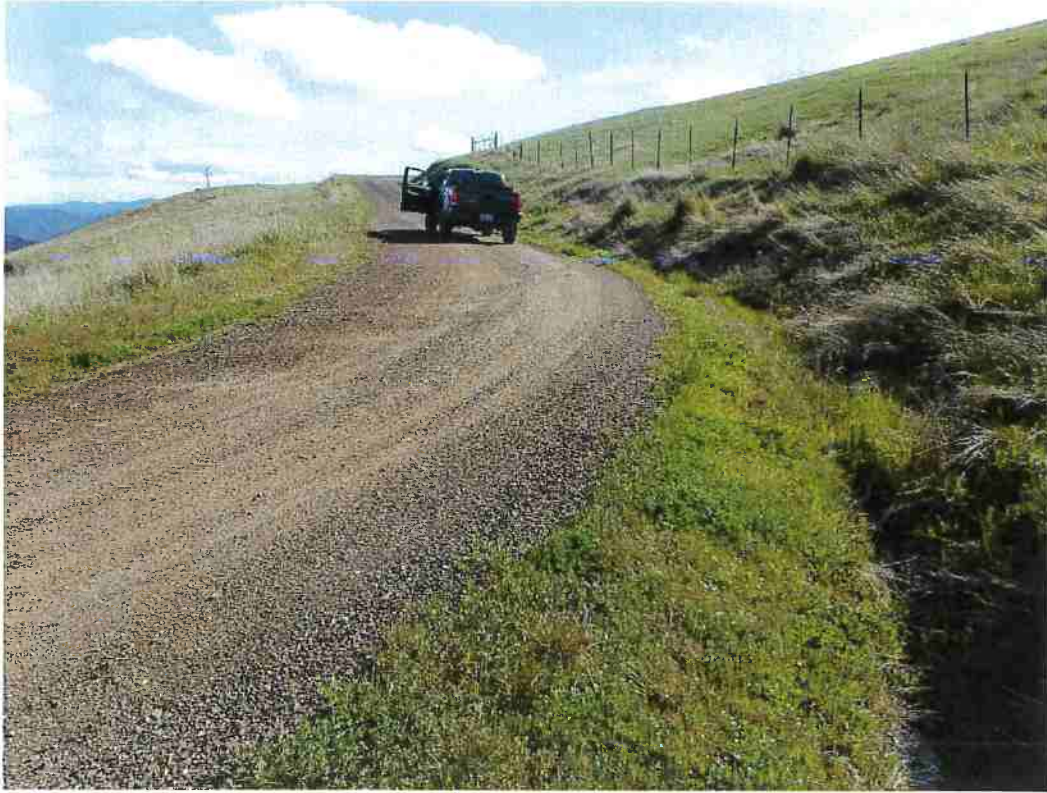
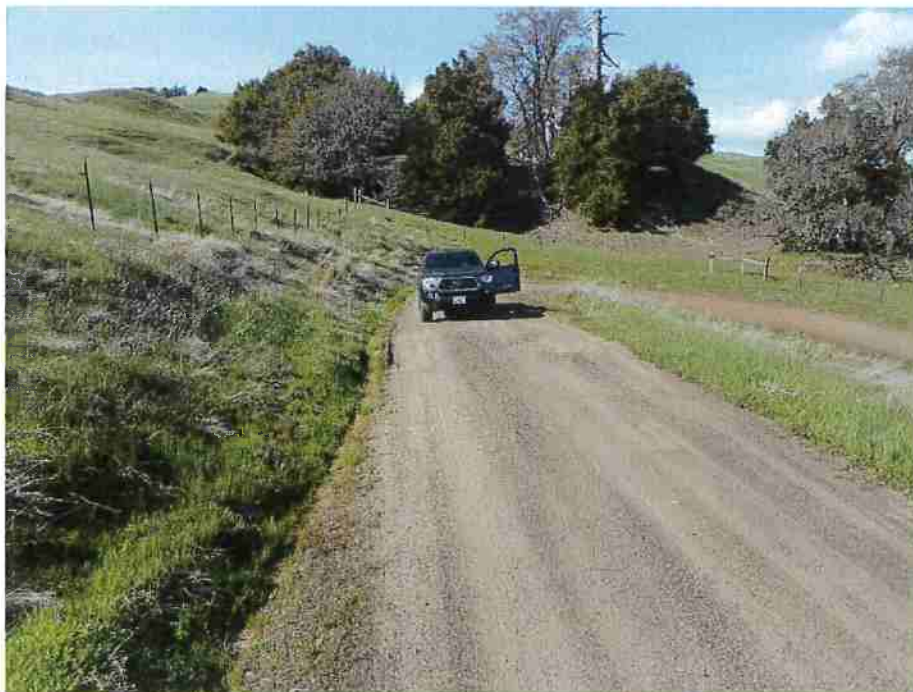
Figure 8: RP 4. Inboard ditch and location of lead-out ditch. Vehicle traveling west. Photo taking facing west.

Figure 9: RP 4. Inboard ditch and location of lead-out ditch. (Lead-out ditch located behind vehicle.) Vehicle traveling west. Photo taking facing east.

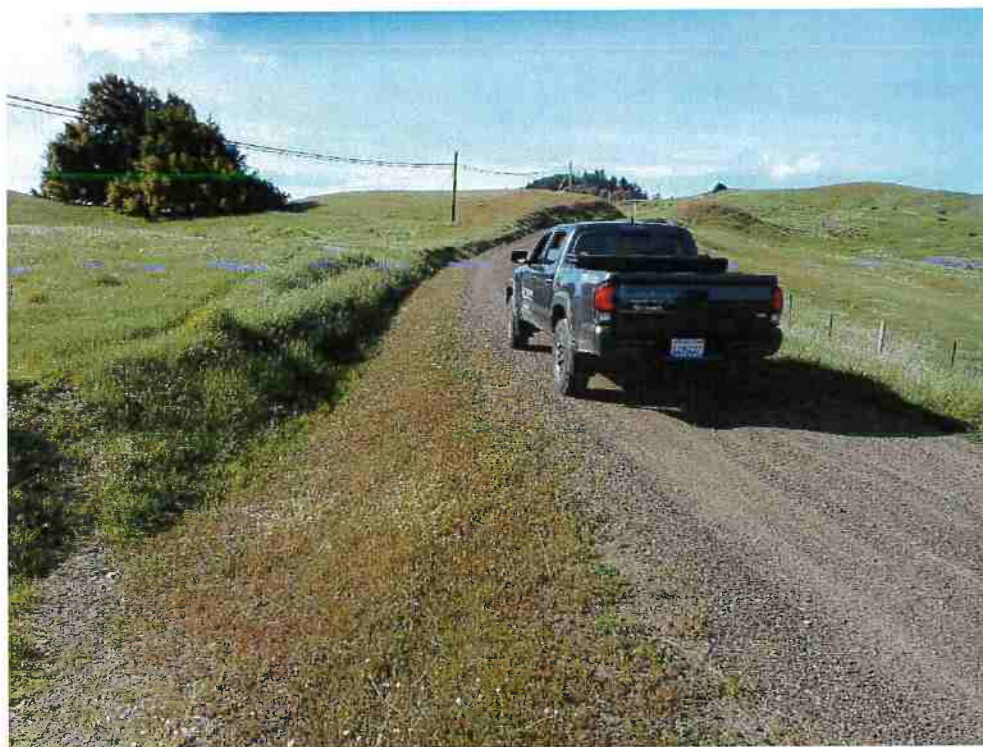
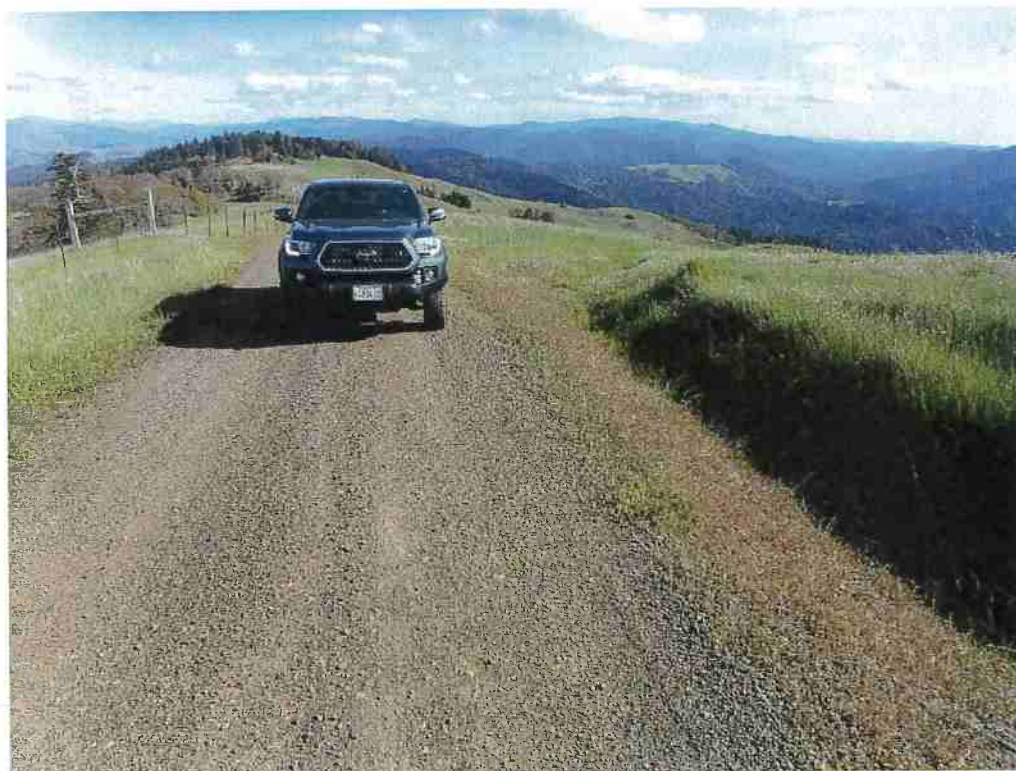
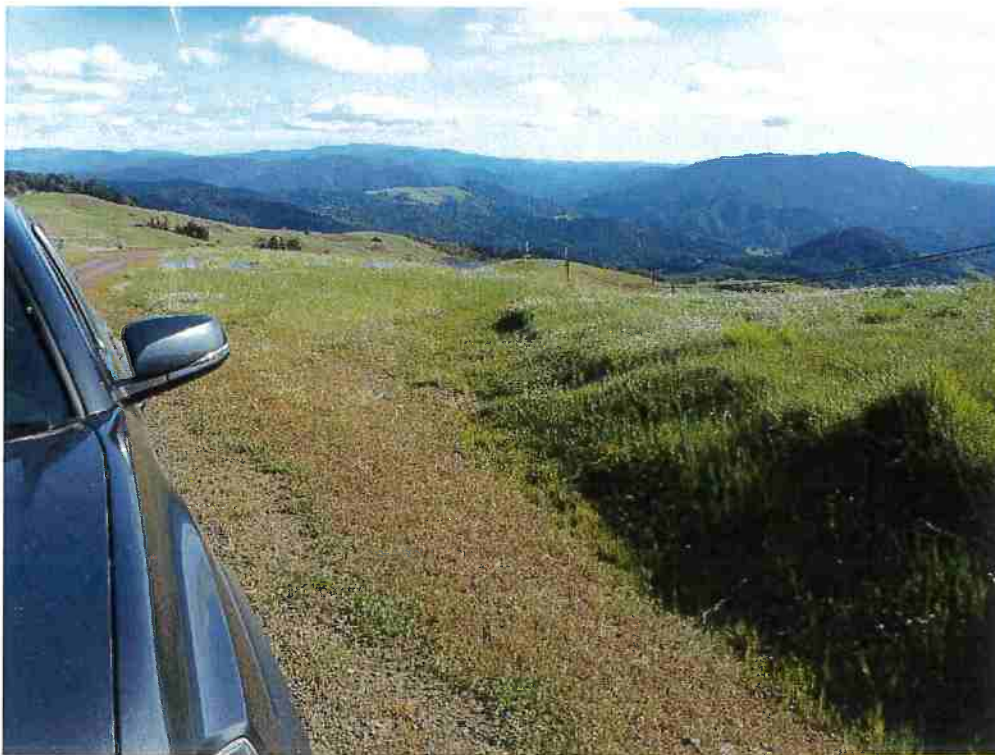
Figure 10: RP 5. Inboard ditch and location of lead-out ditch. Vehicle traveling north. Photo taking facing north.

Figure 11: RP 5. Inboard ditch and location of lead-out ditch. Vehicle traveling north. Photo taking facing south.

Figure 12: RP 5. Lead-out ditch. Photo taken facing west.

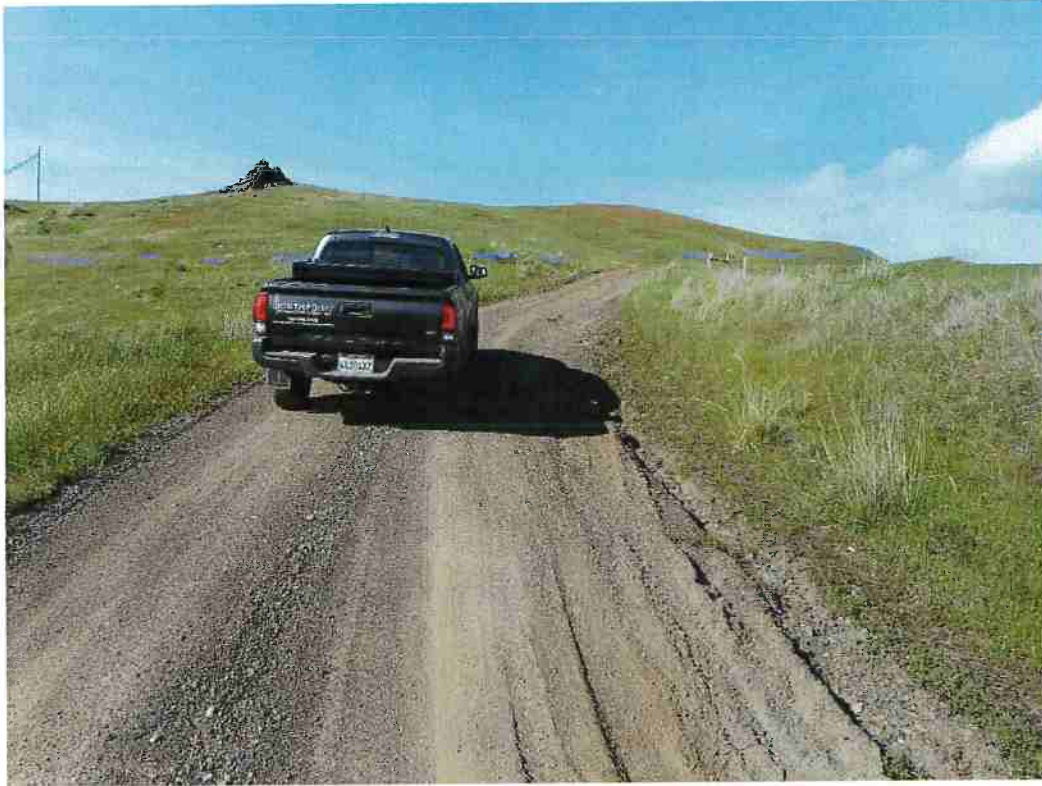
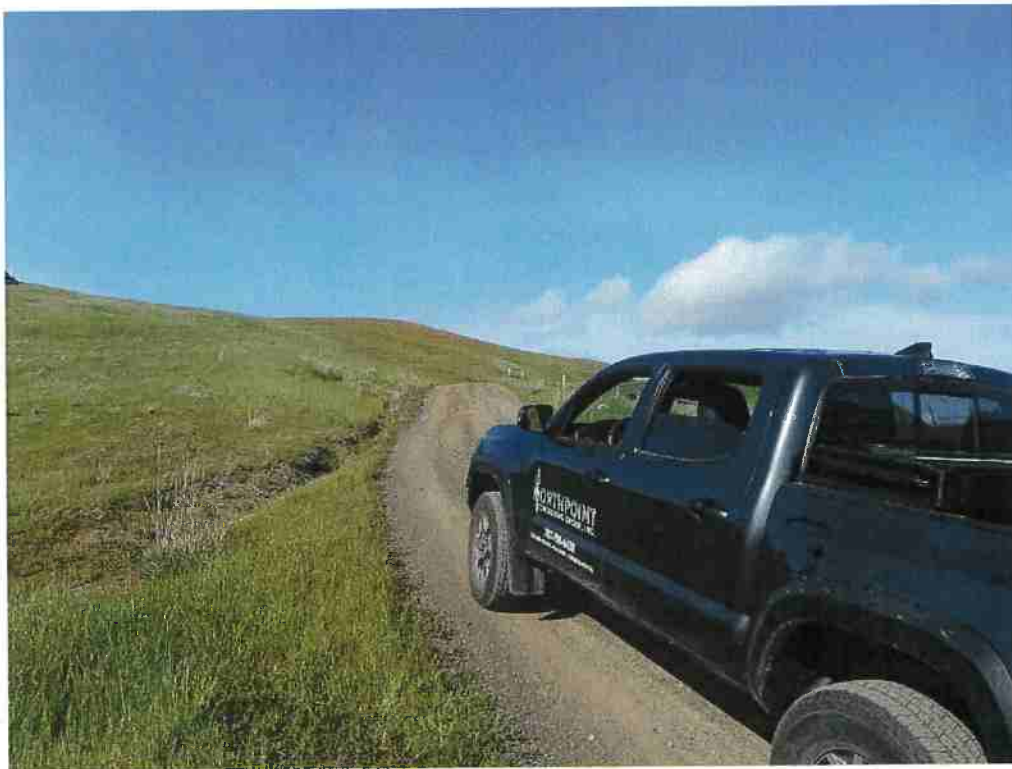
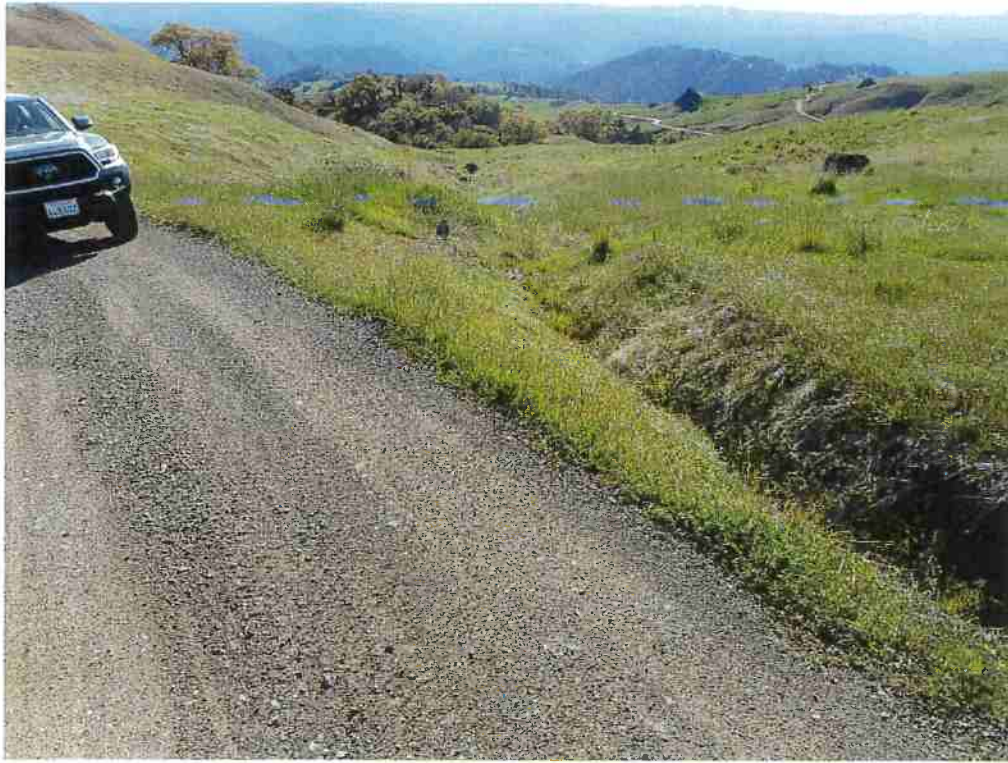
6	13-15	18	40.107572°, -123.690060°	Rutting on west side of roadway for approximately 75' in length. Inboard ditch and lead-out ditch located on the left side of roadway. Inadequate culvert crossing at RP 7 is causing runoff to travel down roadway.	Improve section of roadway to allow water to appropriately drain off road. Maintain existing roadway width, inboard ditch and lead-out ditch.
7	16-19	16	40.107979°, -123.689428°	Ditch relief culvert. Runoff jumps from inlet and travels down roadway.	Improve culvert crossing to allow appropriate conveyance of stormwater. The culvert shall be improved to pass the flow from a 100-year storm event, and to minimize erosion and sediment transport.
8	20-21	18	40.108883°, -123.689037°	Intersection of Pratt Mountain Rd and Private Drive. Gate 16' in width. No sight distance restrictions.	Maintain existing roadway width and sight distance.
9	22-23	15	40.109095°, -123.687206°	Pinch point. Through cut road causes narrow roadway for approximately 85' in length. No sight distance restrictions. Turn outs provided.	Maintain existing roadway width and sight distance.

Figure 13: RP 6. Location of rutting on road surface. Vehicle traveling north. Photo taking facing north.

Figure 14: RP 6. Inboard ditch and location of lead-out ditch. Vehicle traveling north. Photo taking facing north.

Figure 15: RP 6. Lead-out ditch. Vehicle traveling north. Photo taking facing south.

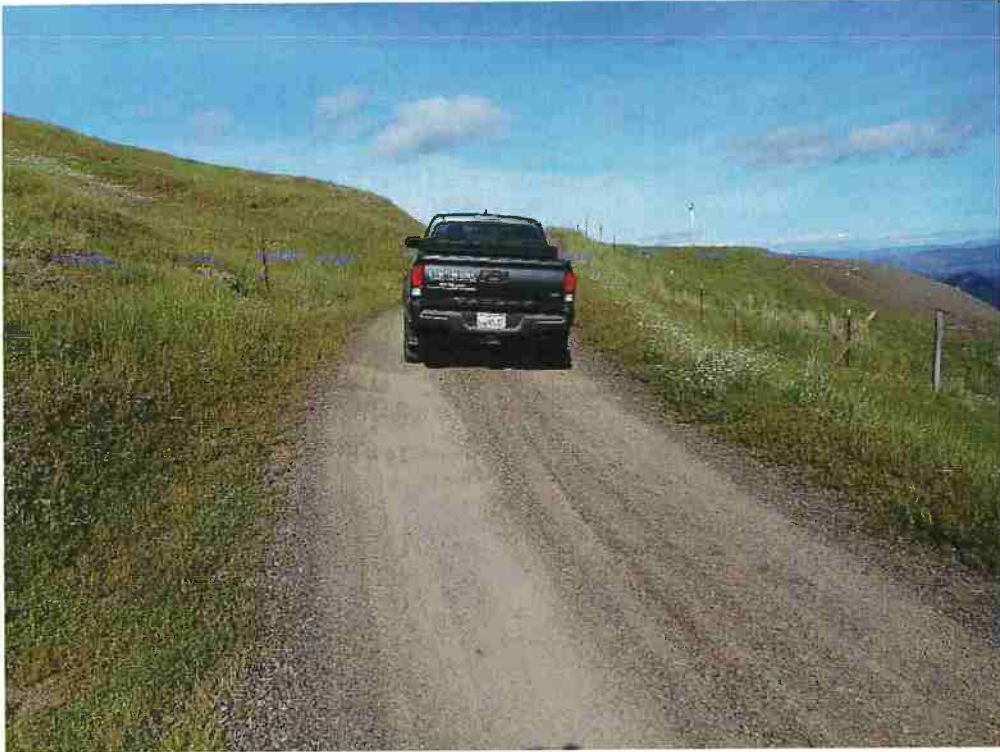
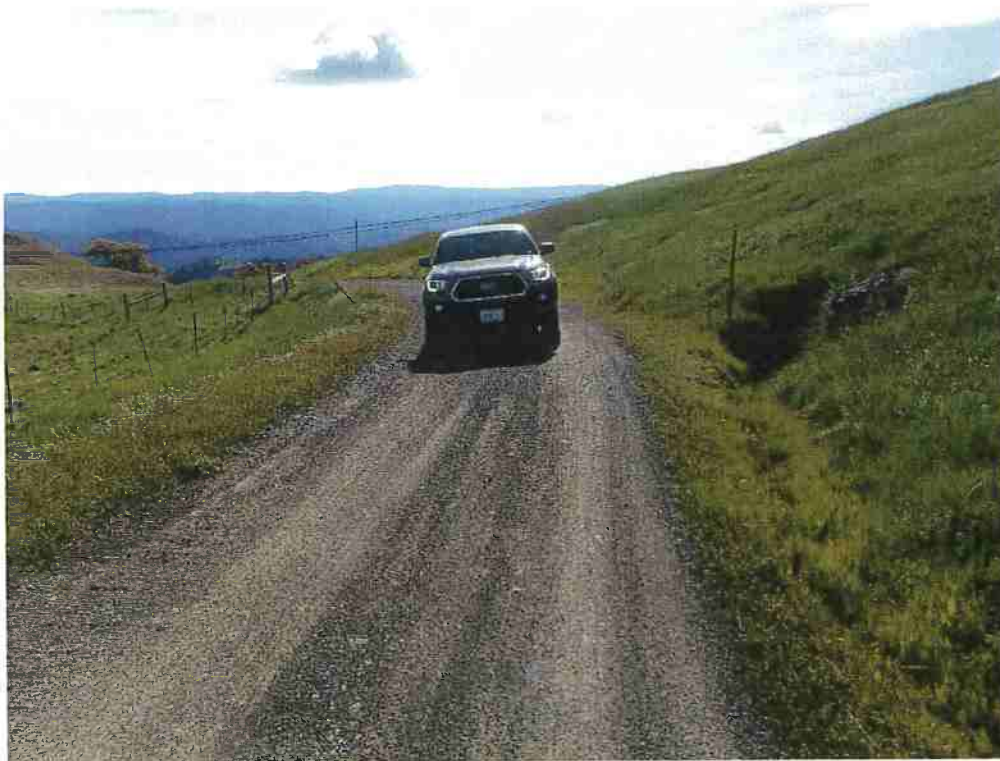
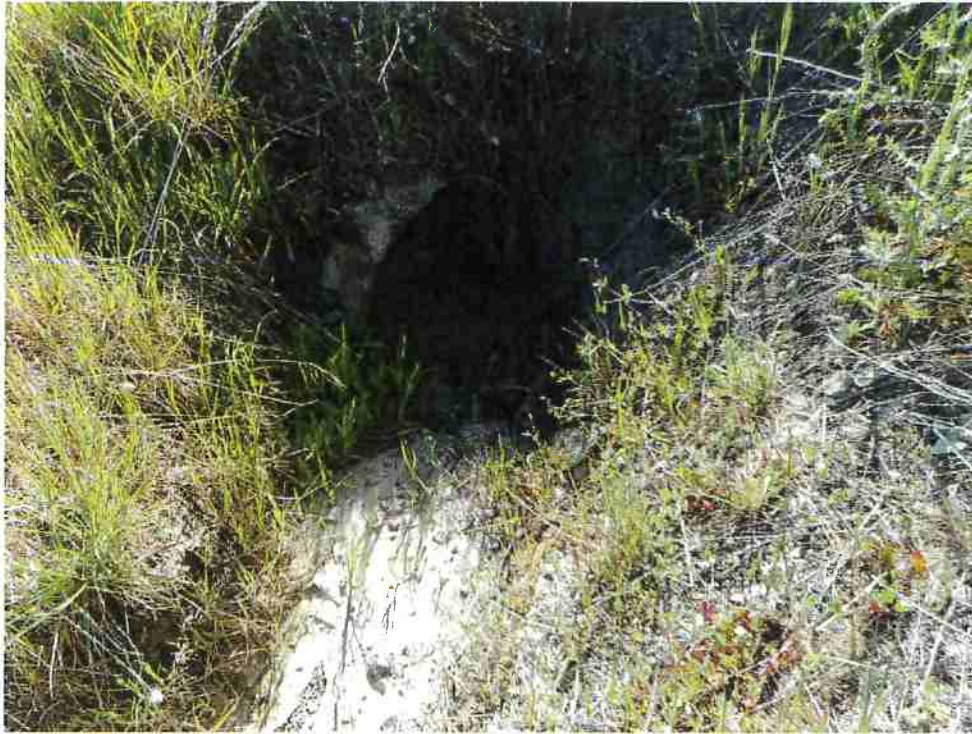
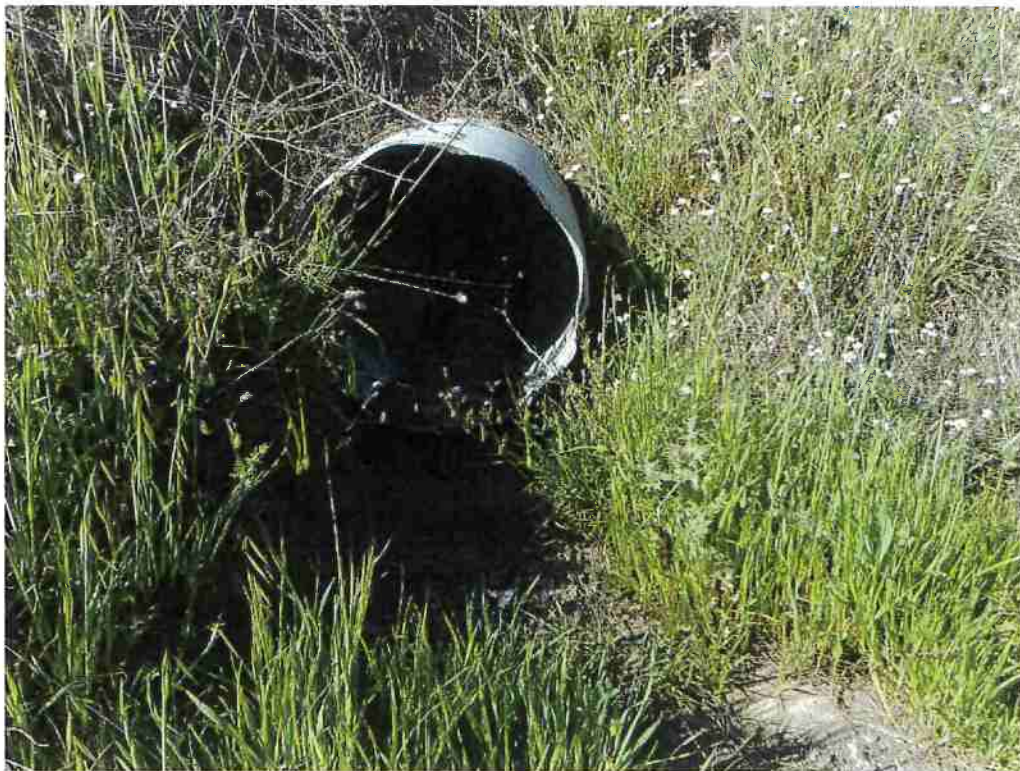
7	16-19	40.107979°, -123.689428°	Ditch relief culvert. Runoff jumps from inlet of culvert and travels down roadway.	Improve culvert crossing to allow appropriate conveyance of stormwater. The culvert shall be improved to pass the flow from a 100-year storm event, and to minimize erosion and sediment transport.
10	24-25	40.108872°, -123.686570°	Inboard ditch and location of lead-out ditch. Lead-out ditch discharges onto a stable, vegetated hillside.	Maintain existing roadway width, inboard ditch and lead-out ditch.
11	26-28	40.108638°, -123.686123°	Inboard ditch and location of lead-out ditch. Lead-out ditch discharges onto a stable, vegetated hillside.	Maintain existing roadway width, inboard ditch and lead-out ditch.

Figure 16: RP 7. Culvert crossing. Vehicle traveling north. Photo taking facing north.

Figure 17: RP 7. Culvert crossing. Vehicle traveling north. Photo taking facing south.

Figure 18: RP 7, Inlet of culvert.

Figure 19: RP 7, Outlet of culvert.

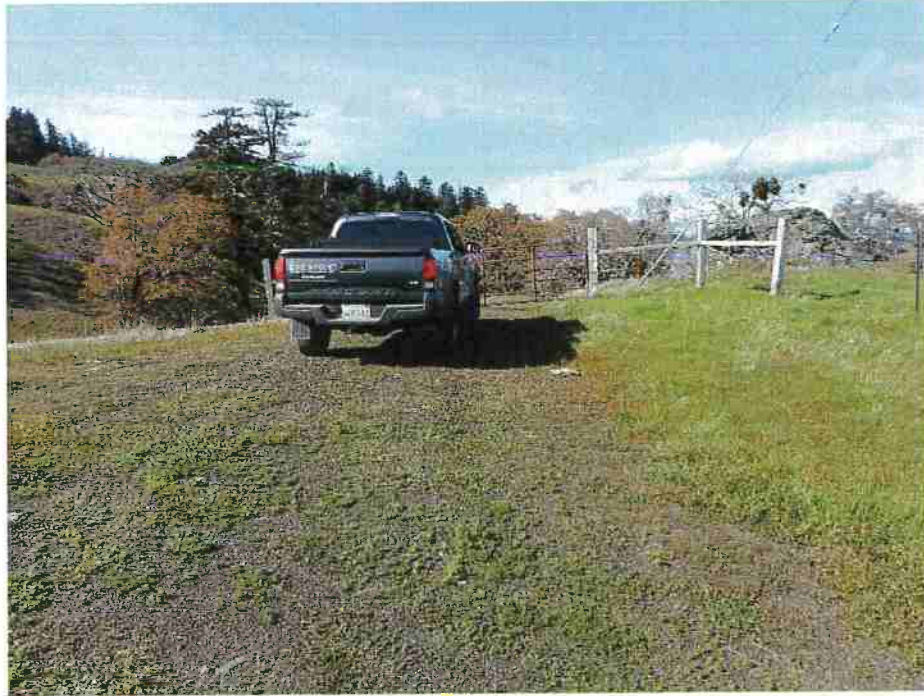
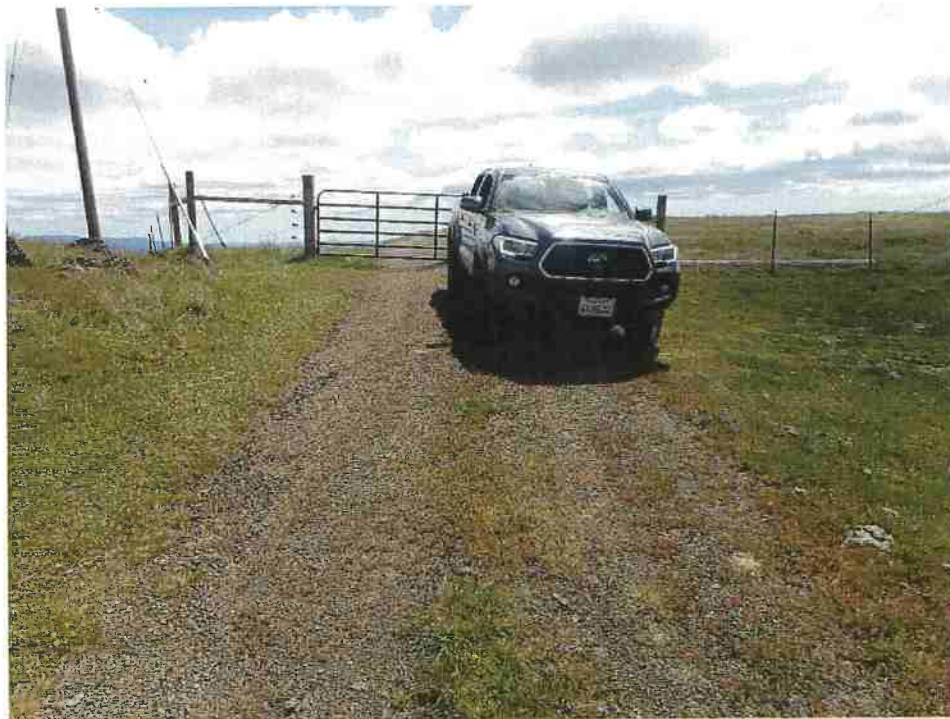
Figure 20: RP 8. Intersection of Pratt Mountain Rd and Private Drive. Gate. Vehicle traveling north. Photo taking facing north.

Figure 21: RP 8. Intersection of Pratt Mountain Rd and Private Drive. Gate. Vehicle traveling north. Photo taking facing south.

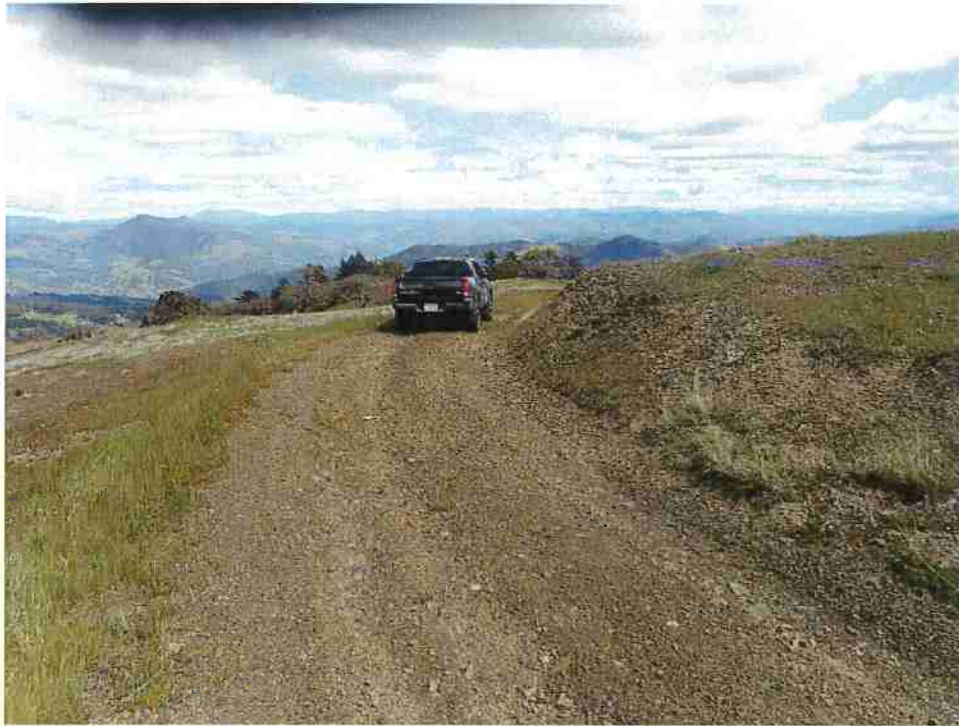
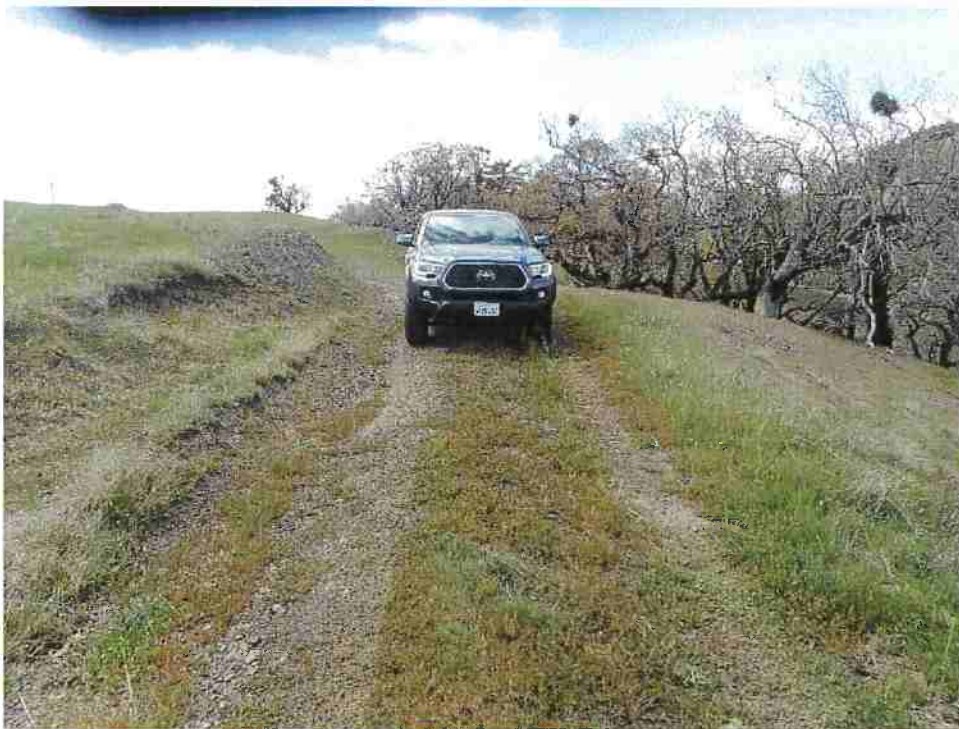
Figure 22: RP 9. Pinch point. Vehicle traveling east. Photo taking facing east.

Figure 23: RP 9. Pinch point. Vehicle traveling east. Photo taking facing west.

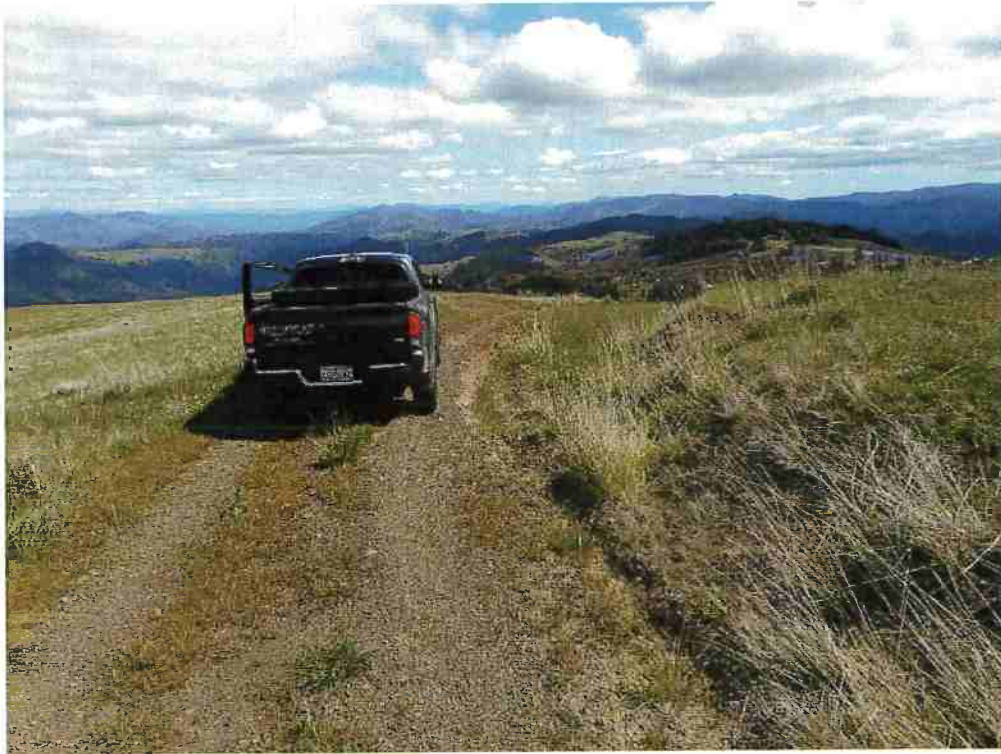
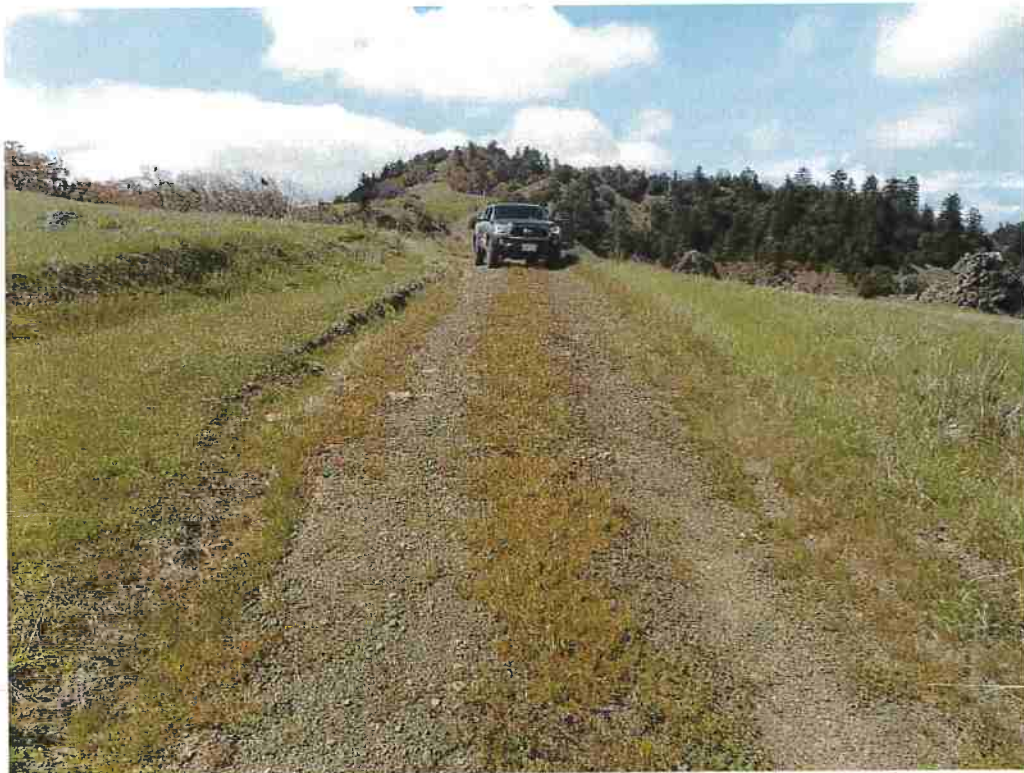
Figure 24: RP 10. Vehicle traveling east. Photo taking facing east.

Figure 25: RP 10. Vehicle traveling east. Photo taking facing west.

10	24-25	16	40.108872°, -123.686570°	Inboard ditch and location of lead-out ditch. Lead-out ditch discharges onto a stable, vegetated hillside.	Maintain existing roadway width, inboard ditch and lead-out ditch.
11	26-28	16	40.108638°, -123.686123°	Inboard ditch and location of lead-out ditch. Lead-out ditch discharges onto a stable, vegetated hillside.	Maintain existing roadway width, inboard ditch and lead-out ditch.
12	29-30	18	40.108457°, -123.684187°	Typical section of roadway.	Maintain existing roadway width and sight distance.
13	31-32	14	40.107937°, -123.682304°	Pinch point. Start of narrow section of roadway. Bench cut road causes narrow roadway for approximately 250' in length. No sight distance restrictions. Turn out provided.	Maintain existing roadway width and sight distance.
14	33-34	16	40.108063°, -123.681518°	Pinch point. End of narrow section of roadway. Bench cut road causes narrow roadway for approximately 250' in length. No sight restrictions. Turn out provided.	Maintain existing roadway width and sight distance.
