Pratt Mountain, LLC

Road System Assessment Report

Record No.: PLN-2019-16117

APN: 216-133-013

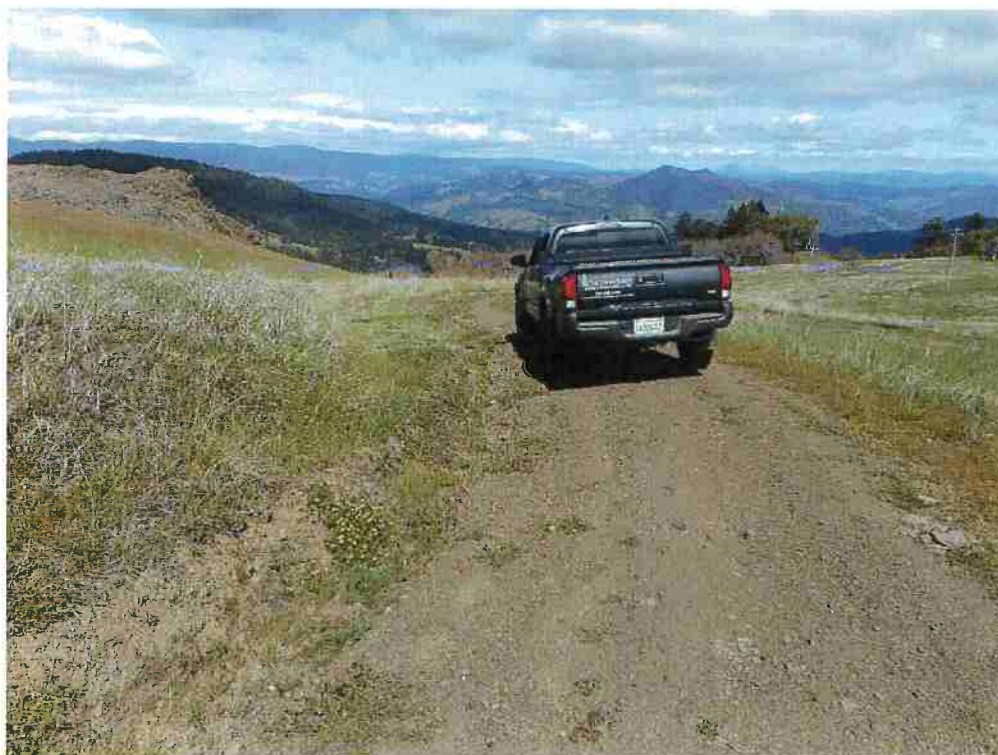
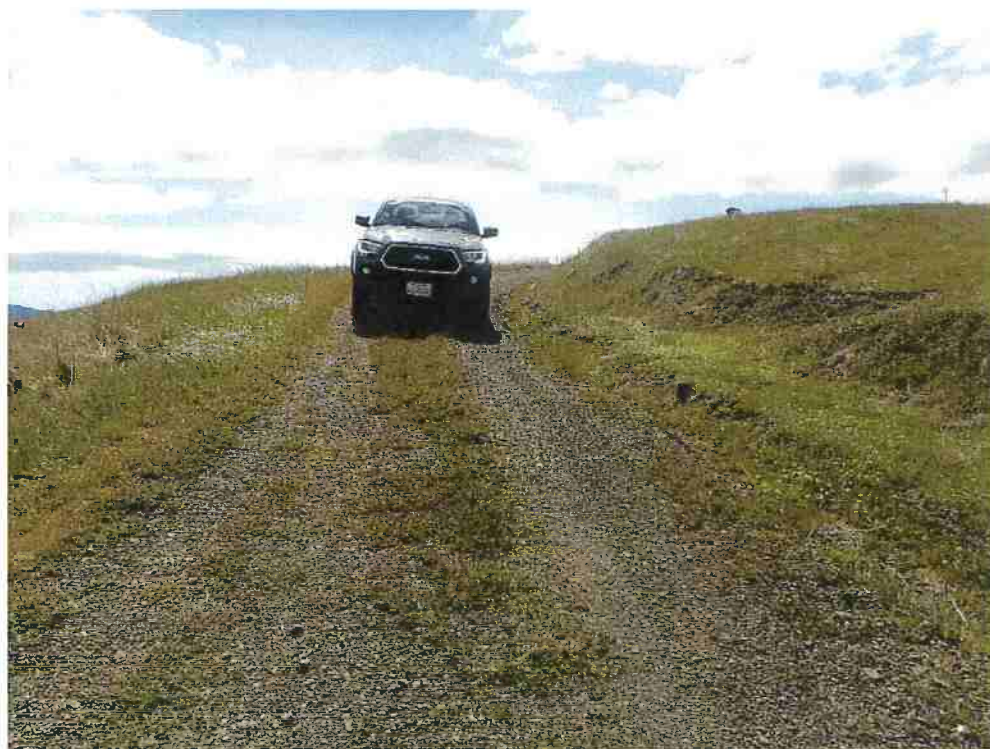
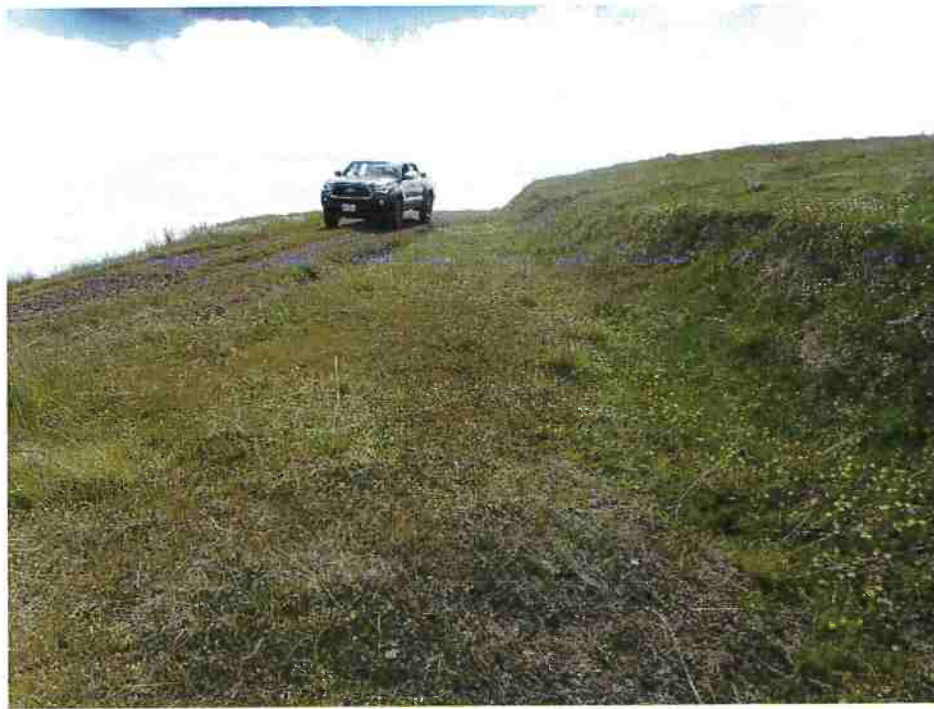
Figure 26: RP 11. Inboard ditch and location of lead-out ditch. Vehicle traveling east. Photo taking facing east.

Figure 27: RP 11. Inboard ditch and location of lead-out ditch. Vehicle traveling east. Photo taking facing west.

Figure 28: RP 11. Lead-out ditch. Vehicle traveling east. Photo taking facing west.

10	24-25	16	40.108872°, -123.686570°	Inboard ditch and location of lead-out ditch. Lead-out ditch discharges onto a stable, vegetated hillside.	Maintain existing roadway width, inboard ditch and lead-out ditch.
11	26-28	16	40.108638°, -123.686123°	Inboard ditch and location of lead-out ditch. Lead-out ditch discharges onto a stable, vegetated hillside.	Maintain existing roadway width, inboard ditch and lead-out ditch.
12	29-30	18	40.108457°, -123.684187°	Typical section of roadway.	Maintain existing roadway width and sight distance.
13	31-32	14	40.107937°, -123.682304°	Pinch point. Start of narrow section of roadway. Bench cut road causes narrow roadway for approximately 250' in length. No sight distance restrictions. Turn out provided.	Maintain existing roadway width and sight distance.
14	33-34	16	40.108063°, -123.681518°	Pinch point. End of narrow section of roadway. Bench cut road causes narrow roadway for approximately 250' in length. No sight restrictions. Turn out provided.	Maintain existing roadway width and sight distance.

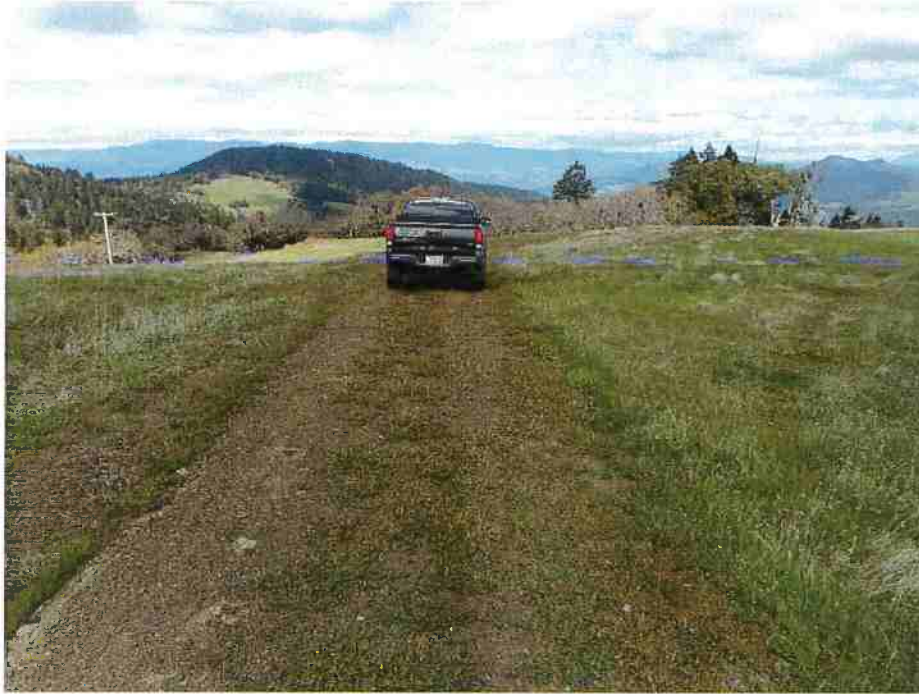
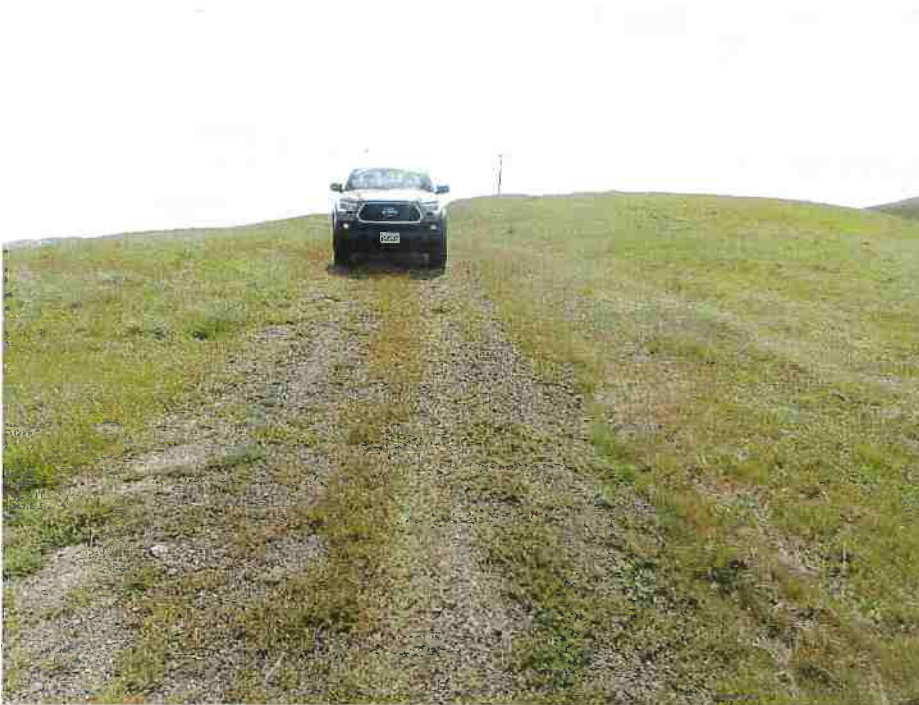
Figure 29: RP 12. Typical section of roadway. Vehicle traveling east. Photo taking facing east.

Figure 30: RP 12. Typical section of roadway. Vehicle traveling east. Photo taking facing west.

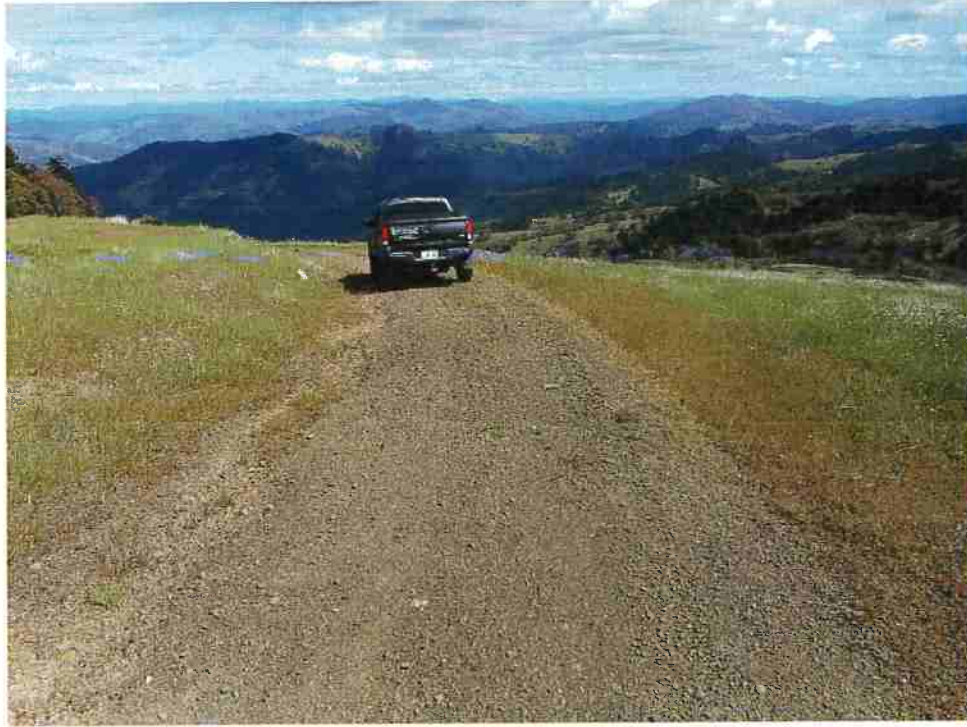
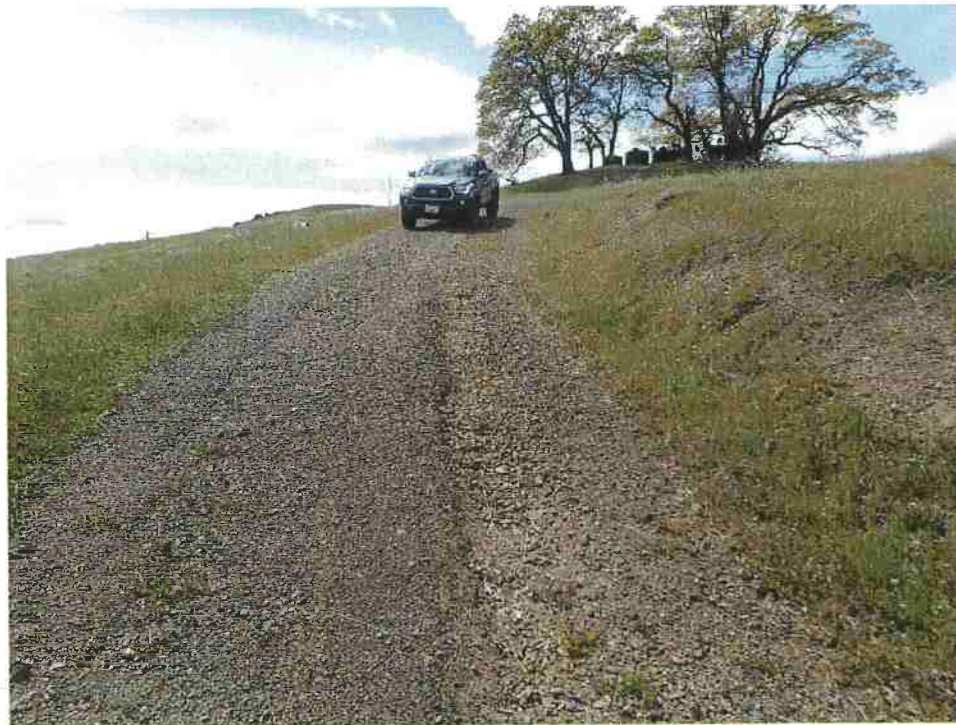
Figure 31: RP 13. Pinch point. Start of narrow section of roadway. Bench cut road causes narrow roadway. Vehicle traveling east. Photo taking facing east.

Figure 32: RP 13. Pinch point. Start of narrow section of roadway. Bench cut road causes narrow roadway. Vehicle traveling east. Photo taking facing west.

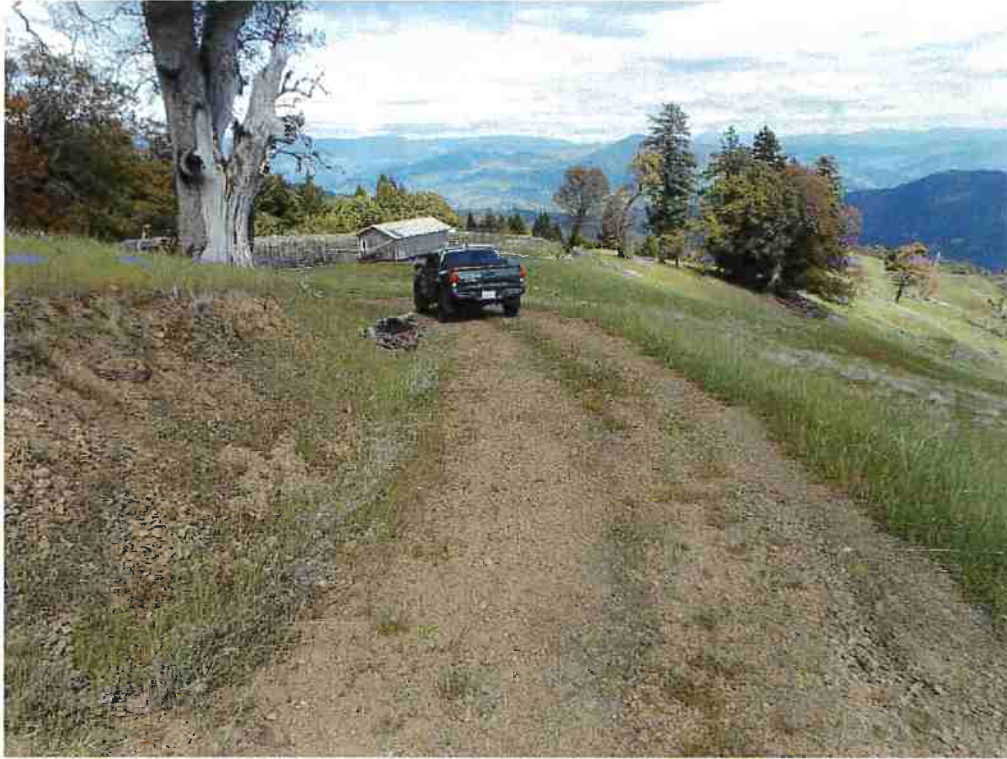
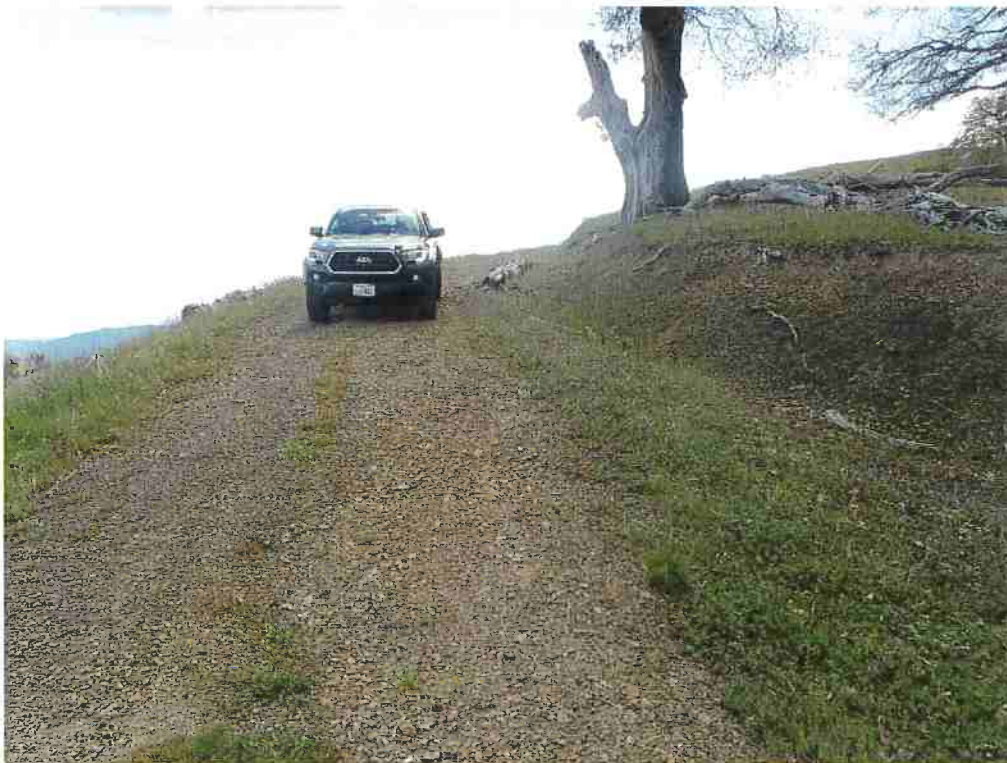
*Figure 33: RP 14. Pinch point. End of narrow section of roadway. Bench cut road causes narrow roadway. Vehicle traveling east.
Photo taking facing east.*

*Figure 34: RP 14. Pinch point. End of narrow section of roadway. Bench cut road causes narrow roadway. Vehicle traveling east.
Photo taking facing west.*

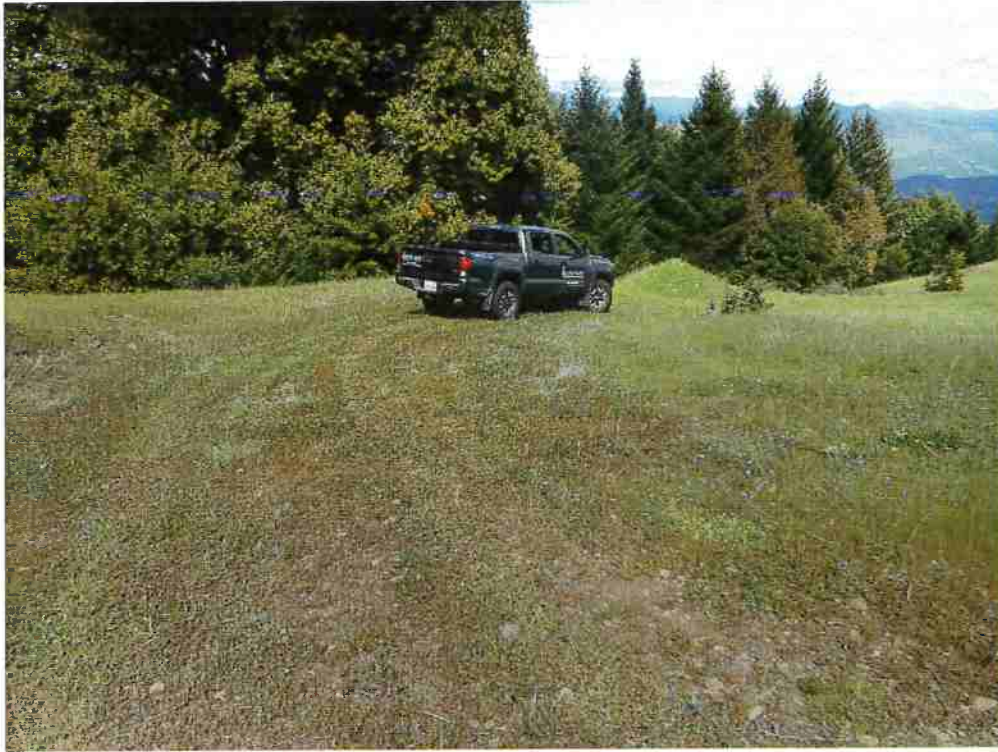
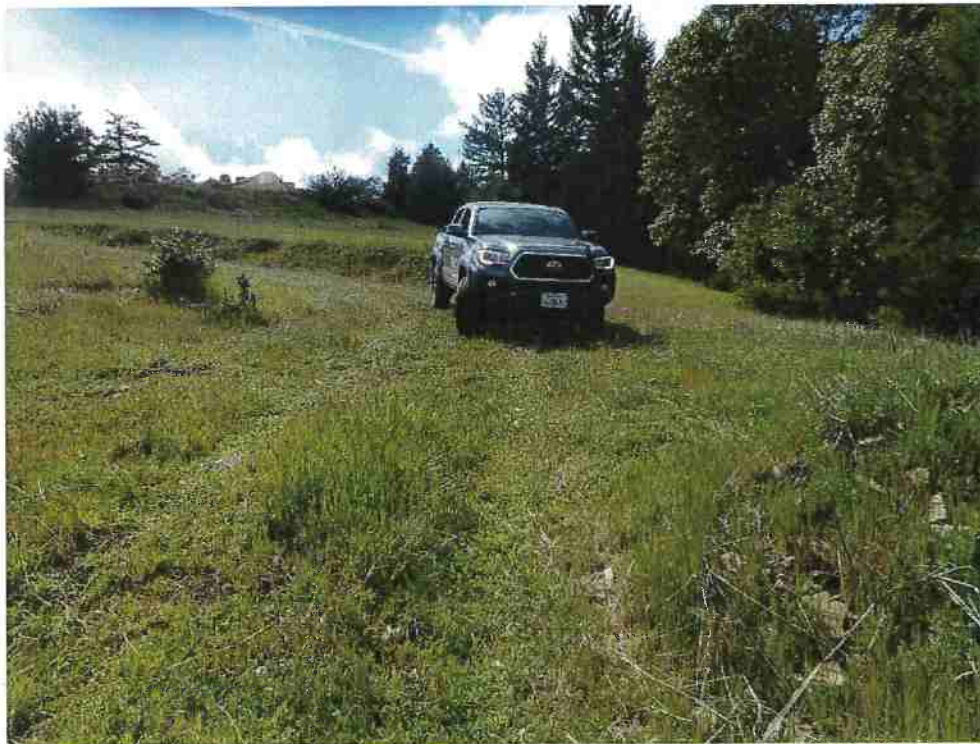
Figure 35: RP 15. End of Road Assessment. Turn around area. Vehicle traveling east. Photo taking facing east.

Figure 36: RP 15. End of Road Assessment. Turn around area. Vehicle traveling east. Photo taking facing west.

15	35-36	20	40.108866°, -123.679658°	End of Road Assessment. Turn around area. No sight distance restrictions.	Maintain existing roadway width and sight distance.
