HUMBOLDT COUNTY DEPARTMENT OF PUBLIC WORKS  
ROAD EVALUATION REPORT

Road Name: River Rd Date Inspected: 10/8/2018 APN: 208-231-013  
From Road: Humboldt / Trinity County Line (Post Mile       ) Planning & Building  
To Road: Private Access Rd (Post Mile 2.50) Department Case/File No.:  
12488

Road Name: Private Access Rd Date Inspected: 10/8/2018 APN: 208-231-011  
From Road: River Rd (Post Mile         ) Planning & Building  
To Road: Residence 208-231-011 (Post Mile 1.25) Department Case/File No.:  
12493

**Subject: Roadway Evaluation for APN 208-231-011, APPS 12493**

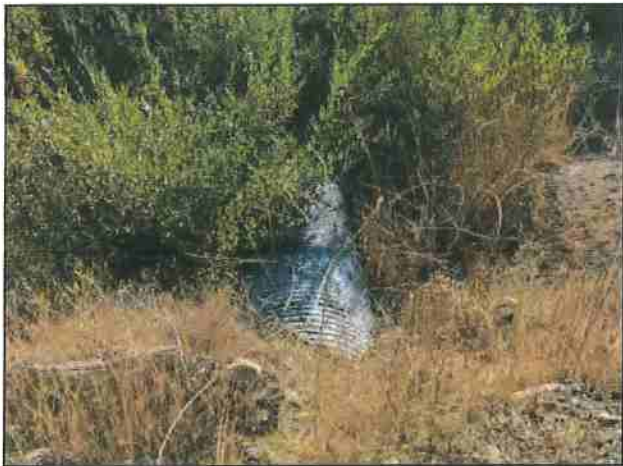
Photo #14 River Rd Looking SE @ Potholing  
Caused by Poor Drainage

- Photo 8/9 Construct rolling dip or waterbar.
- Photo 14 Unclogging nearby culvert will alleviate erosion.
- Photos 25/27, & 30/31/32 Unclogging nearby culvert will alleviate erosion.
- Photo 41 Construct rolling dip or waterbar.
- Photo 60 Re-establish embankment and construct roadside ditches to daylight water from.
- Photo 89 Re-establish embankment and construct roadside ditches to daylight water from.
- Photo 99 Construct rolling dip or waterbar.
- 114/115/116 & 117/118/119 This erosion issue is tied to the nearby slide and lack of culvert. Repair of the slide and installation of a culvert at each location.
- 125/126/127 Re-establish embankment and construct roadside ditches to daylight water from.
- Photo 129 Construct rolling dip or waterbar.
- Photo 140 Unclogging nearby culvert will alleviate erosion.
- Photo 174 Construct rolling dip or waterbar.

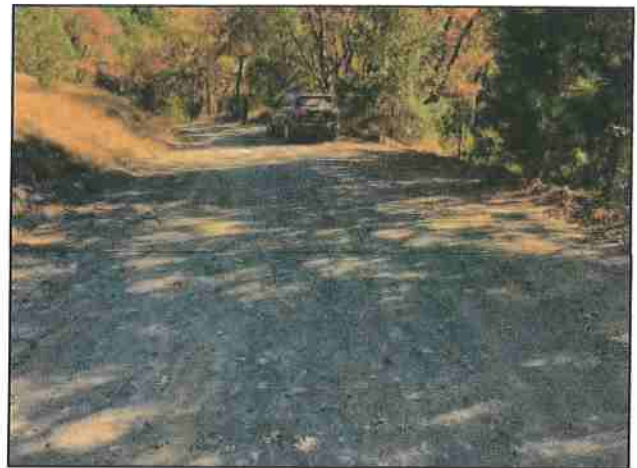
Photo #19 River Rd 14.8% Slope & 11.5' Width

**Width Under 12 Feet:** The Engineer recommends no improvements for Photo locations 19, 43, 94 & 95. The traffic benefits to environmental impacts doesn't justify cutting into hillsides or expanding travel width on hillsides with fill.

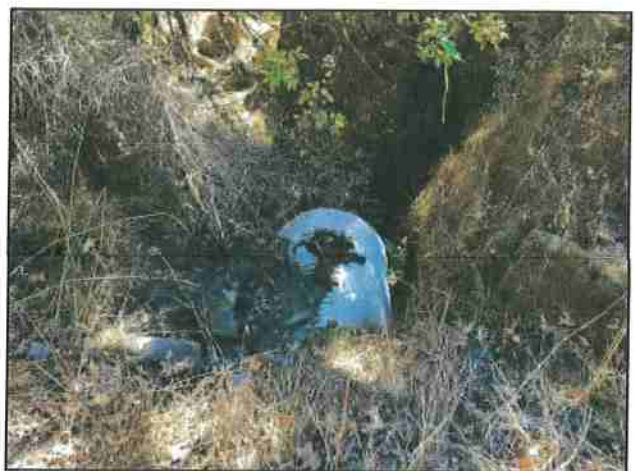
Photo #61 River Rd Looking @ Clogged Culvert In

**Clogged / Partially Culverts:** Almost all culverts locations have clogged inlets or are completely clogged. This has resulted in erosion and drainage issues as shown in Photos 25/26, 28/29, 33, 61, 68/69 (sizing), 111, 125/126, 144, 152/154, 164, 169 (approach culvert), 176, & 179. The Engineer recommends unclogging all culverts that have been shown to be partially clogged or fully clogged.

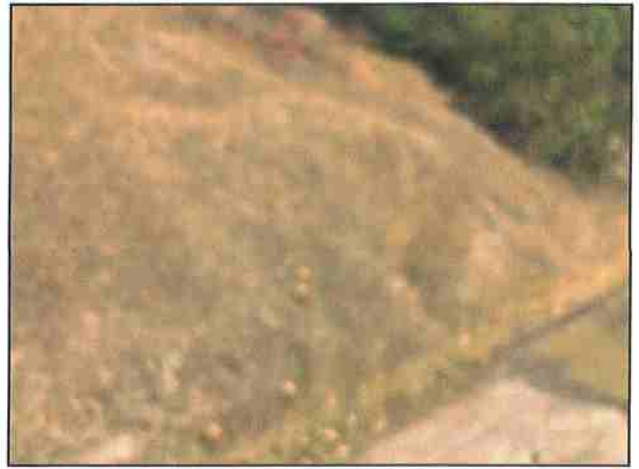
Photo #117 River Rd Looking West @ Narrowed Curve Area w/ Tire Tracks Over Curve Area

**Slide Locations:** The Engineer recommends repairs to areas that slides have occurred. Slides have occurred in Photos 51, 56, 116, 117, & 118 and repairs such as re-establishing a stable slope with grading and placing Rock Slope Protection (RSP) on the slope to stabilize with weight. At some locations, slides have occurred due to clogged culverts and poor drainage.

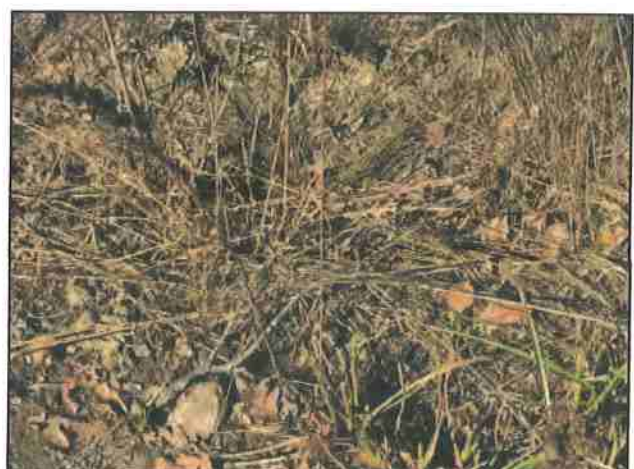
Photo #143 River Rd Looking @ Drainage Path Over Road

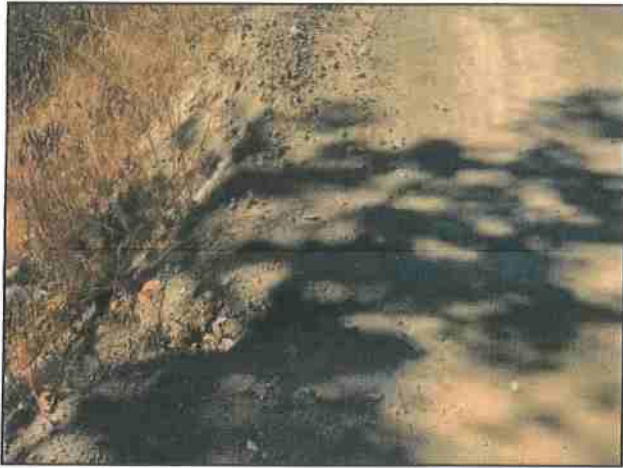
Photo #144 River Rd Looking @ Clogged Culvert Inlet. Outlet Was't Found

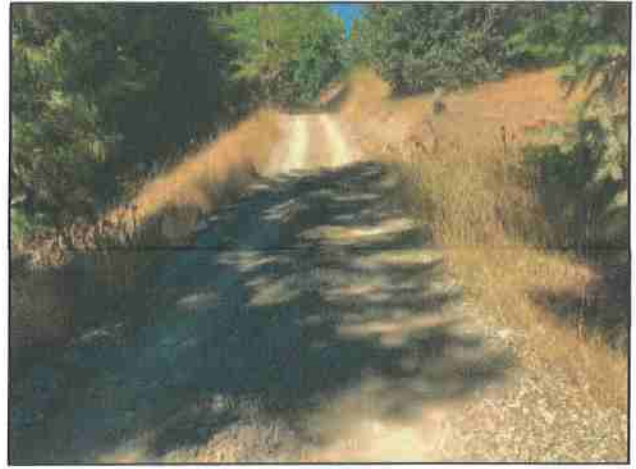
Photo #754 Private Access Rd Looking @ Partially Clogged 18" Culvert In

**Clogged / Partially Culverts:** The Engineer recommends unclogging all culverts that have been shown to be partially clogged or fully clogged.

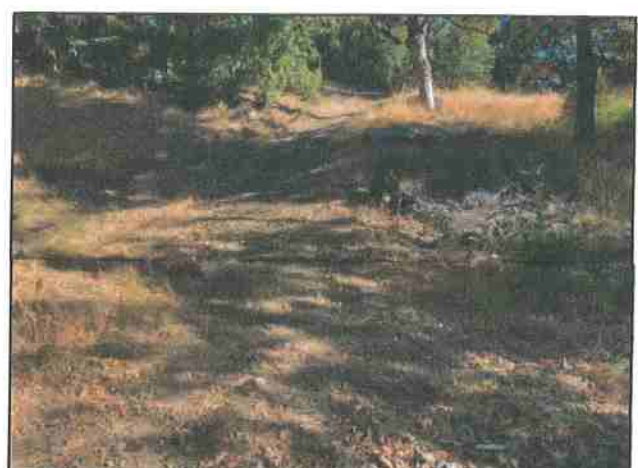
Photo #822 Private Access Rd Slope 15.9% Width 10'2"

**Slopes Over 16%:** The Engineer recommends no improvements for photo locations where slopes are over 16%. The traffic benefits to environmental impacts doesn't justify paving or lowering grades. Typically, the steep grades shown at these locations are for short segments of roadway.

**Width Under 12 Feet:** The Engineer recommends no improvements. The traffic benefits to environmental impacts doesn't justify cutting into hillsides or expanding travel width on hillsides with fill.
