### NOTICE OF VIOLATION

Investigation ID: 11785

#### DIVISION OF WATER RIGHTS INSPECTION OF HUMBOLDT COUNTY APN 223-061-011-000

### DIVISION OF WATER RIGHTS INSPECTION REPORT

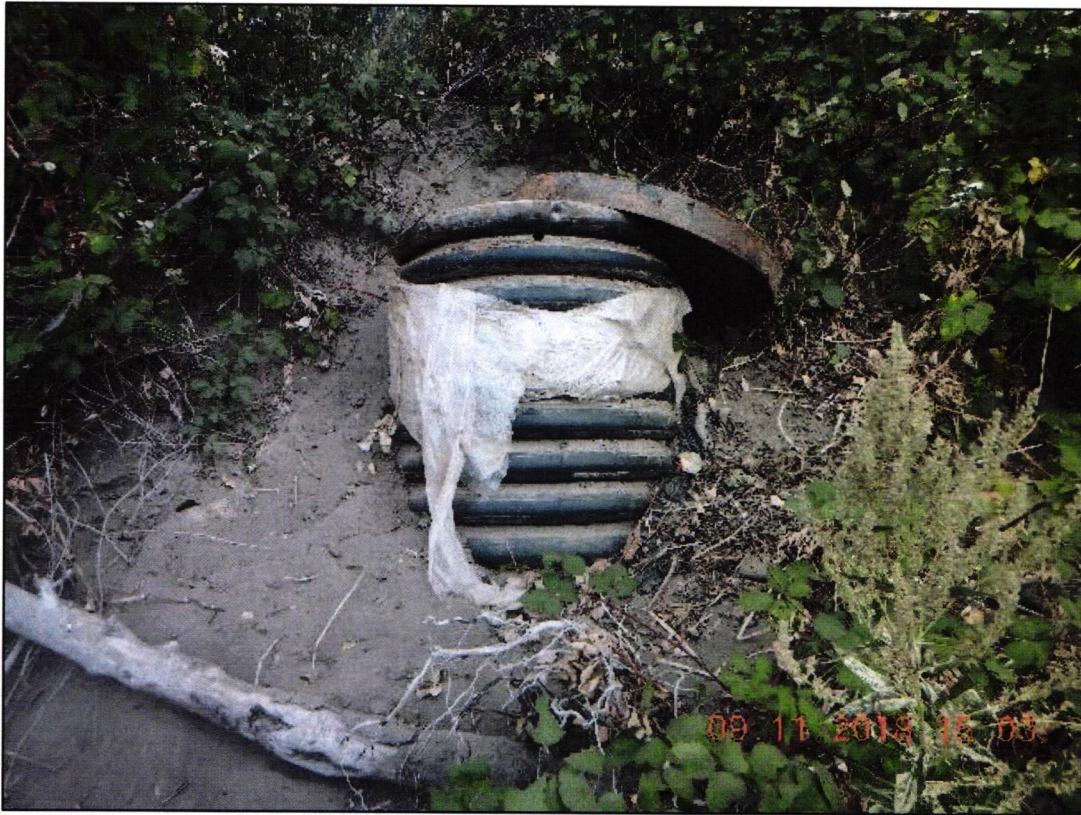
**Photo 1: POD1 – Cistern**

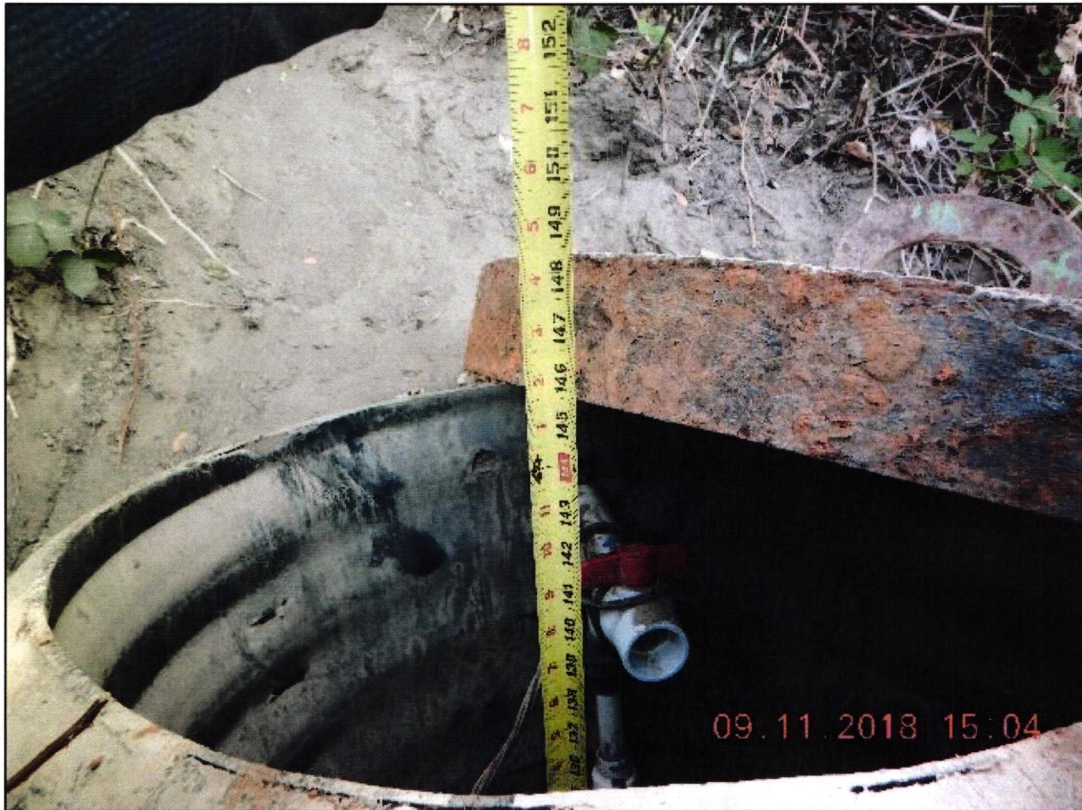
**Photo 3: POD1 – Tape Measure of Water Level.**

feet in depth (Photo 3). According to the July 2, 2014 inspection conducted by the Division, POD1 was constructed approximately 20 years prior to 2014, and the source of water in the cistern is subsurface flows from the South Fork Eel River. Water is pumped from the point of diversion by an electric submersible pump. At the time of inspection, POD1's pump was not running. During the inspection on September 11, 2018 Division staff documented that POD1's water supply line was broken (Photos 13-14). The broken water supply line leads in the direction of POS 19-20. A valve was observed prior to the broken water line that can route water through a black polyethylene water supply line that was observed on the rainwater collection tarp (POD2) (Photos 10-12). Division staff did not measure the diameter of the water supply lines associated with POD1. POD1 has a Small Domestic Use Registration D032753 filed with the Division on June 19, 2018 for domestic uses on the property.

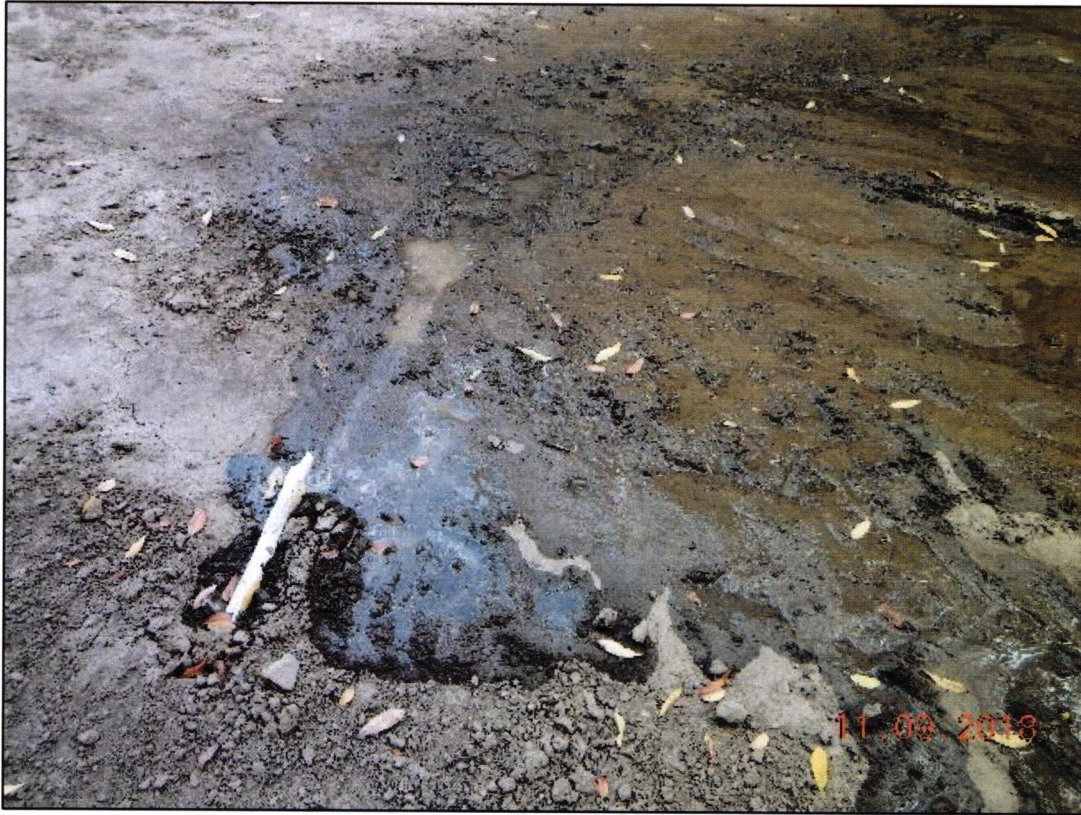
**Photo 13: POD1 – Broken Pipe.**

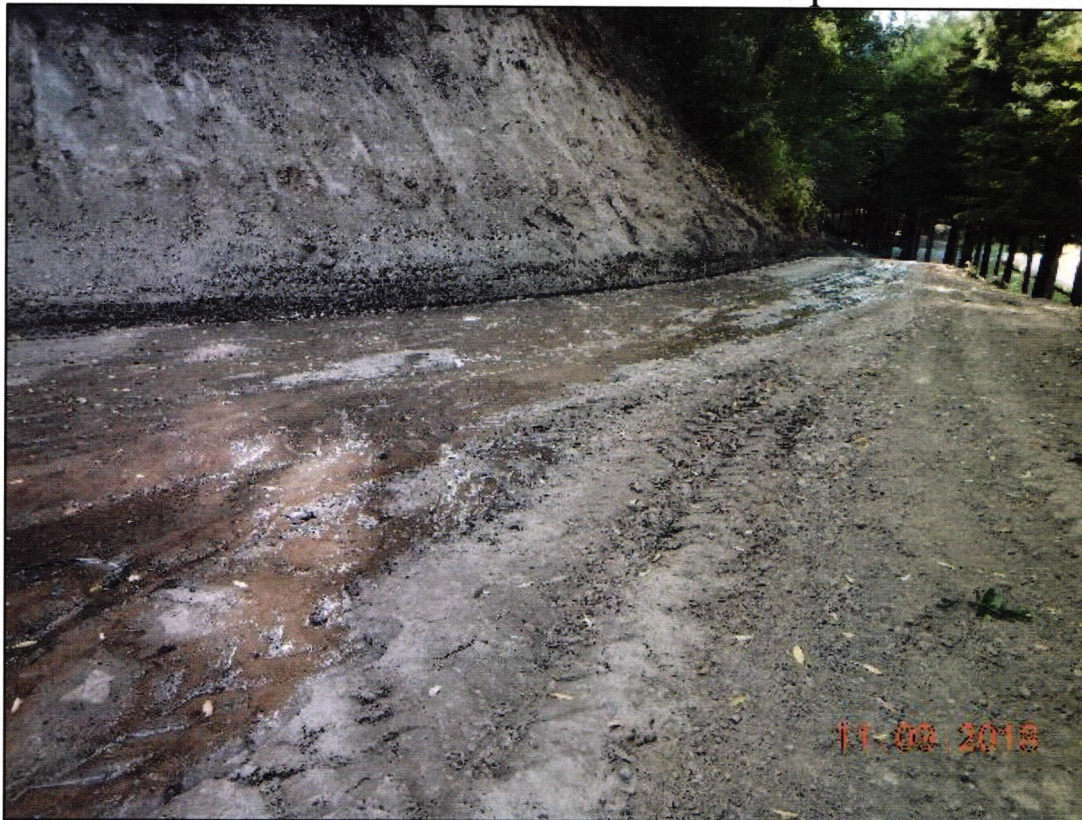
**Photo 14: POD1– water runoff from broken pipe.**

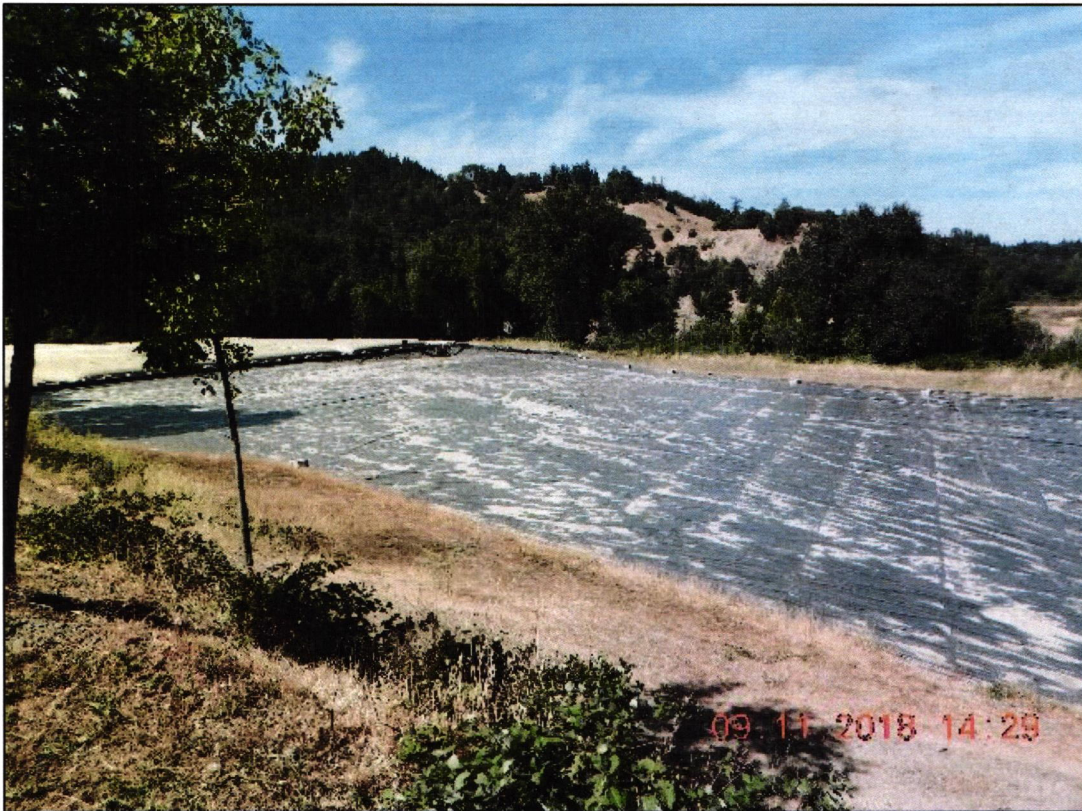
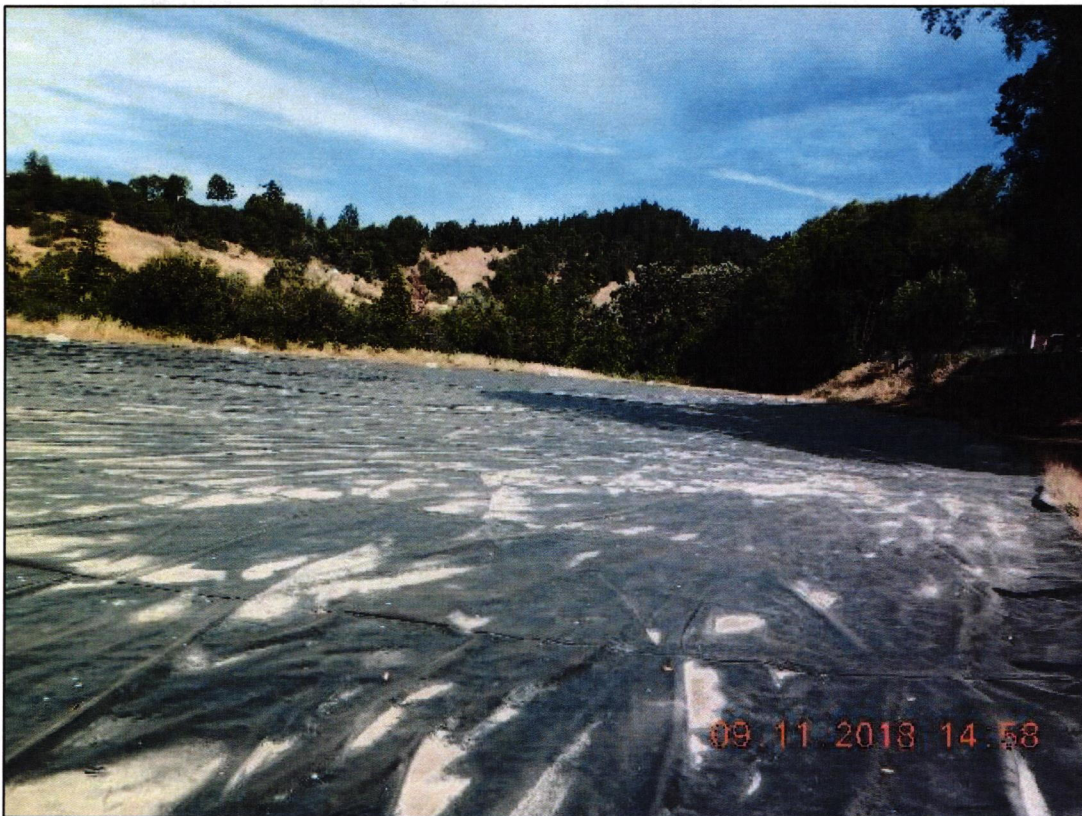
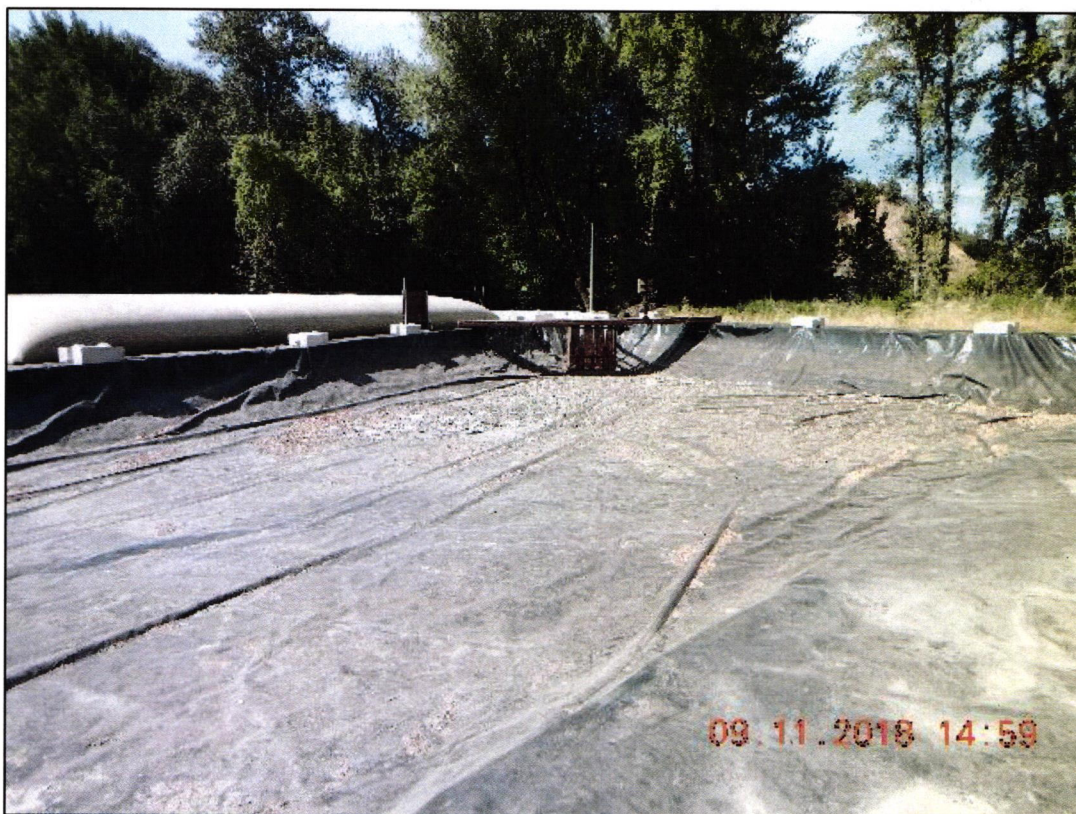
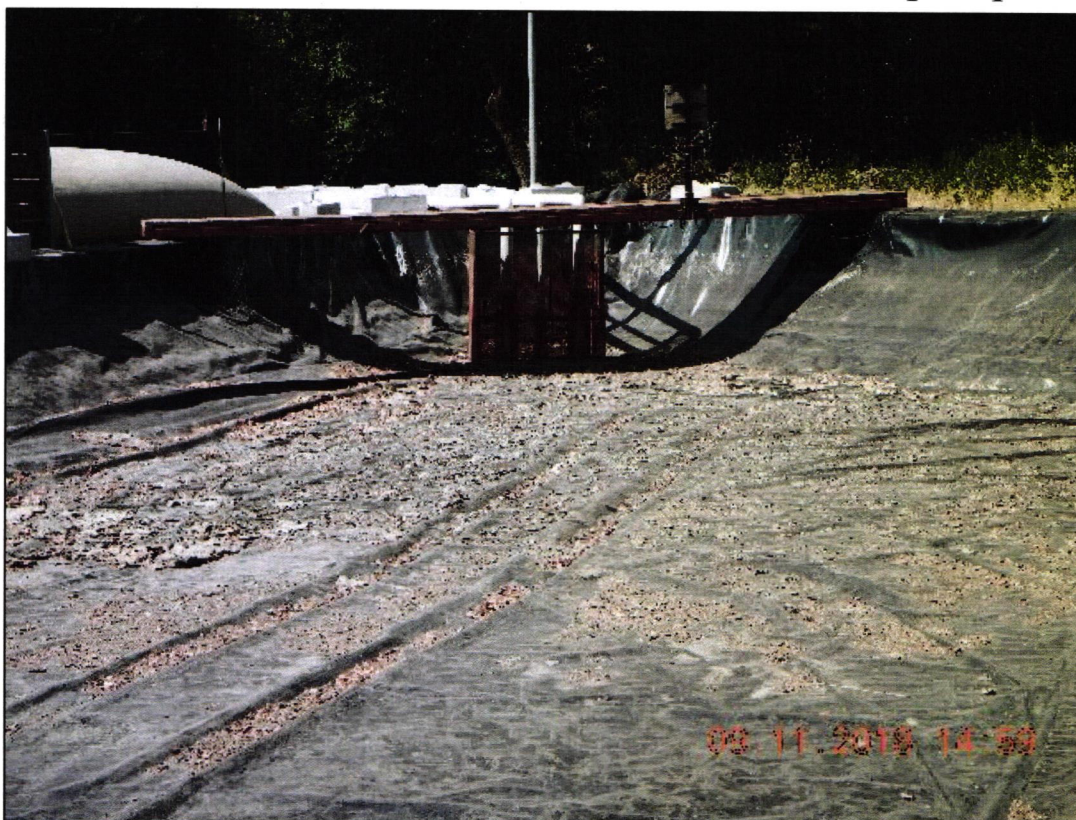
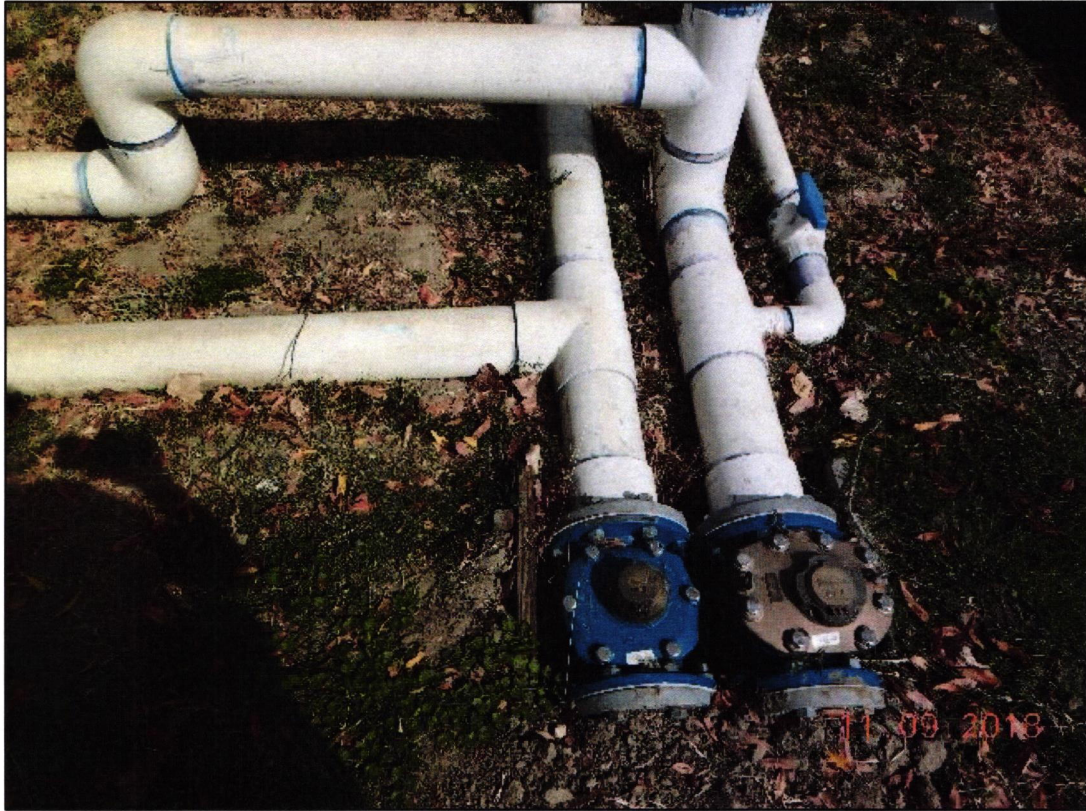
**Photo 15:** POD2 Collection Area - Rain catchment

**Photo 16:** POD2 Collection Area- east facing.

**Photo 17: POD2 Collection Reservoir- inlet pumps.**

**Photo 18: POD2 - Inlet Pumps (closer view)**

**Photo 19: POD2 - Inlet pumps with meters.**

**Photo 20: POD2- Water Meter (Left).**

**Photo 21: POD2- Water Meter (Right)**

POD ID:	POD2
Lat/Long:	40.094335°, -123.801890°
Water Source:	Rainwater and POD1
Watercourse:	Rainwater Collection and POD1
Diversion Type:	Rain Collection System
Description:	POD2 (Photos 15- 21) is an approximately 2.5-acre tarped rain collection area. POD2 collects precipitation that is collected on the tarped area that is sloped down to a sump. Division staff observed a valve that routes water diverted at POD1 through a black polyethylene water supply line onto the rainwater collection tarp area (Photos 11-12). Rainwater or water diverted at POD1 can be collected in the rain collection system that fills a sump with an electric pump. Water collected at POD2 is then pumped to POS 1-14.

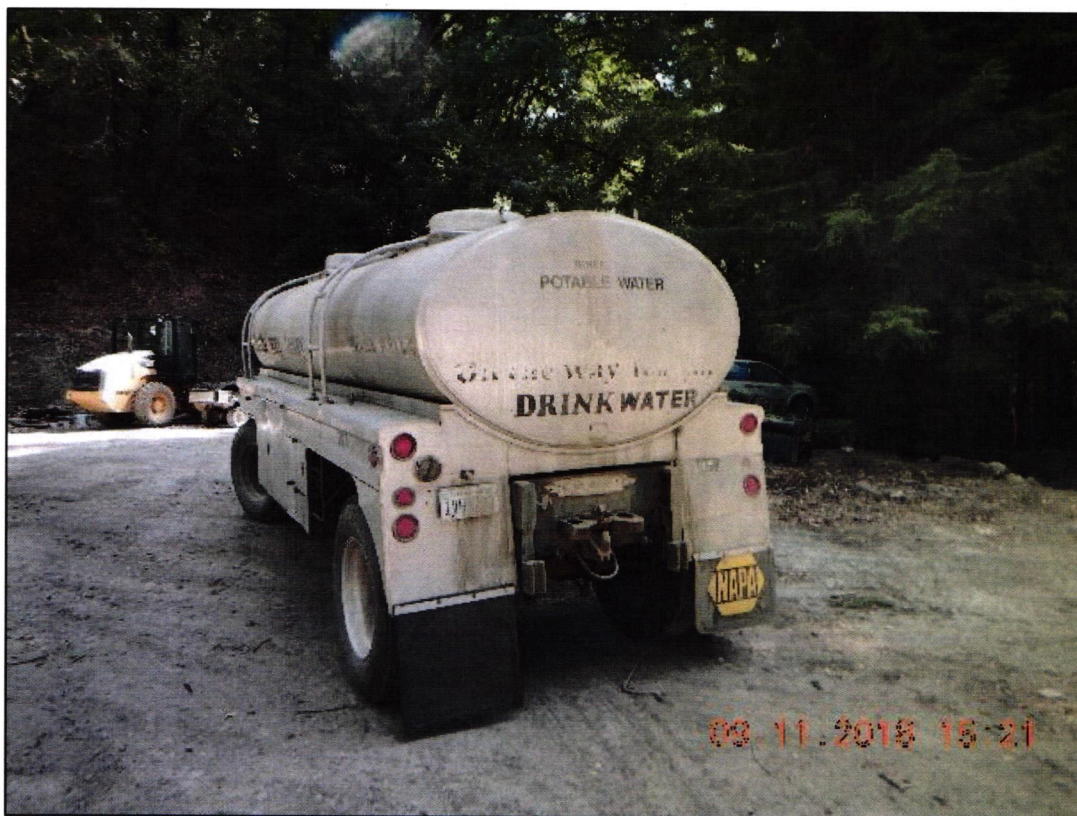
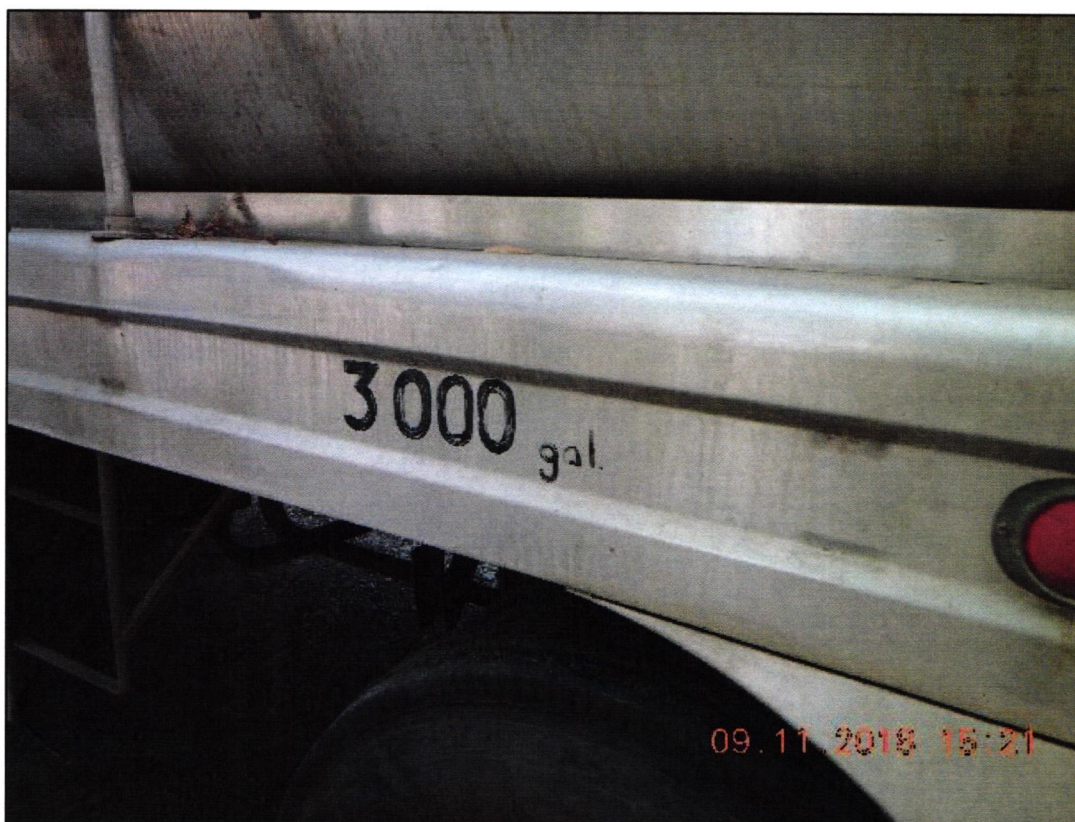
**Photo 25: Water Hauler Truck 1**

**Photo 26: Water Hauler Truck (3,000 gal).**

- Water Hauler Truck 1 (Photos 25-26) is an inactive 3,000-gallon metal water hauling truck located near POI1. The water hauling truck is identified as a potable water truck.
- Water Hauler Trailer (Photo 27) is an inactive 1,025-gallon polyethylene water hauling container attached to a trailer. The container had no water in it at the time of inspection.
- Water Hauler Truck 2 (Photos 28 – 29) is an approximately 3,000-gallon water hauling truck. During the inspection, a water hauling driver working for Carpenter Trucking LLC was observed entering and leaving the property in Water Hauler Truck 2. Water Hauler Truck 2 was observed heading in the direction of POI1. Water Hauling Truck 2 can be filled at POI1.

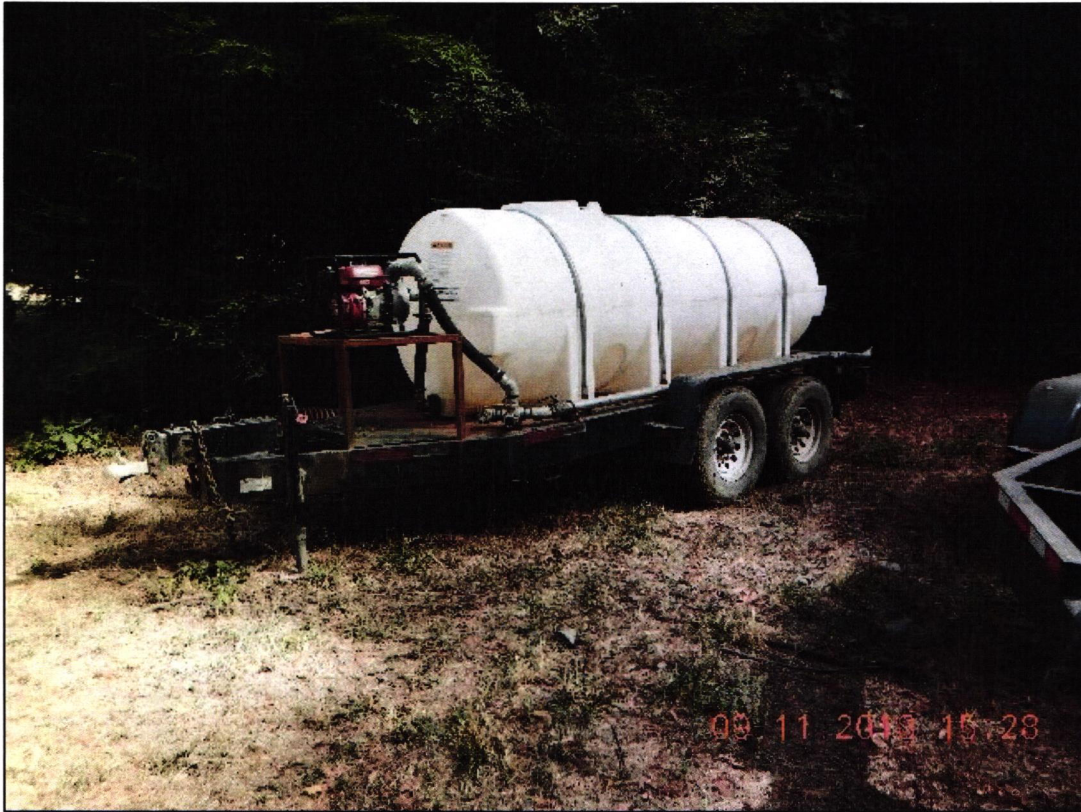
**Photo 27: Water Hauler Trailer**

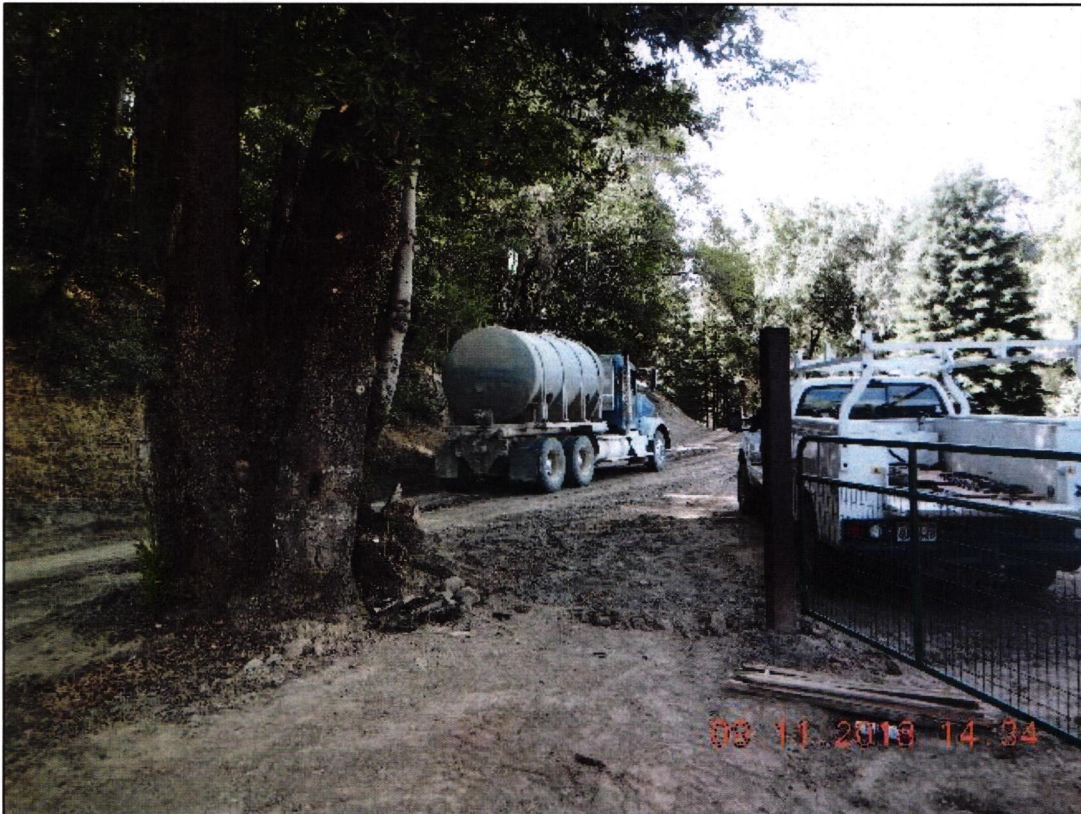
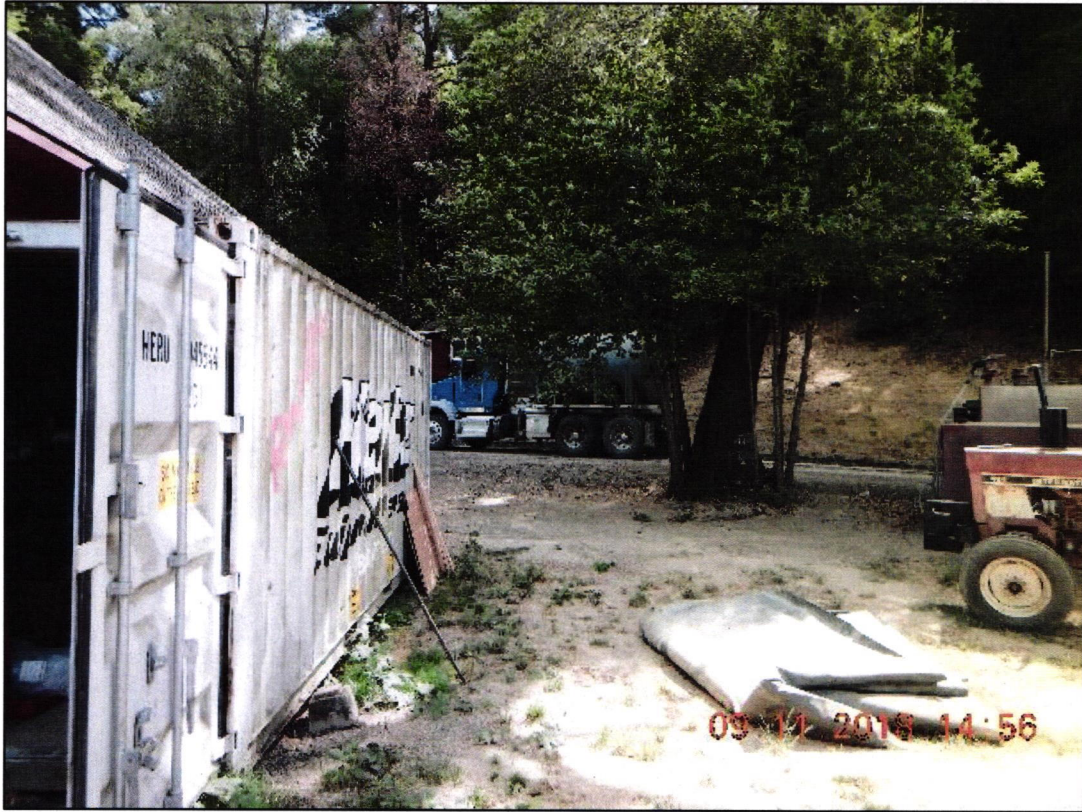
**Photo 28: Water Hauler Truck 2 (entering property).**

**Photo 29: Water Hauler Truck 2 (Leaving property).**

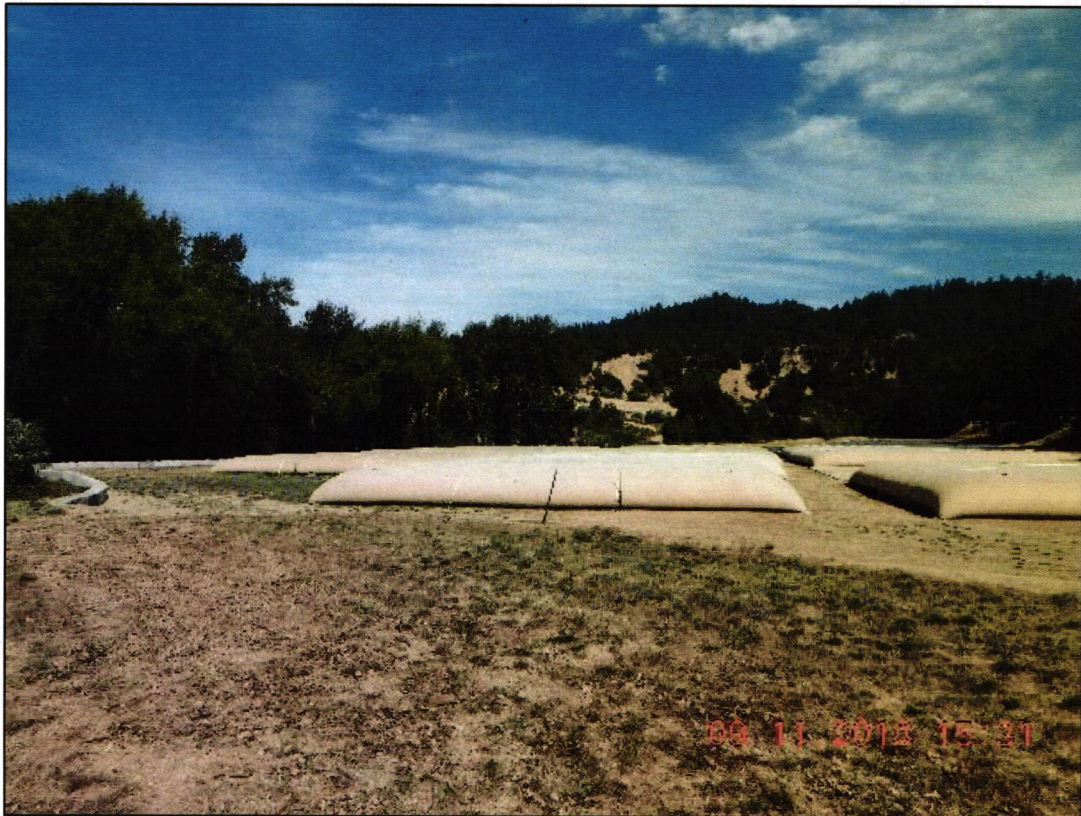
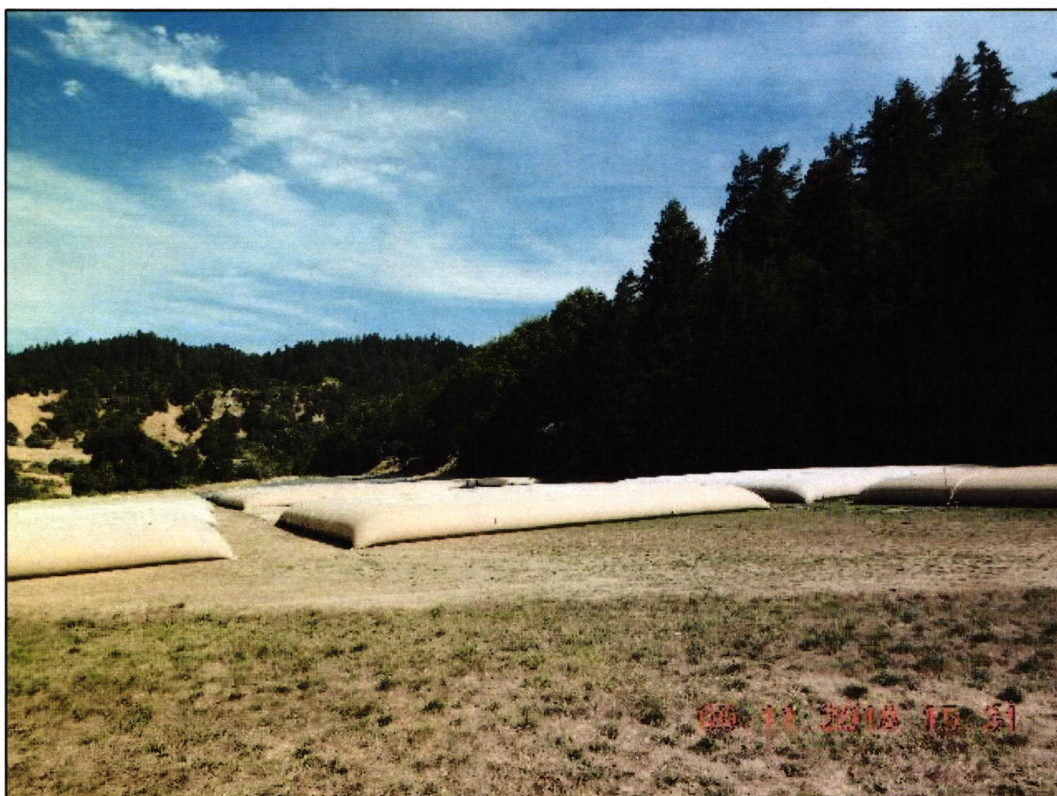
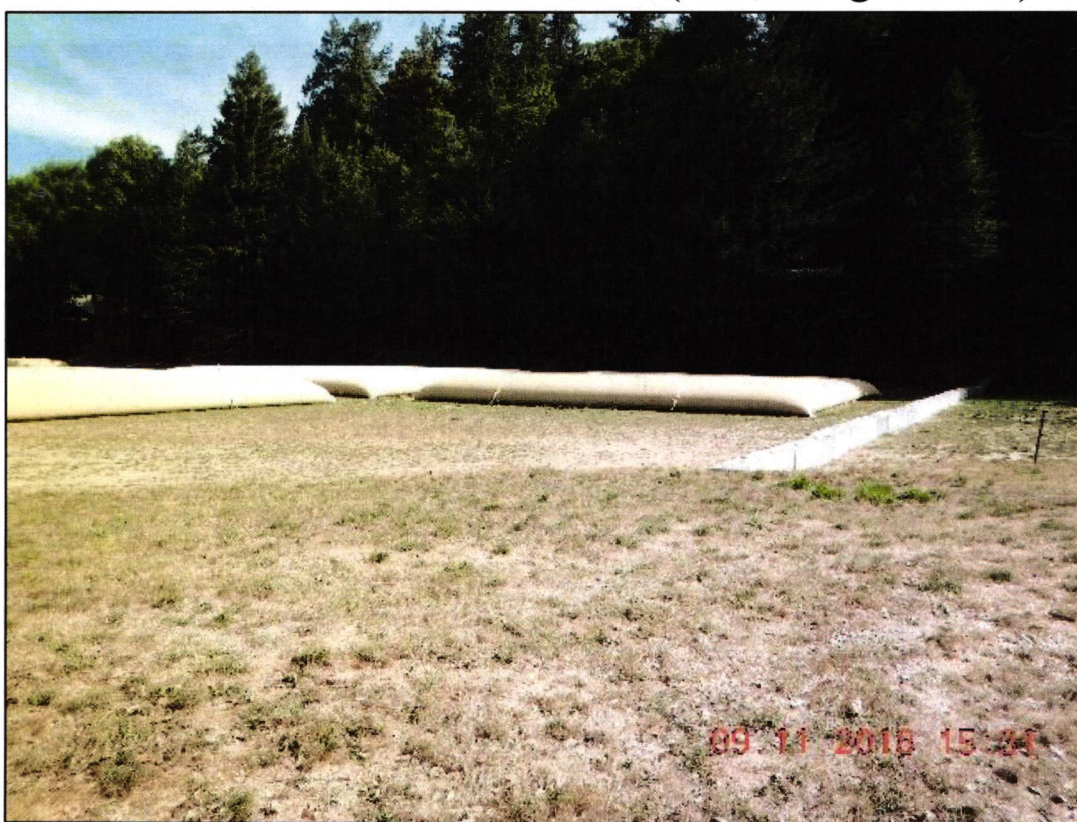
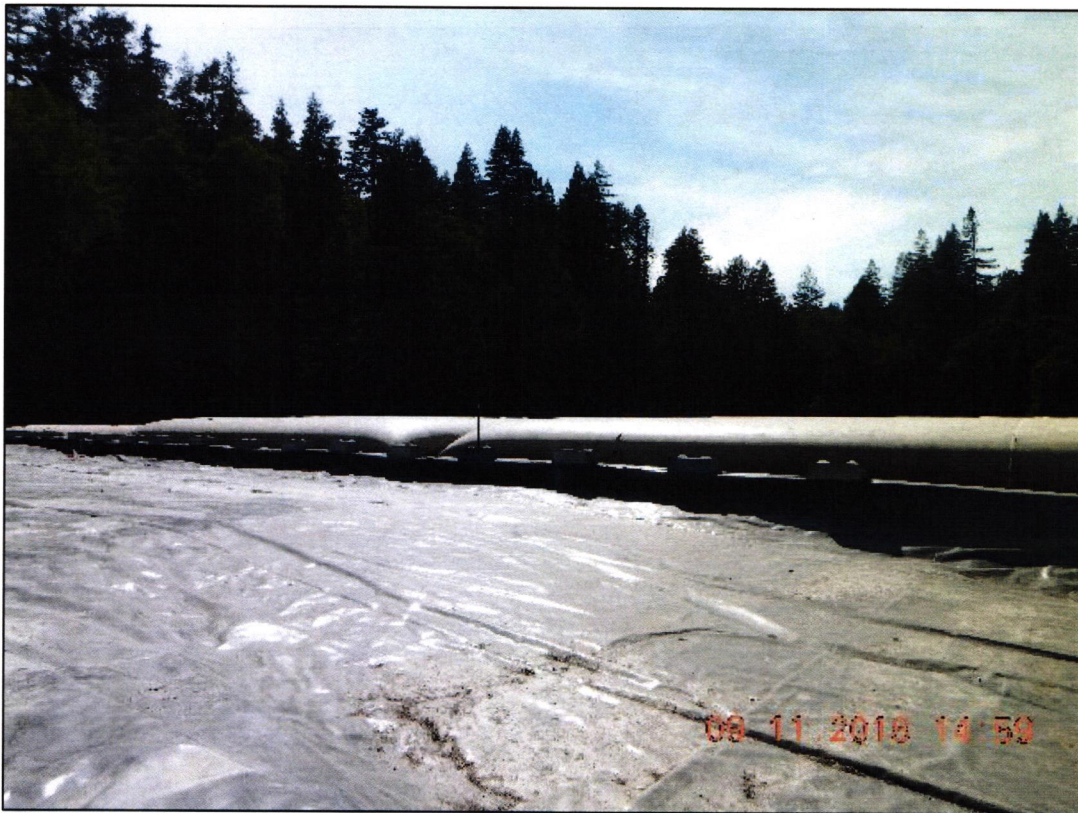
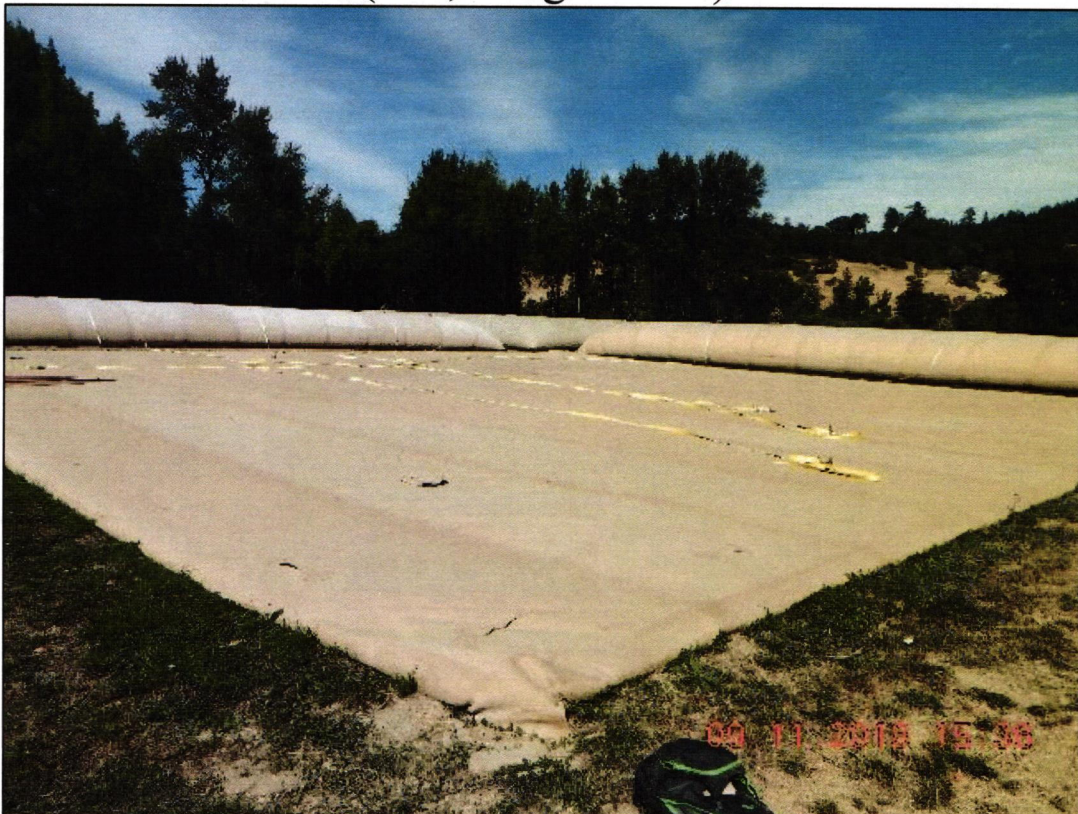
**Photo 30: POS 1-14 - Bladders (210,000 gal. each)**

**Photo 31:** POS 1-14 – Bladders (210,000 gal. each)

**Photo 32:** POS 1-14 - Bladders (210,000 gal. each)

**Photo 33:** POS 1-14 - Bladders near collection area  
(210,000 gal. each)

**Photo 34:** POS 1-14 - low water level bladder

Description: POS 1-14 (Photos 30 - 34) are fourteen water storage bladders that are each 210,000-gallon. At the time of the inspection, thirteen out of the fourteen bladders were at or near full capacity. One of the fourteen bladders was near empty (Photo 34). Additionally, Division staff observed two cleared and level areas designated for water storage bladders but with no water storage bladder present (Photos 35-36). Division staff observed replacement bladders near POI1 (Photos 37-38). Division staff did not document how many replacement bladders were on the property. POS 1-14 receive water via an electric pump from POD2. POS 1-14 had piping that went subsurface. Based on the design, proximity, and available records each of the fourteen bladders has the ability to convey water to POI1 for water hauling. Division staff did not measure the diameter of the water supply lines.

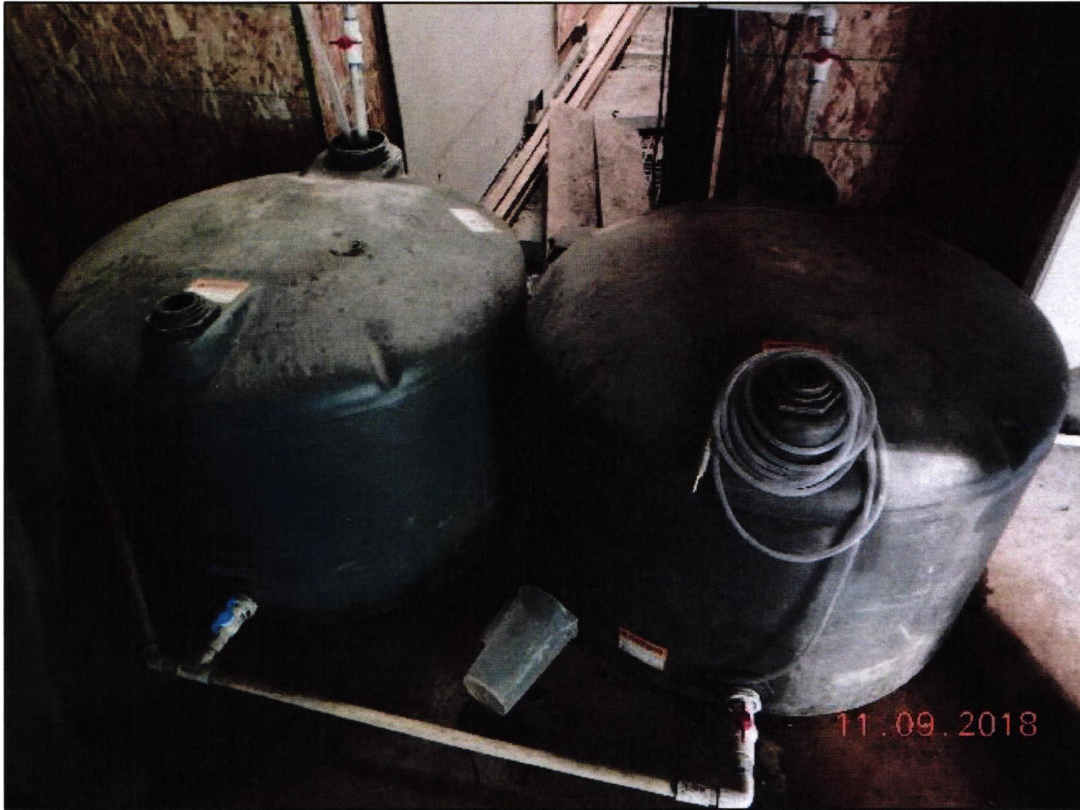
**Photo 39: POS 15-16 - Tanks**

POS ID: POS 15-16  
POD ID: POD1  
POU ID: POU 1-3  
Lat/Long: 40.093711°, -123.802077°  
Type: Tank  
Capacity (Gal): 165-gallons each, or 330-gallons total  
Water Level (%): 10  
Container Color: Black  
Description: POS 15-16 (Photo 39) are two polyethylene water storage tanks. At the time of the inspection, POS 15-16 had about 10% of the water storage container volume inside. Division staff observed POD1 water supply line to POS 15- 20 was broken (Photos 13-14). Based on Division staff observations, POD1 pumps water to POS 19-20 and then conveyed by gravity to POS 15-18. POS 15-16 is used to irrigate POU 1-3. Division staff did not measure the diameter of the water supply lines.

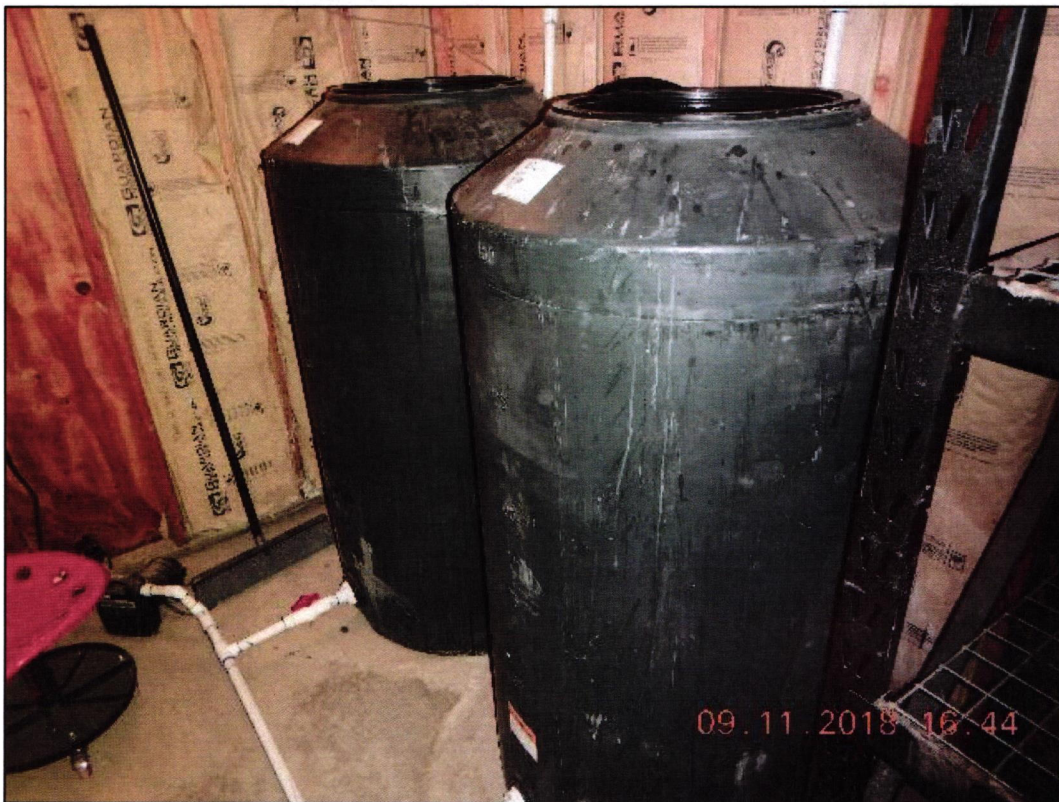
**Photo 40: POS 17-18 - Tanks**

POS ID: POS 17-18  
POD ID: POD1  
POU ID: POU 4-5  
Lat/Long: 40.093590°, -123.801815°  
Type: Tank  
Capacity (Gal): 120-gallons each, or 240-gallons total  
Water Level (%): 100  
Container Color: Dark Green  
Description: POS 17-18 (Photo 40) are two polyethylene water storage tanks. Division staff observed POD1's water supply line to POS 15- 20 was broken (Photos 13-14). POD1 pumps water to POS 19-20 and then conveys water by gravity to POS 15-18. POS 17-18 are used to irrigate POU 4-5. Division staff did not measure the diameter of the water supply lines.

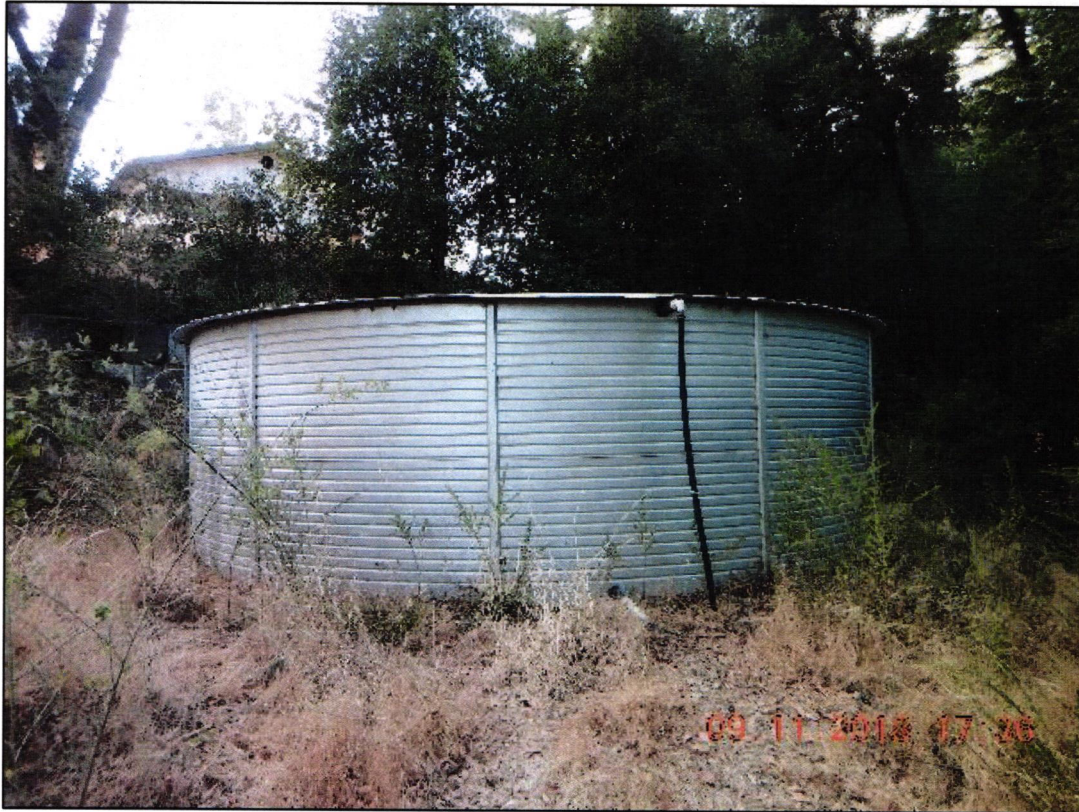
POS ID: POS19  
 POD ID: POD1  
 POU ID: POU 1-9  
 Lat/Long: 40.093399°, -123.803440°  
 Type: Tank  
 Capacity (Gal): Approximately 25,000  
 Water Level (%): 0  
 Container Color: Metal  
 Description: POS19 (Photo 41) is a metal water storage tank. Division staff observed that POD1 water supply line to POS 15–20 was broken (Photos 13-14). POD1 pumps water to POS19 and to POS20. Water stored in POS 19-20 supplies water by gravity to POS 15-18 and POU 1-9. Division staff did not measure the diameter of the water supply lines.

**Photo 41: POS19 - Tank**

Division staff observed two 25,000-gallon metal water storage tanks (POS19 and POS20) located on the property. Both tanks are required to be installed on a reinforced concrete pad providing adequate support and enough space to attach a tank restraint system. Division staff did not observe a concrete pad at either storage facility. Failure to install 8,000 gallon or more storage tank on reinforced concrete pad with a tank restraint system constitutes two violations of Term 92<sup>2</sup> of Section 2 of the Cannabis Cultivation Policy.

- 1) You must install any water storage tank greater than 8,000-gallons on a reinforced concrete pad providing adequate support and enough space to attach a tank restraint system (anchor using the molded-in tie down lugs with moderate tension, being careful not to over-tighten) per the recommendations of a qualified professional; **or**
- 2) You must cease your water diversions for cannabis cultivation.

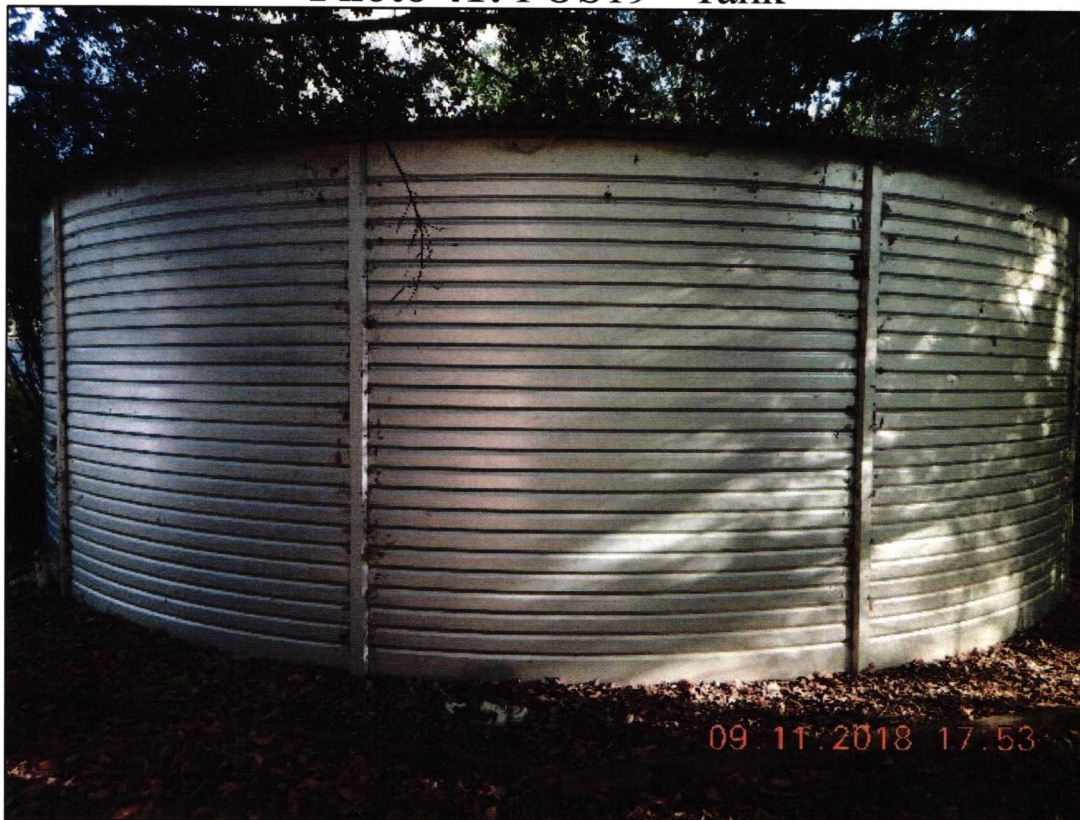
POS ID: POS20  
 POD ID: POD1  
 POU ID: POU 1-9  
 Lat/Long: 40.092849°, -123.804551°  
 Type: Tank  
 Capacity (Gal): Approximately 25,000  
 Water Level (%): 5  
 Container Color: Metal  
 Description: POS20 (Photo 42) is a metal water storage tank. POS20 stored approximately 5% of the water storage container volume. Division staff observed POD1 water supply line to POS 15– 20 was broken (Photos 13-14). The broken water supply line continues in the direction of POS 19-20. POD1 pump water to POS19 and to POS20. Water stored in POS 19-20 supplies water by gravity to POS 15-18 and POU 1-9. Division staff did not measure the diameter of the water supply lines.

**Photo 42: POS20 - Tank**
